Federal Railroad Administration Office of Safety Headquarters Assigned Accident Investigation Report HQ-2005-101

Burlington Northern Santa Fe (BNSF) Ft. Madison, Iowa November 10, 2005

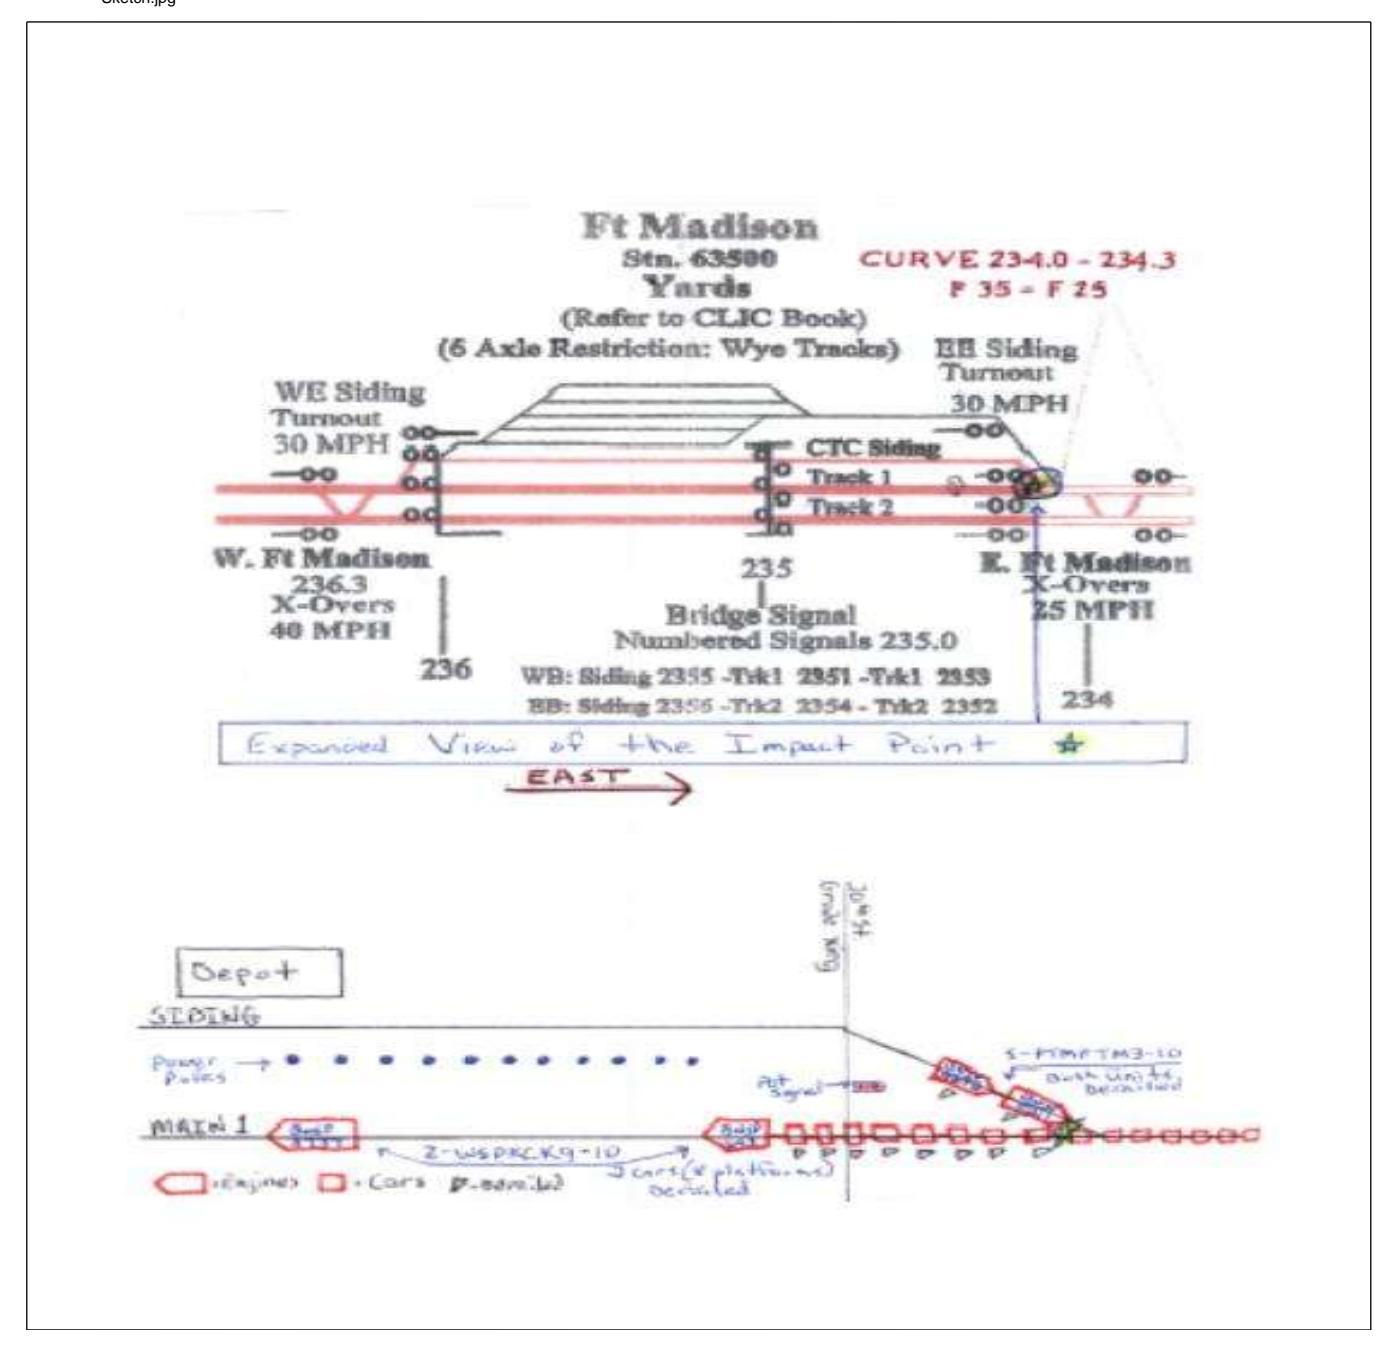
108. DRAW A SKETCH OF ACCIDENT AREA INCLUDING ALL TRACKS, SIGNALS, SWITCHES, STRUCTURES, OBJECTS, ETC., INVOLVED. HQ-101 Sketch.jpg 109. SYNOPSIS OF THE ACCIDENT

An eastbound BNSF consist of light locomotives collided with a westbound BNSF intermodal train on November 10, 2005, at 10:05 a.m. The collision occurred in Ft. Madison, Iowa, at BNSF milepost (MP) 234.1, on the BNSF Chillicothe Subdivision.

The railroad area conditions in the direction in which the eastbound train was then headed are as follows: no significant grade, straight track for approximately 1,100 feet, a slight curve to the left for about 300 feet, then a 3.5 degree curve to the right. The Twentieth Street public grade crossing lies just after the beginning of the right-hand curve. Yard tracks are off to the left. Main Tracks No. 1 and No. 2 are to the right, in that order. A

row of about nine tall power poles, spaced approximately 150 feet apart, is located between the siding and main Track No. 1.

The next signal that would govern movement of the eastbound light locomotive consist was about 1,600 feet away from where they stopped to let the brakeman off the train. It is a pot signal (signal extending approximately 2 feet above the ground) at the east end of the siding and was obscured from view by several wooden power poles that run parallel to the track. Due to these obstructions, the engineer was only able to view the signal at a point approximately 700 feet away from the signal. The conductor could see the signal slightly sooner because of his vantage point from the left side of the locomotive. The engineer initiated movement eastward from the west end of the depot, placing the train's throttle in positions 1, 2, 3, and 4, successively. He then went from position 4 to position 8, with no hesitation in between. The eastbound locomotive consist reached a recorded speed of 25 mph before the engineer backed the throttle from position 8 to the idle position and made an emergency air brake application. The brakes were applied 216 feet from the point of impact with the westbound train traveling on main Track No. 1. The westbound train was also traveling at a speed of 25 mph when the eastbound train struck it approximately 10 feet back from the front of the lead locomotive. Both of the eastbound locomotives and two cars (eight platforms) of the westbound train were derailed.

Visibility of the pot signal for the eastbound train approaching East Ft. Madison on the siding, was restricted due to the size of the signal, the curvature of the track on the approach to the signal, and the presence of power poles in the line-of-sight. GCOR rule 6.28 (Movement on Other Than Main Track) was in effect at this location. This rule requires the engineer to move at a speed which allows him to stop within half the range of vision of stop signals, track appliances, and men or equipment fouling the track.
