U.S. Department of
Transportation

Ground Penetrating Radar (GPR) Technology Evaluation and Implementation

1. AGENCY USE ONLY (Leave blank)		2. REPORT DATE May 2020		3. REPORT TYPE AND DATES COVERED Technical Report June 2015 to January 2018
4. TITLE AND SUBTITLE Ground Penetrating Radar (GPR) Technology Evaluation and Implementation			5. FUNDING NUMBERS DTFR53-11-D-00008 Task Order 357

6. AUTHOR(S) Colin Basye, Stephen Wilk, and Yin Gao				
7. PERFORMING ORGANIZATION NAME(S) AND ADDRESS(ES) Transportation Technology Center, Inc. 55500 DOT Road Pueblo, CO 81001			8. PERFORMING ORGANIZATION REPORT NUMBER

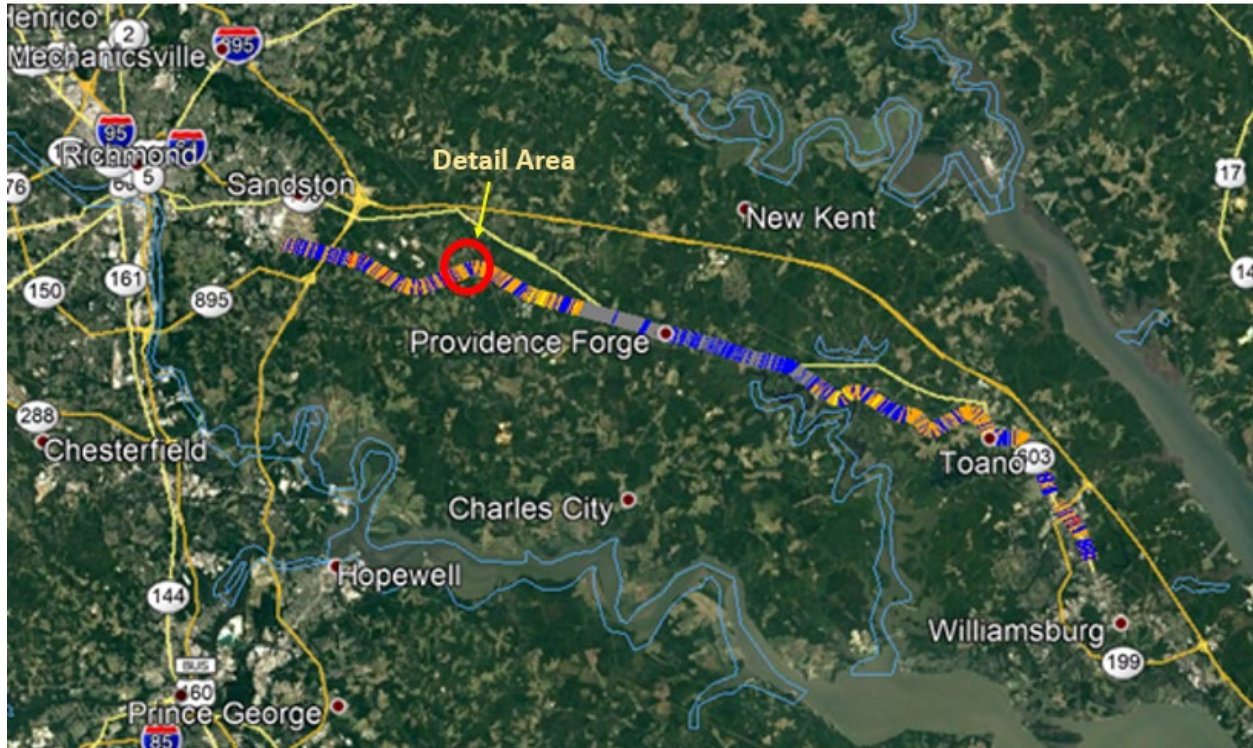
**Figure 10. Google Image Overview of the Tested Zone of the CSX Peninsula Line
Detail Area shown in [Figure 12](#)**

[Figure 10](#) shows a Google Earth overview snapshot of the Peninsula Subdivision route MP 70–70.1 tested by the T-20 car. The data is densely packed in this figure but, using Google Earth, the user can zoom in and turn on/off the different layers to examine specific areas of interest for the different parameters presented. The detail area from MP 70.02 to MP 70.04 below is described in [Figure 12](#).

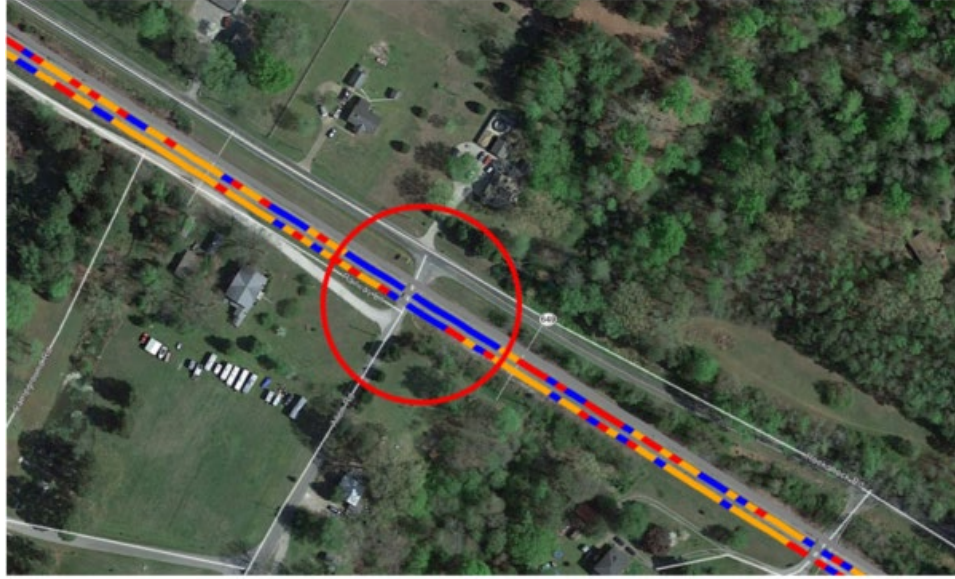
Figure 14. GPR System on the T-20 Car Identifying Areas that Have Crossing Issues or Where Cleaning Equipment Has Terminated ([Figure 15](#))

It may be noted that as the user begins to zoom in to the various segments of the test section, it begins to become apparent what sections have significant levels of fines in the ballast, and possibly where shoulder cleaning equipment has recently serviced the shoulders. For example, potential issues that may need to be examined include road crossings (Figure 14) or areas where ballast cleaning services may have been terminated (Figure 15).

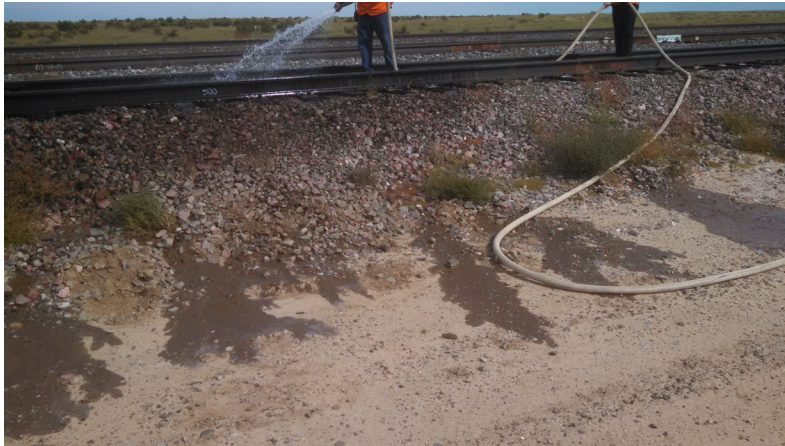
Figure 25. Typical Water Release at HTL Section 40

Figure 25 is a photograph of a typical water release at HTL Section 40.

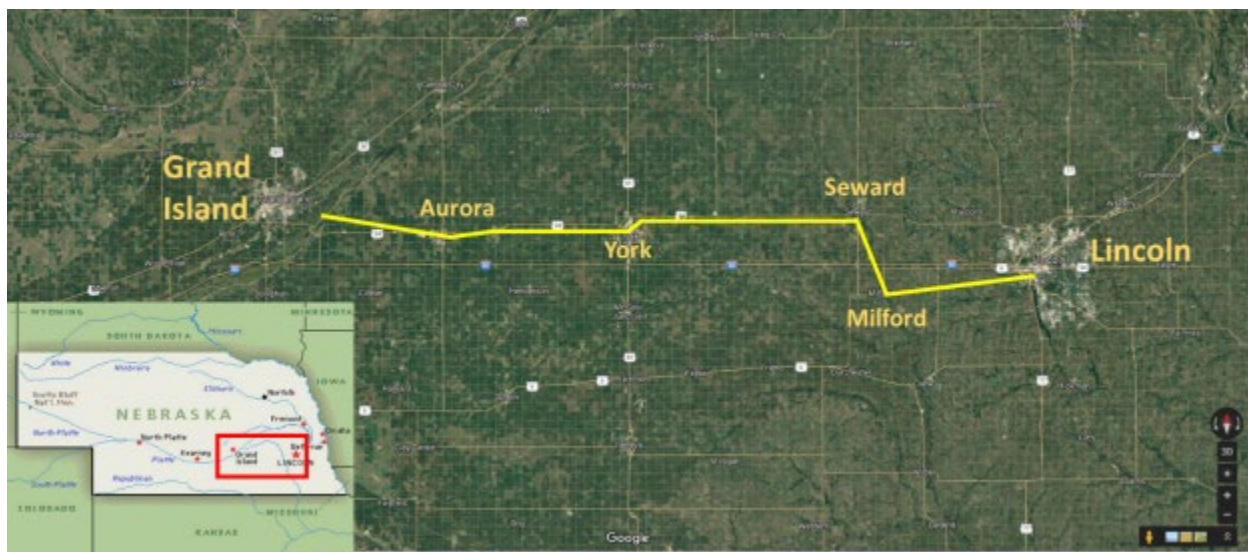
Figure 42. Ravenna Subdivision Sampling and Test Section

The BNSF Ravenna Subdivision from MP 10 to MP 40 was selected for this study and is shown in Figure 42. This line is a double mainline track, with Track 1 primarily concrete ties and Track 2 primarily timber ties. The line supports about 45 million gross tons (MGT) annually of dominantly coal train traffic.

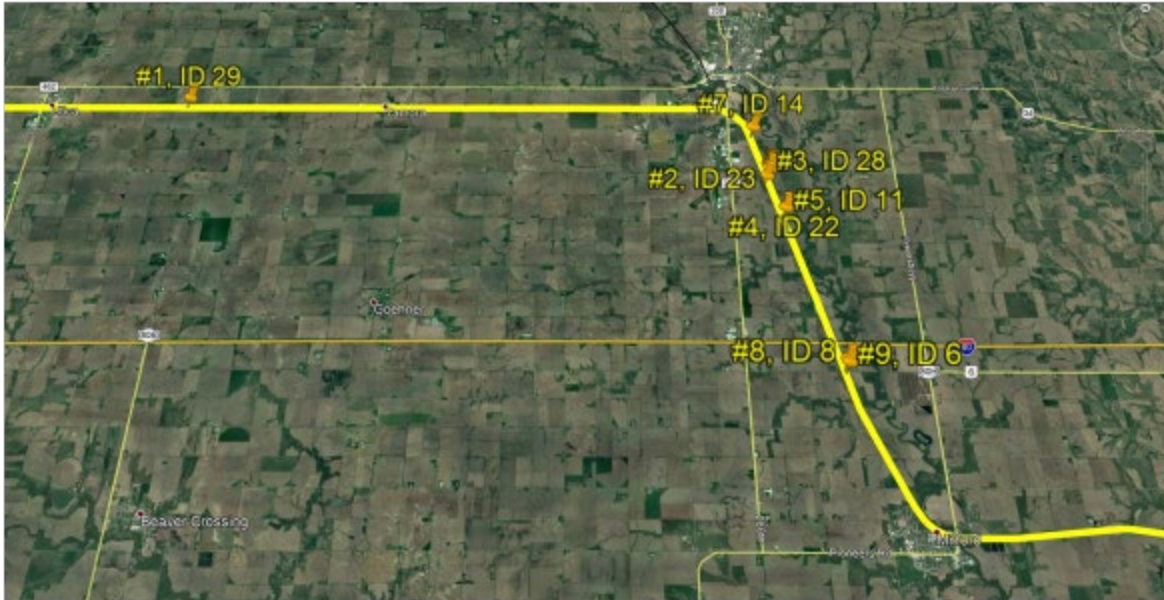
Figure 43. Ravenna Subdivision Sampling Locations

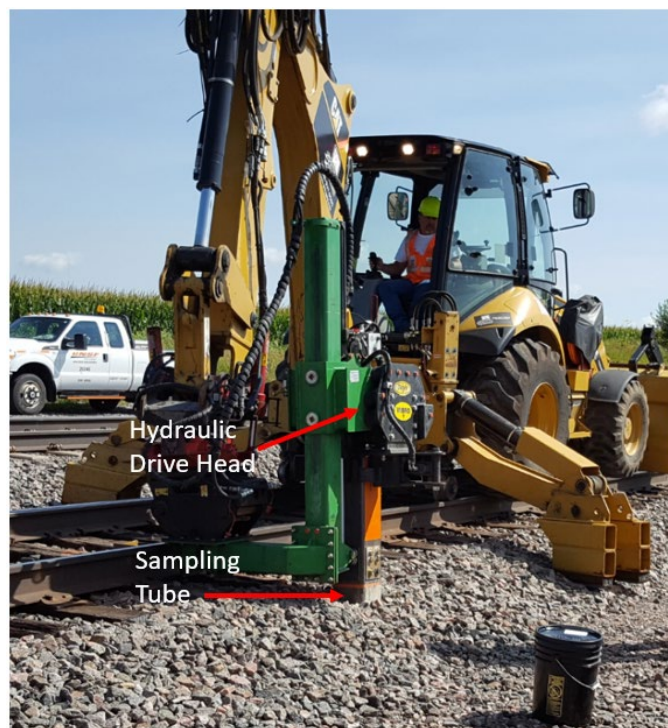
Figure 44. BNSF Vibrosampler at Work

The vibrosampling involved advancing an 8-inch (203 mm) square tube 16 inches (406 mm) deep into the ballast using a hydraulic head that secured the tube, and it produced an axial vibratory oscillation to advance the tube as it was attached and driven by a backhoe. [Figure 44](#) is a photograph of the installation process. Once the tube was driven, the team hand excavated the sampled ballast into 5-gallon buckets down to the 16-inch (406 mm) sample base depth. The samples were then marked, weighed, and transported back to the TTC for gradation testing.

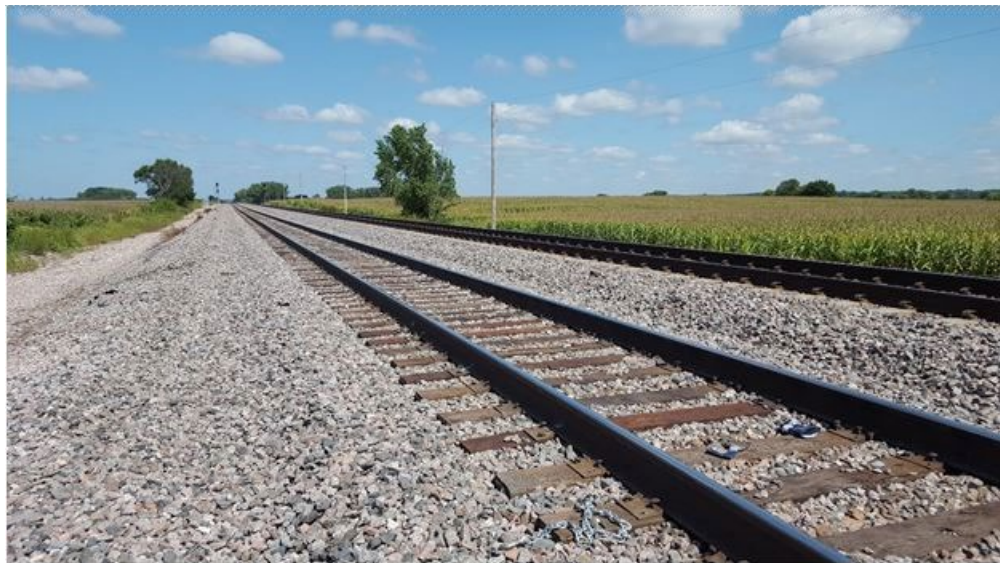
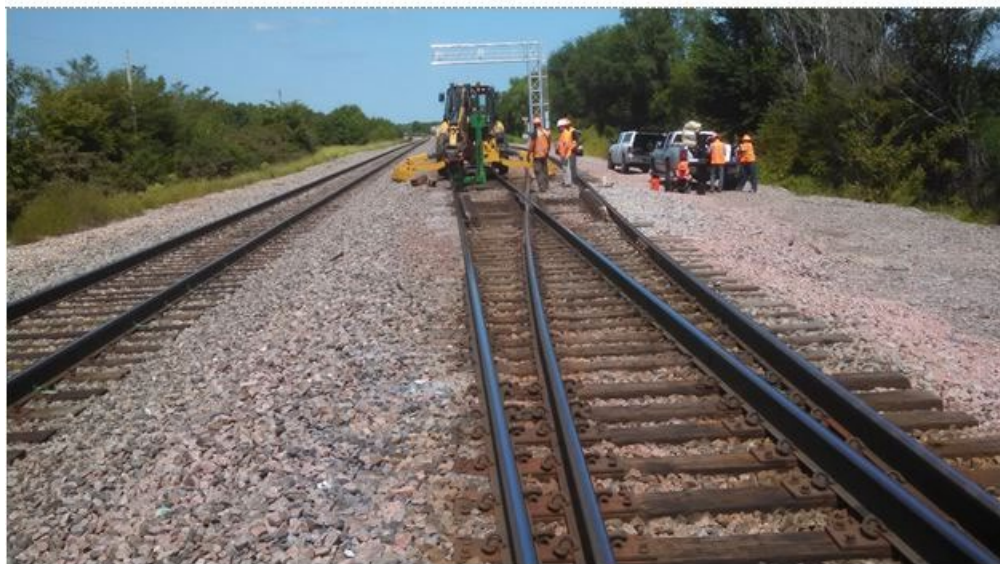
The rail was 136-RE with concrete ties and elastic fasteners on Track 1, and timber ties with cut spikes on Track 2. The ballast surface at all locations were clean and most of the fine particles appeared to be coal. This is notable for the gradation analyses because the specific gravity of coal is about half that of most earth materials. Therefore, a higher percentage of coal per volume will result in a reduced mass, and, therefore, reduced fine weights.

Figure 45. Photographs of (a) Site No. 4 (MP 25.791) and (b) the Switch at Site No. 7 (MP 27.729)

Photographs of a typical site location (Site 4 MP 25.791) is displayed in [Figure 45a](#), and the switch at (Site 7 MP 27.729) is displayed in [Figure 45b](#).

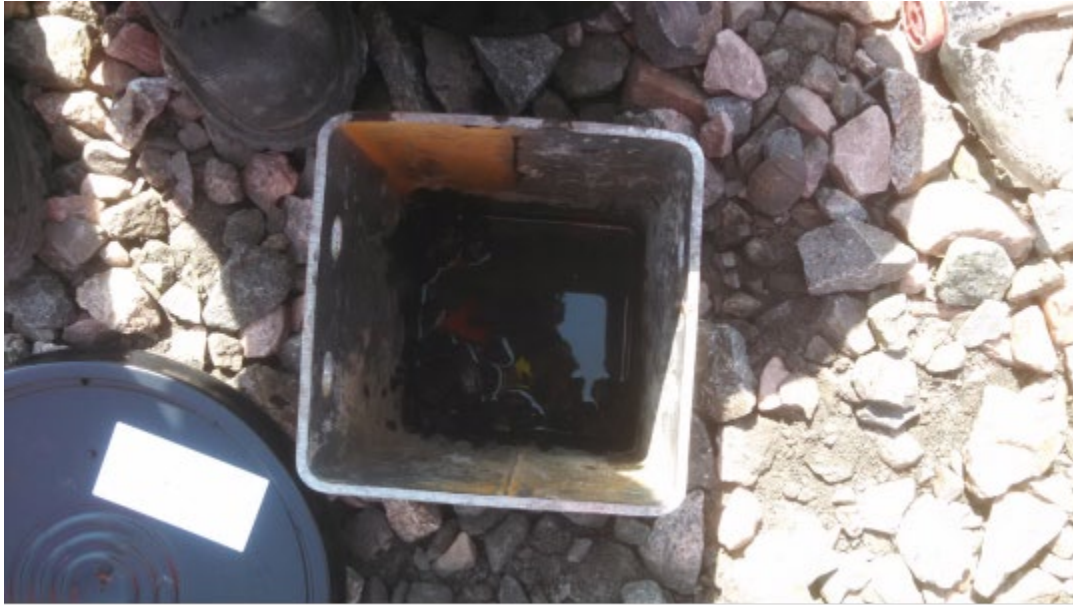
Figure 46. Photograph of the Standing Water in R+2 Sampling Location

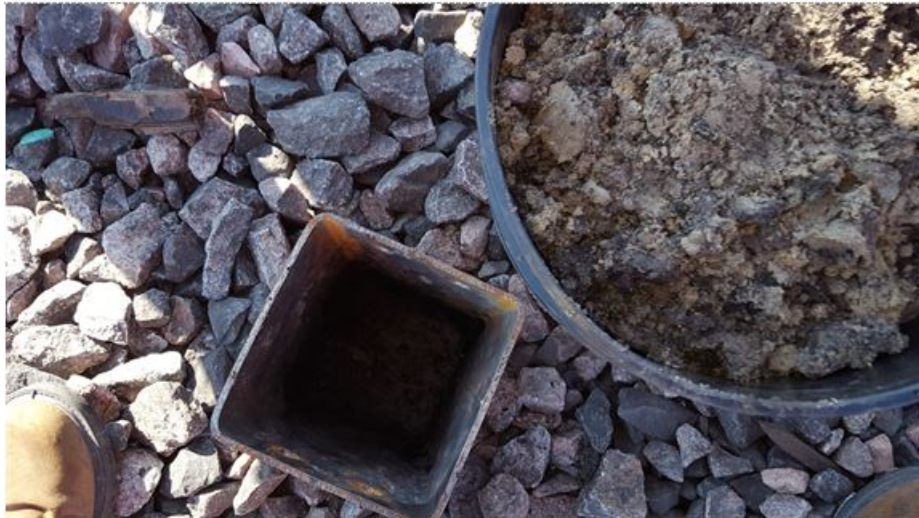
**Figure 47. Photographs of the Sand at the Bottom of the R+2 Location
(a) Bottom of Tube (b) Bucket**

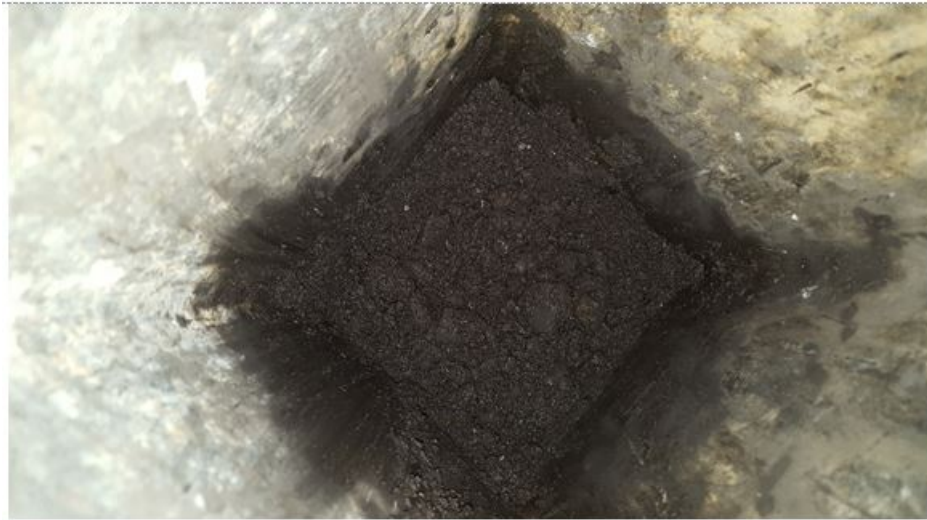
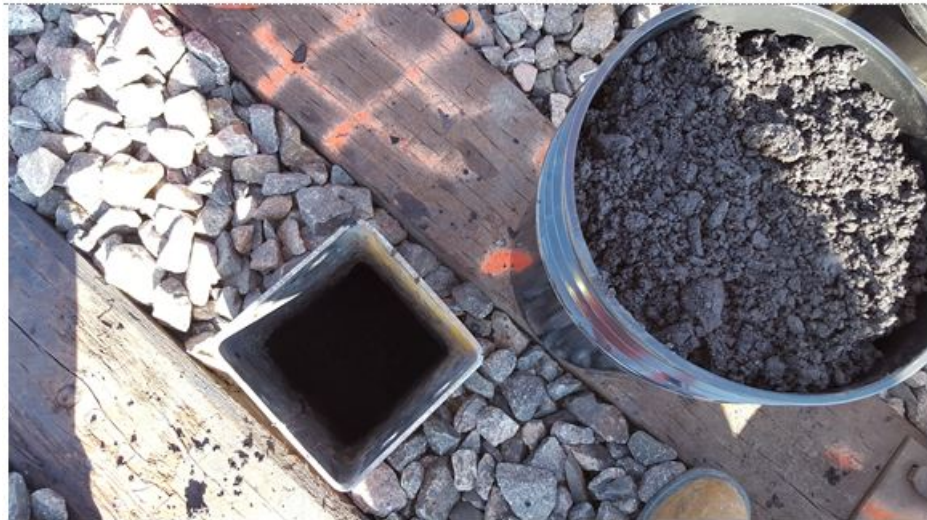
**Figure 48. Photographs of the Coal Particles at the Bottom of the C+0 Location
(a) Bottom of Tub (b) Bucket**

During the driving process, the vibrosampler encountered a hard layer. During sampling, fine particles were observed near the surface, were generally wet and plastic like, and appeared to be coal. The subgrade varied, depending on the location with the right side (R+2) encountering sand, whereas the rest appeared to be sand with coal. [Figure 47 \(a\)](#) and [Figure 47 \(b\)](#) show the sandy subgrade, and [Figure 48 \(a\)](#) and [Figure 48 \(b\)](#) show the coal particles contaminating the ballast to the bottom of the tube. It should be noted that small amounts of coal can make the material look very dark and cause coal percentage to be overestimated. Two Shelby tube samples were taken at C+0 and R+2. [Table 17](#) displays the moisture and gradation results, and [Table 18](#) displays the Shelby tube results from Site 2.

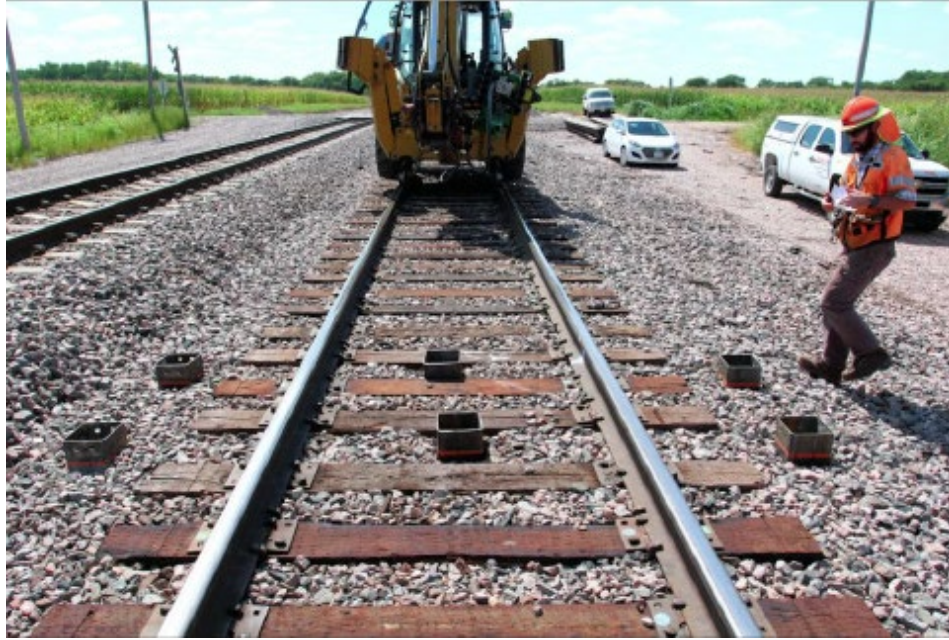
**Figure 57. Sample Locations at Site ID 22, MP 25.7907
(Photo Courtesy of BBRI)**
