U.S. Department
of Transportation
**Federal Railroad
Administration**

RR 20-14 | August 2020

AN AUTOMATED, DRONE-BASED GRADE CROSSING INSPECTION SYSTEM

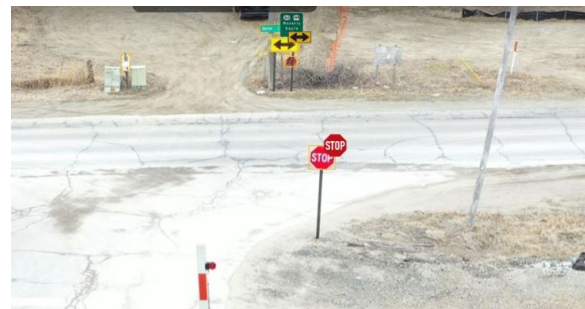
Oblique imagery collected by the DJI Mavic 2 Pro was processed through Mapillary to identify signs at a rail grade crossing. Figure 6 is an example of an oblique image collected for sign identification. Signs identified by the software are outlined by an orange box with the sign interpretation beside it.

Figure 6: Results from Mapillary detecting signs from a drone collected image

Researchers collected additional imagery of the rail grade crossing using the DJI Mavic 2 Pro from an oblique angle for the assessment of automated sign detection capability. Mapillary was used to demonstrate the ability of artificial intelligence/machine learning to detect signs in drone-collected imagery.
