**Federal Railroad
Administration**

Conventional and CEM Passenger Locomotive Impact Test

1. AGENCY USE ONLY (Leave blank)		2. REPORT DATE January 2021		3. REPORT TYPE AND DATES COVERED Technical Report, January 2019
4. TITLE AND SUBTITLE Conventional and CEM Passenger Locomotive Impact Test			5. FUNDING NUMBERS Task Order 0793 DTFR53-11-D-00008L FR17RPD00-TTCI-00-040

9. SPONSORING/MONITORING AGENCY NAME(S) AND ADDRESS(ES) U.S. Department of Transportation Federal Railroad Administration Office of Railroad Policy and Development Office of Research, Development and Technology Washington, DC 20590			10. SPONSORING/MONITORING AGENCY REPORT NUMBER DOT/FRA/ORD-21/02

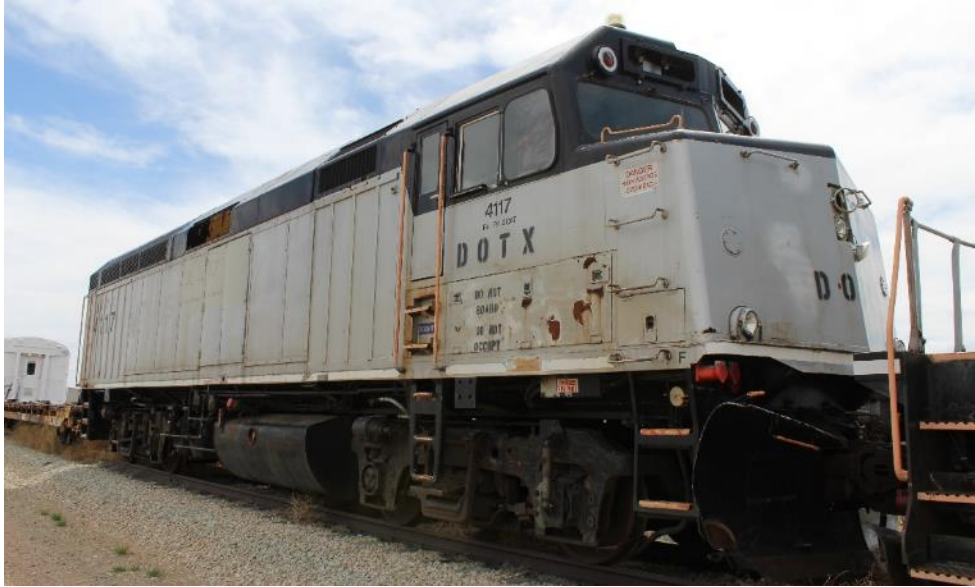
Figure 1. F40 Locomotive 4117

The F40PH-2CAT locomotive is a four-axle diesel-electric locomotive intended for use in passenger service. This test used F40PH-2CAT Locomotive 4117 as the stationary vehicle (Figure 1). The weight of this locomotive was measured to be 257,325 lbs.

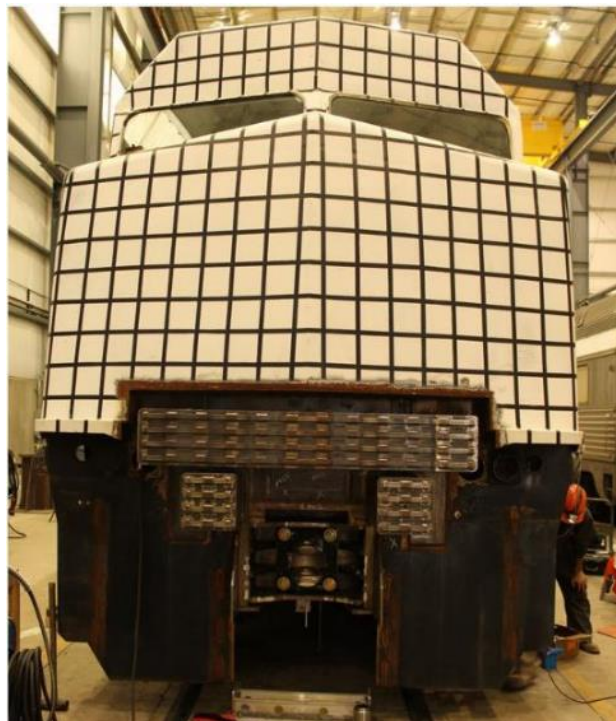
Figure 2. F40PH Locomotive 234

The F40PH locomotive is a four-axle diesel-electric locomotive intended for use in passenger service. This test used F40 Locomotive 234 as the impacting vehicle (Figure 2). The weight of this locomotive was measured to be 232,000 lbs. This locomotive was retrofitted with the CEM system.

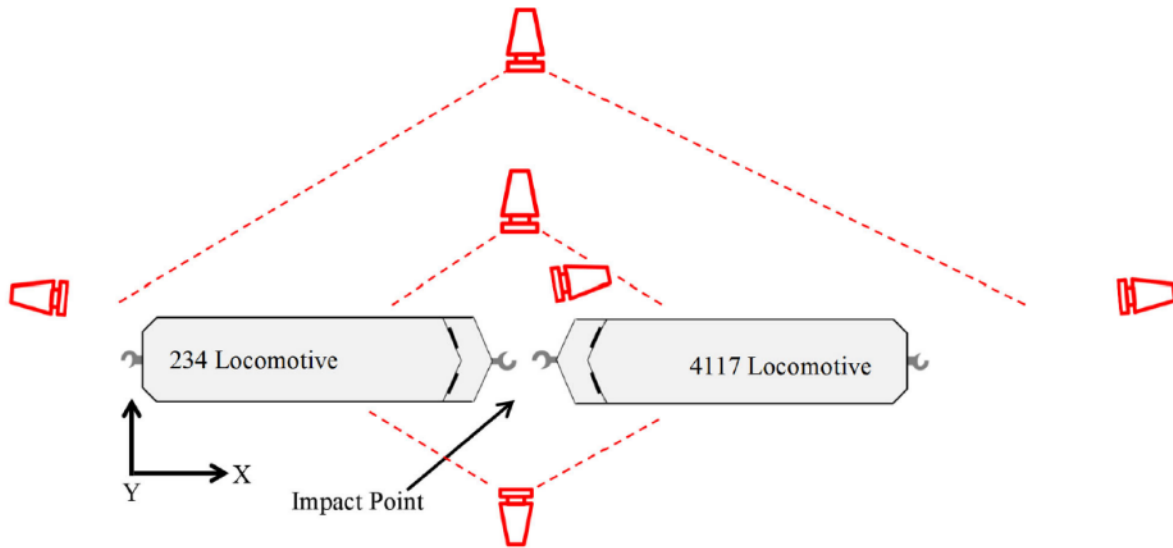
Figure 24. High-Speed Camera Locations

Six high-speed and five real-time, high-definition video cameras documented the impact event. Figures 24 and 25 show schematics of the setup positions of the high-speed and high-definition cameras. All high-speed cameras are crashworthy and rated for peak accelerations of 100 g. Final alignment and sighting of the cameras was done when the locomotives were positioned at the impact point prior to the start of the test. Two flashes were installed on both locomotives, and they were triggered at the same time as the data acquisition systems. Flashes were visible from the high-speed cameras and were used to confirm the time of trigger and to evaluate any trigger time discrepancies between both vehicles.

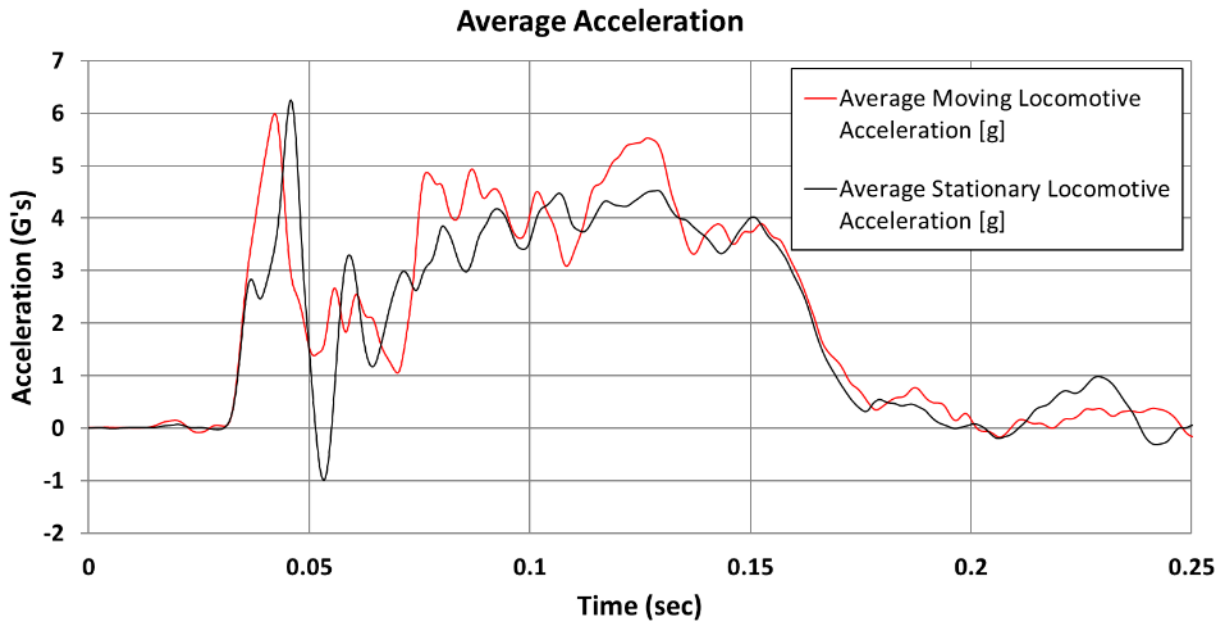
Figure 26 provides the average longitudinal acceleration time history as derived from the locomotive accelerometer data. Impact accelerations are shown as positive in these graphs; however, during an impact, the locomotives are accelerated in the negative X direction based on the established coordinate system. During the impact test, the locomotives failed to couple.

Figure 26. Longitudinal Average Acceleration

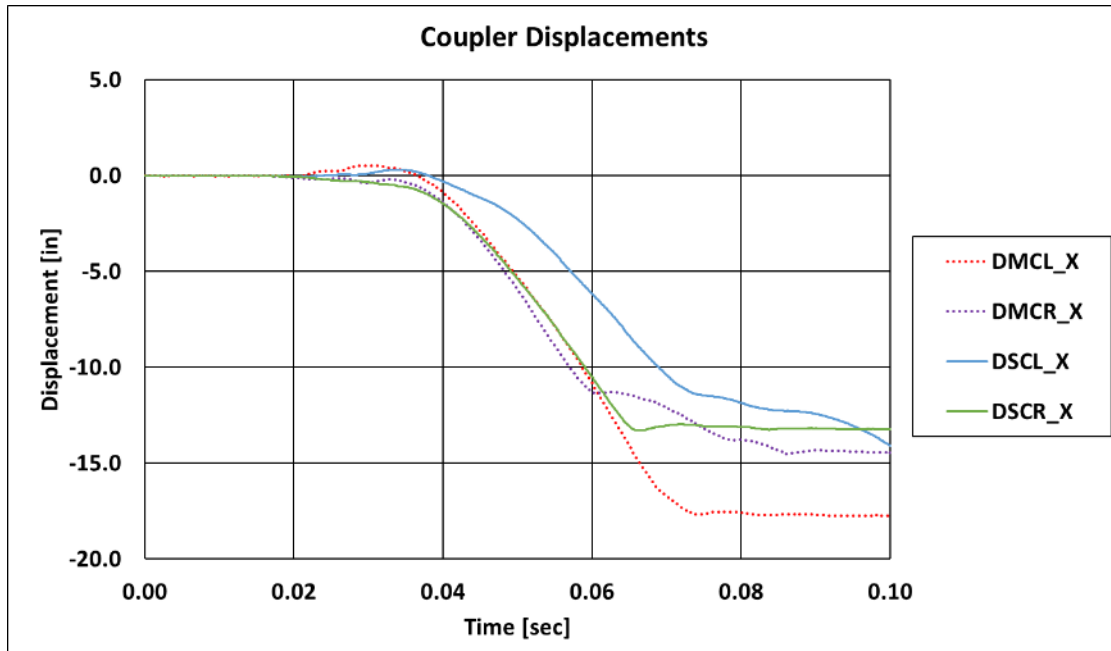
Figure 27 shows the displacement of the locomotive couplers. DMCL_X and DMCR_X represent the left and right side displacements on the moving locomotive's coupler, respectively. DSCL_X and DSCR_X represent the displacements of the stationary locomotive's coupler, respectively. According to the established coordinate system, the coupler moving into the draft pocket was reported as a negative displacement for both the moving and stationary locomotives. The severity of the impact caused all the brackets which attached the strings to the couplers to detach, resulting in flat displacement readings after approximately 0.08 second.

Figure 27. Coupler Displacements

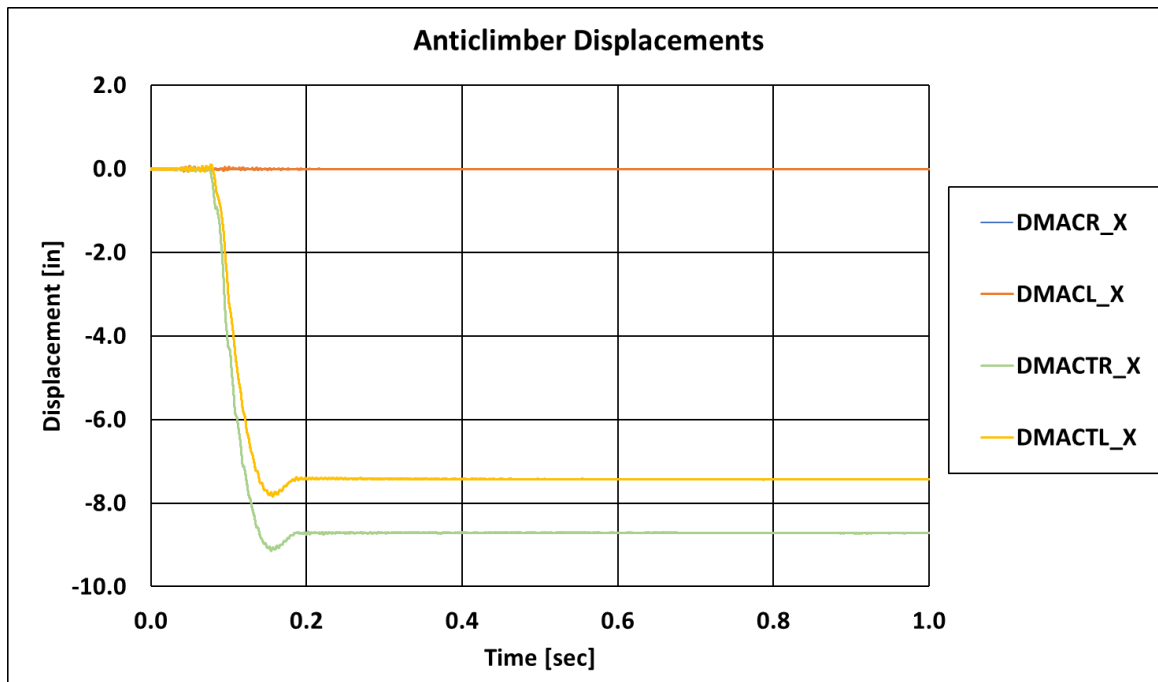
Figure 28 shows measured displacements of all anti-climbers. The top anti-climber was engaged at the impact and deformed. The measured displacements (DMACTR and DMACTL) include bending of the front plate and crush displacements of the tubes. The deformation on both sides was fairly symmetrical with slightly over 1 inch of difference. Two bottom anti-climbers were not engaged; thus, their displacements are zero.

Figure 28. Anti-climber Displacements

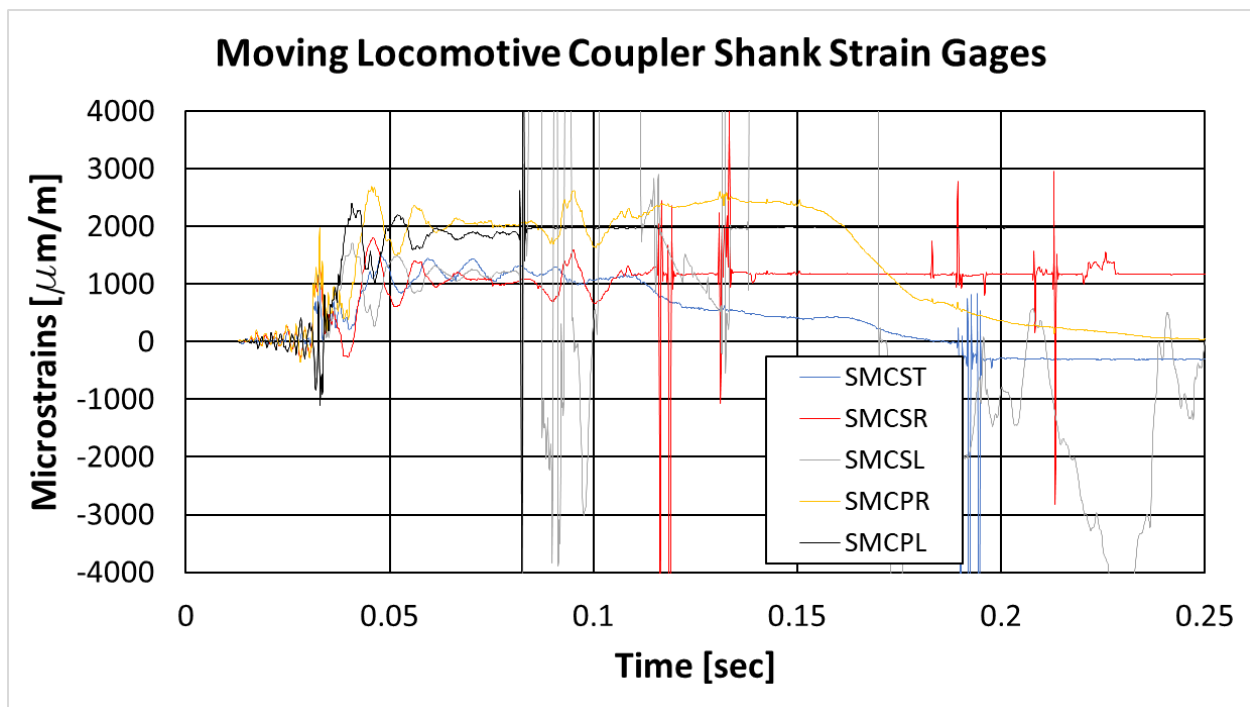
Figure 29. Mobile Locomotive Coupler Shank Strain Results

The moving locomotive was equipped with 33 strain gages, and another 13 strain gages were on the stationary locomotive. Strain gage data from both the moving and stationary locomotives are grouped according to their positions in the vehicles. Figures 29 to 37 show the strain gage data for both locomotives. During the impact, the cables connected to several strain gages were hit by debris or severed, resulting in a loss of useful data after approximately 70 milliseconds. This effect was particularly noticeable on the moving locomotive's coupler and sliding lug strain gages, but other strain gages showed good agreement. Plots below show data from the first 250 milliseconds of impact, which covers the duration of the initial impact.

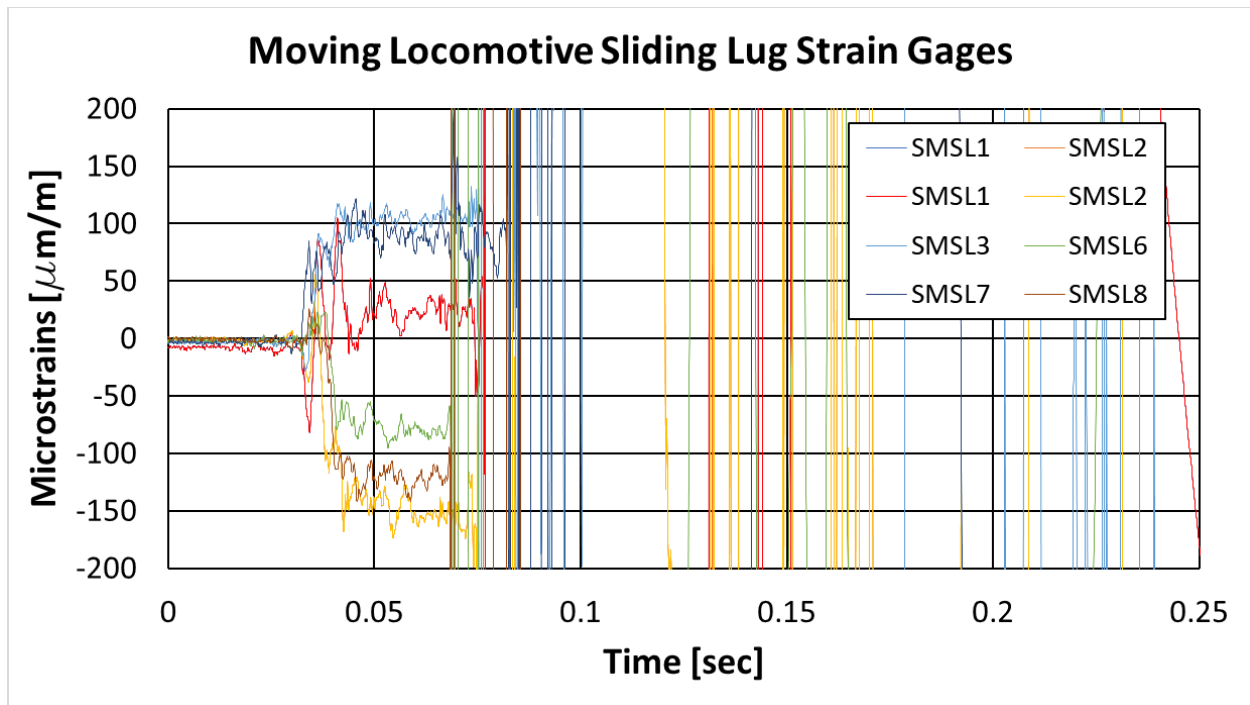
Figure 30. Mobile Locomotive Sliding Lug Strain Results

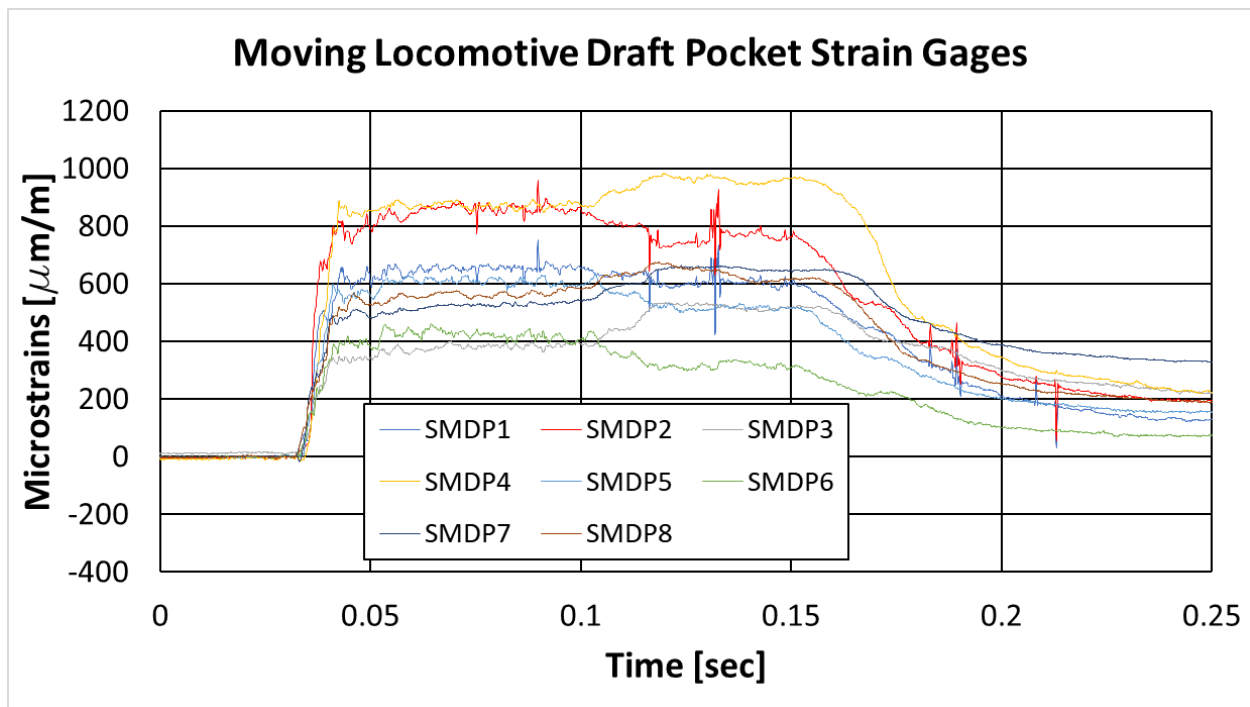
Figure 31. Mobile Locomotive Draft Pocket Strain Results

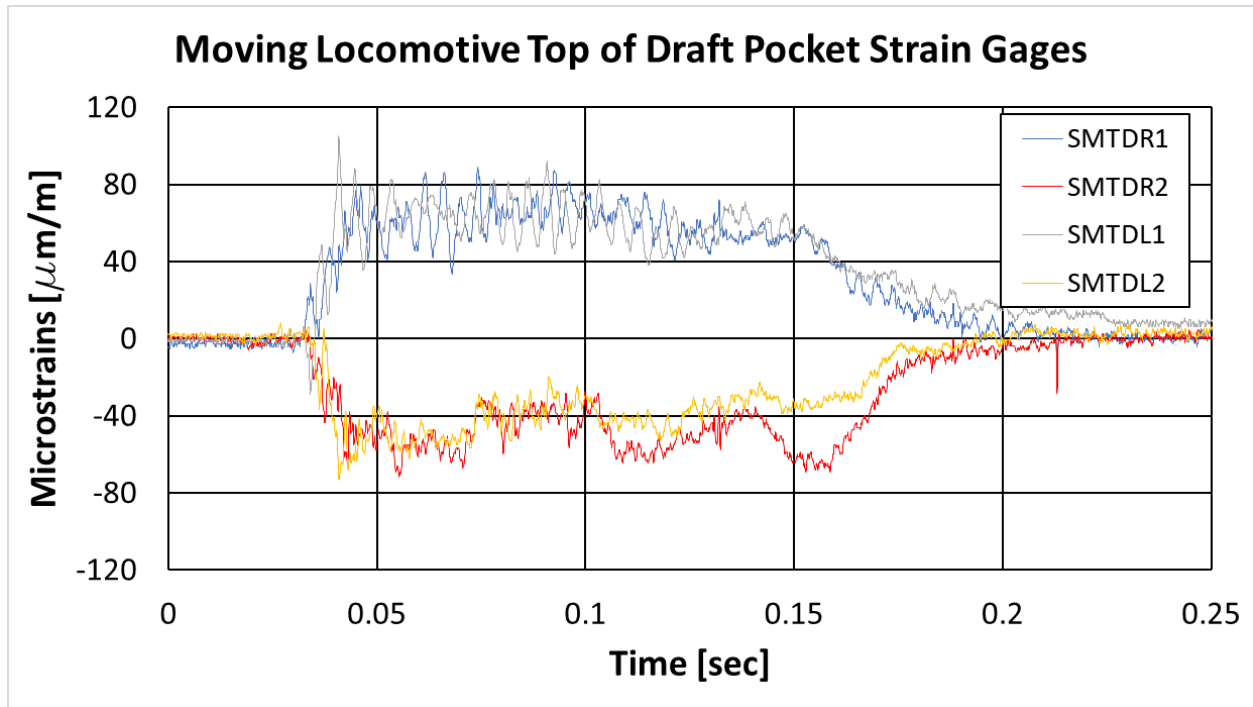
Figure 32. Mobile Locomotive Top of Draft Pocket Strain Results

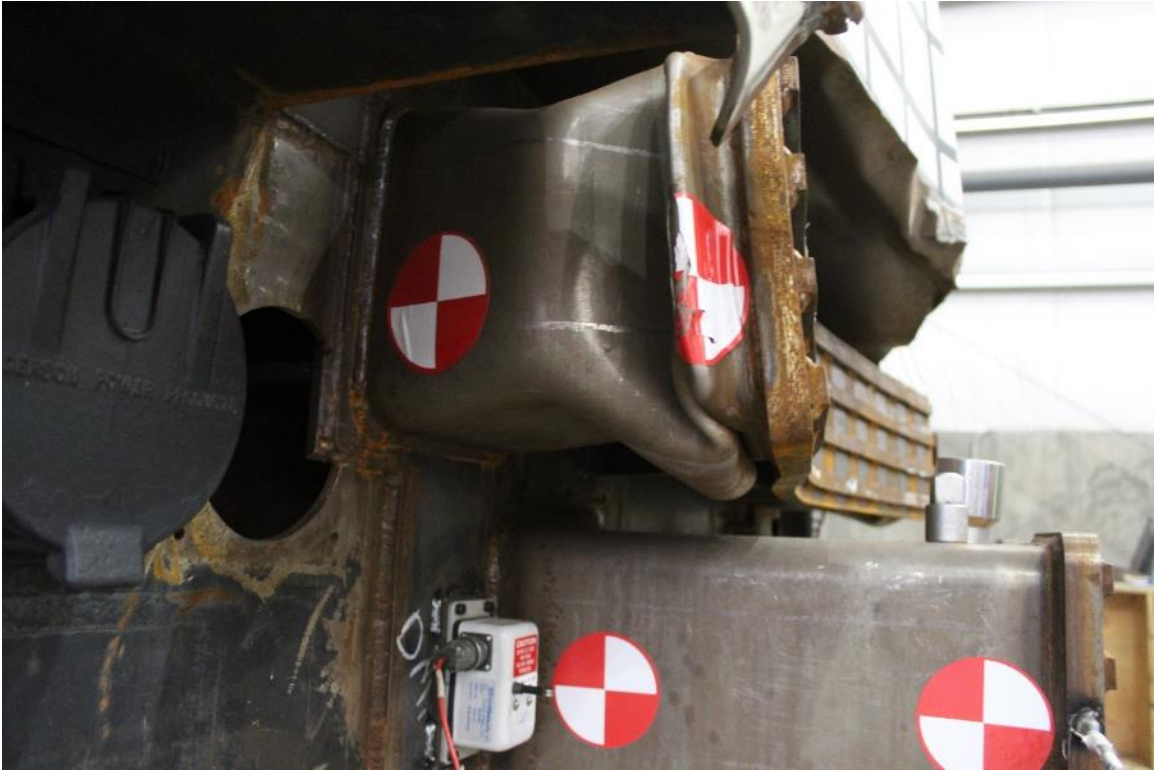
Figure 40. Crushed Anti-climber

After the impact, no structural damage was observed to have occurred on either the stationary or moving locomotives. During the impact, the PBC was activated and nearly exhausted its available stroke. In addition, the upper deformable anti-climber was engaged by the nose of the stationary locomotive. This anti-climber and its crush tubes were deformed under the impact force. The lower set of anti-climbers did not come into contact with the stationary locomotive and were intact after the test. The impact was not sufficient to activate the shear bolts, which were found to be intact after they were removed from the sliding lug. The CEM components after the test are shown in Figures 40 through 43.

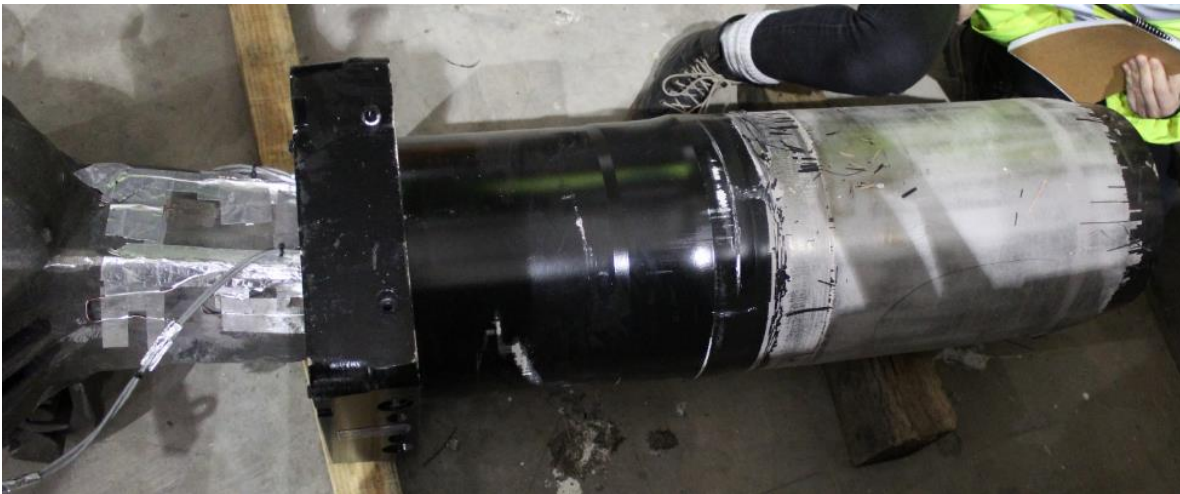
Figure 41. Activated Push-Back Coupler

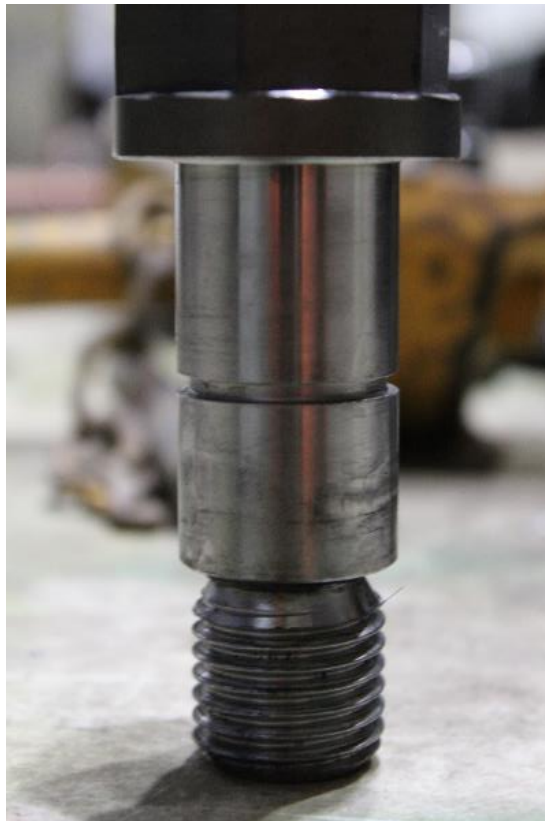
Figure 43. Intact Shear Bolt After Test

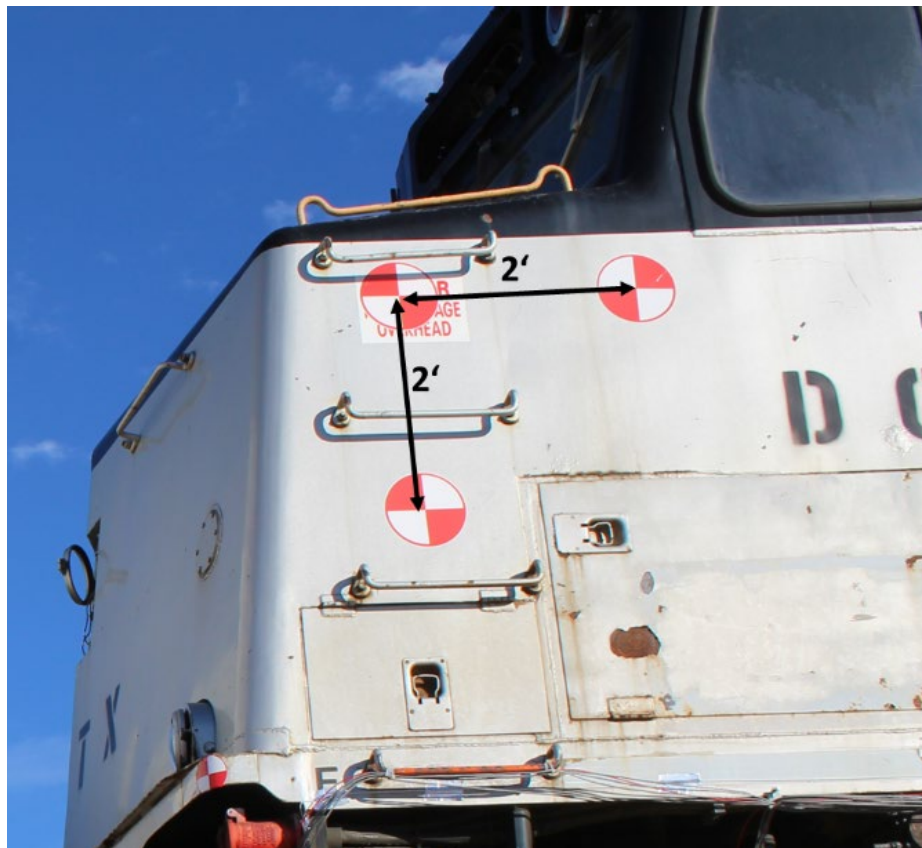
Figure A2. Target Spacing for Locomotive 4117
