**Federal Railroad
Administration**

Wheel Failure Investigation Program: Phase I

1. AGENCY USE ONLY (Leave blank)		2. REPORT DATE February 2021		3. REPORT TYPE AND DATES COVERED Technical Report February 2016
4. TITLE AND SUBTITLE Wheel Failure Investigation Program: Phase I			5. FUNDING NUMBERS DTFR53-12-D-00001L

6. AUTHOR(S) Matthew Dick, Narayana Sundaram, Eric Sherrock				
7. PERFORMING ORGANIZATION NAME(S) AND ADDRESS(ES) ENSCO Inc. 5400 Port Royal Road Springfield, VA 22151			8. PERFORMING ORGANIZATION REPORT NUMBER SERV-REPT-0001670

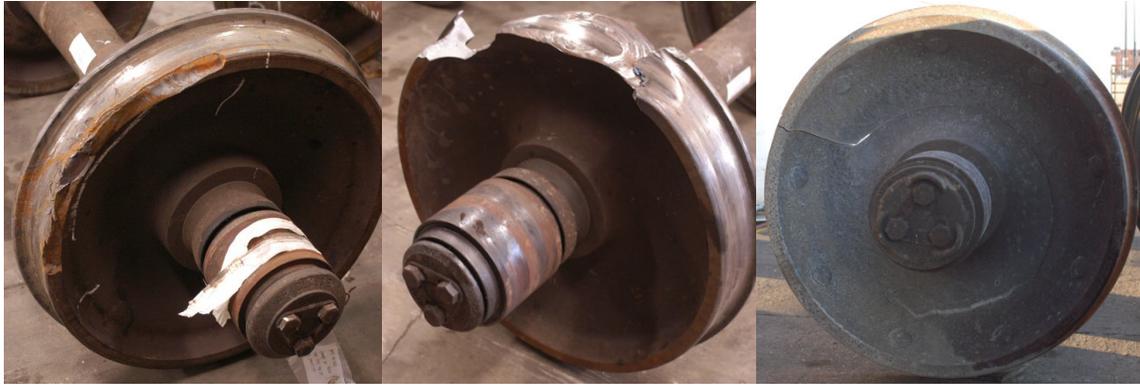
Figure 1. Example of Vertical Split Rim, Shattered Rim, and Thermal Crack Failed Wheels

- **Vertical Split Rim:** An example of a VSR is shown in [Figure 1](#). A VSR occurs when near-surface tread cracking, generally shelling or spalling, reaches a critical location within the rim. This causes a rapid, vertical fracture to occur in the rim with subsequent loss of material. VSR failures have been a growing failure mode in North American heavy haul operations. Unfortunately, current wheel research has not identified the root cause of or proper mitigation actions for VSR failures. Recent research (Lonsdale, C., & Oliver, J., 2013) has identified tensile residual stress in VSR wheel rims, but the origin of the residual stress is currently unknown. Although some railroads have noted a decrease in VSR failures over the past several years, this wheel failure mode continues to represent a derailment risk.

- **Shattered Rim:** A wheel that experienced a shattered rim failure is illustrated in [Figure 1](#). Shattered rim failures are caused by Hertzian contact stress creating subsurface fatigue cracking initiated at voids or inclusions. A thin rim thickness can often aid the Hertzian contact stress to reach subsurface voids/inclusions. The subsurface fatigue crack can generally enlarge before fracture, causing a large loss of material on the wheel rim.

- **Thermal Crack Extended into Plate:** An illustration of a wheel with a thermal crack extending into the wheel plate is provided in [Figure 1](#). A thermal crack is a transverse fatigue crack initiated at the surface of the tread or flange that occurs when the rim hoop residual stress is transformed from the beneficial compressive stress to the detrimental tensile stress. This stress reversal occurs due to significant tread braking. If the fatigue

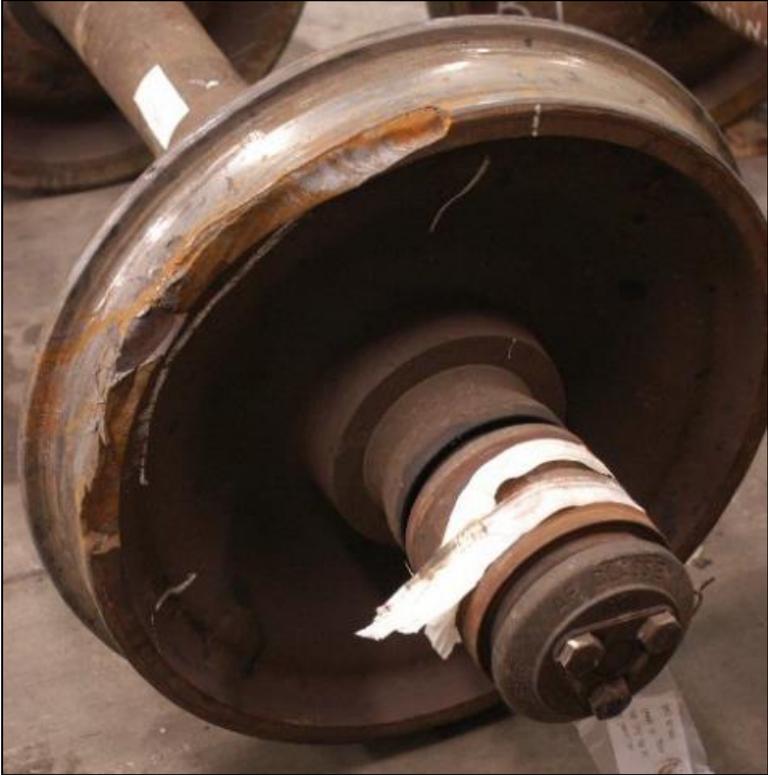
Summary of Major Wheel Failure Modes	
Priority	1
Type	Vertical Split Rim – AAR WM68
Photo

Notes	<ul style="list-style-type: none"> • VSRs are currently the most prevalent high derailment risk failure modes in the North American freight industry. • VSR failures are characterized as a large portion of the front rim face fracturing off. Occasionally it is the back rim face including the flange that fractures off which is then called a VSF. • Currently the underlying mechanism that causes a VSR is not well understood by the industry and it was a major focus of this project to investigate its root cause(s). • Further discussion is provided in Section 3.
Priority	2
Type	Shattered Rim – AAR WM71

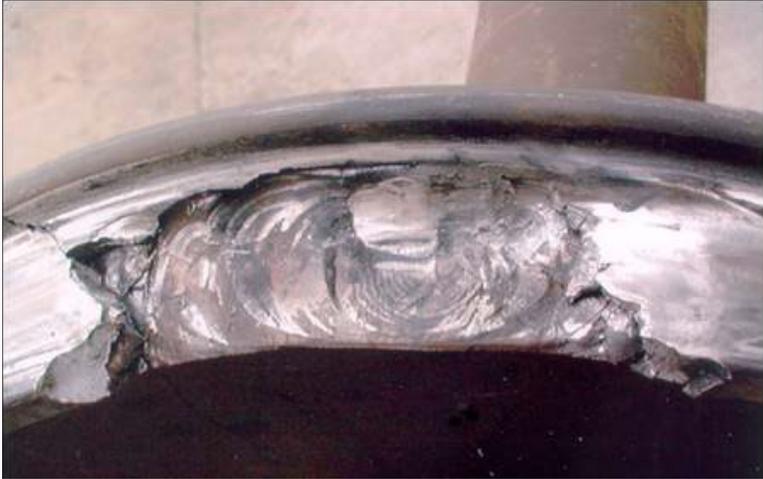
Summary of Major Wheel Failure Modes	
Photo

Notes	<ul style="list-style-type: none"> • Shattered rim failures are the second highest derailment risk failure mode in the North American freight industry. • Shattered rim failures are characterized as a large subsurface fatigue crack created by Hertzian contact stress resulting in a characteristic “bullseye” fatigue fracture. • Shattered rim failures have been on the decline due to improvements to manufacturing processes and removal of high risk wheels such as those manufactured by Southern Wheels (SO or ABEX). • However, shattered rim failures still take place in the industry so further work is still needed. • Further discussion is provided in Section 4.
Priority	3
Type	Broken Flange – AAR WM66
Photo

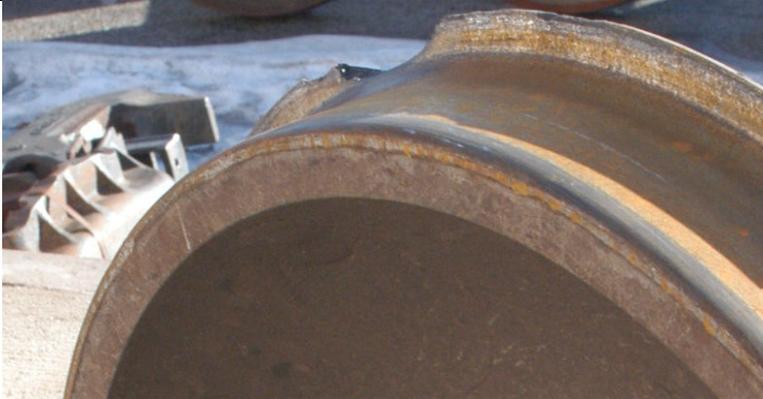
Notes	<ul style="list-style-type: none"> • Broken flanges are characterized by portions of the flange being broken out due to an excessively thin flange. • Generally broken flanges are rare failure types, however, during the review of MD-115 data, it was found that broken flanges were responsible for a significant increase of failures since 2011. Further work is needed to investigate this increase in broken flanges.

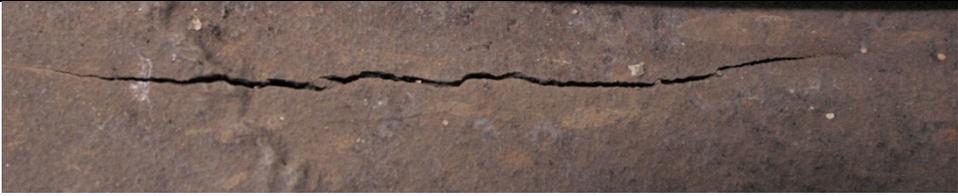
Summary of Major Wheel Failure Modes	
Priority	4
Type	Plate Crack – AAR WM83
Photo

Notes	<ul style="list-style-type: none"> • Plate cracks are characterized as fracture that initiated at the plate, which can cause a large portion of the plate and rim to fracture out. • Plate cracks are generally rare, but when they occur, they can cause derailments. • Plate cracks can be caused by several different mechanisms such as manufacturing defects.
Priority	5
Type	Thermal Cracking in Flange – AAR WM74
Photo

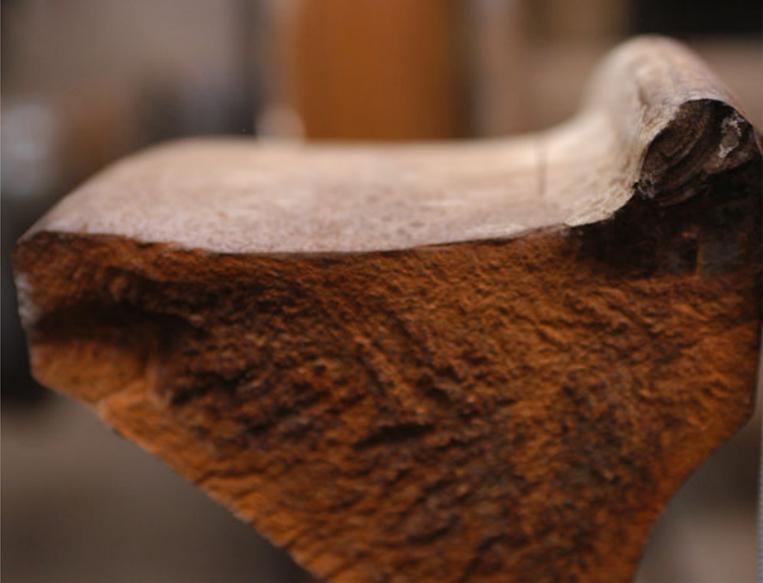
Notes	<ul style="list-style-type: none"> • Thermal cracks are characterized as fatigue cracks originating at the flange or tread that propagate in the transverse direction into the rim. • Thermal cracks are now a very rare failure mode due to the mandatory use of rim quenching starting in 1989 which introduces beneficial compressive hoop residual stress.
Priority	6
Type	Thin Rim Overload Failure – AAR WM68

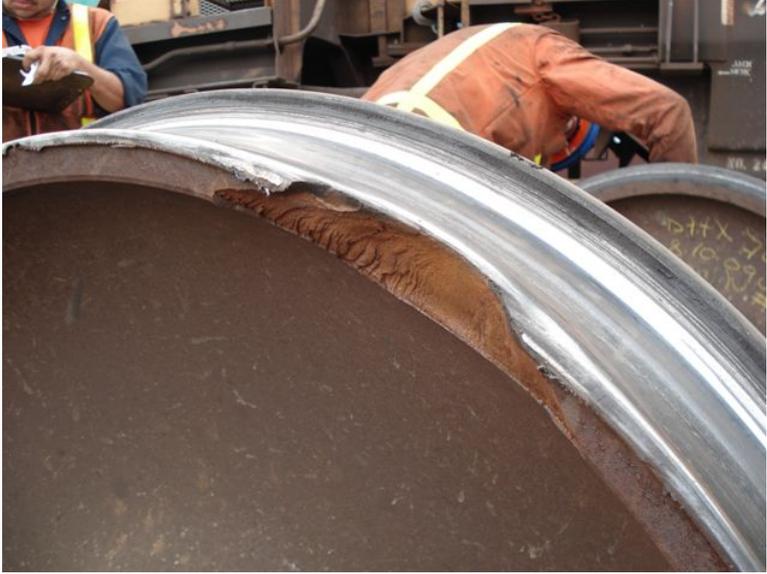
Summary of Major Wheel Failure Modes

Notes	<ul style="list-style-type: none">• A thin rim overload failure is characterized as a portion of the front rim face fractured off due to a thin rim and a large wheel/rail impact. This failure mode differs from a VSR failure type because it is 100 percent overload.• This failure is currently classified as a WM68, which causes confusion with VSRs which are also classified as WM68.• It is anticipated that this failure mode is a relatively low derailment risk, but should still be monitored and investigated.

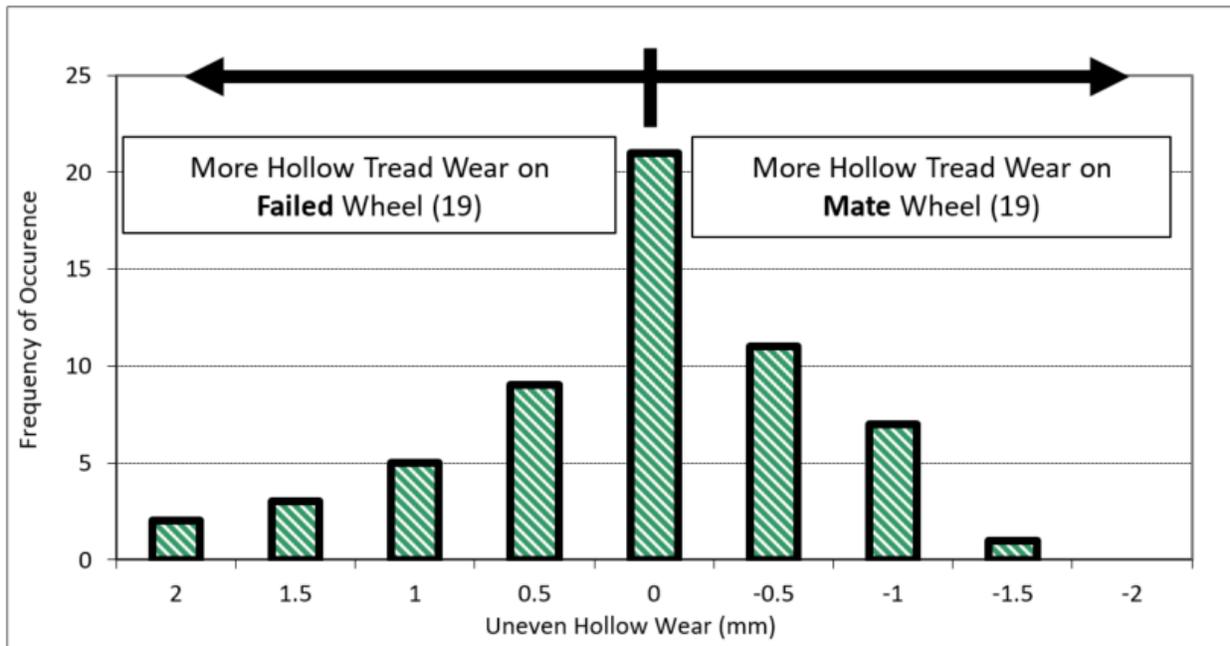
Fifty-three percent of the 111 VSR failed wheels had hollow wear noted on the railroad reports. Most VSR failed wheels have hollow wear of 1 mm or more. [Figure 17](#) illustrates the distribution of differences in tread hollow on wheelsets with VSR wheel failures. There are 38 wheelsets with uneven wear distribution towards the mate wheel or the failed wheel; the rest of the wheelsets had even wear for both the failed and mate wheels. Although there were 19 cases with more tread wear on the failed wheel and 19 cases with more tread wear on the mate wheel, failed wheels tended to exhibit slightly higher amounts of tread hollowing than the mate wheels for the limited number of wheelsets assessed in this initial analysis.

Figure 17. Uneven Hollow Wear Measurements on VSR Failed Wheelsets

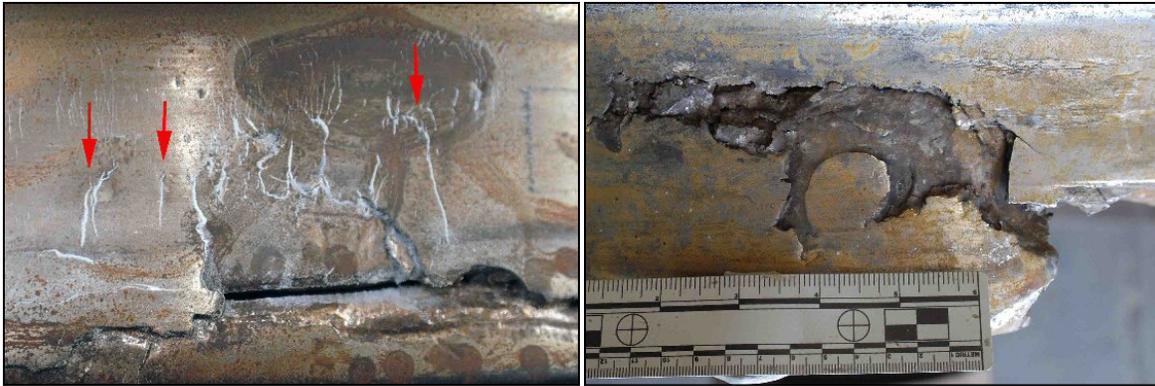
The SWG was in agreement that a horizontal crack forms near the surface of the tread and when it reaches the zone of tensile axial residual stress, the vertical crack forms. However, the SWG did not reach a consensus on the primary mechanism for creating the horizontal crack. Stone, Kristan, and Dick noted that shelling/spalling was the primary mechanism for the horizontal cracking as shown in [Figure 22](#) (Stone, D., Tournay, H., & Cummings, S., 2009) (Stone, D., Dedmon, S., Pilch, J., & Cummings, S., 2010) (Kristan, Elkins, & Stone, 2004) (Dick, M., Snyder, T., Iwand, H., McConnell, D., & Magner, J., 2008). Shelling is surface initiated cracking caused by rolling contact fatigue, thermal cracking, and/or heat checks. Spalling is caused by wheel sliding conditions which cause untempered martensite to form creating a brittle microstructure that quickly fractures out.

(a) Shelling

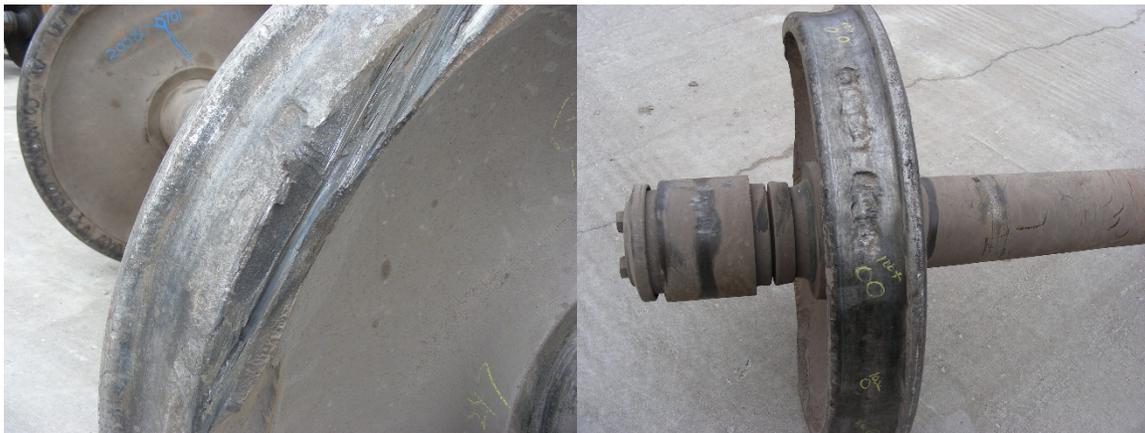
Tournay (2016) and Dedmon et. al. (2016) noted a third mechanism called “delamination.” Delamination is characterized as subsurface fatigue cracking caused by shear stresses that is approximately 0.5 inches to 1.0 inch in width, approximately 1/16th to 3/16th inches below the tread surface and of variable lengths running around the circumference of the rim. The peak Hertzian contact stress corresponds to the depth of delamination. Additionally, Tournay et al. (2016) noted that the delamination is associated with the edge of a work hardening layer from the tread surface. Figure 23 depicts an example VSR with delamination. Figure 24 is an example delamination fracture cut open. Figure 25 depicts a cross-sectional view of a VSR with delamination. Interestingly, Dick (2008) did note that some VSR failures did not have any visible tread damage, which may correspond to delamination.

Figure 23. Example VSR Wheel with Delamination (Photographs courtesy of SWG member Alicia Bitner)

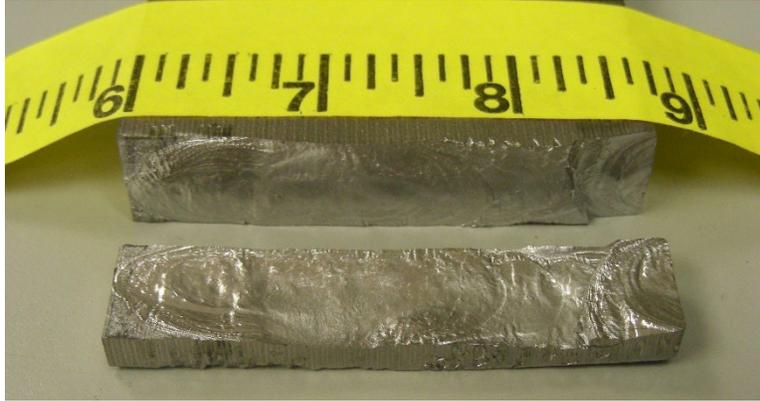
**Figure 24. Delamination Fracture Cut Open
(Photograph courtesy of SWG member Alicia Bitner)**

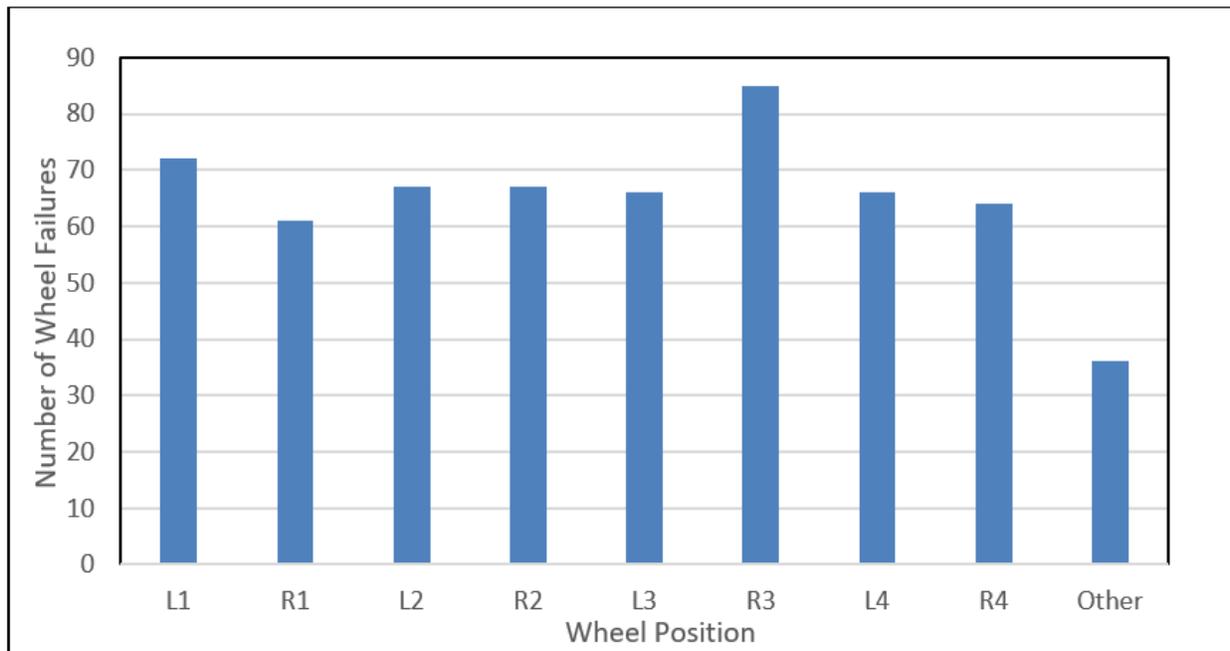
Analysis of the wheel position in the car shows that 267 of the failures occurred at the A-end out of a total of 548 wheels for which the information was available. [Figure 32](#) indicates that shattered rim failures do not tend to be found on a particular truck in a vehicle.

Figure 32. Shattered Rim Failures with Respect to Wheel Position

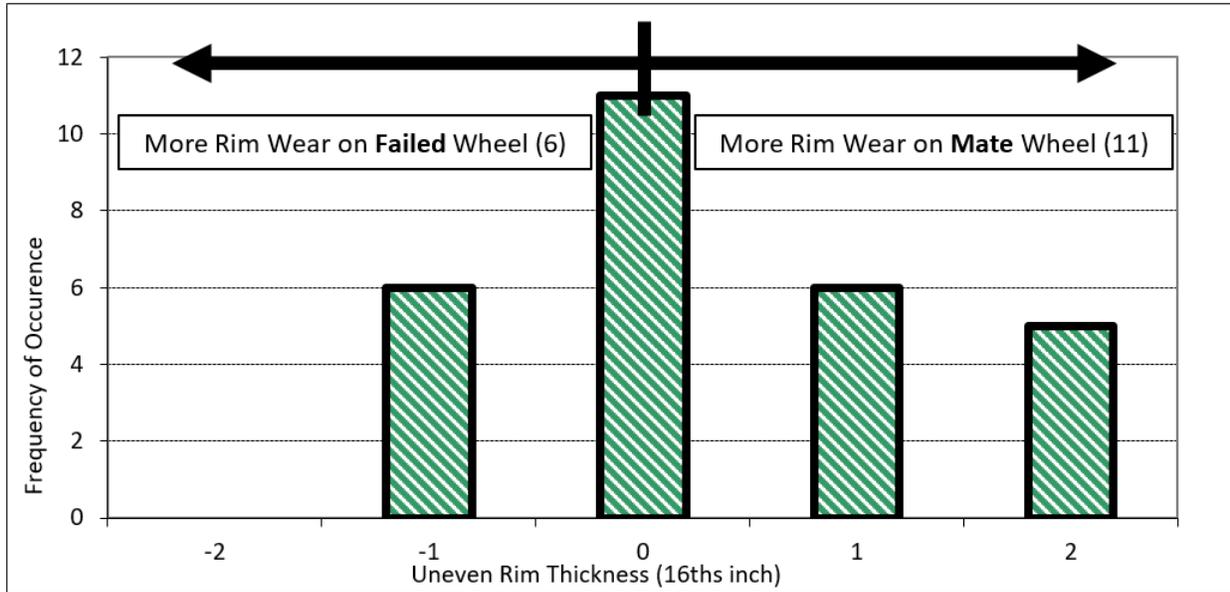
Figure 40. Uneven Rim Thickness on Shattered Rim Failed Wheelset
