U.S. Department
of Transportation
Federal Railroad
Administration

F40 CEM Locomotive and M1 Passenger Car Impact Test

| 14. ABSTRACT An impact test with a F40 locomotive and a M1 passenger car was conducted to evaluate the performance of the vehicles under dynamic conditions. The locomotive was retrofitted with crash energy management (CEM) components – including a push-back coupler (PBC), deformable anti-climbers, and a sliding lug connected to the draft pocket with a set of shear bolts. The impact test was performed in November 2021 at the Transportation Technology Center in Pueblo, Colorado. The M1 passenger car, backed by two empty hopper cars, was impacted by the CEM-equipped locomotive at 32.8 mph. The impact-initiated deformation on one set of anti-climbers, activated the PBC, and sheared all the shear bolts. | | | | | |

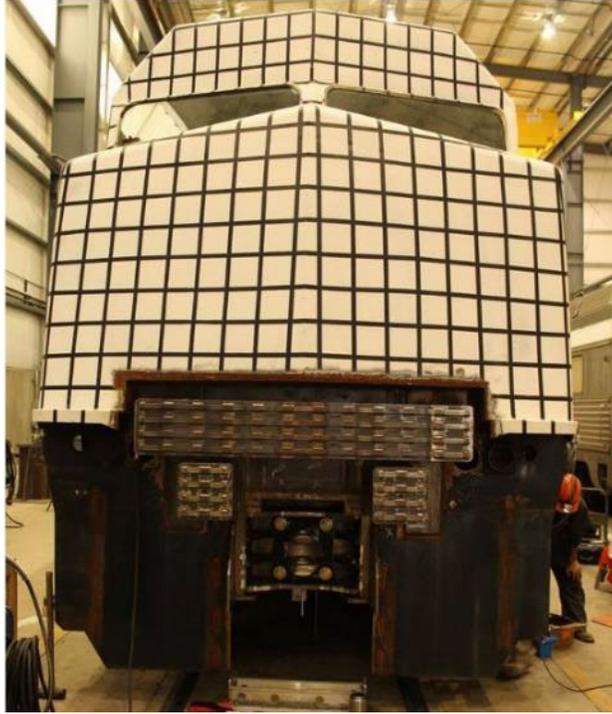
Figure 1. F40PH Locomotive 234

The F40PH locomotive is a four-axle, diesel-electric locomotive intended for passenger service. This test used a CEM-retrofitted F40 Locomotive 234 as the impacting vehicle ([Figure 1](#)); it weighs 231,825 lbs.

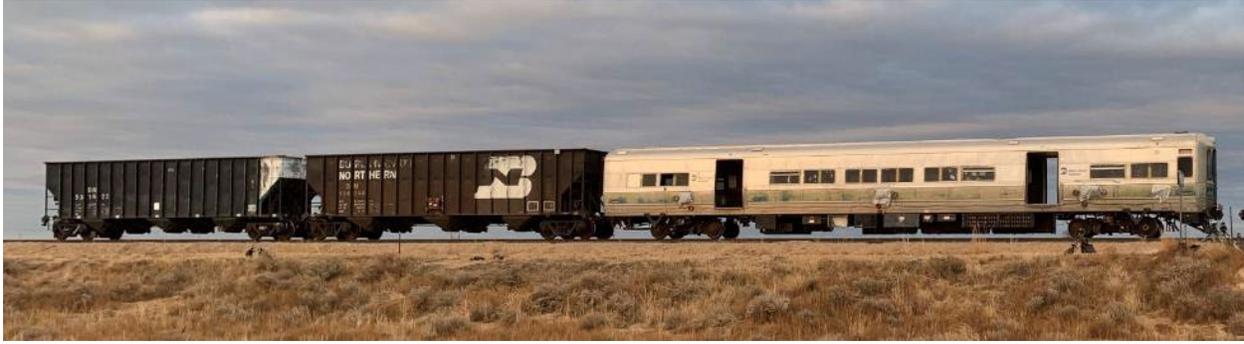
Figure 2. M1 Passenger Car 8333 and Empty Hopper Cars

The stationary consist contained M1 Passenger Car 8333 backed by two empty hopper cars, BN 526308 and BN 531622 ([Figure 2](#)). The M1 passenger car was set up with the cab end toward the impact point; it weighs 80,750 lbs. The empty hopper cars weigh 59,300 lbs. and 59,950 lbs., respectively. The M1 passenger car was partially abated to remove asbestos. This involved removing the seats, flooring, and interior side paneling. The flooring was replaced by two layers of 1/2-inch-thick plywood, secured to the car frame to simulate the original car structure and rigidity.

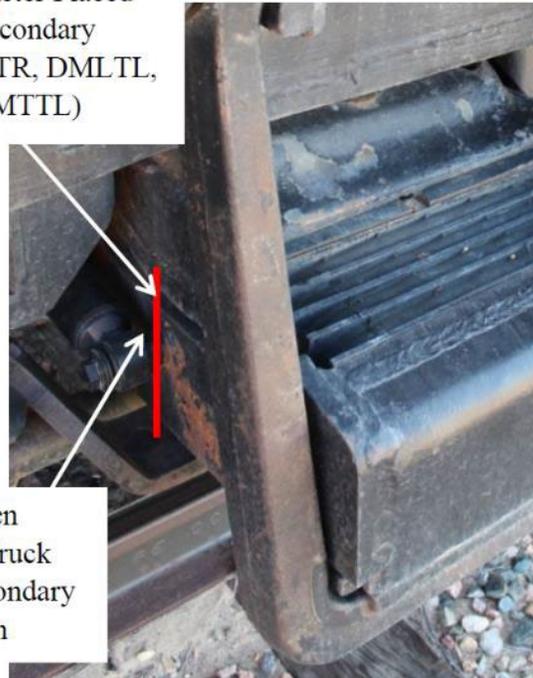
Figure 5. CEM Locomotive Truck Secondary Suspension String Potentiometer Location

String Potentiometer Placed
Across the Secondary
Suspension (DMLTR, DMLTL,
DMTTR, DMTTL)

Gap between
Locomotive Truck
Bolster and Secondary
Suspension

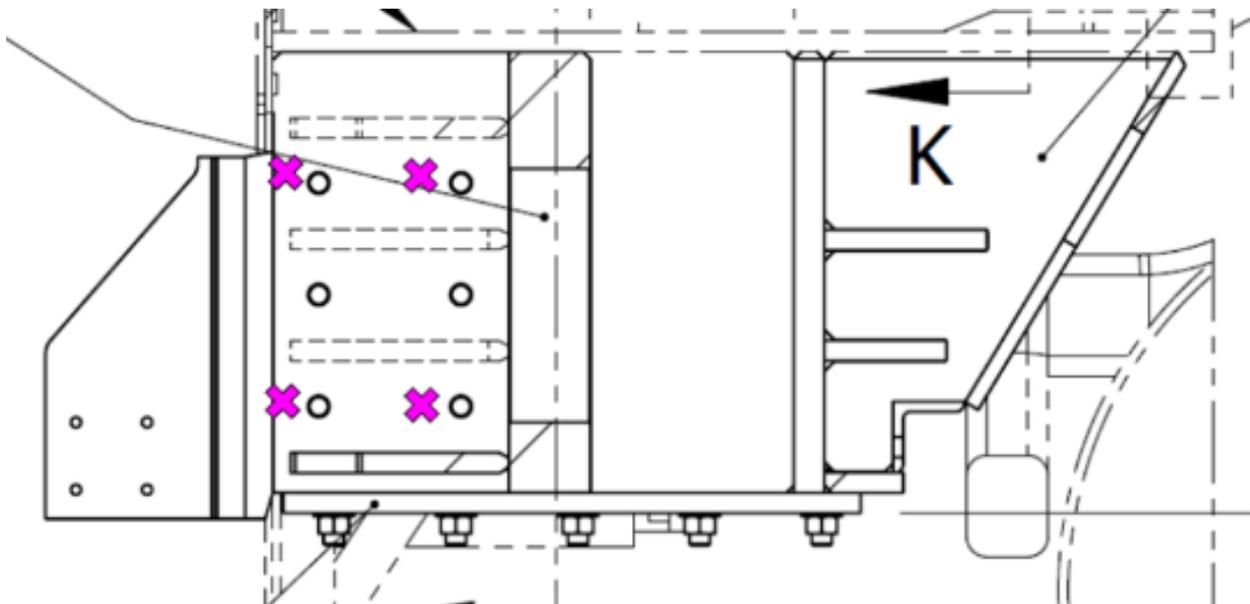
Figure 12. Strain Gage Locations on CEM Locomotive Sliding Lug

Strain gages were installed inside of the lug facing the coupler (Figure 12), 1.5 inches outboard (in front) of each top and bottom hole on both sides.

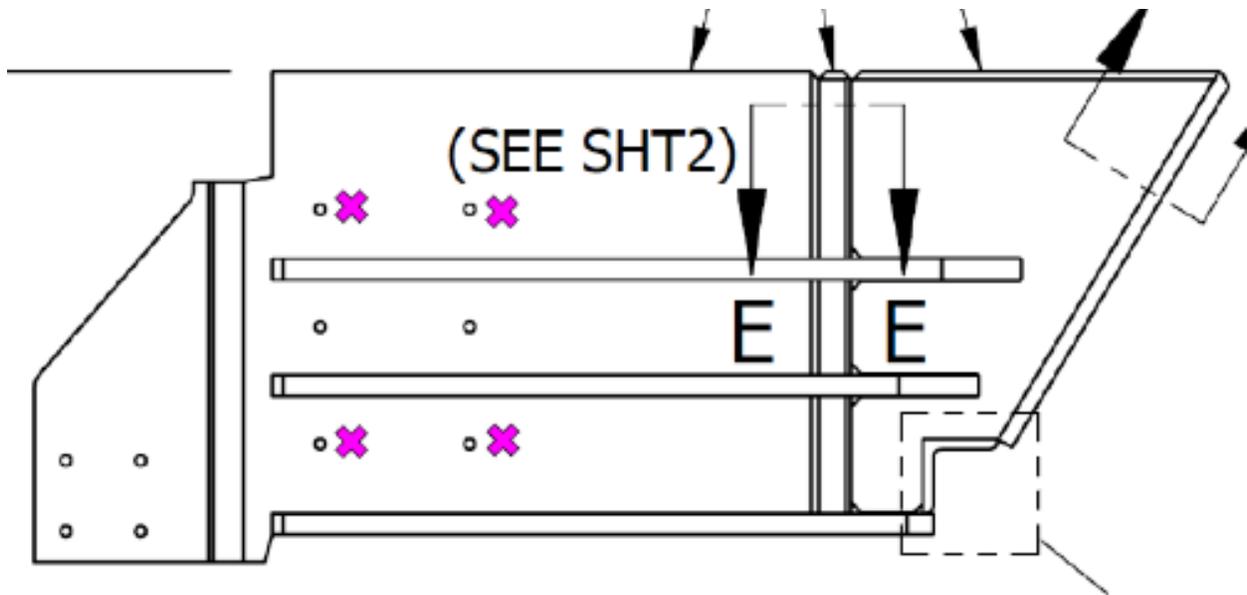
Figure 13. Strain Gage Locations on CEM Locomotive Draft Pocket

Strain gages were installed outside of the pocket facing out (Figure 13), 1.5 inches inboard of (behind) each top and bottom hole on both sides.

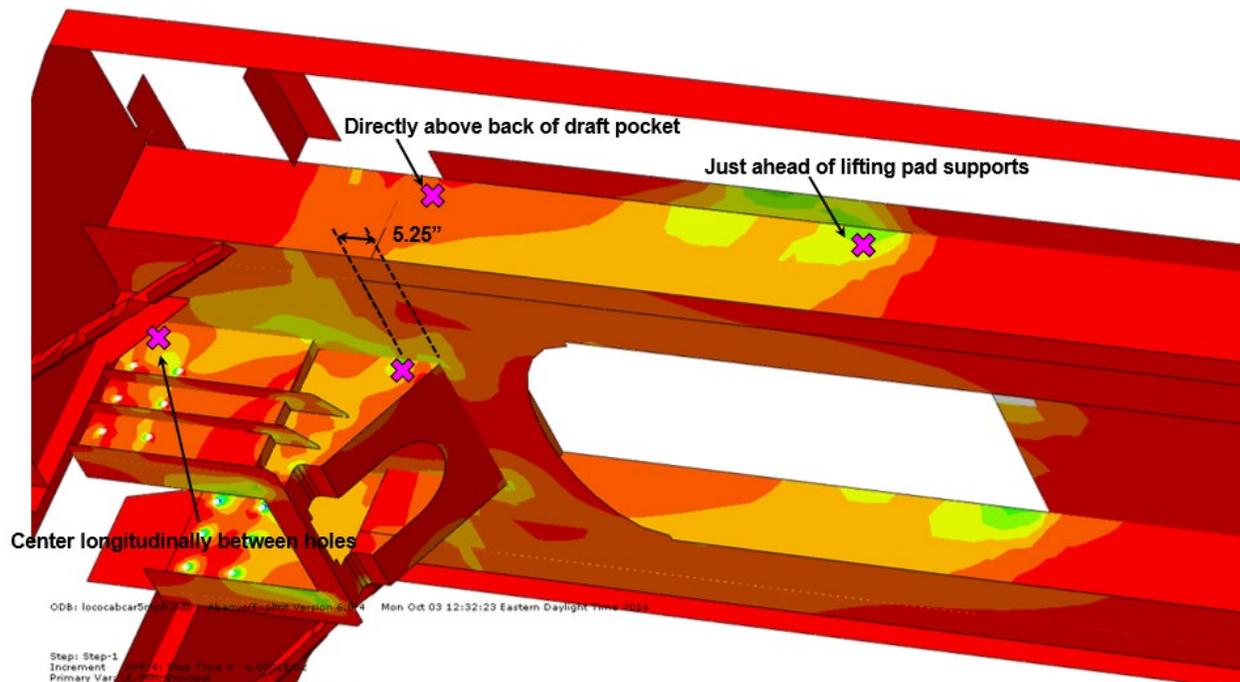
Figure 14. Strain Gage Locations on CEM Locomotive Draft Pocket and Center Sill

Strain gages on the draft pocket were installed on the outside, 2 inches below the connection to the underframe on the left and right sides. Strain gages on the center sill above the draft pocket were installed 2 inches below the top edge of the center sill on the left and right sides. One set of strain gages located on the center sill was placed directly above the back of the draft pocket. The second set of center sill strain gages was placed forward of the locomotive's lifting pad supports. Figure 14 shows approximate locations of these strain gages.

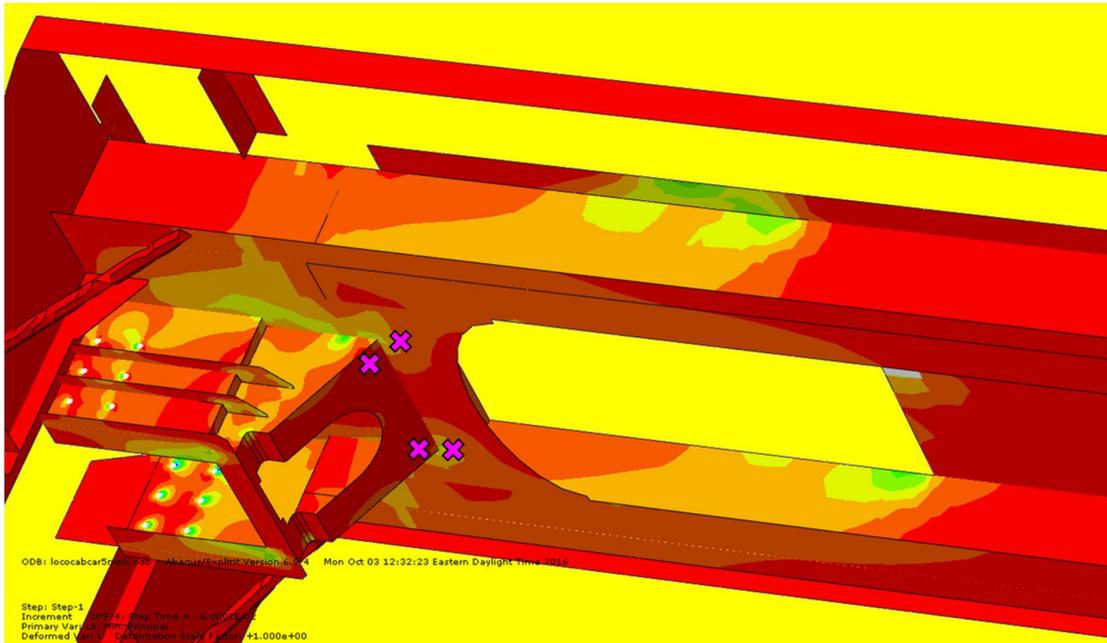
Figure 15. Strain Gage Locations on Cross Plate and Draft Gear Pocket Back Plate

An additional two strain gages (SMXPR, SMXPL) were installed on the cross plate, and two strain gages (SMDAR, SMDAL) were placed at the draft gear pocket back plate. The strain gages on the draft gear pocket back plate were on each near side of the pocket, near the intersection with the cross plate, and oriented in the vertical direction. The strain gages on the cross plate were in line with the side of the pocket corners and oriented in the longitudinal direction. Figure 15 shows approximate locations of these strain gages.

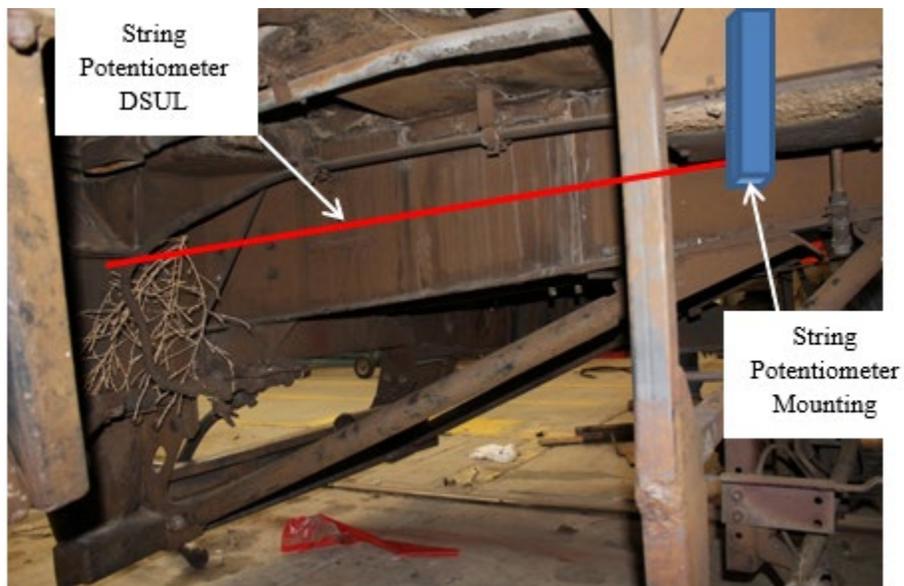
Figure 19. M1 Passenger Car Left Side Underframe String Potentiometer

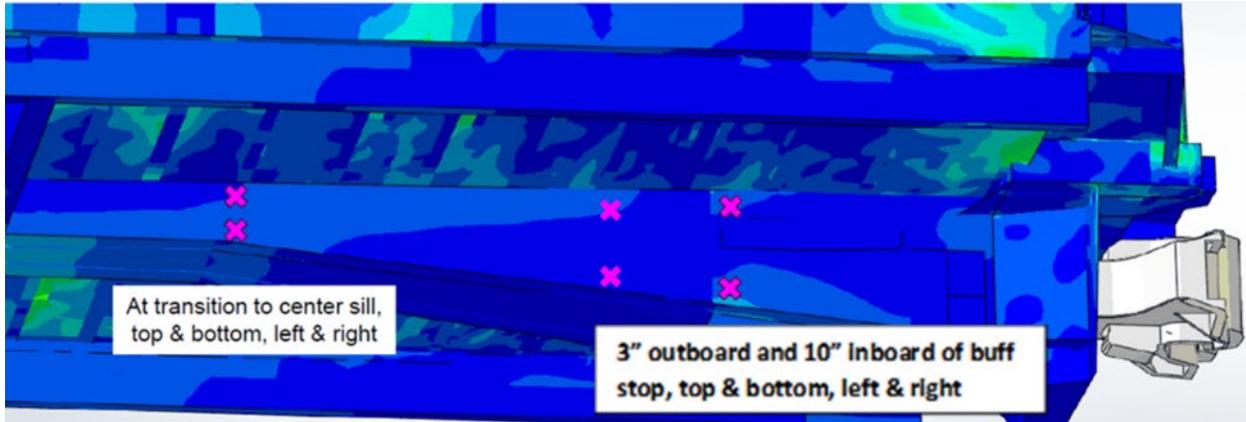
Figure 22. Strain Gage Locations on the M1 Passenger Car Center Sill

Strain gages on the draft sill were installed 3 inches outboard and 10 inches inboard of the buff stop, 2 inches away from the top and bottom edges on the left and right sides. Strain gages at the transition to the center sill were installed 1 inch away from the top and bottom edges on the left and right sides.

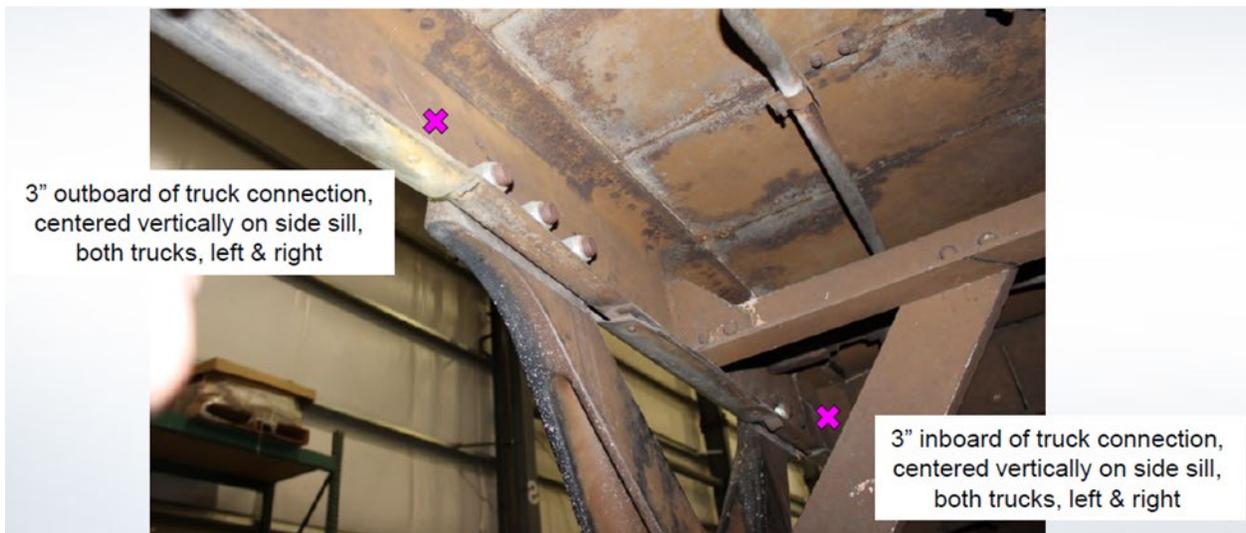
Figure 23. Strain Gage Locations on the M1 Passenger Car Side Sill

Outboard strain gages on the side sill were installed 3 inches outboard of the truck connection on the left and right side of both trucks, centered vertically on the side sill. Inboard strain gages on the side sill were installed 3 inches inboard of the truck connection on the left and right side of both trucks, centered vertically on the side sill.

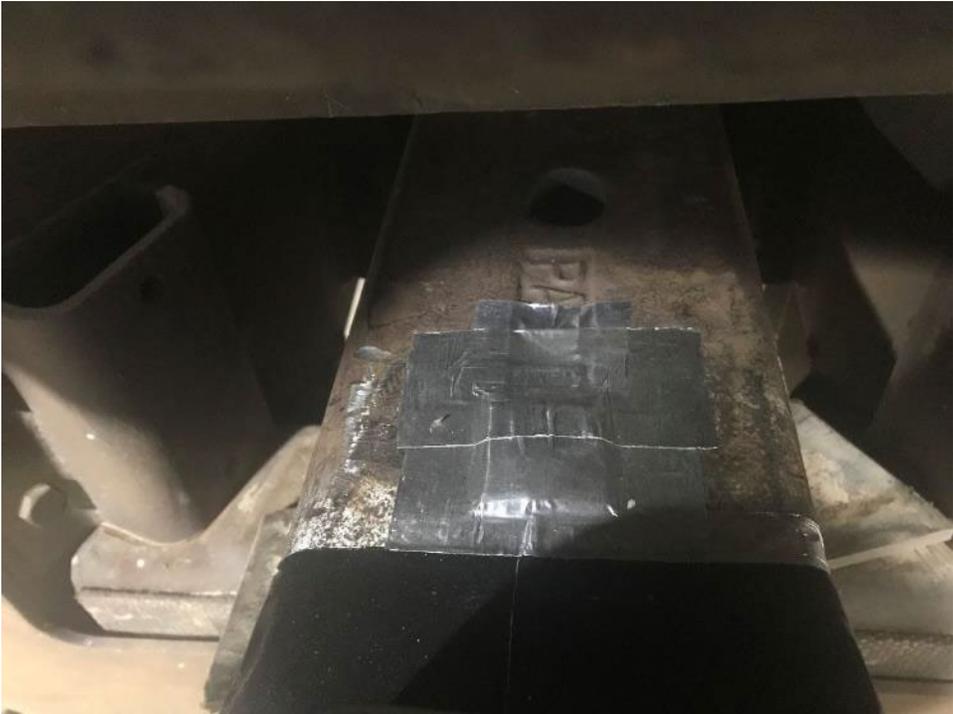
Figure 25. Strain Gage Location on the M1 Passenger Car Rear Coupler

The M1 passenger car was fitted with 25 strain gages and one additional strain gage on the rear coupler. The strain gage on the rear coupler was placed on top of the coupler shank above the coupler carrier. Table 7 summarizes all strain gages on the M1 passenger car. Figure 22 through Figure 25 show approximate locations of the strain gages.

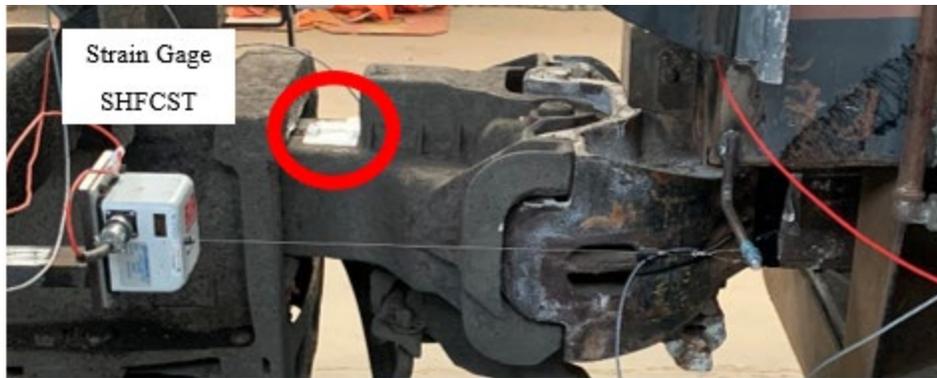
Figure 27. Strain Gage Location on First Hopper Car Front Coupler

The hopper cars were fitted with three uniaxial strain gages. A single strain gage was installed on top of the coupler shank above the coupler carrier for the first hopper car's front coupler, the first hopper car's rear coupler, and the second hopper car's front coupler. Table 9 summarizes all strain gages on the hopper cars. Figure 27 and Figure 28 show the locations of the strain gages.

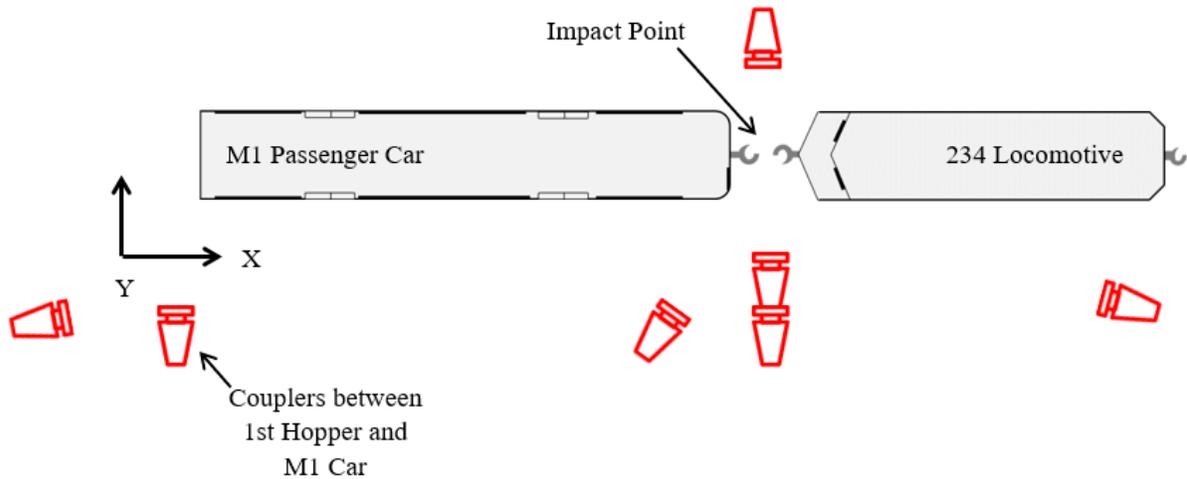
Figure 29. High-Speed Camera Locations

Seven high-speed and eight real-time, high-definition video cameras documented the impact event. [Figure 29](#) and [Figure 30](#) show schematics of the setup positions of the high-speed and high-definition cameras. All high-speed cameras are crashworthy and rated for peak accelerations of 100g. Technicians aligned and sighted the cameras when the vehicles were positioned at the impact point prior to the start of the test. Two flashes were installed on the CEM locomotive and M1 passenger car, and they were triggered at the same time as the data acquisition systems. Flashes were visible from the high-speed cameras and were used to confirm the time of trigger and to evaluate any trigger time discrepancies between vehicles.

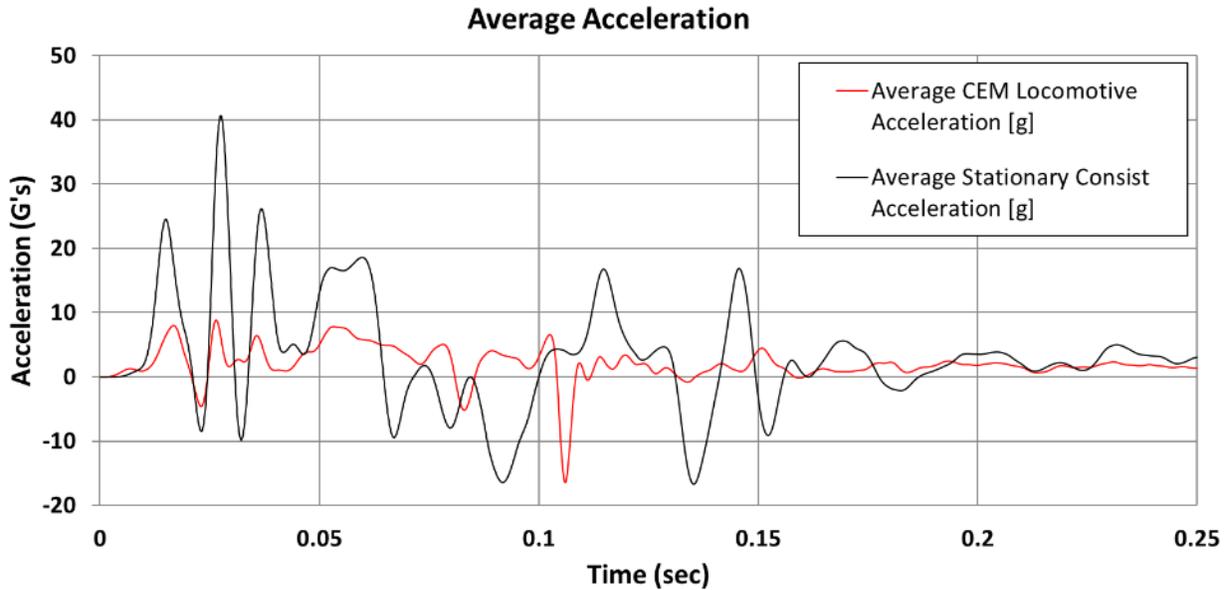
Figure 31. Longitudinal Average Acceleration

Figure 31 provides the average longitudinal acceleration time history as derived from the locomotive accelerometer data. Impact accelerations are shown as positive in these graphs; however, during the impact, the CEM locomotive accelerated in the negative X direction based on the established coordinate system. During the impact test, the vehicles did not couple due to the closed knuckles on the couplers, but the CEM locomotive front end was lodged into the cab end of the M1 passenger car from the force of the impact. The vehicles had to be pulled apart after the completion of the test.

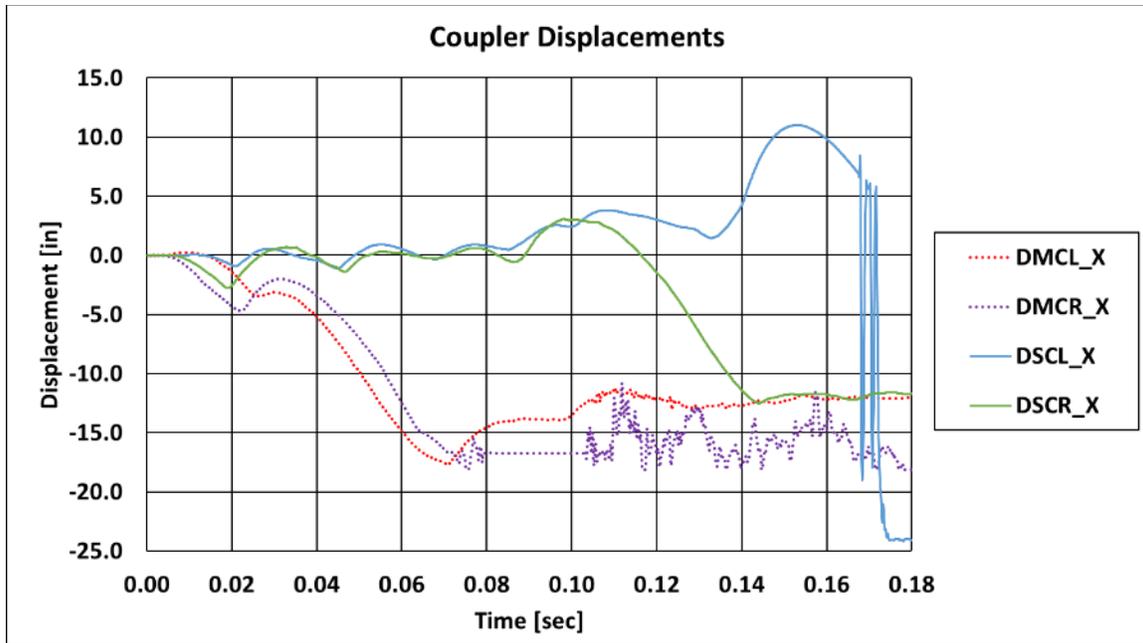
Figure 32. Impacting Coupler Displacements

Figure 32 shows the displacement of the locomotive and M1 passenger car couplers. DMCL_X and DMCR_X represent the left- and right-side displacements on the CEM locomotive's coupler, respectively. DSCL_X and DSCR_X represent the displacements of the M1 passenger car's coupler, respectively. According to the established coordinate system, the coupler moving into the draft pocket was reported as a negative displacement for both the CEM locomotive and the M1 passenger car. The severity of the impact caused the cab end of the M1 passenger car to be crushed, its coupler forced back, and eventually the M1 car's center sill to be collapsed. This caused the coupler head to pivot and the draft system to fail. The draft system damage and the damage to the string potentiometers on the M1 passenger car explain the unusual displacement readings for DSCL_X and DSCR_X.

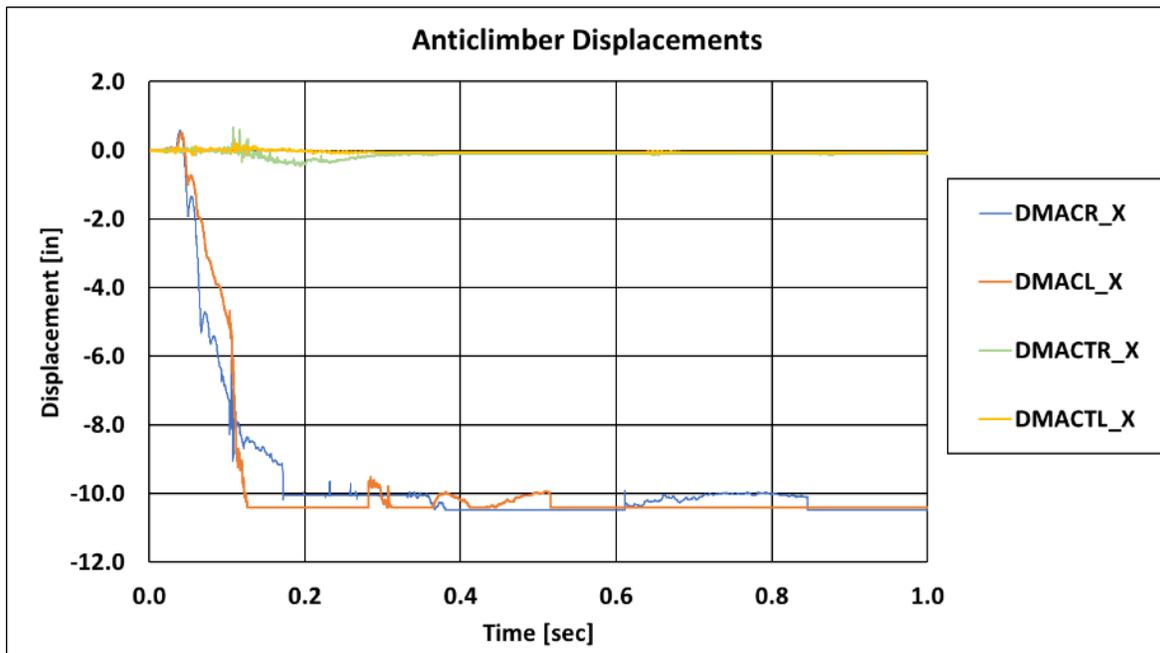
Figure 33. Anti-climber Displacements

Figure 33 shows measured longitudinal displacements of the locomotive’s anti-climbers. The bottom set of anti-climbers were engaged at the impact and deformed. The measured displacements (DMACR and DMACL) included bending of the front plate and crush displacements of the tubes. The deformation on both sides was fairly symmetrical. The top anti-climber experienced negligible deformation over the course of the impact and did not activate; thus, its displacements were nearly zero.

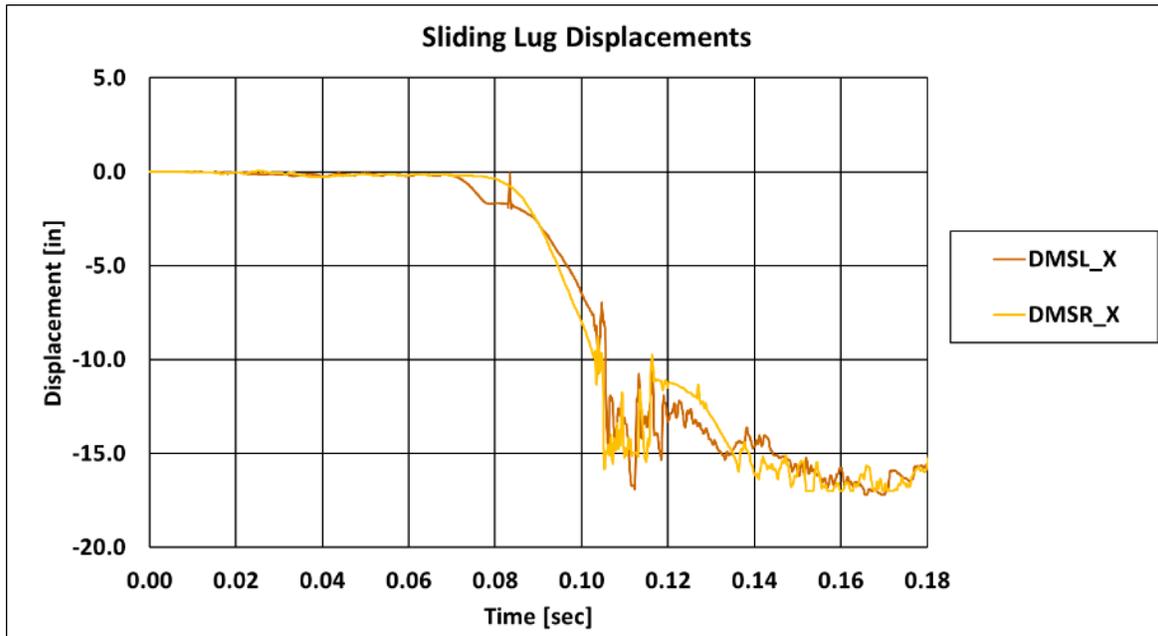
Figure 34. Sliding Lug Displacements

The sliding lug bolts were sheared during impact. Measured displacements of the sliding lug are displayed in [Figure 34](#).

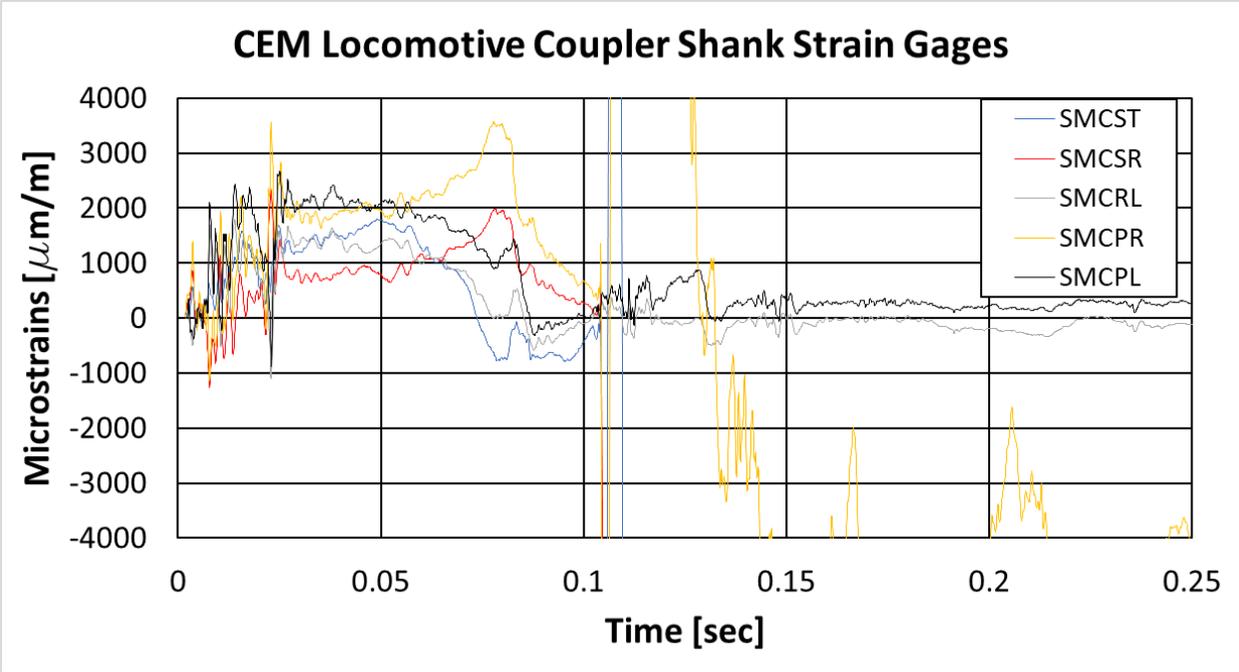
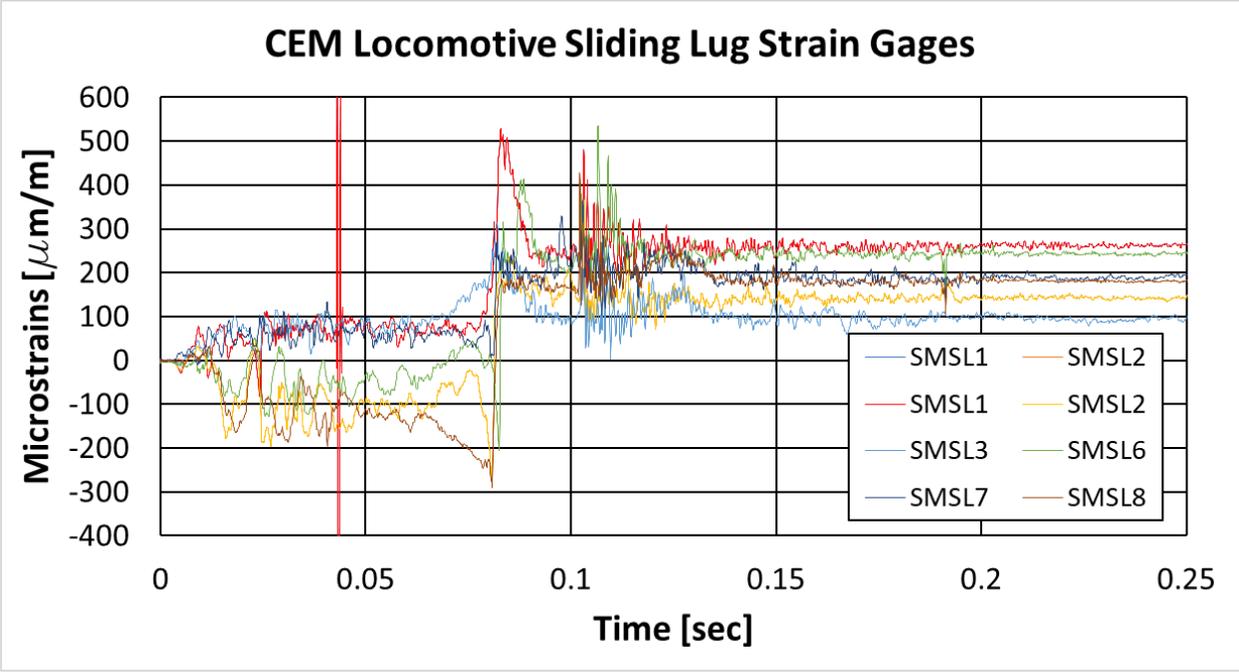
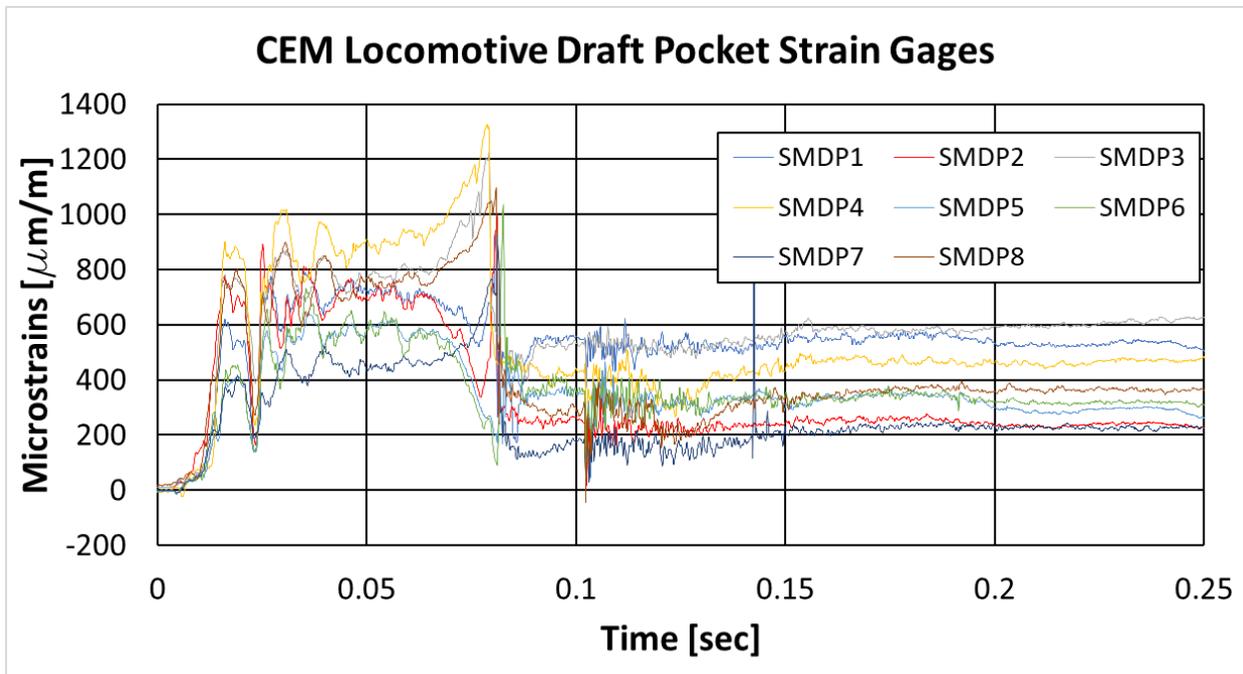
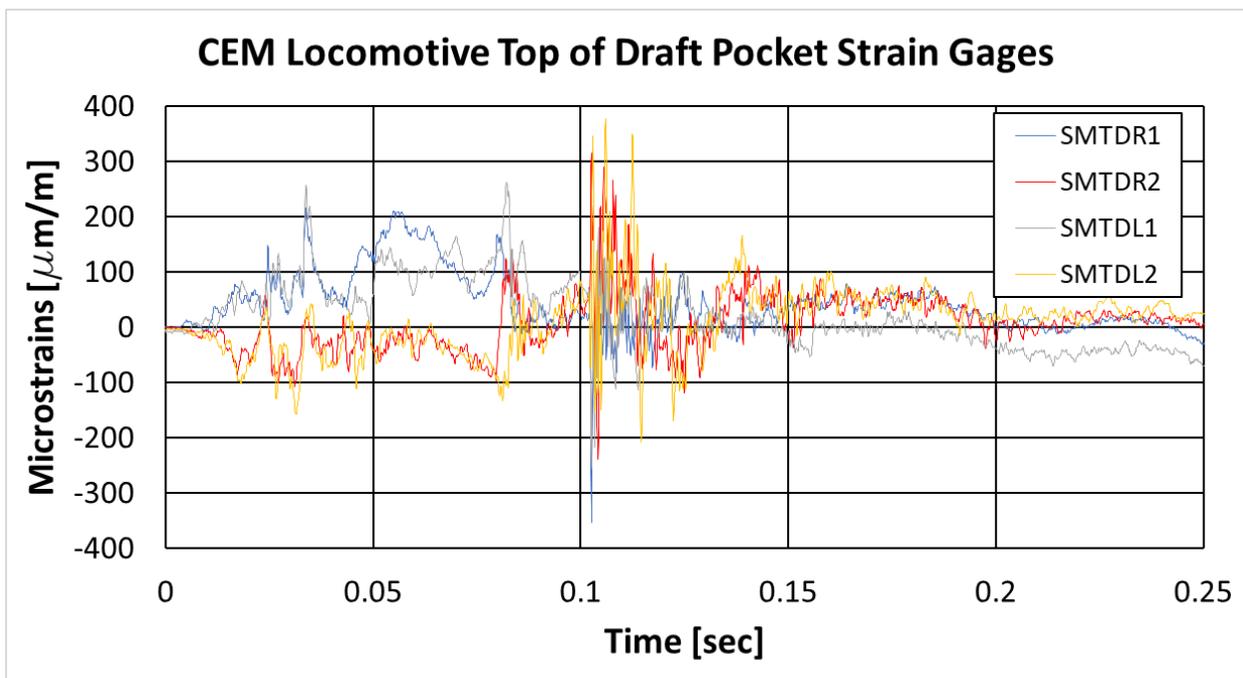
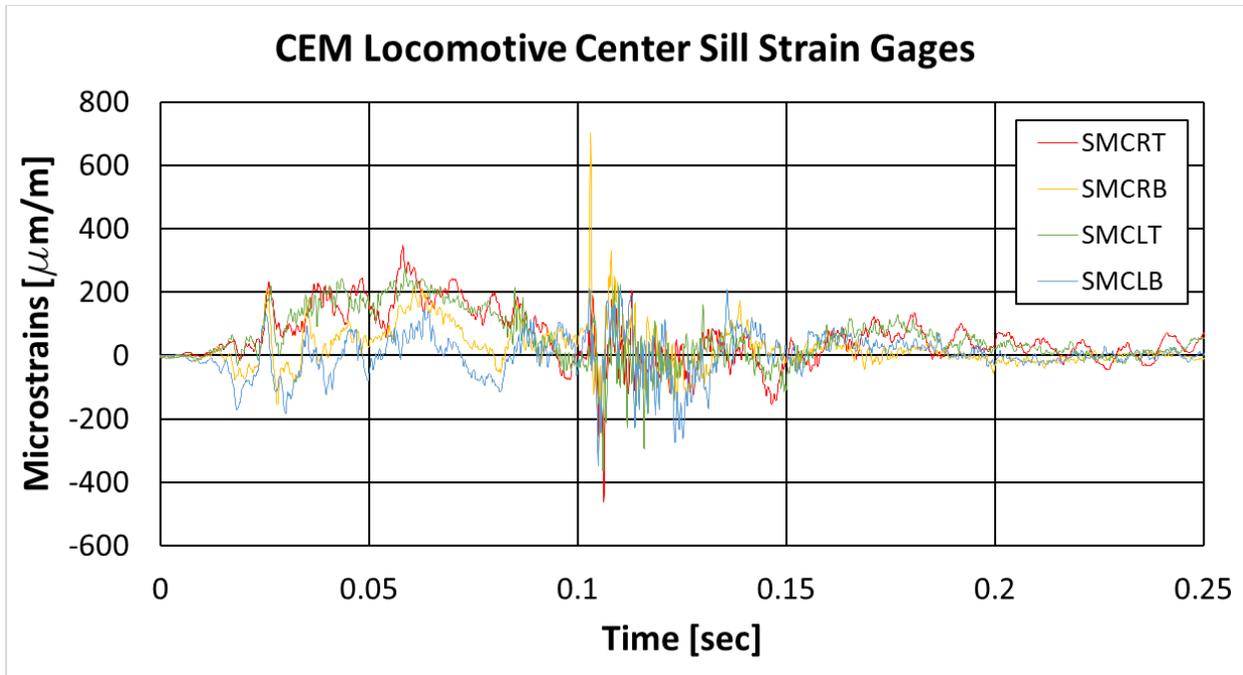
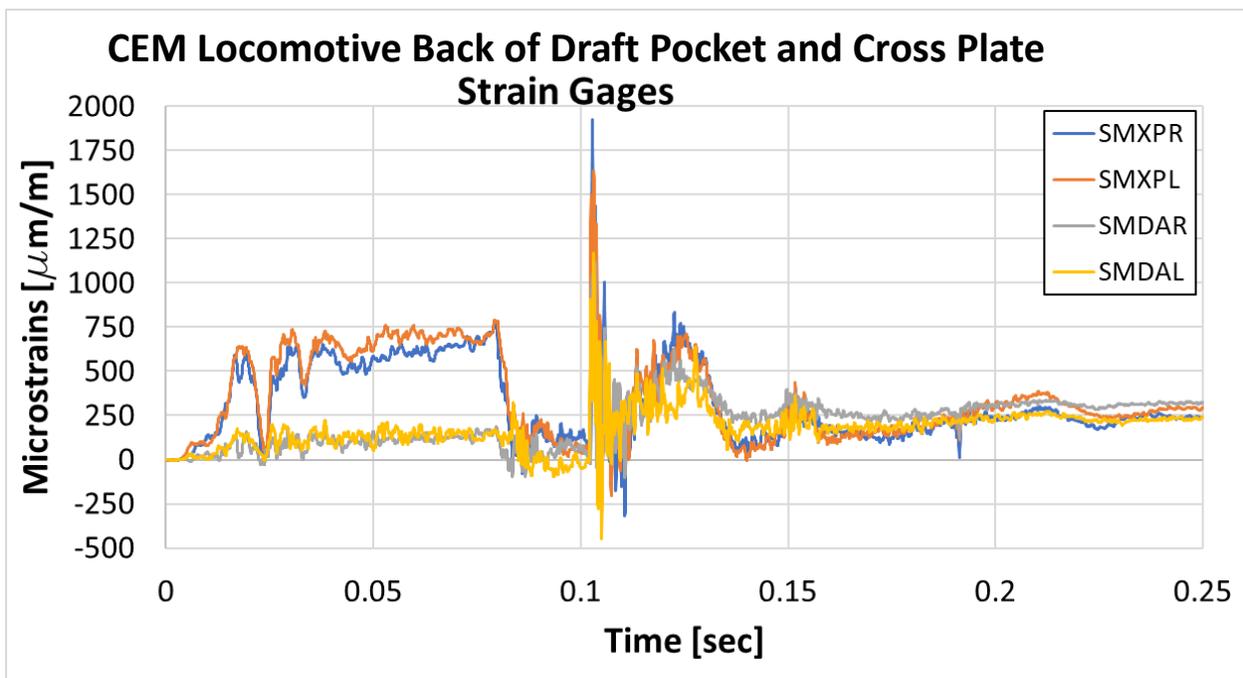
The CEM locomotive was equipped with 33 strain gages, and another 26 strain gages were on the M1 passenger car. An additional 3 strain gages were placed on the coupler shanks of the first hopper car (front and rear coupler) and the second hopper car (front coupler). Strain gage data from both the CEM locomotive and stationary cars are grouped according to their positions in the vehicles. [Figure 35](#) to [Figure 46](#) show the strain gage data for all instrumented vehicles. During the impact, the cables connected to several strain gages were hit by debris or severed, resulting in a loss of useful data after various lengths of time. This effect was particularly noticeable on the CEM locomotive's sliding lug and coupler and the M1 passenger car's front and rear coupler strain gages. The SSRCSST (M1 car, rear coupler shank, above carrier, top) channel did not provide any usable data during the test despite passing checkouts and having no visual evidence of damage to the transducer or cables. Its data have been excluded from the report. Plots below show data from the first 250 milliseconds of impact, which covers the duration of the initial impact. The data acquisition setup resulted in positive strains representing compression and negative strains representing tension.

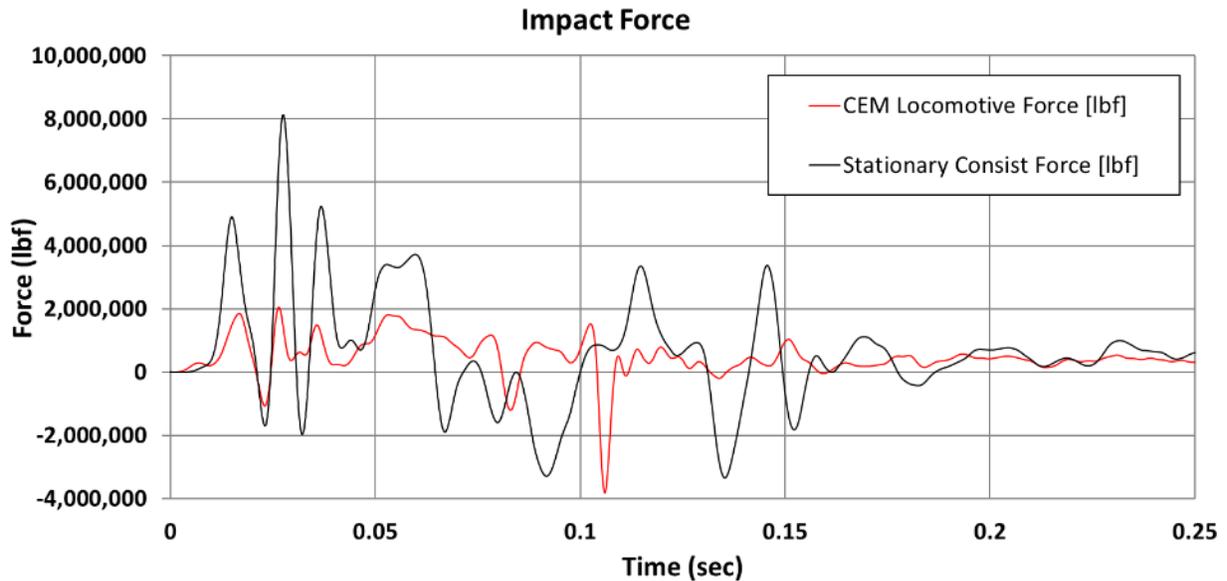
Figure 47. Impact Force

Impact forces between the CEM locomotive and the stationary consist can be calculated as a product of the average acceleration and mass of the corresponding vehicle. Figure 47 shows the time history of the vehicle impact forces.

The force was calculated by multiplying vehicle weight and average carbody acceleration. The average acceleration was calculated as described in Section 3.2.1 and was taken from longitudinal accelerometers mounted on the underframe of each vehicle. The peak impact force was approximately 8 million lbf for the stationary consist and 2 million lbf for the CEM locomotive.

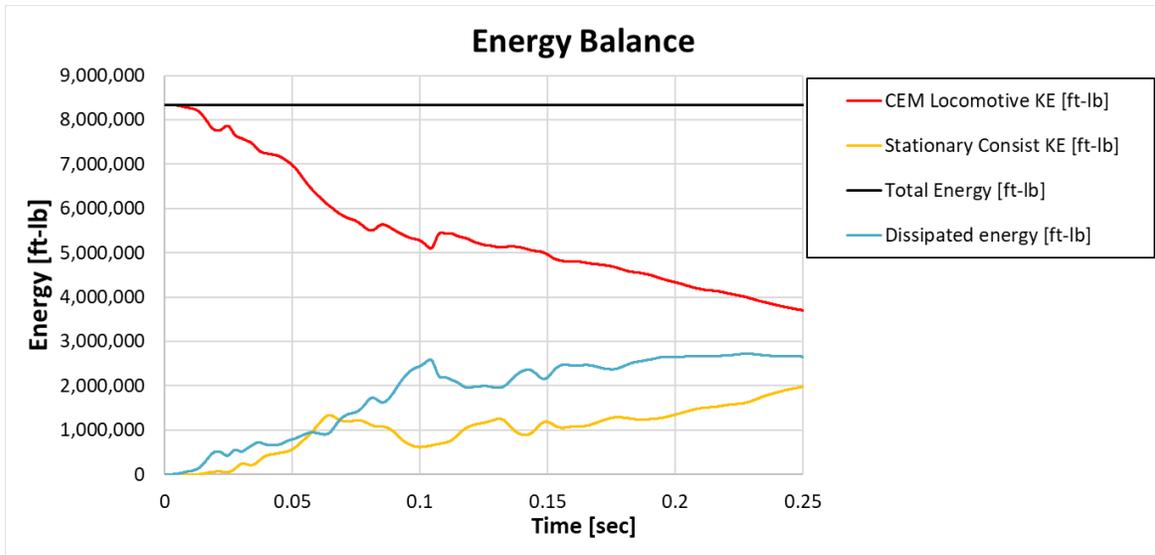
Figure 48. Energy Balance

Energy balance is the summary of the energy transfer during the impact. The total energy at the beginning of the impact is equal to the kinetic energy of the CEM locomotive. After the first impact, all vehicles moved forward on the track until they stopped. The dissipated energy accounted for CEM component deformation, braking, and other energy losses. Because the energies should balance, the dissipated energy was obtained by subtracting the kinetic energies from the total energy. Figure 48 shows the energy balance for the initial impact.

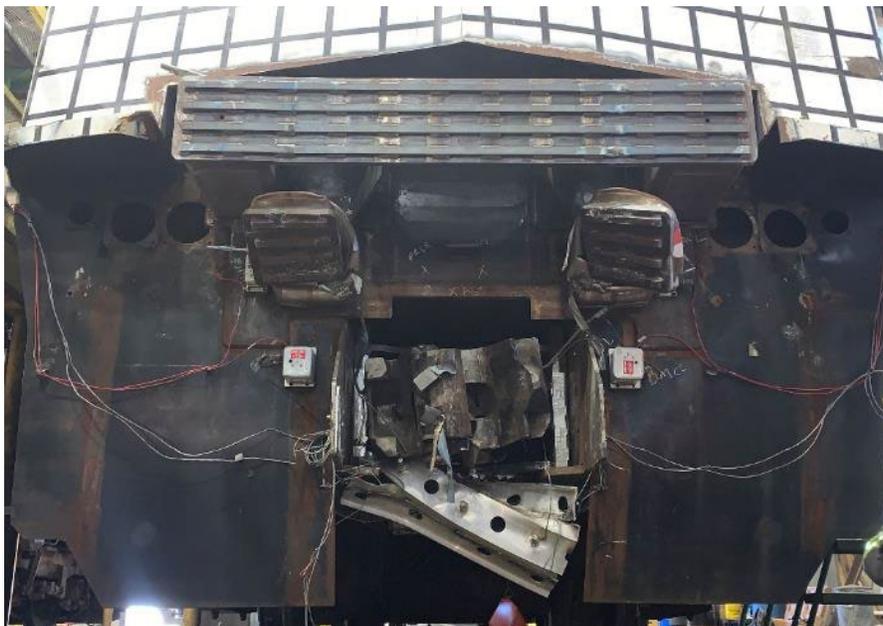
During the impact, the various components of the CEM system were activated. The PBC was activated and exhausted its stroke, and the bottom anti-climbers were engaged and crushed. These anti-climbers and their crush tubes were deformed by the impact. The upper anti-climber appeared to have made slight contact with the M1 passenger car; however, it was still intact after the test. The deformation of the upper anti-climber and its crush tubes was negligible. The impact activated the shear bolts and deformed one bolt hole in the draft pocket. The CEM components after the test are shown in [Figure 49](#) through [Figure 53](#).

Figure 49. Crushed Bottom Anti-climbers

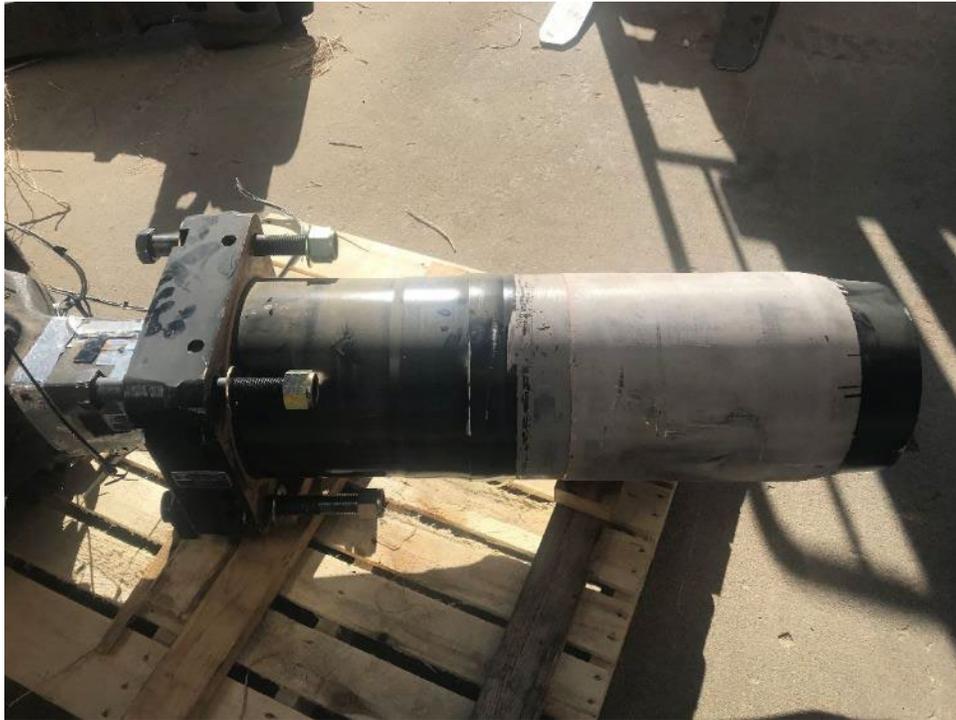
Figure 50. Activated PBC

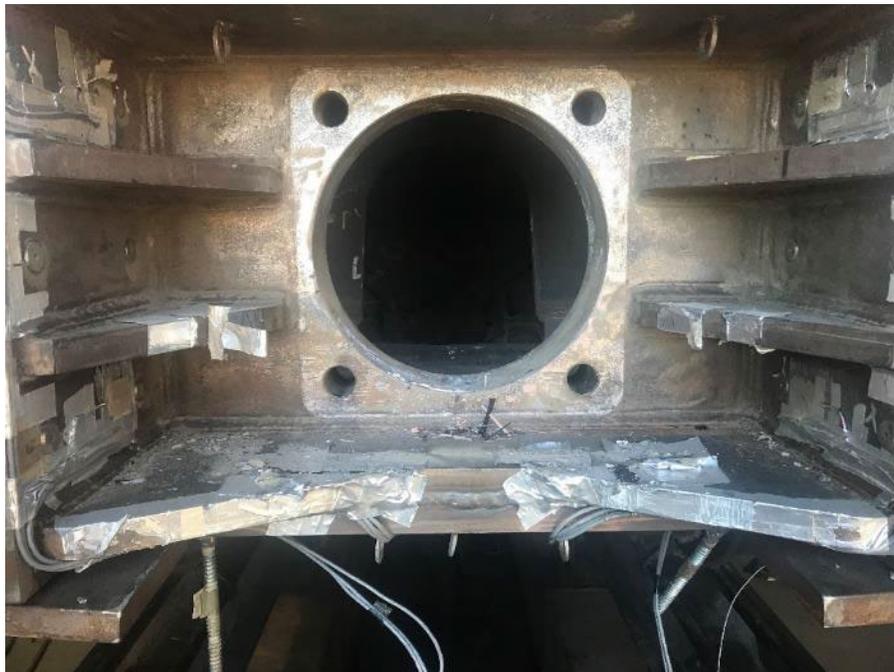
Figure 51. Sliding Lug after Test

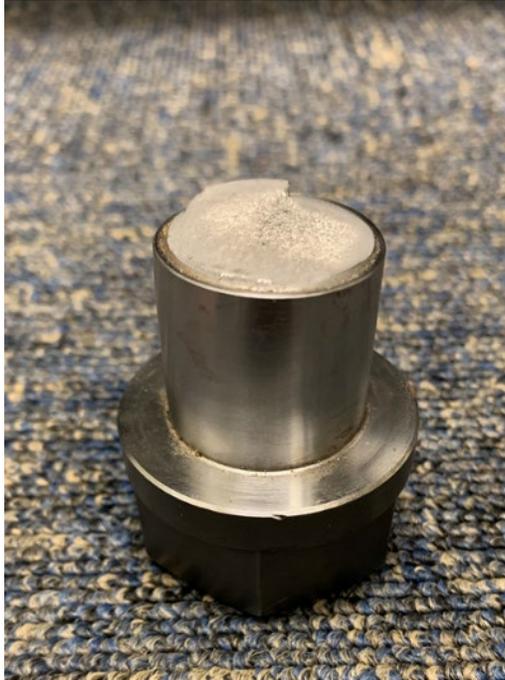
Figure 52. Activated Shear Bolt after Test

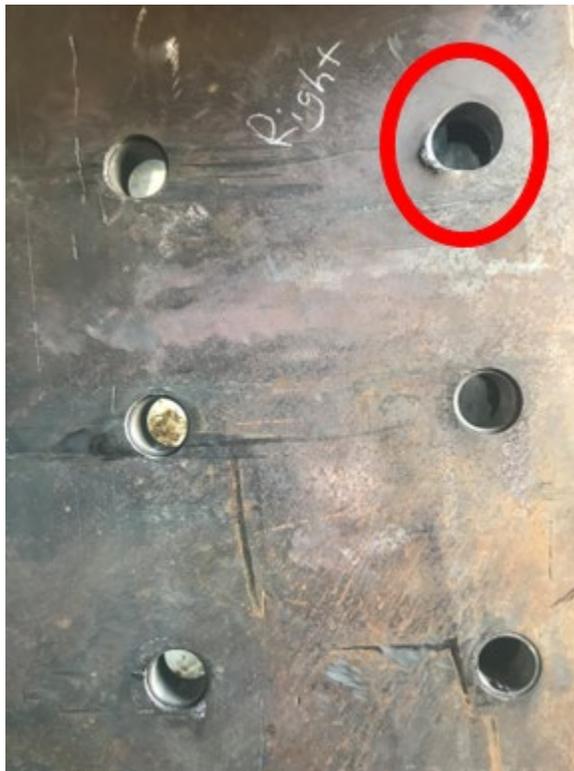
Figure 53. Deformed Bolt Hole in Draft Pocket
