U.S. Department
of Transportation
Federal Railroad
Administration

F40 CEM Locomotive and M1 Passenger Car Impact Test

| 14. ABSTRACT An impact test with a F40 locomotive and a M1 passenger car was conducted to evaluate the performance of the vehicles under dynamic conditions. The locomotive was retrofitted with crash energy management (CEM) components – including a push-back coupler (PBC), deformable anti-climbers, and a sliding lug connected to the draft pocket with a set of shear bolts. The impact test was performed in November 2021 at the Transportation Technology Center in Pueblo, Colorado. The M1 passenger car, backed by two empty hopper cars, was impacted by the CEM-equipped locomotive at 32.8 mph. The impact-initiated deformation on one set of anti-climbers, activated the PBC, and sheared all the shear bolts. | | | | | |

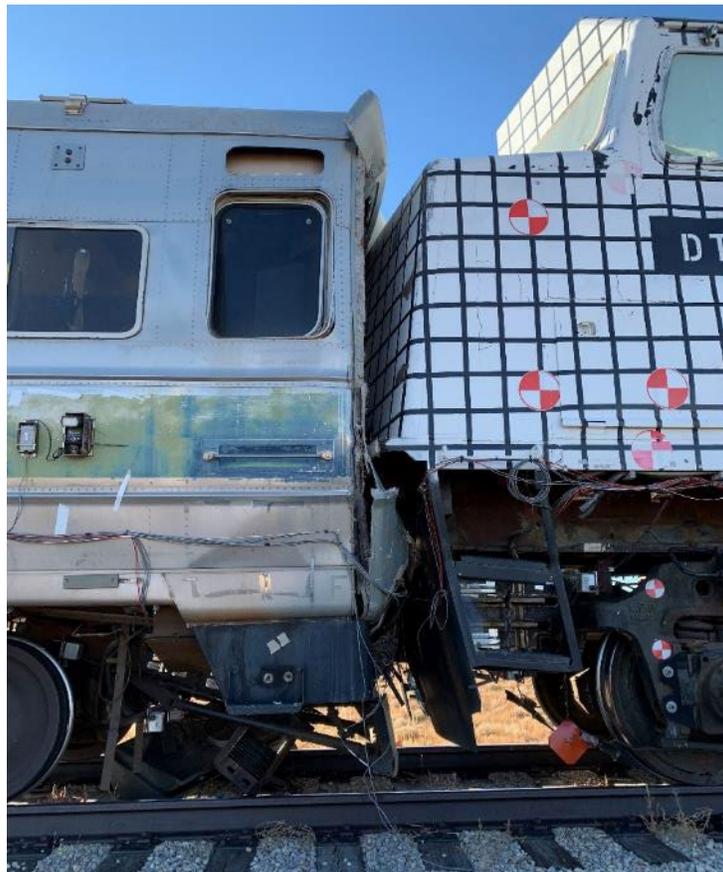
The locomotive and M1 passenger car couplers were closed at impact, preventing the possibility of coupling; however, the locomotive was lodged into the cab end of the M1 passenger car by the force of the impact. The vehicles had to be pulled apart after the test to assess damage to each vehicle. The impact damaged the front plate of the locomotive, bending it back toward the rear of the vehicle. No other structural damage on the locomotive was noted. The cab end of the M1 passenger car was severely damaged during the impact. Damage to the coupler, draft gear system, and occupational area of the carbody occurred. Also, the carbody buckled approximately three-quarters of the length of the car back from the impact point. Aside from the damage to the cab end of the car, the interior of the M1 passenger car was relatively unharmed except for deformation of the flooring. The damage of each vehicle is shown in [Figure 54](#) through [Figure 59](#).

Figure 54. CEM Locomotive and M1 Passenger Car Intertwined after Test

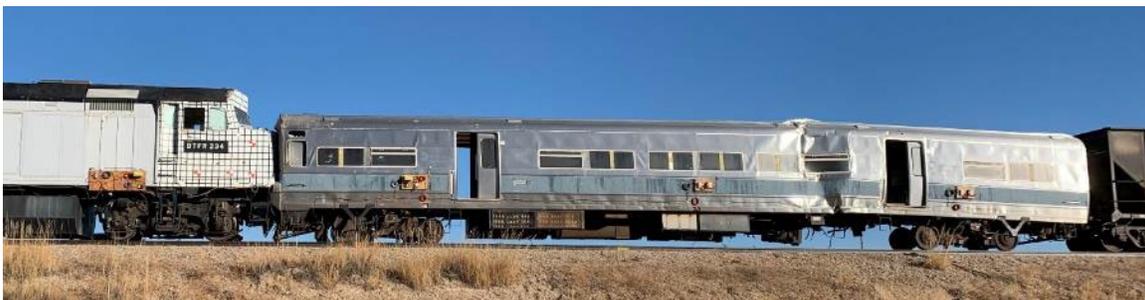
Figure 55. Buckled M1 Passenger Car

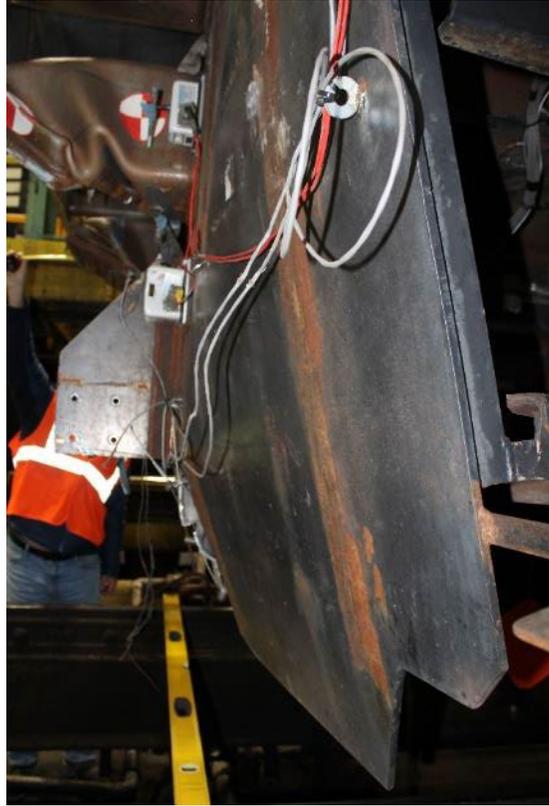
Figure 56. CEM Locomotive Bent Front Plate

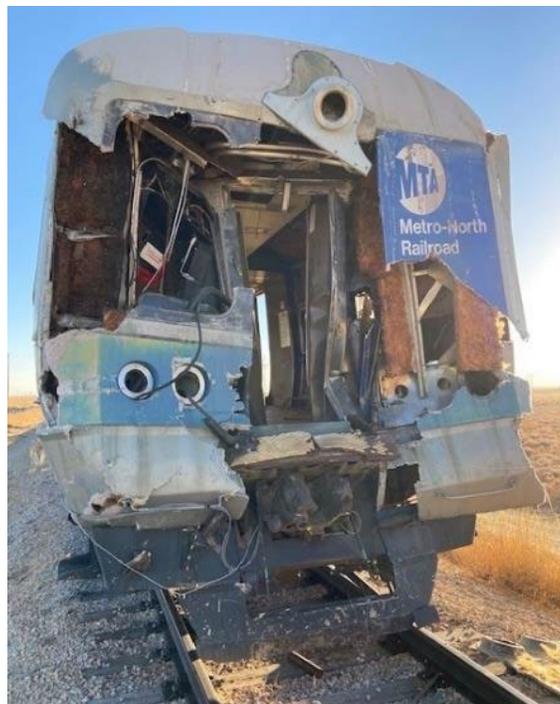
Figure 57. M1 Passenger Car Impact End (Cab) Exterior

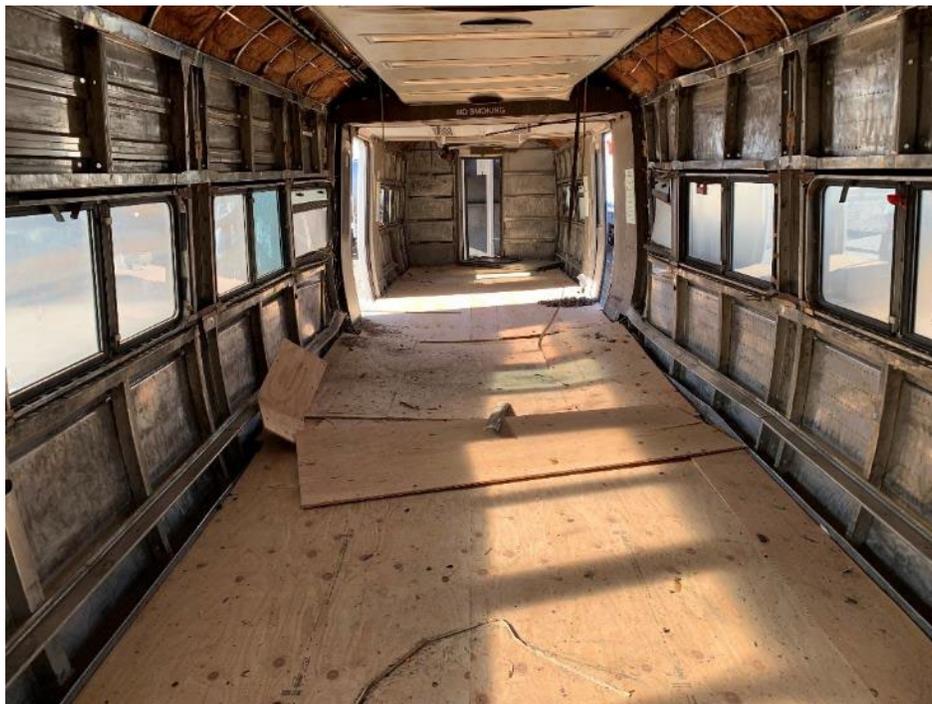
Figure 59. M1 Passenger Car Trailing End Interior
