*Federal Railroad Administration
Office of Railroad Safety*

*Accident Investigation Report
HQ-2022-1488*

*Canadian Pacific Railway Company (CP)
Castalia, IA
January 25, 2022*

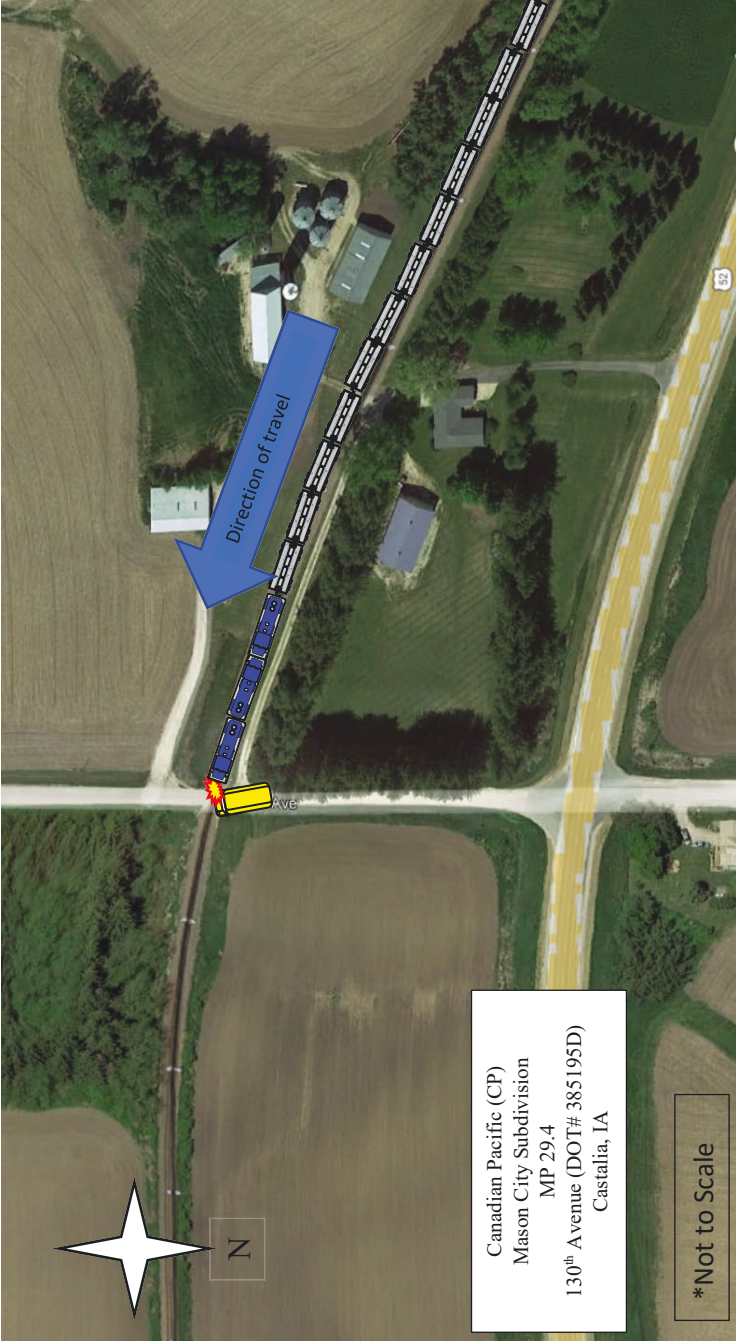
Canadian Pacific (CP)
Mason City Subdivision
MP 29.4
130th Avenue (DOT# 385195D)
Castalia, IA

The incident occurred on the Quad City Division, Mason City Subdivision at Milepost (MP) 29.4 when an eastbound CP freight train en route to Prairie du Chien, Wisconsin, struck a school bus on the passenger front side at the 130th Avenue highway-rail grade crossing (DOT# 385195D) in the city of Castalia, Winneshiek County, Iowa. The collision did not result in a derailment but did involve minor injury.

For this investigation, FRA conducted a sight distance survey using predetermined speed and distances provided in FHWA table 30 and table 32. The timetable speed of the railroad track is 30 mph and the speed limit of 130th Avenue is 55 mph. The sight distance is determined using these speeds and the tables. Cone A is placed at the beginning of the Crossing Approach Zone where the driver should first obtain information that there is a crossing ahead. Cone B is placed at the beginning of Non-Recovery Zone; this is the "last safe stopping point." At the "last safe stopping point," this is where the approaching highway-user must be able to see an approaching train so that a safe stop can be made if necessary. Cone C is placed at the stop line of the road, approximately 15 feet from the nearest rail. Cone D is at the distance along the railroad from crossing (dT): The distance dT is defined as "sight-distance leg along the railroad tracks to permit the maneuvers described as for dH (ft)." The definition of dH (distance along the highway) is defined as "sight-distance leg along the highway allows a vehicle proceeding at speed to cross tracks even though a train is observed at a distance dT from the crossing or to stop the vehicle without encroachment of the crossing area (ft)." Table 30 indicates that cone A needs to be 1,030 feet from cone C, and cone B needs to be 535 feet from cone C. Table 32 indicated cone D needs to be 321 feet down the track from cone C. At cone A and cone B there is zero sight distance to cone D at this location. The trees and brush surrounding the railroad track obstruct the view. During the sight distance survey, a cone was placed at the location where a vehicle could see cone D, and this was 36 feet from cone C.
