U.S. Department  
of Transportation  
Federal Railroad  
Administration

Office of Research,  
Development and Technology  
Washington, DC 20590

## Technologies and Testing to Prevent Water Ingress in Railroad Bearings

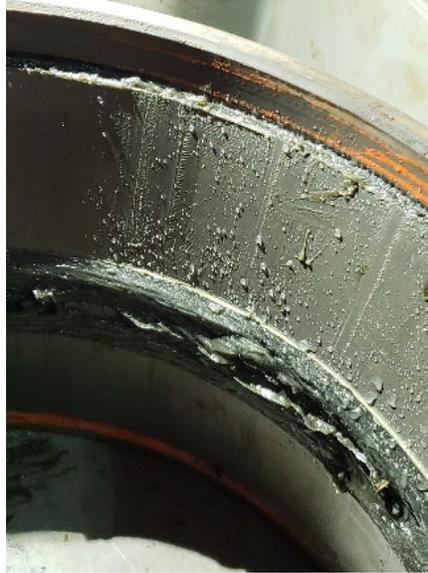
**Figure 1. Bearing Cup Running Surface with Water Ingress**

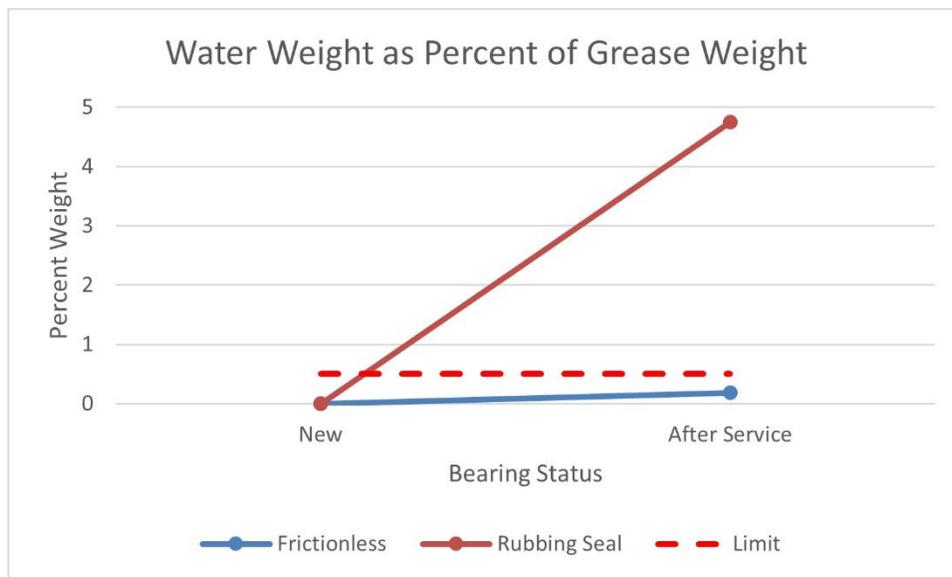
The four bearings with frictionless seals passed the water ingress test. The highest water weight measured was 0.42 percent of the grease weight and the lowest water weight was 0 percent of the grease weight.

Two of the bearings with rubbing lip seals failed the water ingress test. All four bearings with rubbing lip seals had an average free water weight accumulation of 4.26 percent of the grease weight. The highest water weight measured was 13.59 percent of the grease weight and the lowest water weight measured was 0 percent of the grease weight. [Figure 2](#) shows the mean free water weight of these bearings as a percentage of the grease weight.

**Figure 2. Water Weight as Percent of Grease Weight in Test Bearings**

Based on these results, the rubbing lip seals appear less likely to prevent water ingress at the end of their normal service life. Therefore, it was decided to test a larger set of bearings to investigate this finding. The bearing seals were tested at different points in their service life to determine if the seals degraded during performance and, if so, determine the period of wear.

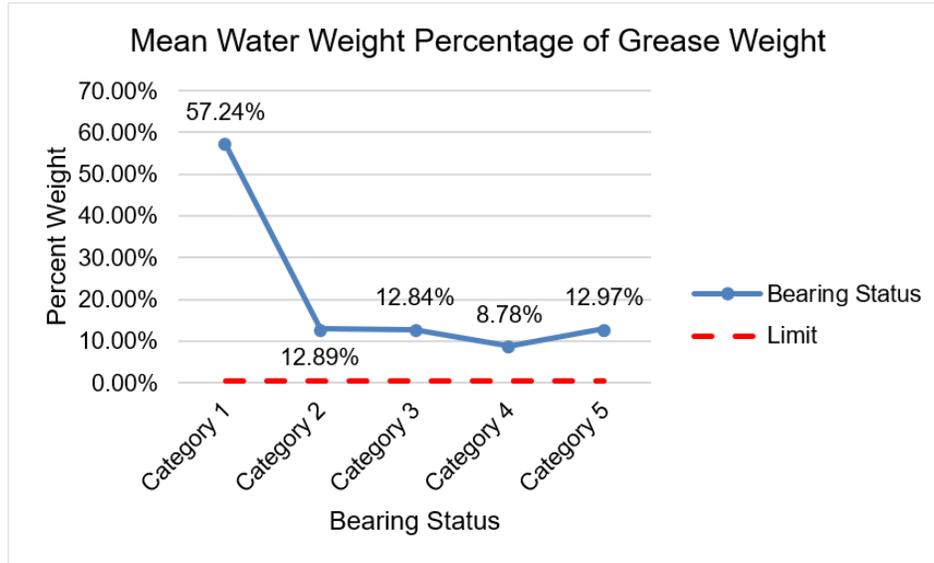
Only three of the 16 bearings tested finished the water spray test with a water weight to grease weight percentage of less than 0.5. [Figure 3](#) shows the mean water weight percentage of the grease weight for each category of bearing service.

**Figure 3. Mean Water Weight Percentage of Grease Weight in Bearings Over Their Service Life**

The results of this test were unexpected. Not only are the means of the water weight high in each category, but they are also similar for most categories (the outlier of Category 1 may be related to the small sample size of that category). If the rubbing lip bearing seals lost their ability to remain watertight over their service life, one would expect to see an increase in the weight of water as the service life period increased or a shift in means at that service life period. A loss of watertightness may occur before the first investigation period, and as a result the degradation of the seals does not increase the water weight allowed in the bearing over time.

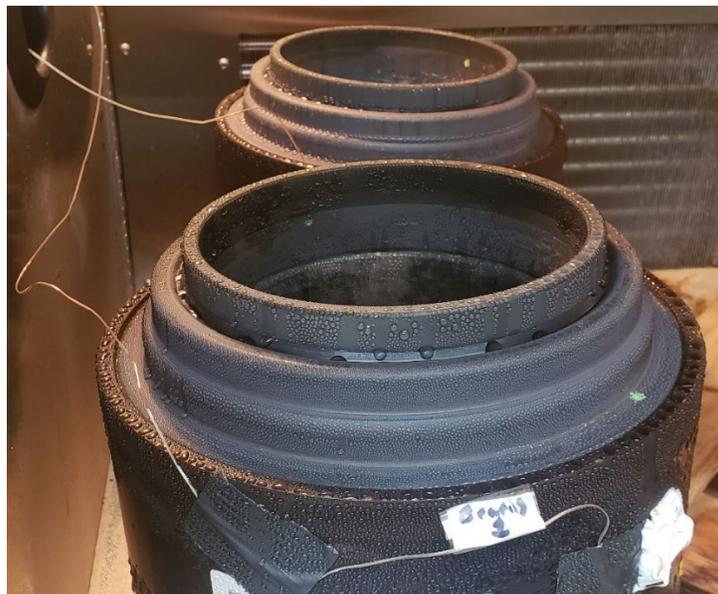
The cycles started at an ambient temperature of 105°F and was held until the bearing reached the same temperature. From test start through completion the relative humidity was held at 70 percent. The ambient temperature was then dropped to 32°F. As the temperature dropped, the moisture in the air condensed onto the surfaces of the bearings. The lower temperature was held until the bearing surface reached the 32 degrees. The water that condensed on the bearing surface then began to freeze. The cycle was then repeated, with the temperature again rising to 105°F and the relative humidity held at 70 percent up to that temperature, allowing the water to evaporate again. [Figure 4](#) shows the bearings in the environmental chamber.

**Figure 4. Bearings in Environmental Chamber**

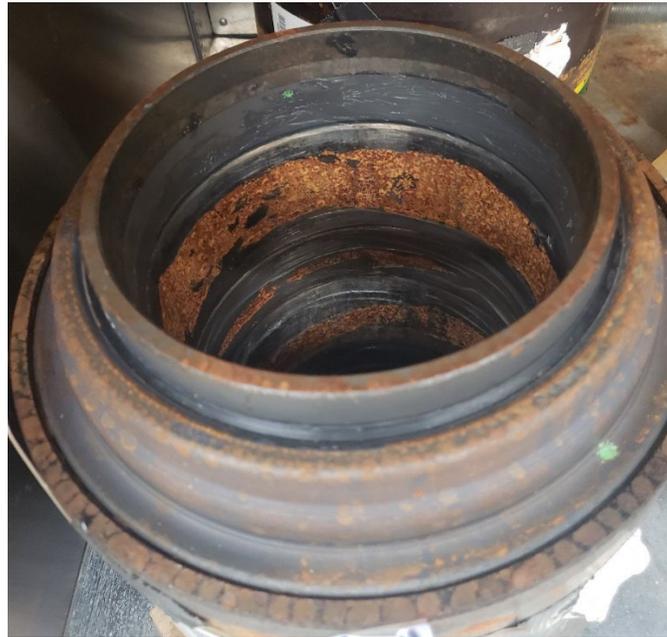
After approximately 125 temperature cycles, two of the frictionless seal bearings and two of the rubbing lip seal bearings were removed from the test chamber. The effect of humidity on many of the bearing components was evident; the exterior surfaces of the bearings, including the cups, backing rings, end caps, and end cap bolts had corroded. This corrosion is shown in [Figure 5](#). While there was evidence of water on the bearing seals, there was no evidence of water penetrating through the seal and seal grease on either bearing seal type.

**Figure 5. Corrosion on Bearing Surfaces**

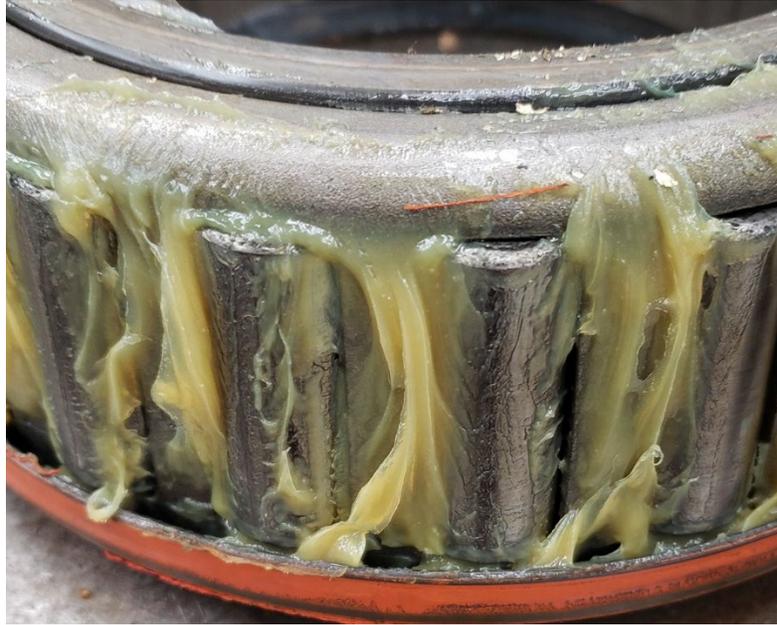
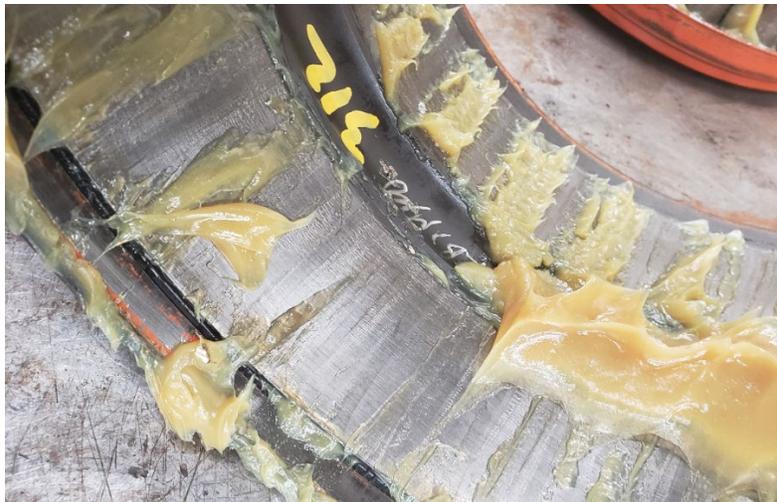
Similarly, after approximately 250 cycles, the remaining two frictionless seal bearings and two rubbing lip seal bearings were removed from the chamber. The corrosion was evident on these bearings as well, but again there was no evidence of water penetrating through the seal and seal grease on either bearing type. The resulting effects on the frictionless seal bearings and rubbing lip seal bearings are shown in [Figure 6](#) and [Figure 7](#), respectively.

**Figure 6. Frictionless Seal Bearing at the End of Environmental Test, (a) cone and (b) cup**

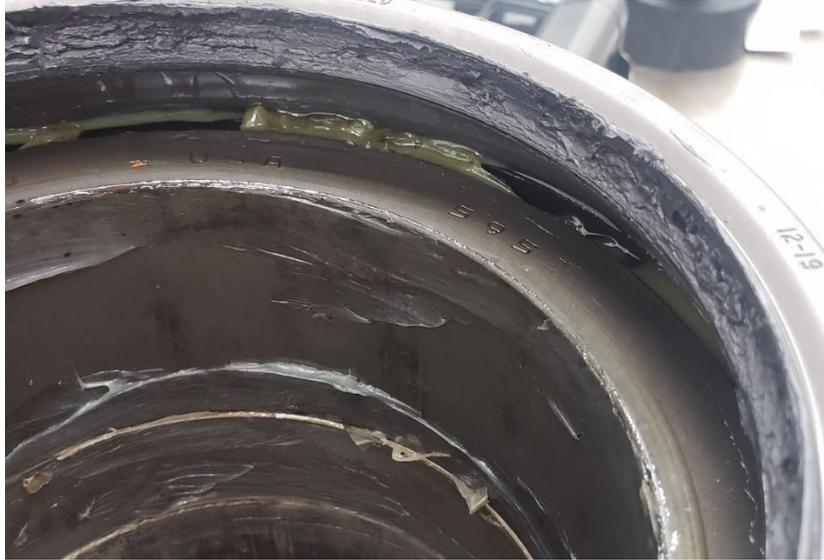
**Figure 7. Rubbing Lip Seal Bearing at the End of Environmental Test**

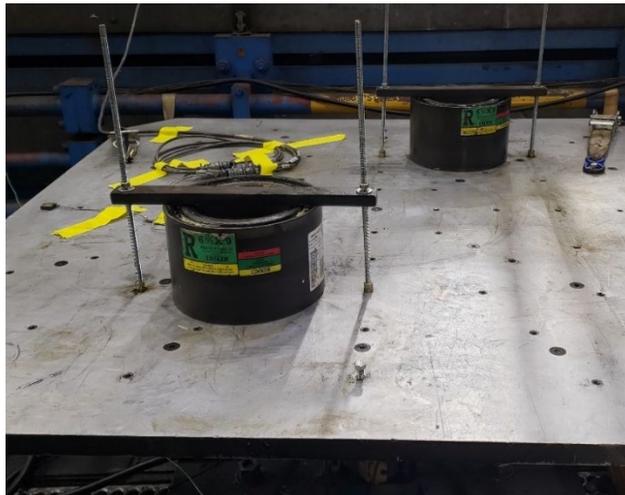
To further understand fretting corrosion, researchers attempted to induce fretting wear in two bearings using a shaker table test. This test induced vibrations on two class K bearings to determine the possibility of revenue service caused fretting wear and corrosion. The bearings were installed on the shaker table without seals with the bearing cup secured to the tabletop. This setup allowed the cone assemblies to move freely. The contact area under observation was between the rollers and cup raceway. The test setup is shown in [Figure 8](#).

**Figure 8. Shaker Table Test Setup**

The shaker table was operated at 12 Hz with a 2mm displacement from zero to peak; this corresponds to 1.15 G zero to peak (0.813 G rms). This displacement distance means that the roller surface and cup raceway surface are categorized into the gross slip fretting regime. Runs were made at 20,000 cycles, 40,000 cycles, and 120,000 cycles. The first two test runs were

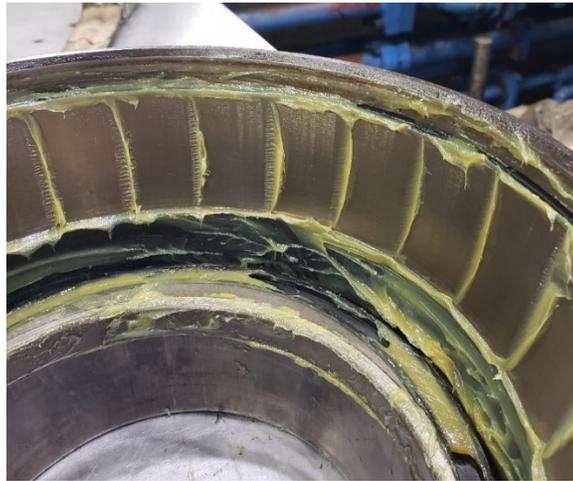
made with the bearing in the “as assembled” operational condition, i.e., fully greased. The bearing was spun sufficiently to ensure the grease was fully distributed across the bearing components. After the second test, it became apparent that vibration alone was insufficient to create fretting conditions in the bearing. The rollers could not penetrate the protective film of the grease and contact the cup running surface. [Figure 9](#) shows the cup running surface after the first two test runs.

**Figure 9. Bearing Running Surface After Second Test**

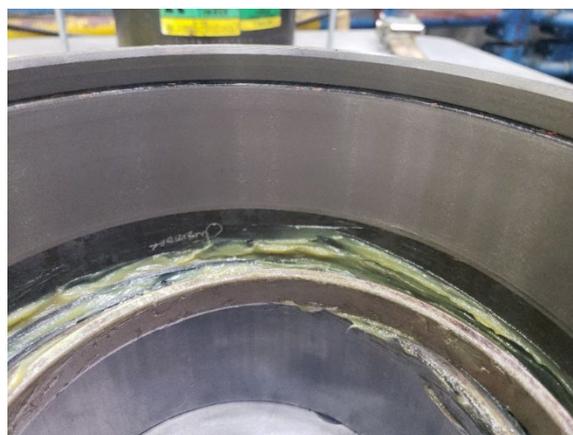
Before the third test run, the grease was physically removed, but not washed away, from the running surfaces. This was done to avoid introducing contaminants to the surface and avoid the unrealistic industry application of a bearing completely without lubrication. Once again, vibration was not sufficient to induce fretting wear on the roller or the raceway surfaces, even after 125,000 cycles, because the roller was not able to penetrate the residual film of the lubricant. [Figure 10](#) shows the running surface after the last test (streaks on the surface are created by the overhead lights).

**Figure 10. Bearing Running Surface After Last Test**

These tests show that for ordinary situations, such as shipping, storage, and installation on unloaded wheelsets, vibration alone is not sufficient to induce fretting wear between the rollers
