Locomotive Crash Energy Management Train-to-Train Collision Test

1. REPORT DATE (DD-MM-YYYY) 21/09/2022		2. REPORT TYPE Technical Report		3. DATES COVERED (From - To) August–September 2022	
4. TITLE AND SUBTITLE Locomotive Crash Energy Management Train-to-Train Collision Test				5a. CONTRACT NUMBER DTFR5311D00008L	
				5b. GRANT NUMBER	
				5c. PROGRAM ELEMENT NUMBER

13. SUPPLEMENTARY NOTES COR: Jeff Gordon					
14. ABSTRACT The Federal Railroad Administration (FRA) sponsored MxV Rail to conduct a collision test using both a moving and a stationary three-car consist. The moving consist included an EMD F40 passenger locomotive equipped with crash energy management (CEM) components backed by two M1-series passenger cars. The M1 passenger cars were also equipped for three occupant protection experiments using wheelchairs and anthropomorphic test devices (ATDs). The stationary consist included a conventional F40 passenger locomotive backed by two empty freight cars. The impact test was performed on August 11, 2022, at the Transportation Technology Center in Pueblo, Colorado. The moving consist impacted the stationary consist at 24.3 mph. The impact initiated deformation of the anti-c

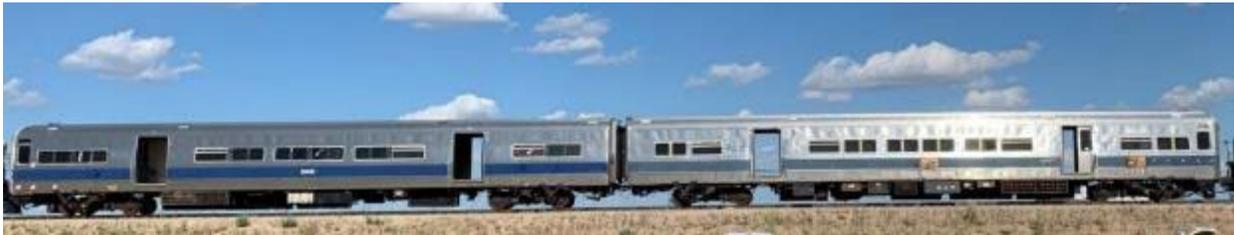
The moving consist contained the CEM locomotive and two M1 passenger cars (Figure 2). The M1 passenger cars were coupled together as a married pair with the cab end of car 8332 coupled to the CEM locomotive and the cab end of car 8221 at the rear of the consist. M1 passenger cars 8332 and 8221 weighed 79,575 lb and 78,000 lb, respectively. Researchers performed asbestos abatement on the M1 passenger cars. The abatement process involved removing the seats, flooring, and interior side paneling from the car. The team replaced the flooring with two layers of 1/2 inch plywood secured to the car frame to simulate the original car floor structure and rigidity. Researchers left empty spaces in the plywood flooring to install three wheeled mobility device restraint systems. The team secured the restraint system components to the frame of the car and filled the area around each experiment with plywood.

Figure 2. M1 Passenger Cars 8332 and 8221

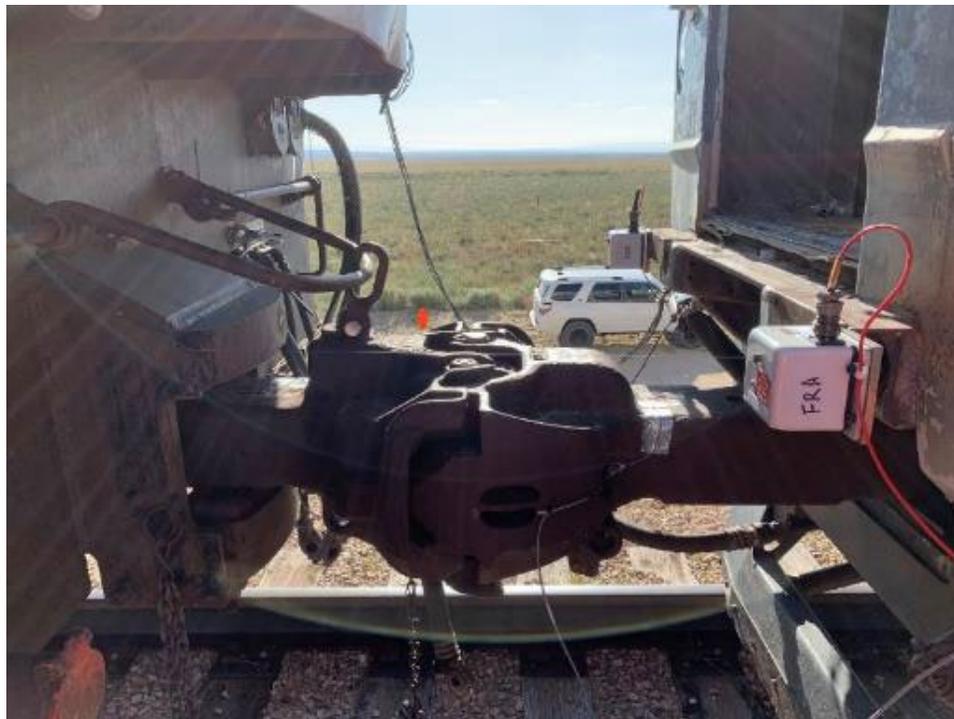
Figure 21. First M1 Passenger Car Front Coupler String Potentiometers

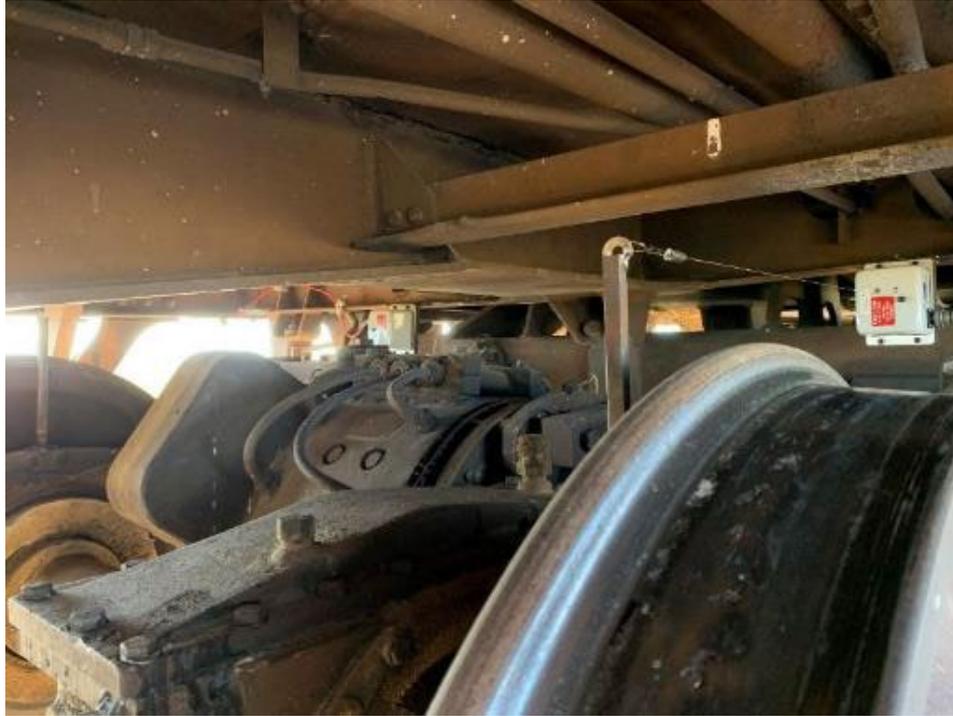
Figure 22. First M1 Passenger Car Lead Truck to Bolster String Potentiometers

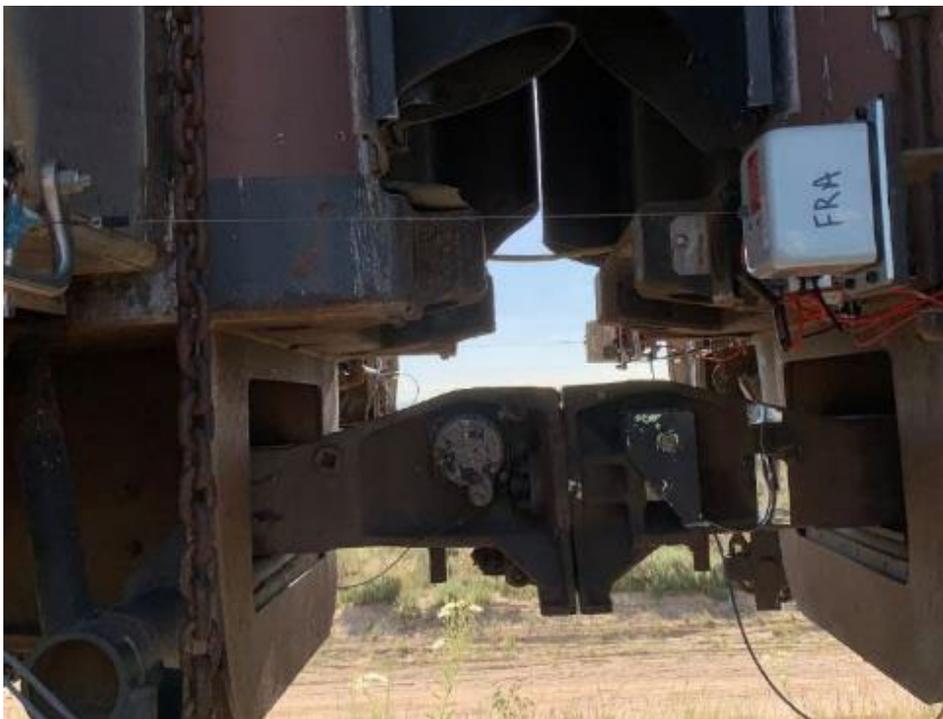
Figure 28. Second M1 Passenger Car Coupler String Potentiometers

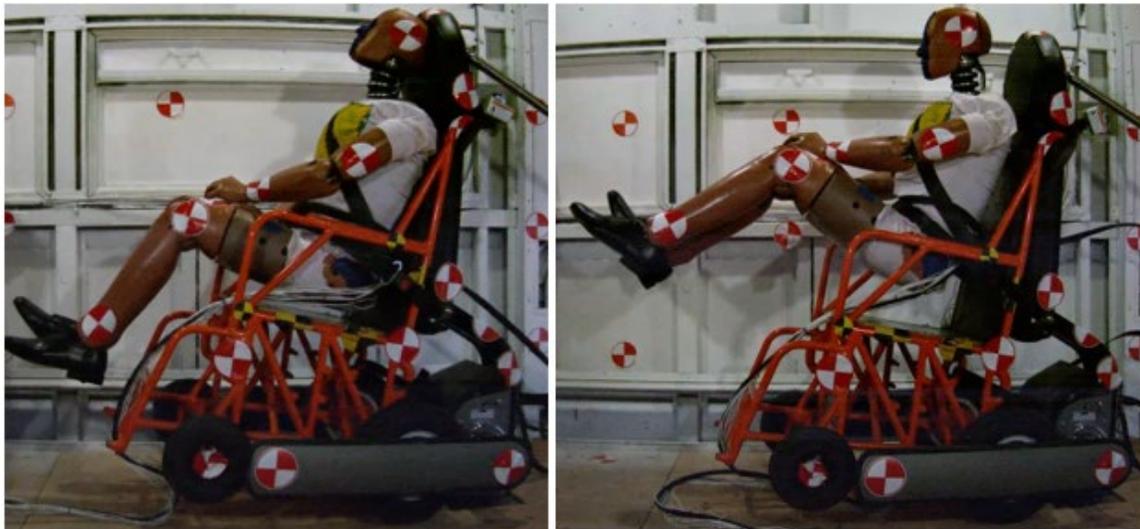
During the impact, the restrained surrogate wheelchair and ATD pushed back into the backboard. Due to the presence of a plate on the bottom of the surrogate wheelchair, the wheelchair contacted the chassis of the Quantum system before the back of the wheelchair could rest against the backboard padding. This contact caused the wheelchair to pivot on its restrained back wheels. As a result of the pivoting motion, the front wheels lifted off the floor and the ATD's head snapped back and contacted the backboard padding. The ATD's head bounced off the backboard and shifted slightly away from the original direction of travel during impact. The ATD became airborne during the rebound and eventually returned to the seat of the surrogate wheelchair. The seatbelt harness helped to prevent the ATD from traveling higher off the seat and possibly falling out of the wheelchair away from the direction of travel on the rebound. The ATD landed back in the wheelchair and was upright at the completion of the test. [Figure 72](#) displays the different movements experienced by the ATD and the surrogate wheelchair during impact.

Figure 71. Occupant Protection Experiment 2.2 Impact Movement

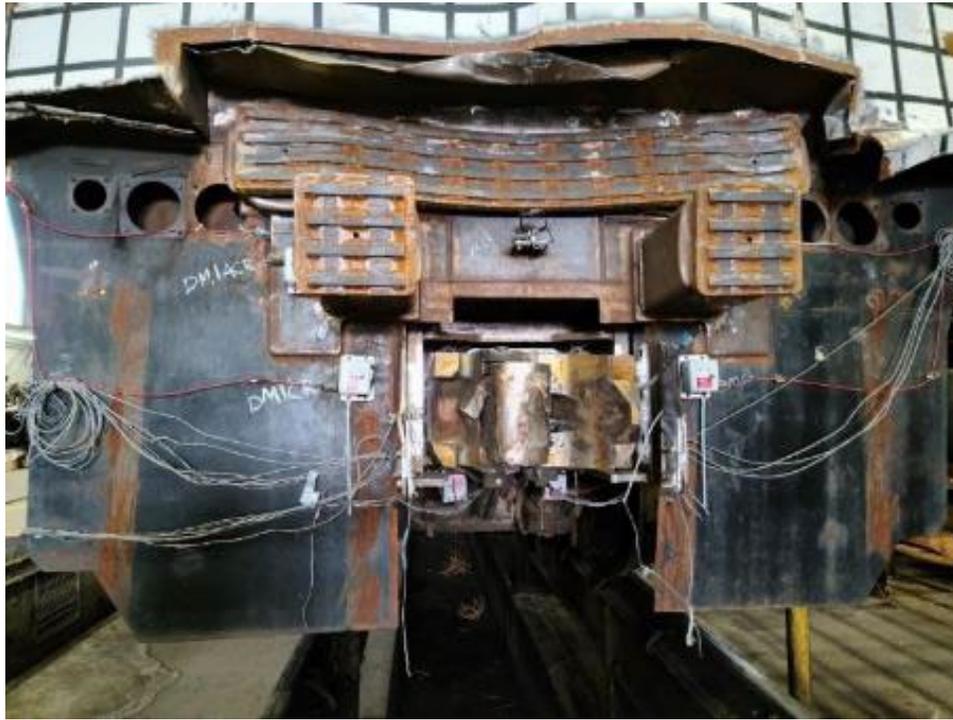
Figure 95. Crushed Upper DAC and Partially Crushed Lower DAC Tubes

of the draft pocket. The CEM components after the test are shown in [Figure 96](#) through [Figure 98](#).

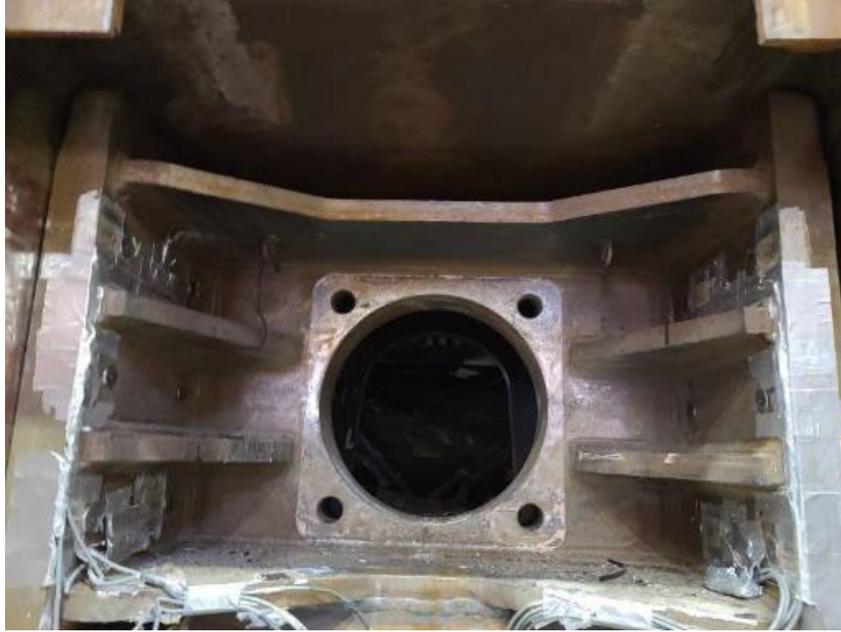
Figure 97. Sliding Lug after Test

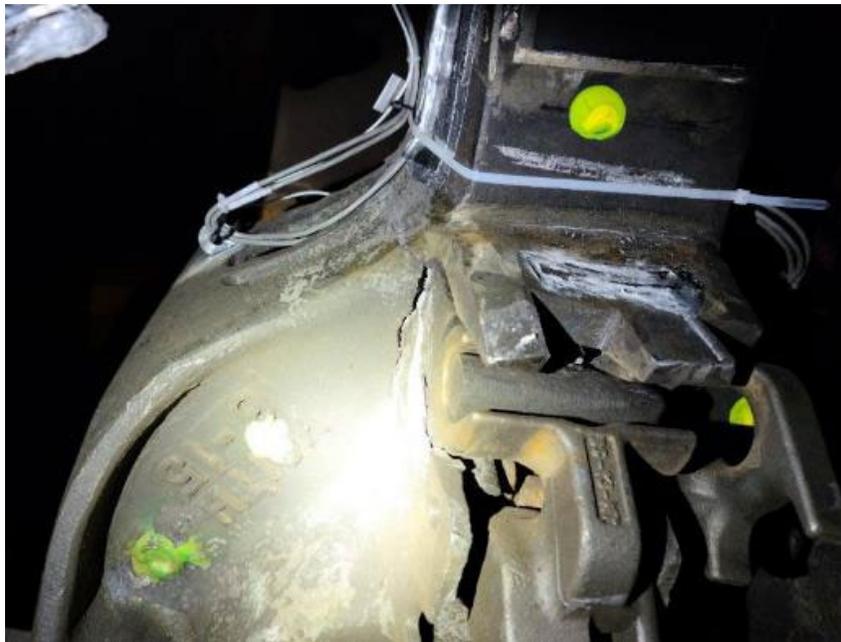
Both the CEM locomotive coupler and conventional locomotive coupler were closed at impact. The force of impact caused the head of the casting on the PBC to split open vertically. The force and damage to the coupler appeared to have allowed the impacting knuckles to bypass each other and end up in a coupled configuration. After both consists stopped, the couplers were locked together and could only be separated using a hydraulic cylinder to force the locomotives apart. The conventional locomotive's coupler showed no outer signs of damage after the impact, but its knuckle did not open correctly. The cracked PBC is shown in [Figure 99](#) and [Figure 100](#). The conventional locomotive's coupler is shown in [Figure 101](#).

Figure 98. Crack Along the Bottom of the PBC Coupler Head

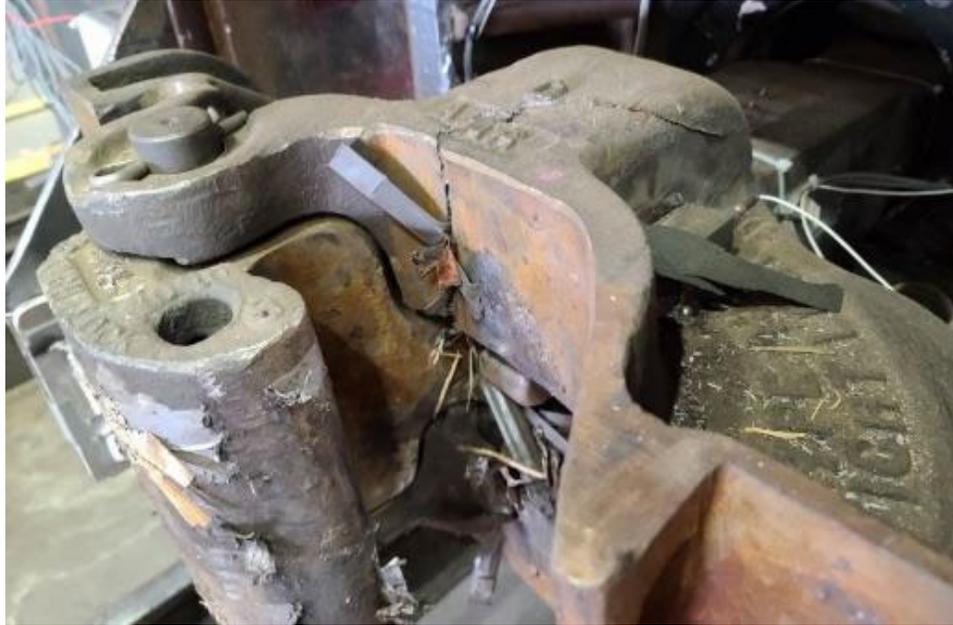
Figure 99. Crack Along the Front and Top of the PBC Coupler Head

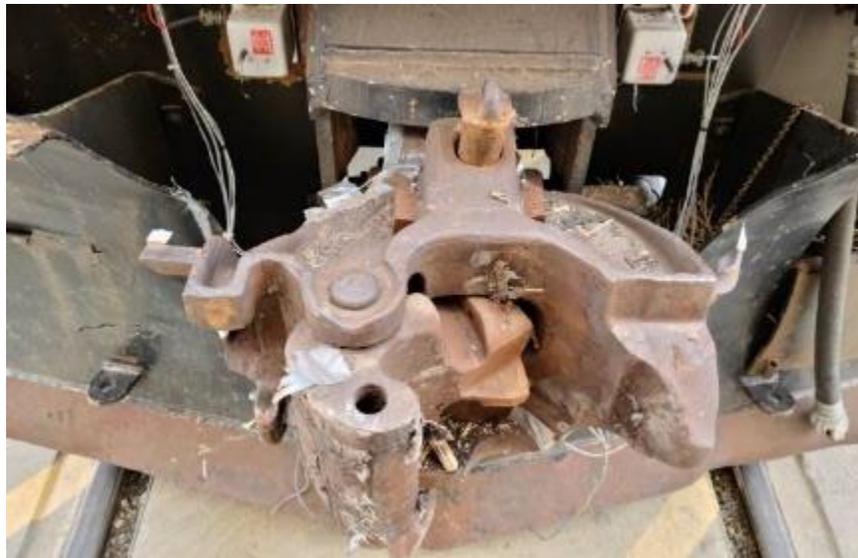
Figure 100. Conventional Locomotive Coupler Head – After Impact

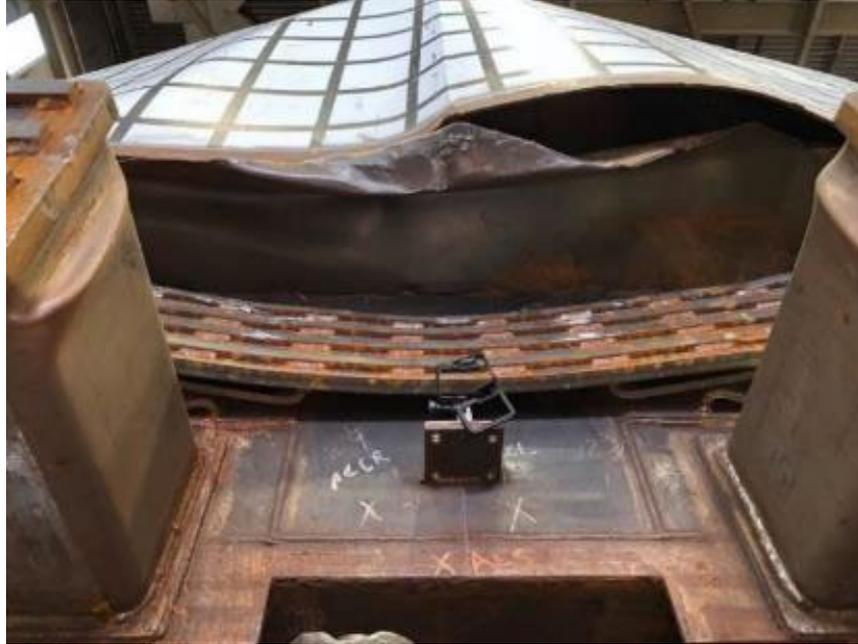
The nose of the CEM locomotive showed significant deformation upon impact (Figure 102). The CEM locomotive's front plate also deformed, bending toward the rear of the vehicle at the outboard edges (Figure 103). There appeared to be cracks along the welds between the CEM locomotive front plate and the reinforced DAC plates on both the left and right side of the locomotive, as shown in Figure 104 and Figure 105. The interior floor of the locomotive behind the nose was deformed as well as the bottom of the interior side structures. Figure 106 and Figure 107 show the deformation of the floor and interior side structures, respectively.

Figure 101. CEM Locomotive – Deformed Nose

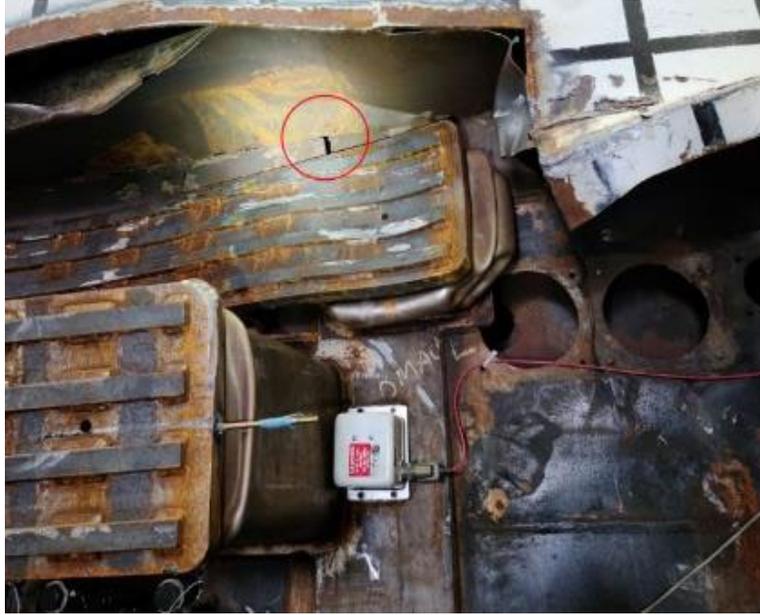
Figure 103. Left Side of the Cracked Front Plate (Highlight in Red)

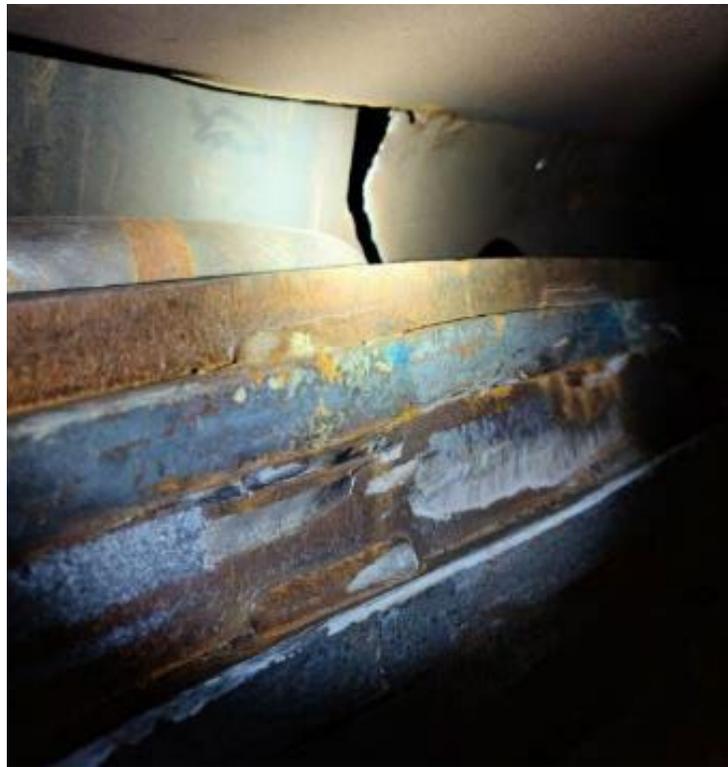
Figure 104. Right Side of the Cracked Front Plate

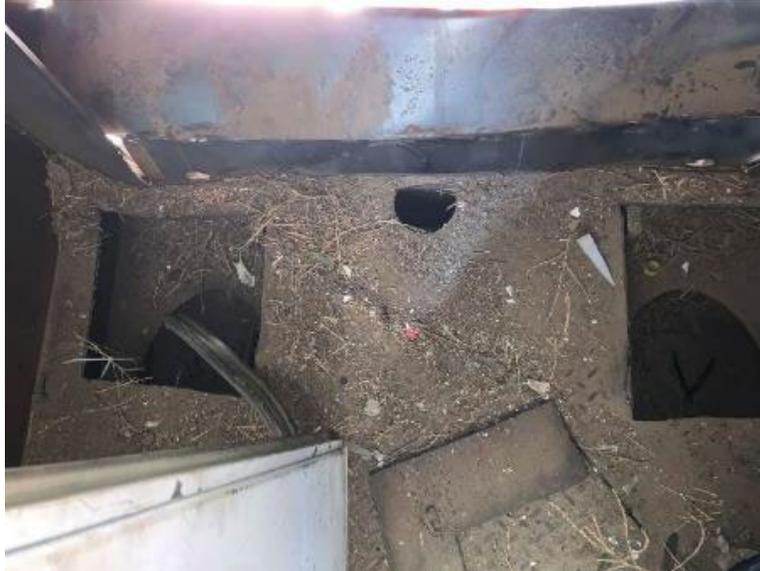
Figure 105. Locomotive Interior Floor behind Nose

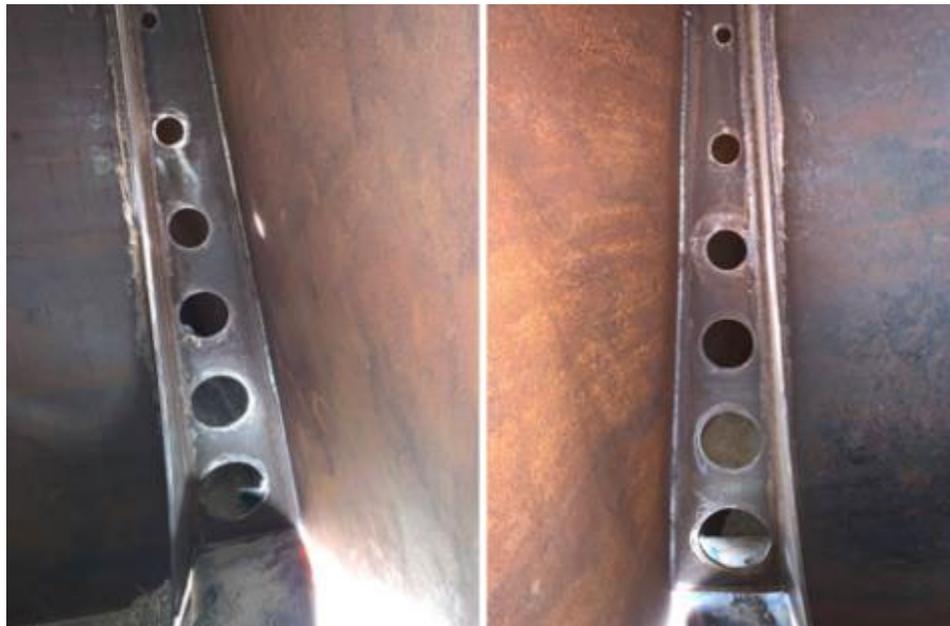
Figure 106. CEM Locomotive Left and Right Interior Side Structures

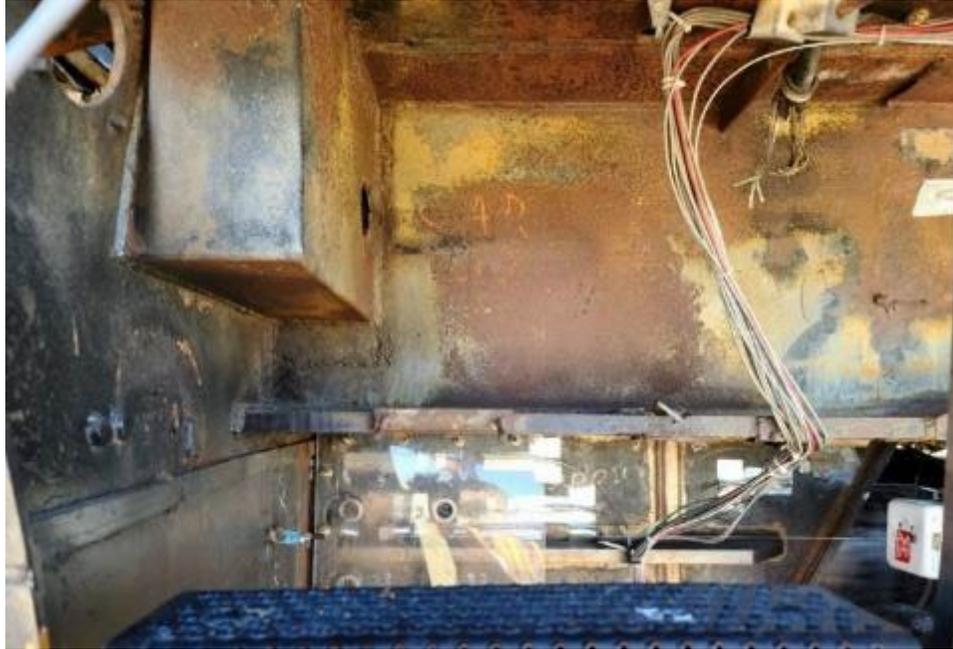
There appeared to be some deformation in either the CEM locomotive's front draft pocket, the center sill, or both. The lower flange of the center sill near the draft pocket had a slight curve after the impact, as shown in [Figure 108](#). In addition, the top of the draft pocket had lowered enough to contact the top of the sliding lug. This caused the sliding lug to bind against the top of the draft pocket, preventing it from moving freely. The top of the draft pocket that contacted the sliding lug is shown in [Figure 109](#).

Figure 107. Curved Center Sill in Front End of CEM Locomotive

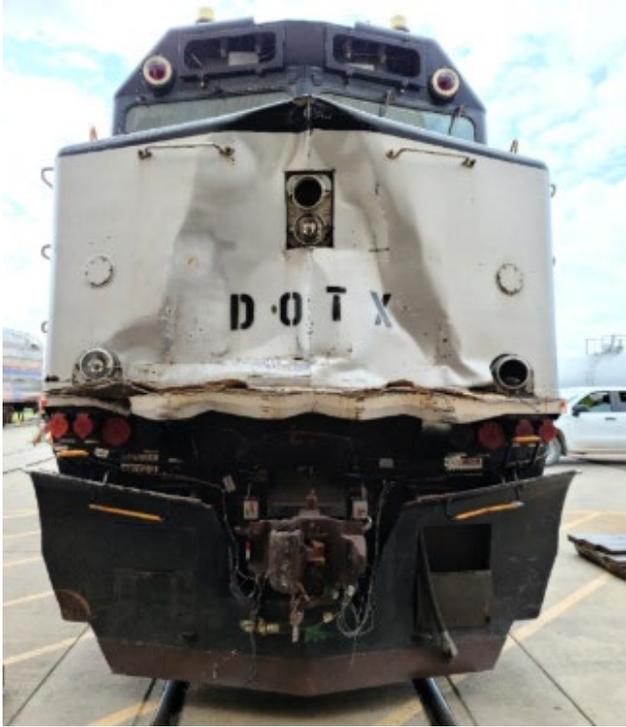
Figure 109. Damaged Front of the Conventional Locomotive

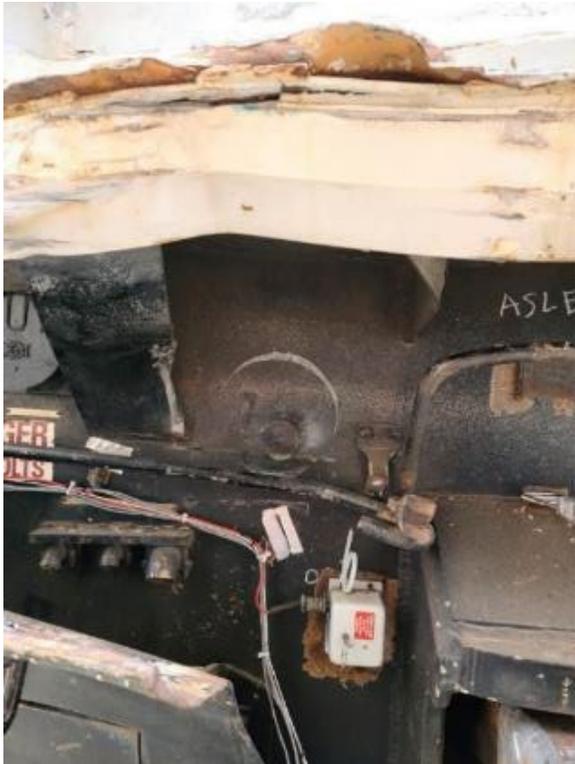
Figure 110. Buckled Floor Structure and Deformed Front Plate, Right Side

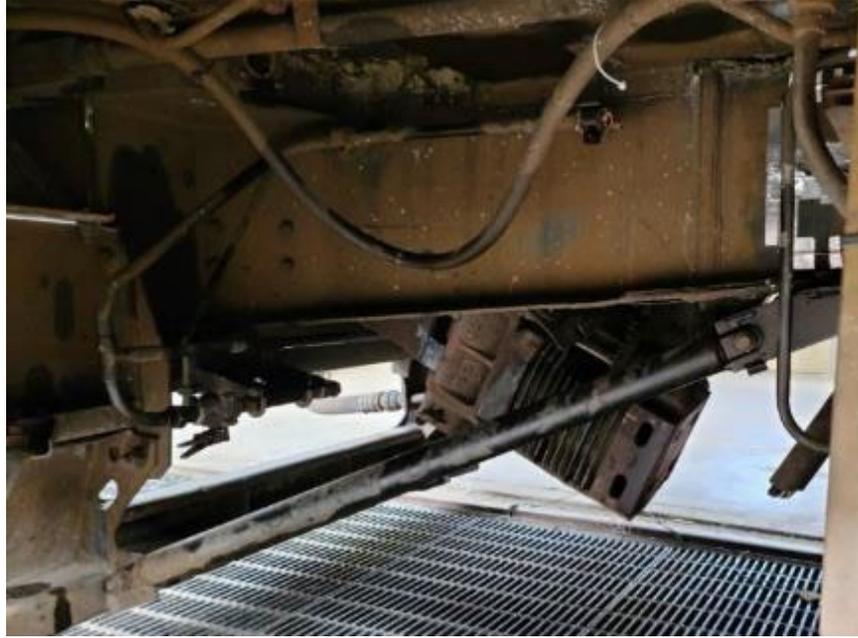
The first M1 car in the mobile consist (i.e., 8332) showed significant damage to its front draft gear. During impact, the plate that held the yoke inside the draft pocket was ejected from the car. The plate ejection allowed the yoke to hang under the draft pocket and forced the front coupler to rest at a sharp upward angle. The upward angle of the coupler also caused a small amount of deformation in the front plate of 8332, just above the draft pocket opening. The yoke and front coupler shank from 8332 are shown in [Figure 114](#) and [Figure 115](#).

Figure 113. Yoke from the Front Coupler on Car 8332

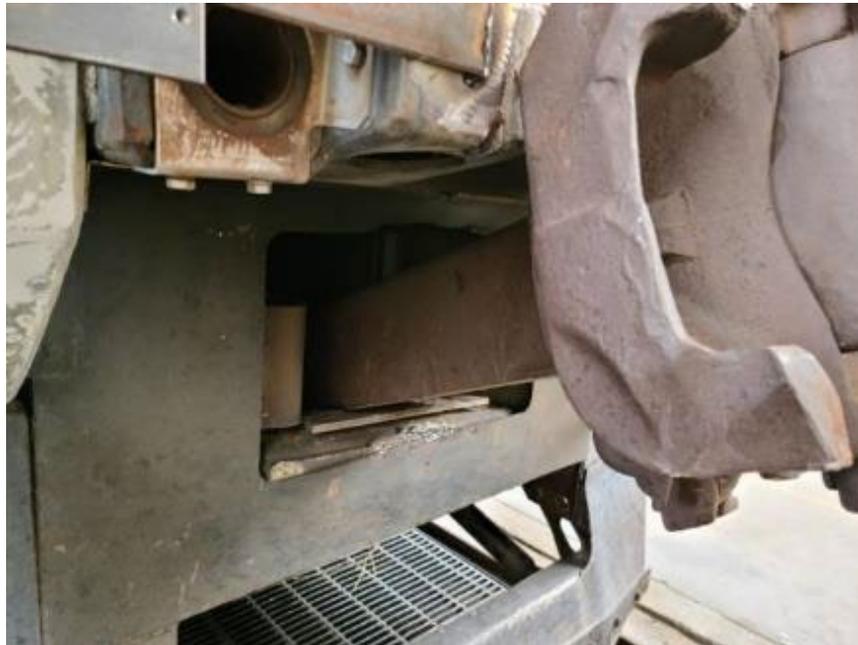
Figure 114. Shank from Front Coupler on 8332 at Upward Angle

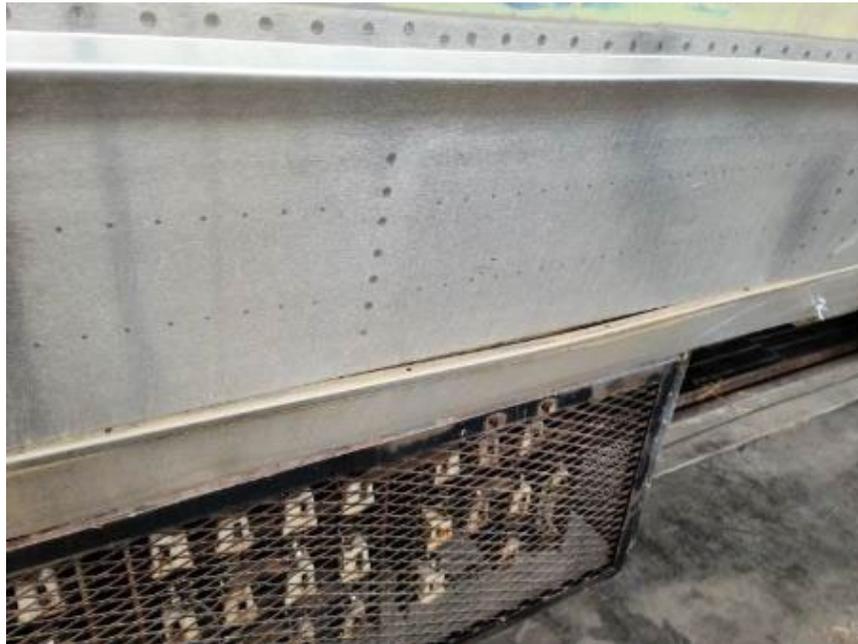
Both M1 cars 8332 and 8221 experienced wrinkling in their stainless-steel skin from the impact. The team also observed small amounts of deformation in the car's side sills, especially near the traction rod connections to the trucks. However, no significant structural damage was observed on either the exterior or interior of the M1 cars. Several traction rods were bent on both 8332 and 8221. The left side traction rod on car 8221's cab end was ejected from its mounts during the impact, damaging the mounting connections on both the carbody and the truck. [Figure 116](#)

Figure 115. Side Sill Deformation on the Right Side of 8332

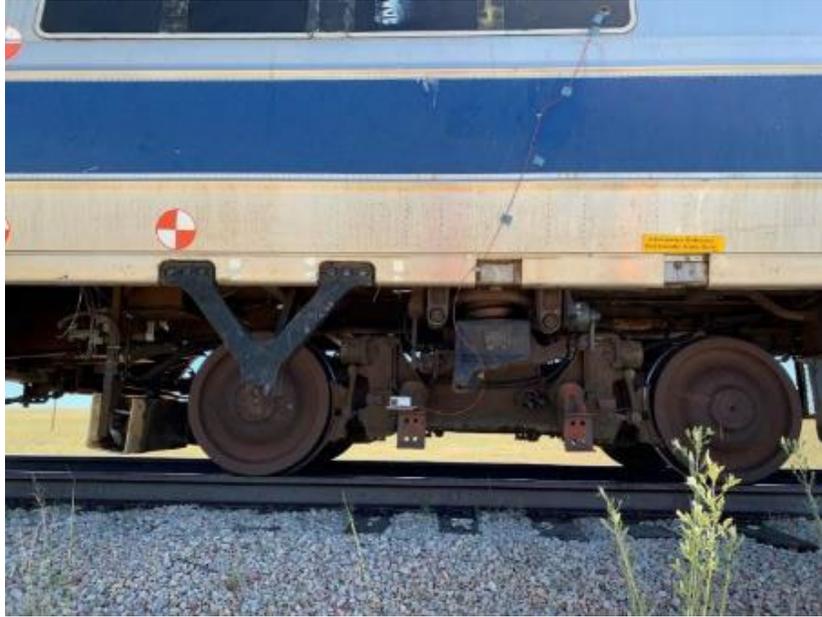
Figure 117. Broken Traction Rod Mountings on Cab End of 8221

shows an example of side sill deformation on car 8332. One of the bent traction rods is shown in [Figure 117](#). The truck on car 8221 with the ejected traction rod is shown in [Figure 118](#).

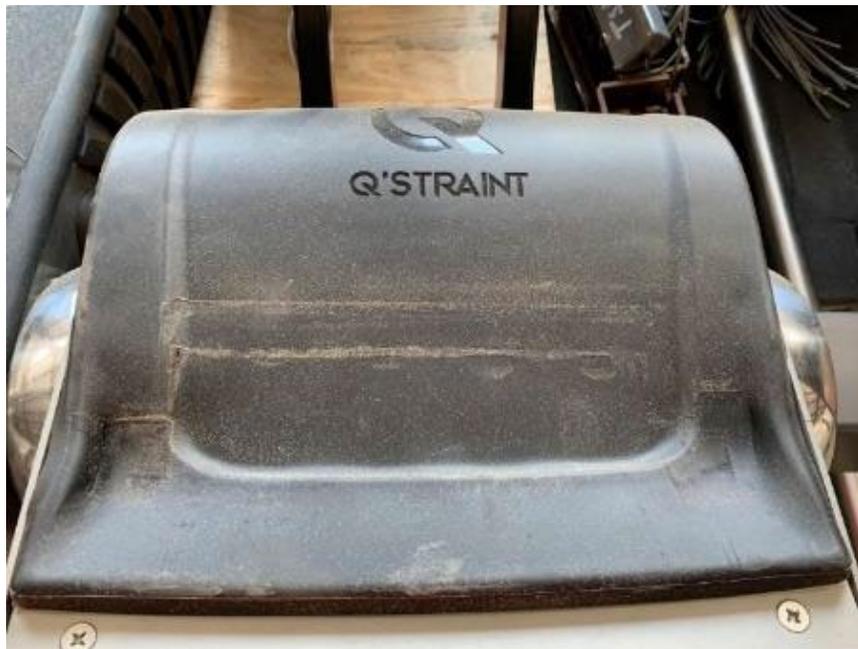
Figure 122. Damaged Cover Plate on the Quantum Chassis

The occupant protection systems held the ATDs and wheelchairs upright during the impact and limited the movement of the equipment and ATDs. A single device was cosmetically damaged due to a point load from the surrogate wheelchair on the chassis' cover plate, but the device was still functional after testing was complete.
