Vertical Split Rim: Causes and Prevention

1. AGENCY USE ONLY (Leave blank)		2. REPORT DATE September 2023		3. REPORT TYPE AND DATES COVERED Technical Report
4. TITLE AND SUBTITLE Vertical Split Rim: Causes and Prevention			5. FUNDING NUMBERS DTFR53-11-D-00008 Task Order 334

9. SPONSORING/MONITORING AGENCY NAME(S) AND ADDRESS(ES) U.S. Department of Transportation Federal Railroad Administration Office of Railroad Policy and Development Office of Research, Development and Technology Washington, DC 20590			10. SPONSORING/MONITORING AGENCY REPORT NUMBER DOT/FRA/ORD-23/30

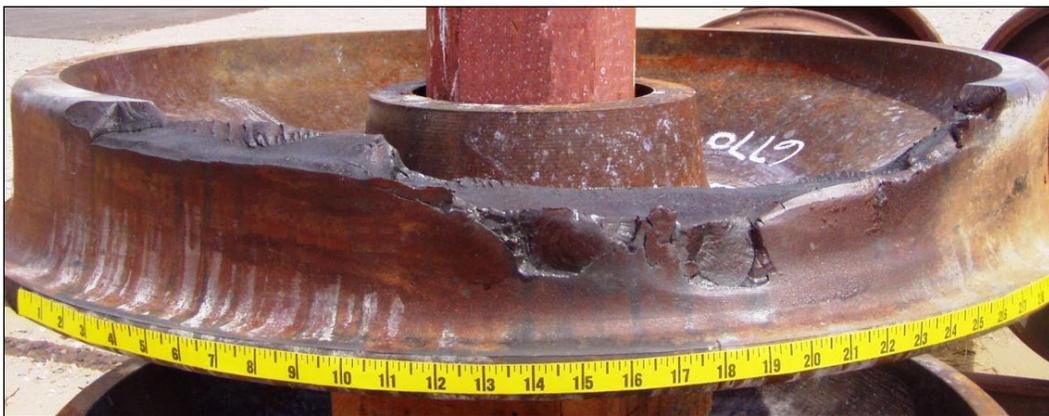
Figure 1. VSR Wheel

VSR and shattered rims are the main failure modes for broken wheel rim accidents. [Figure 1](#) and [Figure 2](#) show examples of VSR and shattered rim wheels.

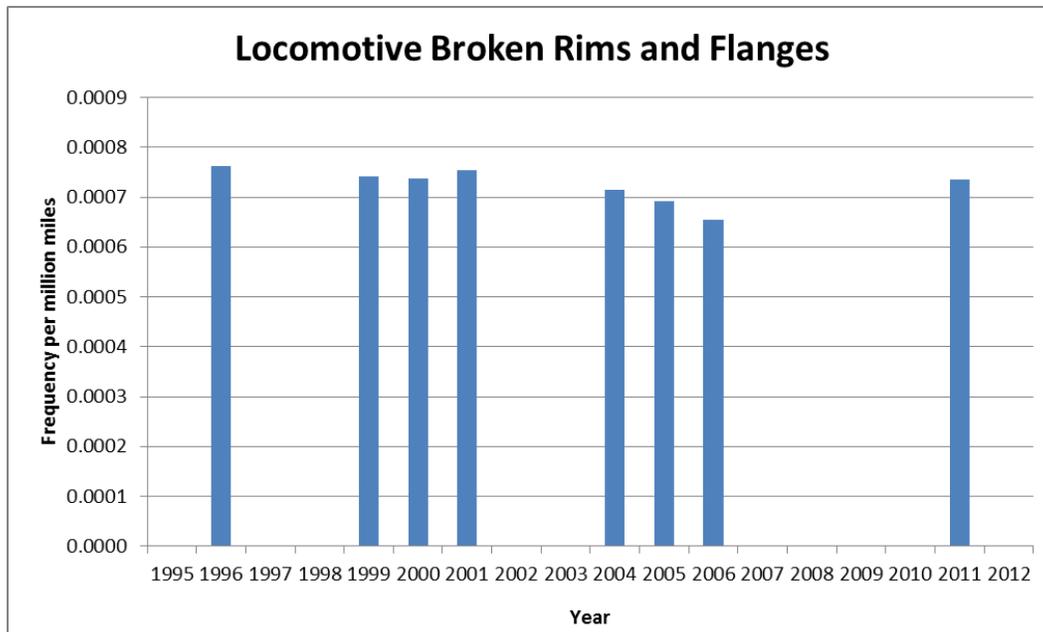
Figure 3. Broken Rims and Flanges per Million Miles in Locomotive Wheels

Between 1995 and 2012, seven accidents were attributed to locomotive wheels with broken flanges or broken rims. During the same time, 297 accidents were attributed to freight car broken flanges or broken rims. To normalize the data, the locomotive numbers were divided by the number of freight road service miles [3]. [Figure 3](#) shows the frequency of broken rims and flanges in locomotives. The freight car broken rims and flanges were divided by the total freight car miles and these data are plotted in [Figure 4](#).

From 1995 to 2012, the overall frequency of broken rims and flanges for locomotive wheels was 0.0003 per million miles; for freight cars, the frequency was 0.741 per million miles.

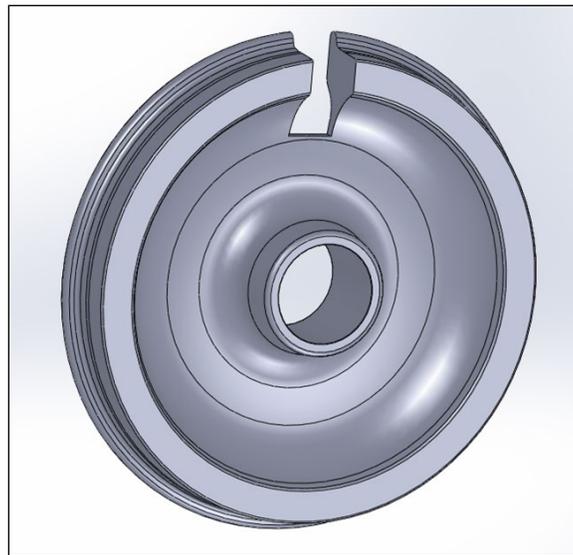
Figure 5. Wheel with Residual Stress Sample Removed

Figure 5 shows a wheel with a sample removed. Strain gages were attached to the sample. A slit was created by electrical discharge machining (EDM) starting from the tread surface and continuing radially to a depth of approximately 2 inches. During the machining, the strain was recorded until the slit was 1.60 inches deep. The pre-existing residual stress was calculated from the measured strain values. Figure 6 shows a sample with a slit.

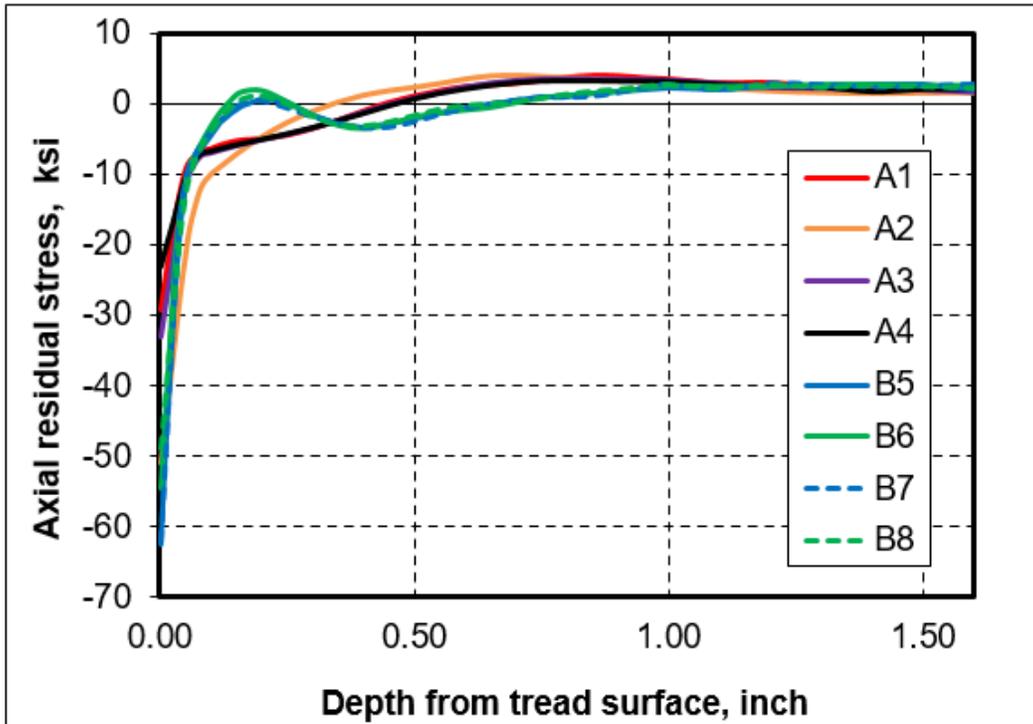
Figure 7. Axial Residual Stress from Tread Surface to Depth of 1.60 inches

For each sample, the residual stress was calculated at specific depths, up to 1.60 inches. Each cut was made 2.00 inches from the front rim face of the wheel. Negative stress values are compressive and positive values are tensile.

- Results from both manufacturers were very similar, within 1 ksi at depths below 1 inch.
- None of the samples exceeded 5 ksi tensile axial residual stress at any of the test depths. This is a positive finding because tensile residual stresses can promote crack growth.

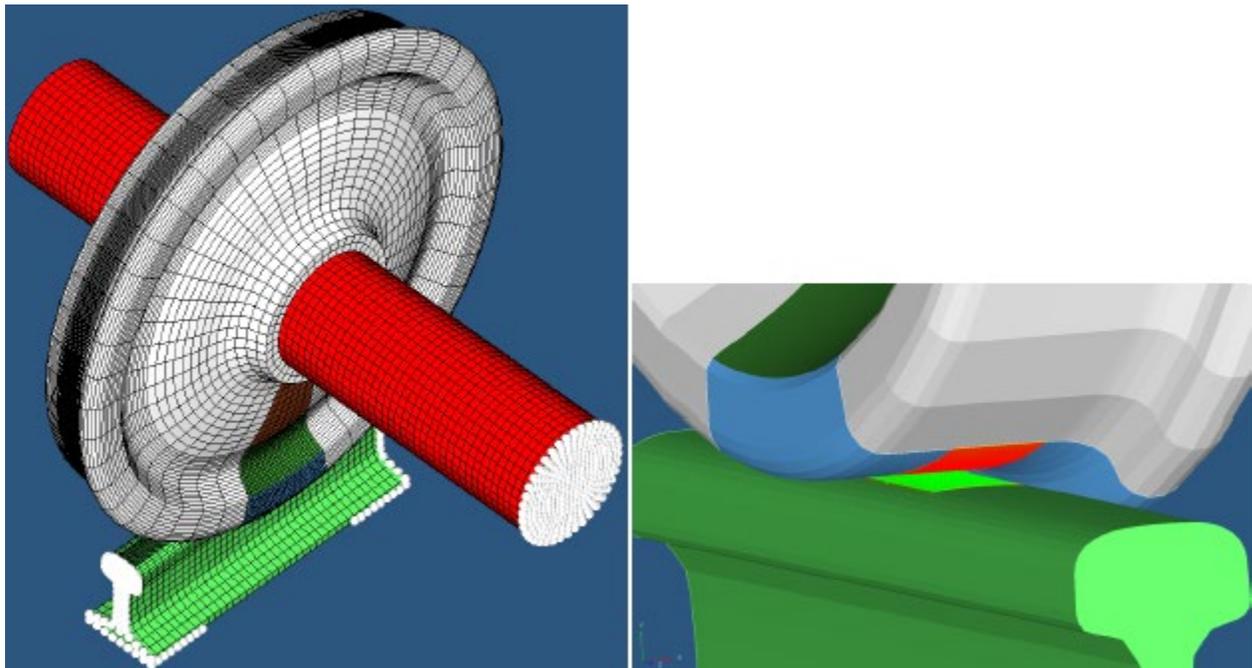
Figure 9. FE Model: (left) Boundary Conditions, (right) Wheel-Rail Contact Interface

A vertical load of 36 kips, which is essentially equivalent to a gross rail car load of 286,000 pounds, was used for the vertical load in this analysis. Lateral, longitudinal, and thermal loads were not considered in this work [7]. Other parameters used were:

- Friction coefficient of 0.3
- No displacements along longitudinal axis of axle (lateral direction)
- Rail constrained in lateral and longitudinal directions where ties would be located
- Elastic and inelastic material behavior

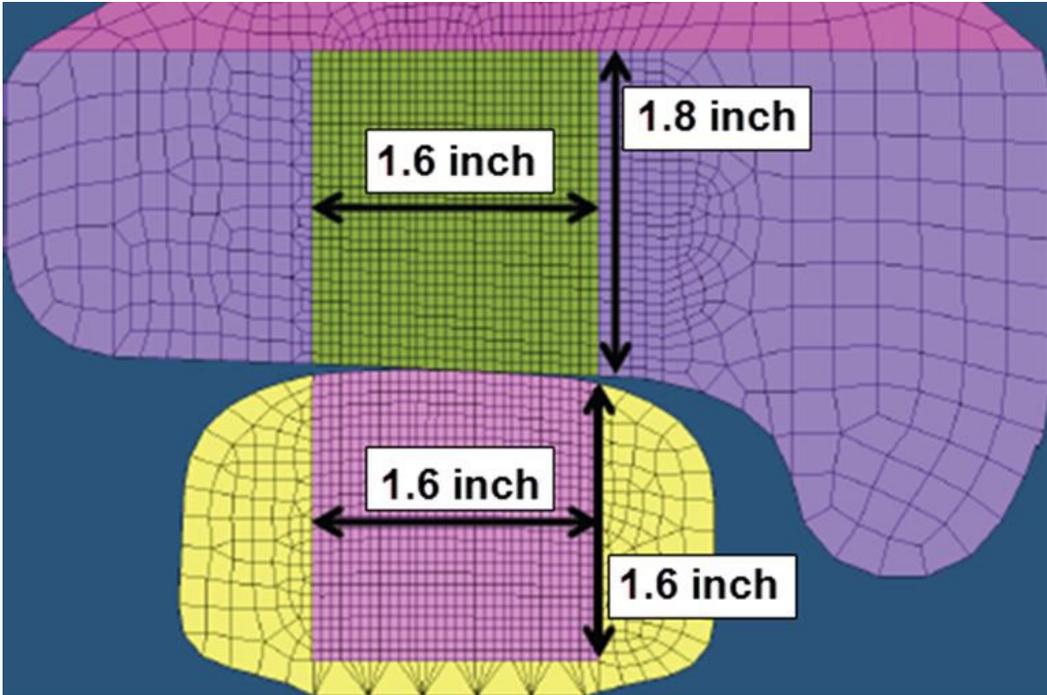
Figure 10. Cross Section of Refined Meshes for Rail and Wheel
Note: 1.6 inch (40 mm) and 1.8 inch (45 mm)

For better results, the FE mesh in and near the contact areas was greatly refined, as shown in [Figure 10](#) and [Figure 11](#). The element size in the refined areas is about 0.051 inch wide by 0.055 inch deep by 0.039 inch long in the rail, and about 0.051 inch wide by 0.055 inch deep by 0.079 inch long in the wheel. In total, the FE model is comprised of about 340,000 elements [7]. The rolling simulation was performed by rolling the FE wheel model 2.8 inches in 0.04-inch increments.

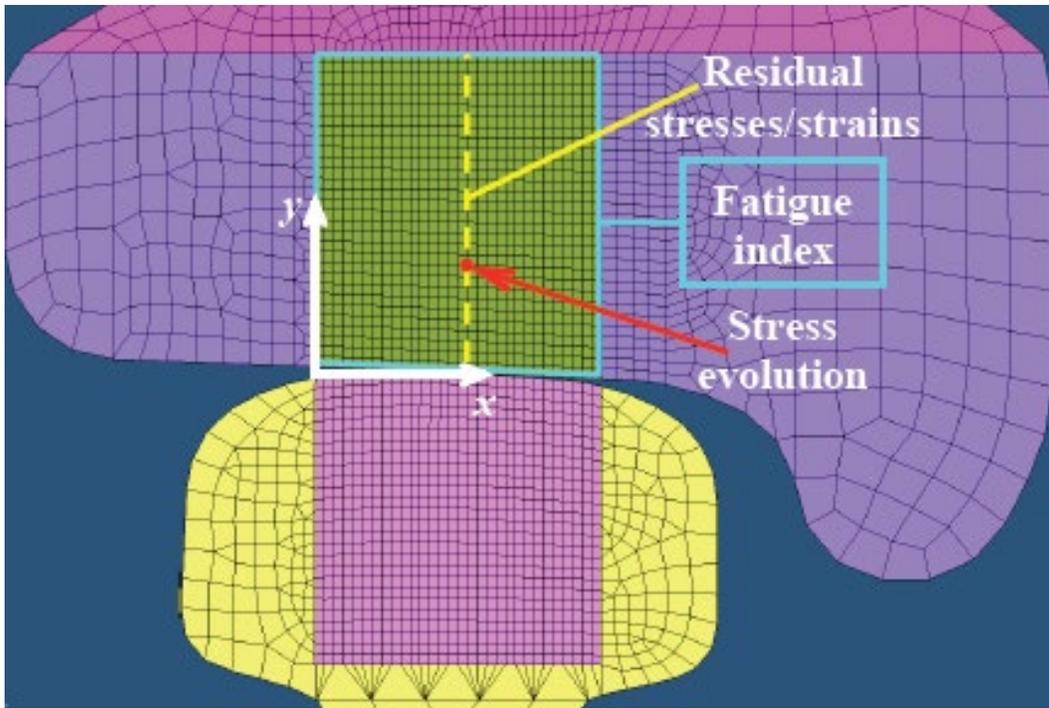
Figure 12. Stress and Fatigue Index Measurement Locations in the Wheel

Figure 12 shows the location of the stress evolution measurements; this node is approximately 0.59 inch below the running surface.

The Fatemi-Socie fatigue index was calculated at each node of the FE model in the area of interest (see Figure 12). As with the Findley fatigue index, the Fatemi-Socie was evaluated at every point of interest on a series of planes at various angles [7]. Previous work from Tangtragulwong (2010) found that a value of $\eta = 1$ correlated best for pearlitic rail steels.

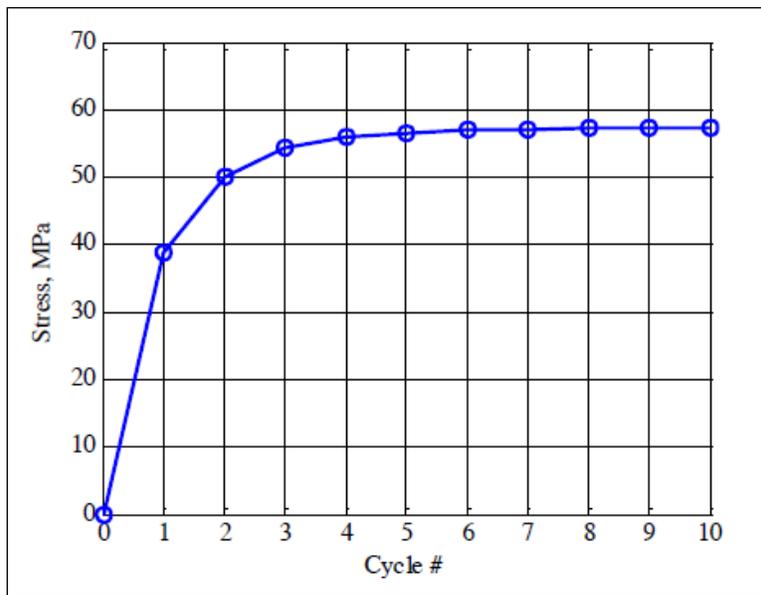
Figure 13. Cyclic Residual Stress Evolution in the Wheel [5]

The FE model was rolled over the contact area several times until the stress-strain response of the material had stabilized. This occurred after the fifth cycle (Figure 13) and agrees with findings by Ekberg [7]. In the study under this task order, the stress-strain responses from the sixth loading cycle were used to obtain the fatigue related results.

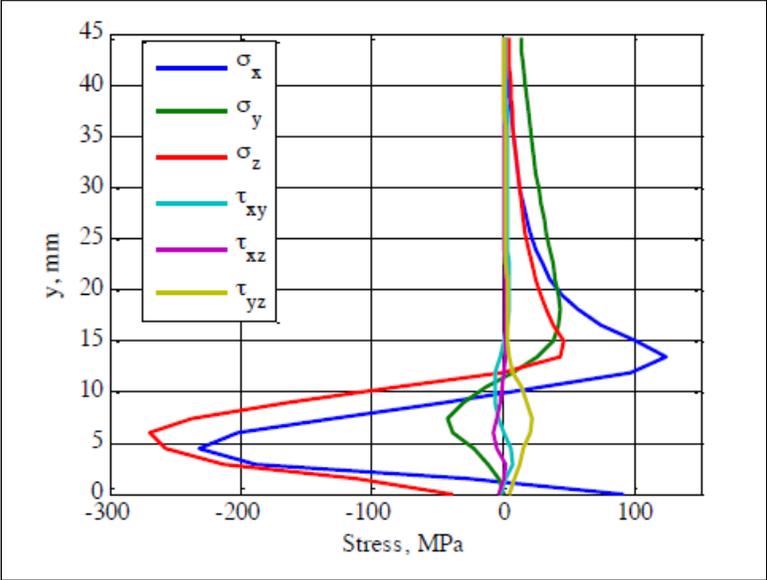
Figure 14. Residual Stress Distribution after the Fifth Load Cycle Along a Line in the Wheel’s Cross Section of Interest [7]

The residual stress and residual strain plots shown in Figure 14 and Figure 15, respectively, show the distributions after the fifth load cycle. The residual axial tensile stress values (σ_x) agree very well with results reported by Lonsdale et al. [5]. The FE model does not account for residual stresses imparted during the heat treat and quenching operations, and thus shows a tensile axial residual stress at the tread surface and transitions to a compressive state at a radial depth of about 0.039 inch.

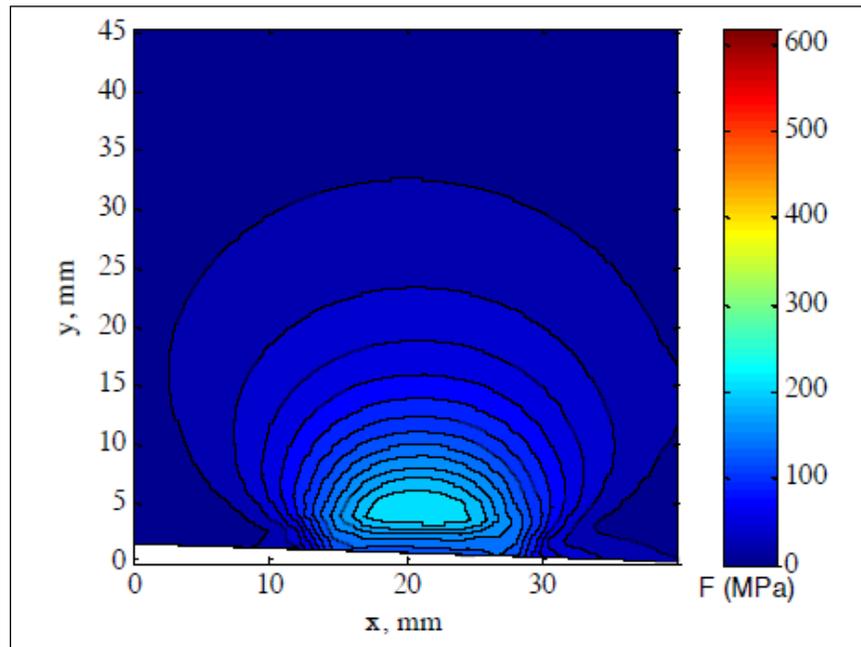
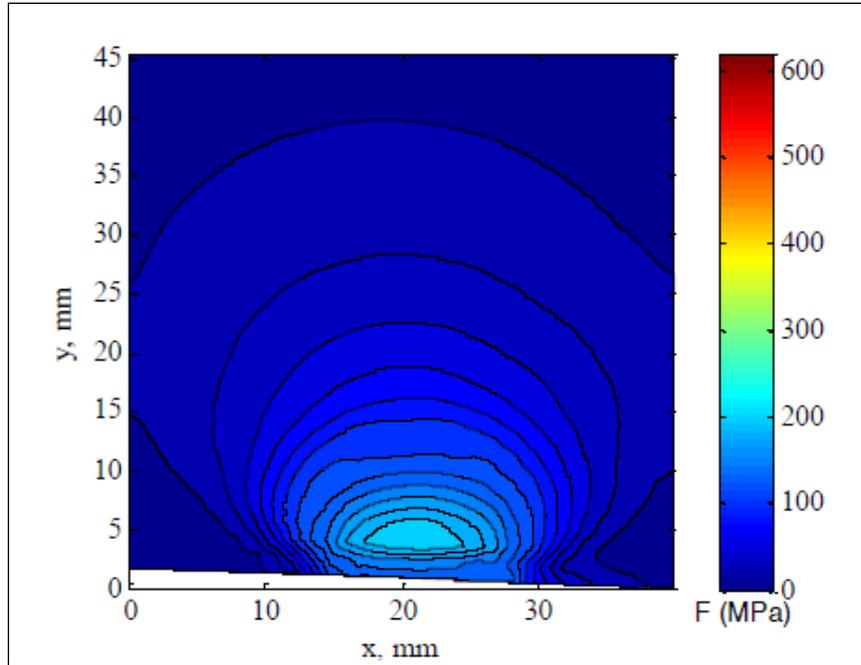
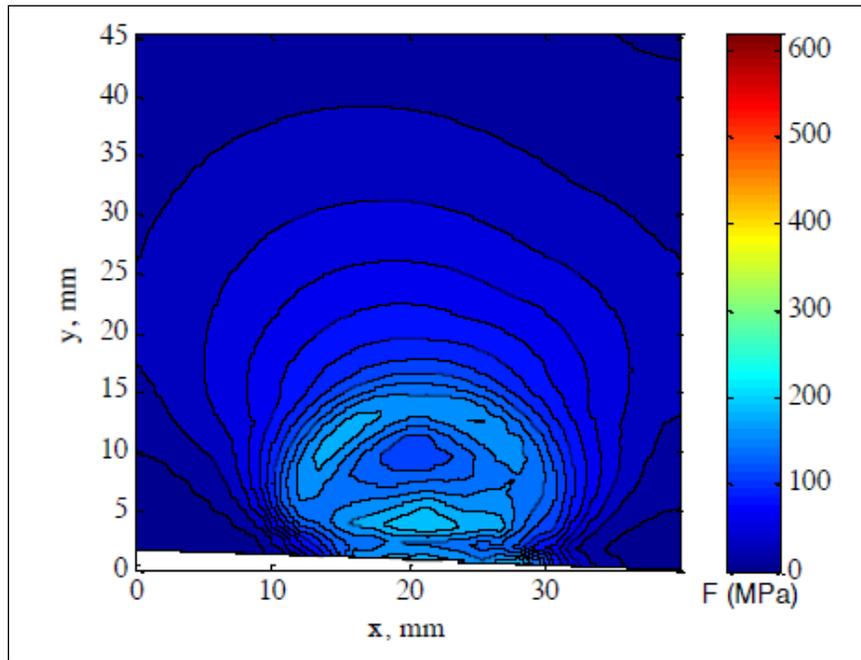
Figure 16, Figure 17, and Figure 18 show the maximum Findley fatigue index at values of $\kappa = 0$, $\kappa = 0.3$, and $\kappa = 1$, respectively. At $\kappa = 0.3$, the maximum Findley fatigue index value was 31.3 ksi at a depth of approximately 0.15 inch in the wheel [7].

Perhaps the most significant finding of the analysis is the agreement of the radial depth of the fatigue initiation spot (3.7 mm or 0.15 inch) in both the Findley and Fatemi-Socie methods. This value corresponds well with the median reported radial depth of VSR crack origins: “Origin radial depths were similar for both VSR and broken flange wheels and ranged from 0.10 inch to 0.25 inch below the tread surface with a median value of 0.17 inch.” [1]

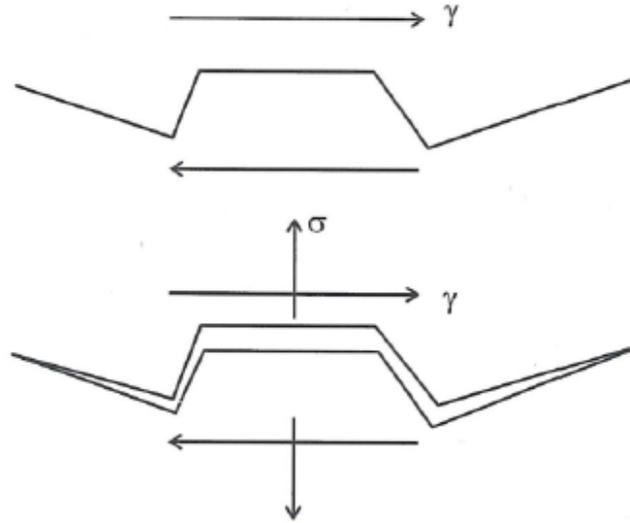
Figure 19. Physical Basis of the Fatemi-Socie Fatigue Model [9]

The physical basis of the Fatemi-Socie Model is that irregular shapes of crack surfaces produce friction forces that oppose shear deformations along the crack's plane (Figure 19). This mechanism limits crack growth, thereby increasing the fatigue life of the material. If tensile stresses normal to the plane of the crack are present, they reduce the normal forces on the crack surfaces, reducing friction forces acting on the crack faces. If this reduction takes place, the crack tips must carry a larger fraction of the shear forces, which is assumed to favor crack growth [7].

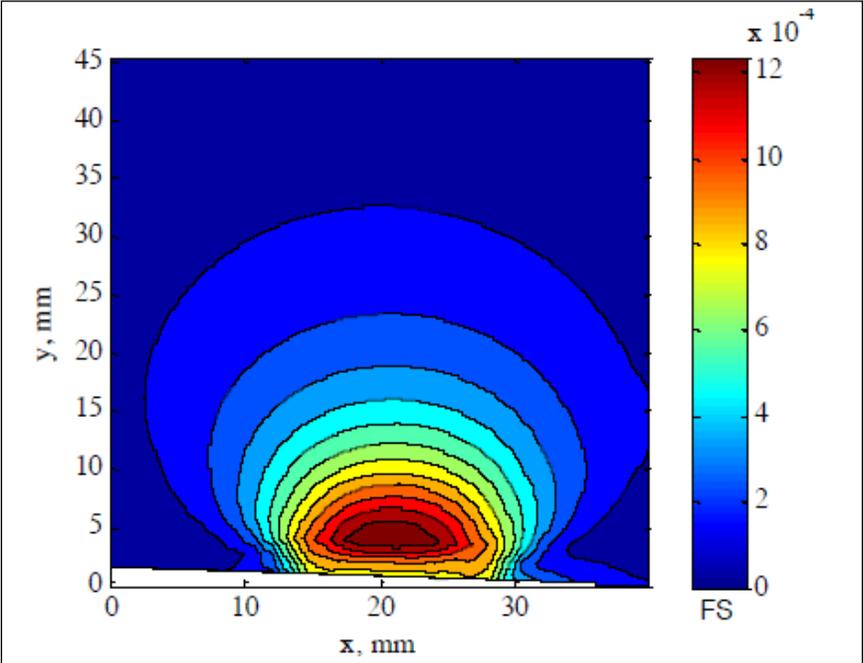
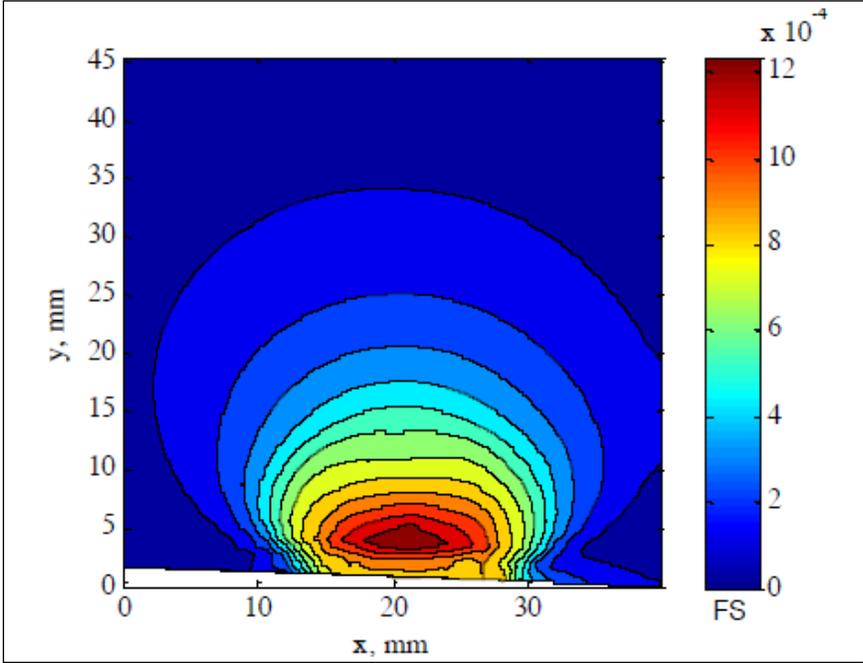
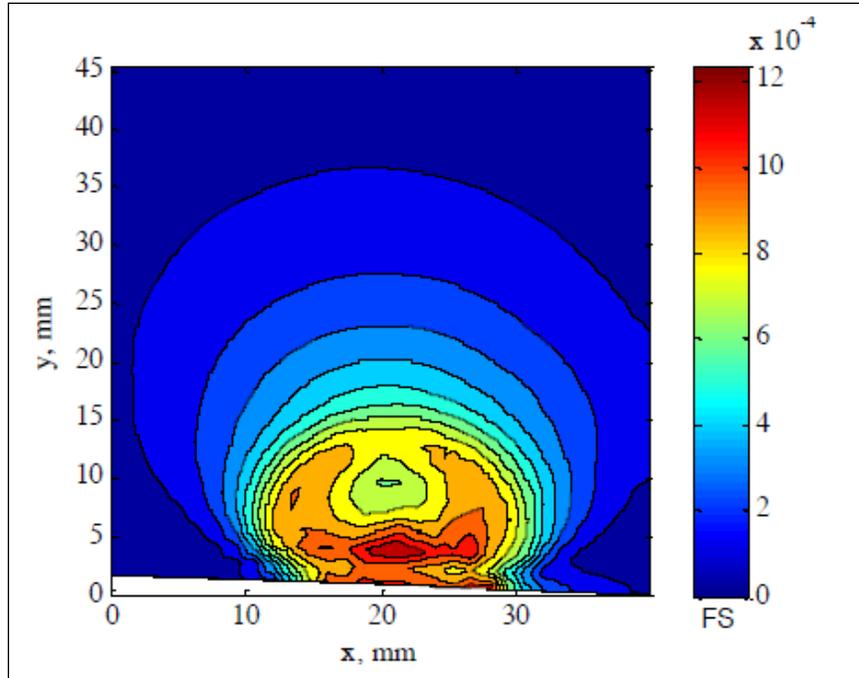
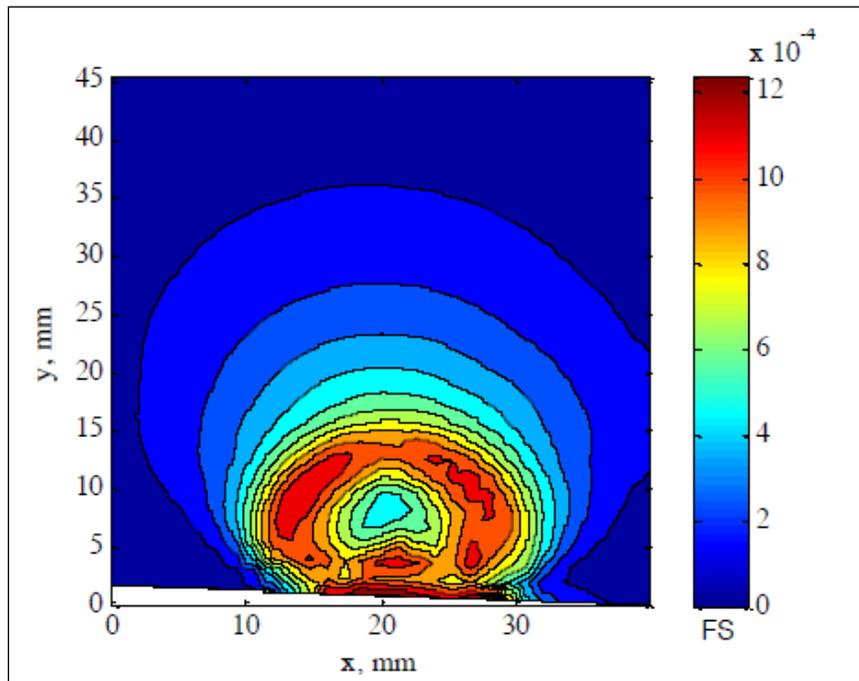
Figure 20 through Figure 23 show the maximum Fatemi-Socie fatigue index at values of $\eta = 0$, $\eta = 1$, $\eta = 3$, and $\eta = 1$, respectively. At $\eta = 1$, the maximum Fatemi-Socie fatigue index value was 0.19 psi at a depth of approximately 0.15 inch in the wheel [7].

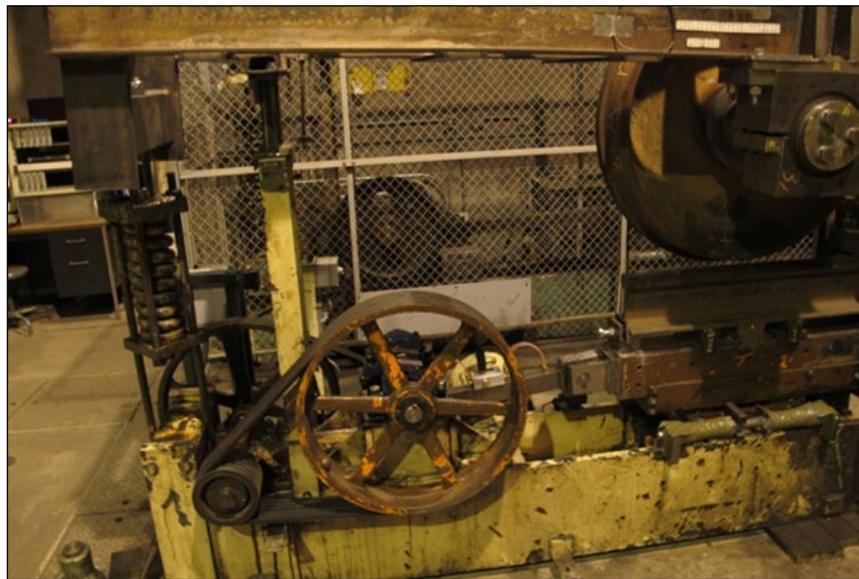
Figure 24. Rolling Load Machine at the TTC

Researchers developed a test plan to create a VSR using a rolling load machine. The primary goal was to prove that a VSR can be created under controlled conditions in a laboratory. [Figure 24](#) shows the rolling load machine setup at TTC.

In this machine, the wheel remains stationary and the rail reciprocates under it. The load was variable, with a maximum of 50 kips. The test began with a load of 36 kips, which is the approximate load experienced by a wheel under a car with a gross weight of 286,000 pounds. The load was then increased to 50 kips maximum.

Wheel manufacturers and research teams have tried to create VSRs under controlled conditions in the past. A rolling load machine, like that shown in [Figure 24](#), was used on a wheel known to have a large subsurface horizontal crack. An initial vertical load application of 60,000 pounds was periodically increased up to a maximum of 90,000 pounds [1]. This was performed twice; both times the machine failed and no VSR was created. Microscopy of the crack showed a small amount of trans-granular crack propagation. A research team also tried to create a VSR using a drop hammer to simulate impact. A tread damaged wheel was impacted over 31,000 times with a drop hammer, producing loads of 250–300 kips [6]. It resulted in severe deformation of the wheel, but no VSR. The approach for this past research is detailed in [Section 5.2](#).

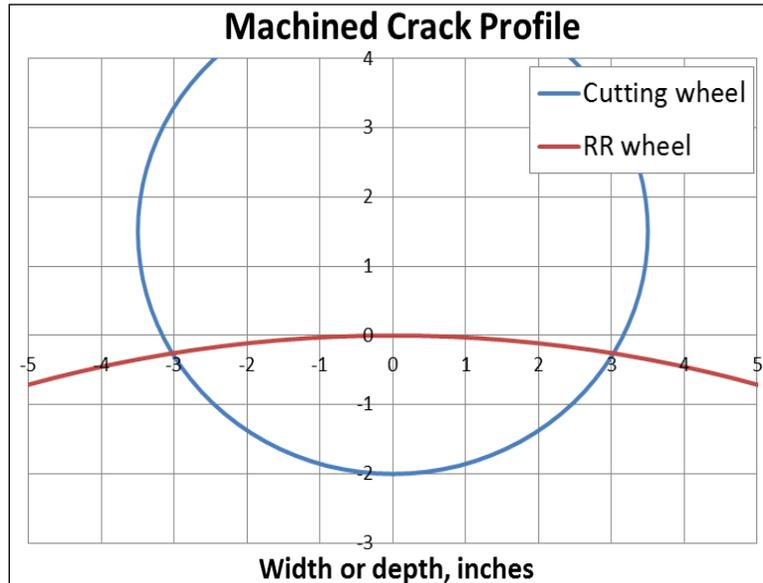
Figure 25. Geometry of Slit in Wheel

To simulate a large VSR crack, a slit was plunge cut in a service worn wheel by using an abrasive disk. The purpose of the slit was to skip the crack formation (i.e., early propagation portion of the VSR failure process) and reproduce the final stage of failure. The maximum depth of the slit was 2.0 inches, and the width was 0.11 inch. [Figure 25](#) shows the geometry of the slit. The slit was cut 2.2 inches from the front rim face of the wheel. The wheel was adjusted laterally in the rolling load machine so that the contact between the wheel and rail was centered near the

crack. Ultrasonic testing was used to verify the crack depth and geometry before testing began. After each day's testing, the wheel was ultrasonically tested to determine whether the crack propagated.

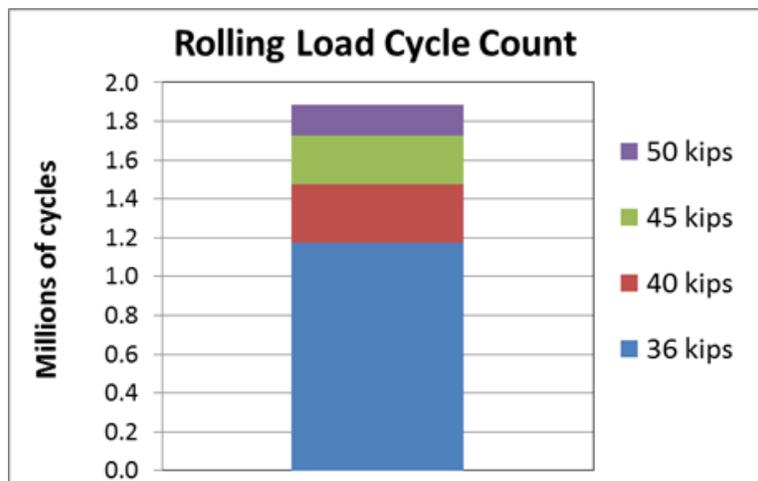
Figure 26. Rolling Load Cycle Count

Figure 26 shows the vertical load was increased at certain intervals from 36 kips to the maximum of 50 kips. After a total 1.88 million cycles, no crack propagation was detected ultrasonically. The test was halted after discussions with other research personnel concerning VSR mechanisms, the test setup, visual inspection of wheels, and mechanical property calculations. Metallography was not performed on the crack.

- The machined slit was much wider than a naturally induced crack, and therefore did not produce the same stress intensity that would be expected at the tip of a crack of the same length and depth.
- The loading conditions did not include any impact forces. The revenue service environment includes occasional impacts when a wheel negotiates a frog or a rail joint. Additionally, most VSR wheels have a history of impact load readings from wayside wheel impact load detectors. This impact loading could play a role in the crack propagation.
- An induced slit made with a grinding wheel leaves the material surface of the cut in a different disposition and less likely to propagate than the surface of a naturally made crack due to wheel metallurgy and service conditions.
