RR 24-10 | September 2024

## EFFICACY OF INCREASED FLASH RATE OF RAILROAD GATE FLASHERS

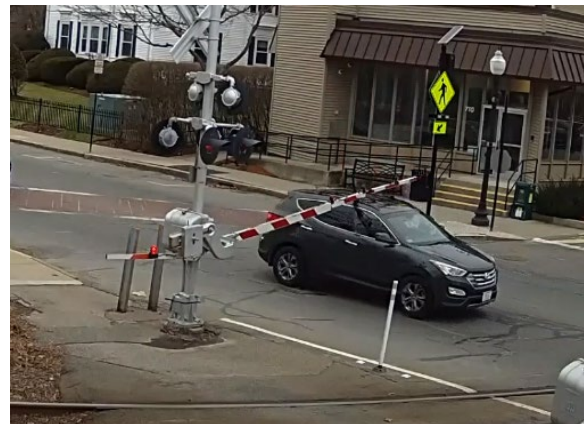
**Figure 1. Crossing Gate Violation Example (Crossing ID# 546 729P)**

Motorists whose visibility is obscured or who are distracted while approaching a rail-highway at-grade crossing may not notice the standard railroad gates and flashing lights. This can lead to unsafe situations such as motorists stopping within the dynamic envelope of the crossing, breaking the descending or horizontal gate, or driving through the crossing and colliding with a train. [Figure 1](#) shows an incident involving a driver violating the crossing gate at the study

crossing on Washington Street in Canton, MA (ID# 546 729P), which resulted in a broken gate.

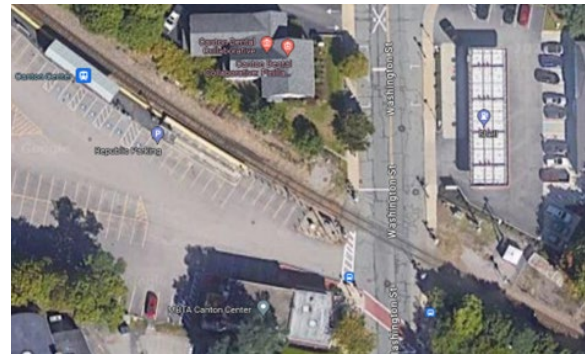
**Figure 2. Washington Street Grade Crossing (Canton, MA)**

**Data Collection and Analysis:** The grade crossing location selected is on Washington Street in Canton, MA (ID# 546 729P). This is a public, at-grade crossing equipped with 8-inch mast-mounted flashers and 4-inch gate-mounted flashers on each of the two approach lanes. It also has pedestrian gates in all four quadrants.

The MBTA is the primary operating railroad using the crossing, with an estimated 28 trains per day on weekdays. There is no weekend commuter rail service. The Canton commuter rail station lies to the west of the crossing on the south side of the tracks, as shown in [Figure 2](#).
