U.S. Department of  
Transportation  
**Federal Railroad  
Administration**

## Over-the-Road Testing of the Instrumented Tank Car—A Load Environment Study

| REPORT DOCUMENTATION PAGE | | | Form Approved<br>OMB No. 0704-0188 | |
|---|---|---|---|---|
| 6. AUTHOR(S)<br>Narayana Sundaram, Tim Martin, Brent Selby, Francisco González, III | | | | |

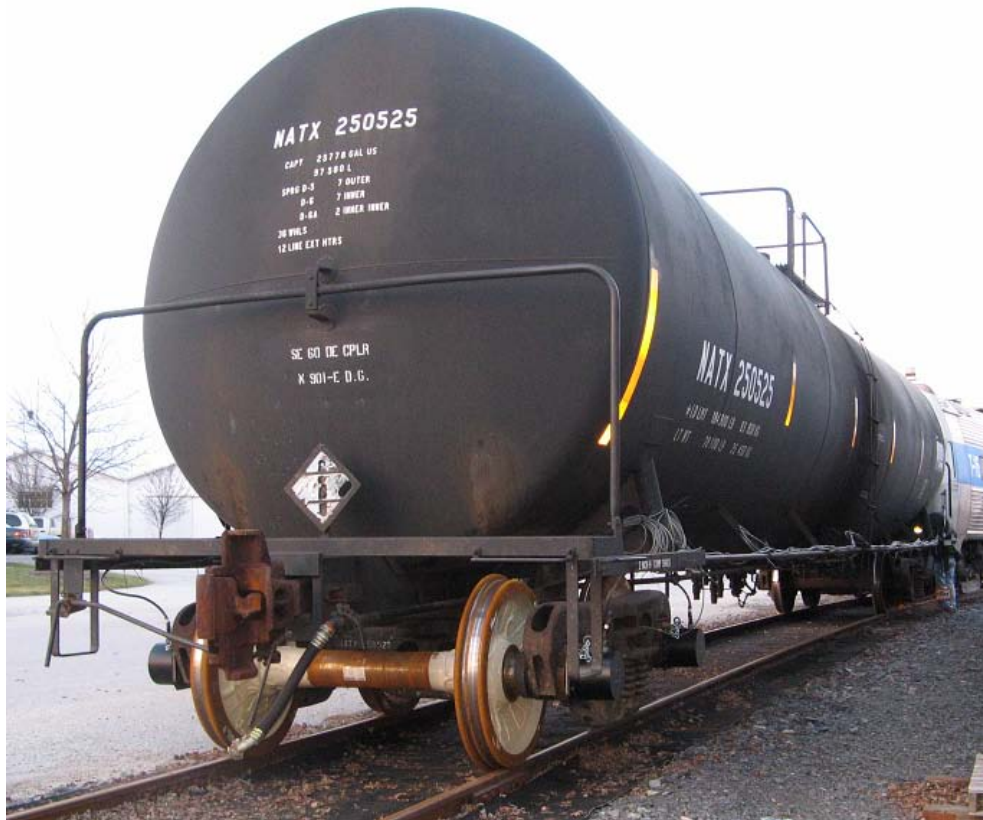
**Figure 1. Tank Car Supplied by General Electric for Conducting Research**

FRA contracted ENSCO, Inc., to instrument and run a second instrumented tank car over the road during a special test. Testing was conducted in a special consist with the intent to collect data from the instrumented tank car, instrumented wheelsets, and track geometry. The tank car used for this effort was provided by General Electric (GE) and is shown in Figure 1. This report describes the instrumentation, calibration and testing efforts conducted by ENSCO.

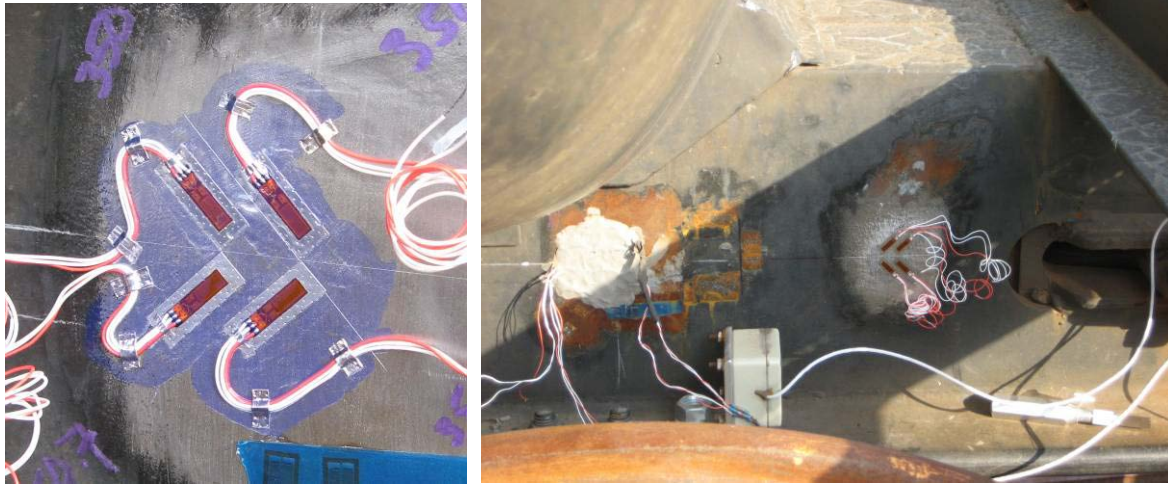
**Figure 3. Shear Gages Measuring Vertical Coupler Force. Left: Close up of installation. Right: New gages on the right replace gages (covered with sealant) on the left which were then disconnected**

Coupler forces were measured between the tank car (A-end) and the rest of the consist. A special coupler instrumented with strain bridges was used to measure the longitudinal forces. The instrumented coupler was provided by FRA for the purpose of this test. To measure vertical forces a pair of shear gages is mounted on each side of the coupler channel as shown in Figure 3. These gages are wired using a completion card to form a full bridge. A second set of gages are mounted next to the original set as a spare (total eight gages, four on each side). The mounting process included grinding the surface to provide a smooth area to which the strain gages could adhere. To increase resolution after unsatisfactory initial testing, new gages were applied at a location closer to the end of the car but not beyond the points on contact between the coupler channel and the coupler.

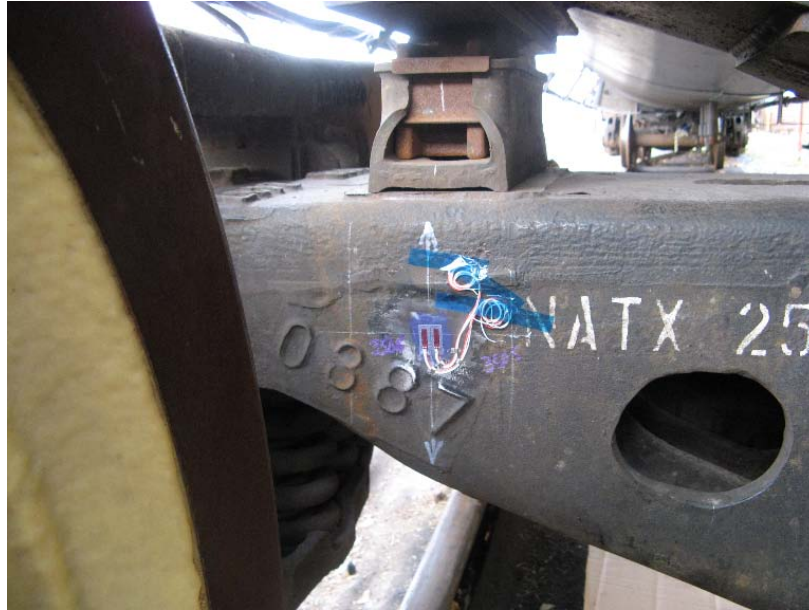
**Figure 4. Strain Gages Measuring Bolster Side Bearing Loads**

A second set of strain gages were mounted on the truck bolster underneath the side bearing as shown in Figure 4. One gage is mounted on each side to form a half bridge. Bridge completion resistors were used to complete the bridge. A spare set of gages were mounted adjacent to the main gages. An identical set of gages were mounted on the truck bolster on the other side of the vehicle. These gages were used to measure the side bearing loads.

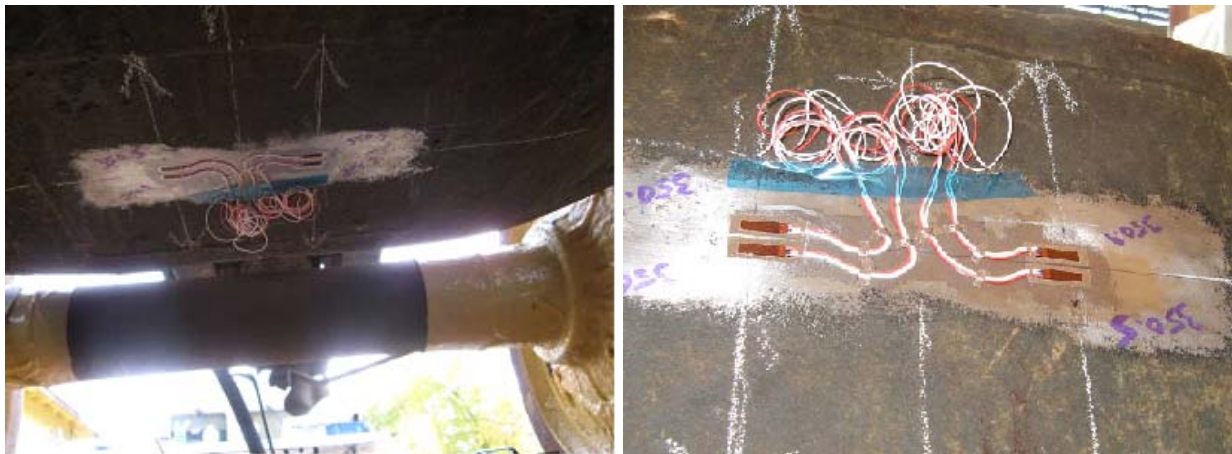
**Figure 5. Strain Gages Measuring Bolster Center Bowl Load**

A third set of strain gages are mounted on the each side of the bottom center of the bolster as shown in Figure 5. One gage is mounted on each side to form a half bridge. Bridge completion resistors are used to complete the bridge. A spare set of gages are mounted adjacent to the main gages. These gages are used to measure the bolster center bowl load.

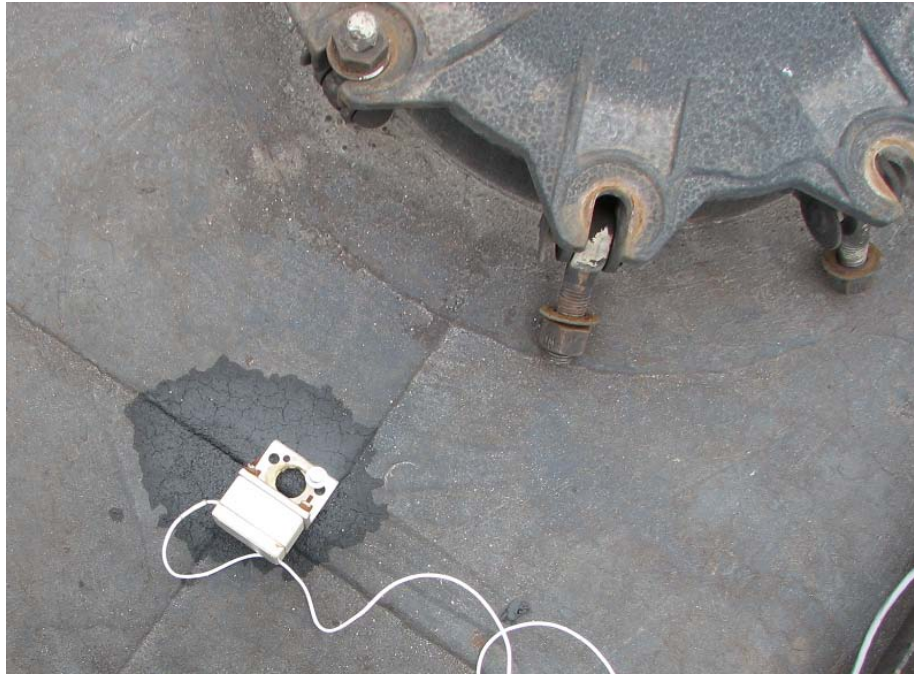
**Figure 6. Triaxial Accelerometer Mounted on Top of Carbody**

Accelerometers are installed at several locations on the tank car. The first is a triaxial accelerometer mounted on top of the carbody as shown in Figure 6. The second and third accelerometers are mounted on the stub sill at each end of the car as shown in Figure 7. These measure accelerations in the vertical direction only. The fourth and fifth accelerometers are on

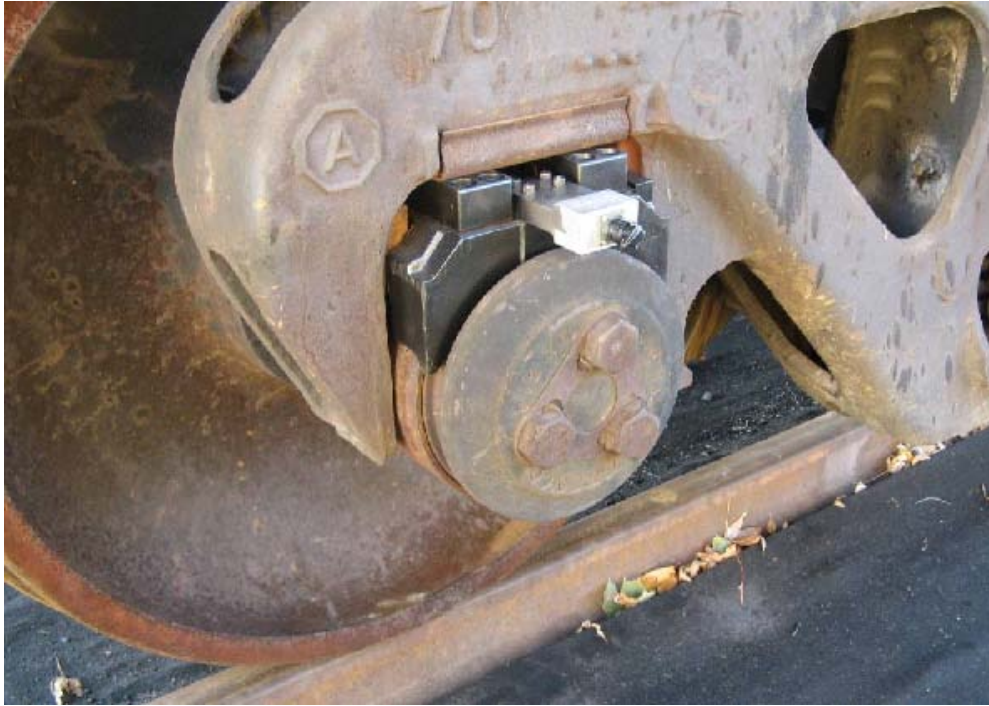
**Figure 9. Vertical Load Adapter**

Vertical load adapters are modified bearing adapters used to measure the vertical wheel forces. The vertical load adapters are made using strain gages. After they are calibrated, they are used like any other load cells. Figure 9 shows a vertical load adapter mounted on the tank car. Four of these were mounted on the B-End of the tank car, opposite to most of the instrumentation.

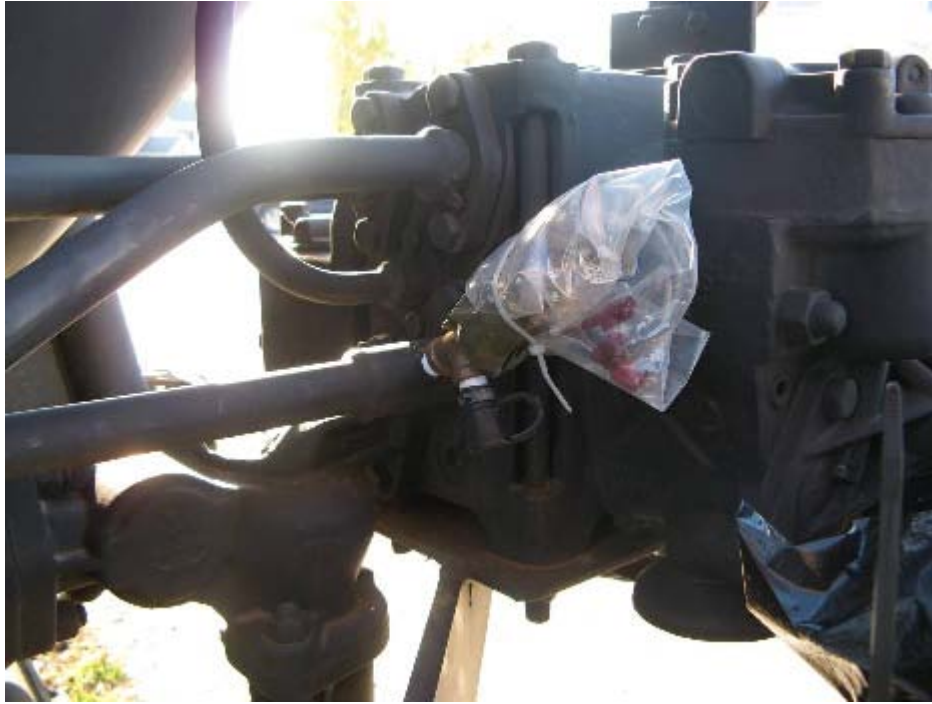
**Figure 10. Brake Pressure Transducer**

Brake application data was gathered to correlate the force and strain data to the operation of the car. This measurement was achieved by using a pressure transducer to measure the brake cylinder pressure. Only one pressure transducer is needed for the entire vehicle. Figure 10 shows the installation of the brake pressure transducer with the wires disconnected and protected from moisture before the test.

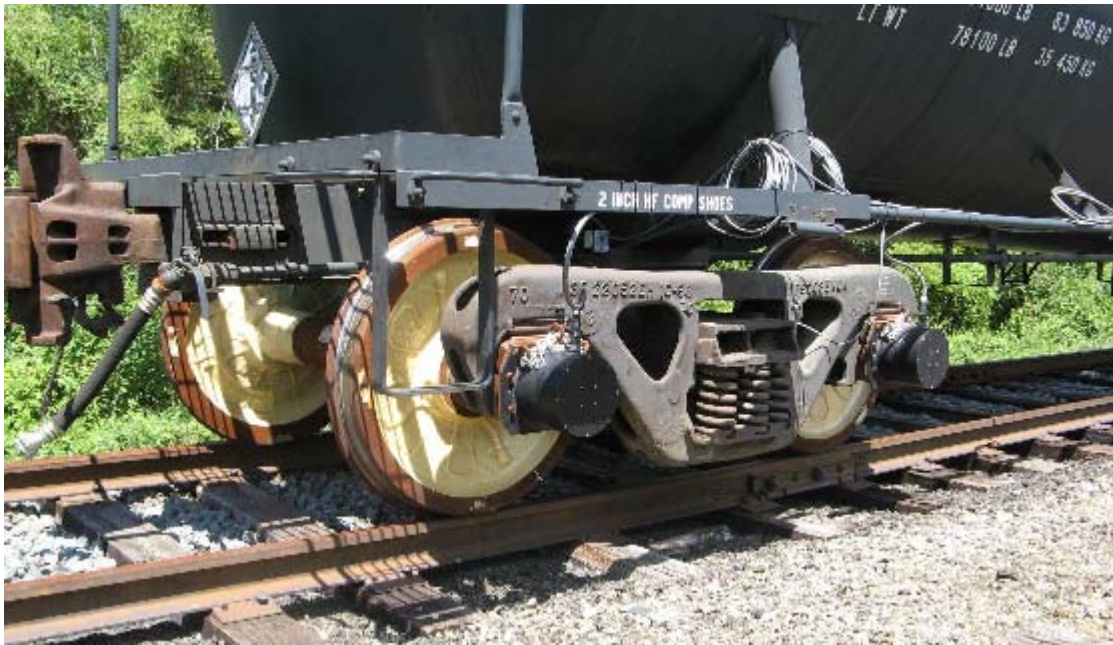
**Figure 11. Instrumented Wheelsets**

One of the most sophisticated and useful tools to measure the vehicle dynamics is to use instrumented wheelsets. Each wheel and axle of one truck is instrumented with strain gages in several configurations. Once calibrated, these are used to measure the vertical, lateral, and longitudinal forces at the wheel/rail interface. They are also used to measure the contact position on the wheel. Figure 11 shows the instrumented wheelsets mounted on the A-end of the tank car. The instrumented wheelsets have their own signal conditioning units and computers. There are fully synchronized with DOTX-218's track geometry system.

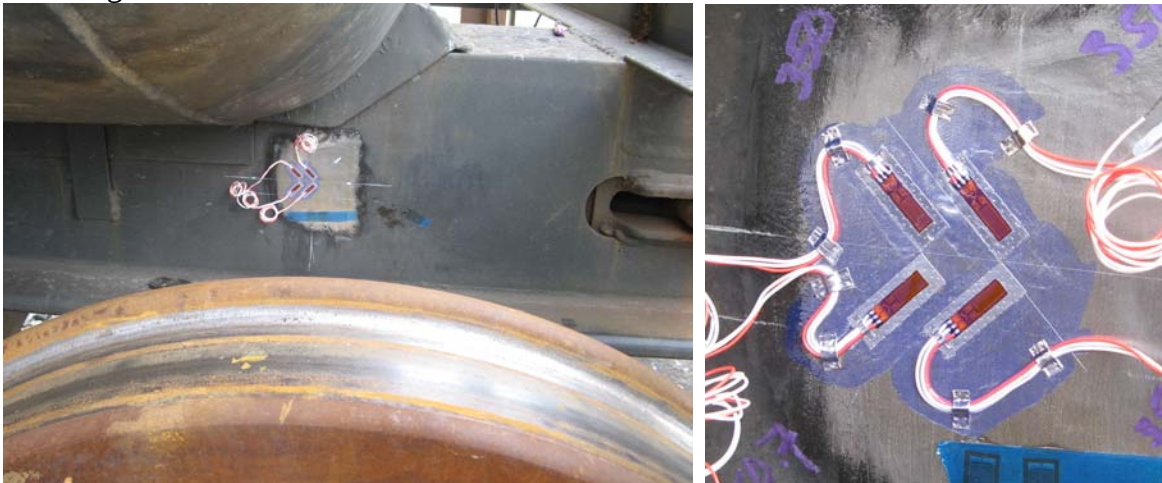
**Figure 1. Shear Gages Measuring Vertical Coupler Force**

Strain gages will be attached in several locations to obtain the forces in several components. The first measures the vertical coupler force. A pair of shear gages is mounted on each side of the coupler channel as shown in Figure 1. These gages are wired to form a full bridge. A second set of gages are mounted next to the original set as a spare. These are cabled to a signal conditioning unit onboard T-18.

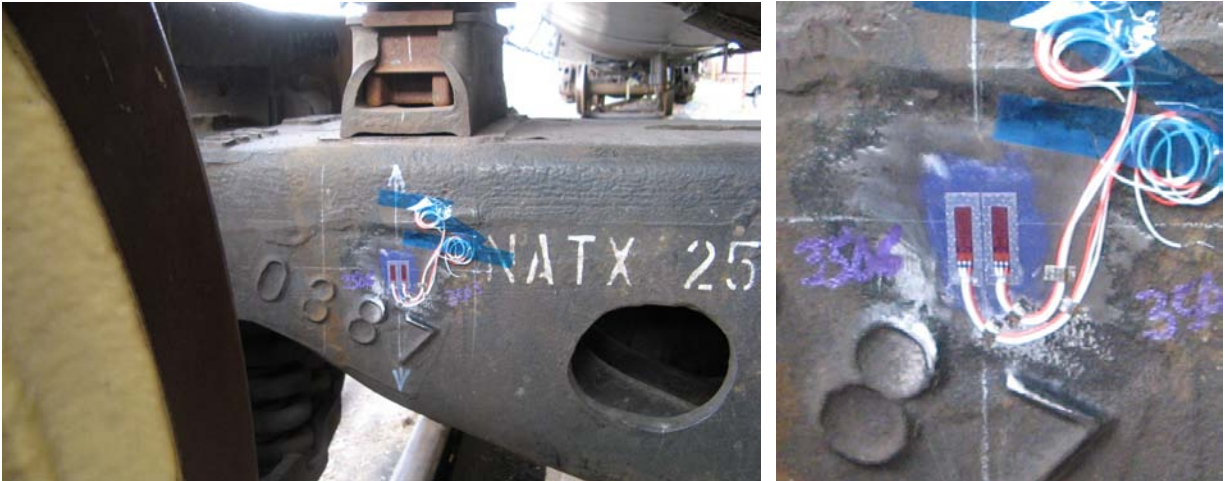
**Figure 2. Strain Gages Measuring Bolster Side Bearing Loads**

A second set of strain gages are mounted on the truck bolster underneath the side bearing as shown in Figure 2. One gage is mounted on each side to form a half bridge. Bridge completion resistors are used to complete the bridge. A spare set of gages are mounted adjacent to the main gages. An identical set of gages are mounted on the truck bolster on the other side of the vehicle. These gages are used to measure the side bearing loads.

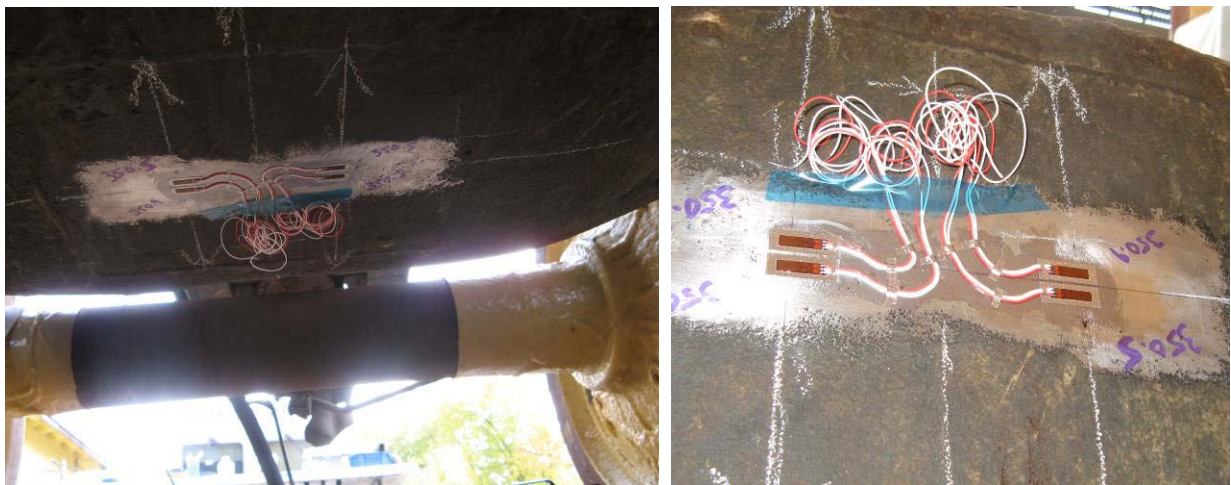
**Figure 3. Strain Gages Measuring Bolster Center Bowl Load**

A third set of strain gages are mounted on each side of the bottom center of the bolster as shown in Figure 3. One gage is mounted on each side to form a half bridge. Bridge completion resistors are used to complete the bridge. A spare set of gages are mounted adjacent to the main gages. These gages are used to measure the bolster center bowl load.

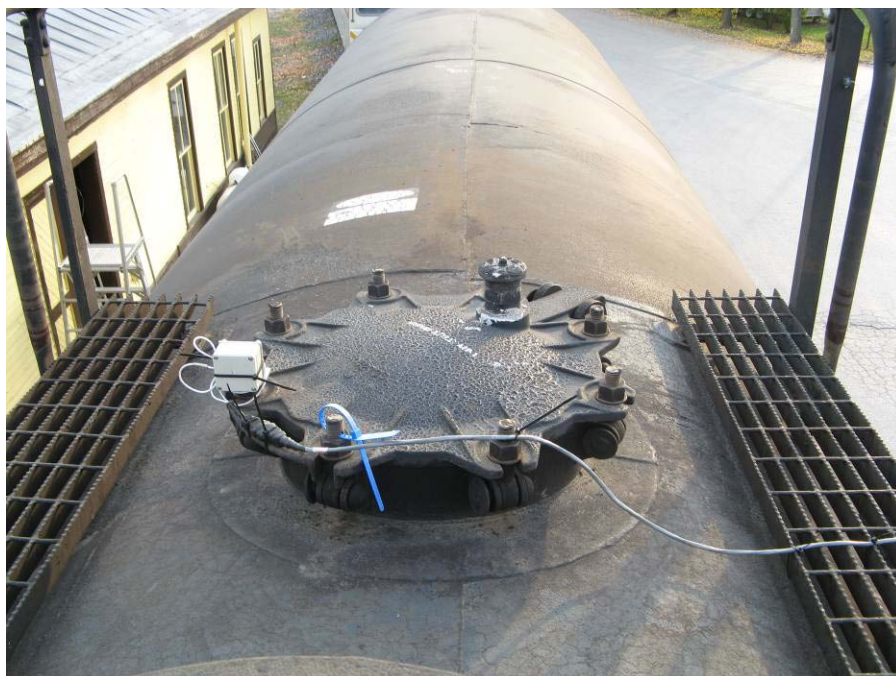
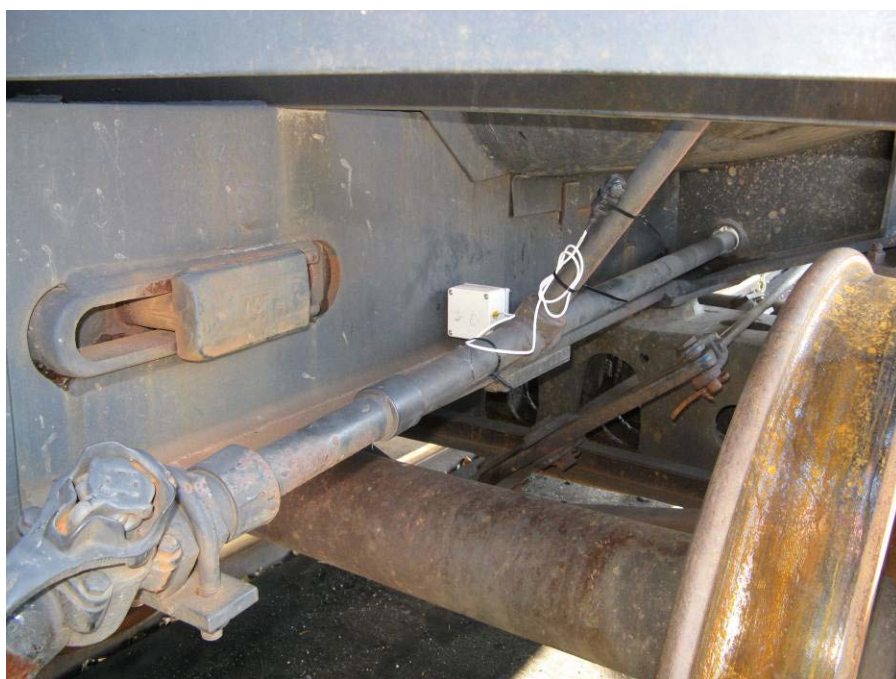
Several accelerometers are installed at several locations on the tank car. The first is a triaxial accelerometer mounted on top of the carbody as shown in Figure 4. A second accelerometer will be mounted on top of the carbody near the plate shown in Figure 4 (several feet from the first accelerometer). This will be used to correlate with previous data collect by the car owner. A third and fourth accelerometer will be mounted on the stub sill at each end of the car as shown in Figure 5. These will measure the vertical accelerations. A fifth and sixth accelerometer will be mounted on the bearing adapter on both sides of the first axle as shown in Figure 6. These will measure the vertical axle accelerations.

**Figure 4. Triaxial Accelerometer Mounted on Top of Carbody**

**Figure 5. Vertical Accelerometer Mounted on the Stub Sill and Each End of the Car**

**Figure 6. Vertical Accelerometer Mounted on the Axle on Both Sides of the Car**

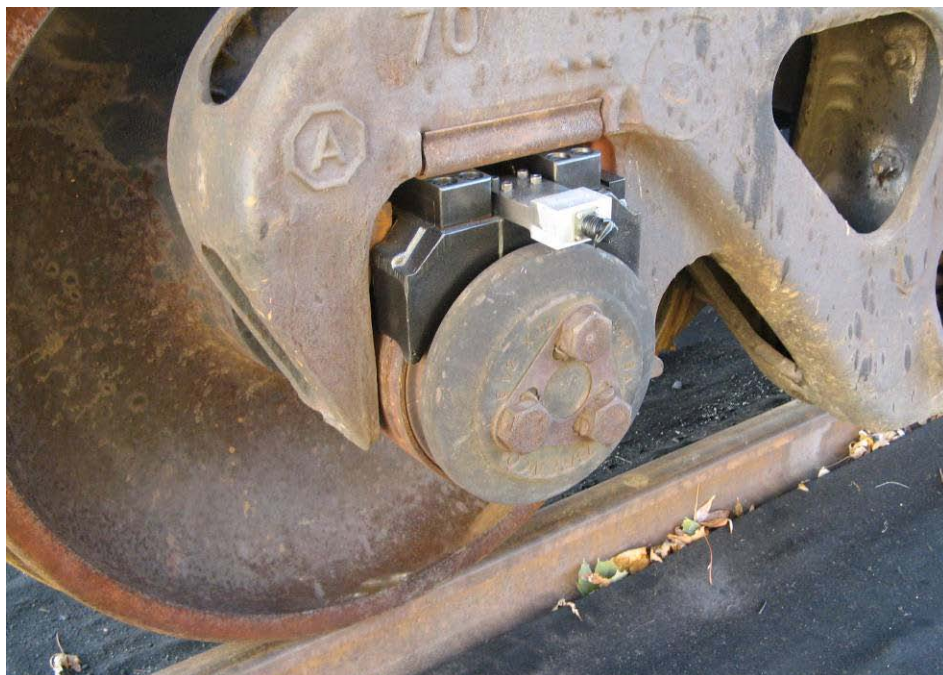
**Figure 7. Vertical Load Adapter**

Vertical load adapters are modified bearing adapters used to measure the vertical wheel forces. The vertical load adapters are made using strain gages. After calibrated, they are used like any other load cells. Figure 7 shows a vertical load adapter mounted on the tank car. Four of these are mounted on the B-End of the tank car, opposite most of the instrumentation.

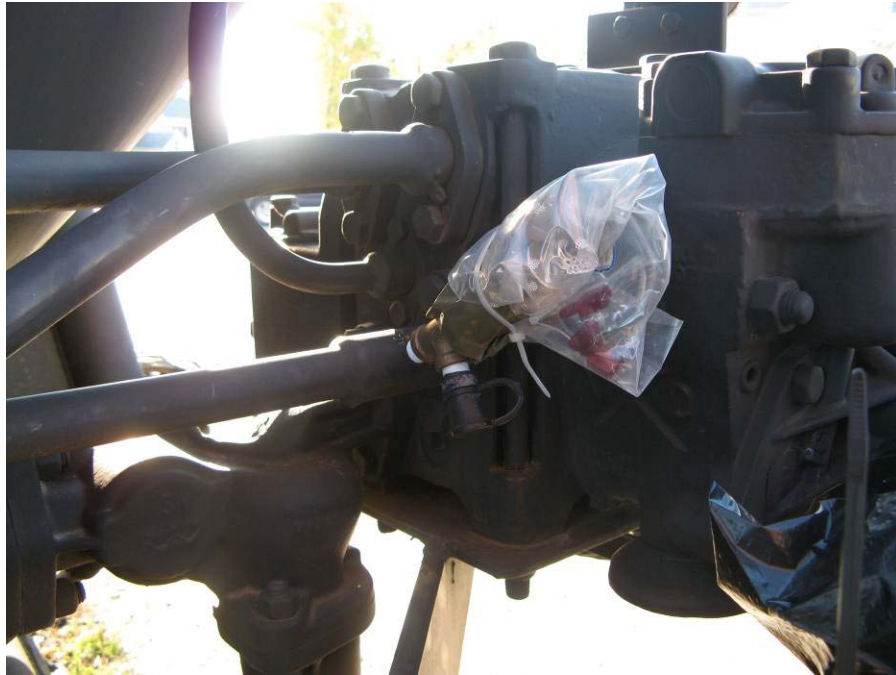
**Figure 8. Brake Pressure Transducer**

One important piece of information needed is when the brakes have been applied. This measurement is achieved by using a pressure transducer to measure the brake cylinder pressure. Only one pressure transducer is needed for the entire vehicle. Figure 8 shows the installation of the brake pressure transducer.

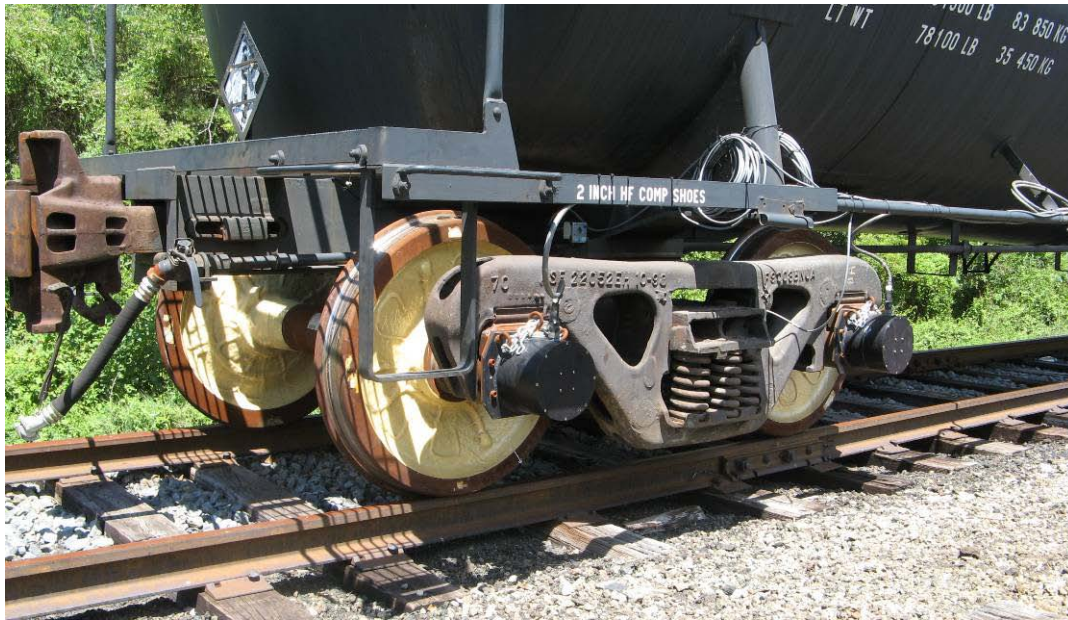
**Figure 9. Instrumented Wheelsets**

One of the best tools to measure the vehicle dynamics is to use instrumented wheelsets. Each wheel and axle of one truck is instrumented with strain gages in several configurations. Once calibrated, these are used to measure the vertical, lateral, and longitudinal forces at the wheel/rail interface. They are also used to measure the contact position on the wheel. Figure 9 shows the instrumented wheelsets mounted on the A-end of the tank car. The instrumented wheelsets have their own signal conditioning units and computers. They are fully synchronized with T-18's track geometry system. One of the requirements of instrumented wheelsets is that the brakes on those wheels/axles need to be removed or disabled. This is to ensure accurate measurements and to prevent damage to the wheelsets. This will require at least four vehicles in the train consist to ensure that there is at least 85 percent braking.

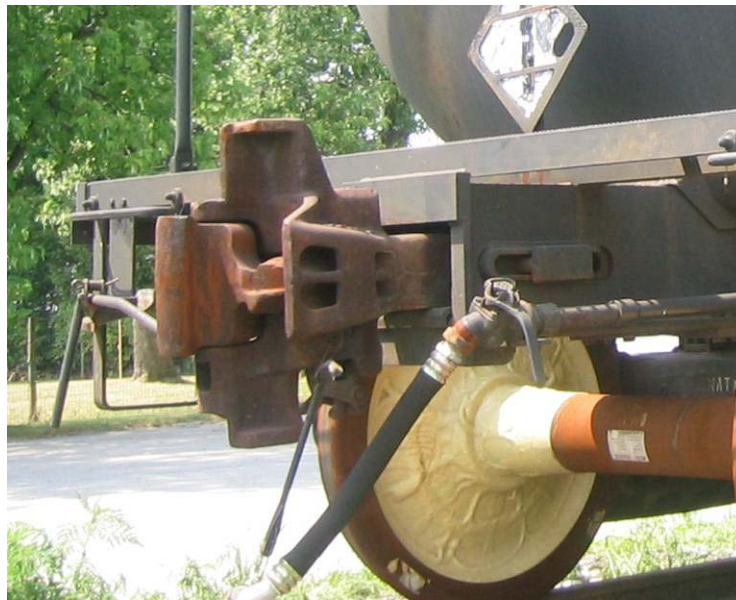
The last sensor is an instrumented coupler as shown in Figure 10. The instrumented coupler uses strain gages to measure the longitudinal coupler force. Because only one instrumented coupler was available, it will be mounted between the tank car and the rest of the consist (opposite T-18).
