**Federal Railroad  
Administration**

# Vehicle Proximity Alert System for Highway-Railroad Grade Crossings-Prototype Research

DOT/FRA/ORD-01/01

Final Report  
April 2001

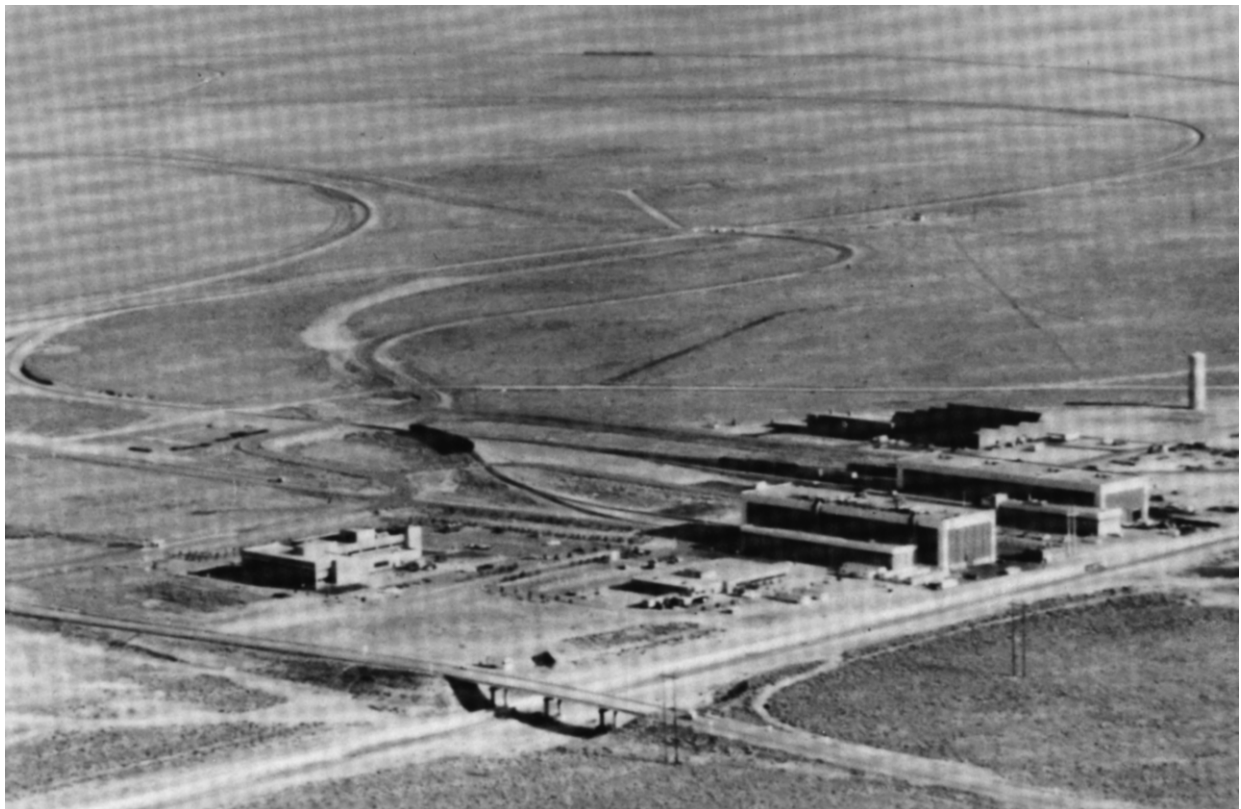
**Figure 4-1. TTC Test Site Aerial Photograph**

The TTC test site (shown in Figure 4-1) is located in a generally flat, semi-arid, high-altitude open area with little vegetation in Pueblo, Colorado. This area is subject to heavy sustained gusting winds and sudden shifts in wind speed and direction. It is also subject to wide fluctuations in temperature between daytime and nighttime. Since the testing was regularly conducted during pre-dawn hours as well as mid-day, the temperature swings during testing were

a factor. Since all of the tests were also conducted during winter or late fall, the test temperatures ranged from subfreezing to 70s° F (25° C), and the precipitation consisted of snow, rain, and a mixture of both. Although weather was not a formal test variable in any of the test phases, it was always considered to be a factor that could affect system performance and was monitored regularly, as discussed in Section 4.2.
