U.S. Department
of Transportation
**Federal Railroad
Administration**

REVISED RAILROAD TANK CAR DAMAGE ASSESSMENT GUIDELINES FOR PRESSURE TANK CARS

1. Report No. DOT/FRA/ORD/03/22	2. Government Accession No.	3. Recipient's Catalog No.	
4. Title and Subtitle Revised Railroad Tank Car Damage Assessment Guidelines for Pressure Tank Cars		5. Report Date June 2002

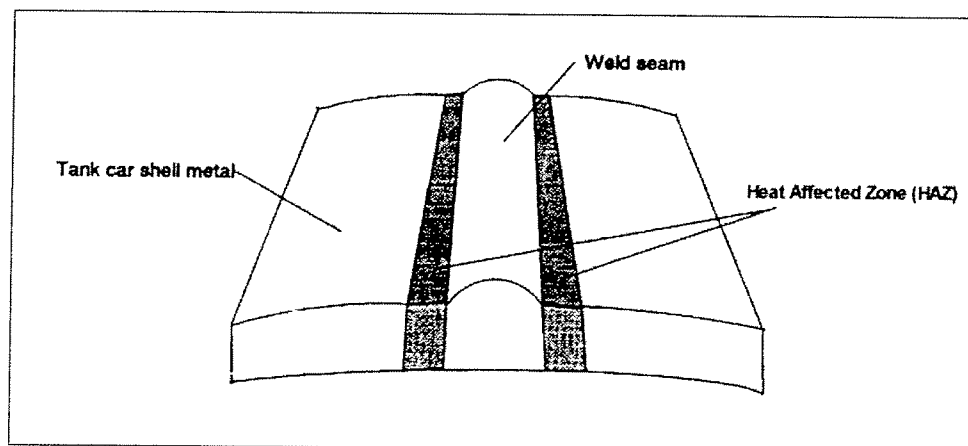
Figure 1. Heat-affected zone

The heat-affected zone (HAZ), is an area in the undisturbed tank metal on both sides of the actual weld bead (see Figure 1). The width of each zone is approximately the same as the width of the bead itself. This zone is less ductile than either the weld or the plate due to the deleterious effect of the heat generated by the welding process on the steel. The HAZ is most vulnerable to damage, as cracks are most likely to initiate there. This was the case with the Flomaton, AL car.

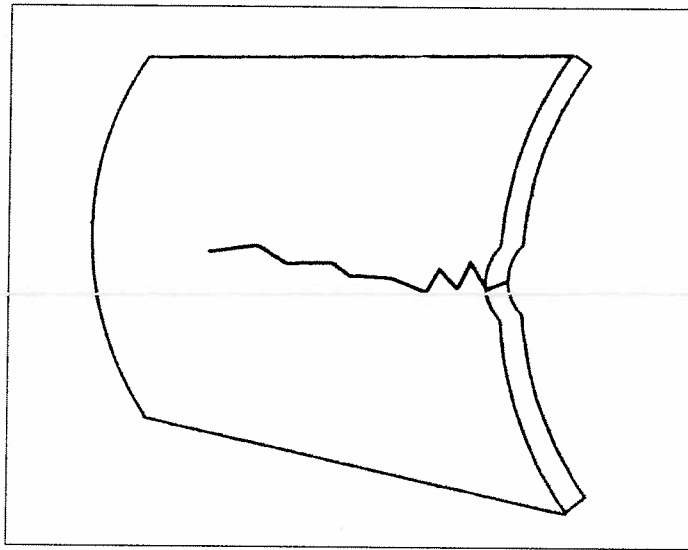
Figure 2. Illustration: Crack in the Tank Metal

As illustrated in Figure 2, a crack is a narrow split or break in the tank metal, which may or may not penetrate through the tank metal. Cracks may be microscopic or macroscopic (visible to the naked eye).

- Since there is no way to detect a crack that has become critical, a crack found anywhere in the base metal or weld of a tank is justification for unloading the car in place.
- Cracks in attachment pads or the welds of these pads are not serious unless they extend into the base metal of the tank. **Caution:** Cracks have been found recently in heads of certain tanks equipped with head blocks.
- Cracks, which run longitudinally to the long axis of the car, are at least 50-75 percent more serious than those that are perpendicular to the long axis.
- Cracks in conjunction with other types of damage are more serious than if found alone (e.g., a crack in the valley of a dent).

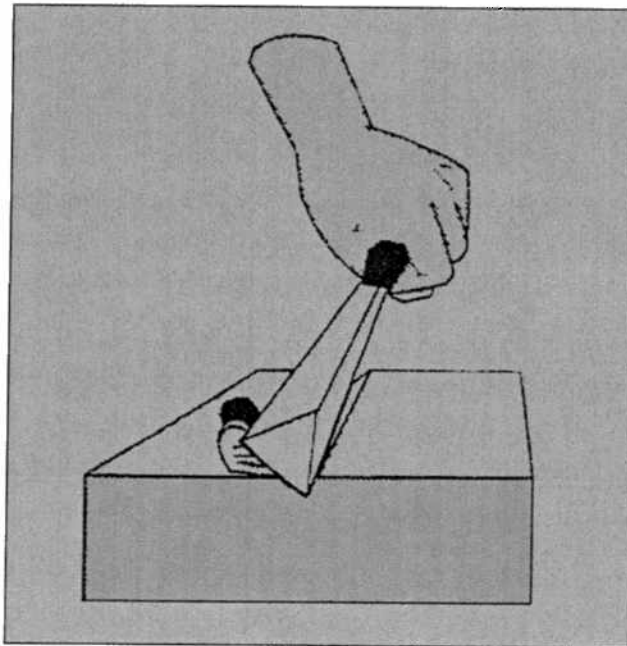
Figure 3. Illustration: Score

A score is a relocation of tank or weld metal so that the metal is pushed aside along the track of contact with another object. This causes a reduction in tank metal thickness. Scores and gouges in conjunction with dents are discussed in Section

Scores or gouges crossing a weld and removing only the weld reinforcement (crown) are not critical (see Figure 3).

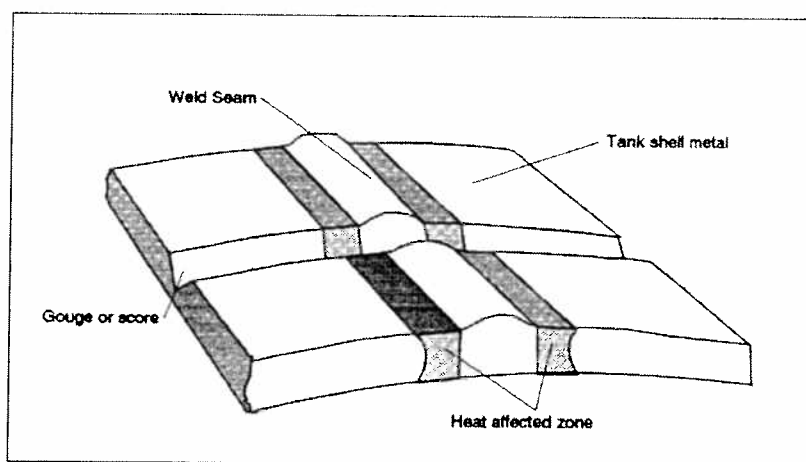
Figure 4. Illustration of Gouge Crossing the HAZ

As shown in Figure 4, longitudinal scores or gouges crossing welds and damaging the heat-affected zone(s) are critical and the contents of the tank should be transferred immediately without raising the internal pressure of the tank (see various transfer methods in *Field Product Removal Methods For Tank Cars*).

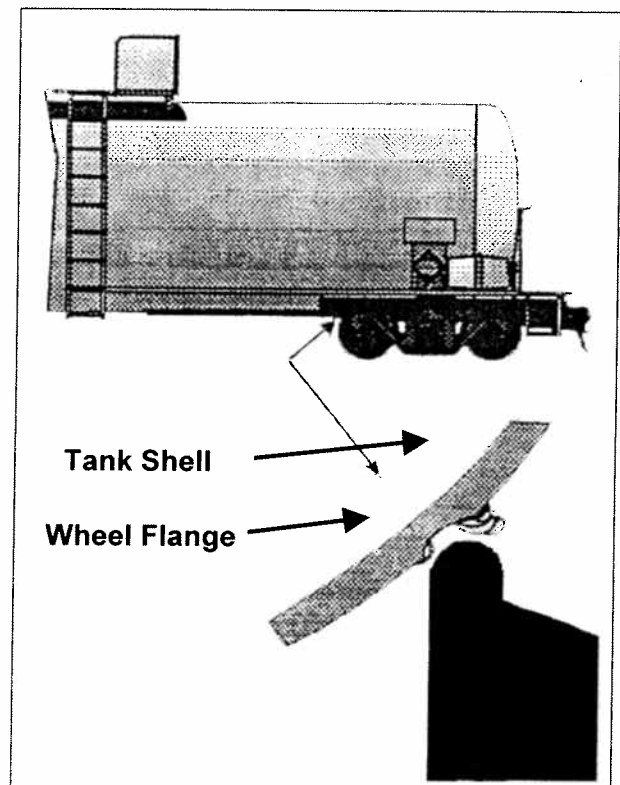
Figure 6. Illustration: Wheel Burn

As shown in Figure 6, a wheel burn is similar to a gouge but is caused by prolonged wheel contact with the tank, which often causes metal discoloration and potential metallurgical damage. The discoloration itself does not cause serious damage.

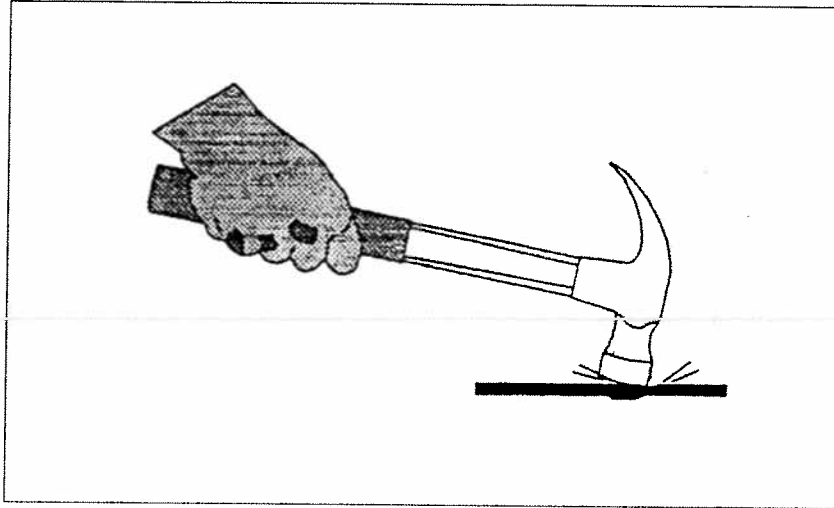
Figure 7. Illustration: Dent

Figure 7 depicts a dent, which is a deformation that changes the tank's contour from that of original manufacture as a result of impact with a relatively blunt object (coupler, draft sill, or the end of an adjacent car).

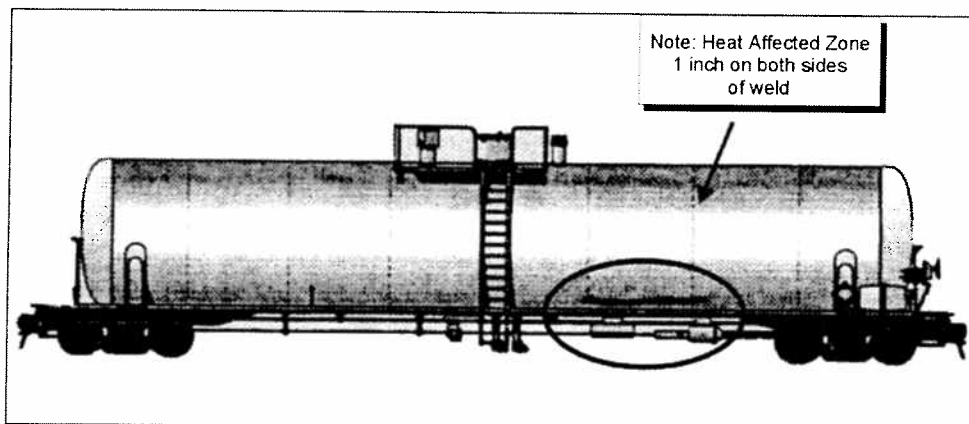
Figure 8. Rail Dent

A rail dent is a long dent, usually parallel to the length of the tank (i.e., parallel to the longitudinal axis of the tank) that crosses a weld and causes cold work (Figure 8). The tank falling on, or passing over a stationary object such as a rail generally causes it. Rail dents are sometimes referred to as rail burns when the sliding action of the tank over the rail produces a discoloration of the surface metal. This surface discoloration (burn) is superficial and is not serious.

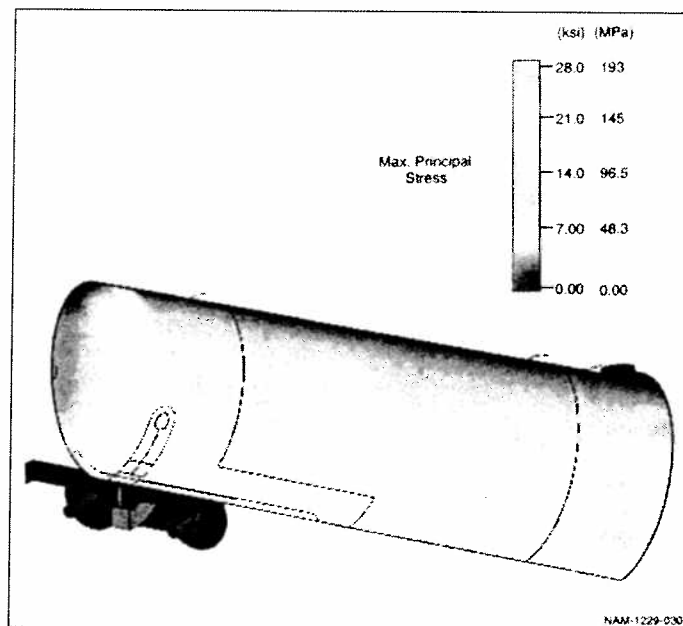
Figure 9. Maximum Principal Stress Distribution from 130-psi Internal Pressure and Lading

Computer modeling studies indicate that when a tank car is lifted properly (i.e., a straight lift from the body bolster or stub sill) the lifting loads imparted into the tank structure will not significantly reduce the safety factors used in evaluating a damaged car. These loads are relatively small relative to the stresses imparted by the internal pressure on the tank exerted by the lading. There are two possible exceptions: 1) when it is a car with critical damage in the area adjacent to the stub sill or bolster; or when a car with a deep (6" or more in this case), long dent is lifted in a way that would cause the dent to flex (Figure 9). This is one case where a circumferential dent can be critical, even when it does not cross a weld.
