Quasi-Static Test on a State-of-the-Art Collision Post and End Post Assembly

April 2009
Draft Report

6. AUTHOR(S) Mark White			
7. PERFORMING ORGANIZATION NAME(S) AND ADDRESS(ES) Transportation Technology Center, Inc. 55500 DOT Road P.O. box 11130 Pueblo, Colorado 81001		8. PERFORMING ORGANIZATION REPORT NUMBER DTFR53-00-C-00012 Task Order 204

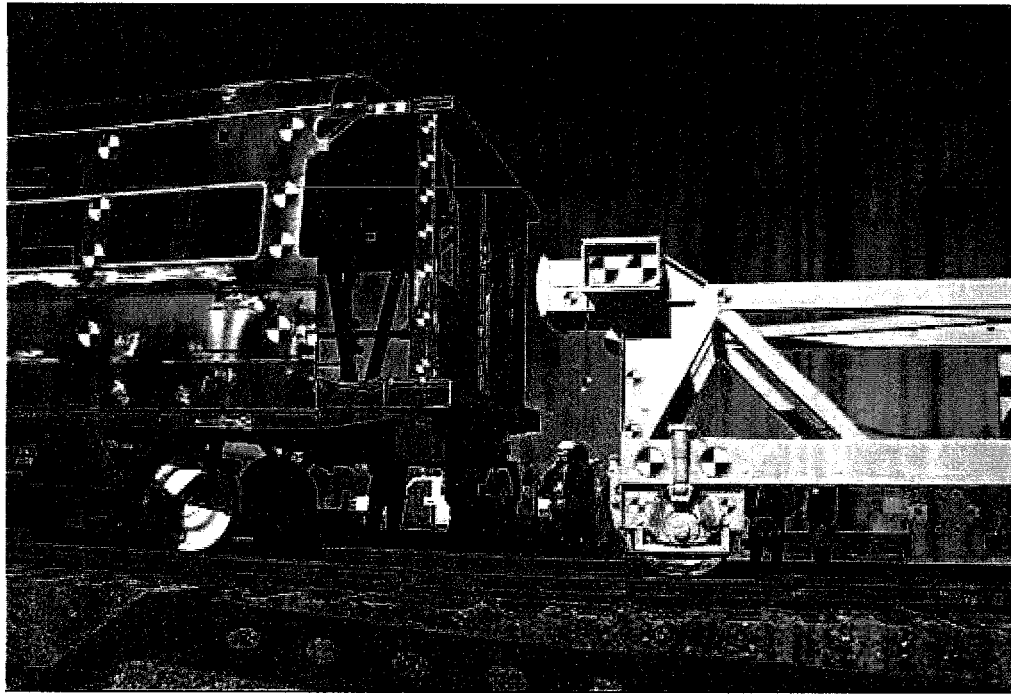
Figure 3. Dynamic Test Setup Collision Post Impact

New state-of-the-art end-frames were assembled at TTC. Components were fabricated by Zimmerman Metals, Denver, based on a design furnished by the Volpe Center through a contract with TIAX LLC, Cambridge. End frames were the same design as that used for the dynamic test, with the exception that some modifications were performed at the shelf reinforcing channel and bulkhead plate where they attached to the collision and end posts for the end post test. End frame assembly drawings are Number D038-009-010. This report contains a CD of Microsoft PowerPoint format files with progress reports showing the fabrication process of the end assemblies, as reference. See Figure 3 showing the Dynamic Test setup for reference.

The 48-inch diameter coil shape used on the impactor cart (see Figure 3) was mounted on the base end of the hydraulic ram as the contact shape against the collision and end posts (Figure 4). The cylinder end has a series of four 100,000-pound load cells sandwiched between the reaction car and the cylinder head to measure force directly in a pin style connection (compression only). A pressure transducer was also installed in the hydraulic line to correlate hydraulic pressure with force applied through the hydraulic ram. A 10,000 pound per square inch rated hydraulic pump was used to provide pressure to the actuator that is rated for a maximum of 1,000,000 pounds force. The ram was suspended in place with an overhead crane to support and hold the ram, should an abrupt failure occur. There was a safety concern that the stored energy in the end frame could release suddenly during the test. Lateral movement of the two cars during loading could also affect the hydraulic ram and make loading of the end frame unstable. As the test post displaces inward, contact is made with the shelf (C-channel) and bulkhead plate assembly, which could impose an eccentric load on the coil shape. Loading on the four load cells was watched for signs of instability. Although the four load cells did show variable loading between the load cells during the test, the system was stable and behaved well over the entire displacement range. A rectangular spacer was placed behind the shim plate to make up the difference between the end frame and the reaction car when the hydraulic cylinder was compressed. This allowed a range of up to 12 inches of displacement before the cylinder was fully extended. The cylinder was then compressed, and a second rectangular spacer was used that was 10 inches longer to extend the displacement range of the test setup.
