REPORT NO. FRA/ORD-80/5, III

SLEEVE EXPANSION OF BOLT HOLES IN RAILROAD RAIL

Volume III - Field Experiment Results

BOEING COMMERCIAL AIRPLANE COMPANY
P.O. Box 3707
Seattle WA 98124

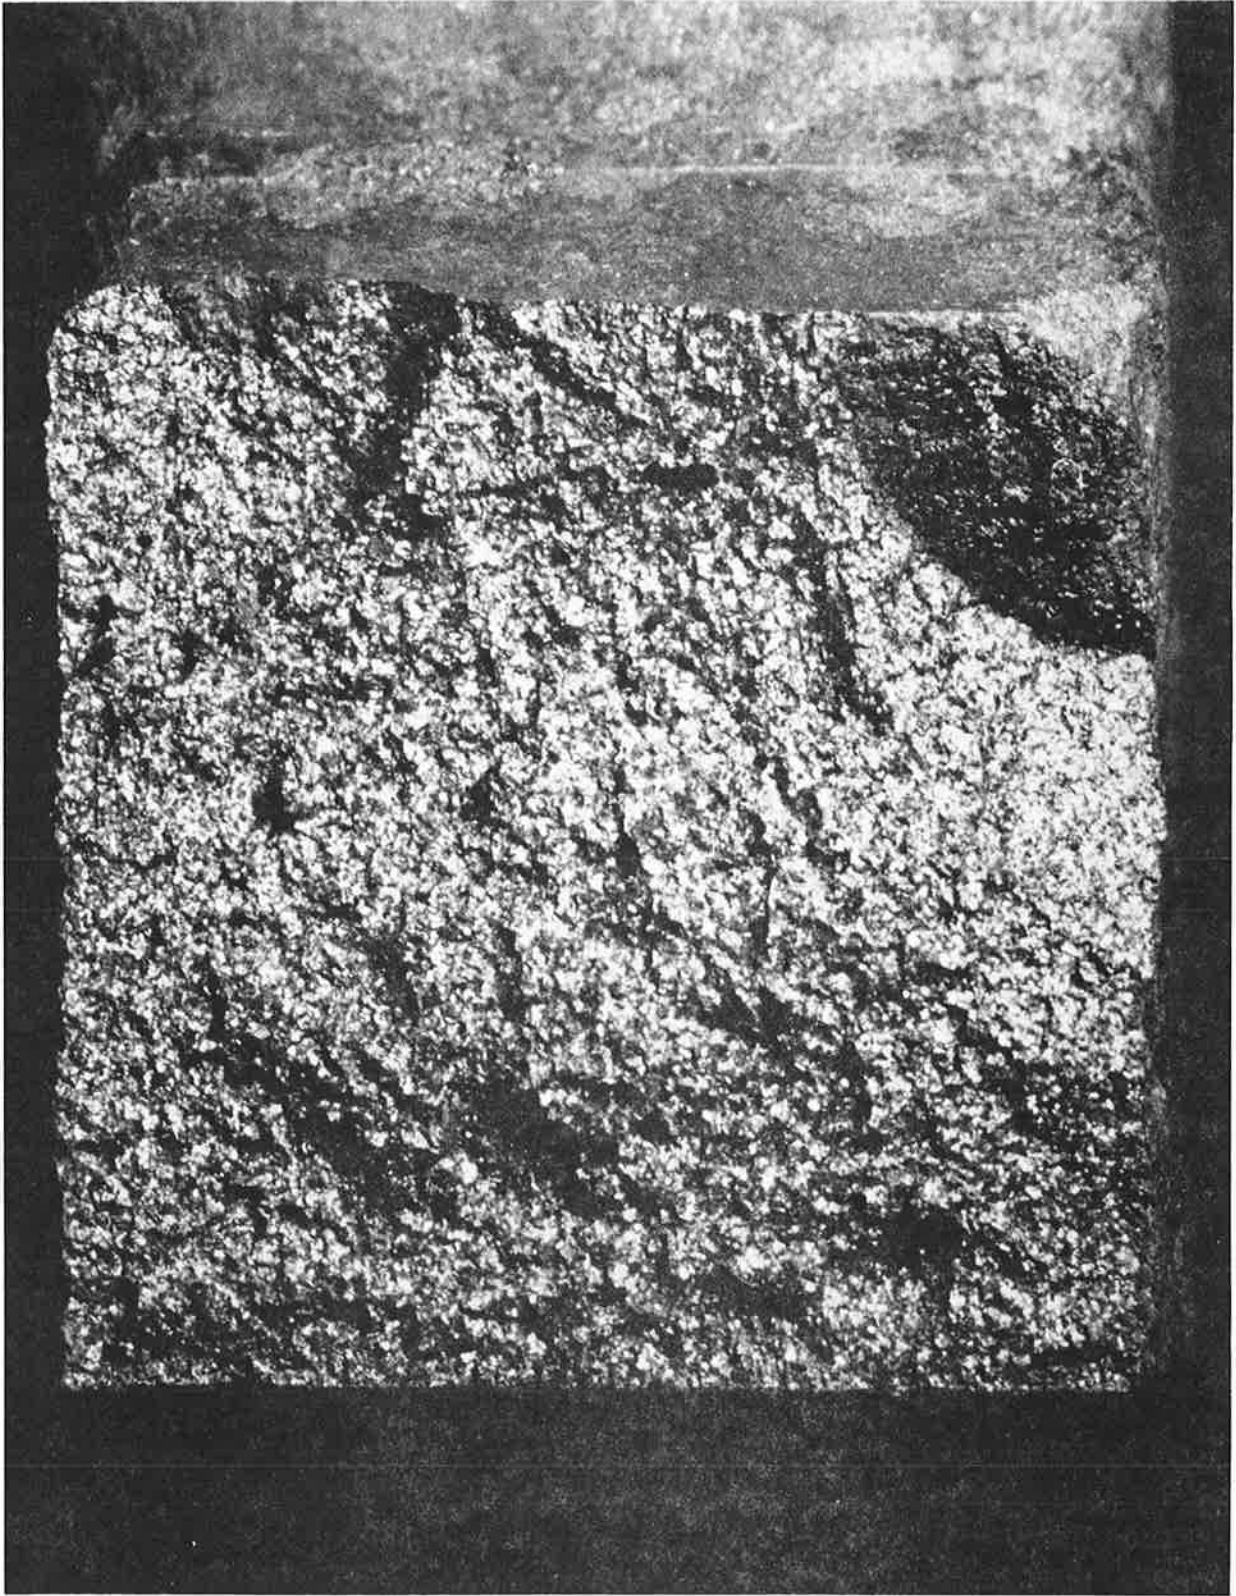
Figure 3.—Preexisting 1/4-inch Crack—Milepost 107.27

In April 1978, the test section was relaid. The three rails with preexisting 1/4-inch crack were cropped and sent to Boeing for inspection. Fracture-face examination of the rails indicated the cracks to be of considerable age, with no growth in recent months. The rail crack reported in September to have grown from 1/4 to 1/2 inch was still only 1/4 inch in length. The fracture faces of the three rails are shown in figures 2, 3, and 4.

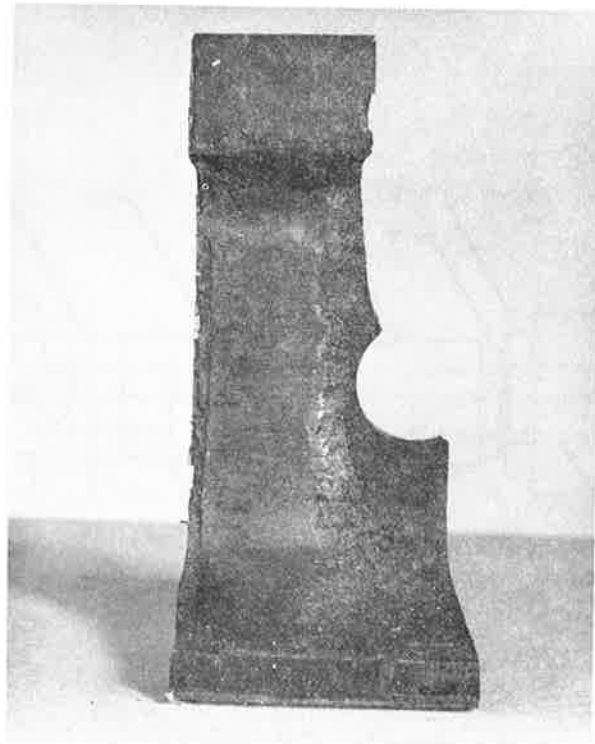
Figure 5.—Sleeve-Expanded Bolt-Hole/Weld Relationship

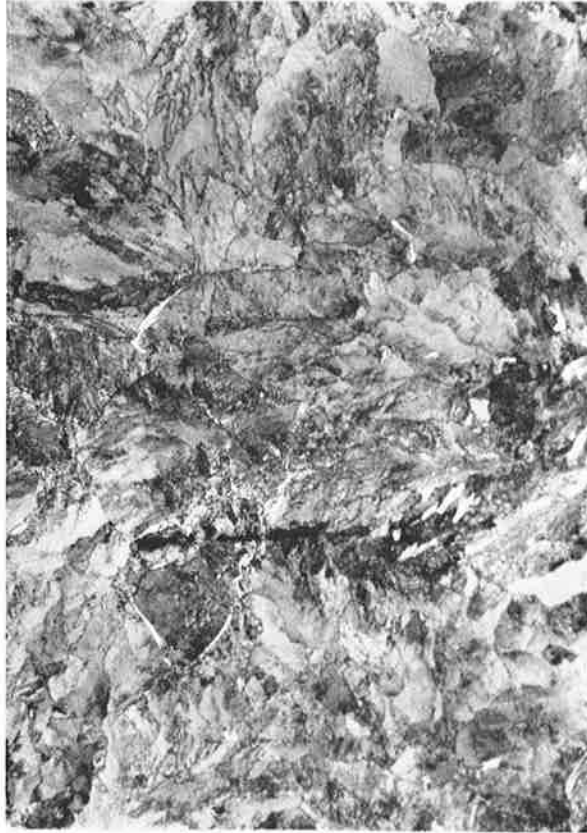
Magnification x 400.
a) Plane xx – yy (Figure 3).

Figure 5.—Micrographs from rail steel A. Etch - Super Picral.
