Report Nos.: DOT-TSC-OST-76-4/FRA-OR&D-76-142

## AN ASSESSMENT OF RAILROAD LOCOMOTIVE NOISE

Paul J. Remington  
Michael J. Rudd

Bolt Beranek and Newman Inc.  
50 Moulton Street  
Cambridge MA 02138

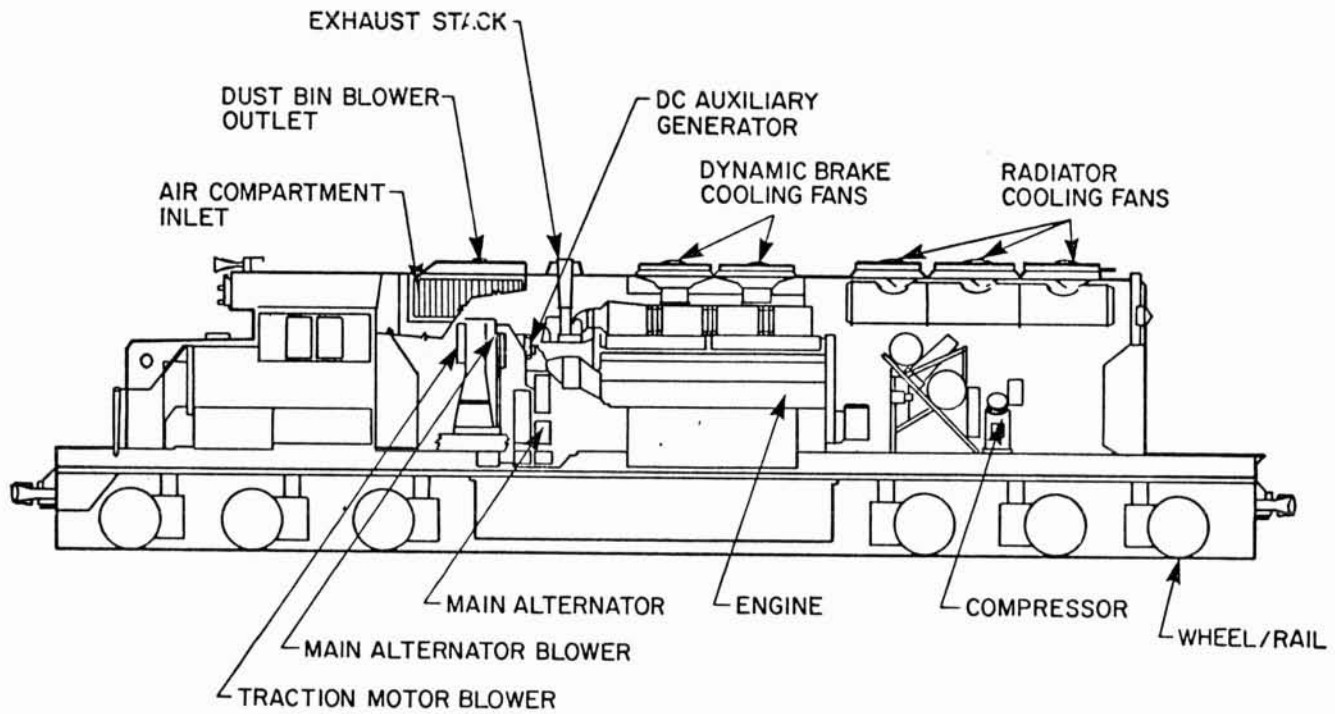
FIG. 2.2. MAJOR NOISE SOURCE LOCATIONS IN THE SD40-2 LOCOMOTIVE.

Twelve major noise sources that were investigated in the diagnostic phase of this program are shown in Fig. 2.2; in Sec. 2.2, we briefly describe each source and its operation.

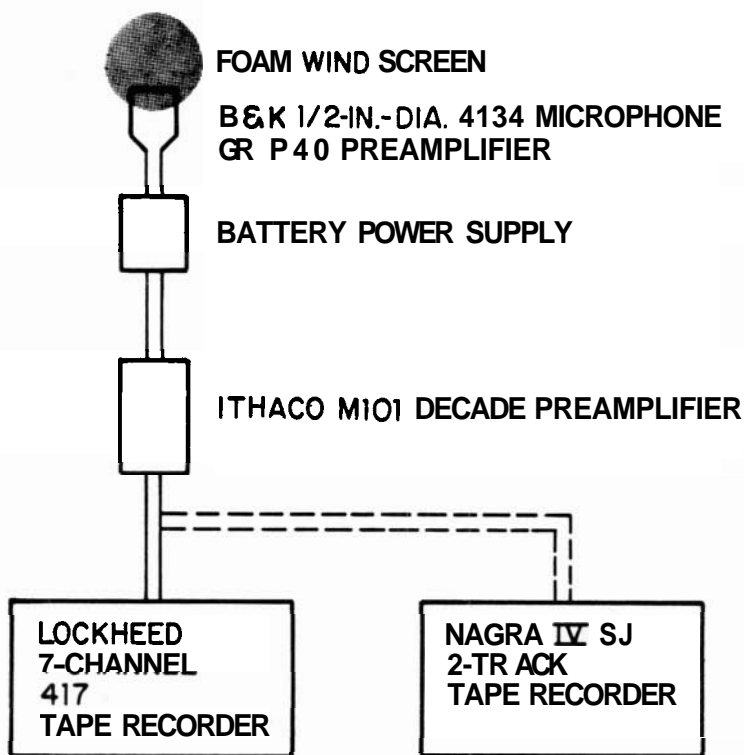
FIG. 3.6. TYPICAL MICROPHONE INSTRUMENTATION CHAIN.

A typical microphone instrumentation chain is shown in Fig. 3.6. Up to seven microphones were running at any given time, not always with the same equipment. Occasionally, a B&K No. 2209 microphone power supply was substituted for the GR P40. In

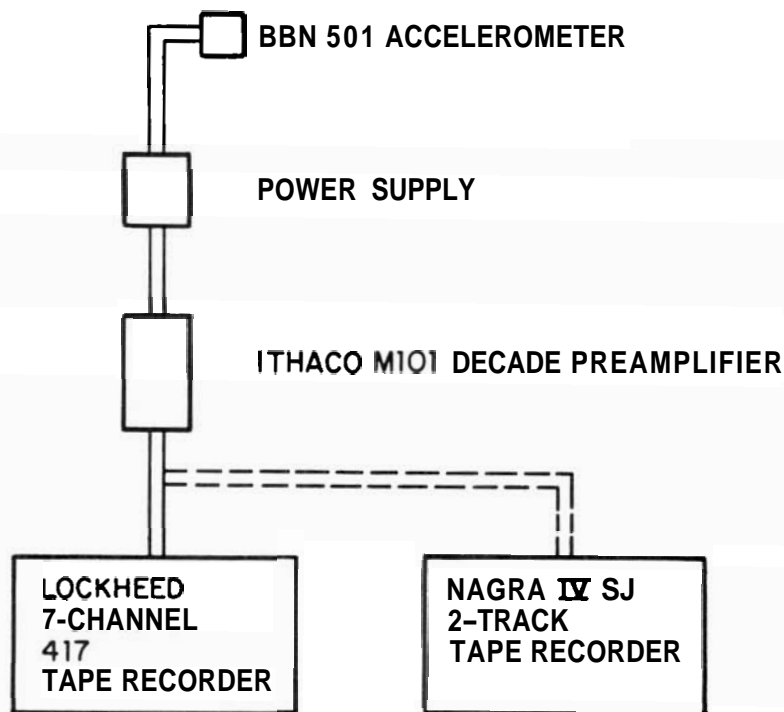
FIG. 3.7. TYPICAL ACCELEROMETER INSTRUMENTATION CHAIN.

addition, a General Radio 1-in. crystal microphone and P42 pre-amplifier were substituted for the B&K microphone and GR P40 pre-amplifier at a given location when the latter failed. Though the Lockheed tape recorder was used at 3-3/4 ips for most multichannel recordings, failure of the drive system on that instrument later in the program required all subsequent recordings to be made using the Nagra recorder at 7.5 ips, two channels at a time. For all cases in which only two channels were required, the Nagra machine was used in place of the Lockheed. Acceleration records were similarly obtained. A typical accelerometer instrumentation chain is shown in Fig. 3.7.

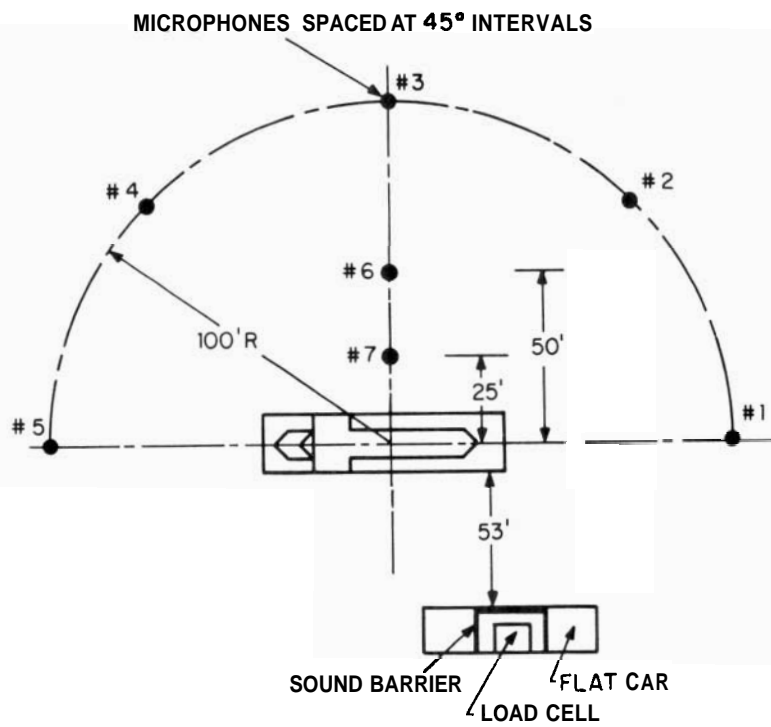
FIG. 3.8. DIAGNOSTIC TEST.

The instrumentation for the diagnostic tests is the same as that described in Sec. 3.2.1 for the baseline tests. The diagnostic tests, however, were done late in the measurement program after failure of the Lockheed tape recorder. As a result, all recording was made on the Nagra tape recorder either one or two channels at a time through a switch box.

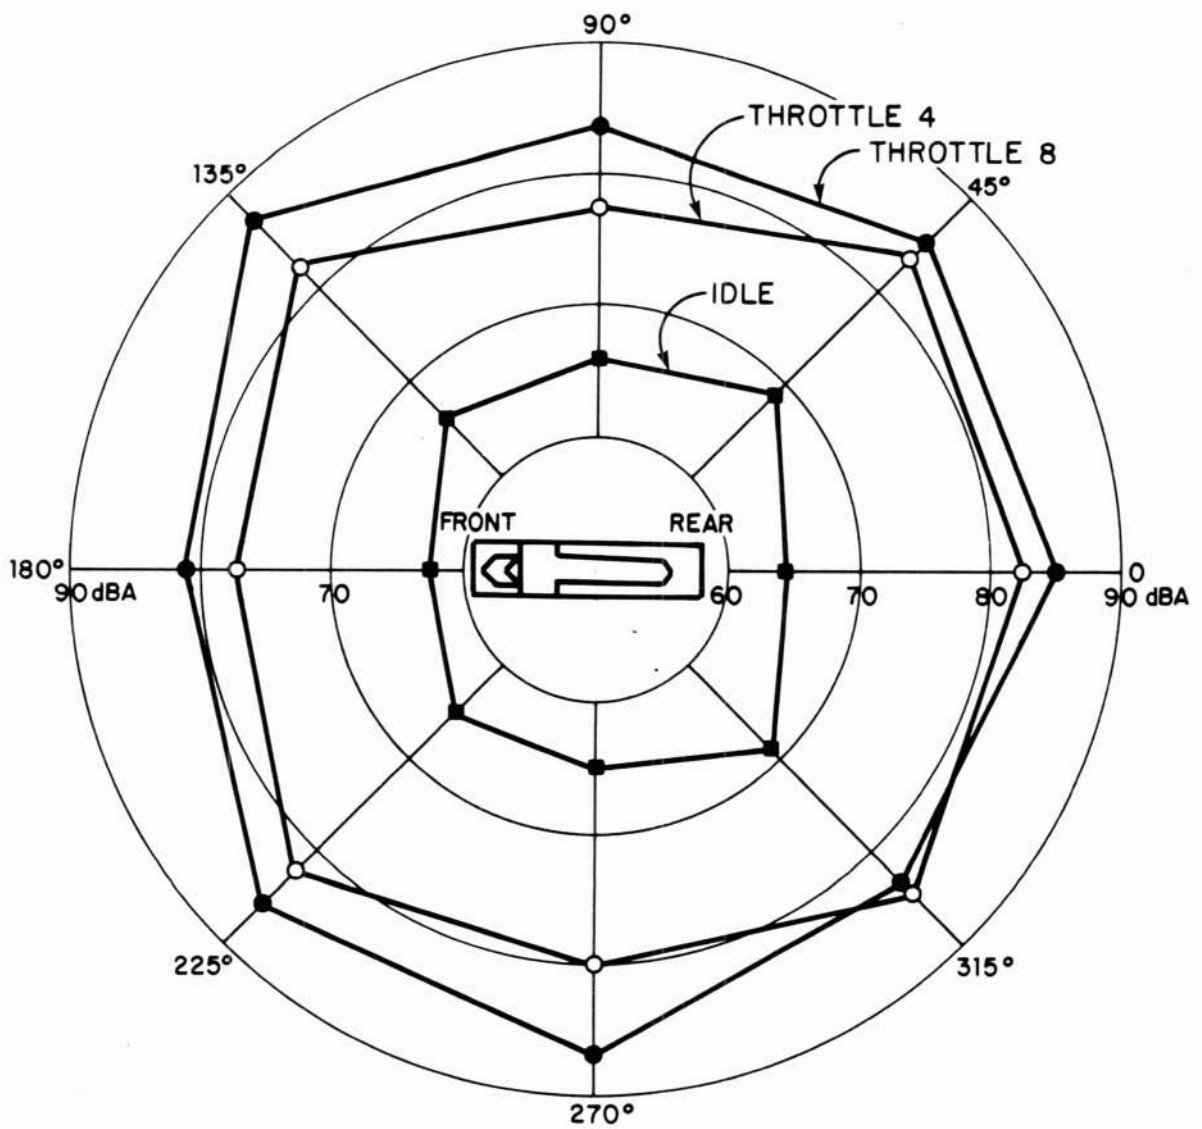
FIG. 4.6. DIRECTIVITY OF LOCOMOTIVE NOISE.

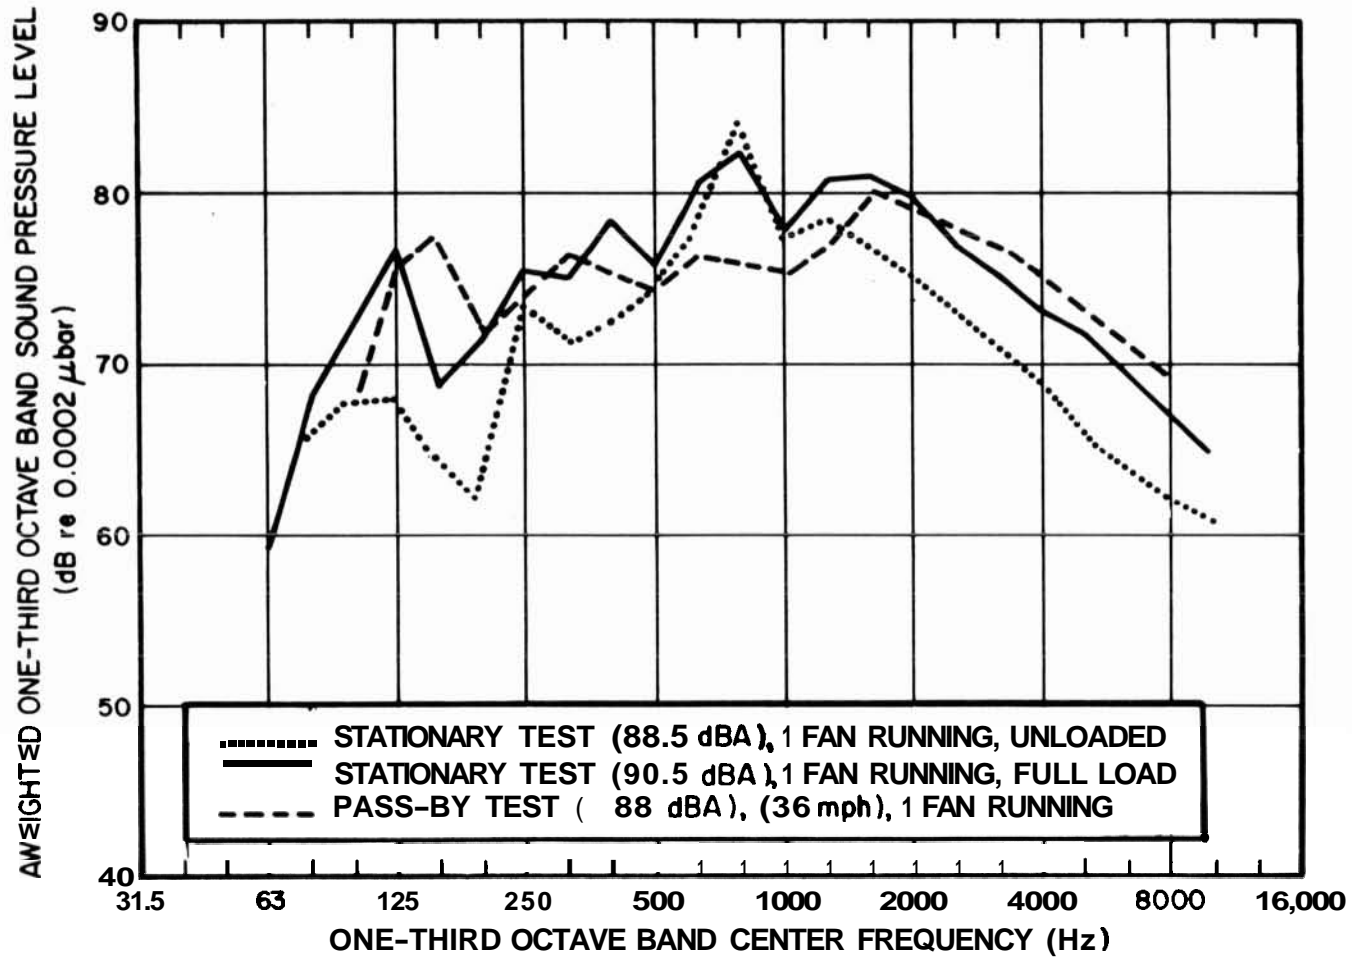
FIG. 4.20. COMPARISON OF STATIONARY AND PASS-BY TESTS AT THROTTLE 8, 50 FT, 36 MPH.

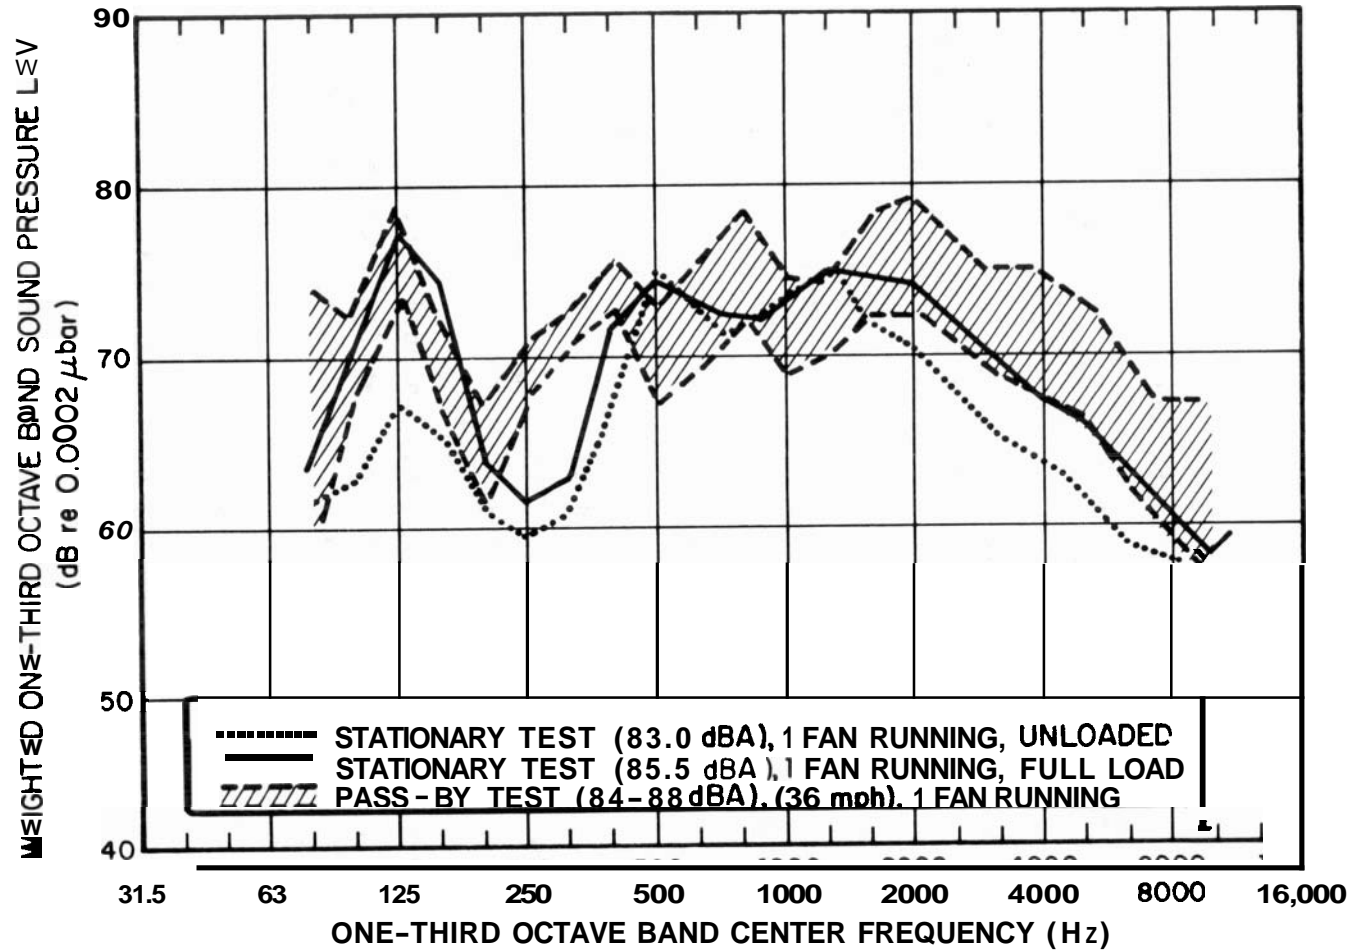
FIG. 4.21. COMPARISON OF STATIONARY AND PASS-BY TESTS AT THROTTLE 8, 100 FT, 36 MPH.

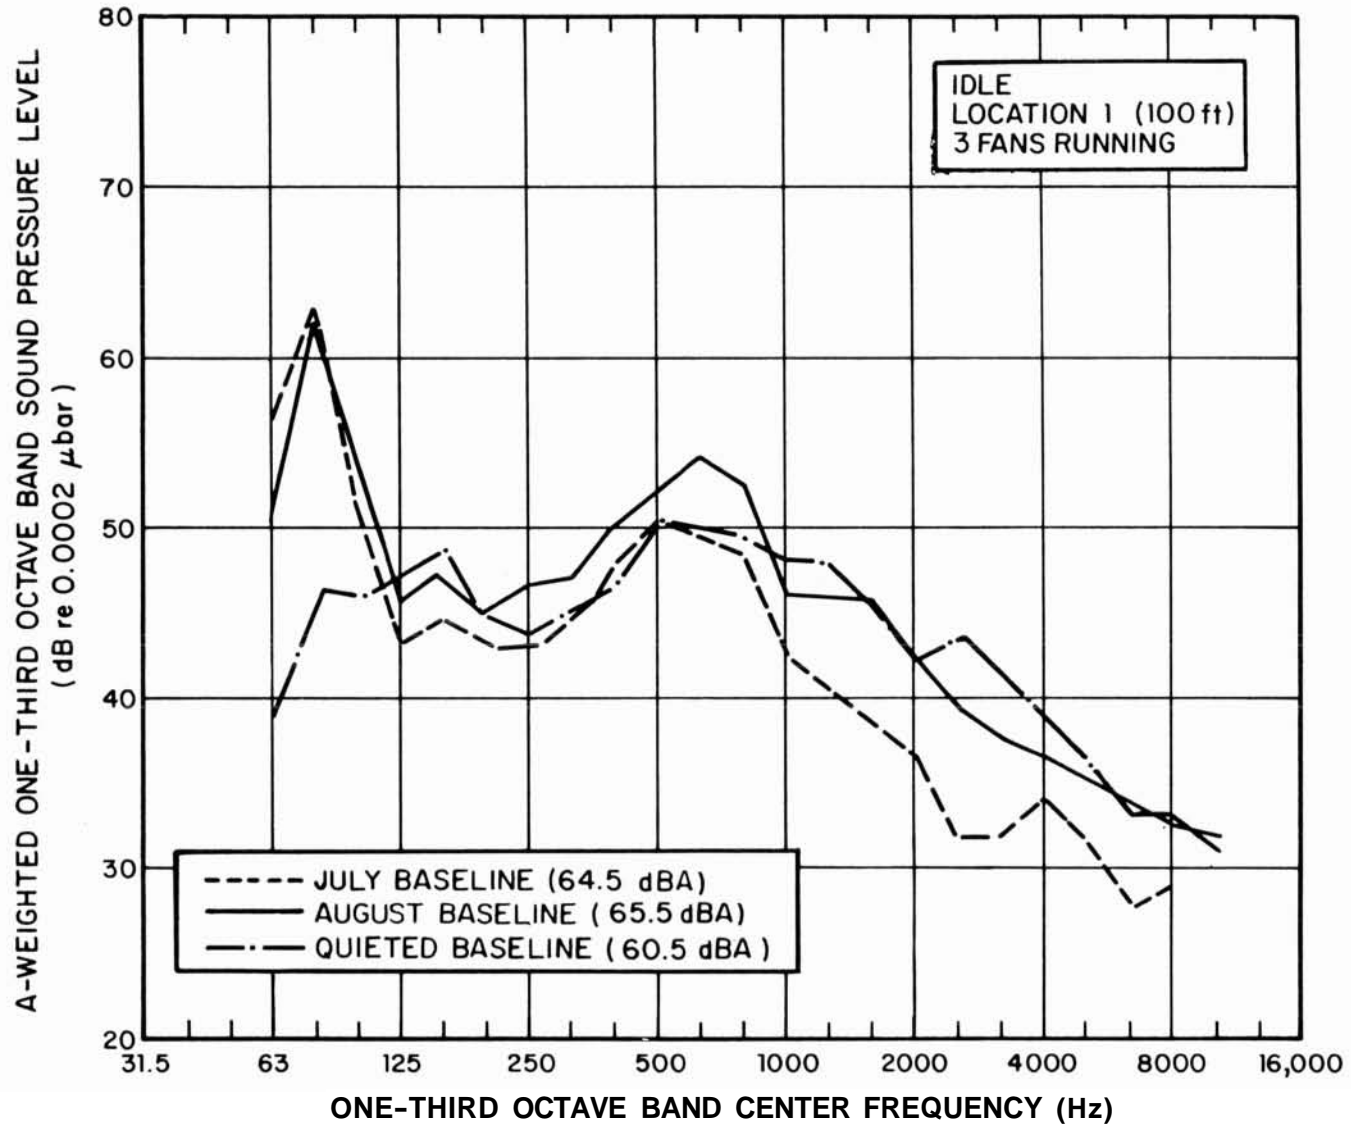
FIG. A.1. LOCOMOTIVE BASELINE NOISE, IDLE, MICROPHONE LOCATION 1.

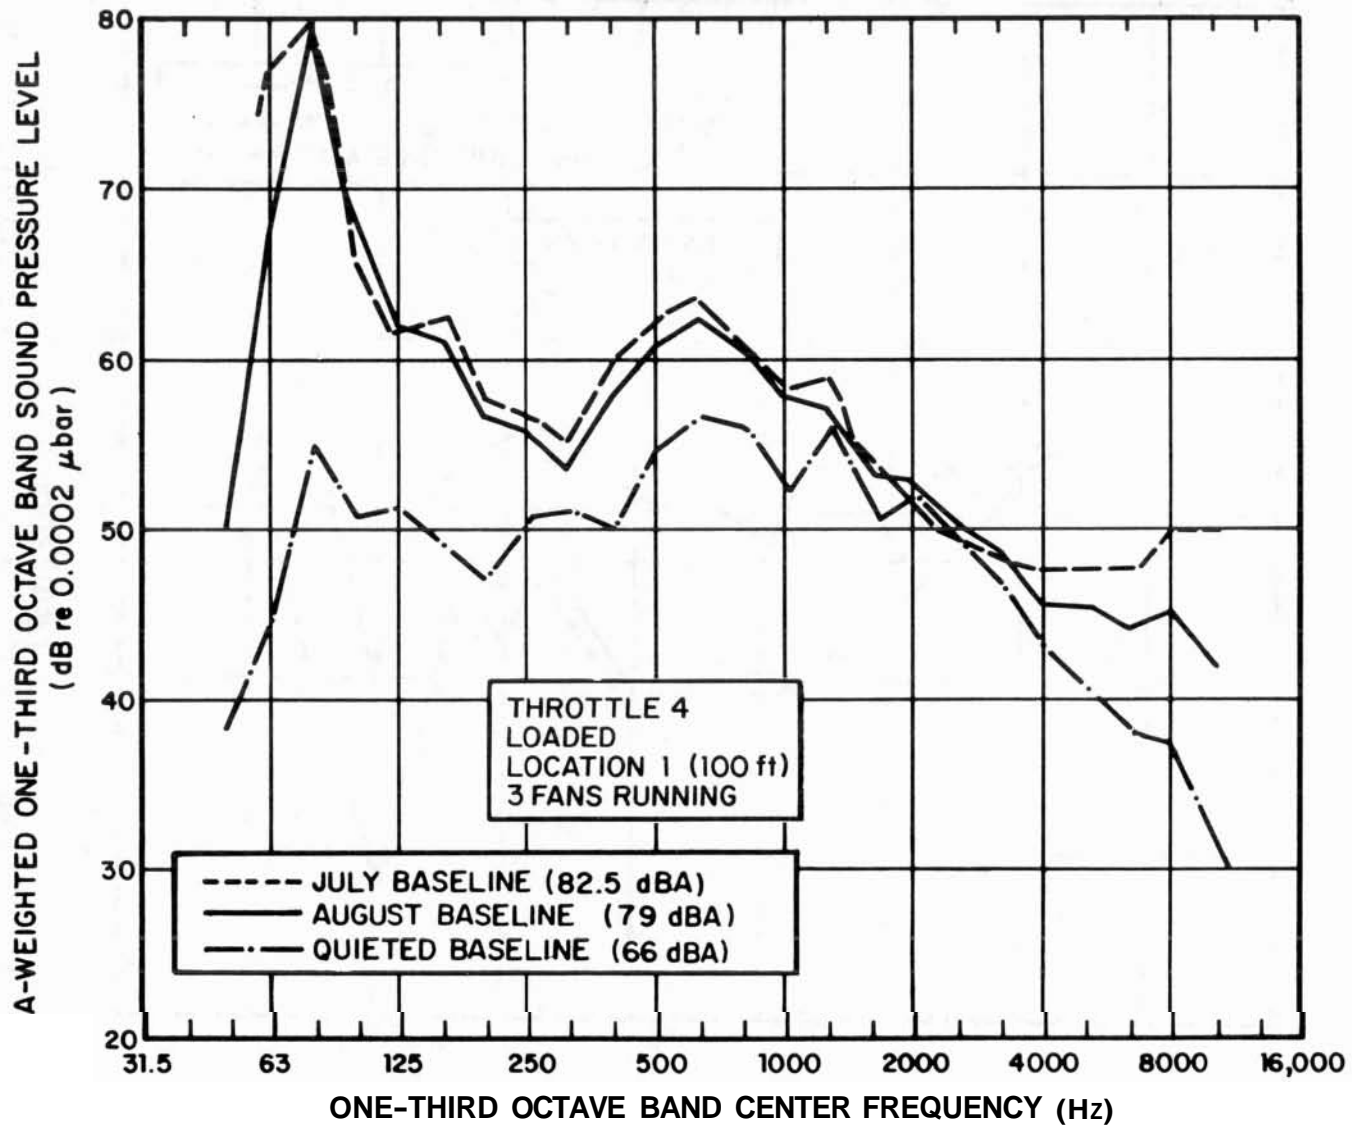
FIG. A.2. LOCOMOTIVE BASELINE NOISE, THROTTLE 4, FULL LOAD, MICROPHONE LOCATION 1.

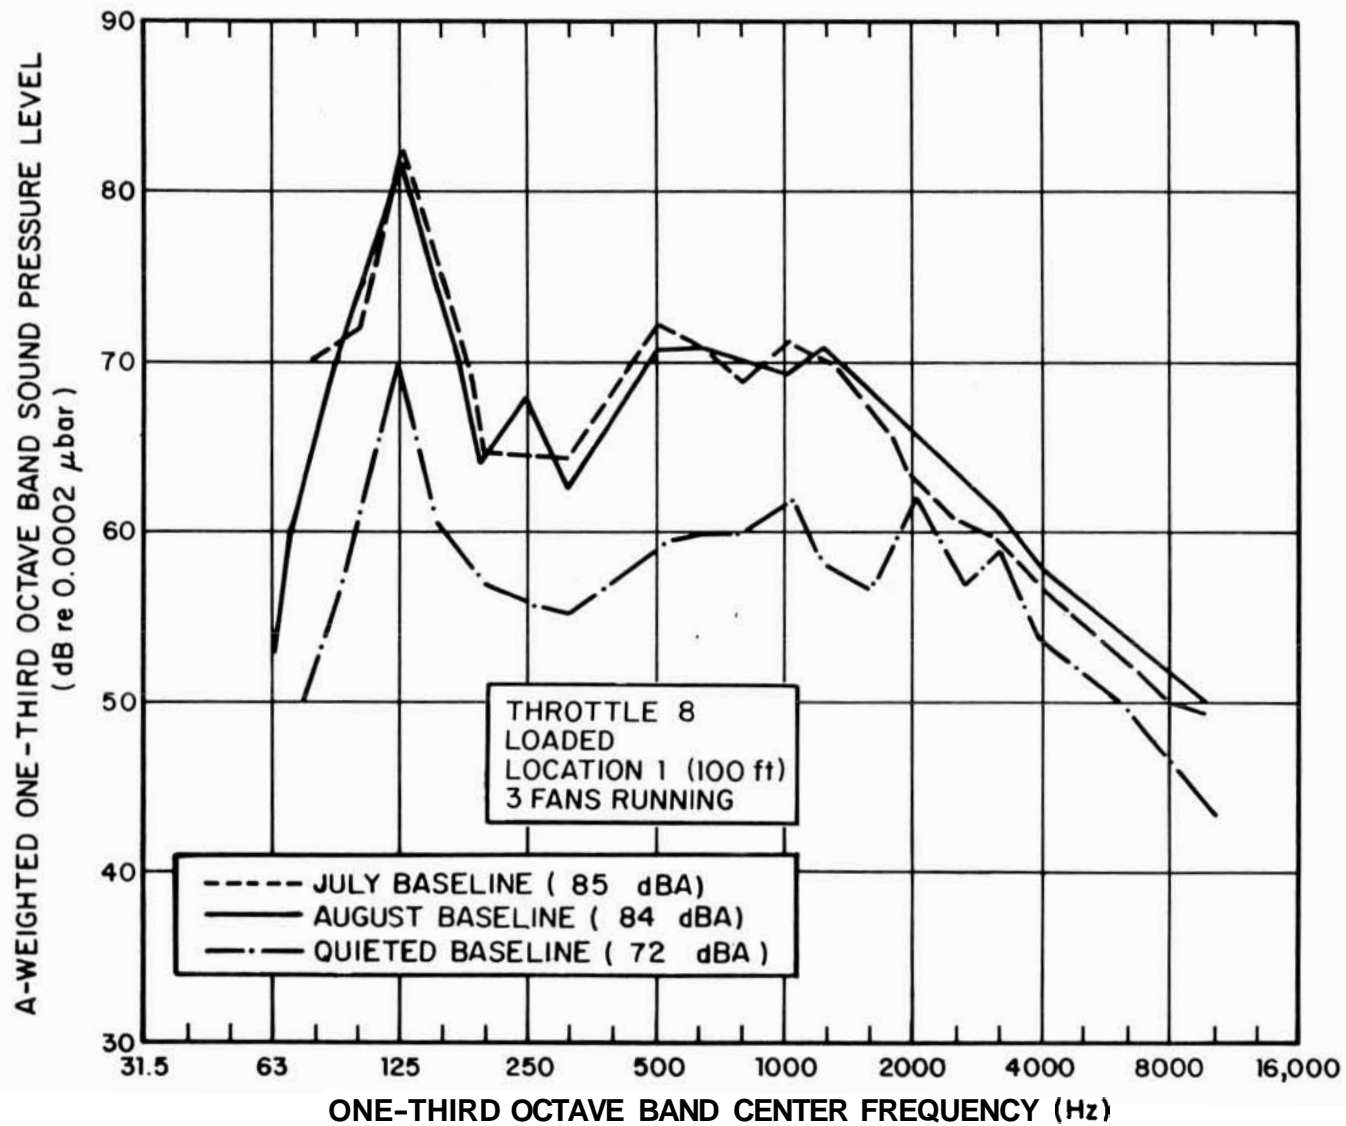
FIG. A.3. LOCOMOTIVE BASELINE NOISE, THROTTLE 8, FULL LOAD, MICROPHONE LOCATION 1.

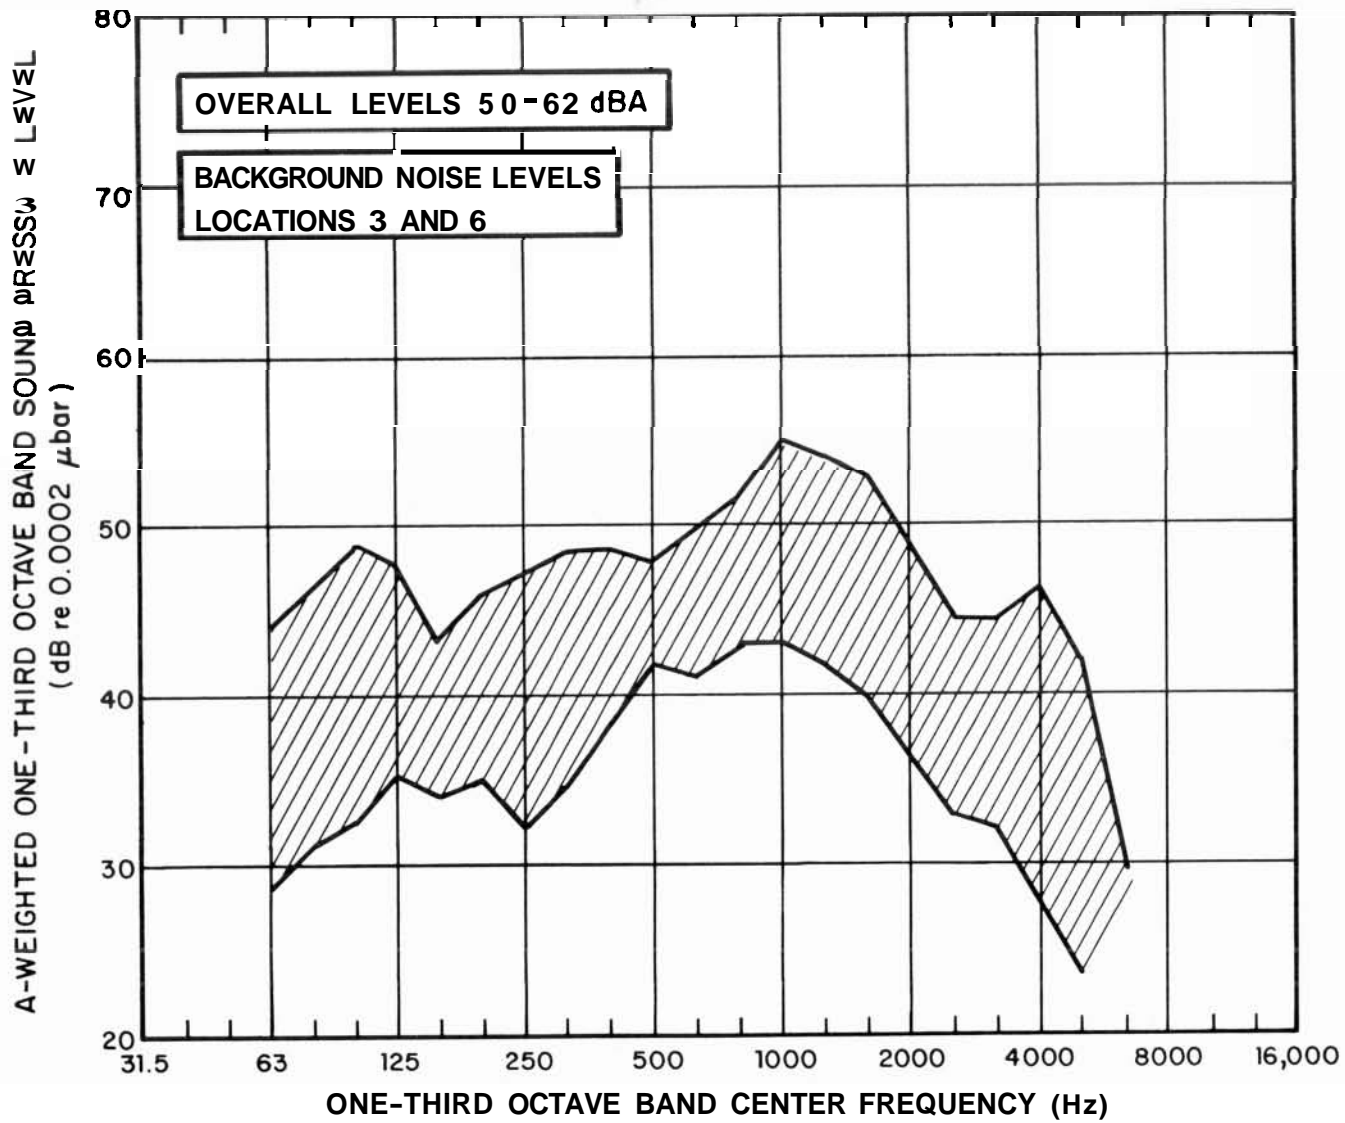
FIG. A.28. THE RANGE OF BACKGROUND LEVELS AT MICROPHONE LOCATIONS 3 AND 6.

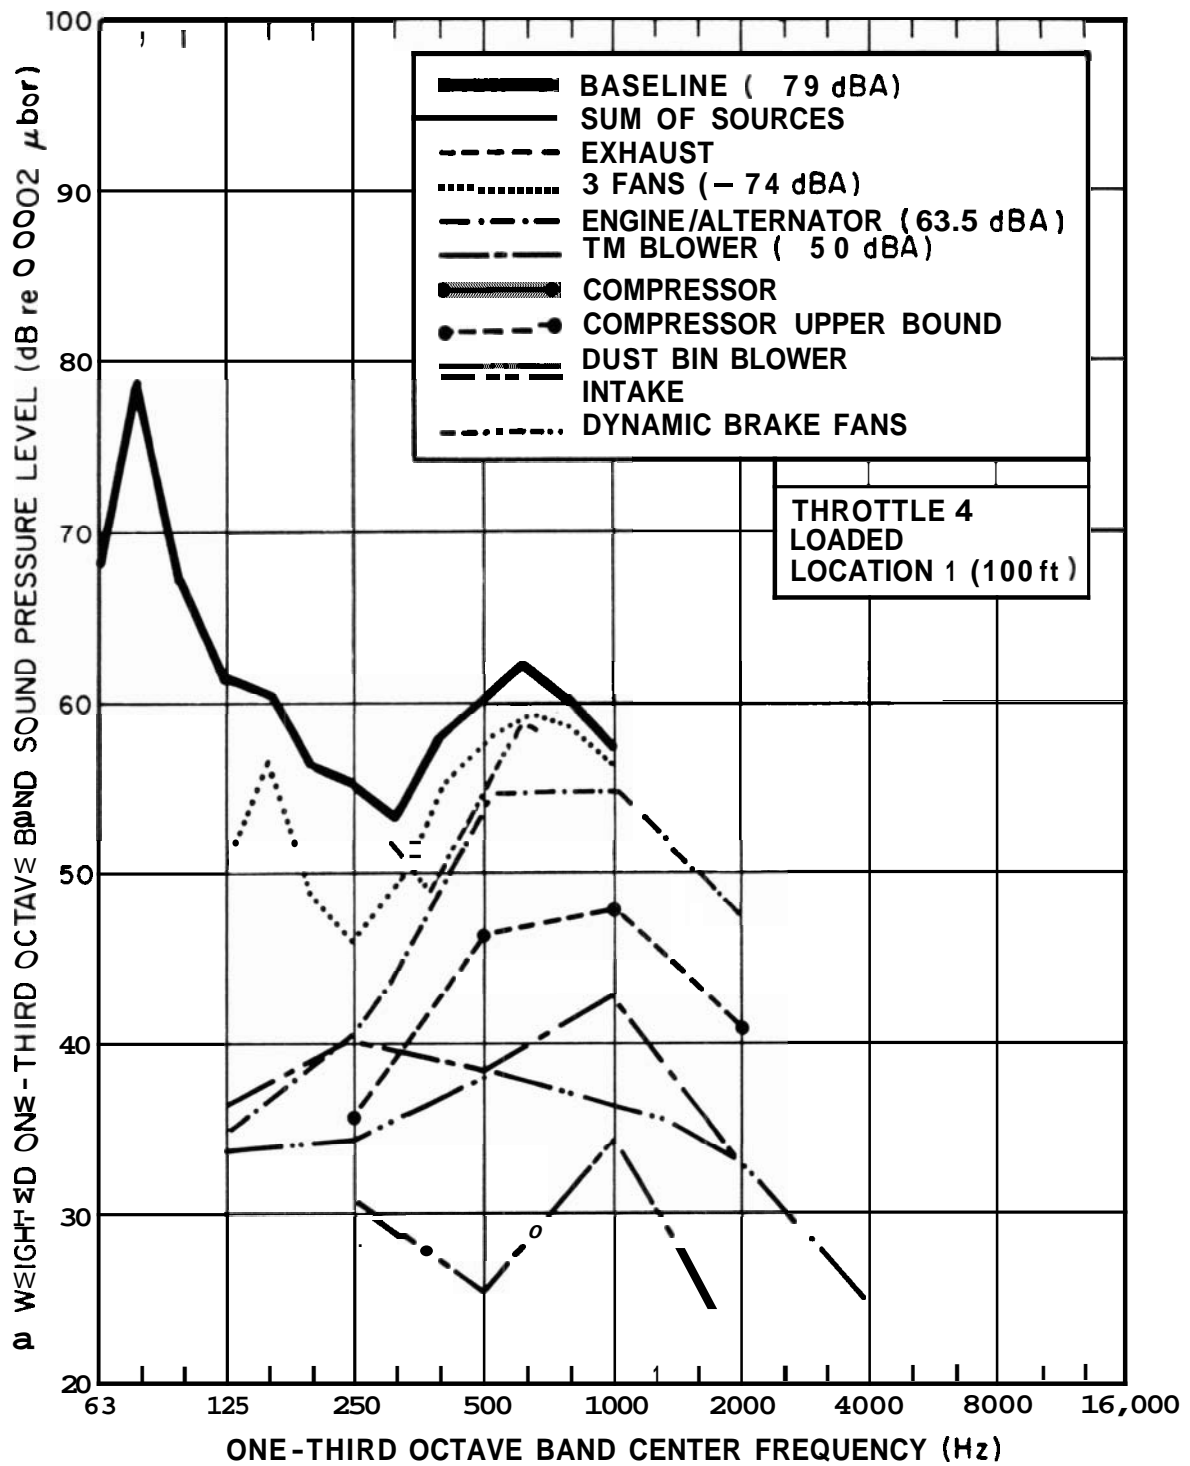
FIG. B.1. SOURCE SPECTRA AT THROTTLE 4, FULL LOAD, MICROPHONE LOCATION 1.

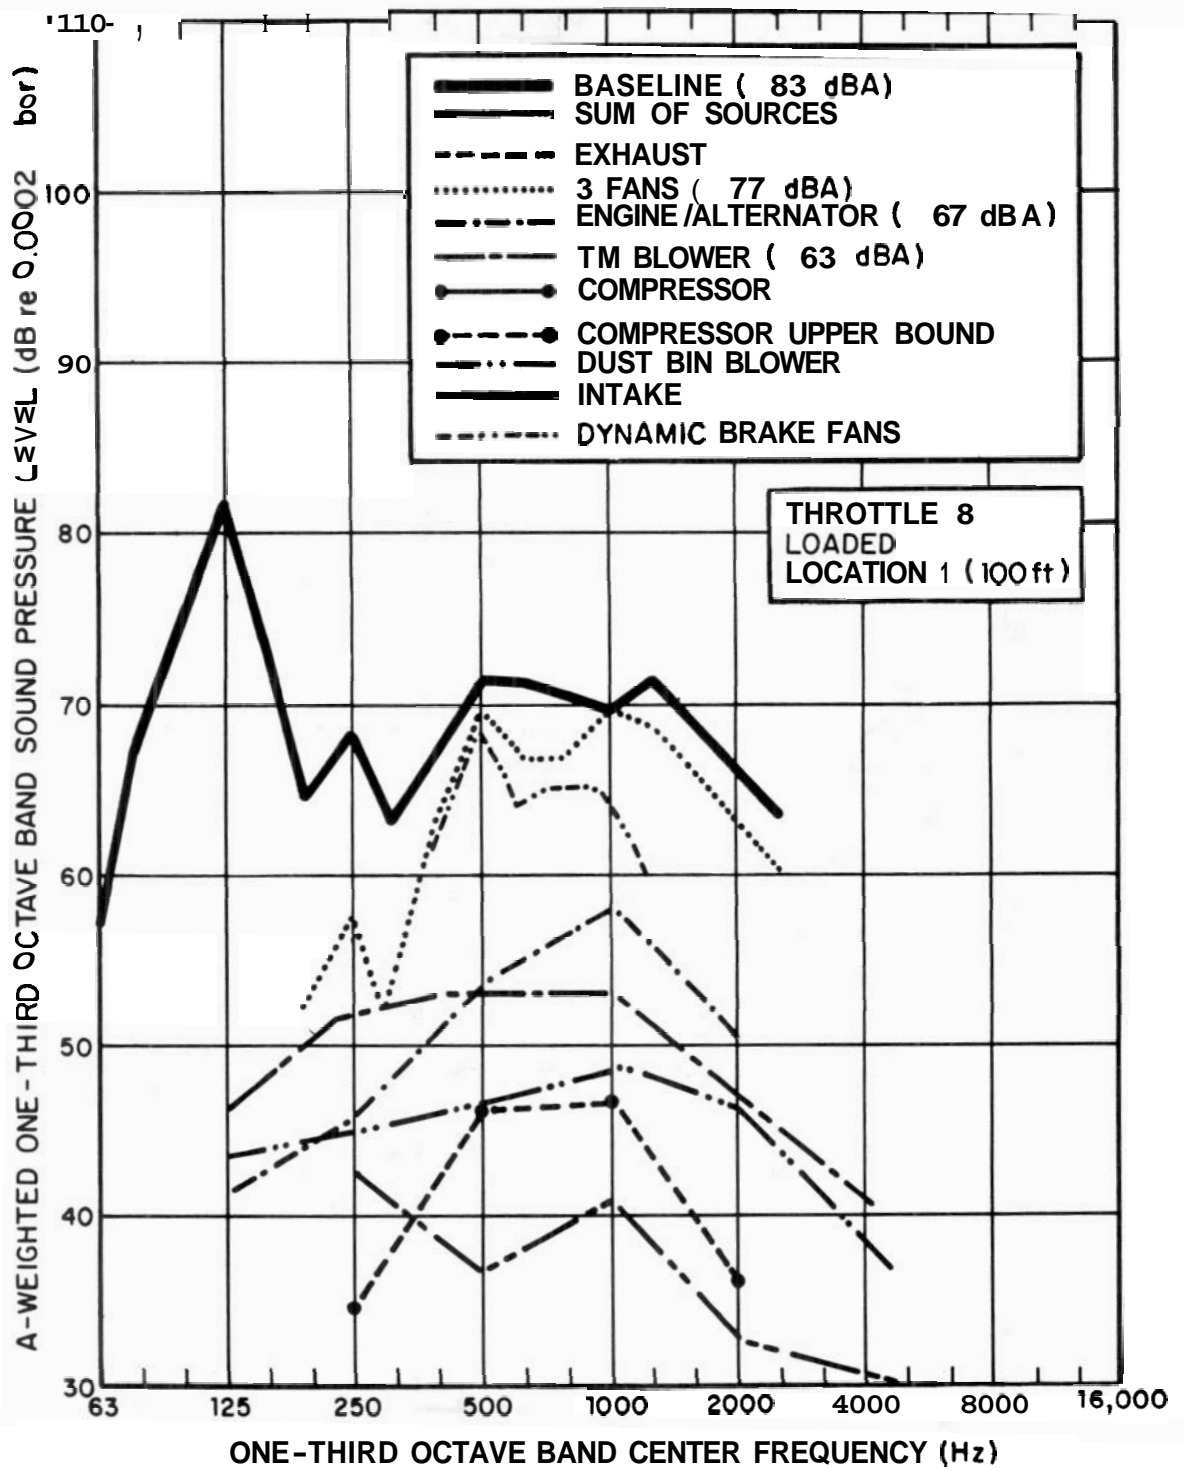
FIG. B.2. SOURCE SPECTRA AT THROTTLE 8, FULL LOAD, MICROPHONE LOCATION 1.

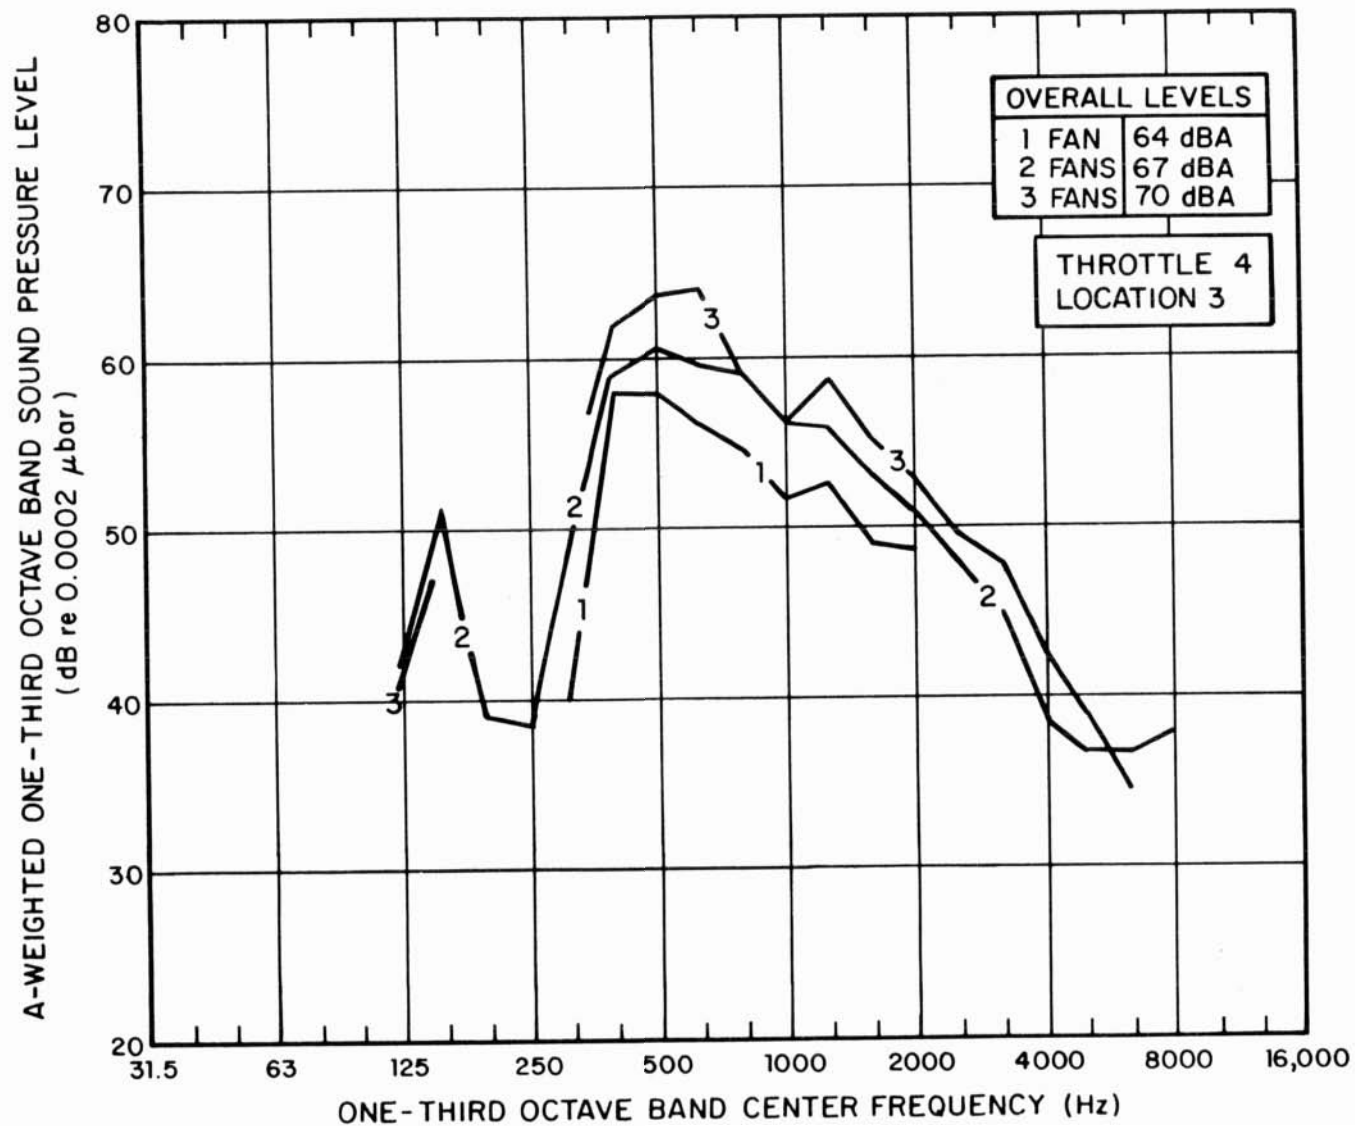
FIG. B.21. FAN SOURCE SPECTRA, THROTTLE 4, MICROPHONE LOCATION 3. THE NUMBERS REFER TO THE NUMBER OF FANS OPERATING.

The *cooling fan source spectra* were obtained by turning all three cooling fans on with the locomotive in the fully quieted condition and running unloaded. The difference between the noise spectra with the cooling fans running and the fans shut off yielded the fan source spectra. Gaps in the spectra indicate

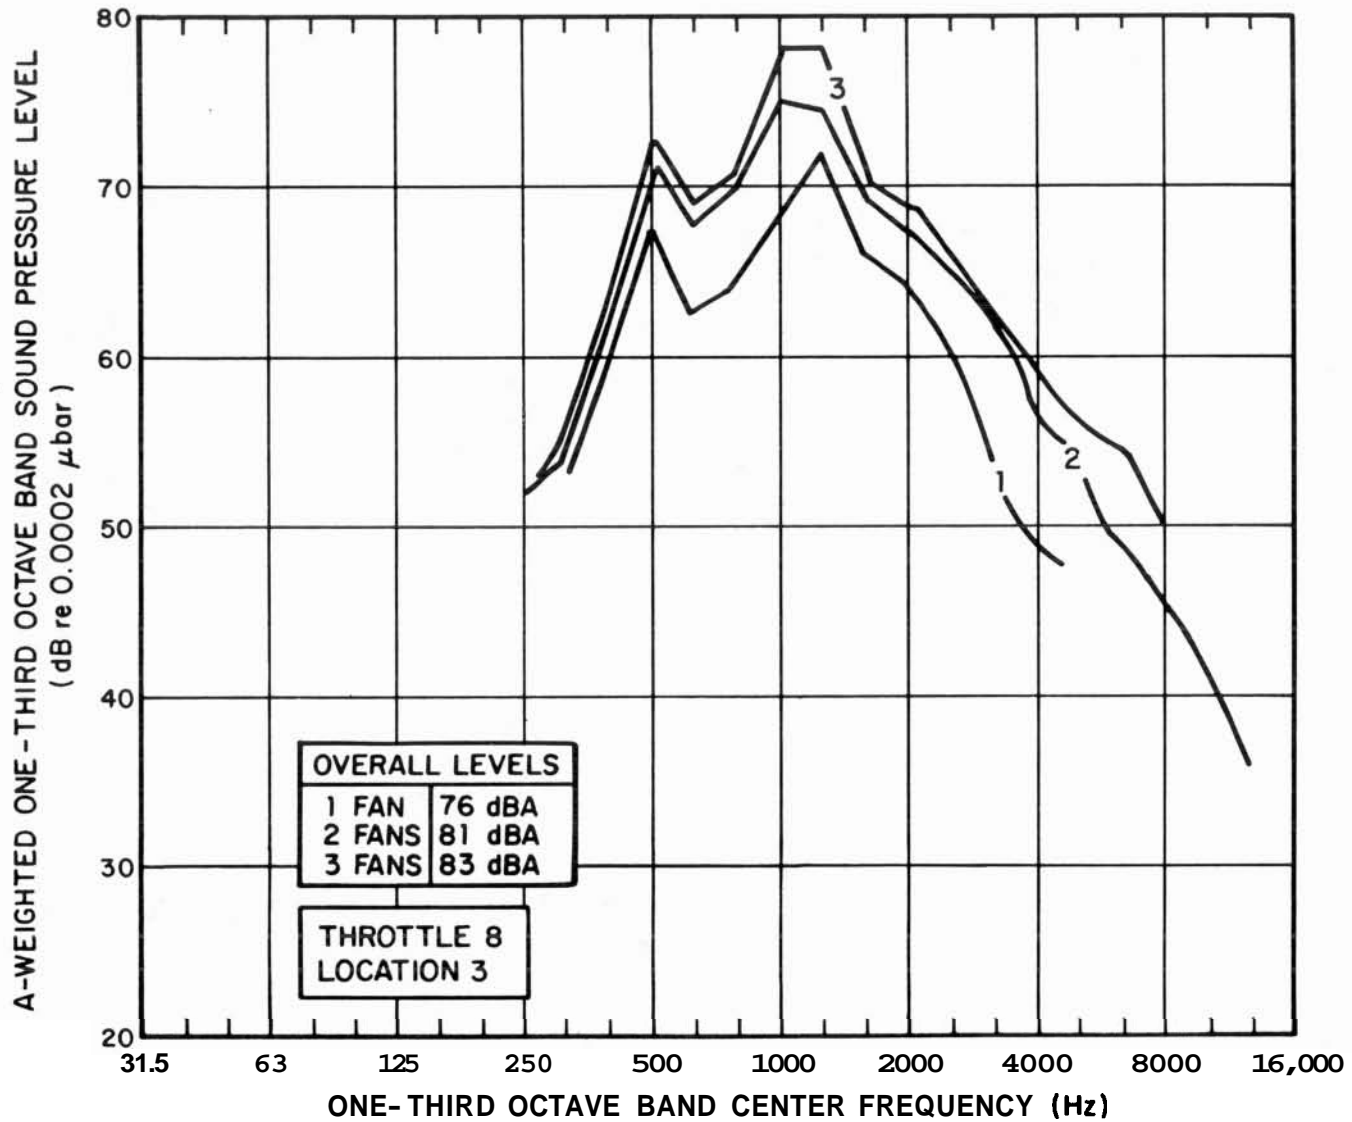
FIG. B.22. FAN SOURCE SPECTRA, THROTTLE 8, MICROPHONE LOCATION 3. THE NUMBERS REFER TO THE NUMBER OF FANS OPERATING.

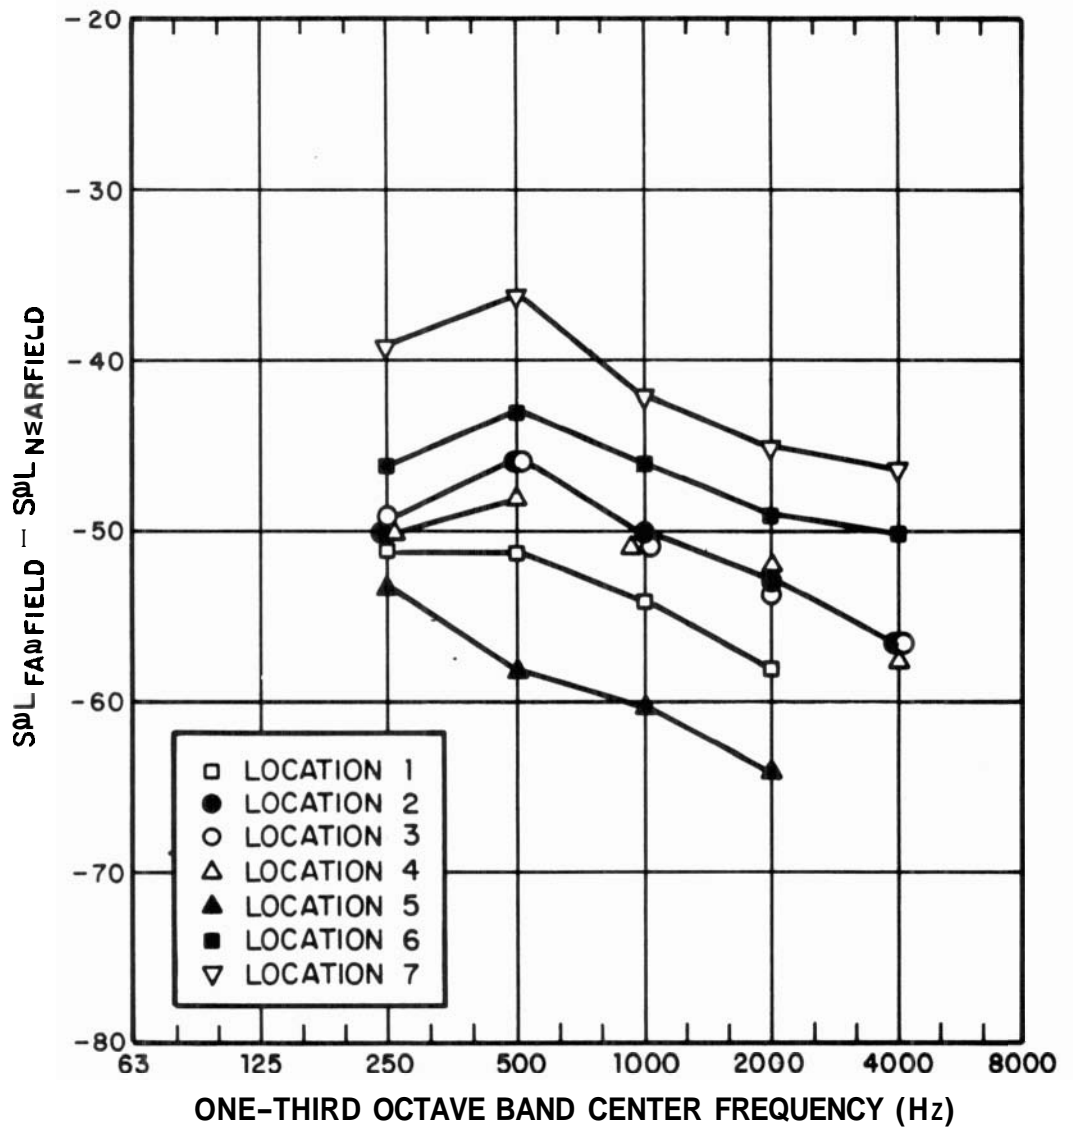
FIG. C.2. COMPRESSOR AIRBORNE PATH TRANSFER FUNCTIONS.

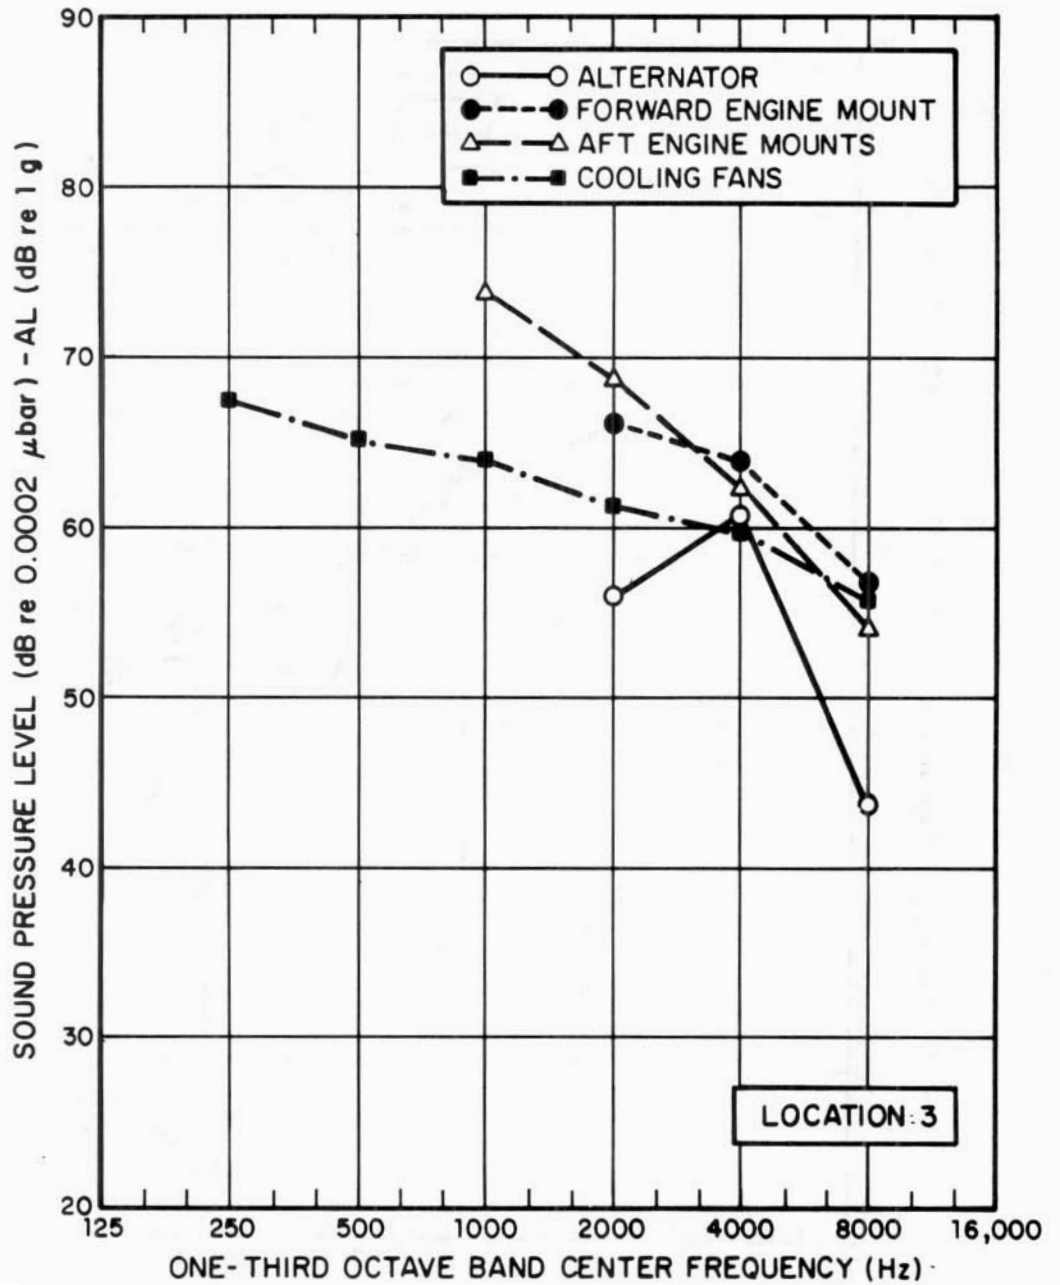
FIG. D.1. STRUCTUREBORNE TRANSFER FUNCTIONS FOR MICROPHONE LOCATION 3.

The structureborne transfer functions are shown in Figs. D.1 and D.2 for microphone locations 3 and 7, respectively. Since location 3 is three times as far away from the locomotive as location 7, one would expect location 7 to be on the order of 10 dB higher than location 3 for localized sources. This is very nearly the case, as the two figures show.
