Report Nos.: DOT-TSC-OST-76-4/FRA-OR&D-76-142

## AN ASSESSMENT OF RAILROAD LOCOMOTIVE NOISE

Paul J. Remington  
Michael J. Rudd

Bolt Beranek and Newman Inc.  
50 Moulton Street  
Cambridge MA 02138

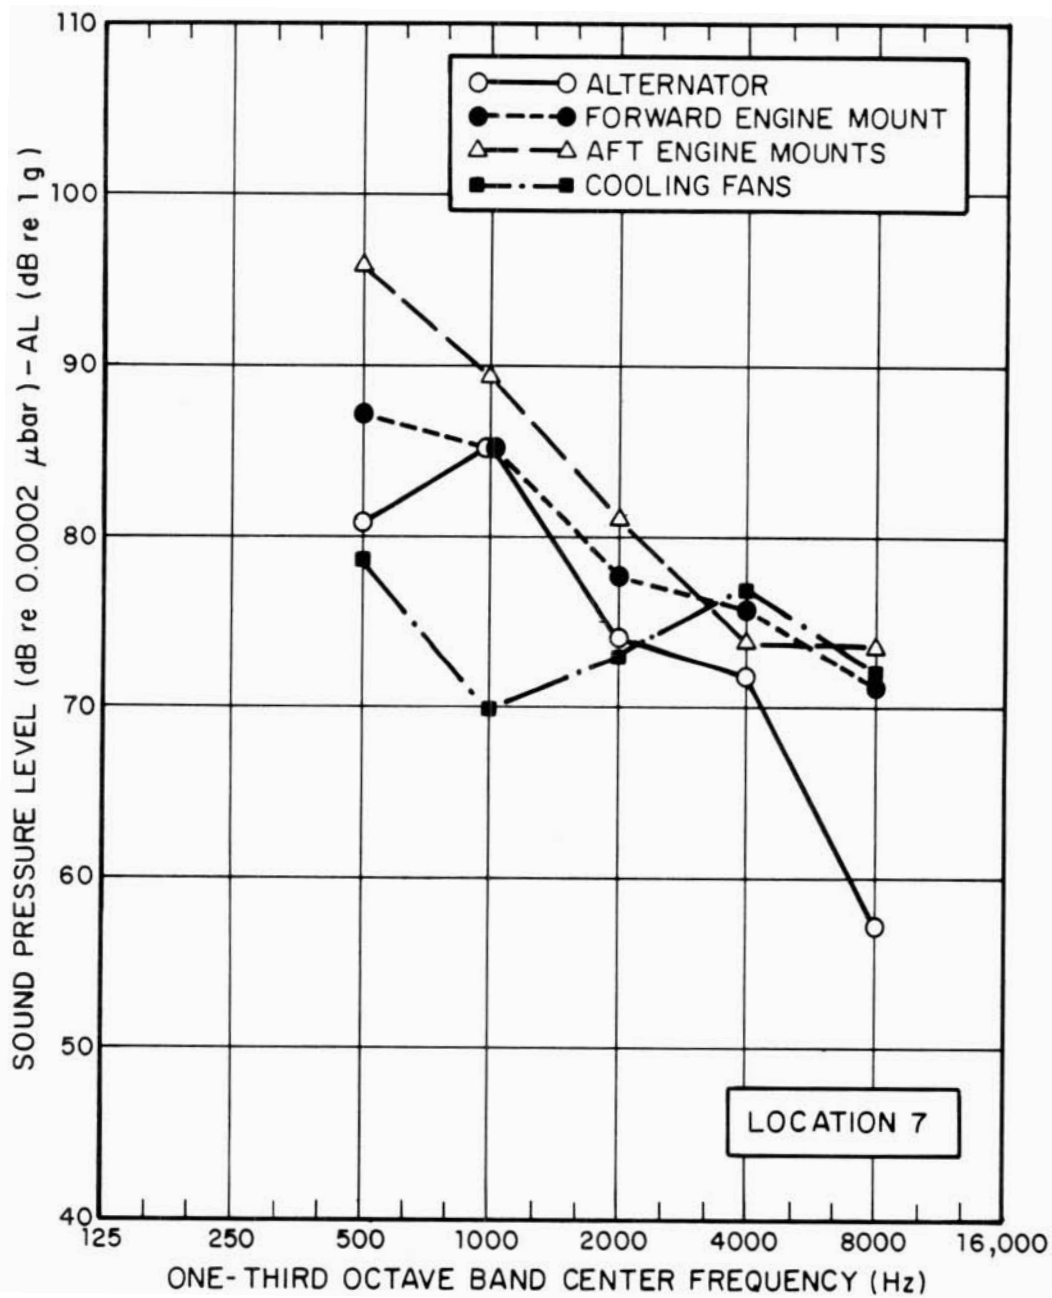
FIG. D.2. STRUCTUREBORNE TRANSFER FUNCTIONS FOR LOCATION 7.

The structureborne transfer functions are shown in Figs. D.1 and D.2 for microphone locations 3 and 7, respectively. Since location 3 is three times as far away from the locomotive as location 7, one would expect location 7 to be on the order of 10 dB higher than location 3 for localized sources. This is very nearly the case, as the two figures show.

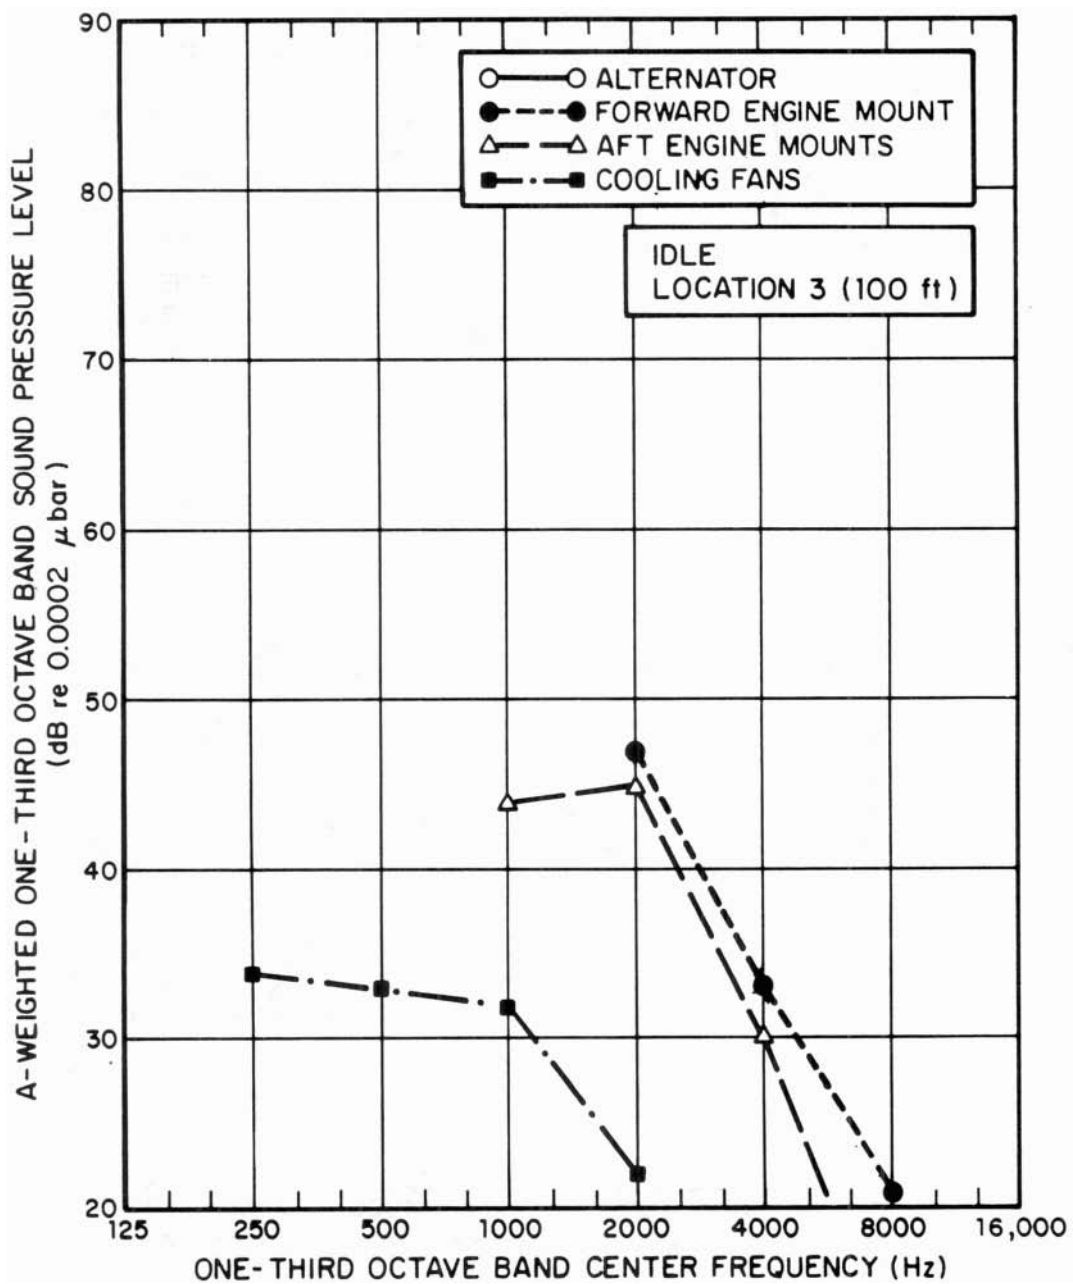
FIG. D.3. STRUCTUREBORNE NOISE AT IDLE, LOCATION 3.

Estimates of the structureborne noise at locations 3 and 7 are shown in Figs. D.1 to D.8. These estimates were obtained by adding transfer function levels to measured vibration levels. The engine is seen to be the dominant structureborne noise source.

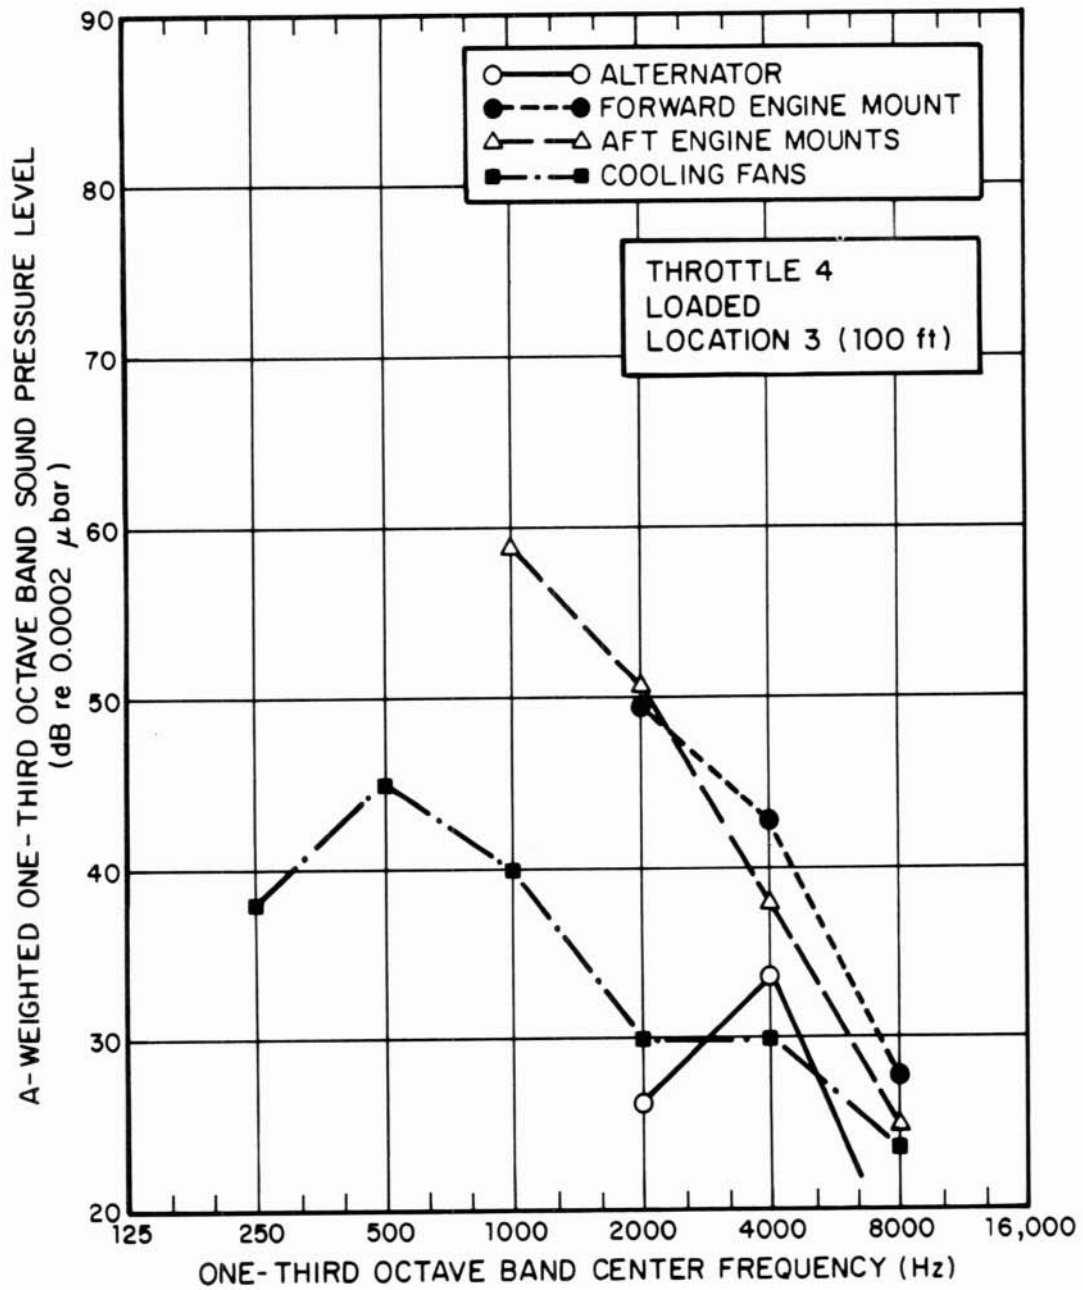
FIG. D.4. STRUCTUREBORNE NOISE AT THROTTLE 4, FULL LOAD, LOCATION 3.

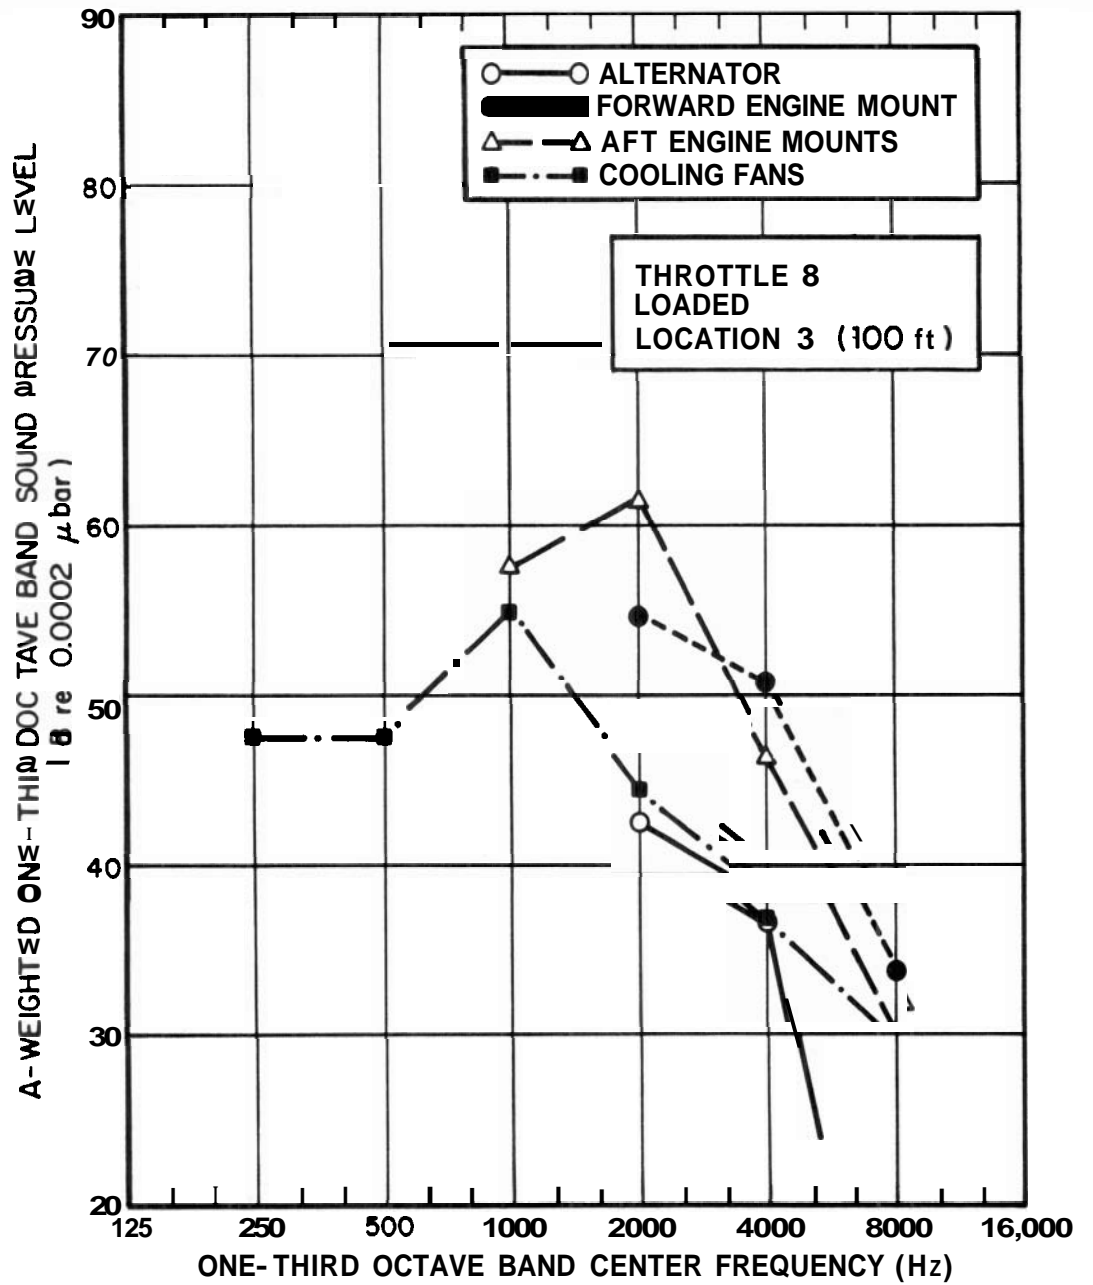
FIG. D.5. STRUCTUREBORNE NOISE AT THROTTLE 8, FULL LOAD, LOCATION 3.

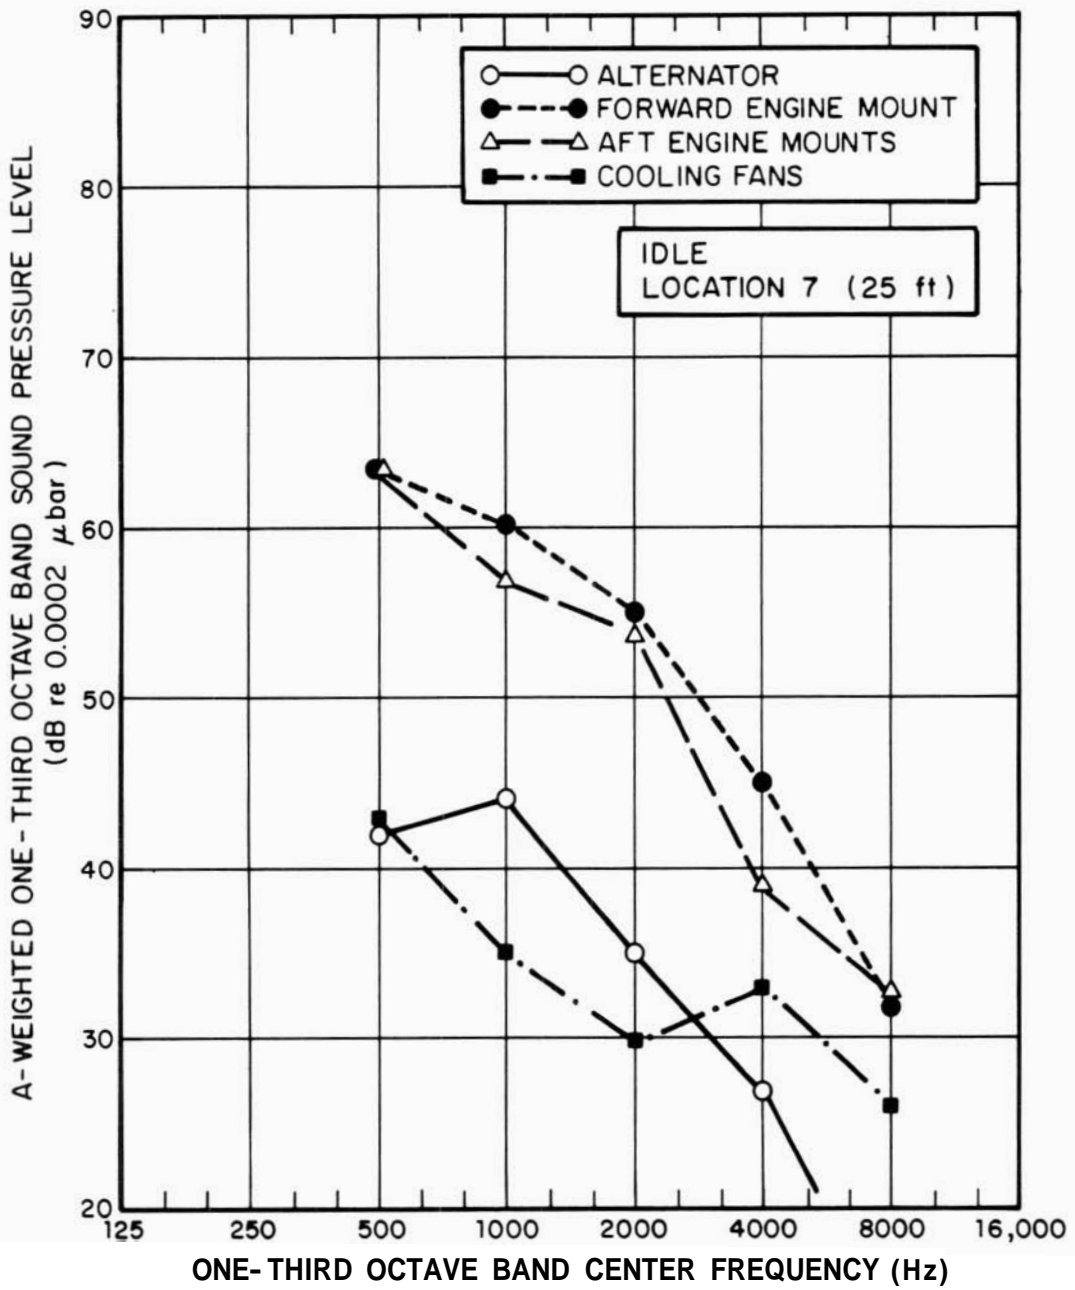
FIG. D.6. STRUCTUREBORNE NOISE AT IDLE, LOCATION 7.

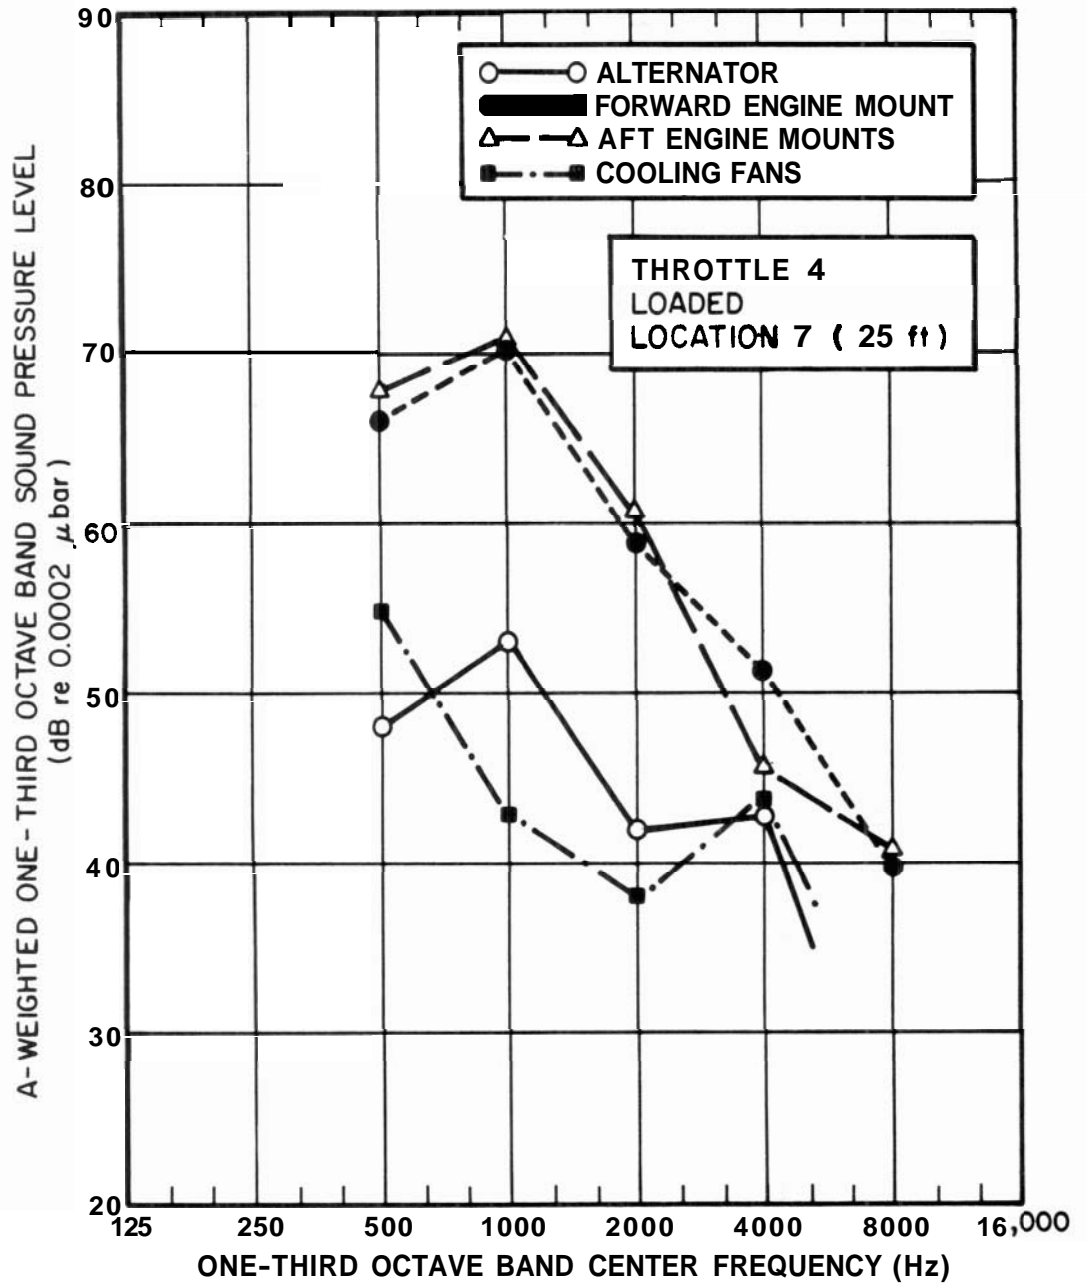
FIG. D.7. STRUCTUREBORNE NOISE AT THROTTLE 4, FULL LOAD, LOCATION 7.

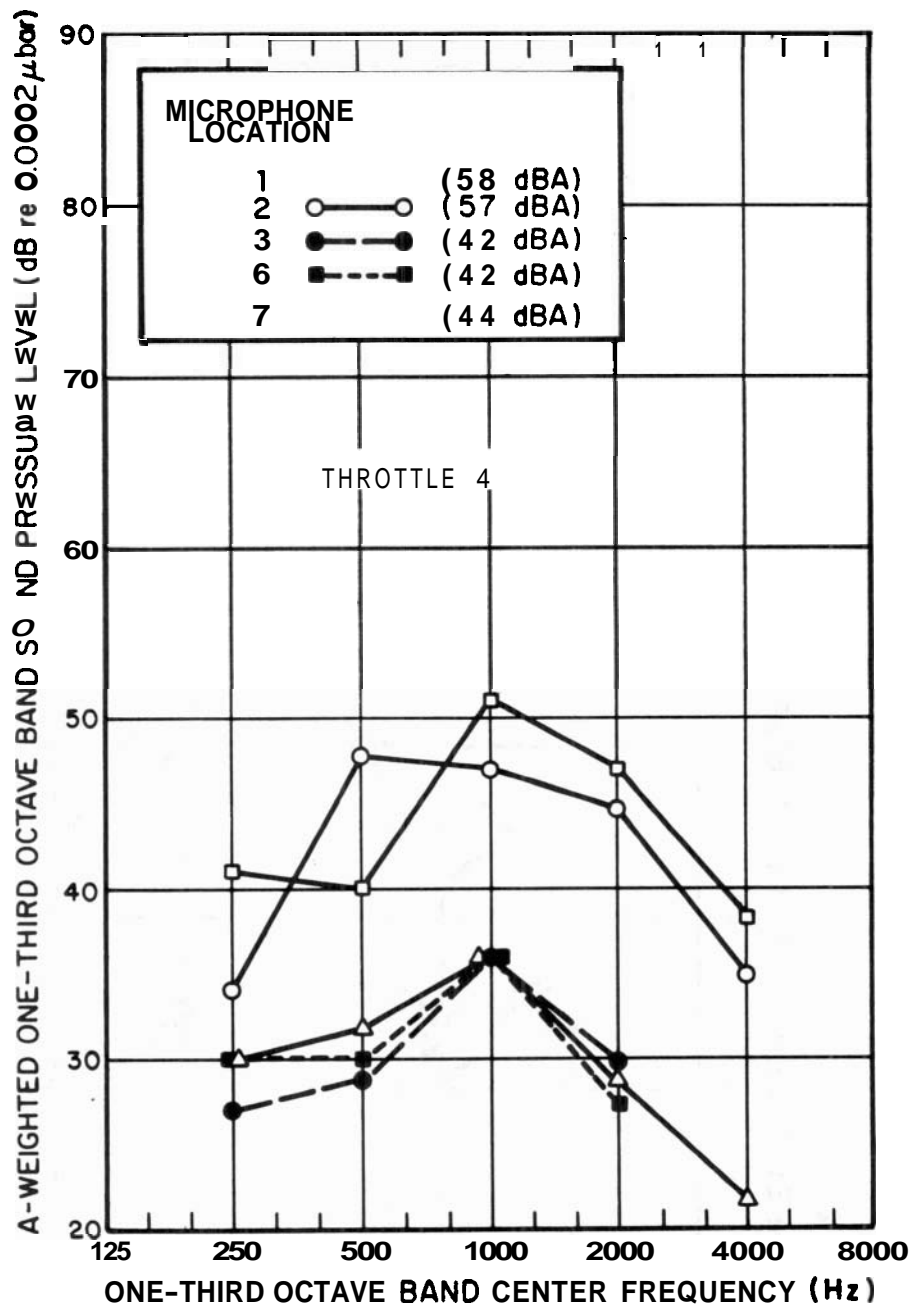
FIG E.3. LOAD CELL NOISE AT THROTTLE 4.

Figures E.3 and E.4 show the estimated A-weighted 1/3 octave band sound levels due to the load cell at the microphone locations of interest.

Consistent with the observation that the load cell could not be heard at locations 3, 6 and 7, the estimated load cell noise levels at those locations are much lower than the locomotive noise levels measured there with the locomotive in the fully quieted condition. Consistent with the observation that the load cell *could* be heard at locations 1 and 2 the estimated load cell spectra levels there are comparable to the quieted baseline spectral levels at the higher frequencies.
