U.S. Department of  
Transportation

**Federal Railroad  
Administration**

## **Load Environment of Rail Joint Bars – Phase III Assessment of the Effects of Installation and Maintenance Practices**

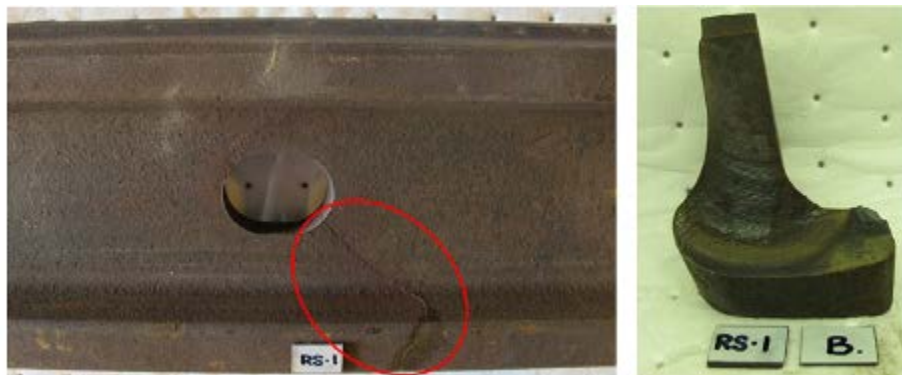
**Figure 2. Joint Bar Bolt Hole Crack**

**Joint Bar Bolt Hole Crack:** Cracks may be initiated at the rough spots on the inside of bolt holes that are produced from hot punching. In other words, the stress concentration that causes this type of crack is from the fabrication or manufacturing process rather than applied wheel loading. Such cracks appear to propagate toward the bottom or top of the joint bar at an angle. Figure 2 shows photographs of a joint bar bolt hole before and after the bar was broken to expose the fracture surfaces.

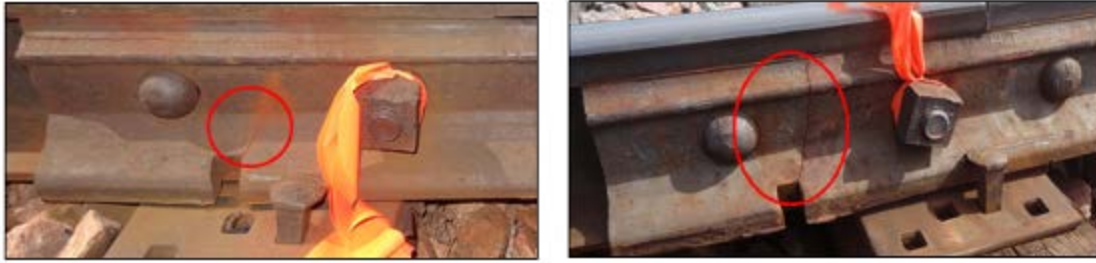
**Figure 5. Quarter Crack and Quarter Break**

**Quarter Crack/Quarter Break:** The quarter crack or break is commonly found in older types of angle bars that are longer manufactured. These angle bars have a long toe with square or rectangular holes to accommodate spikes. The corners of these spike holes are locations of high stress concentration, which leads to crack formation. Photographs of quarter defects are shown in Figure 5. The photograph on the left-hand side shows a crack emanating from the spike hole. The photograph on the right-hand side of the figure shows a crack that has propagated through the entire width of the bar, and in this case is called a quarter break.

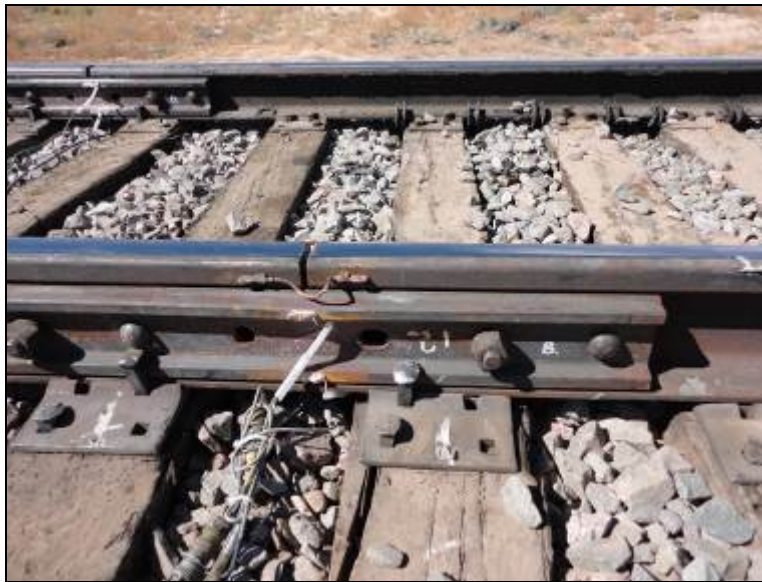
**Figure 7. Installation of the Joint Bars in the Test Zone at FAST**

The notching of joint bars, which is induced by cyclical contact with the ends of the parent rails under traffic, is a well understood phenomena in the industry. Notches that are formed in this way can lead to the propagation of cracking or, ultimately, the failure of the joint bar entirely due to fracturing from cracks initiating at these points of contact. This study investigated the possibility of such failures resulting from regular track maintenance activities (i.e., track surfacing). Joint bars with and without notches were installed on a section of track that reflects typical settlement conditions that are seen in the revenue service environment (Figure 7). Strains from the joints bars were collected during the track lifting, and the joints bars were inspected after testing for any signs of cracking.

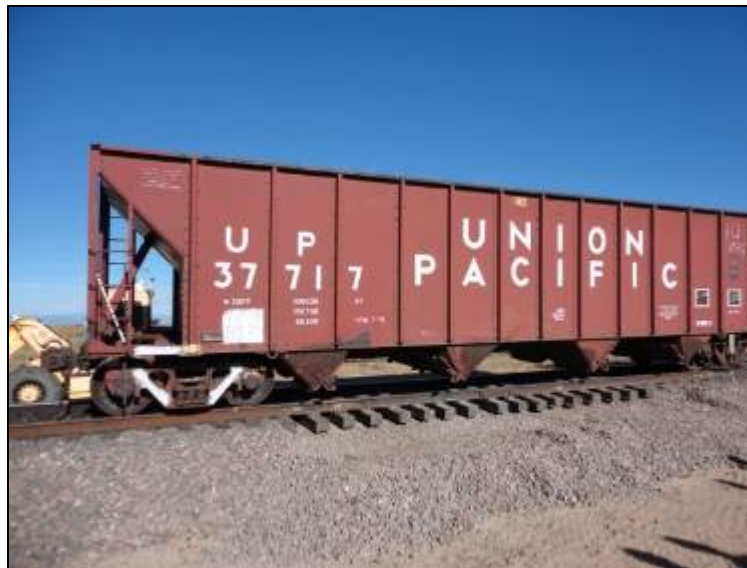
**Figure 9. Placement of the Loaded Freight Car in the Test Zone**

Before tamping, top-of-rail (TOR) elevations were taken over the test zone and on 20 crossties on either side of the rail joints. TOR elevations were taken with and without a static load of a freight car (approximately 315,000 lb), as Figure 9 shows. Then, the ballast was replaced and tamped before another set of elevation measurements was taken under identical conditions (i.e., with and without the static load of a loaded freight car).

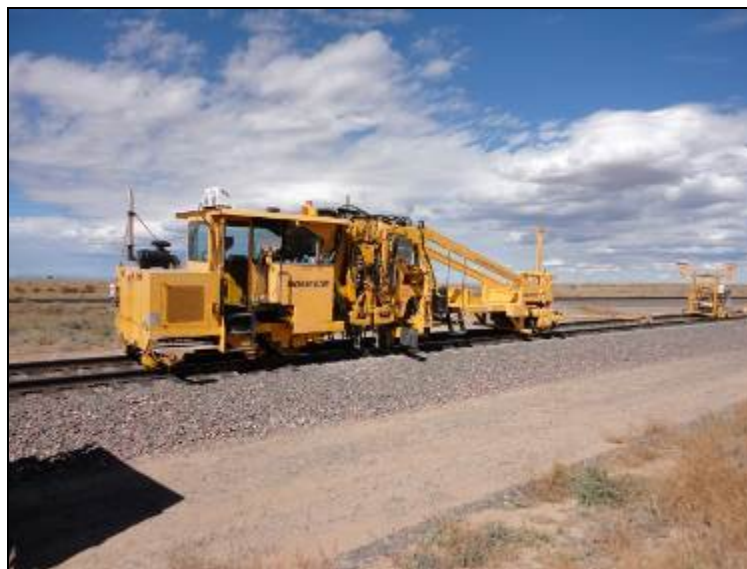
**Figure 11. Tamper Used to Complete Surfacing Operations at FAST for this Study**

which consisted of (1) lifting of the rail (three times to approximately 1 in), (2) tamping the ballast underneath the cross-ties, and (3) ensuring the proper alignment of the rail.

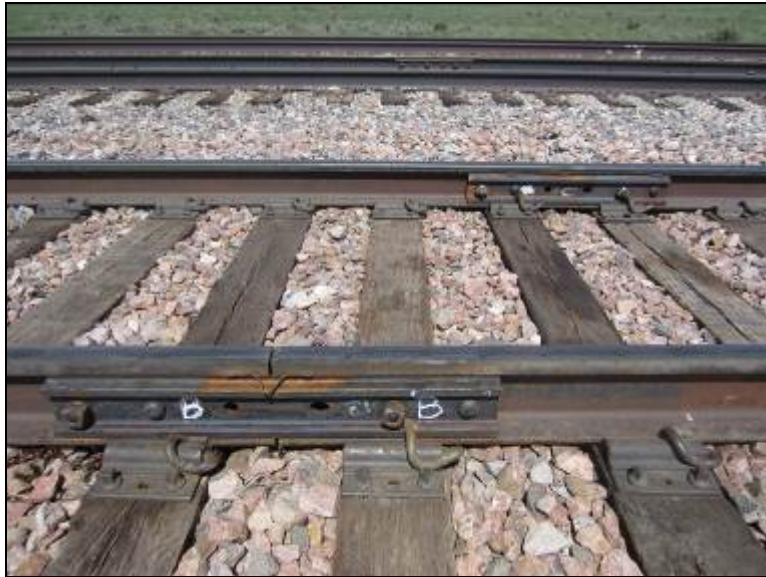
**Figure 18. Installation of Standard and Post-Hardened Joint Bars at FAST**

Before installation, baseline longitudinal profile measurements were taken on all four of the joint bars with a portable electronic profile measurement device. Next, the joint bars were installed in suspension on a tangent section of track at FAST and subjected to 55 MGT of HAL traffic over the course of five months. The two post-hardened joint bars were installed on the field side of the outside and inside rails, while the untreated bars were installed on the gage side of the rails. Four bolts were installed on each set of joint bars, as Figure 18 shows, and tightened to 600 ft-lb of torque. A second and final set of measurements were gathered after the joint bars were removed from the track.

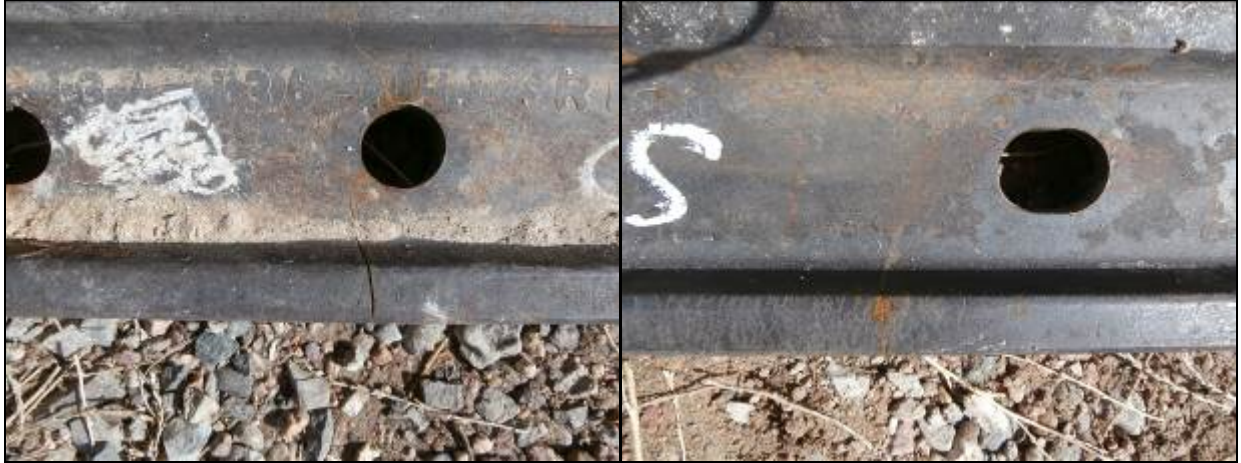
**Figure 21. Fatigue Cracking in an Untreated (left) and a Post-Hardened (right) Joint Bar**

During the in-track testing, cracks began to form on an untreated and a post-hardened joint bar (Figure 21), which emanated from the bottoms of the joint bars and progressed upward (under the center-left bolt hole in the untreated bar and at the midsection in the post-hardened bar). Both joint bars were removed from track before the cracks reached the bolt holes.

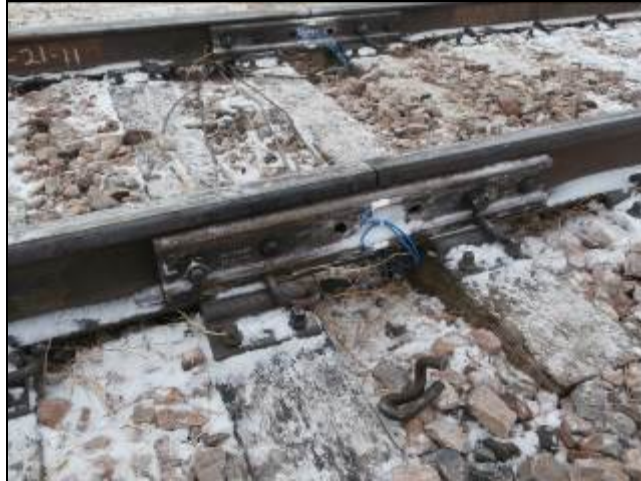
**Figure 22. Installation of Instrumented Joints Bars at FAST**

Four standard 132-pound joint bars were instrumented with strain gages along the central axis (recall Figure 10). These joint bars were then installed in suspension on a tangent section of track at FAST (see Figure 22), joining the parent rails with two short plugs, one on each rail (i.e., outside and inside). Both joints were located across from one another, offset by two crossties. These short plugs were joined to the adjacent parent rail, using the test bars on the west end and standard bars on the east end of each plug. This configuration allowed the gap to be easily adjusted for the differing gap sizes, as per the requirements of testing. The gap was maintained using rail anchors to prevent movement of the plug rail underneath the test train consist. An IWS, with a static wheel load of 39,000 lb, was used to gather data on the vertical impact forces at each of the joints. Sampled at 1200 Hz and filtered at 100 Hz, the IWS allows for the continuous measurement of wheel/rail forces at the interface, namely vertical, lateral, and longitudinal forces with a valid upper frequency of approximately 600 Hz. Wheel/rail forces and bending strain data (with a sampling rate of 512 Hz) were collected from both pairs of joints for 0-,  $\frac{1}{2}$ -, and 1-in gaps at 10, 25, and 45 mph (clockwise (CW) and counterclockwise (CCW) movements). It should be noted, however, that due to the winter weather conditions at the time of testing, the gap could not be fully closed for the 0-in test runs, resulting in a gap approximately  $\frac{1}{8}$ -in wide.

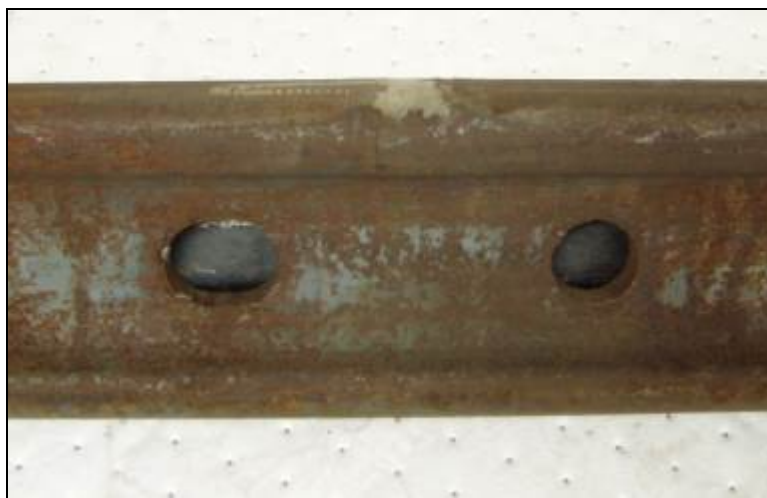
**Figure 30. Area of Interest/Stress Concentration Location**

One hundred samples were collected from both revenue service and at TTC (80 joint bars were temporarily donated by a western railroad and 20 were collected from onsite trackage at TTC). Information on material flow and hardness was collected on all samples, then TTCI's NDE team performed computed radiography on all samples and determined whether there was a correlation between the metal flow and propagation of fatigue cracking. The inspection area of the joint bars focused on high-stress concentration locations between the center bolt holes and the head of the joint bar (Figure 30).

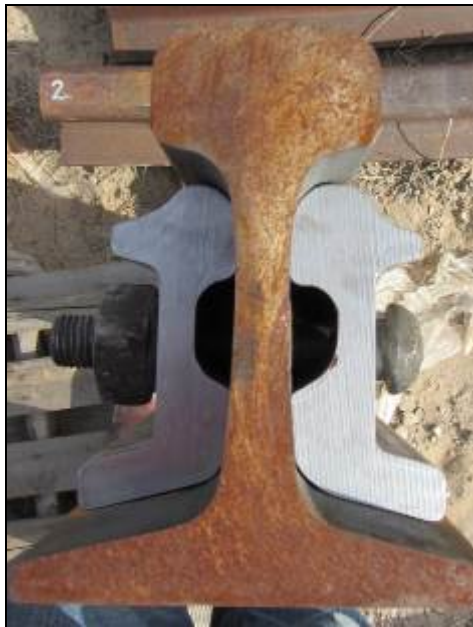
**Figure 36. Example Prototype Joint Bar Design**

A nonproprietary example of these designs is shown in Figure 36 [8]. The bar provides for more contact area with the rail in the web and corner fillets. Figure 37 compares the rail contact areas of the standard and new design joint bars. This larger area is intended to increase longitudinal load carry capacity before allowing rail slippage. The cross section also allows for an easement at the top of the bar. This is intended to reduce the gouging seen on the tops of some current bars from which joint bar cracking is known to occur. This design also claims to reduce bar stresses near bolt holes by improving bar support in this area.
