REPORT NO. FRA-ORD&D-75-12

## FRACTURE RESISTANCE OF RAILROAD WHEELS

C.S. Carter  
R.G. Caton

INTERIM REPORT

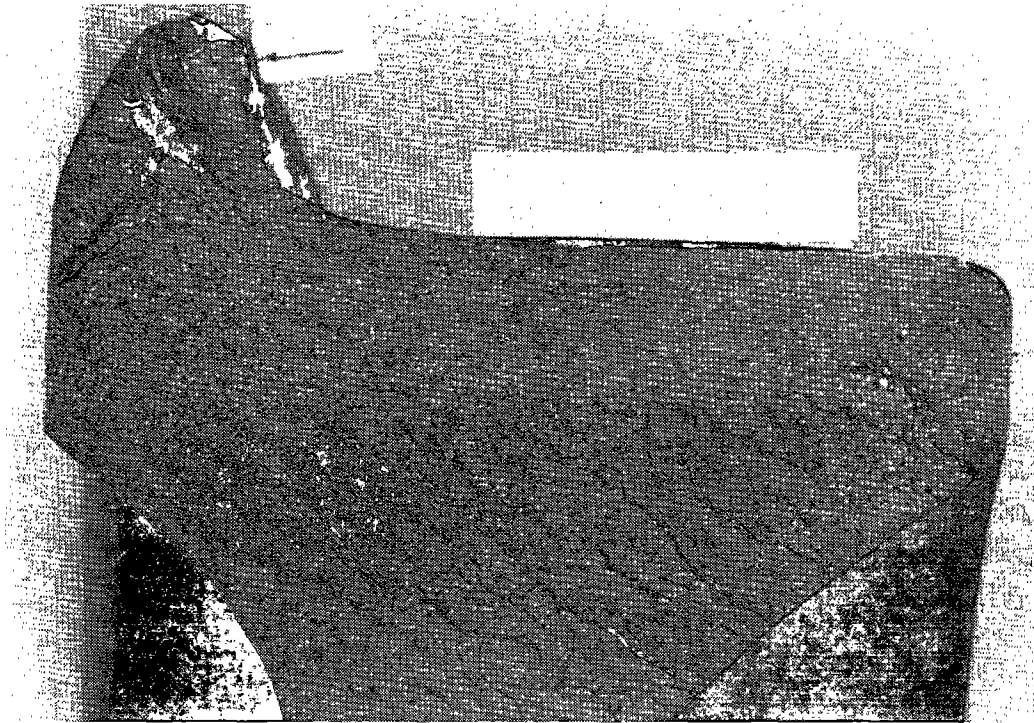
FIGURE 1.—THERMAL CRACK GROWTH BY A FATIGUE MECHANISM IN A CLASS-U WHEEL

Thermal cracks can propagate to critical length by either mechanism (figs. 1 and 2) but have also been observed to extend by each mechanism acting alternately (fatigue-cleavage-fatigue) as shown in figure 3 (refs. 3 and 4).

Fatigue-type thermal cracks generally exhibit the characteristic progression marks of fatigue fracture (fig. 1) and extend much more slowly than cleavage type cracks. Wandrisco

and Dewez (ref. 2) reported that fatigue-type cracks are usually associated with frequent brakings and relatively low energy dissipation such as occurs in wheels under multiple unit cars or switcher locomotives. They also noted that these cracks often originate near the front edge of the tread, when an overhanging brake shoe condition exists, or at the tip of a flange (fig. 1).

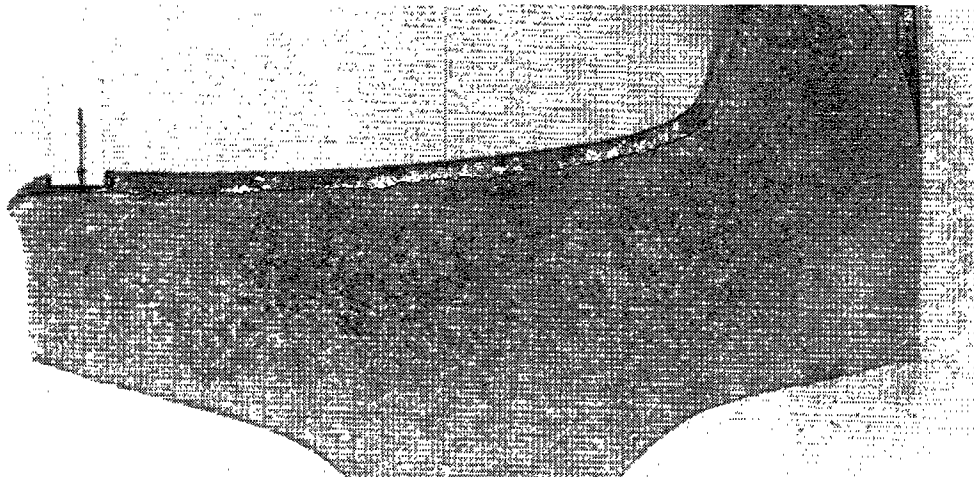
FIGURE 2.—THERMAL CRACK GROWTH BY A CLEAVAGE MECHANISM IN A CLASS-U WHEEL

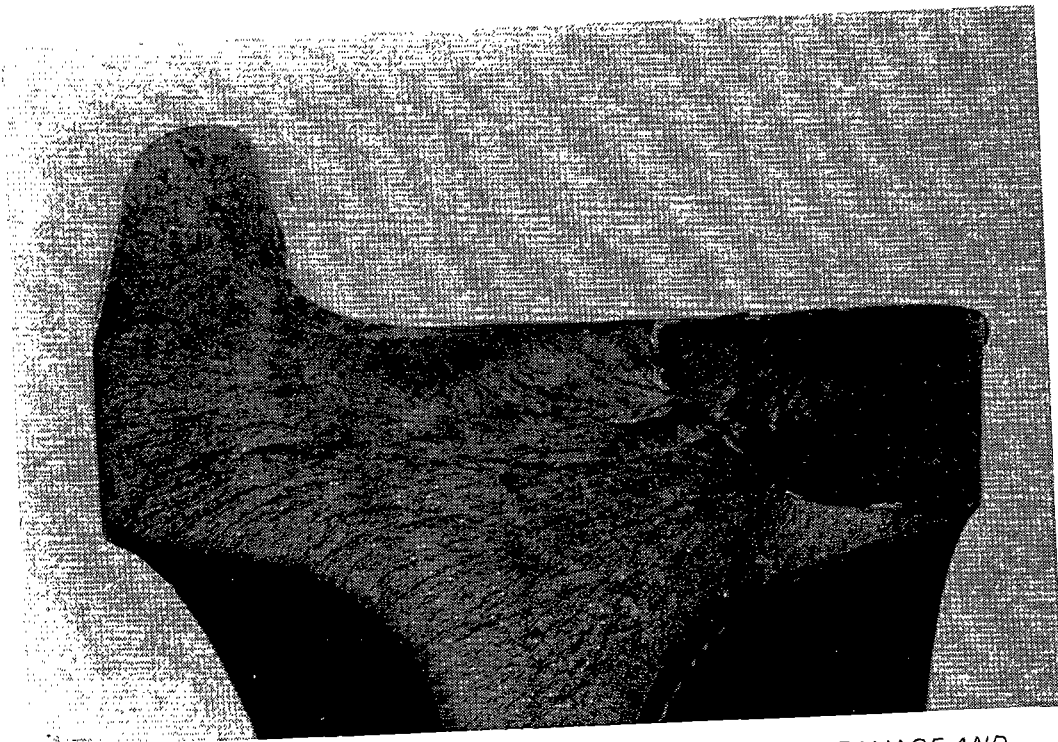
*FIGURE 3.—THERMAL CRACK GROWTH BY ALTERNATE CLEAVAGE AND  
THERMAL FATIGUE MECHANISMS IN A CLASS-U1 WHEEL*

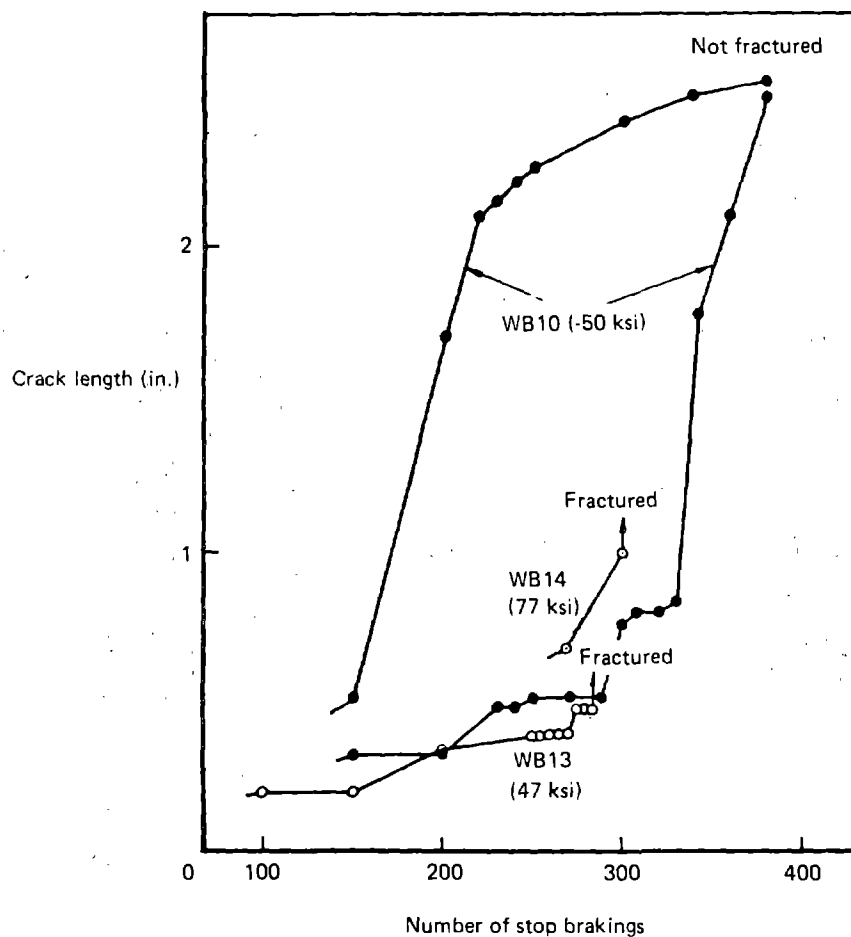
FIGURE 4.—EFFECT OF NUMBER OF STOP BRAKINGS ON THERMAL CRACK GROWTH IN THREE WHEELS WHICH HAD BEEN PREVIOUSLY DRAG BRAKED TO PRODUCE THE RESIDUAL STRESSES SHOWN IN PARENTHESES (RESIDUAL STRESS MEASURED ON FRONT RIM 0.4 IN. BELOW TREAD CORNER).

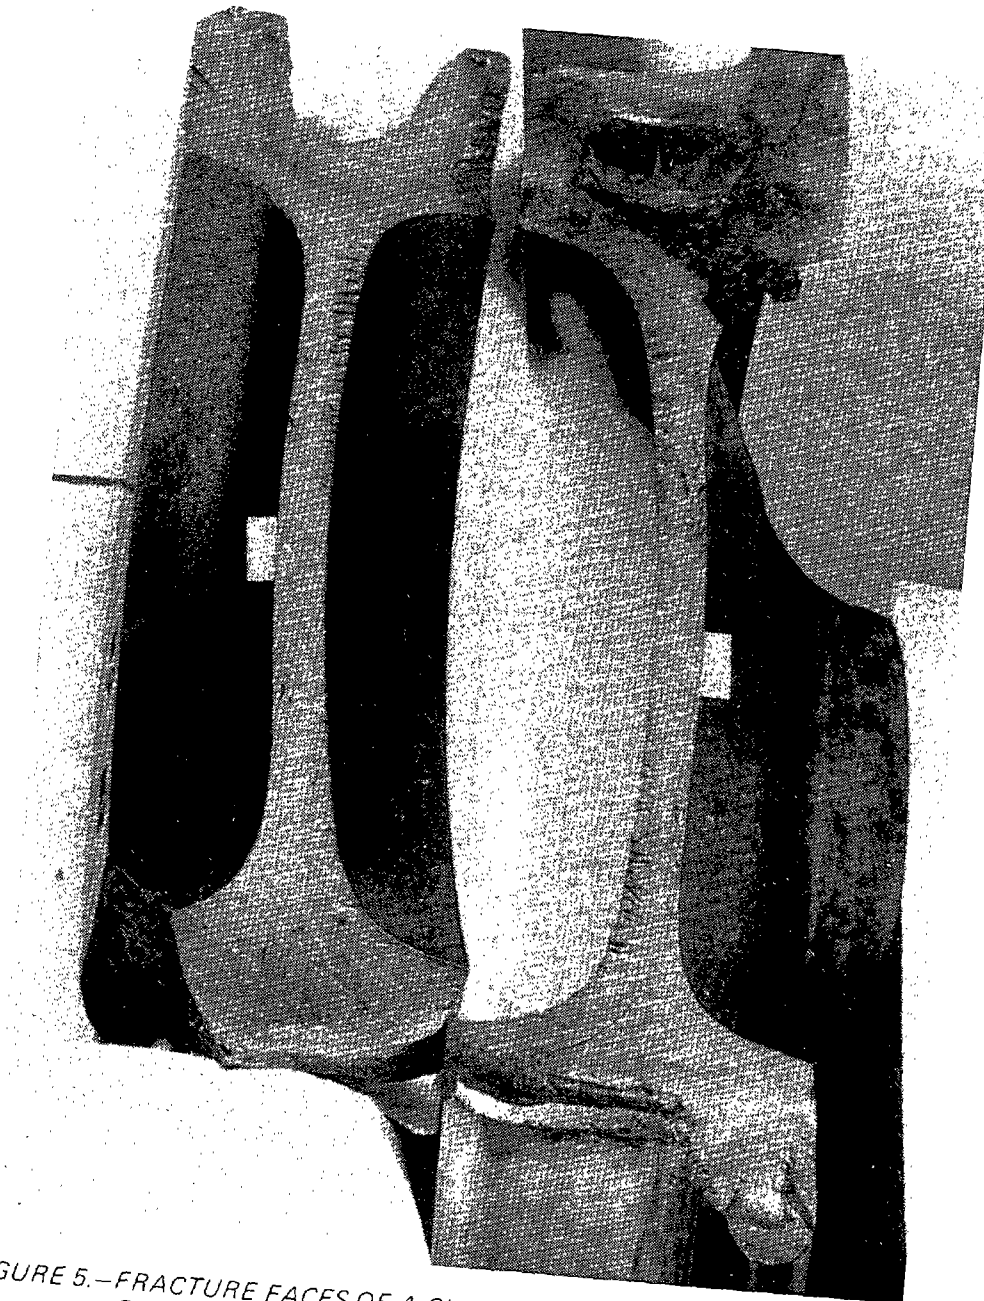
FIGURE 5.—FRACTURE FACES OF A CLASS-C WHEEL THAT FAILED FROM A FATIGUE CRACK AT THE BACK RIM FILLET

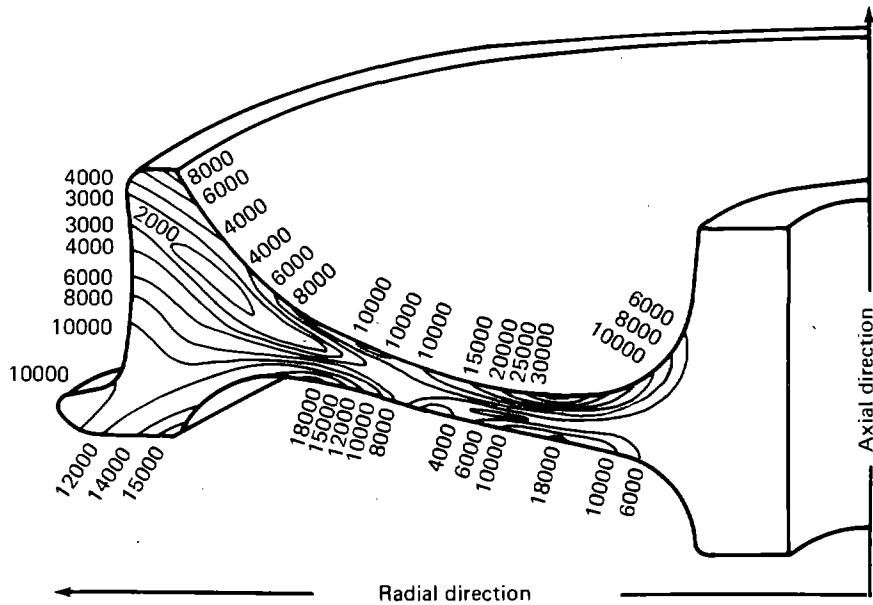
FIGURE 11.—ISOBAR MAP OF OCTAHEDRAL SHEAR STRESSES ( $S_{II}$ ) AFTER 20 MIN OF CYCLIC DRAG BRAKE APPLICATION; TRAIN VELOCITY: 21 MPH (AFTER NOVAK AND ECK, REF. 32)

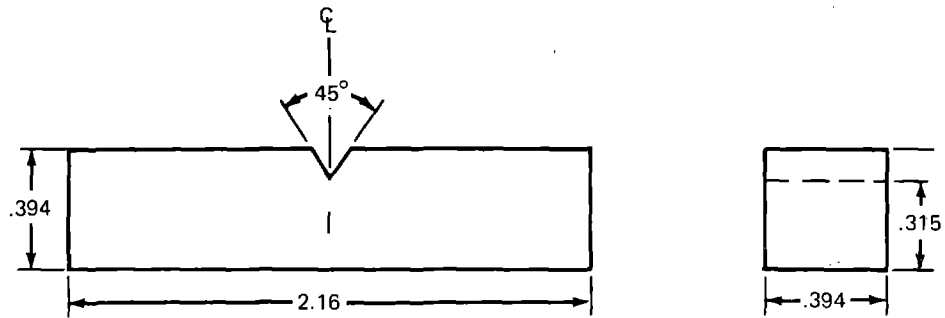
All dimensions in inches  
Dynamic fracture toughness specimens  
have a fatigue crack grown at the notch  
root

*FIGURE 25.—CHARPY AND DYNAMIC FRACTURE TOUGHNESS SPECIMEN  
CONFIGURATION*

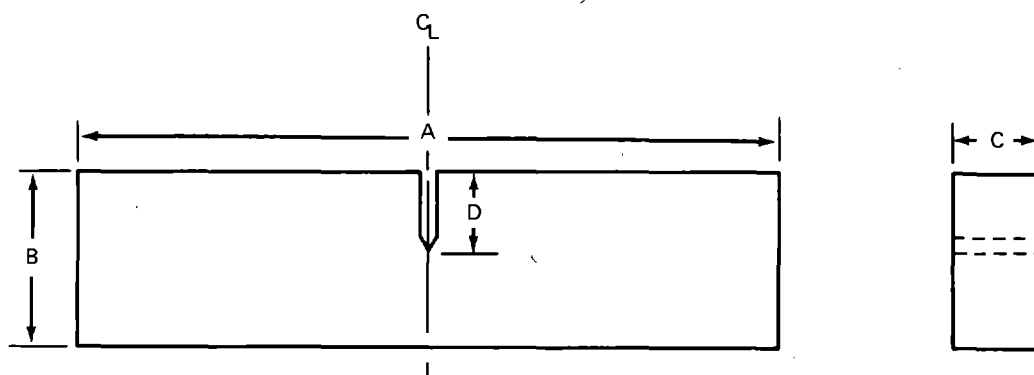
Wheel number		Dimensions			
		A	B	C	D <sup>a</sup>
1	Rim	8.2	2.00	1.00	0.90
	Plate	7.0	1.71	0.75	0.75
2	Rim	8.2	2.00	1.00	0.90
	Plate	7.0	1.71	0.75	0.75
3	Rim	8.2	2.00	1.00	0.90
	Plate	8.2	2.00	0.75	0.90
4	Rim	8.2	2.00	1.00	0.90
	Plate	8.2	2.00	0.75	0.90
5	Rim	8.2	2.00	1.00	0.90
	Plate	8.2	2.00	0.75	0.90
6 <sup>b</sup>	Rim	7.0	1.70	0.70	0.75
	Plate	7.0	1.70	0.70	0.75
7	Rim	8.2	2.00	1.00	0.90
	Plate	8.2	2.00	0.75	0.90

FIGURE 26.—SLOW BEND FRACTURE TOUGHNESS SPECIMEN AND SIZES TESTED FOR EACH WHEEL

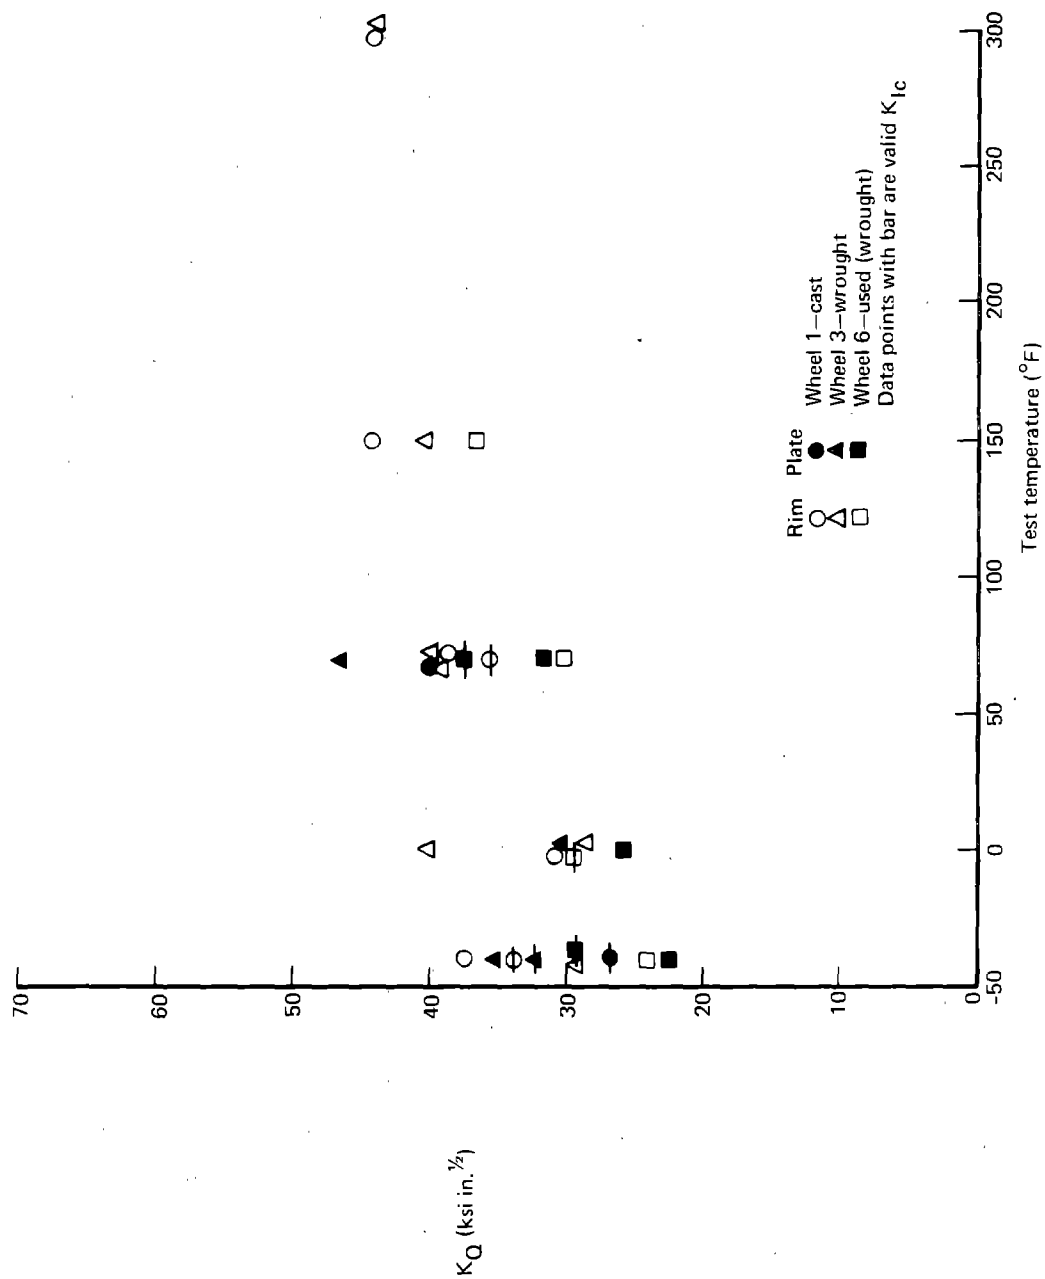
FIGURE 29.—EFFECT OF TEMPERATURE ON FRACTURE TOUGHNESS, CLASS U WHEELS

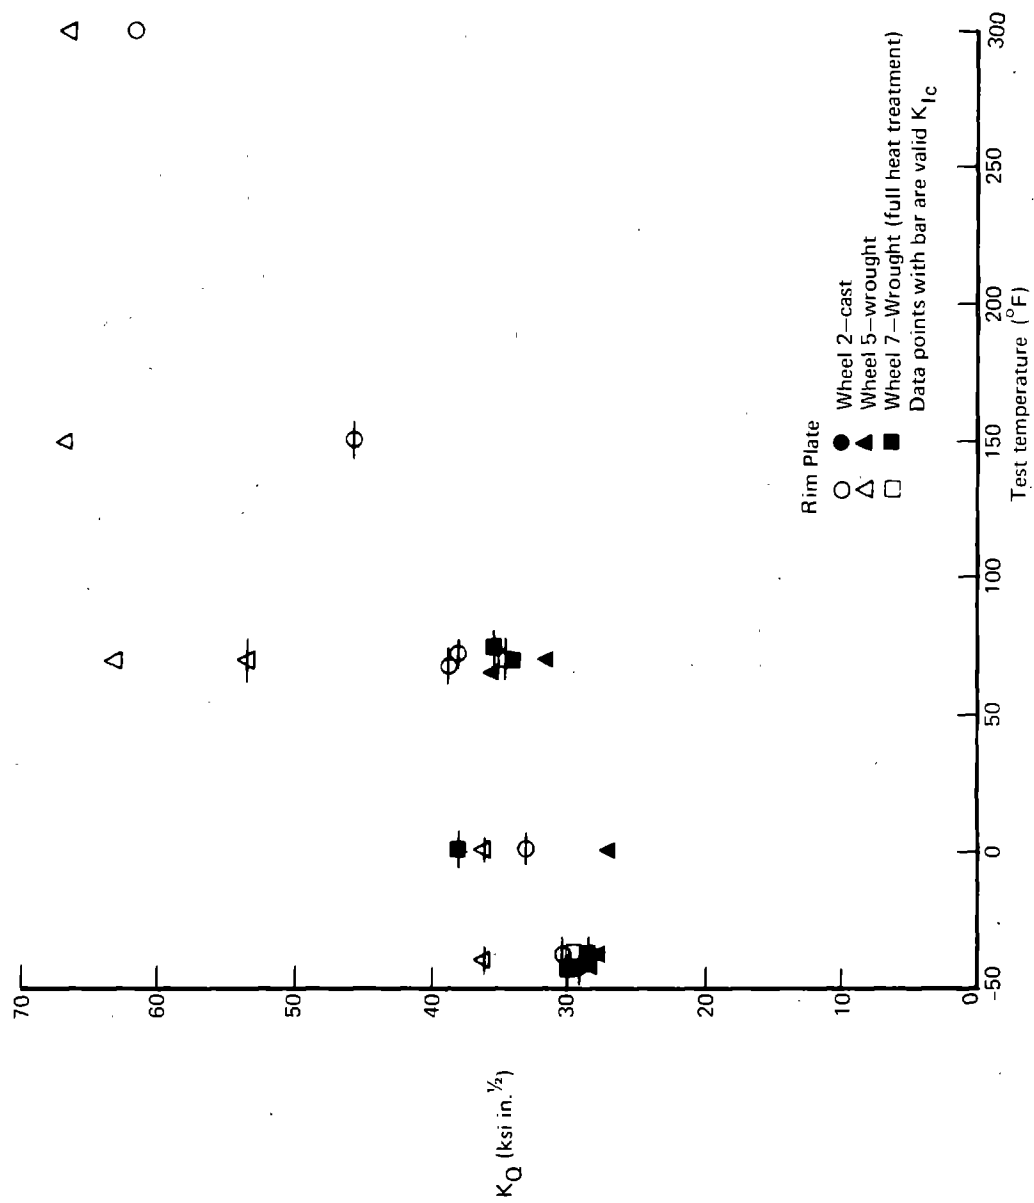
FIGURE 30.—EFFECT OF TEMPERATURE ON FRACTURE TOUGHNESS, CLASS C WHEELS

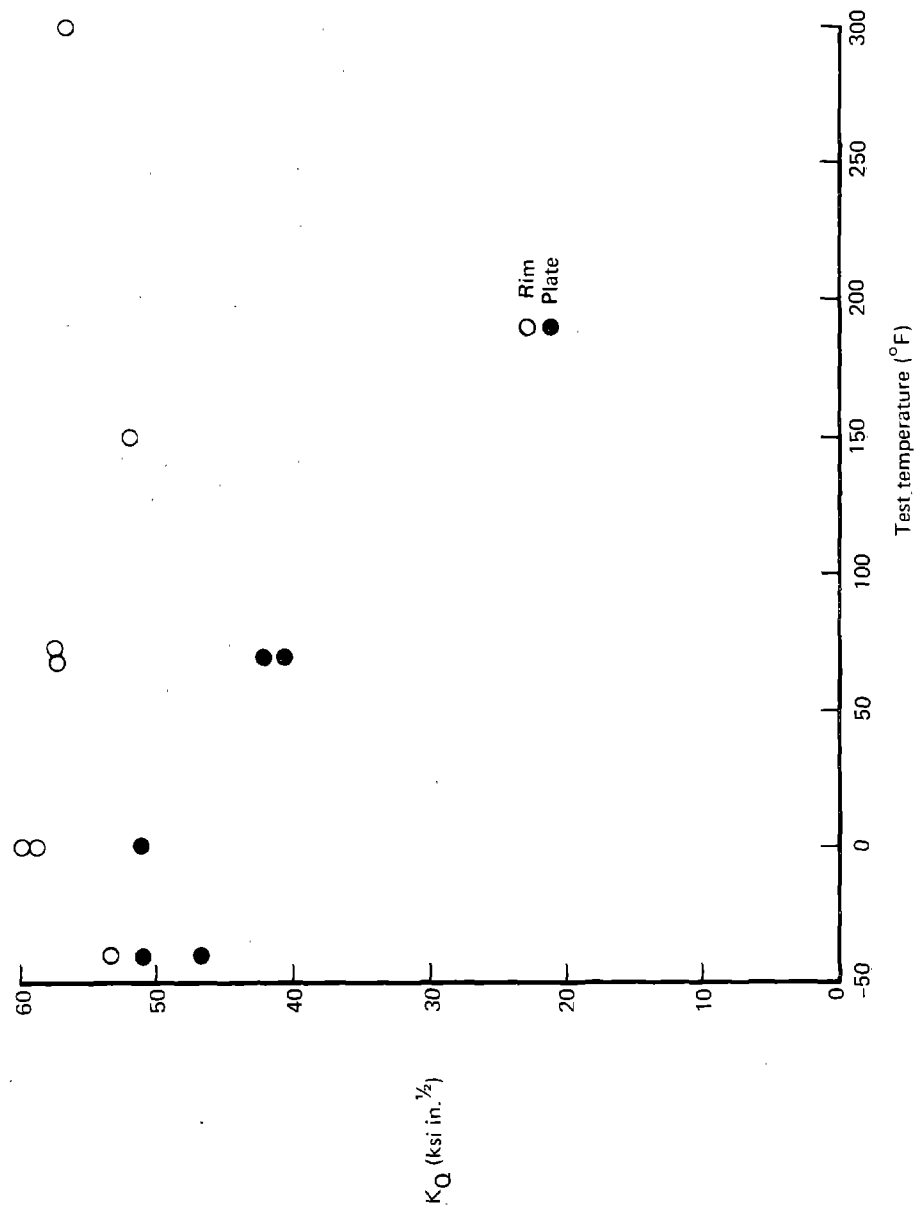
FIGURE 31.—EFFECT OF TEMPERATURE ON FRACTURE TOUGHNESS, CLASS A WHEEL

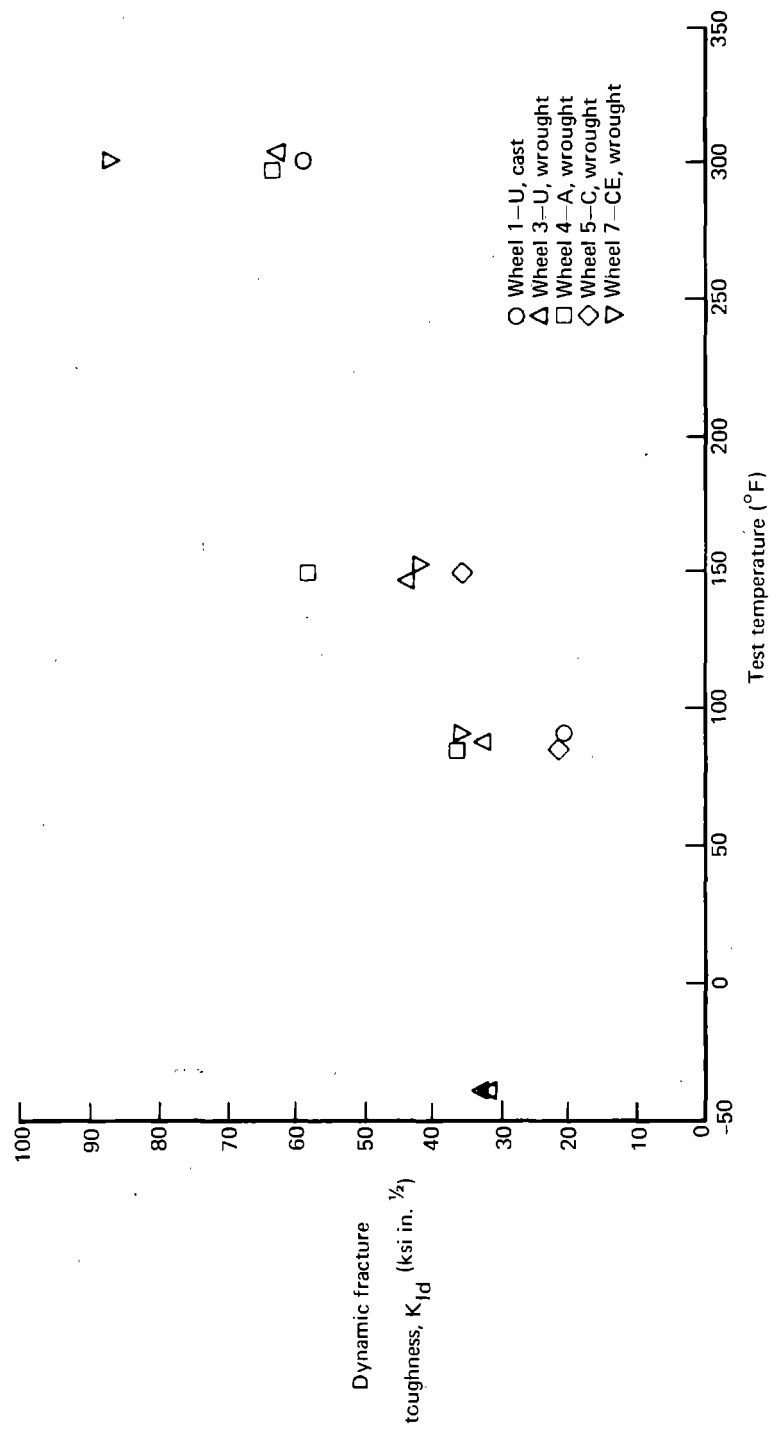
FIGURE 32.—EFFECT OF TEMPERATURE ON DYNAMIC FRACTURE TOUGHNESS ( $K_{Id}$ )

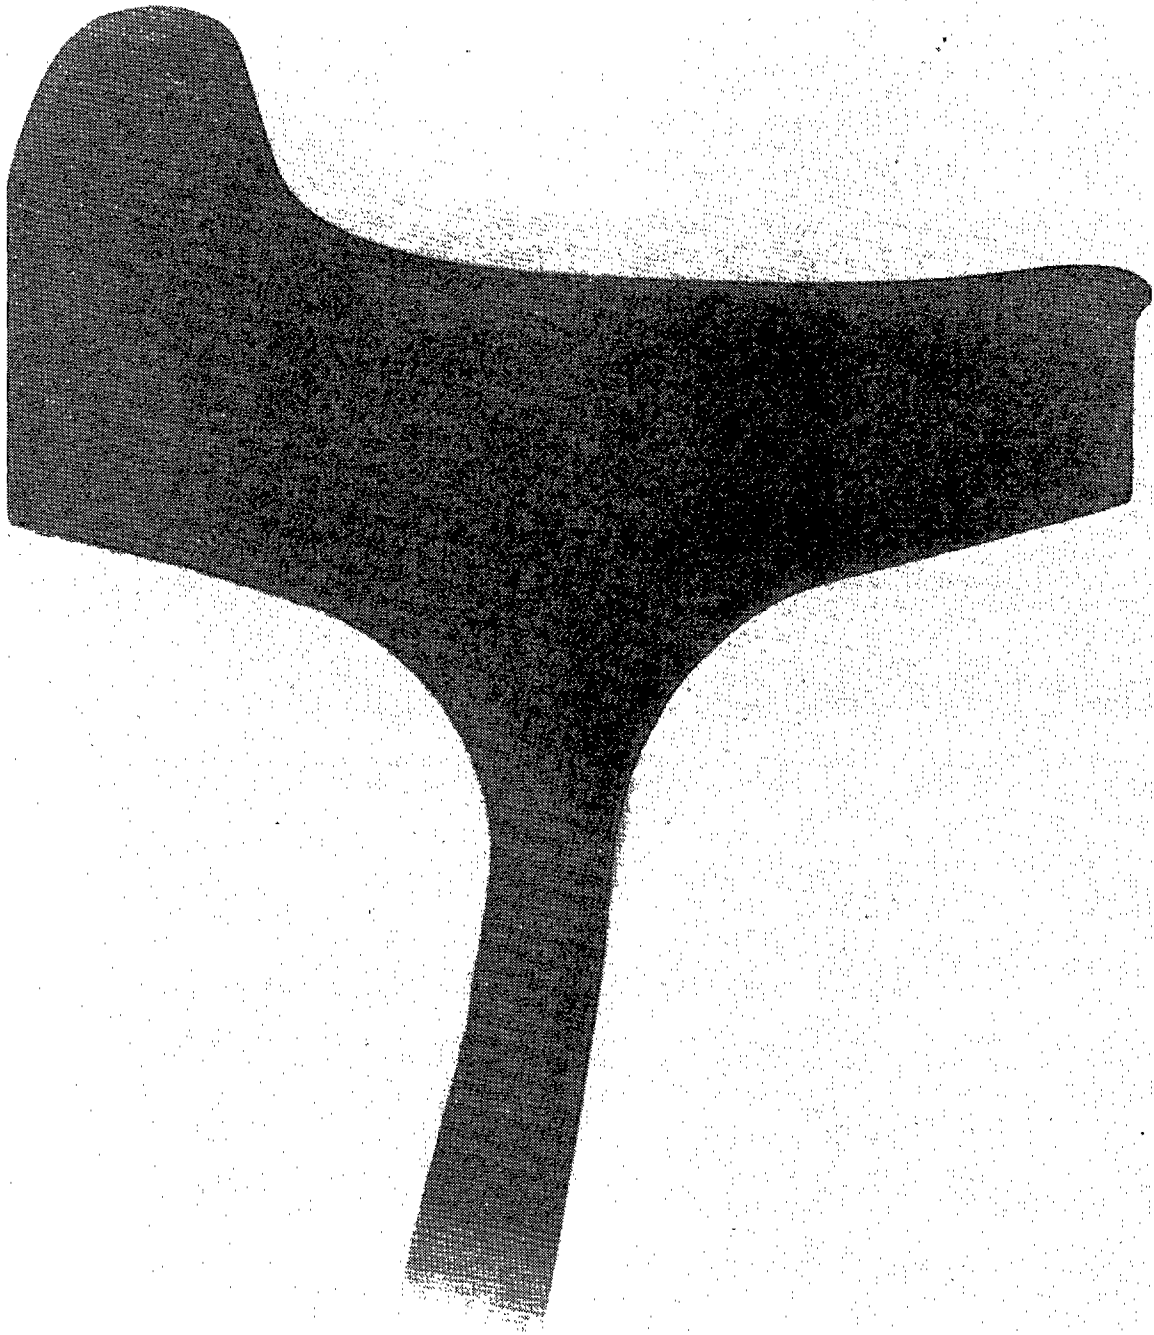
FIGURE 45.—MACROSECTION OF WORN WROUGHT CLASS-U WHEEL (WHEEL 6),  
1.1 APPROXIMATE MAGNIFICATION

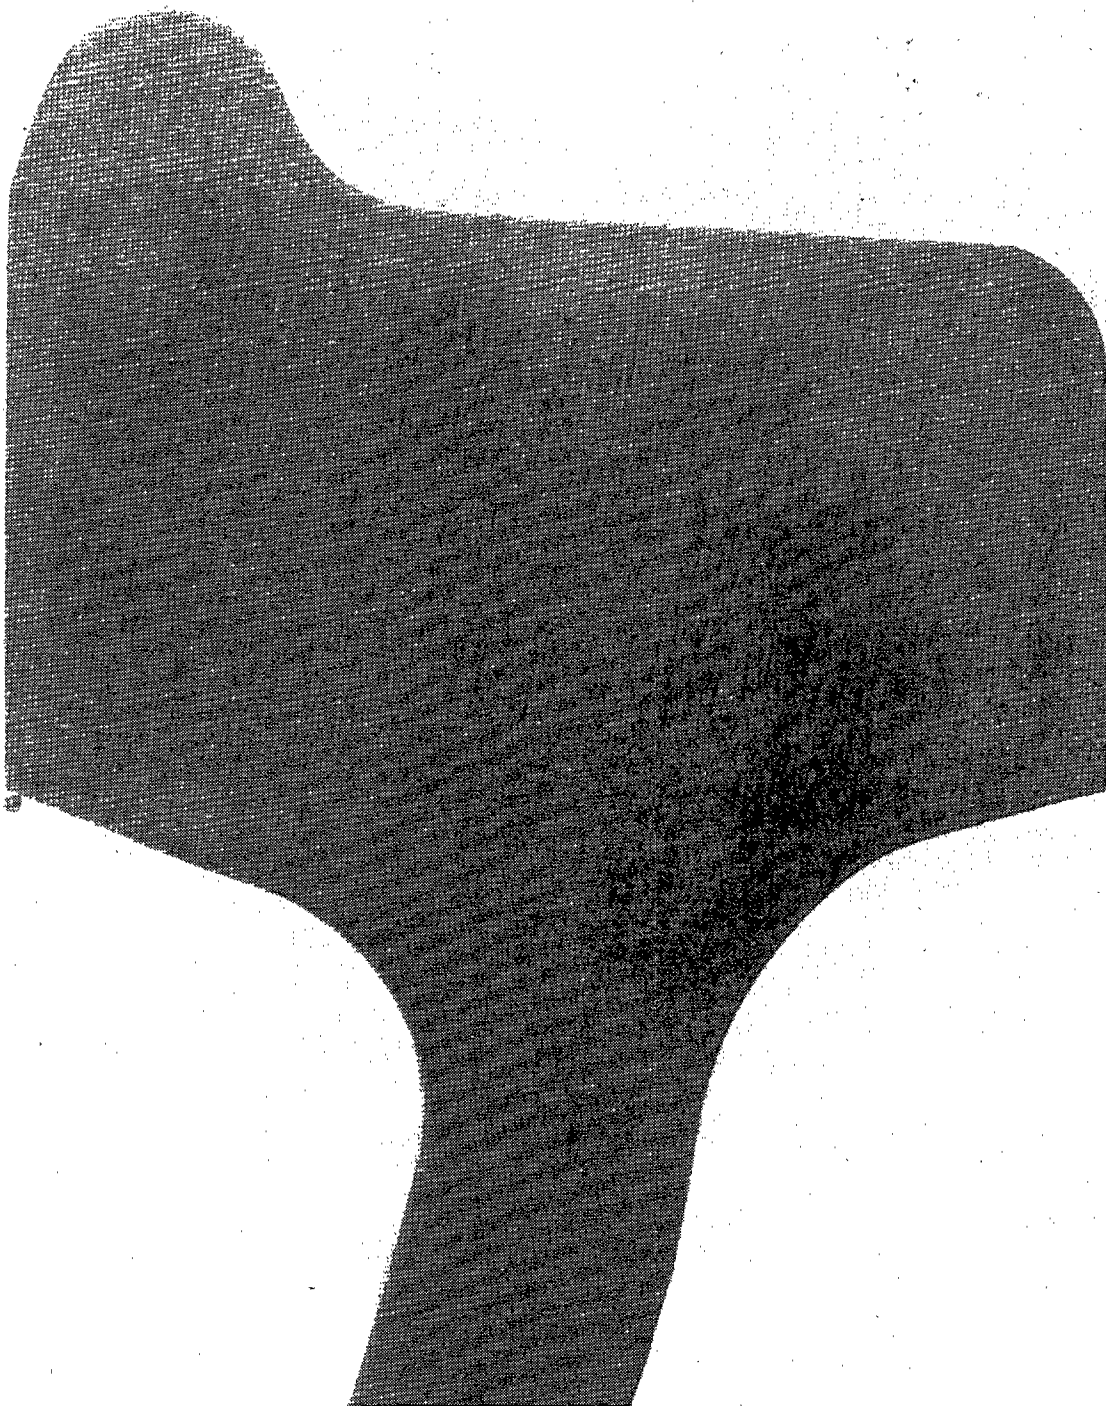
FIGURE 46.—MACROSECTION OF WROUGHT CLASS-CE WHEEL (WHEEL 7),  
1.1 APPROXIMATE MAGNIFICATION

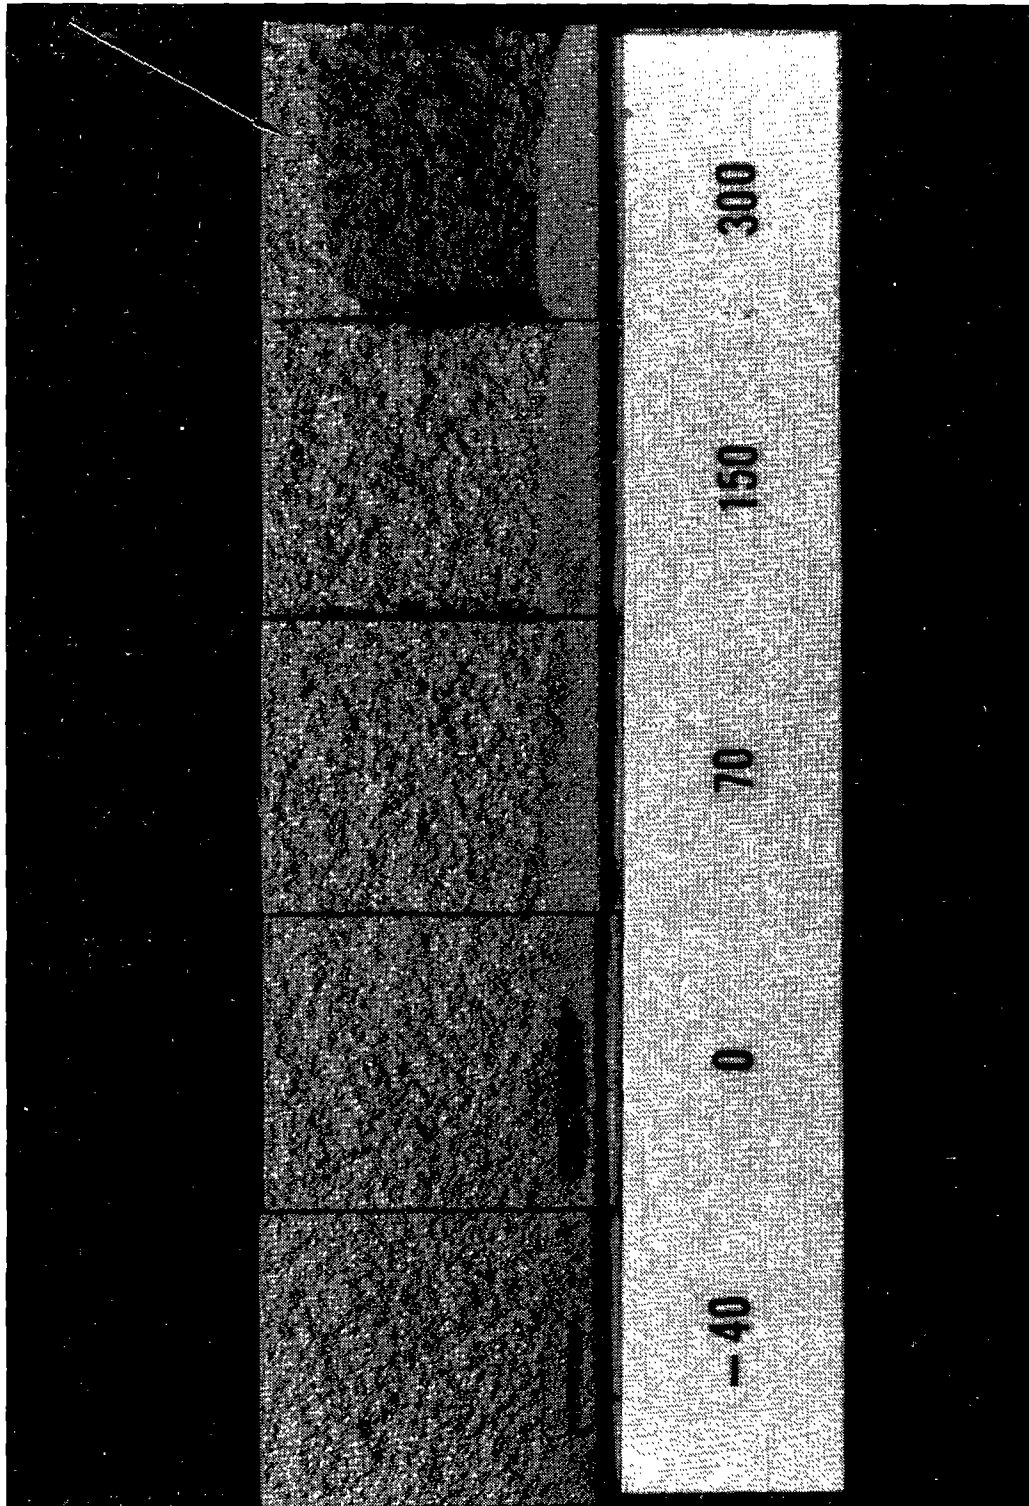
FIGURE 54. - $K_{IC}$  FRACTURES FROM THE CAST CLASS-U WHEEL-RIM-ARROW INDICATES THE CLEAVAGE CAUSED BY BREAKING OPEN THE SPECIMEN AT ROOM TEMPERATURE SINCE COMPLETE SEPARATION DID NOT OCCUR AT 300°F (NUMBERS INDICATE TEST TEMPERATURES), X1.7 MAGNIFICATION

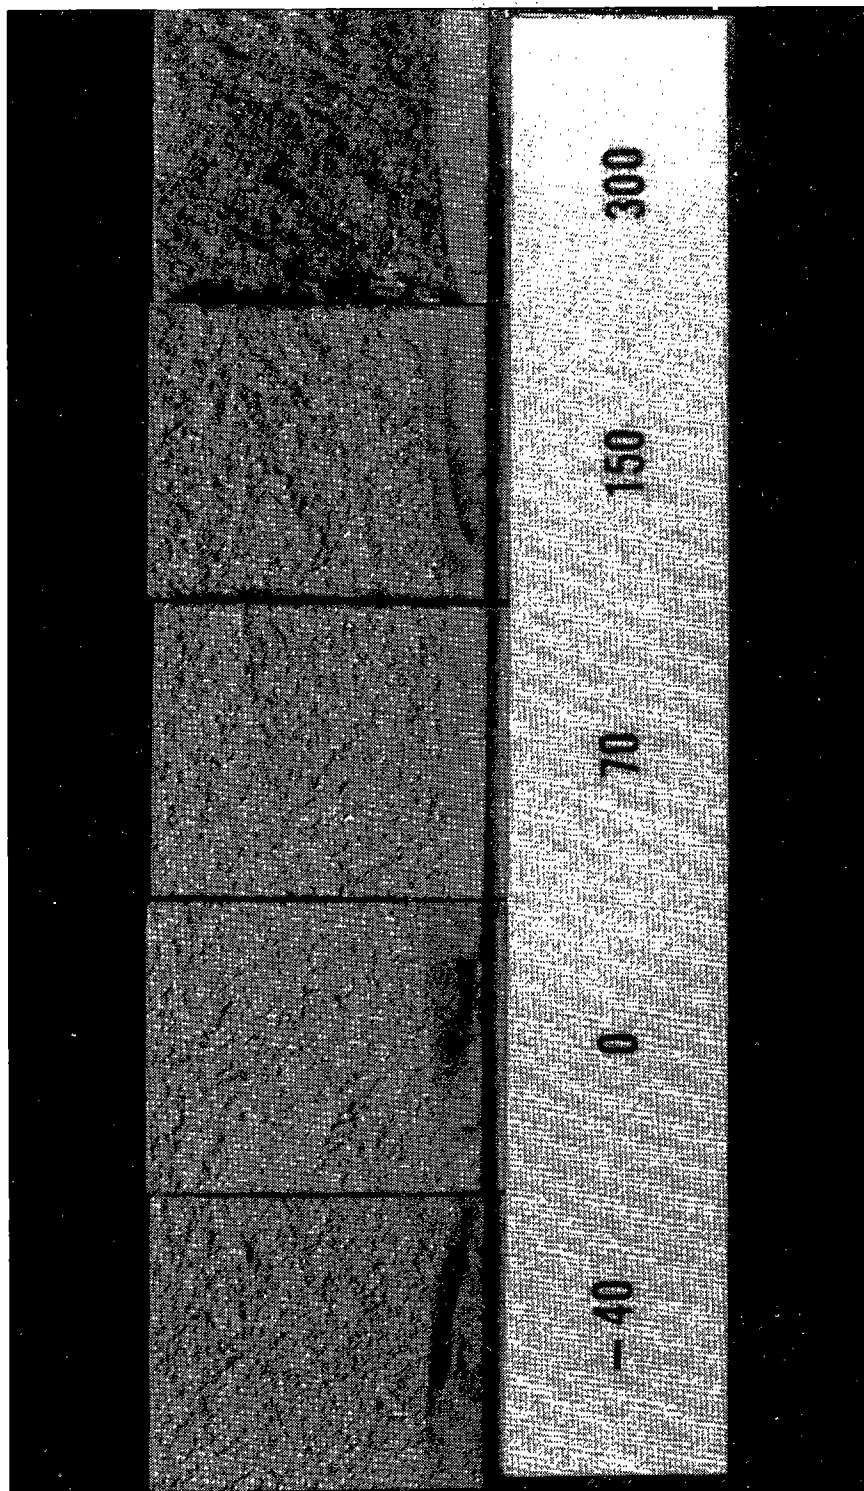
FIGURE 55.— $K_{IC}$  FRACTURES FROM THE CAST CLASS-C WHEEL RIM (NUMBERS INDICATE TEST TEMPERATURE), X1.7 MAGNIFICATION

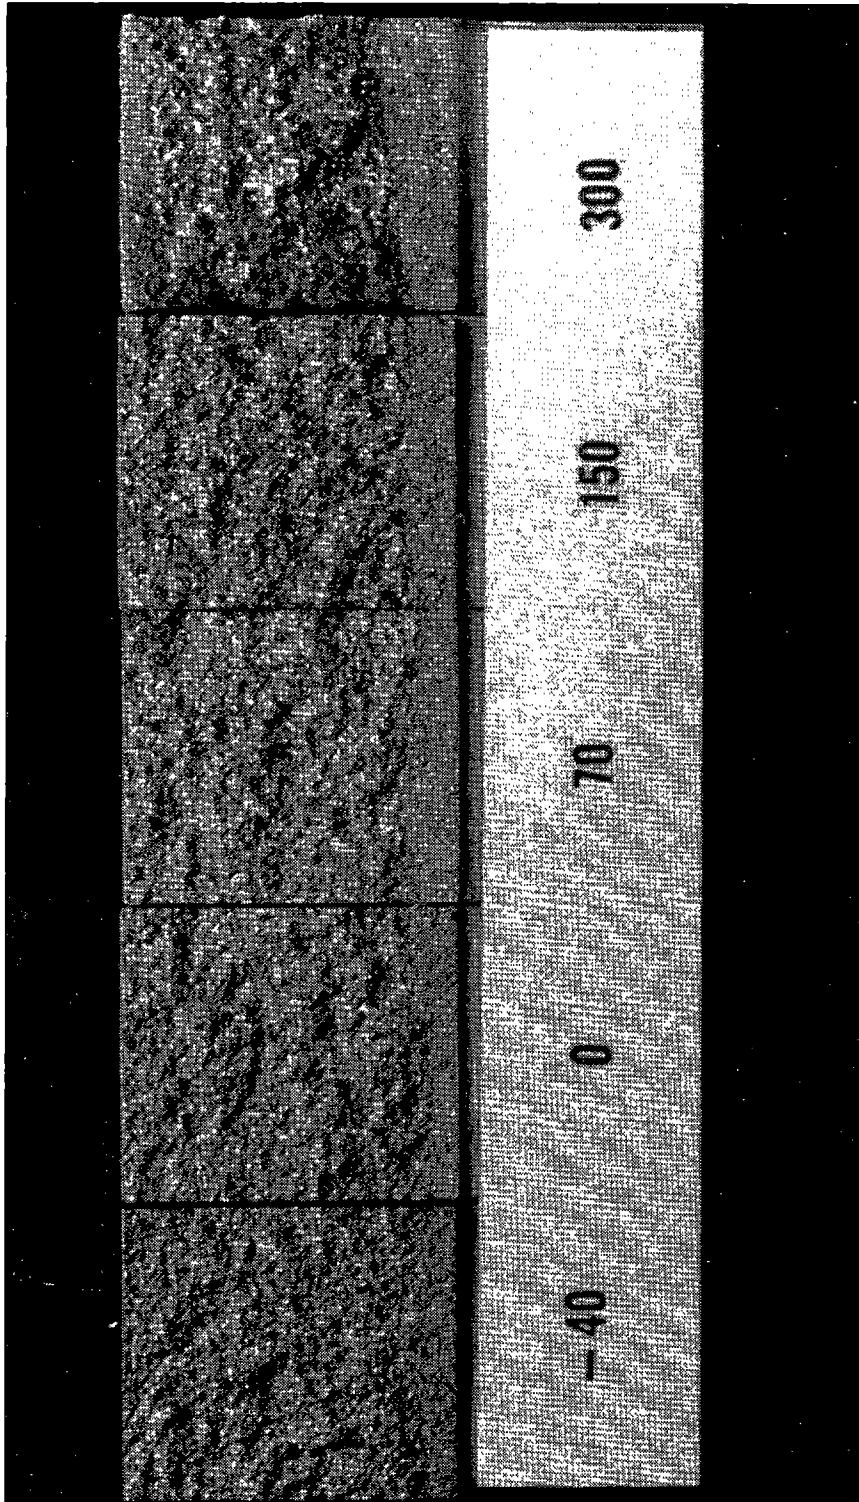
FIGURE 56. - $K_{IC}$  FRACTURES FROM THE WROUGHT CLASS-U WHEEL RIM (NUMBERS INDICATE TEST TEMPERATURE), X1.7 MAGNIFICATION

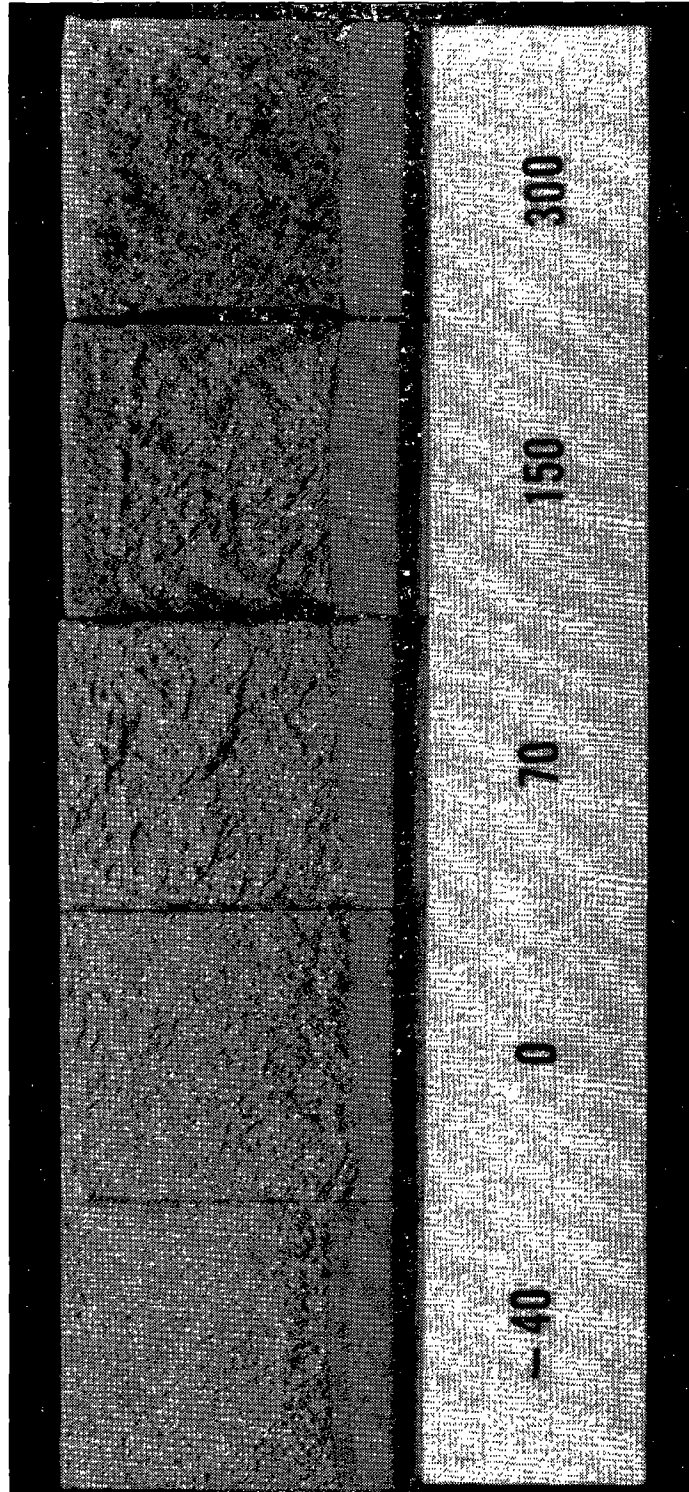
FIGURE 57.— $K_{1C}$  FRACTURES FROM THE WROUGHT CLASS A WHEEL RIM (NUMBERS INDICATE TEST TEMPERATURES), X1.7 MAGNIFICATION

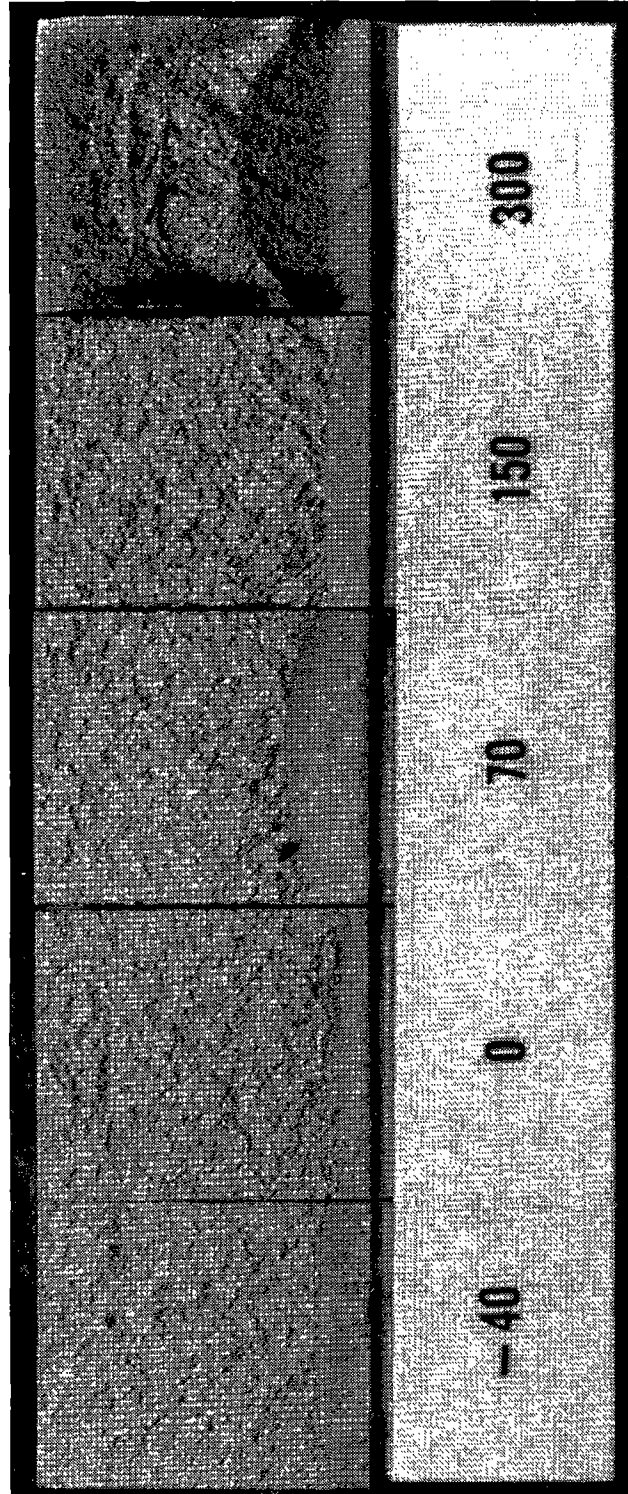
FIGURE 58.—K<sub>IC</sub> FRACTURES FROM THE WROUGHT CLASS-C WHEEL RIM (NUMBERS INDICATE TEST TEMPERATURES), X1.7 MAGNIFICATION

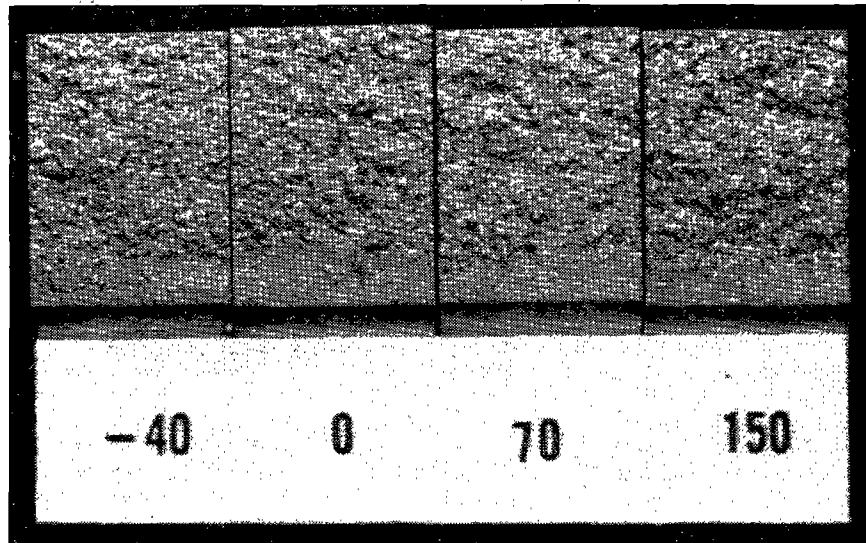
FIGURE 59.— $K_{IC}$  FRACTURES FROM THE USED (WROUGHT CLASS U) WHEEL RIMS (NUMBERS INDICATE TEST TEMPERATURES), X1.7 MAGNIFICATION

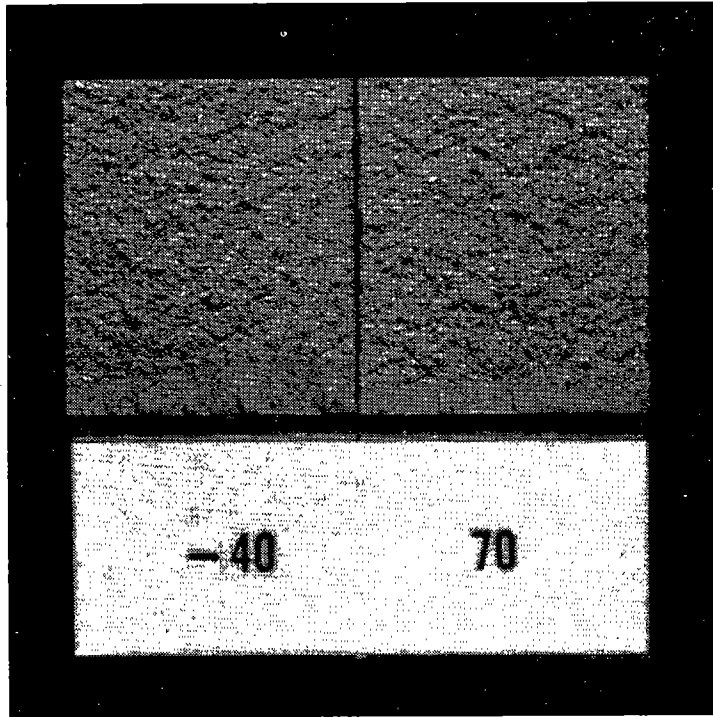
FIGURE 60.— $K_{IC}$  FRACTURES FROM THE WROUGHT CLASS-CE WHEEL (NUMBERS INDICATE TEST TEMPERATURES), X1.7 MAGNIFICATION

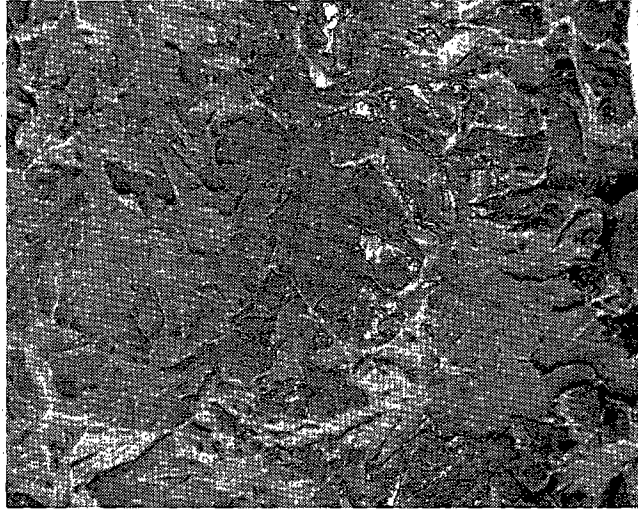
FIGURE 61.—FRACTOGRAPH (SEM) OF  $K_{IC}$  SPECIMEN FROM CAST CLASS-U WHEEL RIM (70°F), X110 MAGNIFICATION

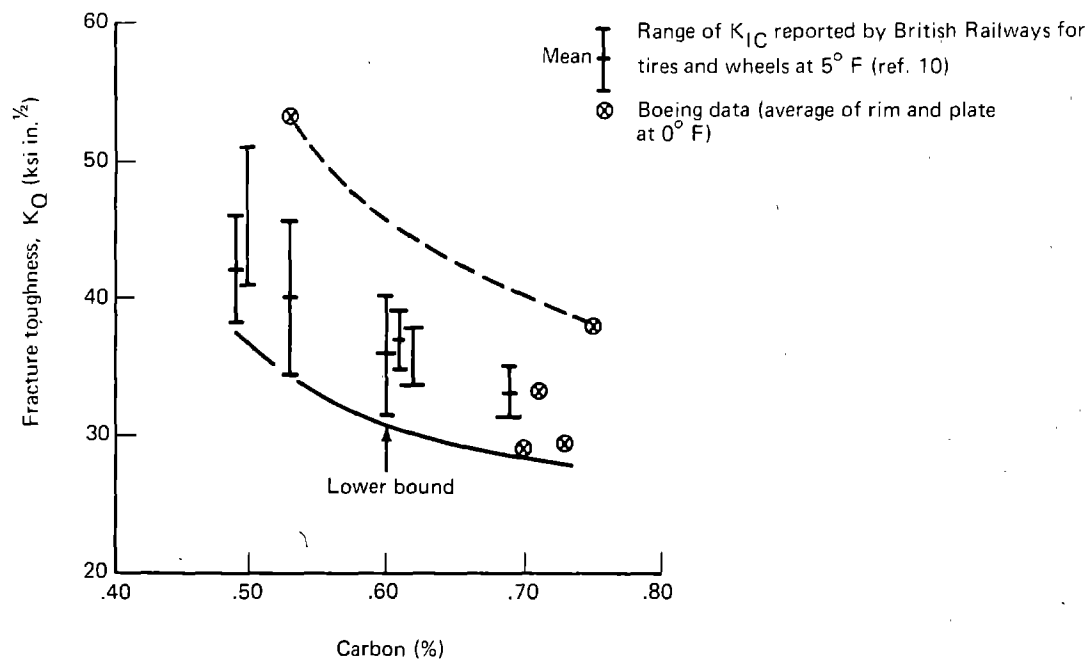
FIGURE 69.—EFFECT OF CARBON CONTENT ON FRACTURE TOUGHNESS (0°-5°F)
