REPORT NO. FRA-ORD&D-75-12

## FRACTURE RESISTANCE OF RAILROAD WHEELS

C.S. Carter  
R.G. Caton

INTERIM REPORT

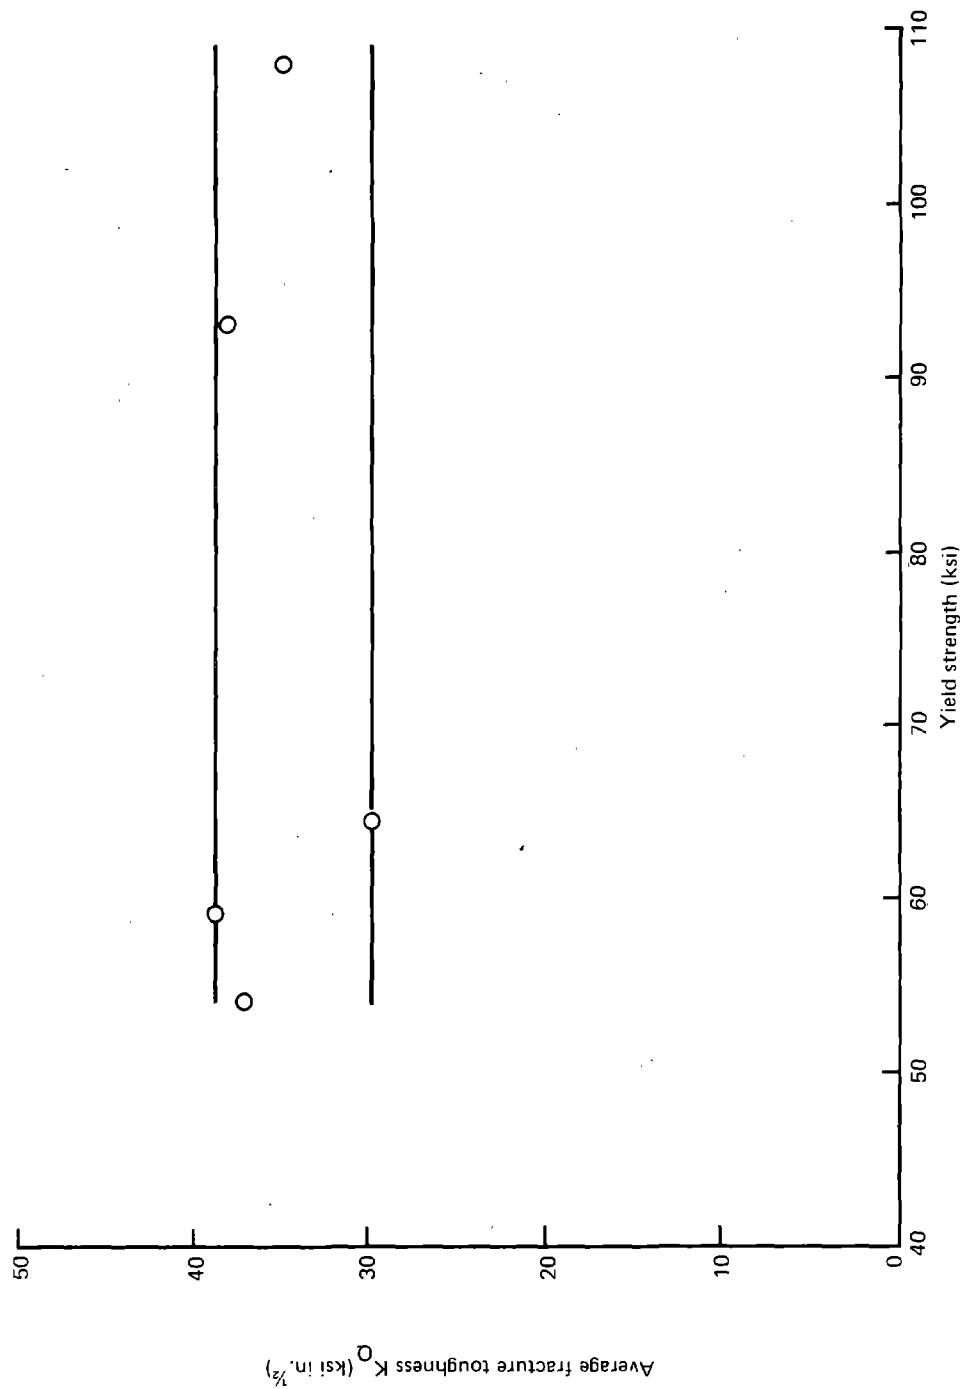
FIGURE 70.—RELATIONSHIP BETWEEN FRACTURE TOUGHNESS (AT 70°F) AND YIELD STRENGTH FOR WHEEL RIMS CONTAINING 0.70-0.75% CARBON

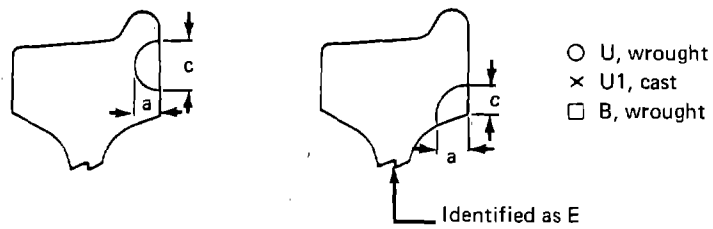
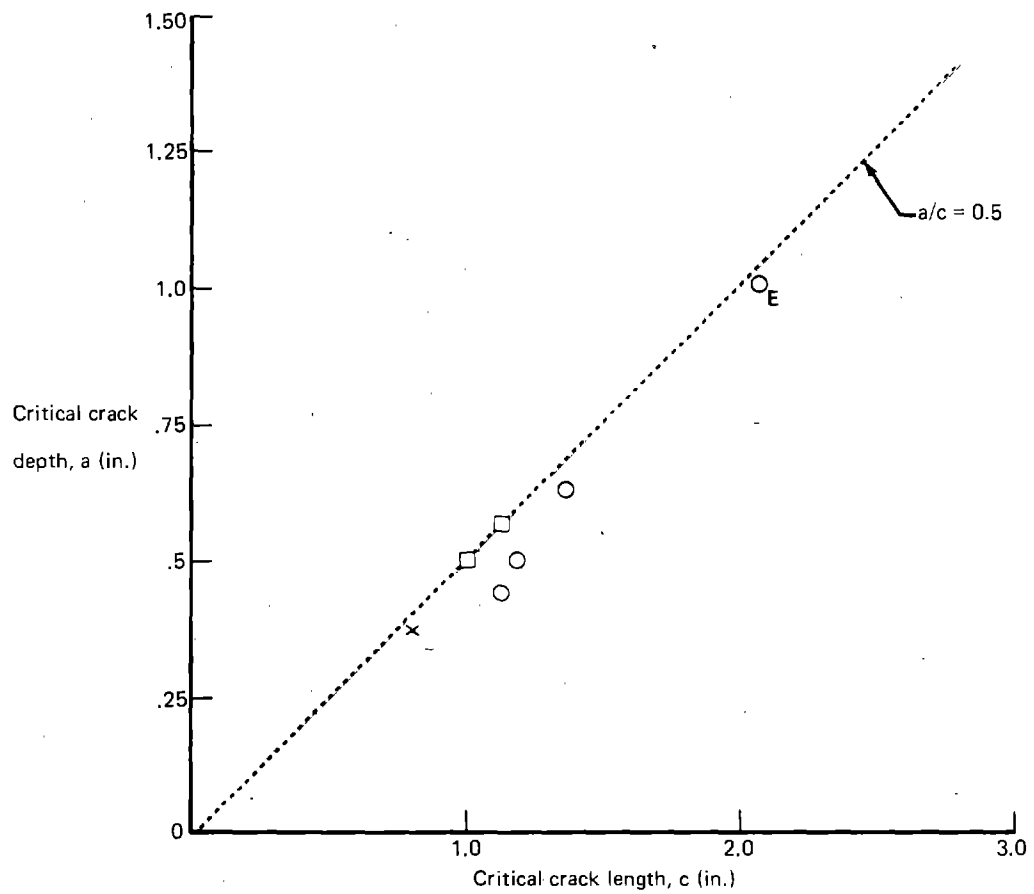
FIGURE 74.—CRITICAL SIZE OF THERMAL CRACKS AT REAR-RIM FACE FOR WHEEL FRACTURE

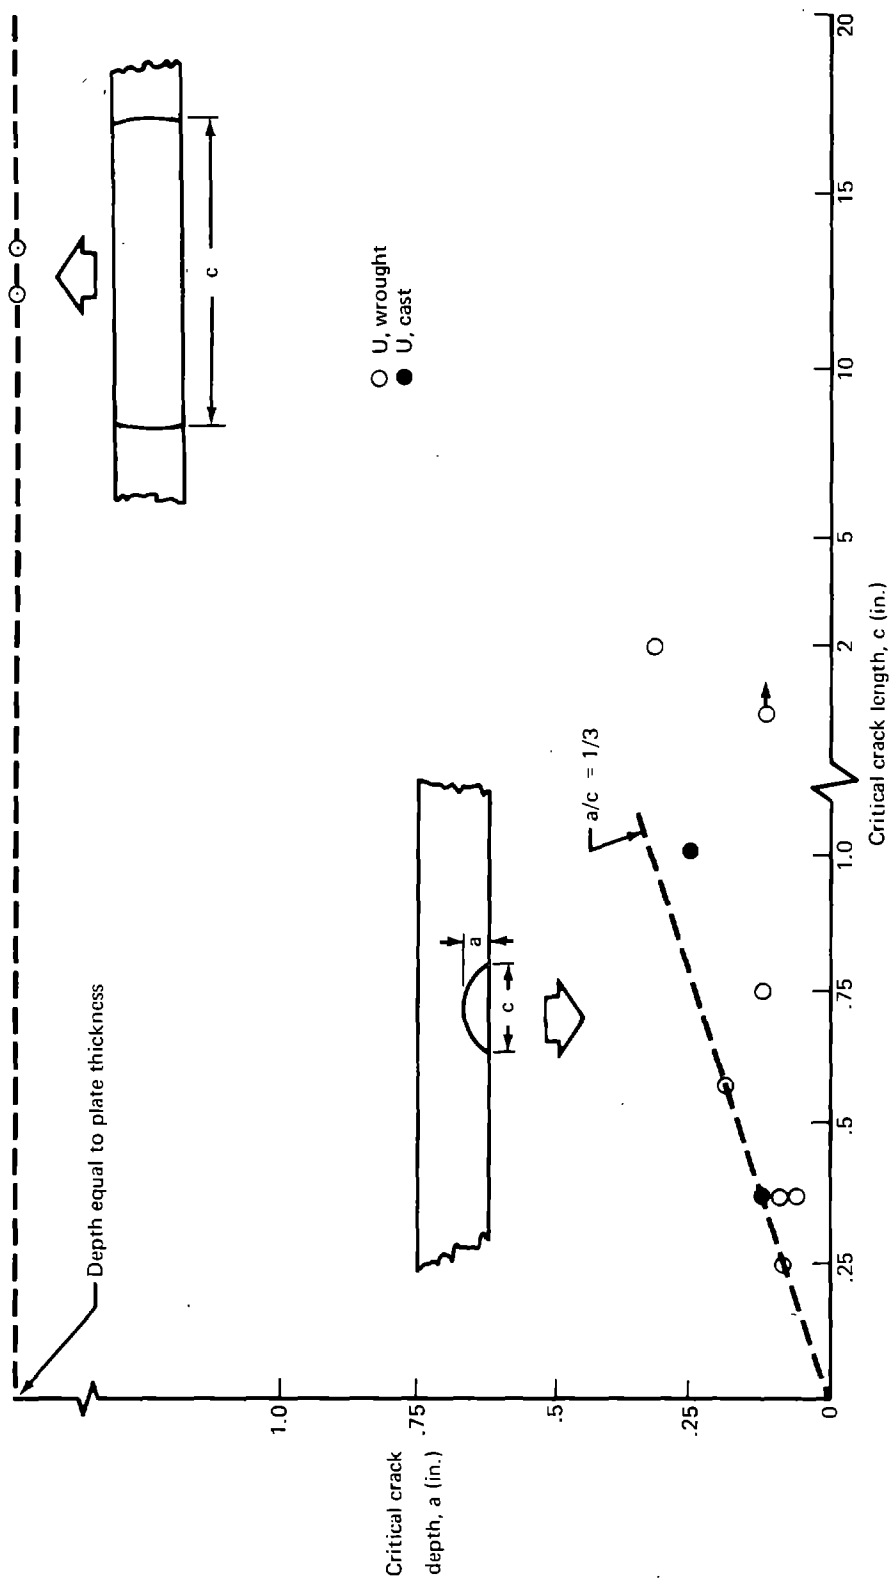
FIGURE 75.—CRITICAL CRACK SIZE AT FRONT HUB FILLET FOR PLATE FRACTURE

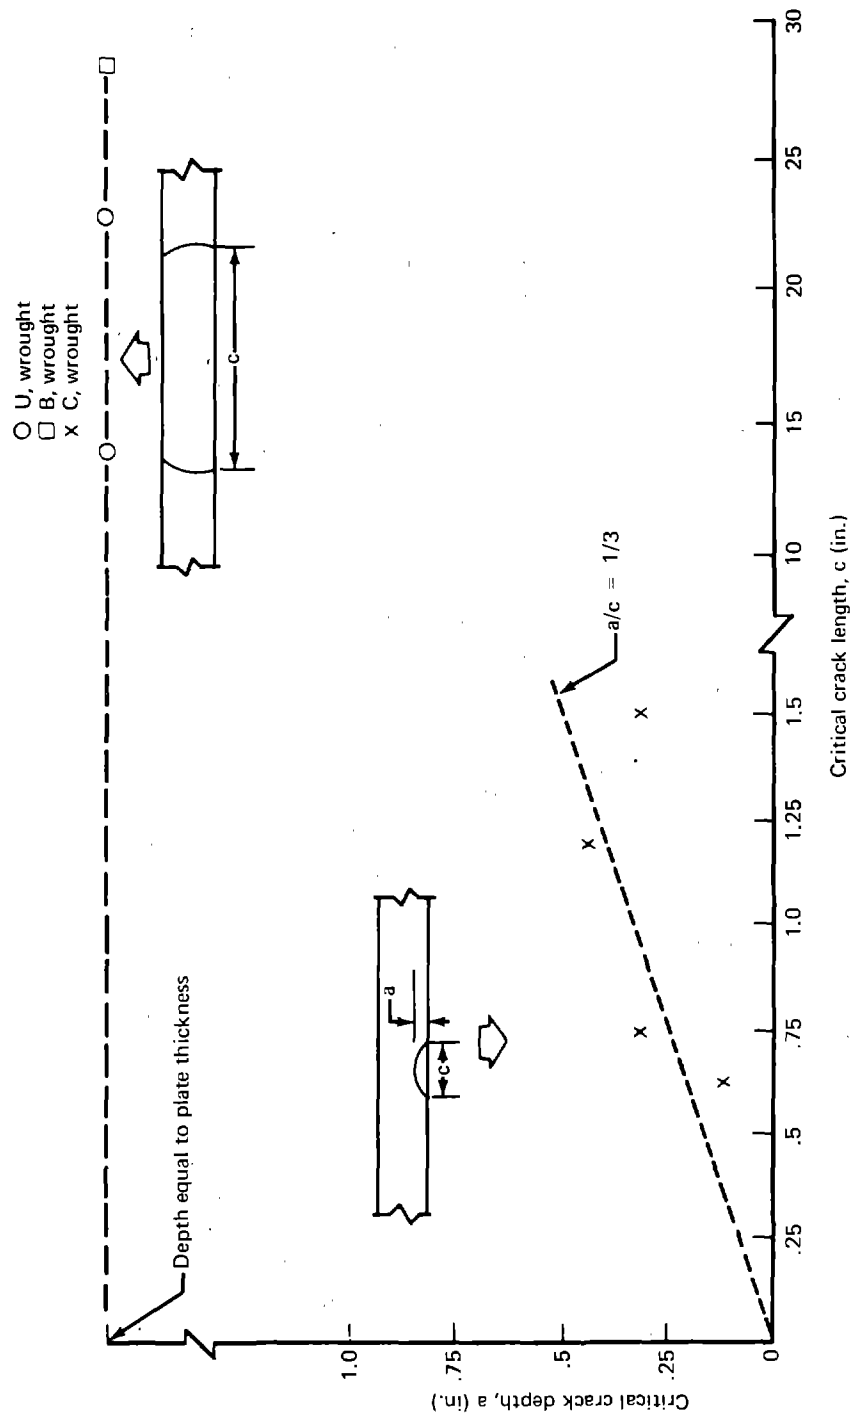
FIGURE 76.—CRITICAL CRACK SIZE AT REAR RIM FILLET FOR PLATE FRACTURE

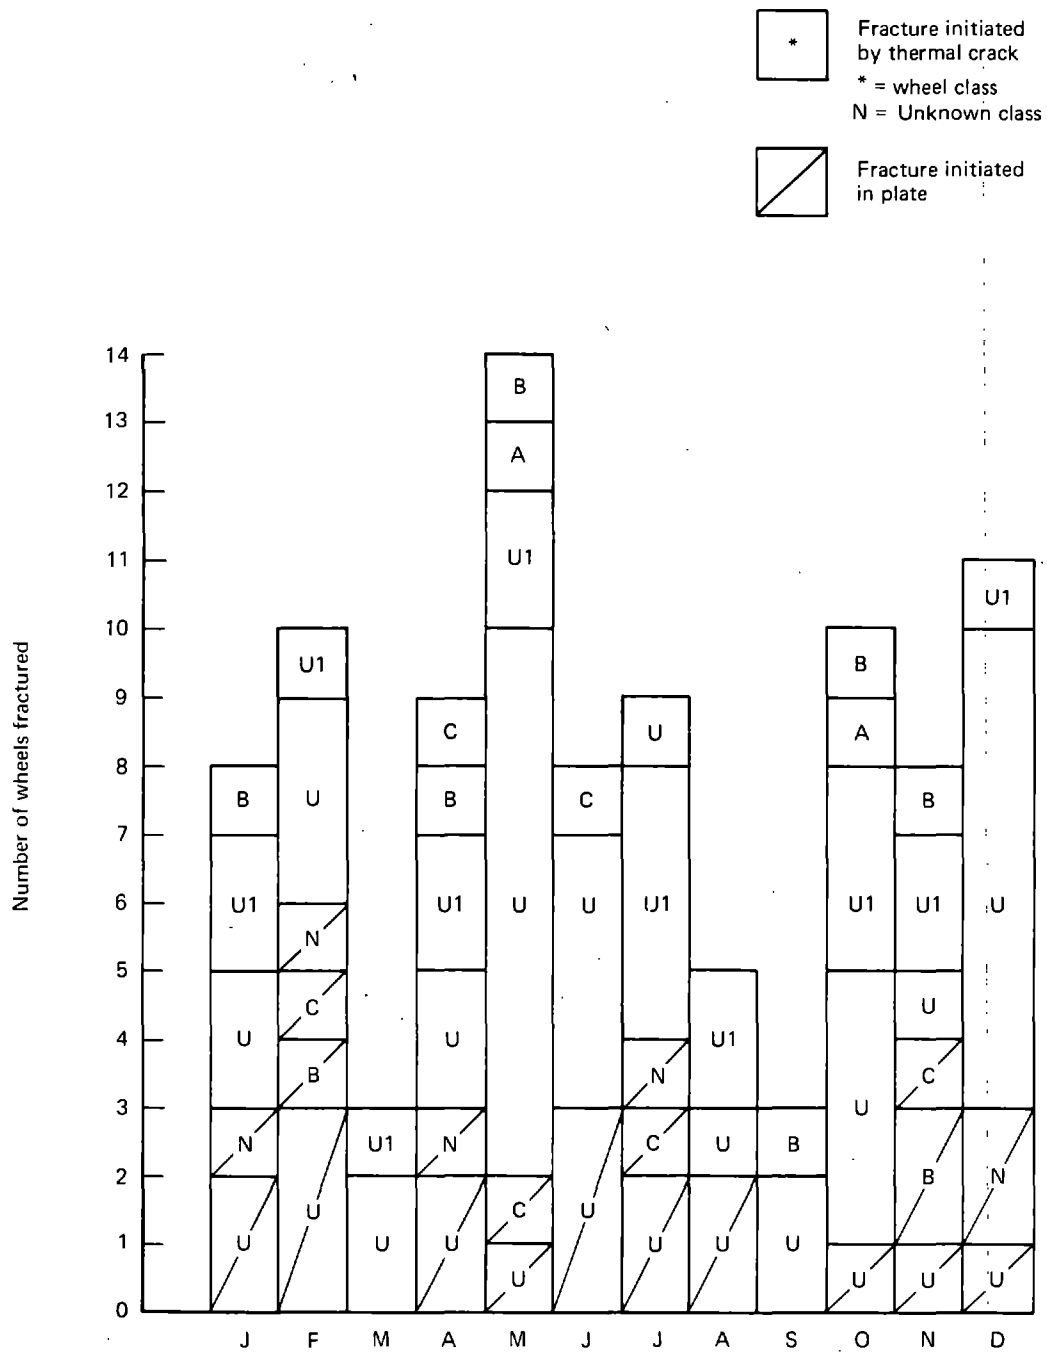
FIGURE 77.—INCIDENCE OF WHEEL FRACTURE WITH RESPECT TO TIME OF YEAR

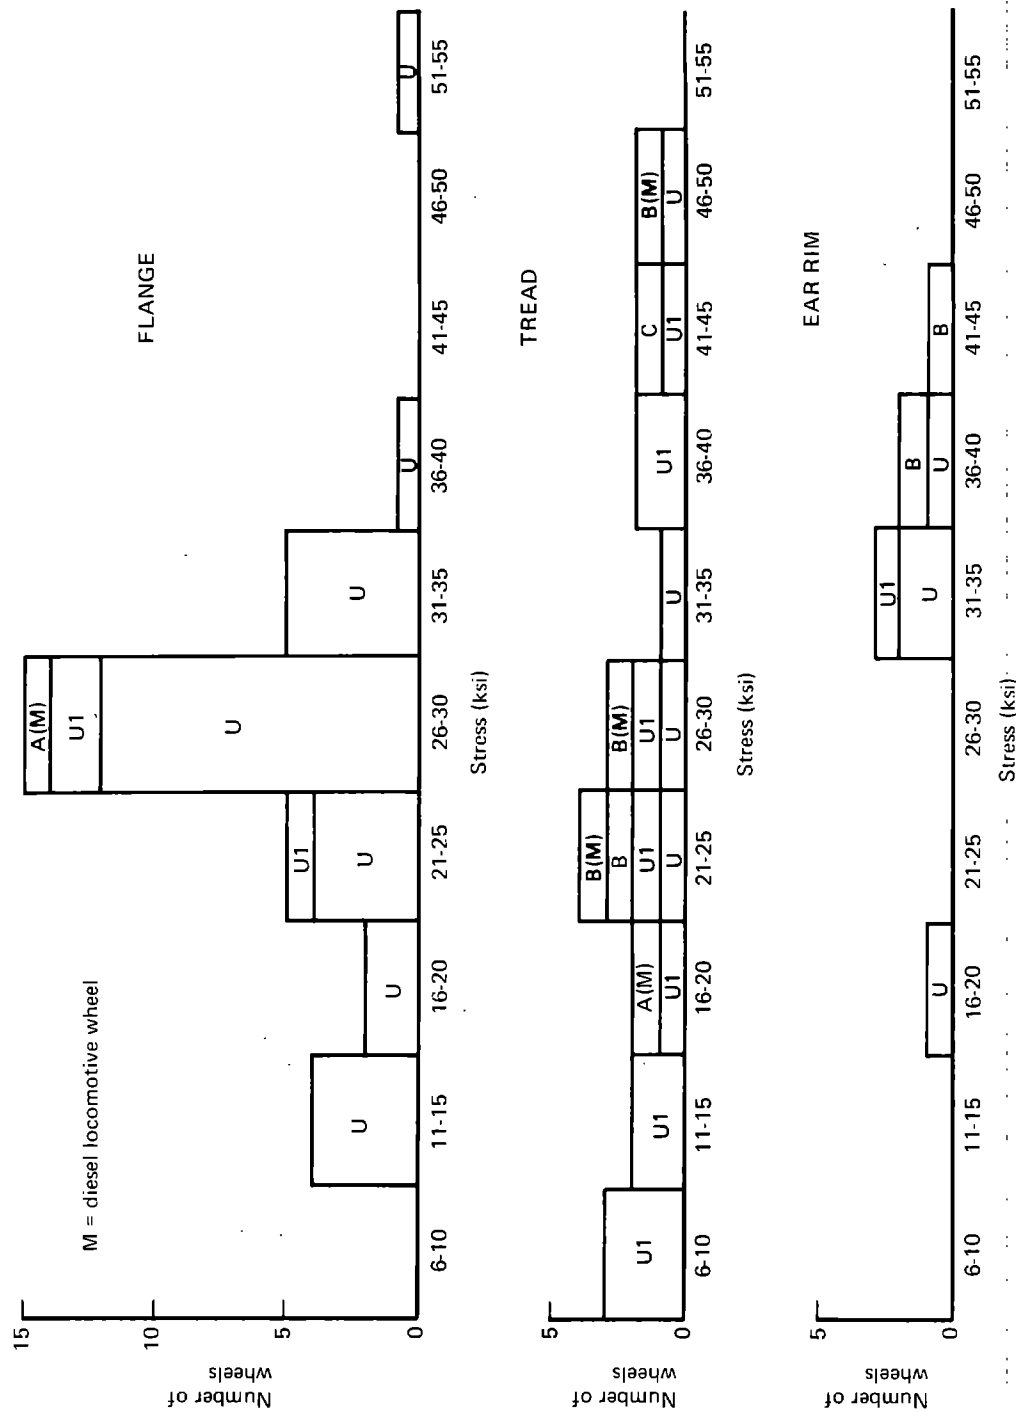
FIGURE 79.--SUMMARY OF ESTIMATED FAILURE STRESS FOR WHEELS THAT FRACTURED FROM THERMAL CRACKS

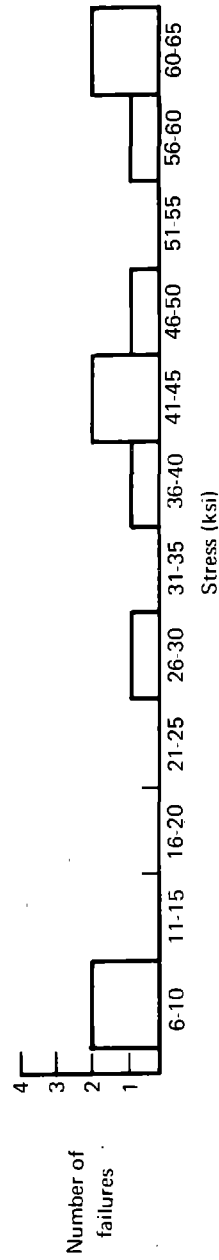
a) FRONT HUB FILLET,  
CLASS-U WHEELS

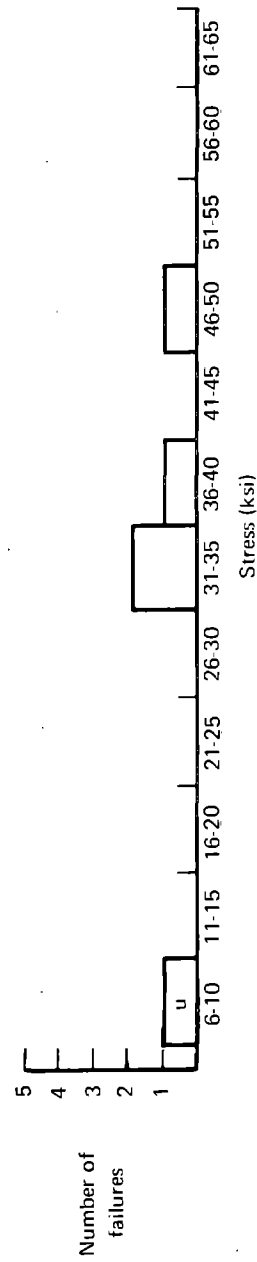
b) REAR RIM FILLET,  
CLASS-C WHEELS EXCEPT WHERE INDICATED

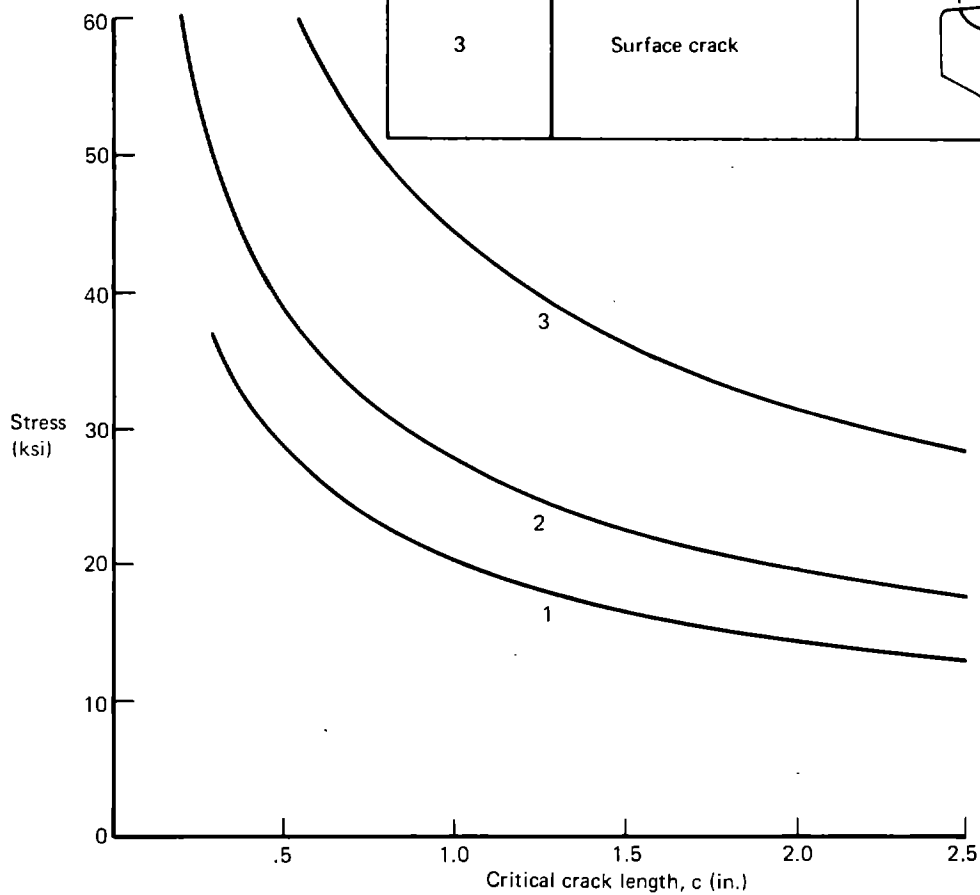
FIGURE 81.—APPLIED STRESS/CRITICAL CRACK LENGTH RELATIONSHIPS FOR THERMAL CRACKS IN CLASS-A WHEELS ( $K_{IC} = 40 \text{ KSI IN.}^{1/2}$ )

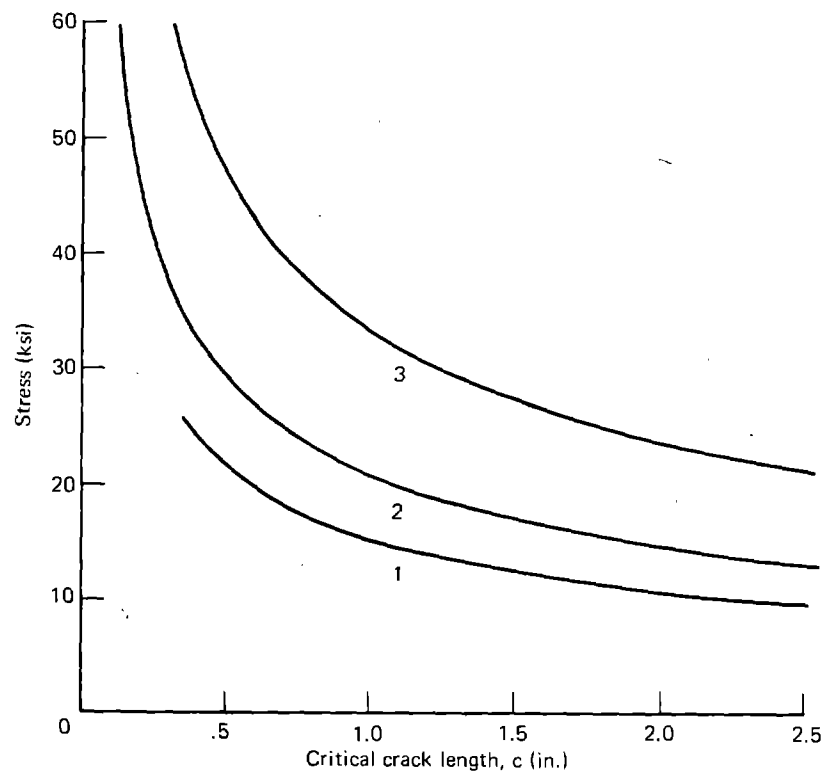
FIGURE 82.—APPLIED STRESS/CRITICAL CRACK LENGTH RELATIONSHIPS FOR THERMAL CRACKS IN CLASS-B WHEELS ( $K_{IC} = 30 \text{ KSI IN.}^{1/2}$ )

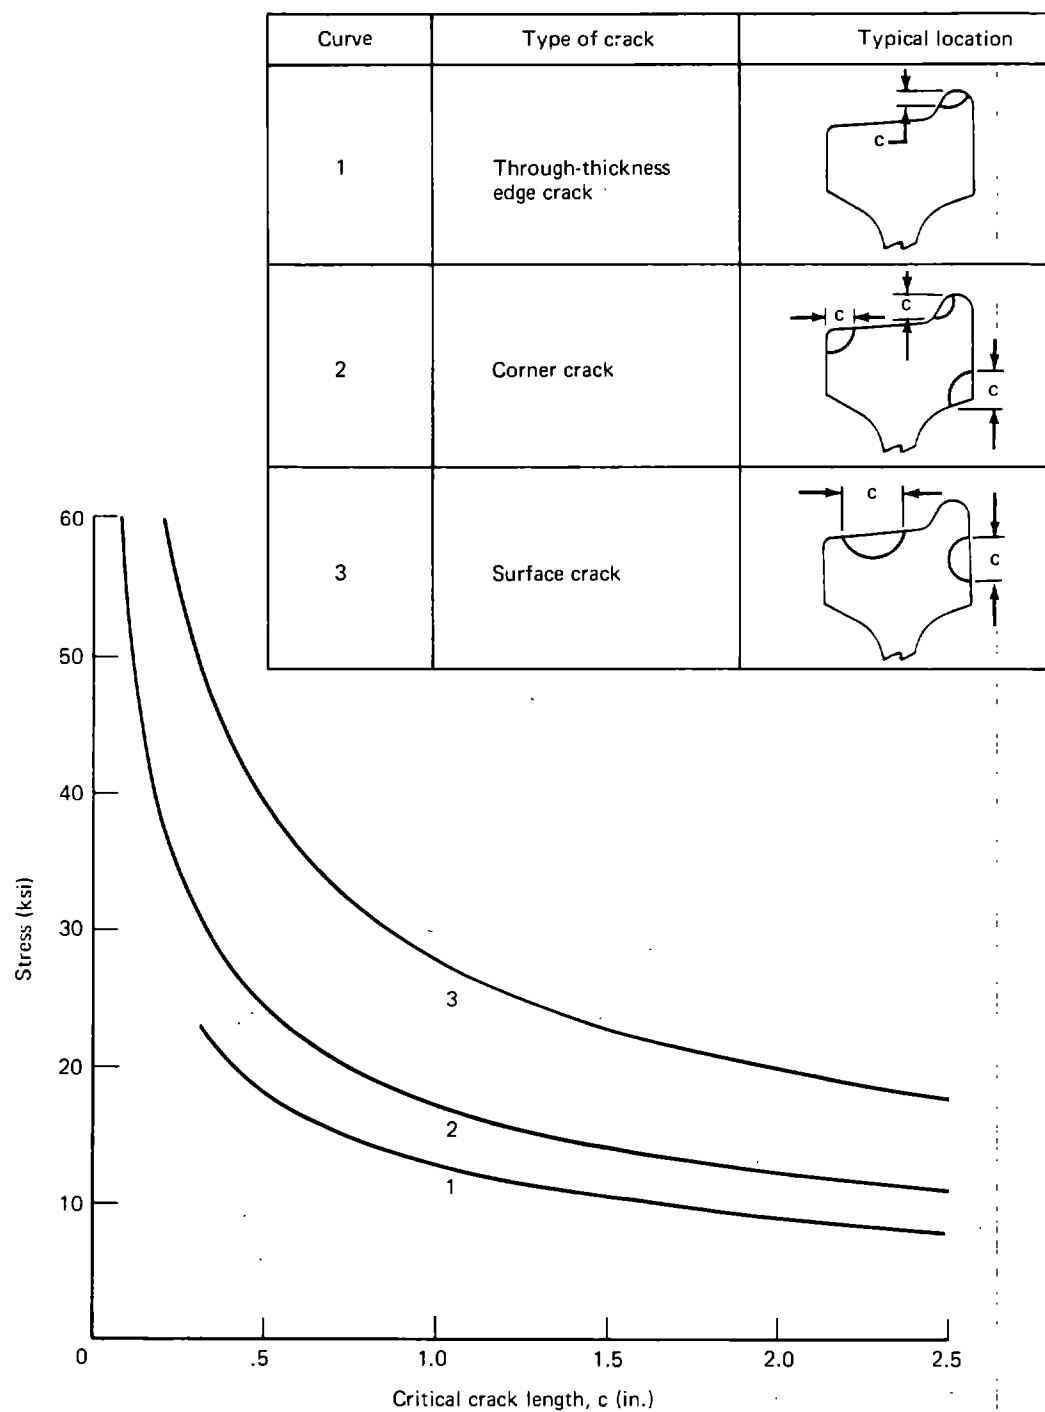
FIGURE 83.—APPLIED STRESS/CRITICAL CRACK LENGTH RELATIONSHIPS FOR THERMAL CRACKS IN CLASS-C AND CLASS-U WHEELS ( $K_{IC} = 25 \text{ KSI IN.}^{\frac{1}{2}}$ )

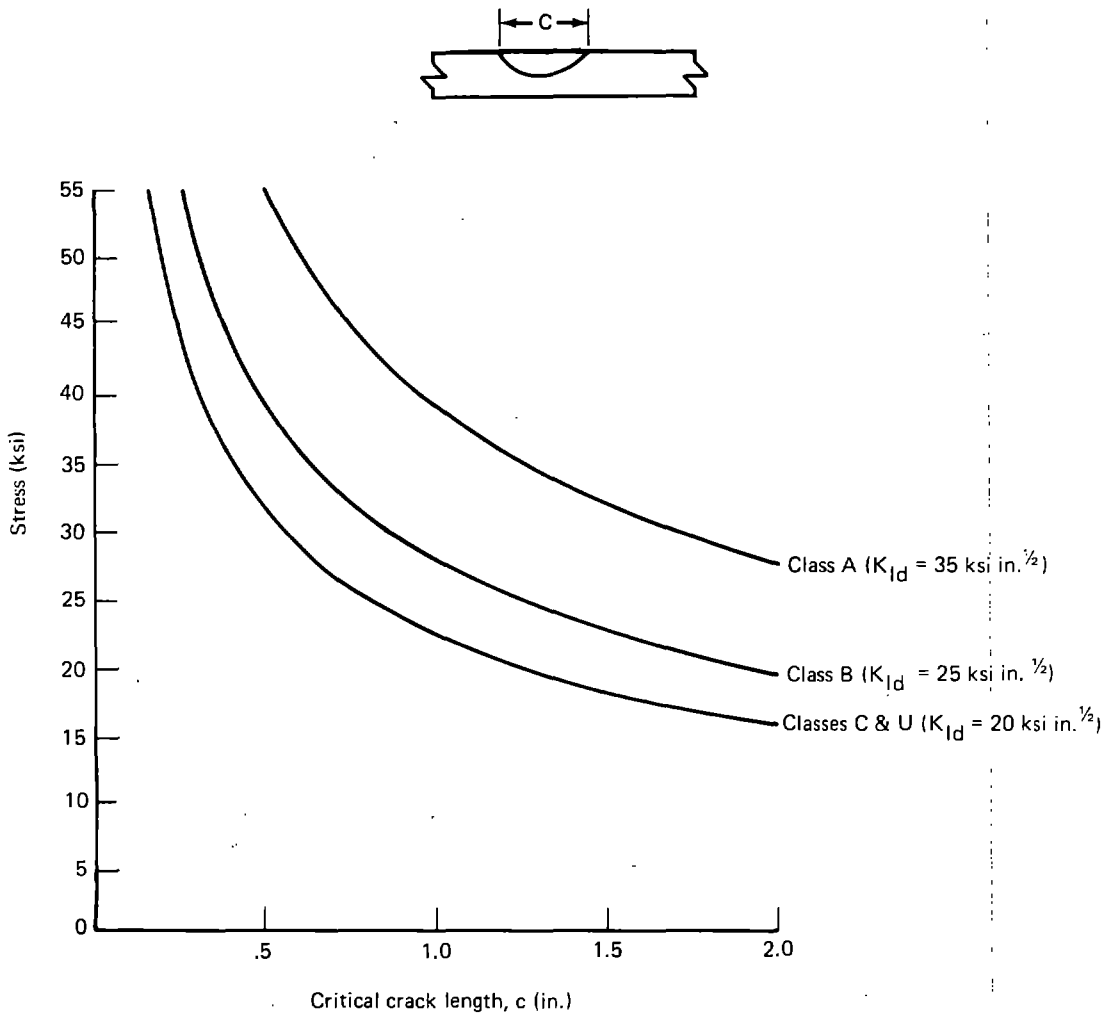
FIGURE 85.—APPLIED STRESS/CRITICAL CRACK LENGTH RELATIONSHIPS FOR SURFACE CRACKS IN WHEEL PLATES

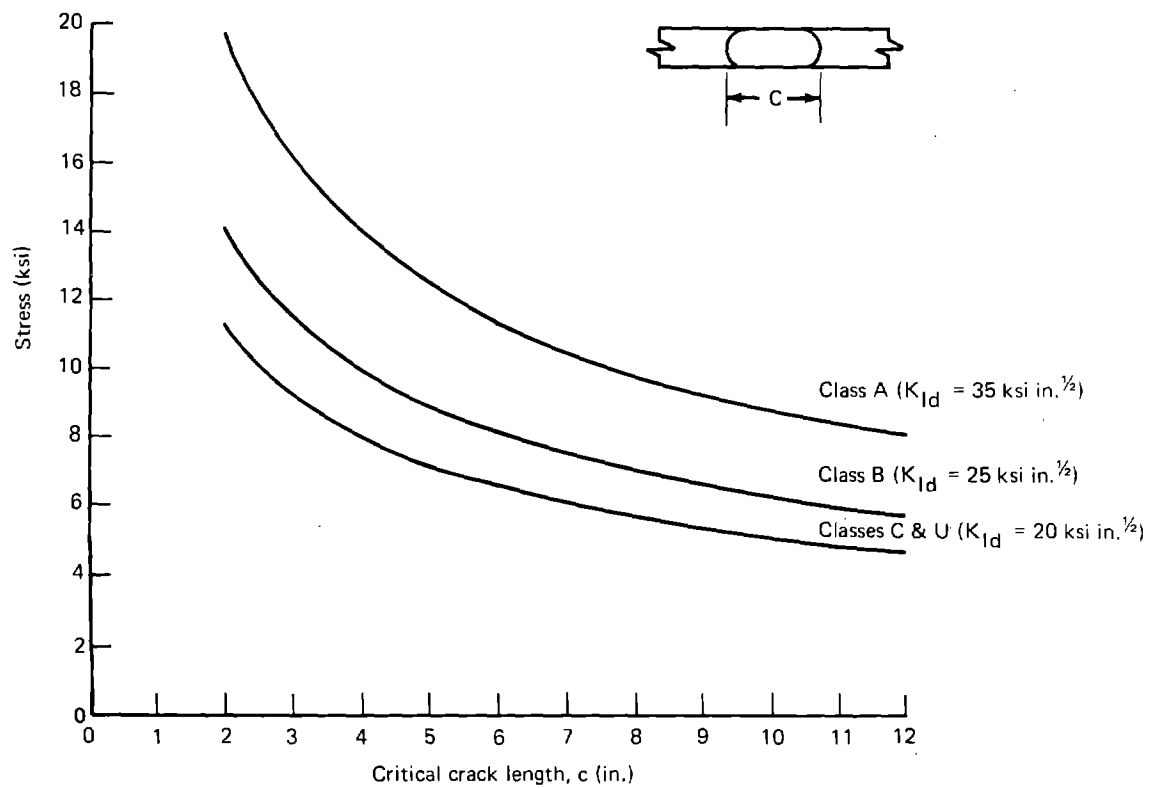
FIGURE 86.—APPLIED STRESS/CRITICAL CRACK LENGTH RELATIONSHIPS FOR THROUGH-THICKNESS CRACKS IN WHEEL PLATES

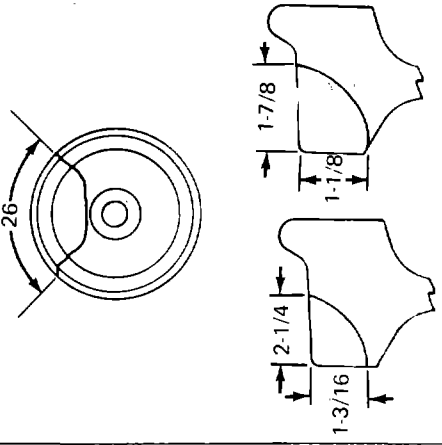
9	Failure initiated from two thermal cracks which were 26 in. apart.

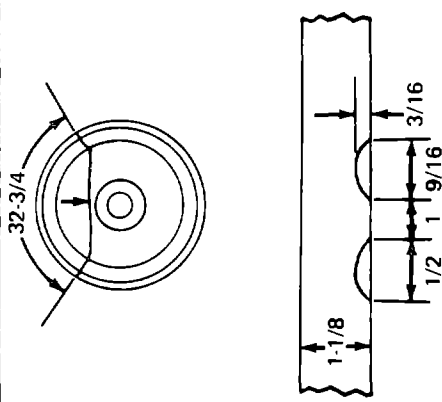
45	1) Crack initiation associated with mill scale. 2) One stage brittle fracture.
33 in (Wr) 1W	U	—	1-1/16	April

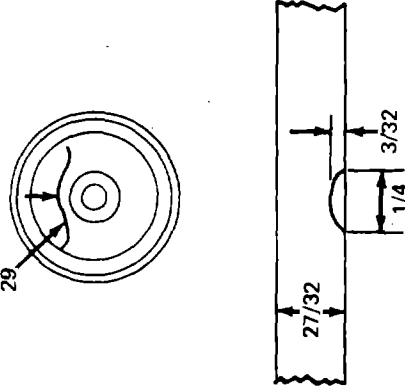
65	1) Crack initiation associated with pitting due to embedded mill scale. 2) Crack arrested 3-4 in. below tread.
33 in (Wr) 1W	U	12	1	July

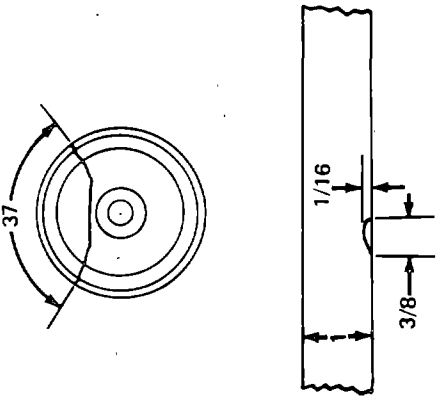
62	<p>1) Crack initiated in area of pitting (0.027 in. deep) due to entrapped mill scale. Microstructure also altered in this area by processing.</p> <p>2) One stage brittle fracture.</p>
33 in (Wr) 1W	U	7	3/4	February

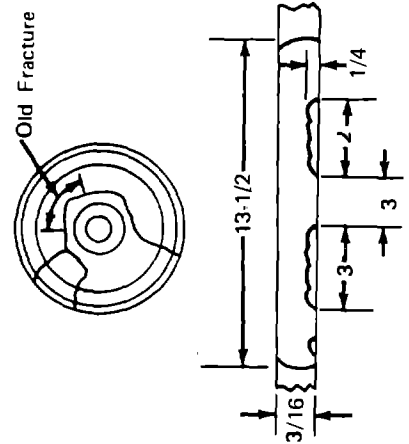
6	1) Multiple fatigue cracks initiated in rough area, and developed into 13-1/2 long crack, probably by fatigue. Final rapid fracture of wheel initiated from 13-1/2 in crack. 2) One stage brittle fracture.

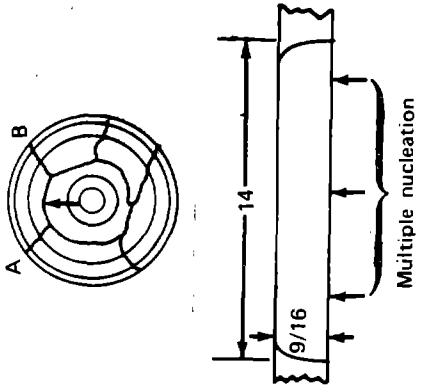
6	<p>1) Multiple fatigue cracks initiated in roughly machined area.</p> <p>2) Rapid brittle fractures to A &amp; B developed thru rim from 14 in. long fatigue crack.</p> <p>3) One stage brittle fracture.</p>
33 in (Wr) 1W	U	3	1-1/4	January
