AEM-7

ELECTRIC LOCOMOTIVE TESTING AT THE TRANSPORTATION TEST CENTER

| 4. Title and Subtitle AEM-7 Electric Locomotive Testing at the Transportation Test Center | | 5. Report Date | |
| 16. Abstract This report describes the tests conducted at the Transportation Test Center (TTC) on the first production AEM-7 locomotive, AMTRAK 900. These tests, which were conducted between April 1980 and May 1981, were to evaluate the locomotive characteristics on 25 kV 60 Hz and 12.5 kV 60 Hz voltage supplies, and to examine the locomotive reliability under high speed operating conditions. The accelerated Northeast Corridor (NEC) schedules (2 hrs 40 min from New York to Washington, D.C., and 3 hrs 40 min from Boston to New York) were used for the Endurance Test Operations. A route simulator programmed with the Train Performance Calculation (TPC) predicted speed/time profile was used to prompt the locomotive engineer. A train consist of between four and eight cars was used for the test. The actual trip times and energy consumed were measured. Major problems were experienced with the locomotive pantographs, truck assemblies wheel bearings, traction motors, and ground brush assemblies. A new phase

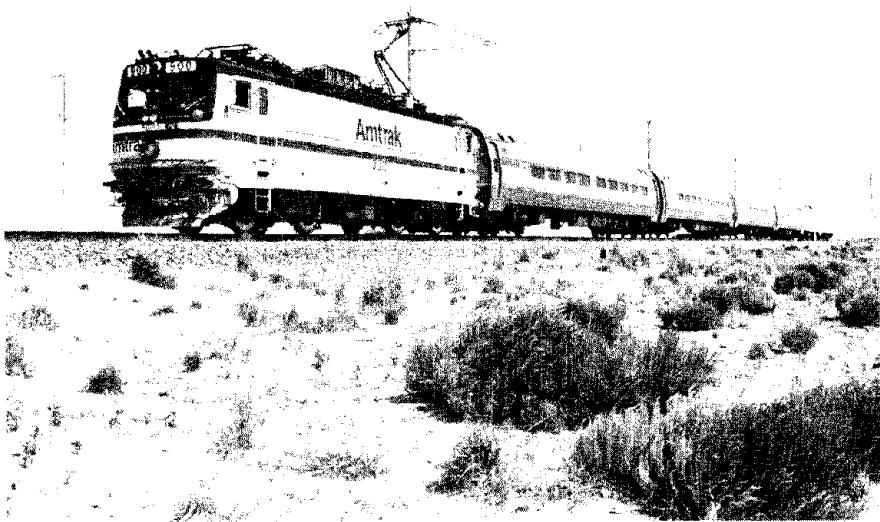
FIGURE 1-1. THE AEM-7 LOCOMOTIVE, AMTRAK 900.

The first unit, AMTRAK 900 (Figure 1-1) was delivered to AMTRAK at Wilmington, Delaware in February 1980. After acceptance testing by AMTRAK and General Motors on the NEC, AMTRAK 900 was transferred to the TTC for further extensive testing. The TTC testing was funded by NECPO through the FRA/OR&D.

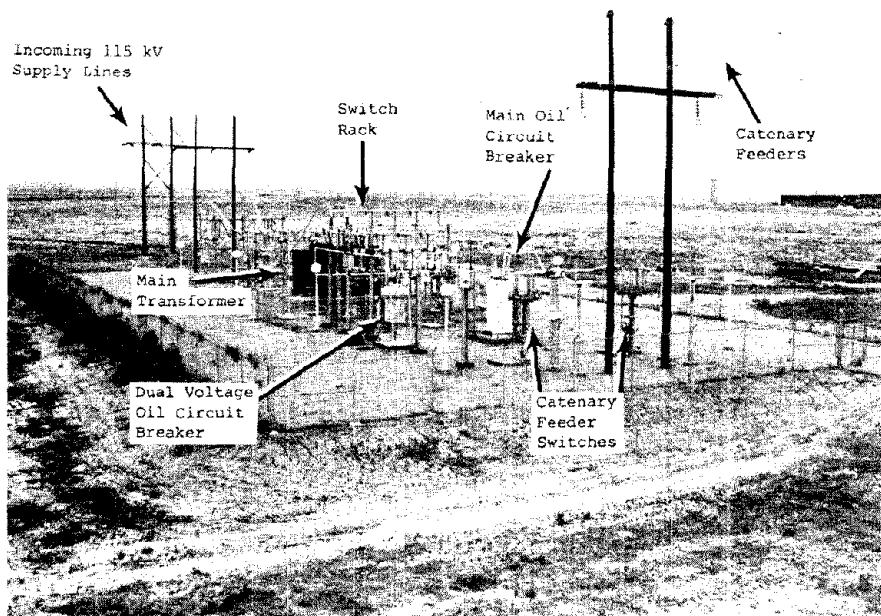
while the other pair were parallel connected. The series windings were then fed to OCB #315 and switcher #314-1 to provide 25 kV to the south half of the catenary system. An extra switcher, #S12, was provided in the switch rack to isolate the output from each pair of windings. A second OCB, #316, complete with lightning arrestor was added, along with a pair of isolation switchers, #314-6 and #314-5. The output from #316 was connected through #314-5 to the catenary side of original catenary north feed switcher, #314-3. With switcher #314-3 in the open position a 12.5 kV supply to the north half of the catenary could be controlled by OCB #316. A picture of the modified substation is shown in Figure 4-11. The necessary controls and relaying modification were installed in substation control panel #5. The new OCB is rated at 25.8 kV and has an interrupt current level of 11 kA.

FIGURE 4-11. GENERAL VIEW OF THE RTT SUBSTATION.

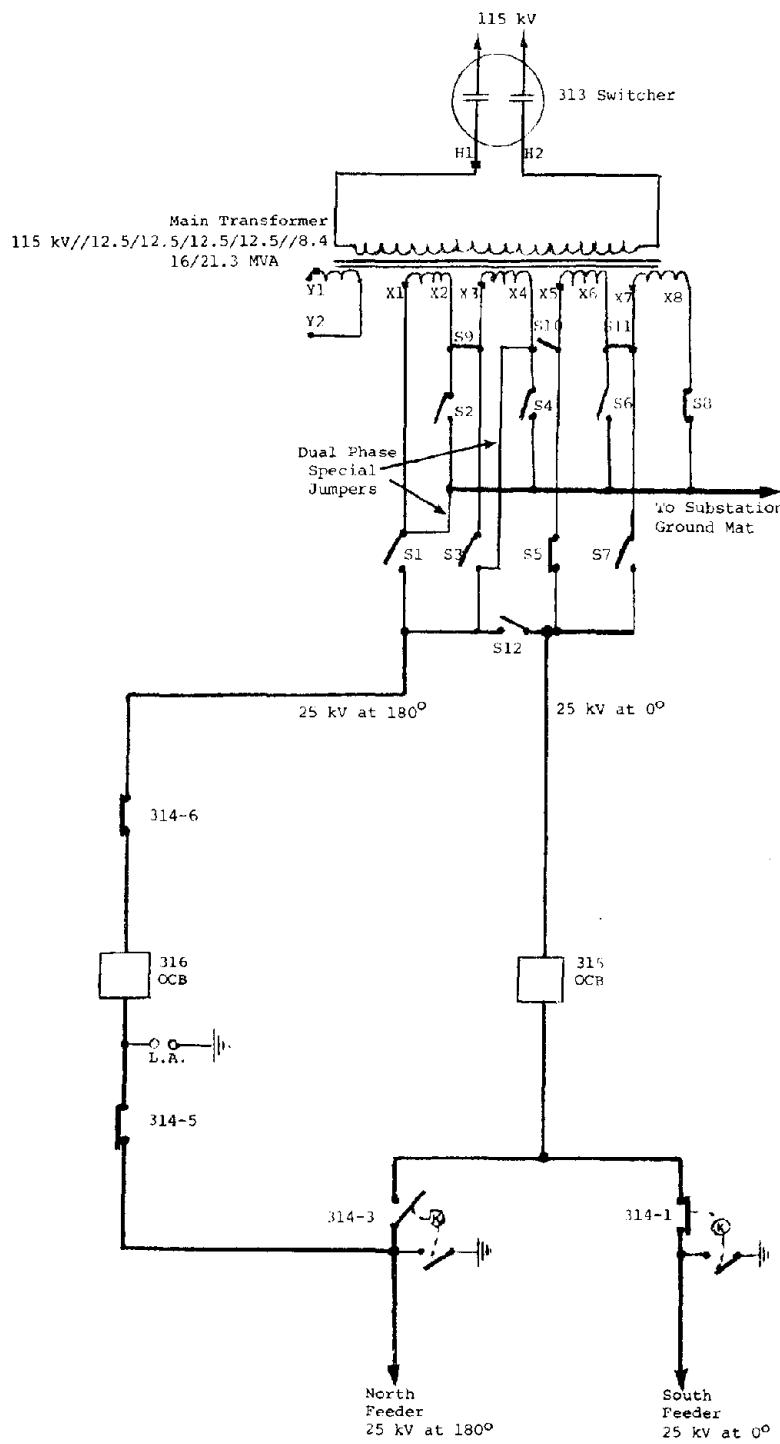
Thus two 25 kV out-of-phase RMS voltages were supplied to the two halves of the catenary system through the two OCB's (#315 and #316). This resulted in a 72 kV peak voltage across the phase breaks at each half cycle.

FIGURE 4-12. DUAL PHASE CONFIGURATION.

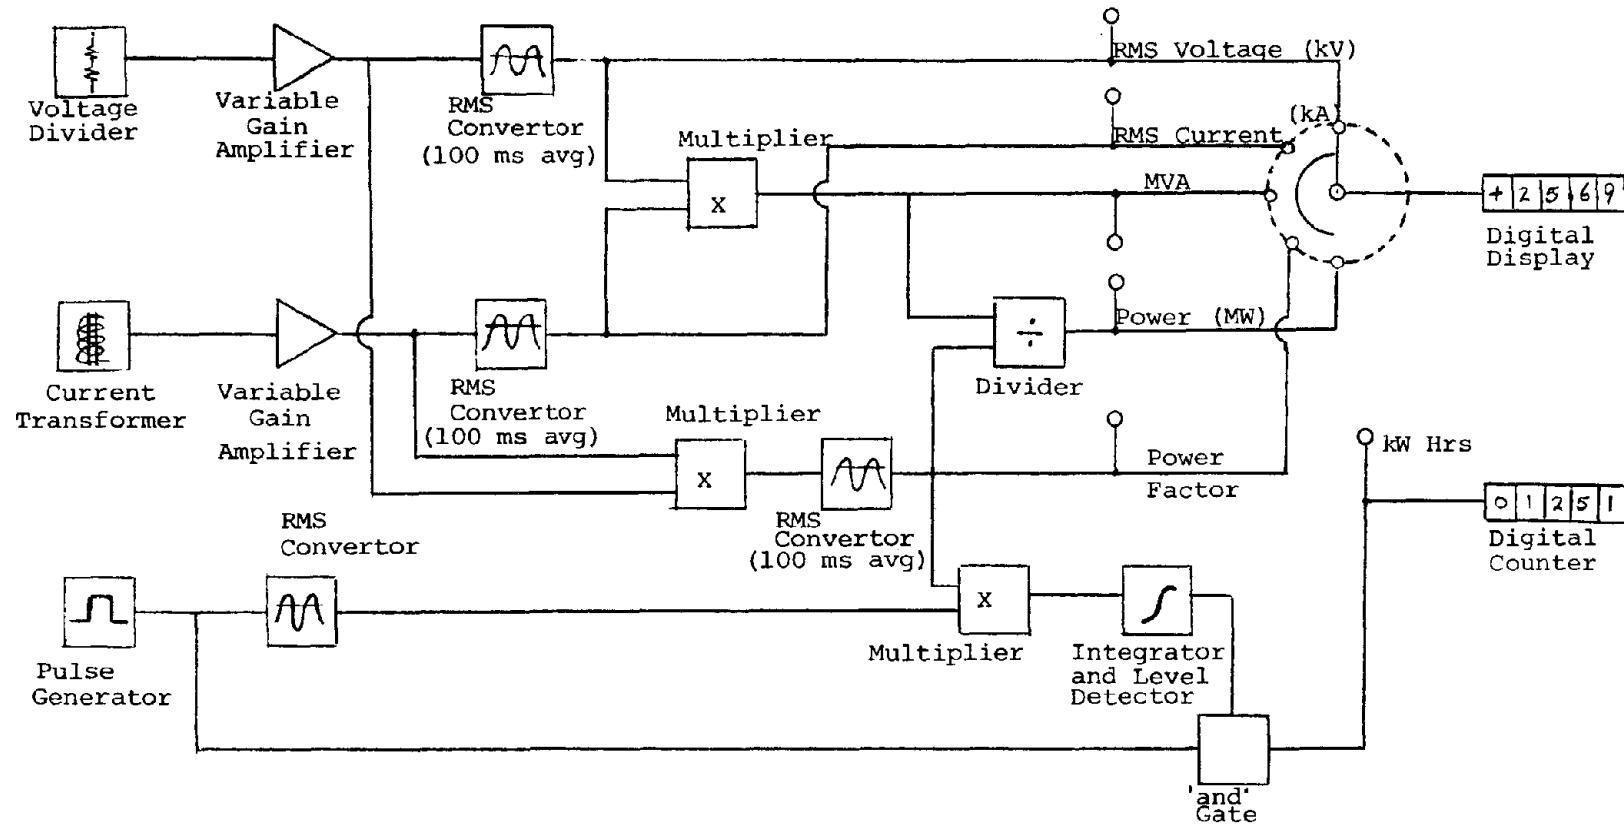
FIGURE 7-1. SCHEMATIC DIAGRAM OF THE POWER CONSUMPTION PROCESSOR.

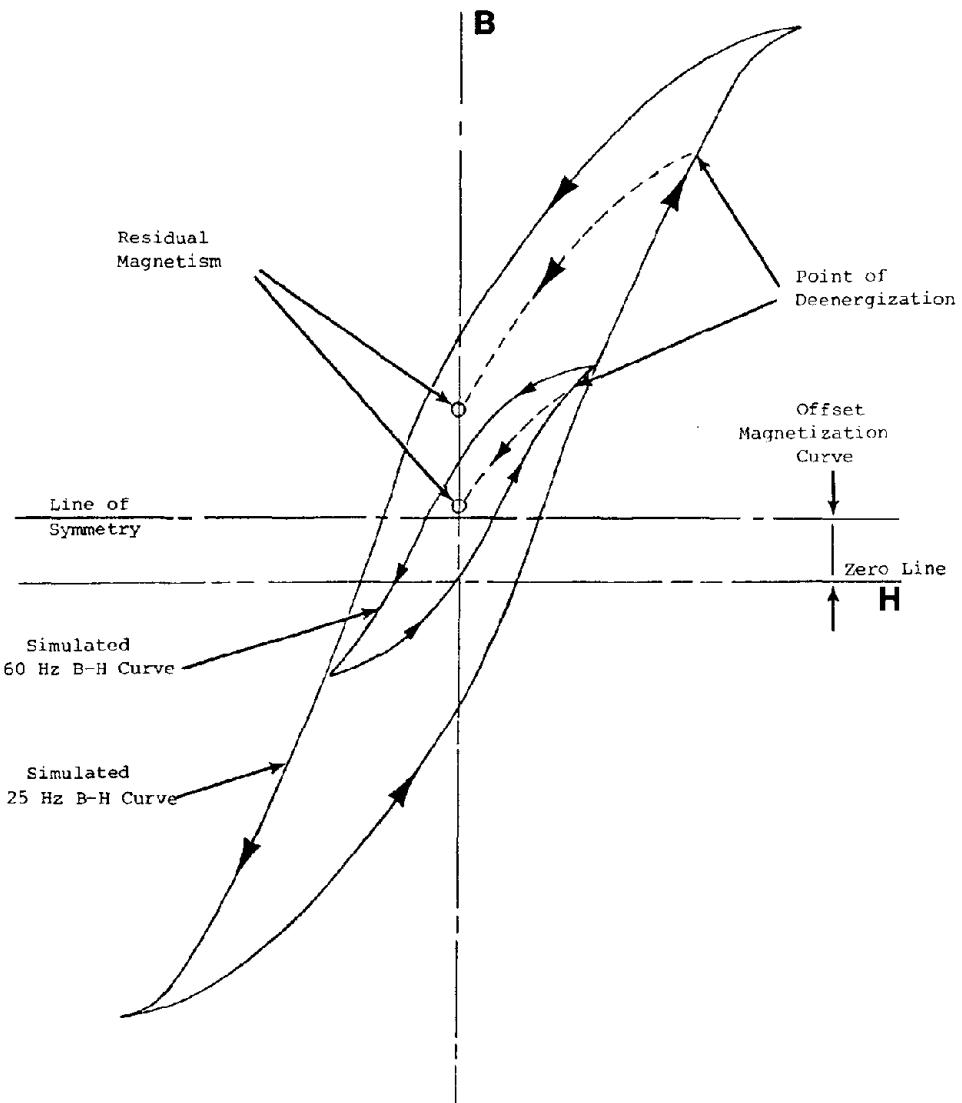
Upon re-energization a transient current (inrush) flows which attempts to return the core magnetization to the equivalent steady state value for the

FIGURE 7-2. TYPICAL B-H MAGNETIZATION CURVE FOR A TRACTION TRANSFORMER.

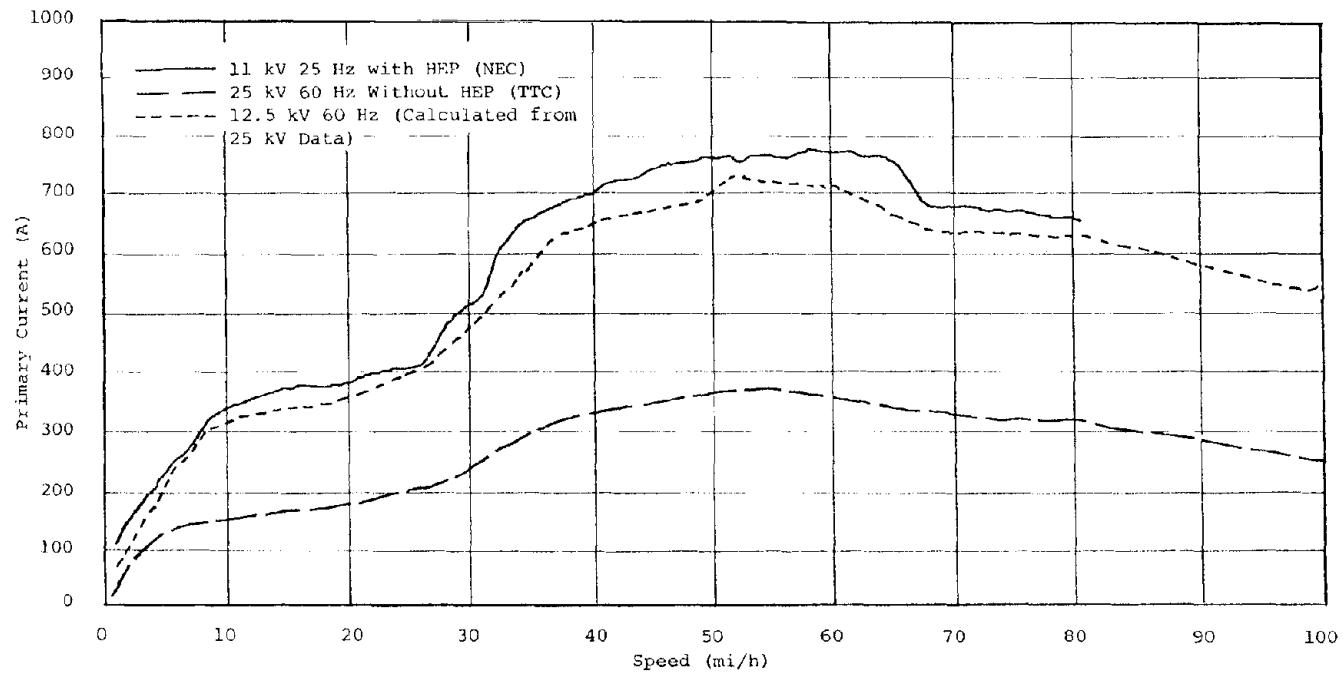
FIGURE 7-6. PANTOGRAPH CURRENT/SPEED CURVES FOR THE TTC AND NEC TESTS.

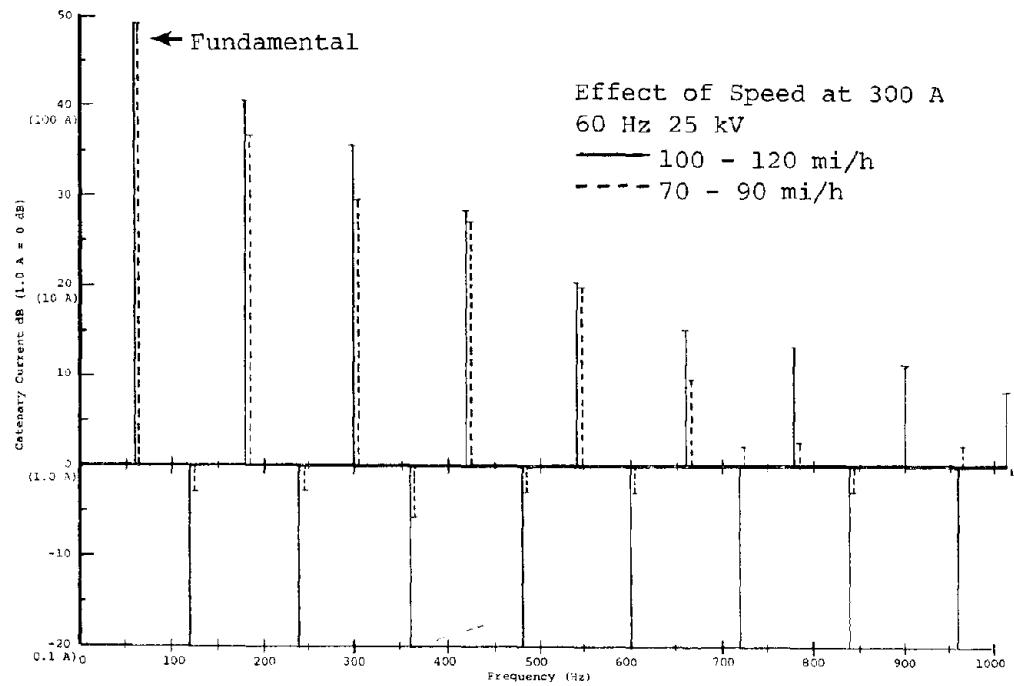
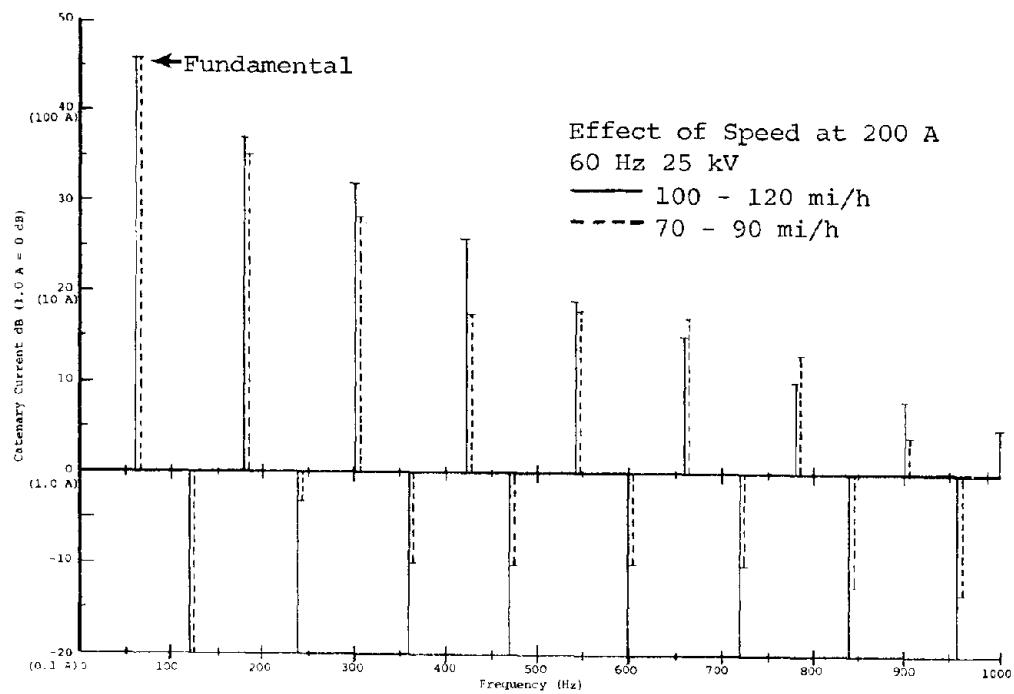
The catenary voltage and primary current data collected on board the locomotive during the phase break dual voltage tests (section 11.3) were later analyzed for harmonic content in order to augment the data collected in the

FIGURE 7-7. AEM-7 LOCOMOTIVE HARMONIC ANALYSIS.

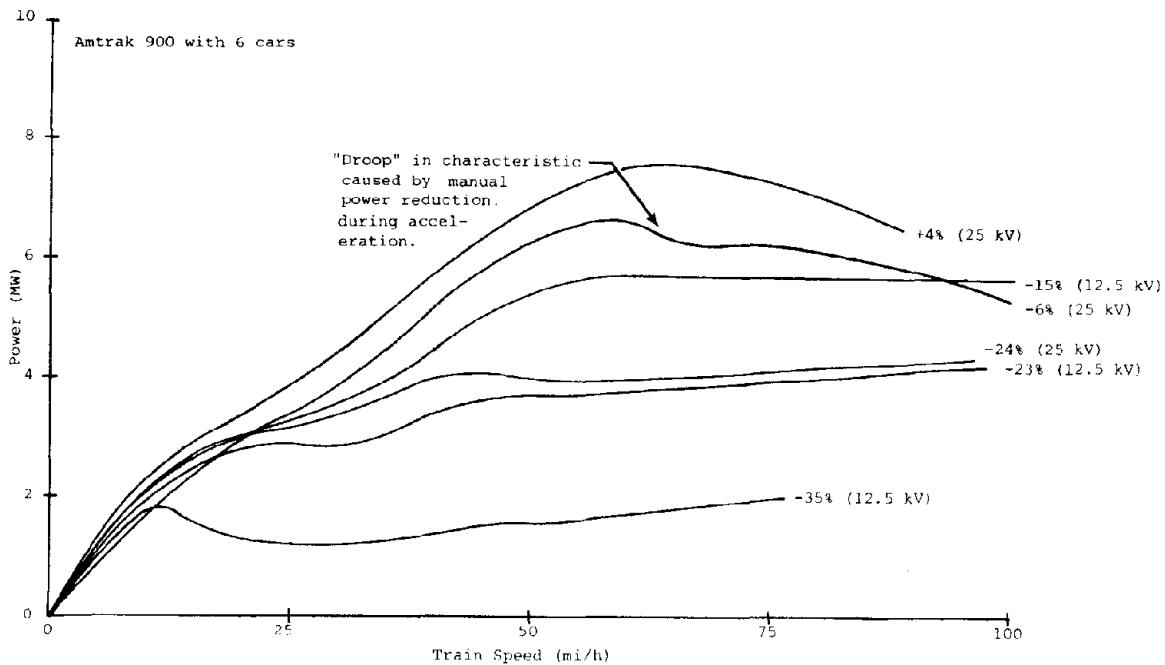
There were no operational failures at the +10%, Nominal, or -20% levels, but some traction power reduction was noted at -20%. At -35% severe traction power reduction was noted. In addition, the auxiliary voltage dropped to 375 V from the nominal 440 V, a reduction of 12.5%. This resulted in a slowdown of the blower fan motors for the cooling air systems and lockout of the locomotive battery charger.

FIGURE 7-11. POWER VS SPEED CURVES FOR THE AEM-7 LOCOMOTIVE AT THE CATENARY VOLTAGE LIMITS.

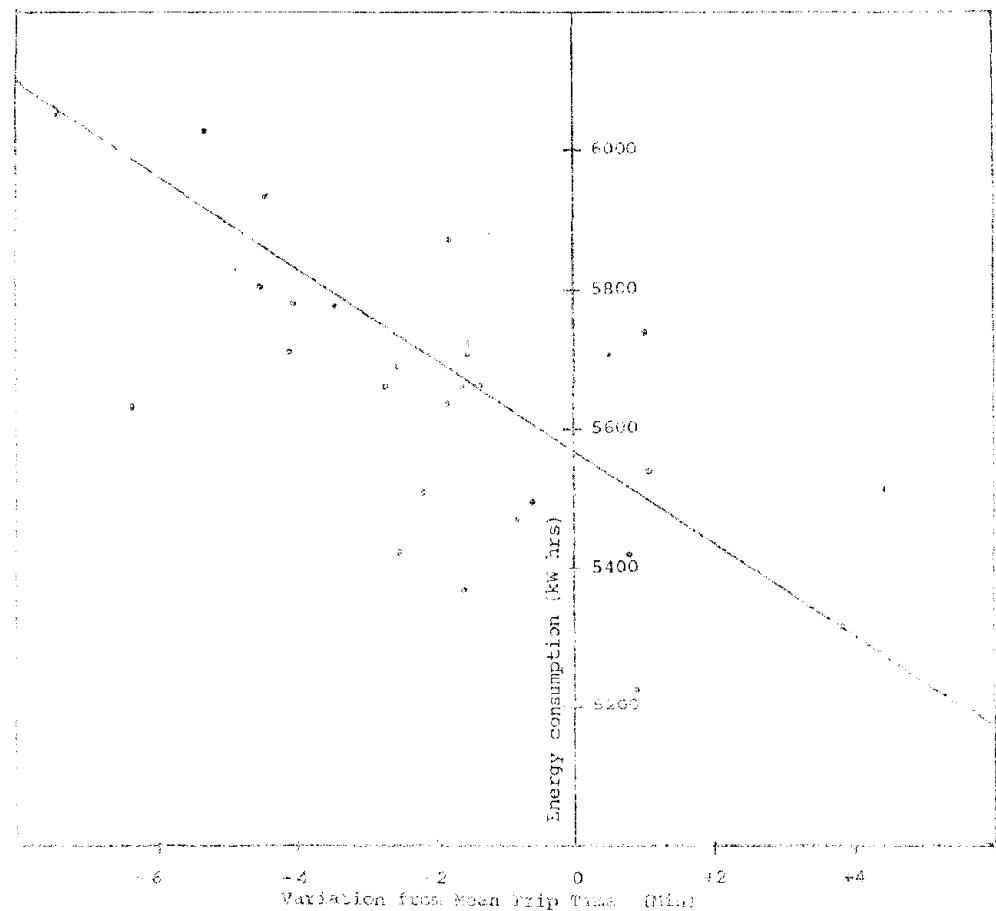
- c. The Effect of Journey Time on Energy Consumption. A section of the data for a series of six-car consist operations was plotted against the difference between measured and predicted profile journey times. This data is shown in Figure 8-9. The sensitivity of the energy consumption to accelerated journey time is smaller than expected, representing approximately 1.25% increase in energy consumed for each minute of journey time saved. However, the scatter on the energy consumption data caused by variations in train handling techniques, weather conditions, Head End Power loads, and direction of travel on the test track is +5%. It should be noted that, while the data as presented approximates a linear function for the small time segment taken, this does not necessarily represent the relationship between energy and journey time over a much larger time frame.

FIGURE 8-9. RELATIONSHIP BETWEEN ENERGY CONSUMPTION AND TRIP TIME

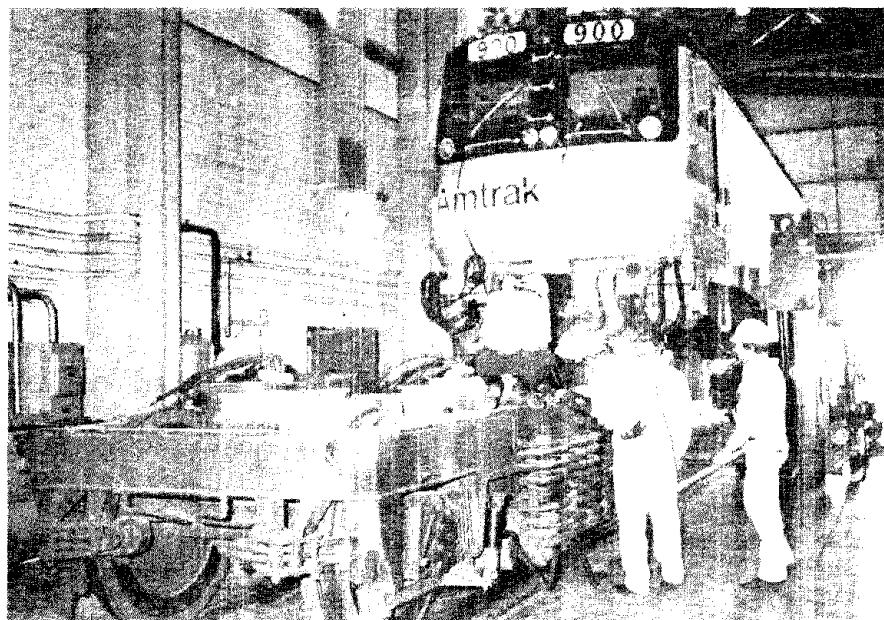
Locomotive and car detrucking is carried out on one of the three plain tracks using four 50-ton capacity electromechanical screw jacks, one at each corner of the vehicle. The jacks are electrically connected to provide simultaneous operation, and are designed to lift on the normal jacking pads supplied with the vehicle. Figure 8-10 shows the AEM-7 during a typical detrucking operation.

FIGURE 8-10. THE AEM-7 LOCOMOTIVE DETRUCKING OPERATION.

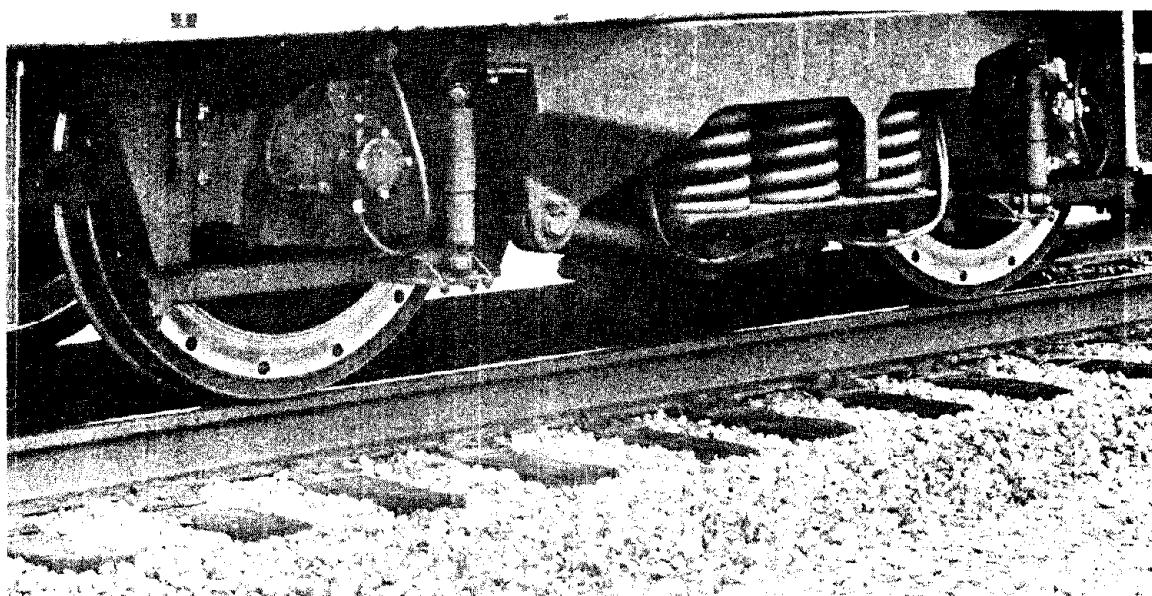
Much of the early unscheduled repair resulted from the failure of the yoke assembly structure and the yoke-to-body retaining bolts. The yoke assembly (Figure 8-11) forms the main interface between the top of the secondary vertical suspension springs and the locomotive body. It also acts as the body side anchor structure for the longitudinal traction rods and the secondary lateral and vertical shock absorbers. The yoke assembly is located onto the underside of the locomotive underframe by means of two 3 inch diameter (Figure 8-12) dowel pins, which are designed to react the loads between the yoke and body. The yoke is retained on the dowel by means of 7/8" diameter bolts, designed only to support the assembly for lifting the vehicle during a derailment recovery operation.

FIGURE 8-11. THE AEM-7 YOKE ASSEMBLY.

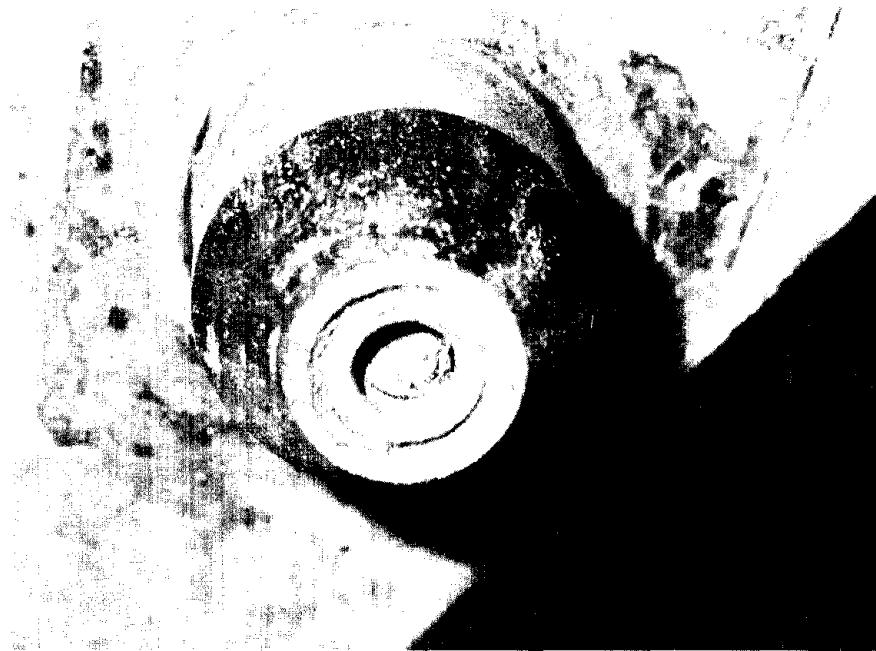
FIGURE 8-12. THE YOKE ASSEMBLY DOWEL PIN.

In May 1980 the four yoke assembly fabrications were replaced at the request of General Motors due to faulty manufacture of the original units.

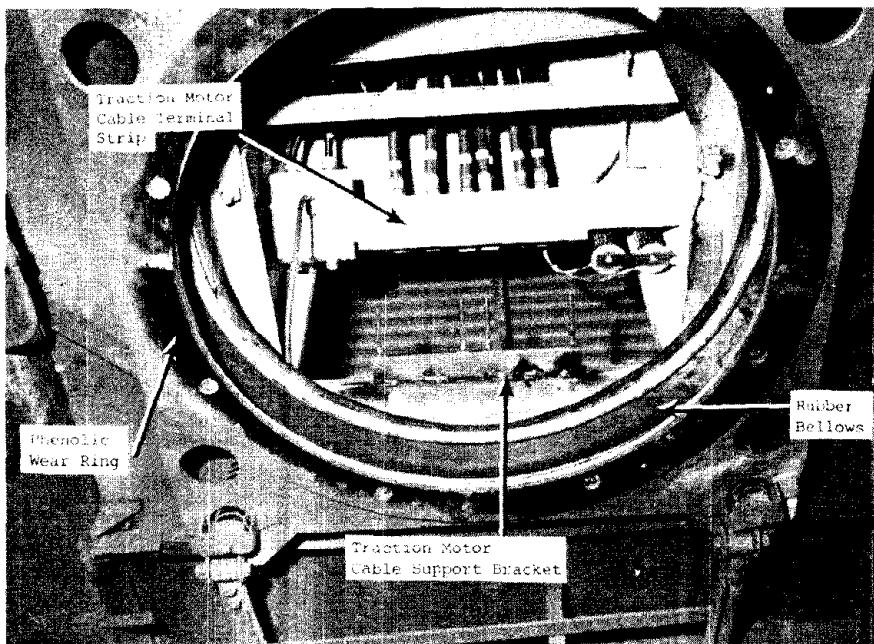
The continuity between the top of the traction motor and the underside of the locomotive body is maintained by a flexible bellows attached to the body to allow for minor truck movements, with a sliding contact surface on the traction motor to allow for major truck movements. The sliding contact surface consists of a phenolic ring riveted to the underside of the bellows (see Figure 8-13).

FIGURE 8-13. THE TRACTION MOTOR BELLows.

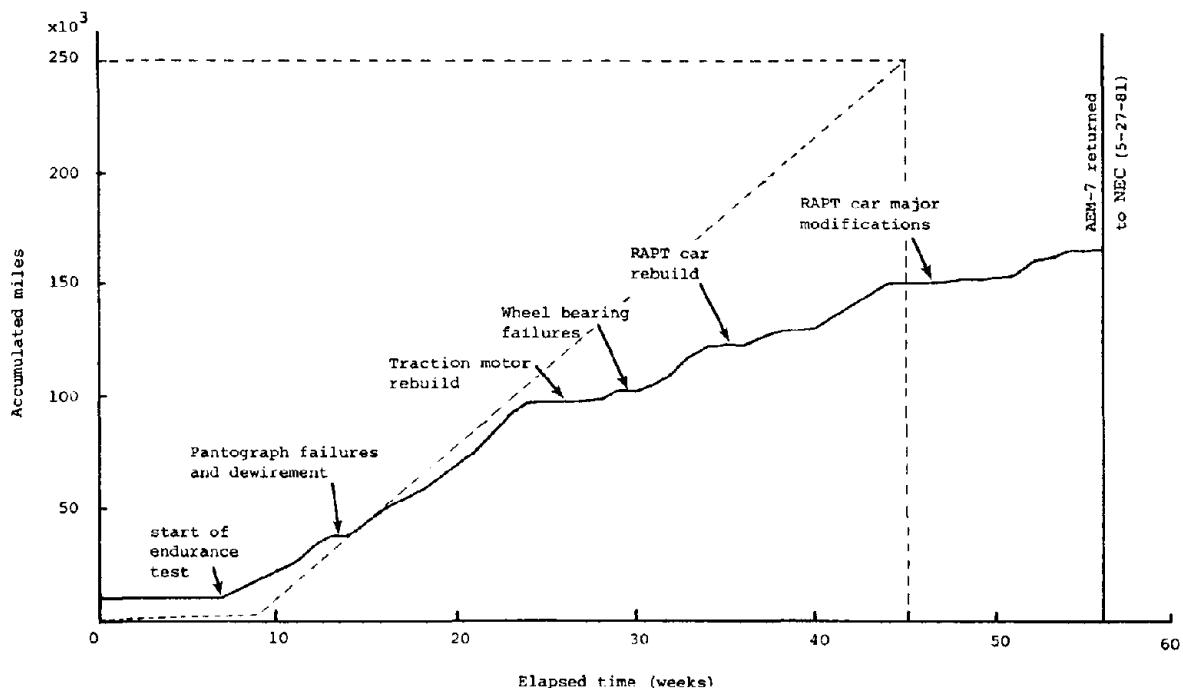
A time history of the mileage accumulation rate is presented in Figure 8-14. Superimposed is the original target of 250,000 miles in 36 weeks.

FIGURE 8-14. MILEAGE ACCUMULATION RATE FOR AMTRAK 900 AT THE TTC.

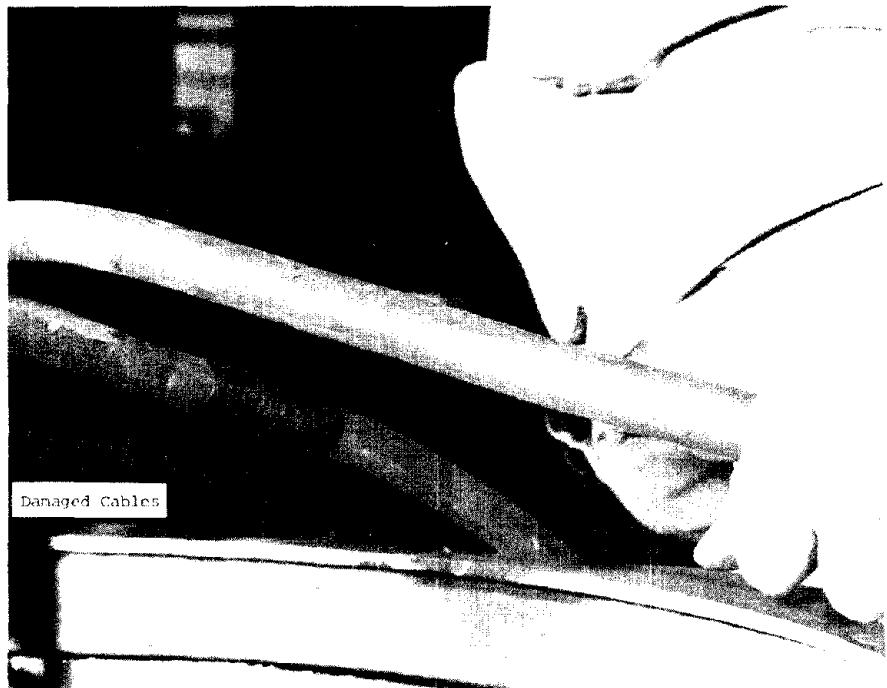
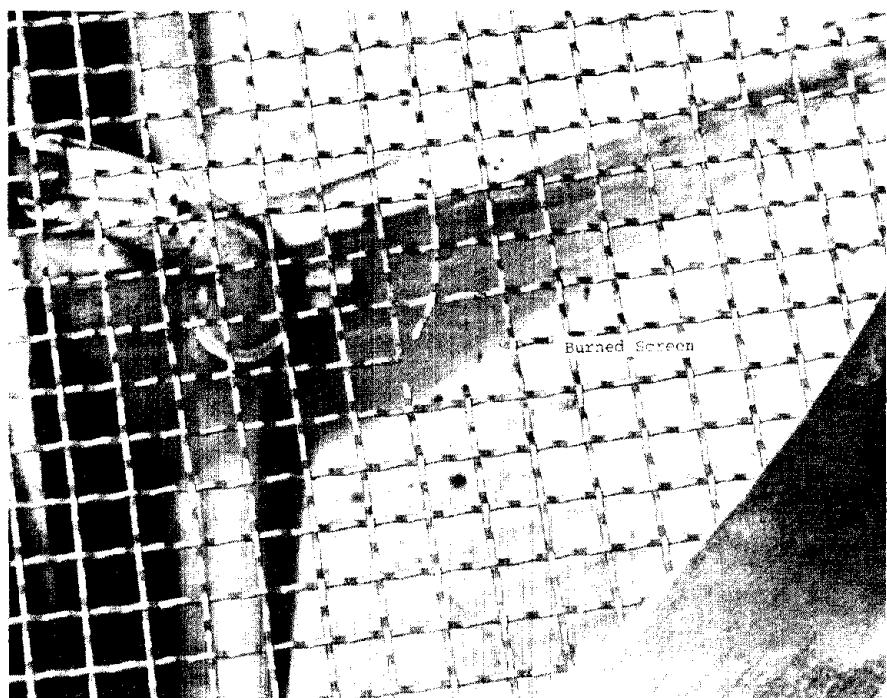
It was later found that due to a design oversight the upper cabinet was also sealed and was consequently pressured by the traction motor cooling supply. A vent to atmosphere was provided in the upper cabinet and the pressure switch system functioned normally.

FIGURE 9-2. TRACTION MOTOR #4 CABLE DAMAGE.

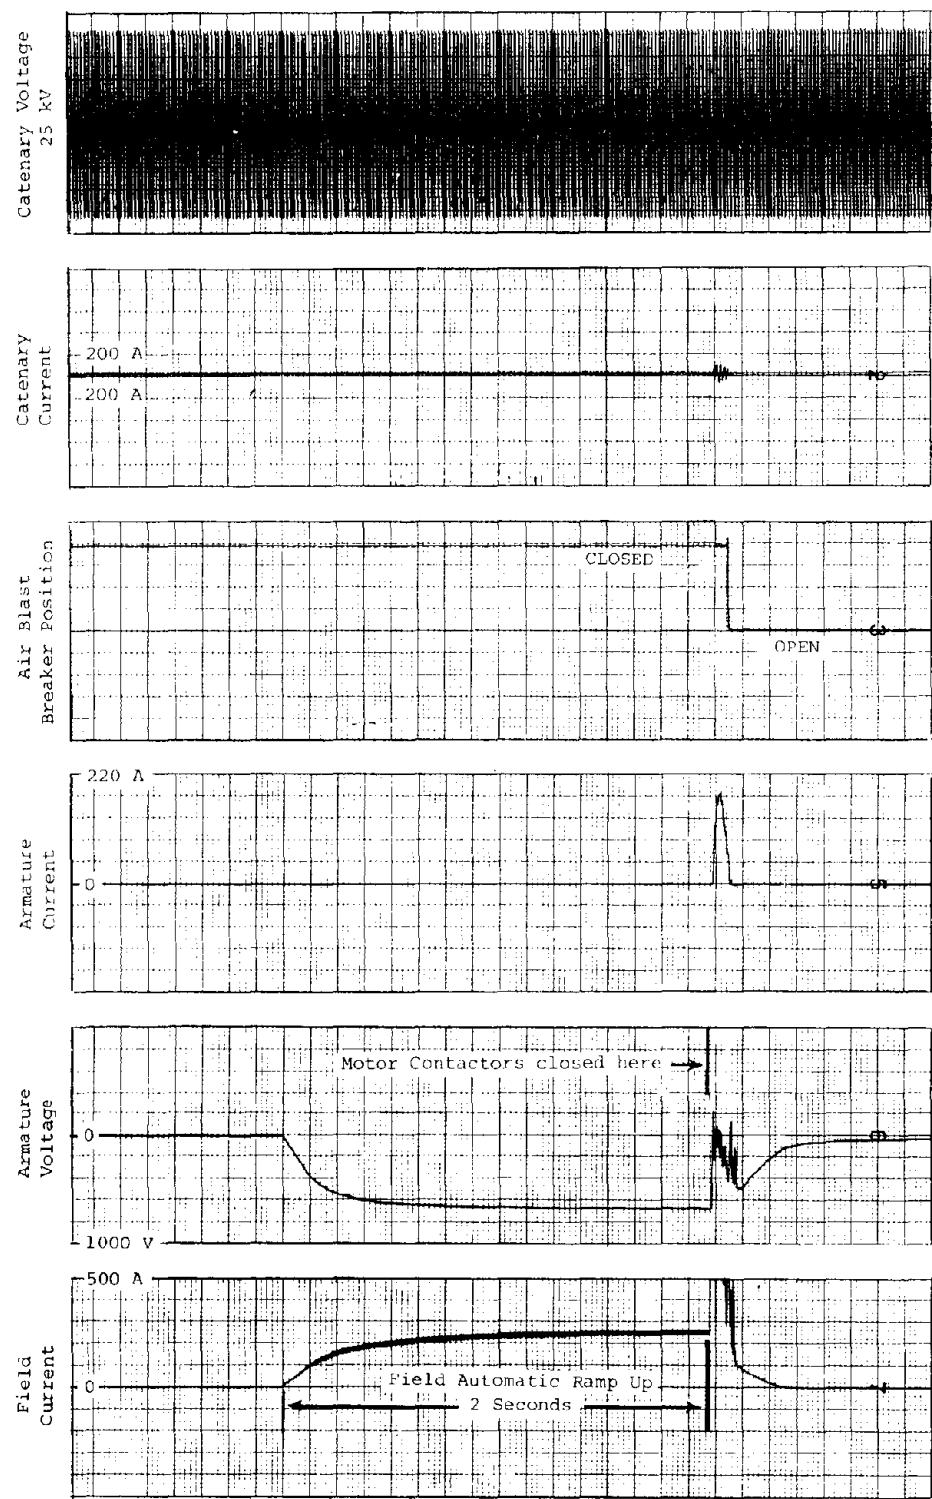
FIGURE 9-3. TRACTION MOTOR FLASHOVER (CURRENT AND VOLTAGE DATA).

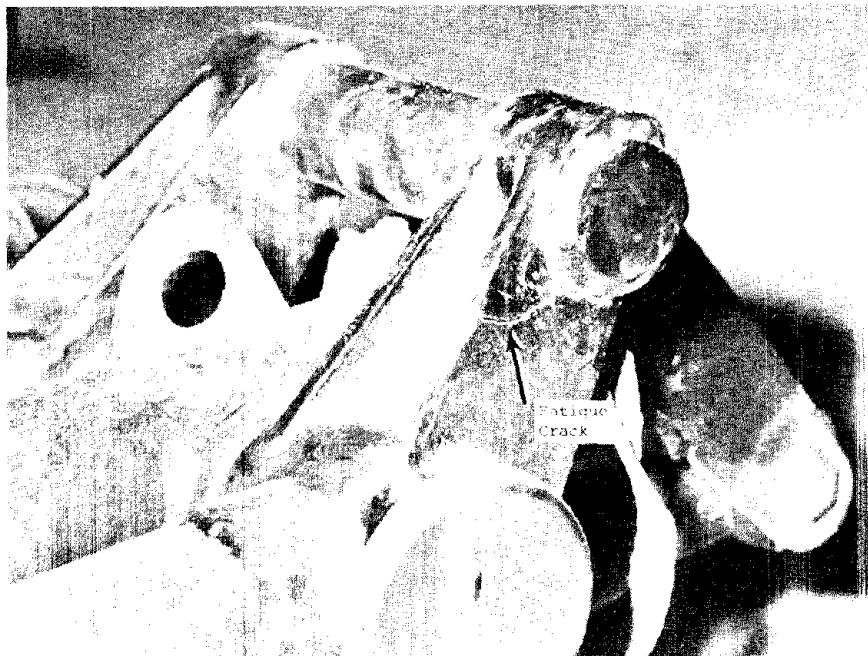
During a routine inspection of the 'B' end pantograph (Type DS 11) it was found that the main joint casting was completely cracked through, (see Figure 10-3). The structural integrity of the knuckle was retained only by the bearing shaft, which was held in place by the retaining nuts. Fortunately the fault was discovered before more serious damage was sustained.

FIGURE 10-3. FAIVELEY DS 11 PANTOGRAPH FAILED KNUCKLE ASSEMBLY.

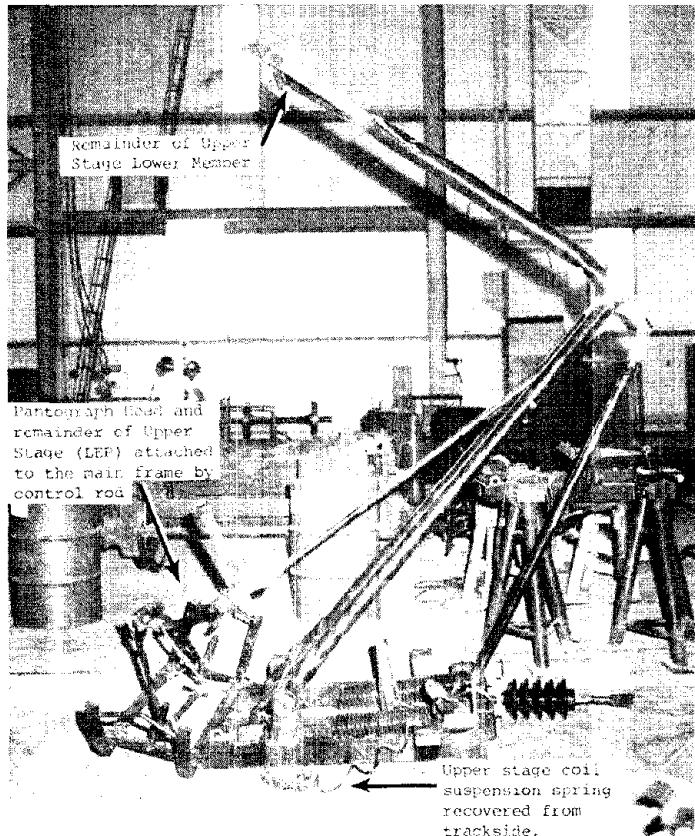
Inspection of the catenary showed there to be extensive damage between stations R21 clockwise to R32. Inspection of the pantograph showed that the collector shoe and upper member of the LEP were still attached to the GEP by means of the control rod (Figure 10-4), and that both members of the GEP were severely distorted (see Figure 10-5). Very little remained of the aluminum casting forming the lower member of the LEP (Figure 10-5) or the LEP suspension (Figure 10-4). This was later found at the trackside.

FIGURE 10-4. FAIVELEY DS 11 PANTOGRAPH AFTER THE DEWIREMENT.

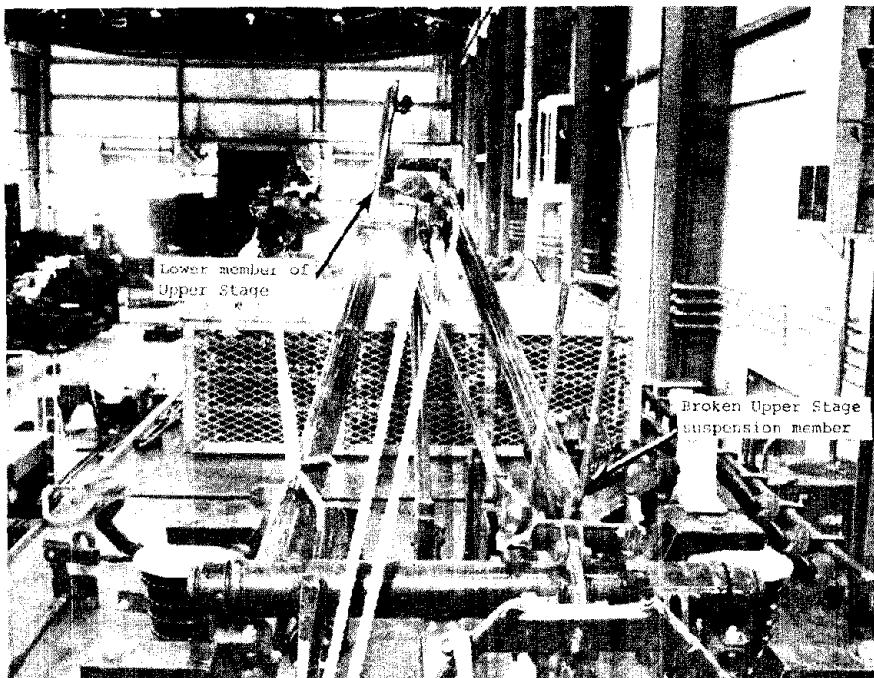
FIGURE 10-5. THE DAMAGED MAIN FRAME (GEP).

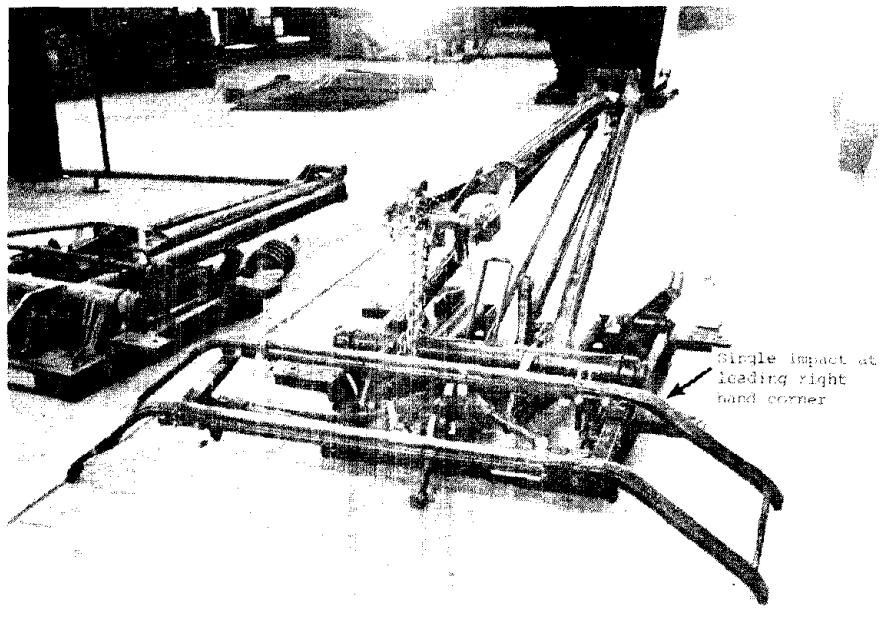
- The pantograph was known to be in good condition at the last pass over the Balfour Beatty phase break as witnessed by trackside observers.
- The only sign of damage to the collector shoe was a single impact (Figure 10-6) at the leading right hand corner looking in the direction of travel. This indicated that the wire did not come off the end of the horn due to track or catenary misalignment.

FIGURE 10-6. IMPACT DAMAGE ON THE PANTOGRAPH HEAD.

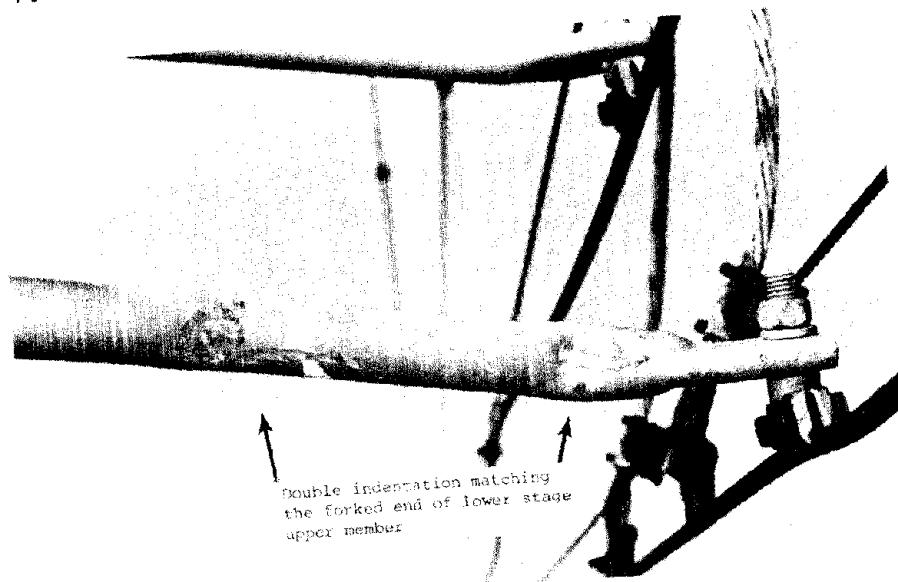
| STRUCTURE | LOCATION | COMMENTS |
|---|---|---|
| 12/31 | R21+381 | Bent registration arm (Figure 10-8) the first sign of heavy catenary damage. The double indentation in the registration arm matched the spacing of the forked end on the upper member of the GEP. |

FIGURE 10-8. DOUBLE INDENTATIONS ON THE REGISTRATION ARM AT STRUCTURE 12/31.

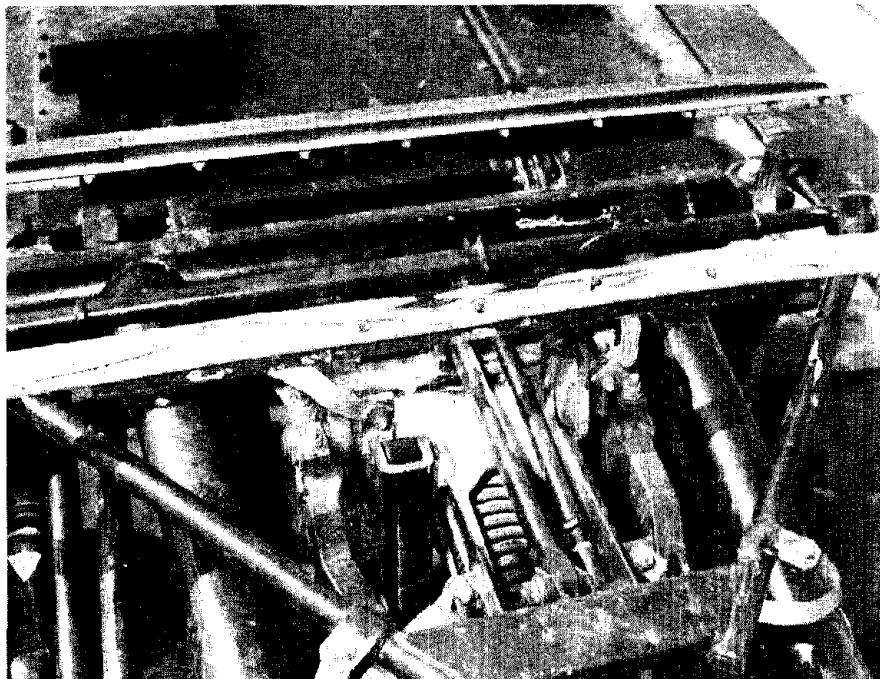
- e. Pantograph Head Failure. It is almost certain that the pantograph head failure started with the loss of a carbon segment from the lead collector strip. The resultant gap was rapidly widened due to removal of the remaining carbons in the lead strip by the contact wire and phase breaks. Once the carbons were removed, the support structure became an open channel section with little resistance to longitudinal forces generated by motion along the contact wire and phase breaks. After a short time, the damaged lead collector strip collapsed in the vertical direction, whereupon the pantograph rode on the trailing collector strip only. Before final collapse and probable dewirement, the damaged unit was discovered. Figure 10-14 shows the damaged head before it was removed from the pantograph.

FIGURE 10-14, GENERAL VIEW OF THE FAIVELEY 'LIGHTWEIGHT' HEAD DAMAGE.

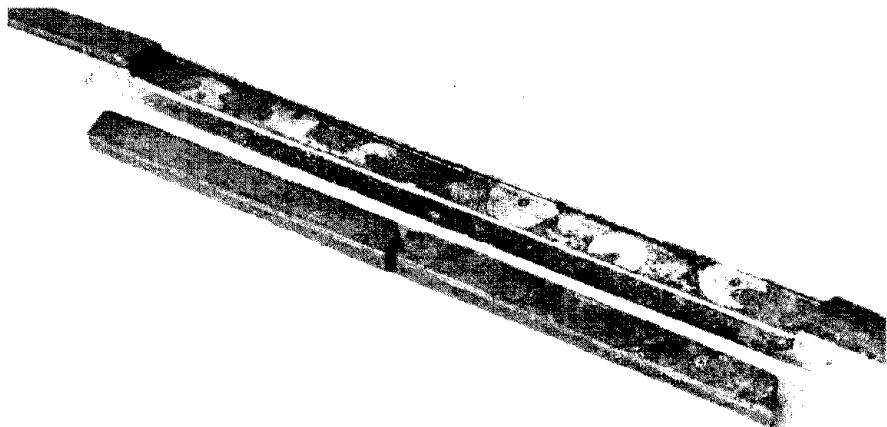
- Loose carbon sections caused by the use of an unsuccessful crimping arrangement for holding the carbons. The resulting poor electrical contact between the carbon sections and aluminum extrusion caused electrical erosion of the aluminum, see Figure 10-23. This problem was overcome by adopting the conventional clipping arrangement similar to that shown in Figure 10-17 and by using conducting graphite grease under the carbons.

FIGURE 10-23. ELECTRICAL EROSION UNDER THE CRIMPED CARBON SEGMENTS.

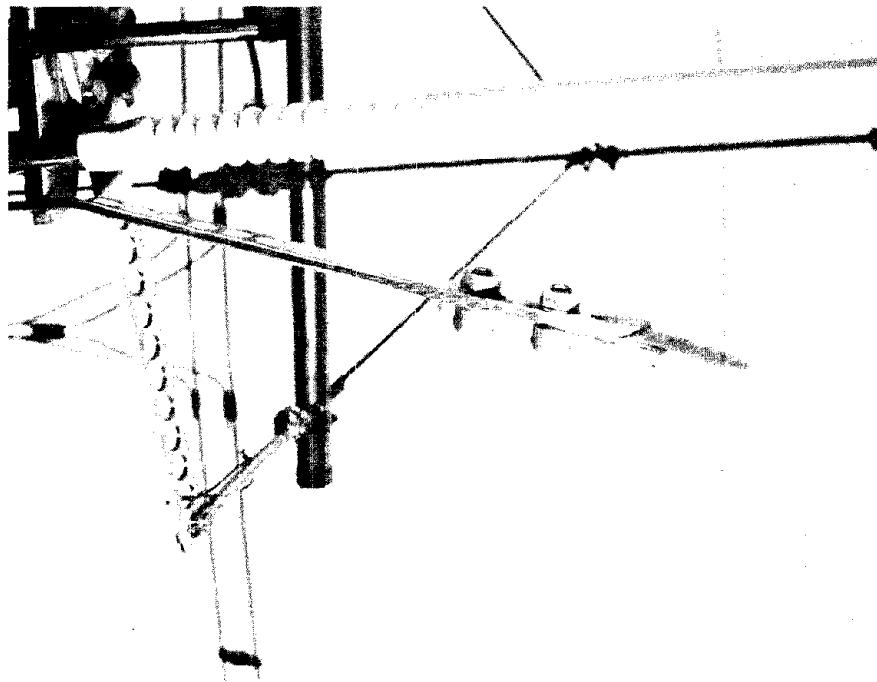
After two days of operations, damage to pantograph carbons began to appear. Inspection of the phase break showed there to be severe damage to the approach skids (Figure 11.1), uneven wear on the teflon rods, and evidence of wear on the rod end skids. The contact wire height of the two spans on either side of the phase break was carefully checked. It was found that the phase break center was four inches higher than the contact wire at the adjacent support structures. This represented a wire gradient of 1:300 (0.33%) which is 2.5 times the Task 16 recommended maximum.

Figure 11-1. DAMAGED SKIDS ON THE KUPLER PHASE BREAK.

To accommodate the new method of operation, the phase break was much longer than conventional units. Consequently, extra care was needed in the initial set up. Immediately after installation of the original phase break extensive pantograph carbon damage was sustained until the phase break was carefully readjusted.

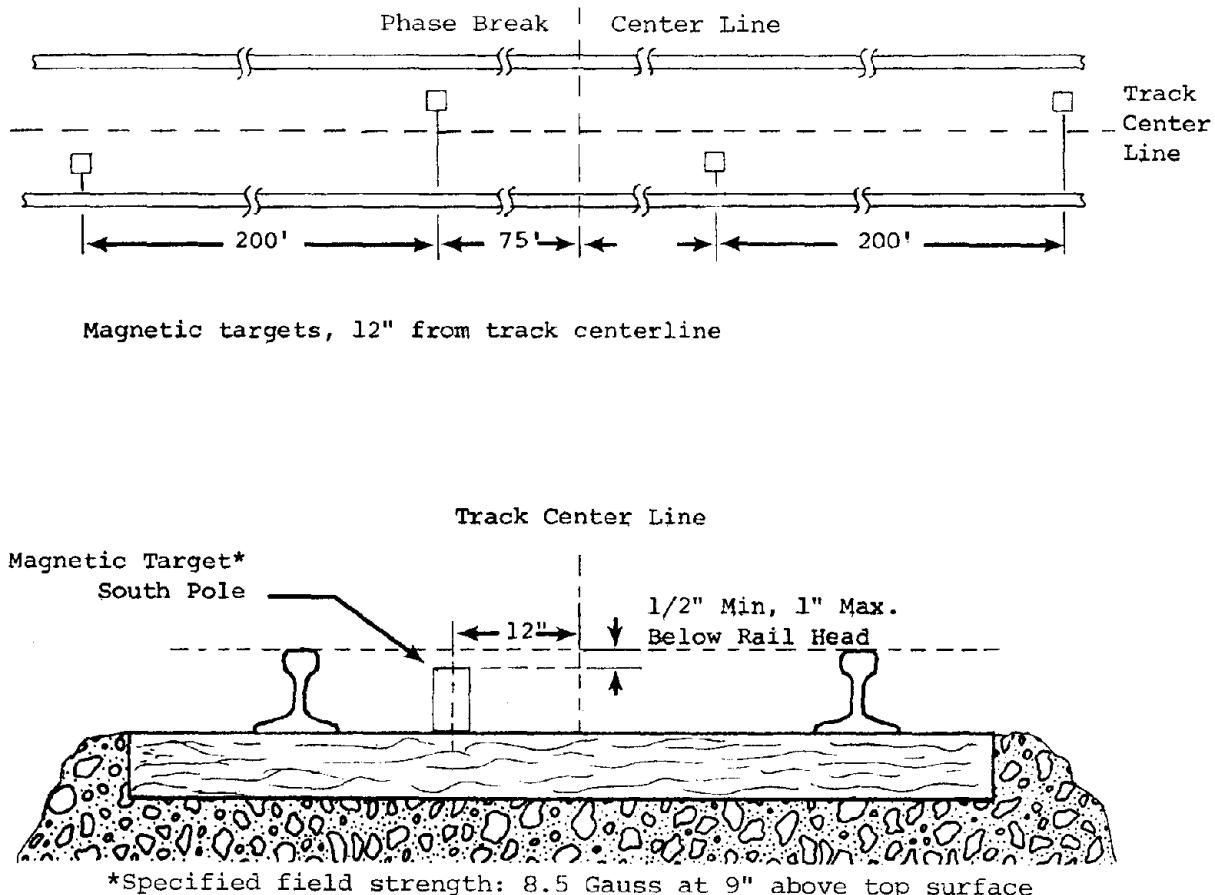
The magnetic target spacing was originally specified in the report of a study conducted by Louis T. Klauder and Associates.¹⁵ Slight modifications to the along-track spacings were found necessary for AEM-7 operation, and the final arrangement is shown in Figure 11-2.

FIGURE 11-2. FOUR MAGNET AUTOMATIC PHASE BREAK CONTROL SYSTEM - TTC TARGET LAYOUT.
