AEM-7

ELECTRIC LOCOMOTIVE TESTING AT THE TRANSPORTATION TEST CENTER

| 4. Title and Subtitle AEM-7 Electric Locomotive Testing at the Transportation Test Center | | 5. Report Date | |
| 16. Abstract This report describes the tests conducted at the Transportation Test Center (TTC) on the first production AEM-7 locomotive, AMTRAK 900. These tests, which were conducted between April 1980 and May 1981, were to evaluate the locomotive characteristics on 25 kV 60 Hz and 12.5 kV 60 Hz voltage supplies, and to examine the locomotive reliability under high speed operating conditions. The accelerated Northeast Corridor (NEC) schedules (2 hrs 40 min from New York to Washington, D.C., and 3 hrs 40 min from Boston to New York) were used for the Endurance Test Operations. A route simulator programmed with the Train Performance Calculation (TPC) predicted speed/time profile was used to prompt the locomotive engineer. A train consist of between four and eight cars was used for the test. The actual trip times and energy consumed were measured. Major problems were experienced with the locomotive pantographs, truck assemblies wheel bearings, traction motors, and ground brush assemblies. A new phase

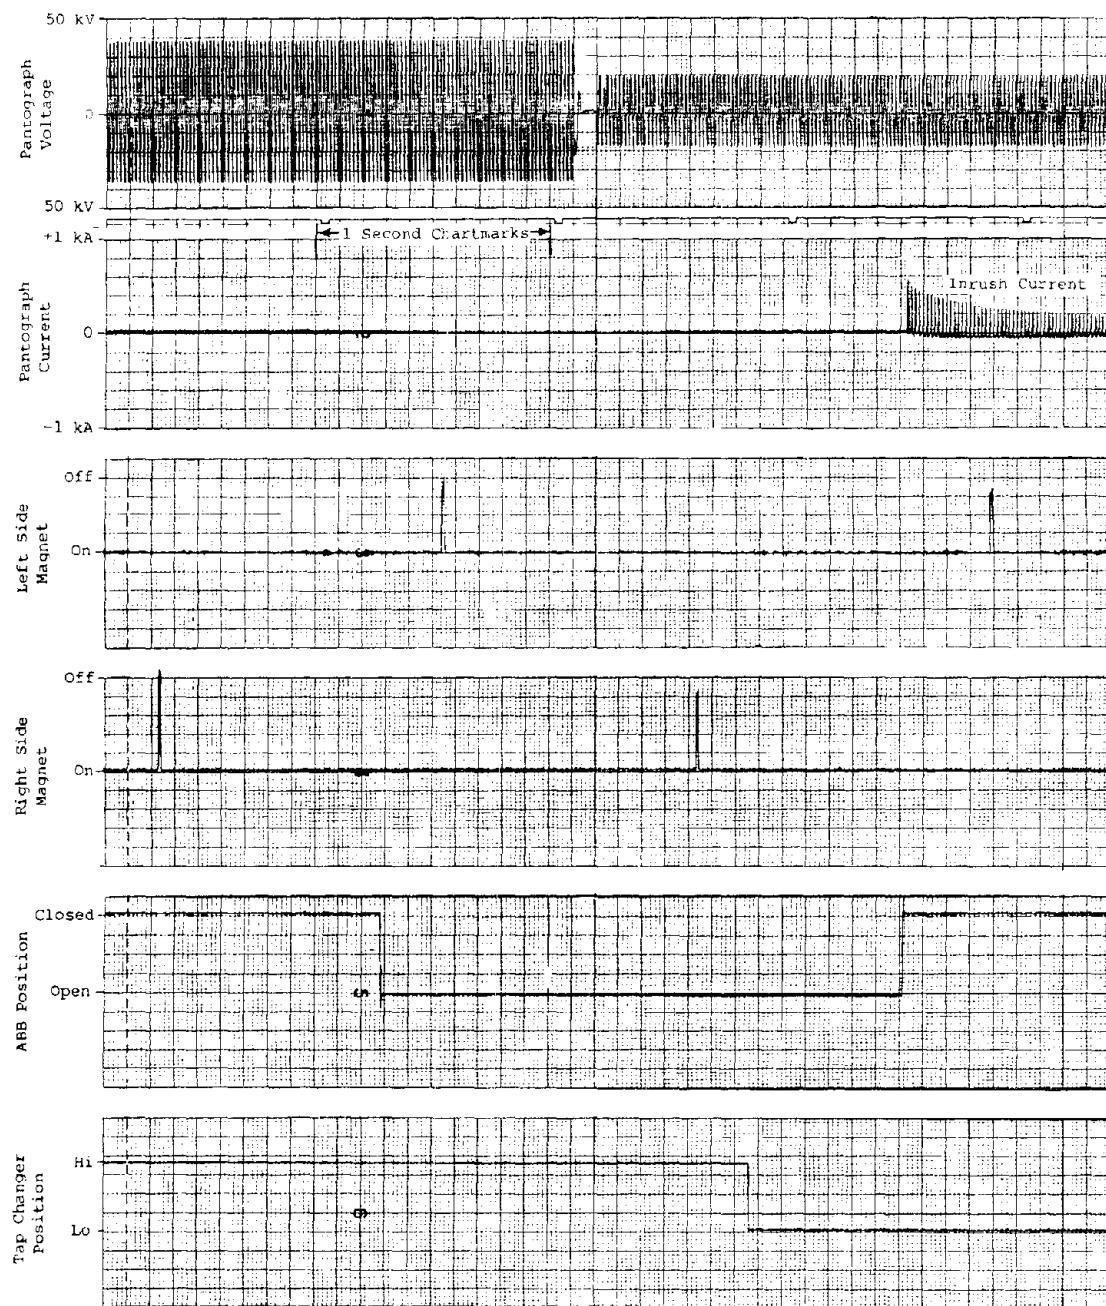
FIGURE 11-3. FOUR MAGNET CONTROL SEQUENCE AT A SPEED OF 120 MI/H.

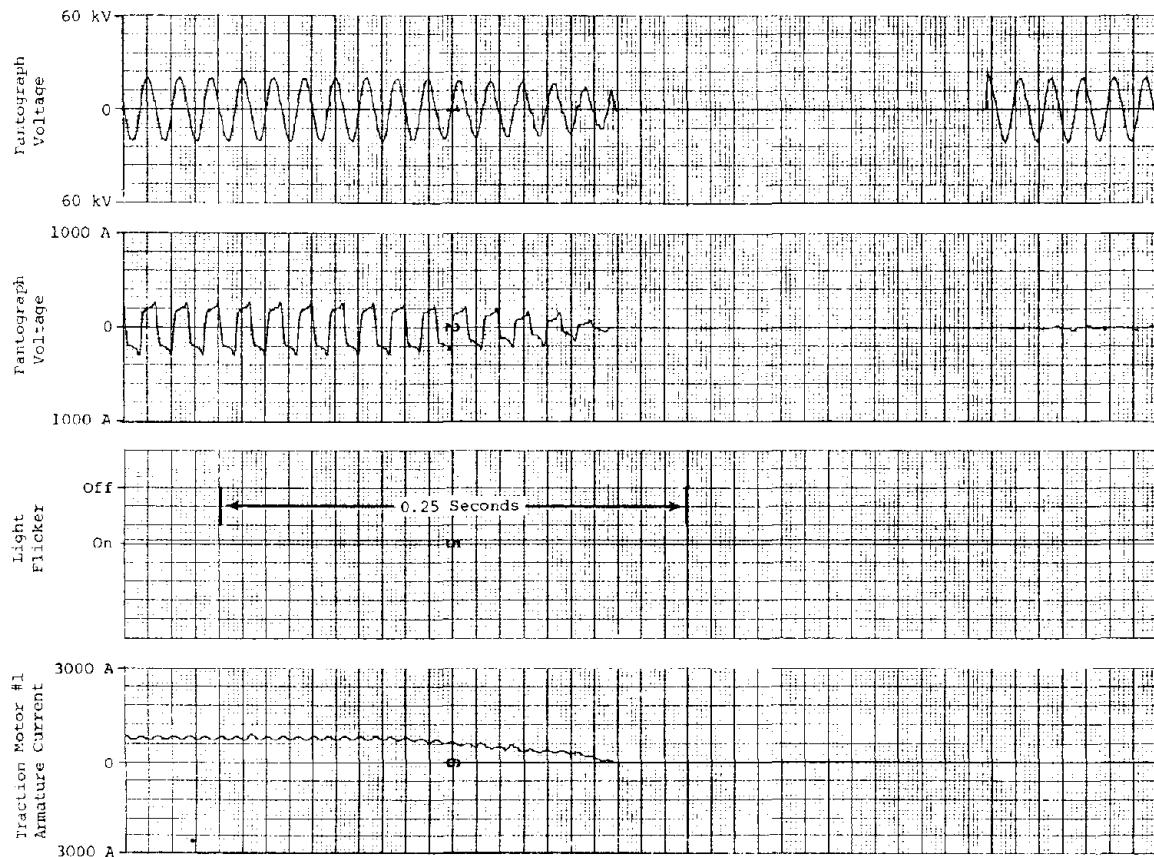
to function as long as the voltage remains above the -35% nominal level at which point the system switches off. The normal automatic power reduction system also functions to ramp the traction power off with decreasing voltage as can be seen in Figure 11-4.

FIGURE 11-4. TRACTION MOTOR CLOSE DOWN AT THE PHASE BREAK.

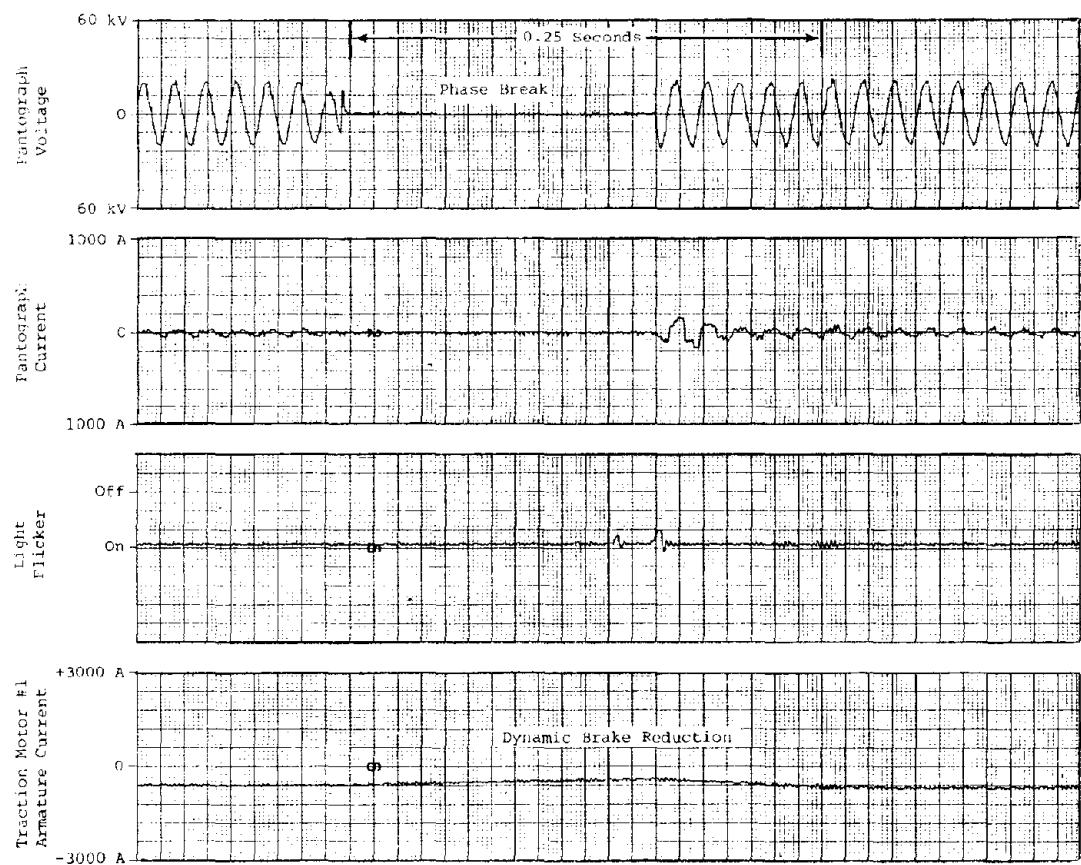
The dynamic braking system continues to function through the phase break, although some reduction in braking effort is noted, (Figure 11-5). This is not surprising since the dynamic braking armature current is independent of the pantograph. The dynamic braking field current is dependent on the pantograph supply, but is sustained by the field convertor.

FIGURE 11-5. DYNAMIC BRAKE REACTION TO THE PHASE BREAK.

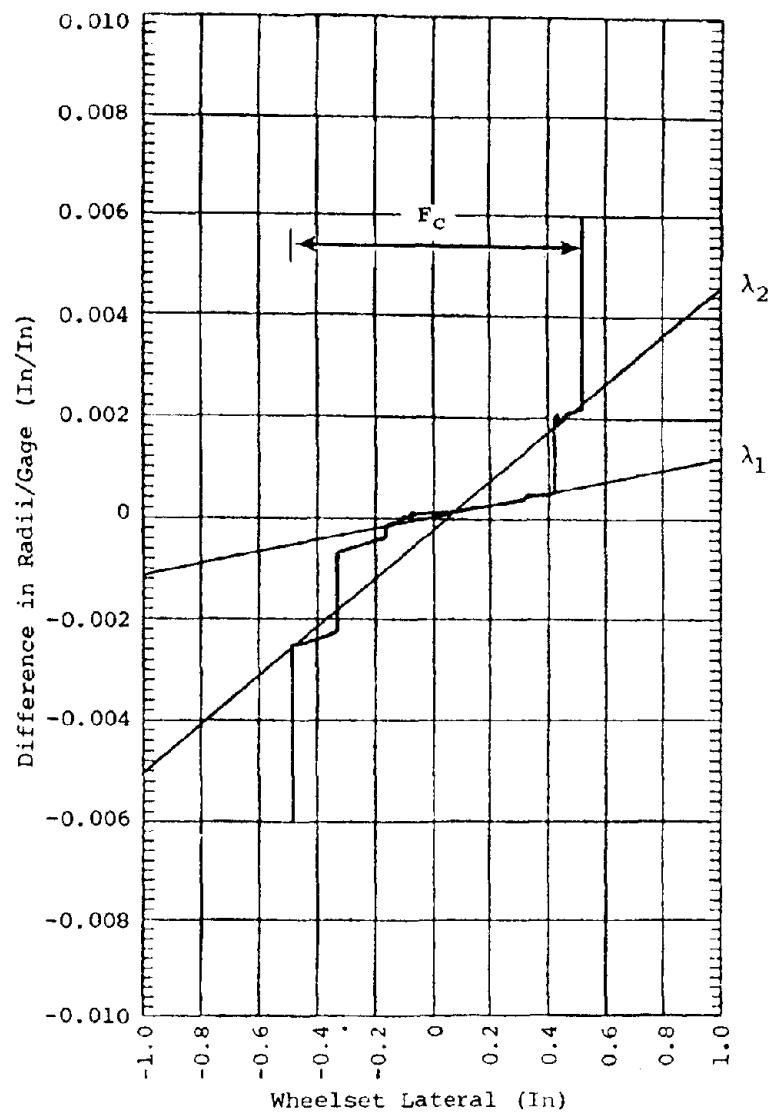
FIGURE 12-15. THE EFFECTIVE CONICITY OF A WORN WHEEL.

The wheel wear data indicated that the wheel flanges wore very rapidly over the first 2,000 miles of running. Thereafter, the rate of wear slowed down. It was the initial wear that developed the effective conicity to generate the kinematic frequency motion of the trucks on curves. The wheel wear rates were considered unique to operations on the RTT due to the uniform rail profile and high proportion of curved track, but the modest conicity developed by wheel wear could easily be repeated on the NEC.

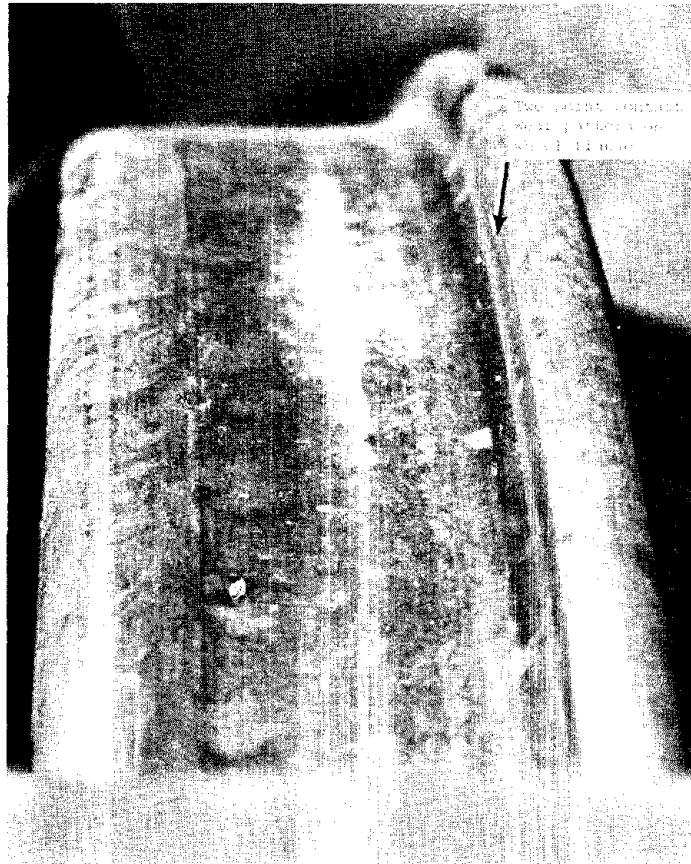
FIGURE 12-23. VIEW OF THE INITIAL RAPID FLANGE WEAR PATTERN.

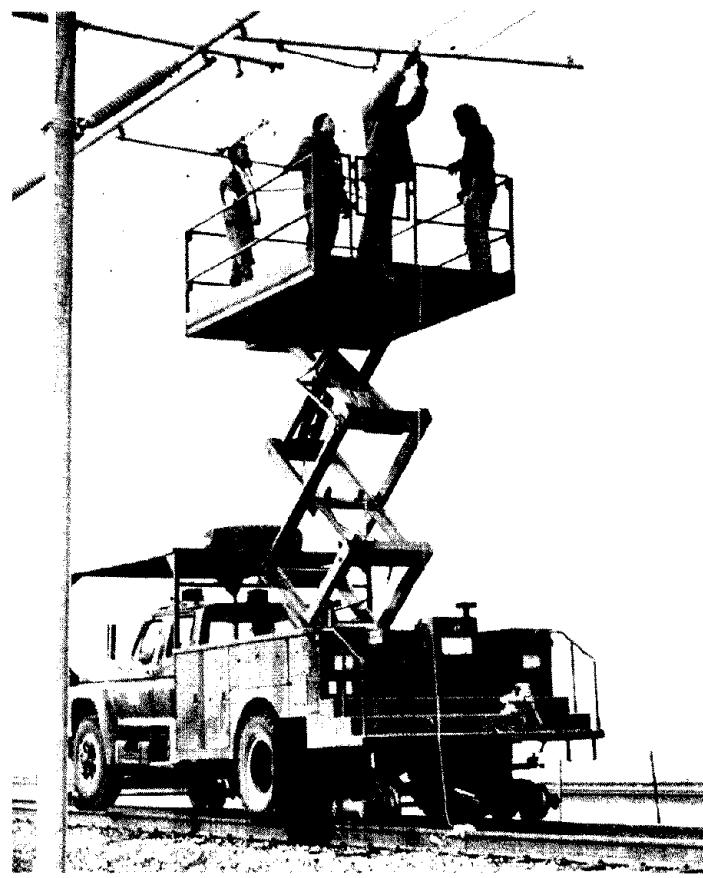
FIGURE 17-1. OVERHEAD CATENARY MAINTENANCE VEHICLE.

As part of the RTT catenary construction and commissioning program the TTC was provided with a road/rail vehicle (Figure 17-1) designed specifically for catenary maintenance. This vehicle, which was one of eighteen procured by NECPO for NEC catenary maintenance, has proved to be extremely useful for TTC catenary maintenance purposes.

The maintenance vehicle converts from a standard four wheel road vehicle to a rail vehicle by means of hydraulically applied rail trucks at the front

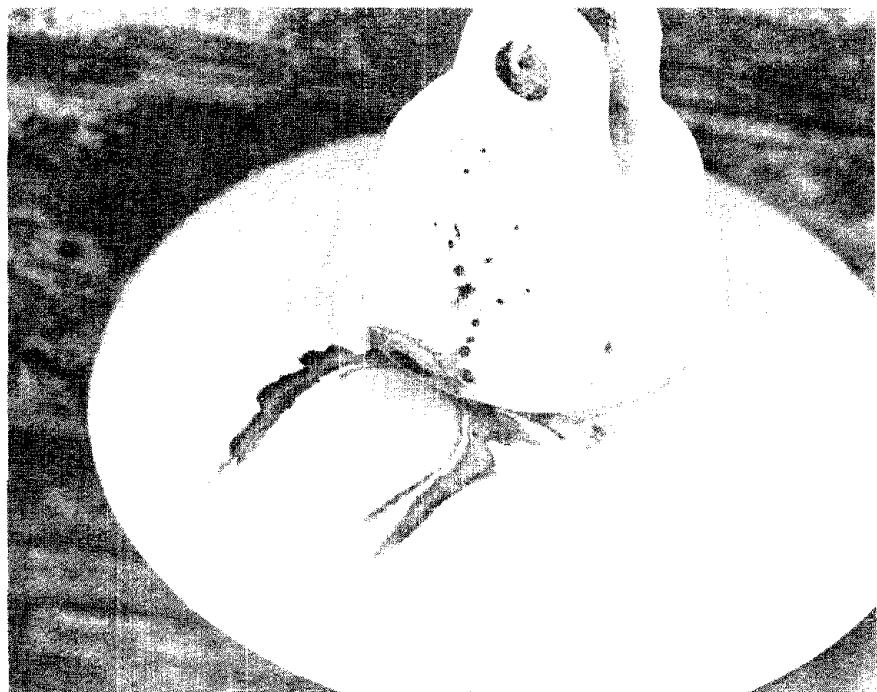
FIGURE 17-5. CATENARY INSULATOR - LIGHTNING DAMAGE.

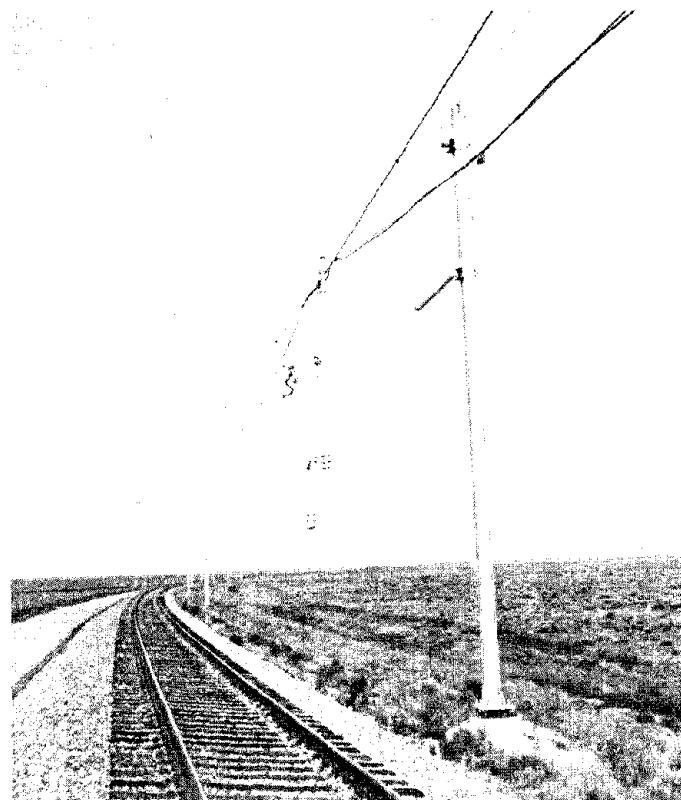
FIGURE 17-6. GENERAL VIEW OF THE DEWIREMENT DAMAGE IN TENSION SECTION #3.

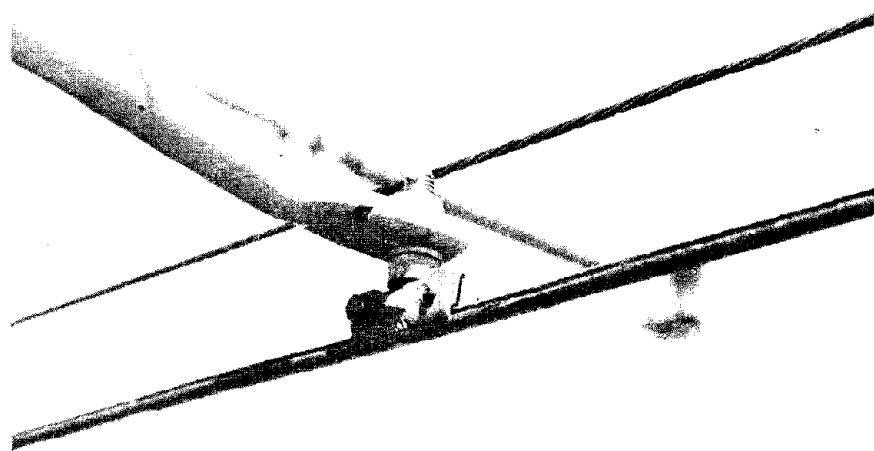
FIGURE 17-7. DAMAGED REGISTRATION ARM IN THE 'LIGHTLY' DAMAGED SECTIONS.

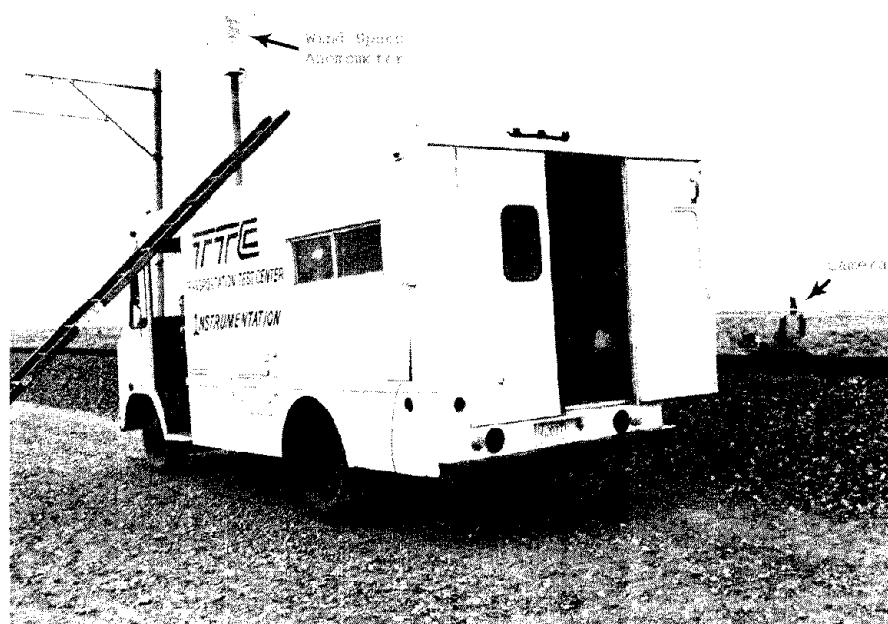
FIGURE 17-9. BLOWOFF MEASUREMENTS - DATA VAN.

An anemometer to measure the wind speed was set up on the roof of a data van (Figure 17-9) which also contained the recording instrumentation and camera remote control. The data van also provided the house power required to run the instrumentation and camera. A time code generator was provided to synchronize the wind speed measurements and film frame by inserting a time code signal simultaneously on the recorder and on the film frame edge.

The test equipment was assembled in the data van awaiting the first weather report of potentially high wind conditions. Once the report was received the equipment was dispatched to an RTT location which was predicted to receive a cross wind. The equipment was set up as described above and made ready for operation.

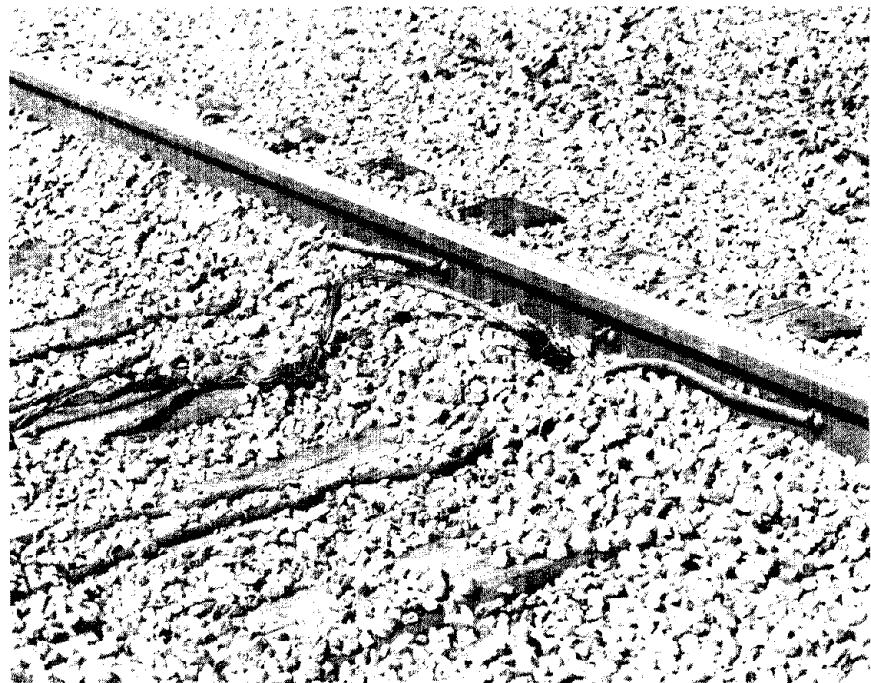
FIGURE 17-12. DAMAGED TRACK AND SUBSTATION BONDS.
