# **THE KANSAS TEST TRACK**

## **PART I - ANALYSIS OF TEST DATA**

**NOVEMBER 1979**  
**FINAL REPORT**

Prepared for  
**U.S. DEPARTMENT OF TRANSPORTATION**  
**FEDERAL RAILROAD ADMINISTRATION**  
**Office of Research and Development**  
**Washington, D.C. 20590**

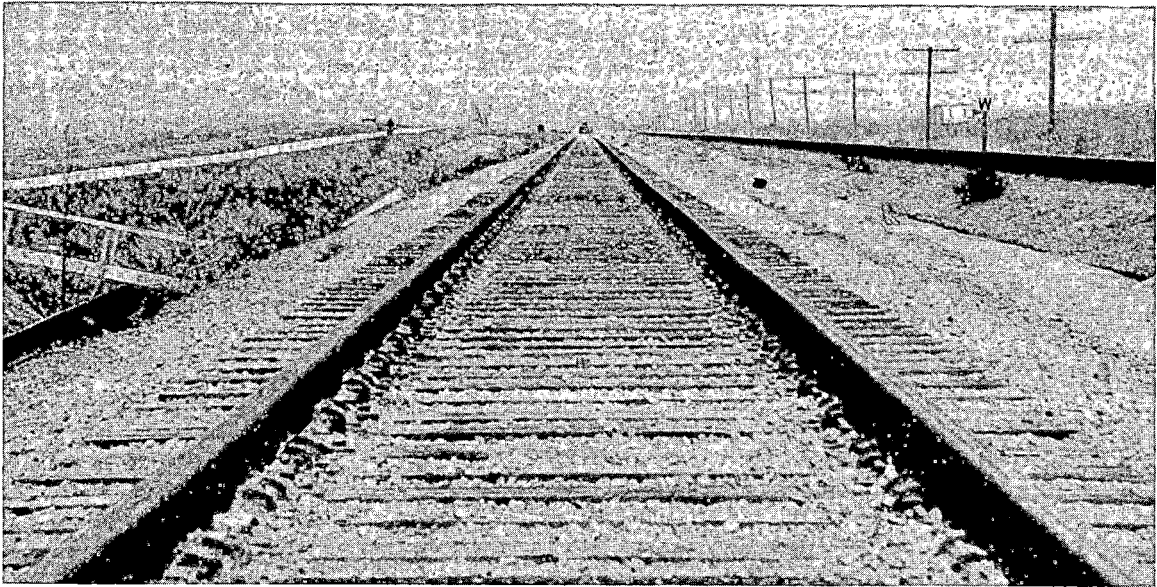
FIGURE 3 - GENERAL VIEW OF WOOD TIE SECTION

General views of the wood tie, concrete tie, twin beam, and concrete slab sections are shown in Figures 3, 4, 5 and 6, respectively.

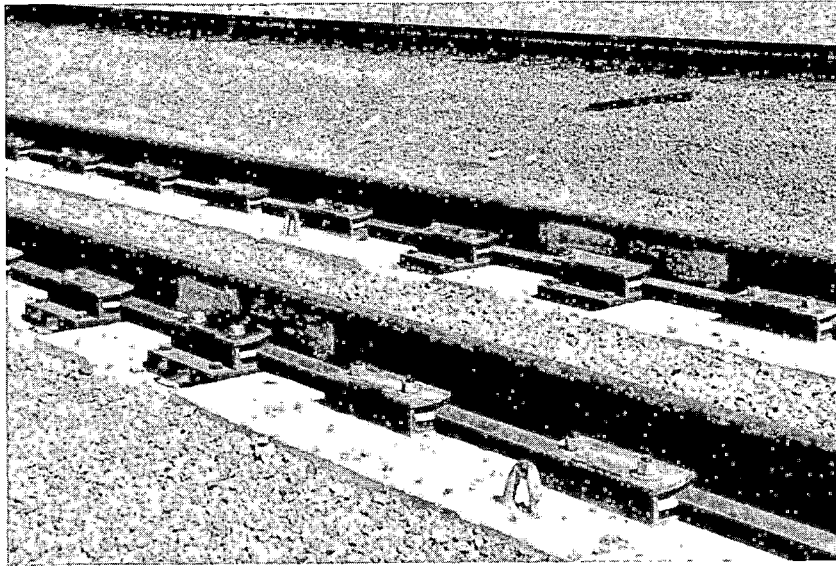
FIGURE 5 - GENERAL VIEW OF CONCRETE BEAM SECTION

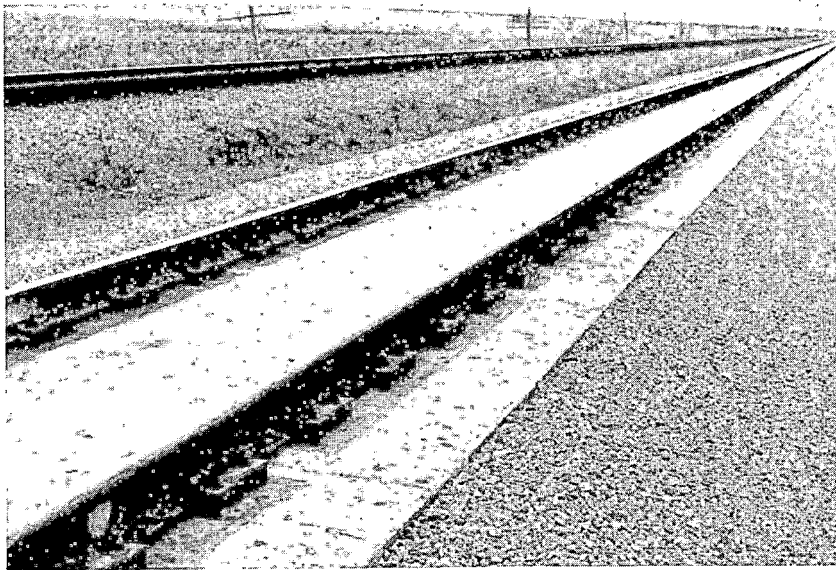
FIGURE 6 - GENERAL VIEW OF CONCRETE SLAB SECTION

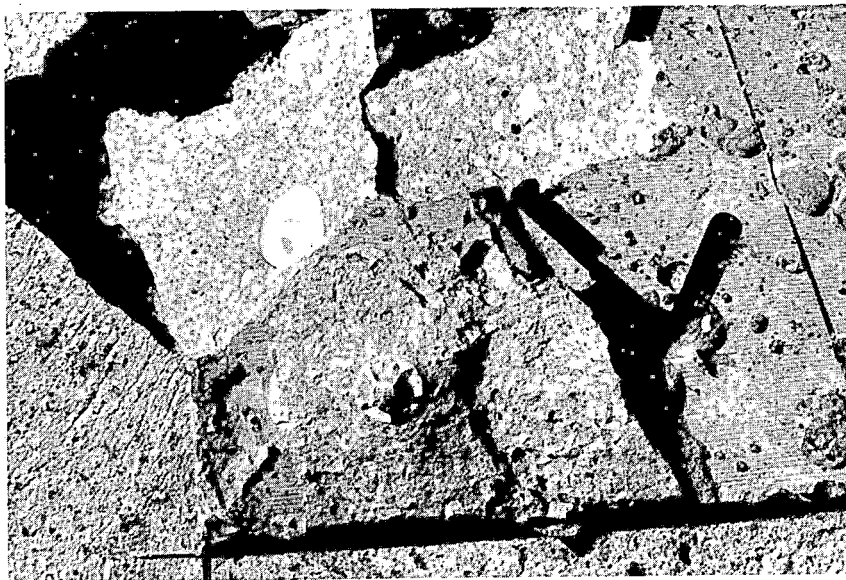
FIGURE 15 - PULLOUT FAILURE OF FASTENING ANCHOR BOLT

Pullout tests were conducted on 4 anchor bolts in an unused panel stored near the test track. Test results shown in Table 2 indicate an average pullout force of 4,788 lbs. A typical pullout failure of an anchor bolts is shown in Figure 15.

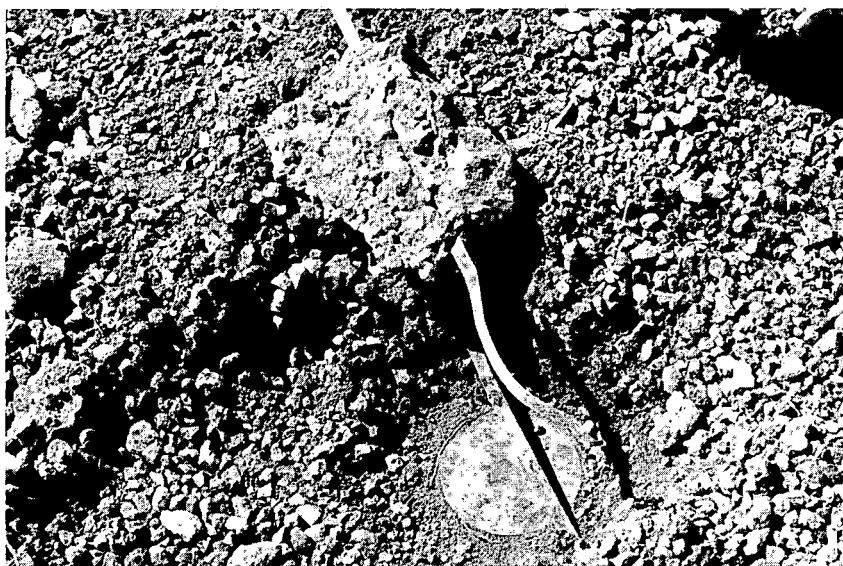
FIGURE 44 - BANDING STRAPS AND DIRECT BEARING OF CONCRETE ON  
LOAD CELL
