U.S. Department of
Transportation

**Federal Railroad
Administration**

Improved Quality Truck Castings

1. AGENCY USE ONLY (Leave blank)		2. REPORT DATE June 2016		3. REPORT TYPE AND DATES COVERED Technical Report – June 2014
4. TITLE AND SUBTITLE Improved Quality Truck Castings			5. FUNDING NUMBERS DTFR53-00-C-00012 FRA Task Order 254

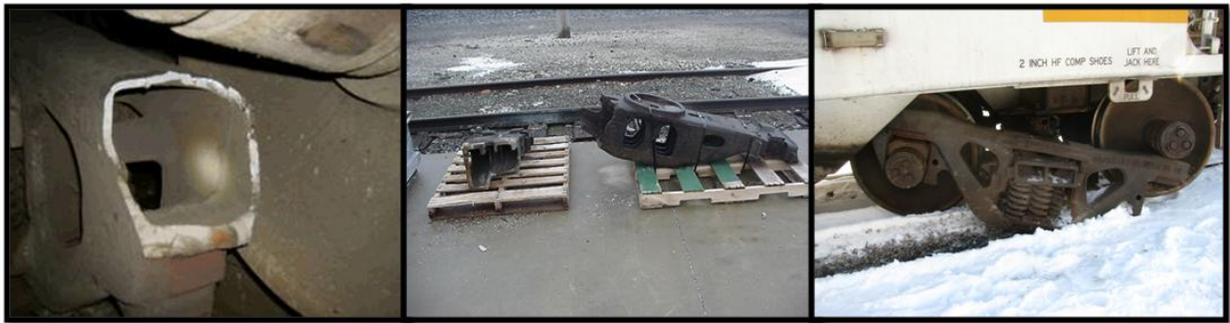
Figure 1. Examples of Brittle and Fatigue Failure in Truck Castings

Brittle failures can be attributed to marginal strength and poor impact resistance of the cast steel material. This failure mode is dangerous because it occurs instantaneously and under stresses that can be below the yield strength of the material. Figure 1 shows several examples of brittle and fatigue failures.

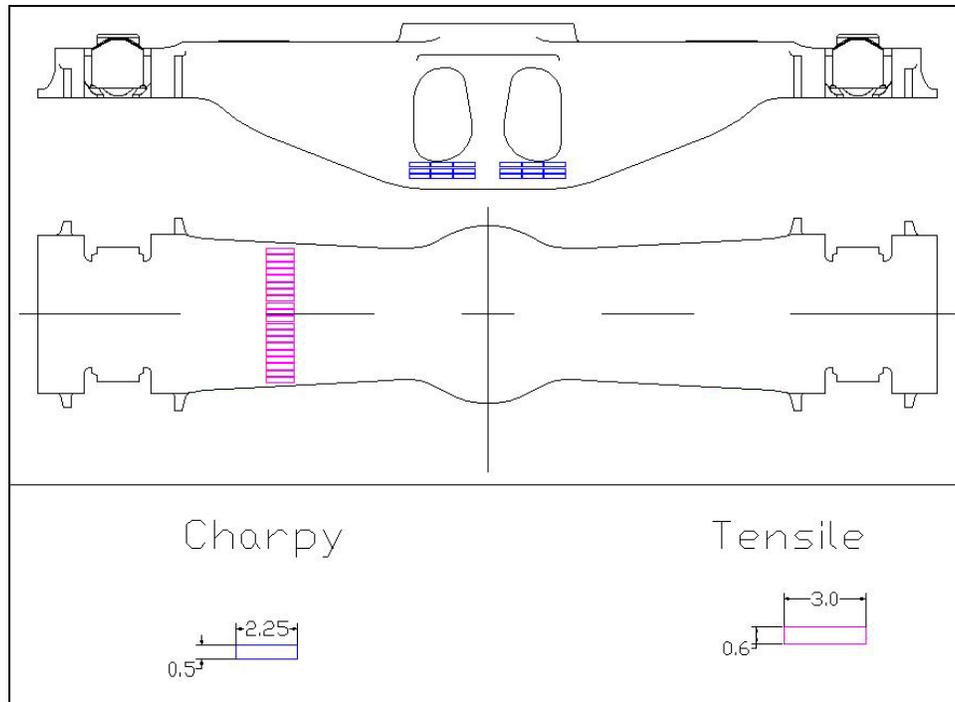
Figure 2. Tensile and Charpy Impact Test Locations

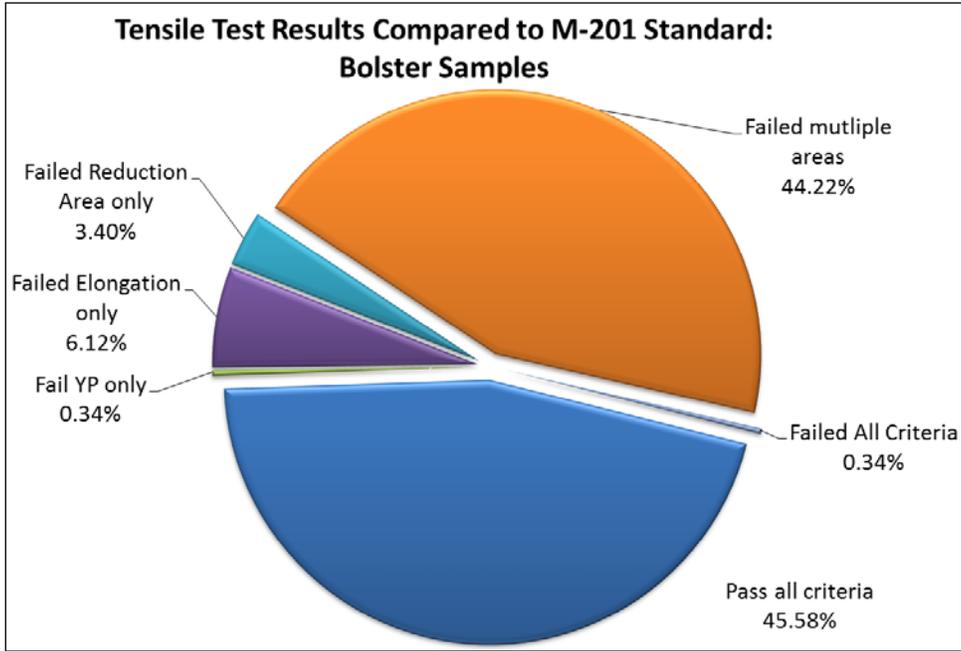
Figure 3. Tensile Tests Results from All Bolster Samples [4]

Fourteen tensile specimens were tested from each bolster; for the foundries that provided keel blocks, four additional specimens were tested. A total of 313 tensile tests were performed. Ultimate tensile strength, 0.2 percent offset yield strength, elongation, and reduction of area were measured in each test. Figures 3 and 4 show summaries of the results.

As seen in Figures 3 and 4, a large number of specimens from the bolsters did not meet the minimum requirements. Of these, most were low on both elongation and reduction of area. The keel block specimens performed somewhat better, but there were still some that tested below the requirements. For the keel block samples, 25 percent of them did not pass the yield strength requirement. Some of the low performing samples were examined with low power optical microscopy; the fracture surfaces indicated very rough surfaces and porosity.

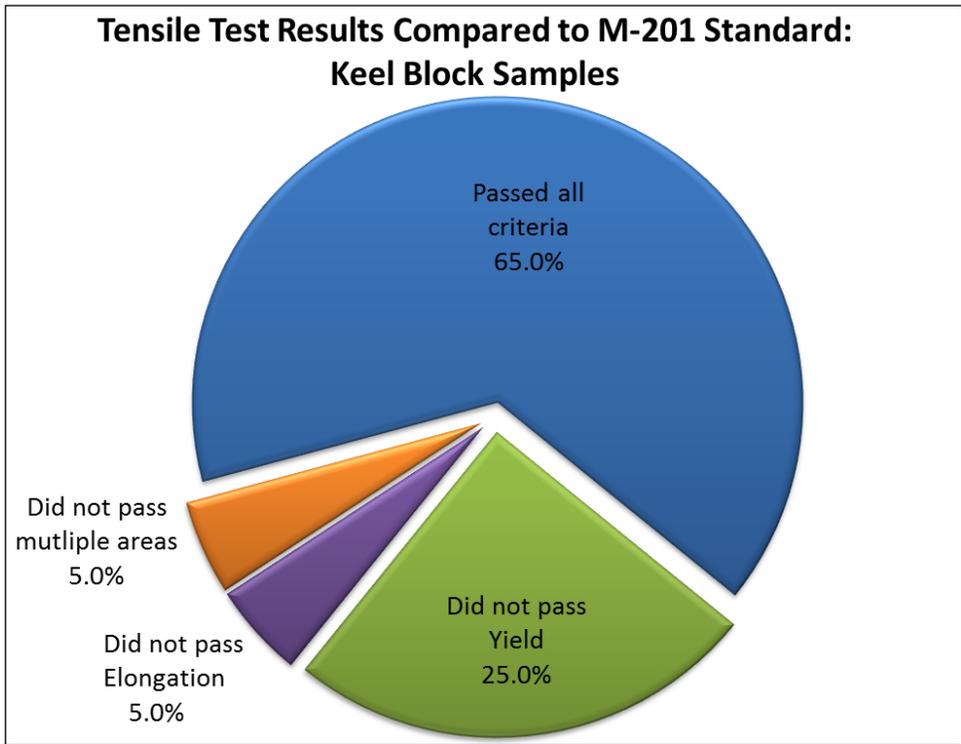
Figure 4. Tensile Test Results from Keel Block Samples [4]

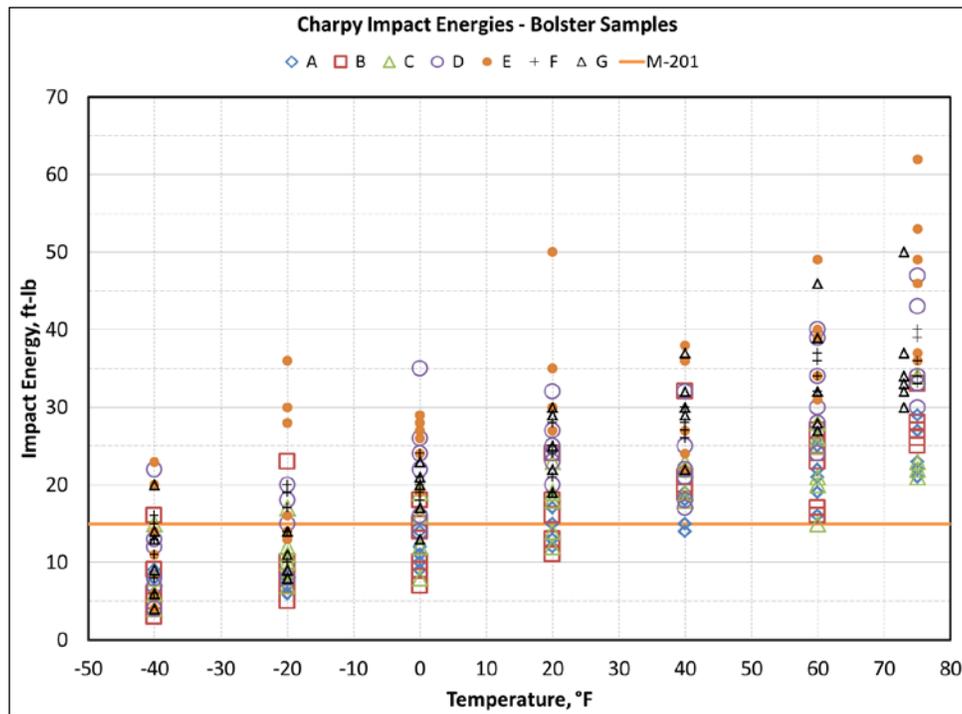
Figure 5. Charpy Impact Test Results from All Bolster Samples

Fourteen Charpy impact samples were tested from each bolster. There were seven test temperatures, and two samples per test temperature per bolster were tested. For the foundries that supplied keel blocks, four additional Charpy samples were tested. The keel block data is not presented here due to the small sample size. Figures 5 and 6 show the test results for the bolster samples.

The testing was conducted over a wide range of temperatures, but the critical test temperature per the AAR M-201 standard is 20 °F (-7 °C). Foundries A and B had samples that did not meet the minimum requirement of 15 ft-lbs (20 N-m) at the critical temperature [5]. These two suppliers also had the largest number of tensile samples that did not meet the elongation and reduction of area requirements.

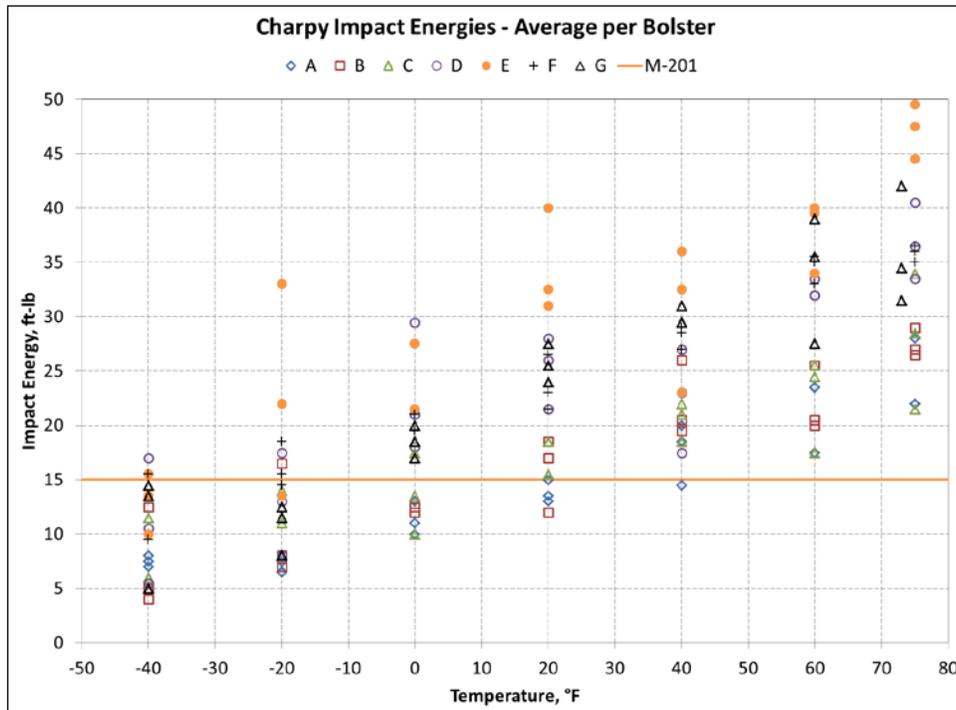
Figure 6. Average Charpy Impact Test Results per Bolster

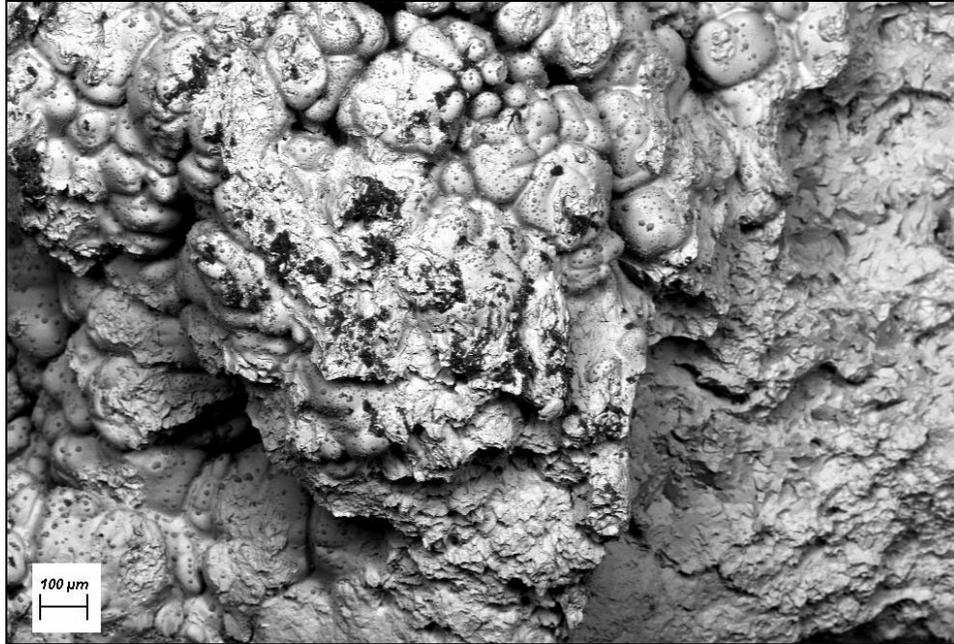
Figure 7. Gas Porosity in a Low Performing Charpy Impact Specimen

To further investigate the causes of the low impact energies, the fracture surfaces of 11 of the lowest performing Charpy impact samples were analyzed with a scanning electron microscope (SEM) [6]. All of the samples in this group showed some degree of shrinkage porosity on the fracture surface. As expected, most of the samples tested at relatively warm temperatures exhibited at least partially ductile fracture surfaces, while the samples tested below 0 °F (-18 °C) were entirely brittle. Figure 7 shows a SEM of the sample with the lowest absorbed energy of the 11 samples [6]. This feature is inside a large pore. The black oxide material on the dendrites indicates this porosity was likely caused by gas; the large pore was likely a major reason for the low absorbed energy of this sample. Shrinkage porosity can be controlled by modifying the gating and risering system, and by monitoring the melt temperature. Gas porosity has two sources: core gases and dissolved gases in the metal.

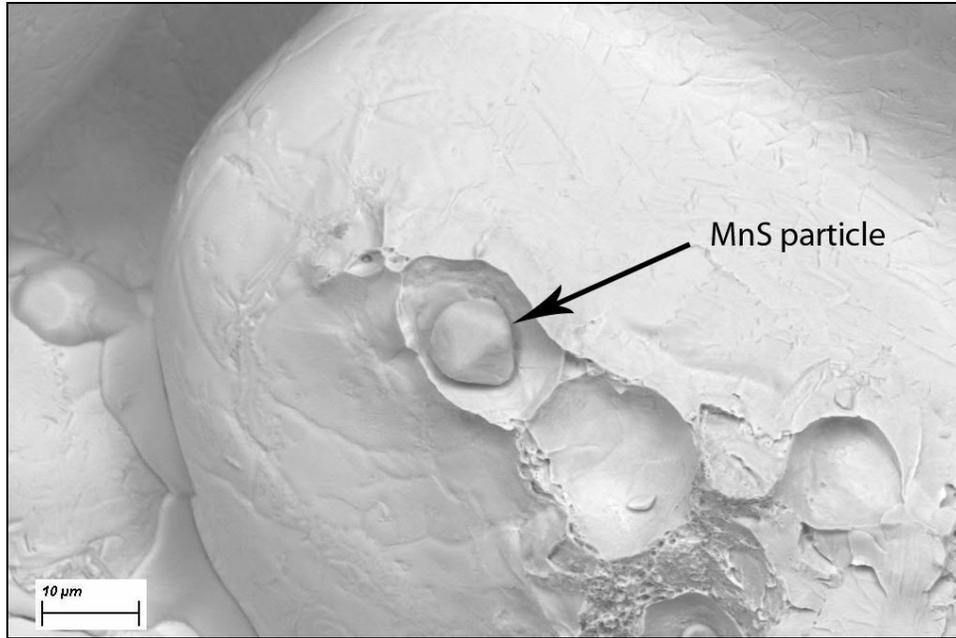
Figure 8. Manganese Sulfide Particle in Charpy Specimen

Also, inclusions can greatly reduce the strength or impact energy; these are frequently present as oxides or sulfides. The oxygen and sulfur atoms typically combine with a metal atom, forming a hard inclusion. These inclusions form discontinuities in the material and cause lower mechanical properties. Figure 8 shows an inclusion that energy dispersive spectroscopy revealed to be a manganese sulfide (MnS) particle in a pore of a Charpy impact fracture surface [6]. Inclusions occur because of residual elements in the scrap steel used for melt material, oxygen entrained during melting and pouring, or sand from the mold. Control of scrap sources, gate modification, and improved molding techniques can reduce these inclusions.

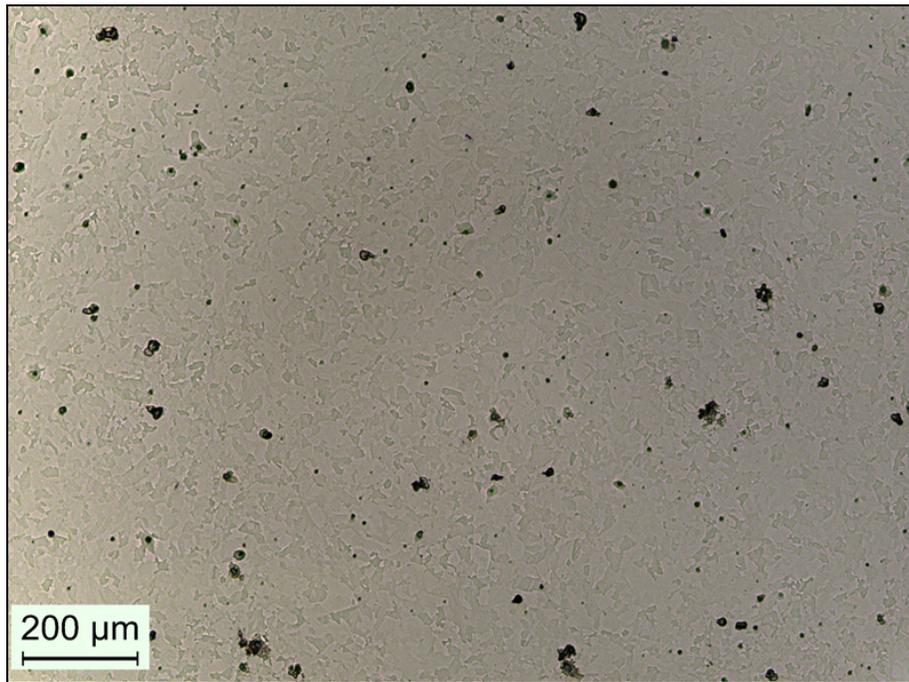
Figure 10. Ferritic Microstructure of a Bolster Mechanical Test Sample (2% Nital Etch)

Figures 10–12 are photomicrographs of samples from three bolster mechanical test samples; each sample is from a different supplier. These photomicrographs are representative of the samples observed. The mechanical test results did not always correspond to the amount of porosity. No inclusions were found in these samples, but high amounts of porosity were found in most samples.

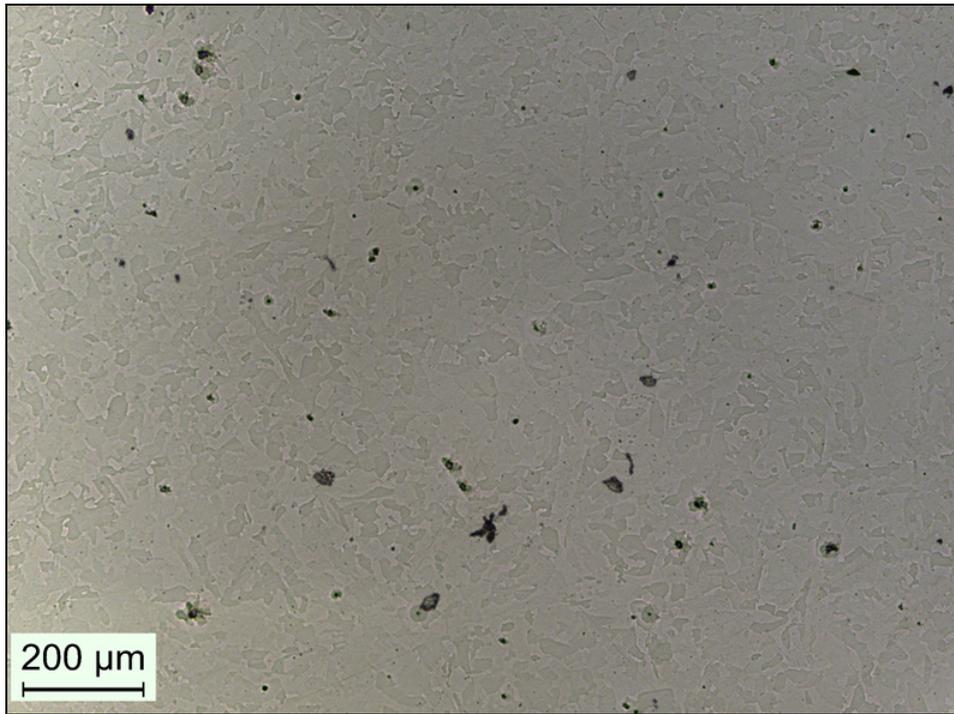
Figure 11. Ferritic Microstructure of a Bolster Mechanical Test Sample (2% Nital Etch)

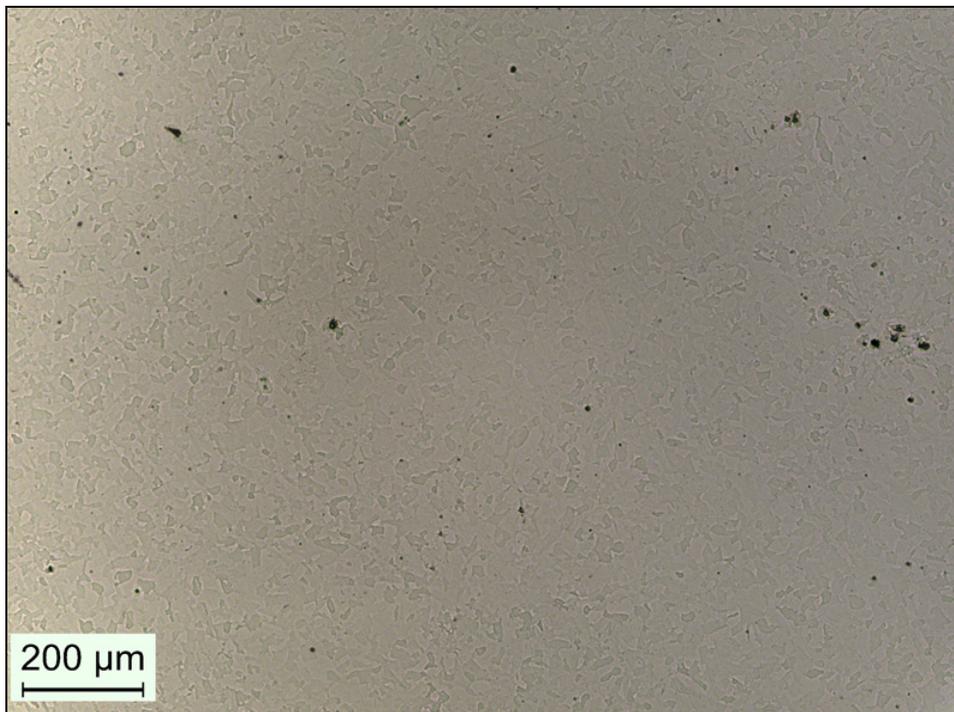
Figure 12. Ferritic Microstructure of a Bolster Mechanical Test Sample (2% Nital Etch)

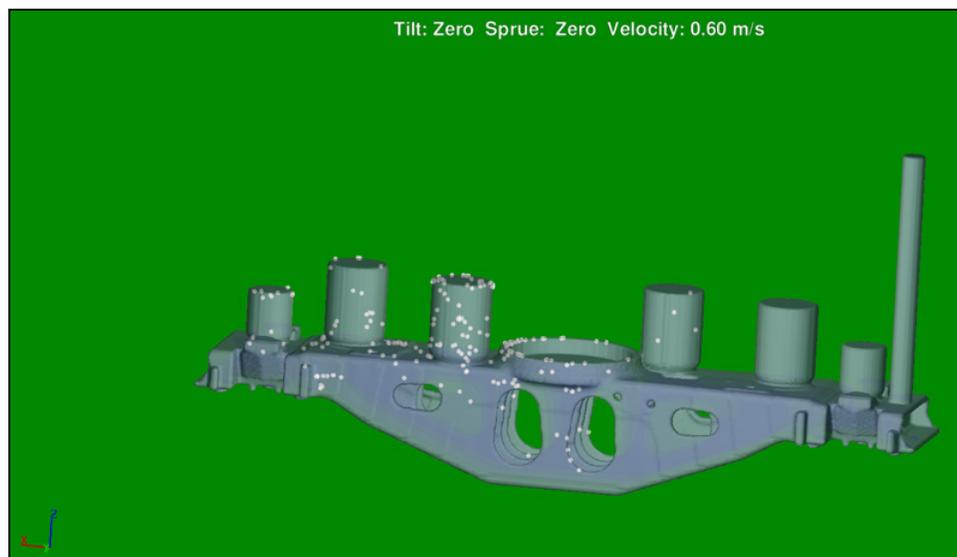
Figure 13. Mold Angle: 0° Sprue Angle: 0° Initial Velocity: 0.60 m/s

Figures 13–18 show the particle locations at the end of filling for each set of parameters.

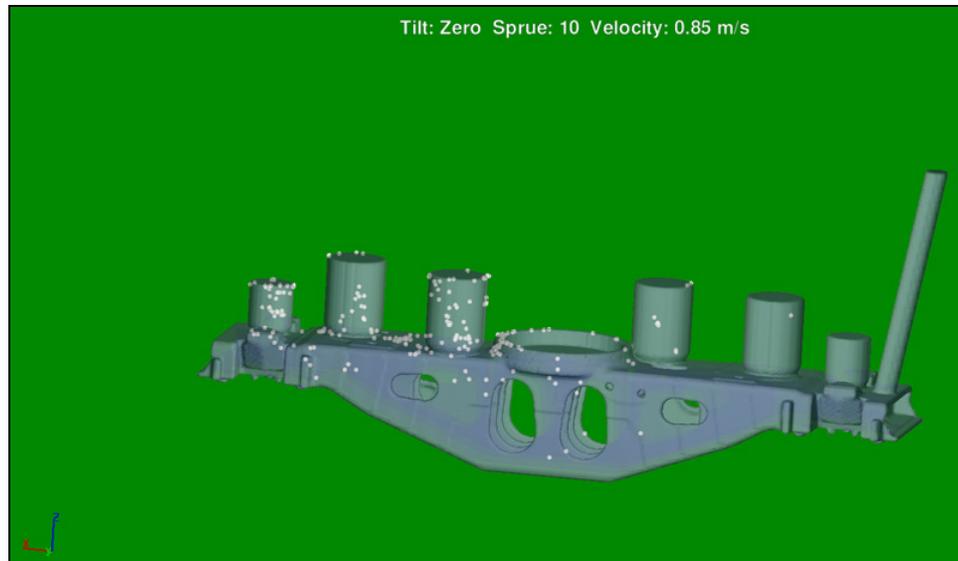
Figure 14. Mold Angle: 0° Sprue Angle: 10° Initial Velocity: 0.85 m/s

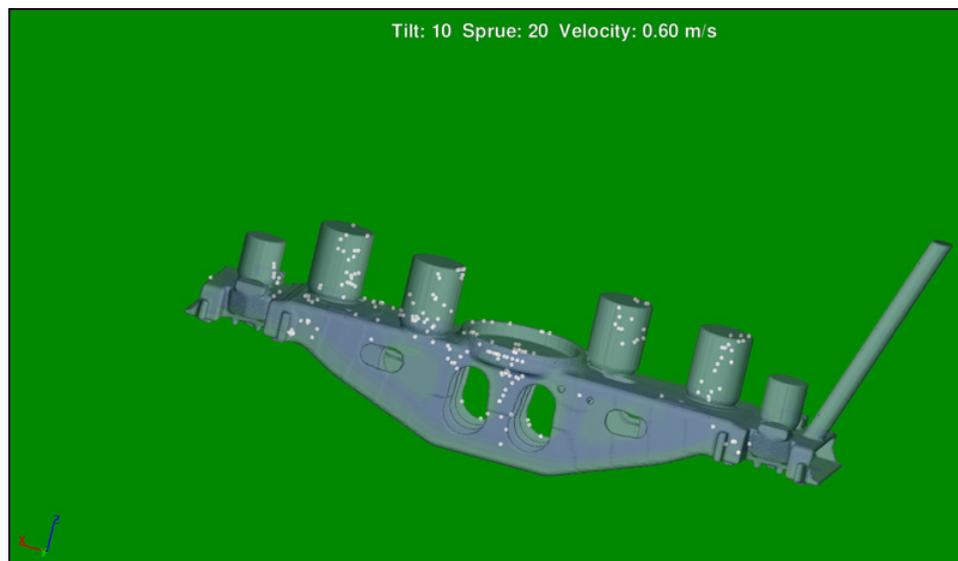
Figure 15. Mold Angle: 10° Sprue Angle: 20° Initial Velocity: 0.60 m/s

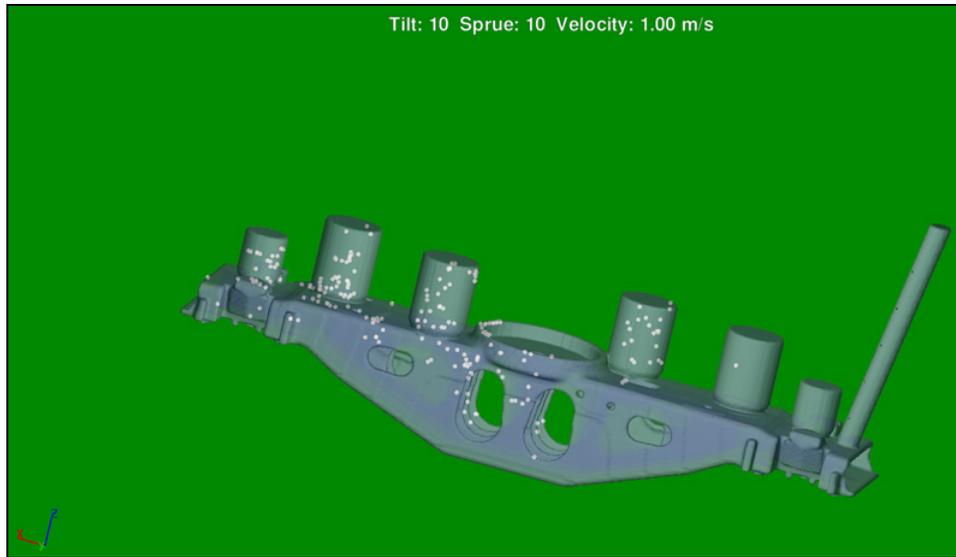
Figure 16. Mold Angle: 10° Sprue Angle: 10° Initial Velocity: 1.00 m/s

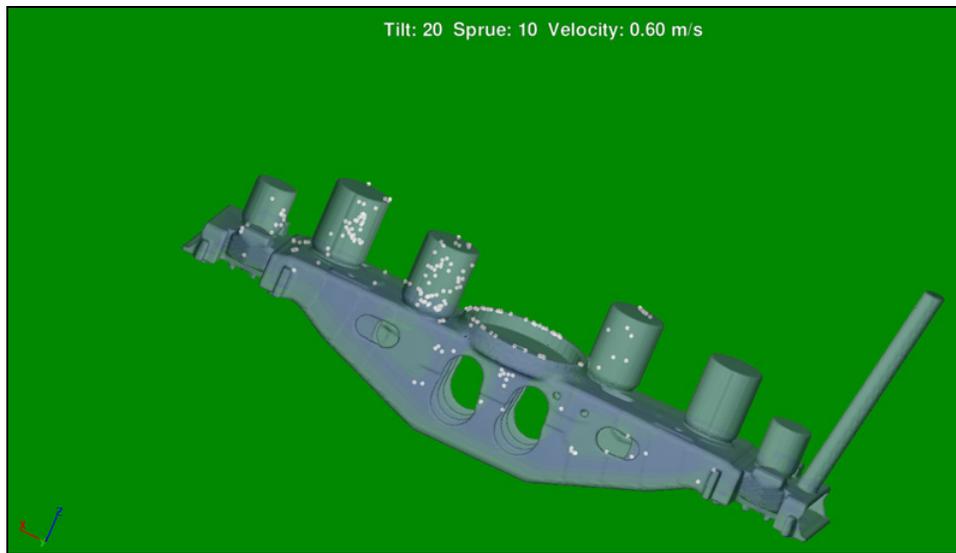
Figure 17. Mold Angle: 20° Sprue Angle: 10° Initial Velocity: 0.60 m/s

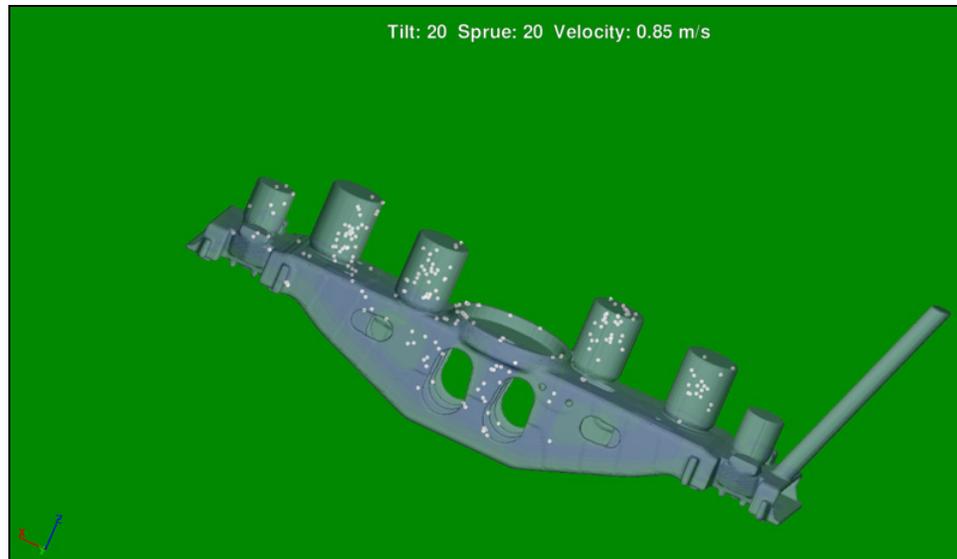
Figure 18. Mold Angle: 20° Sprue Angle: 20° Initial Velocity: 0.85 m/s

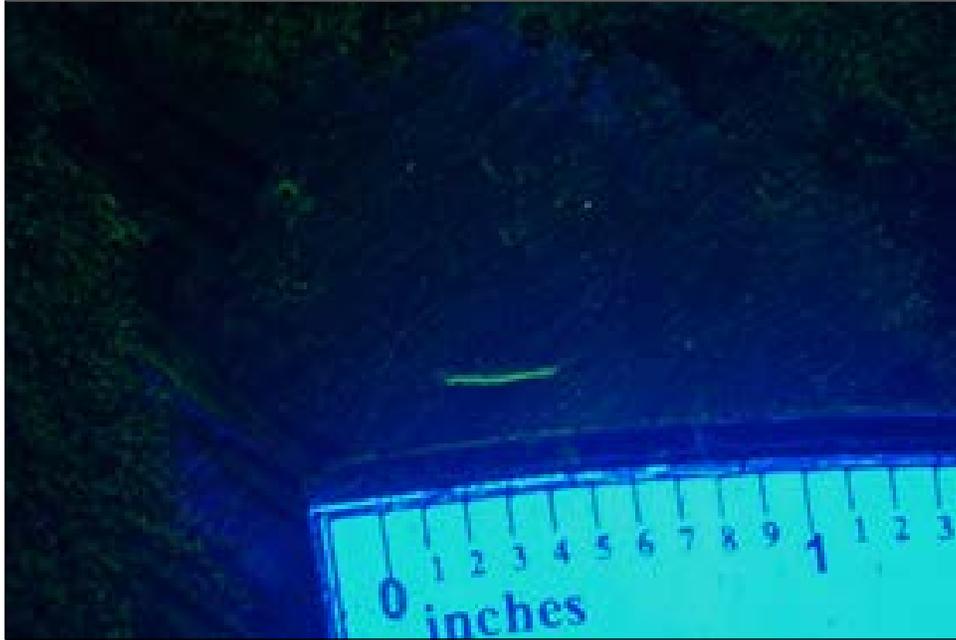
Figure 19. Crack Detected by Magnetic Particle Testing

The dry magnetic particle, wet magnetic particle, visual, and liquid penetrant testing were performed on 50 side frames and 50 bolsters at two repair facilities. Figure 19 shows a crack detected by magnetic particle testing.

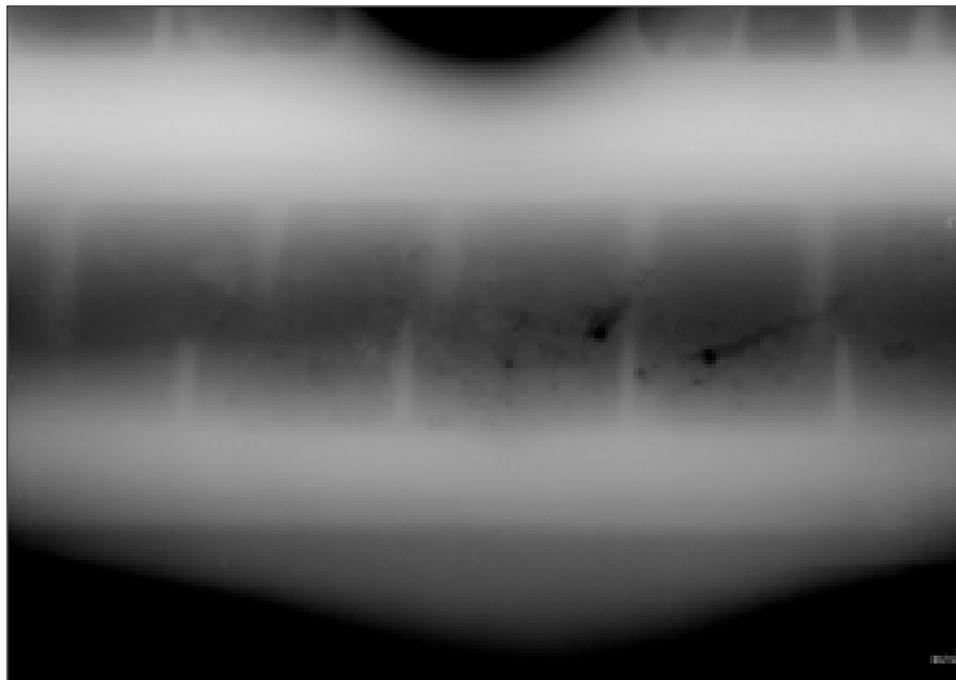
Figure 20. Defects in Bolster Shown by Radiography [11]

Radiographic inspection was able to evaluate all of the critical areas of the bolster castings. TTCI had less success with side frames, because the shape of the part limited the placement of the imaging plate for critical areas [11]. Knuckles were not evaluated. Figure 20 shows a radiograph displaying casting defects in a bolster. This test showed that the time required to acquire a clear image of critical areas can be less than 25 minutes, even with thicker wall sections and double wall exposures. Computed radiography was very convenient, because of its quick development and reusability. However, many in the NDT industry maintain that traditional film should be used if the main goal is to find cracks.

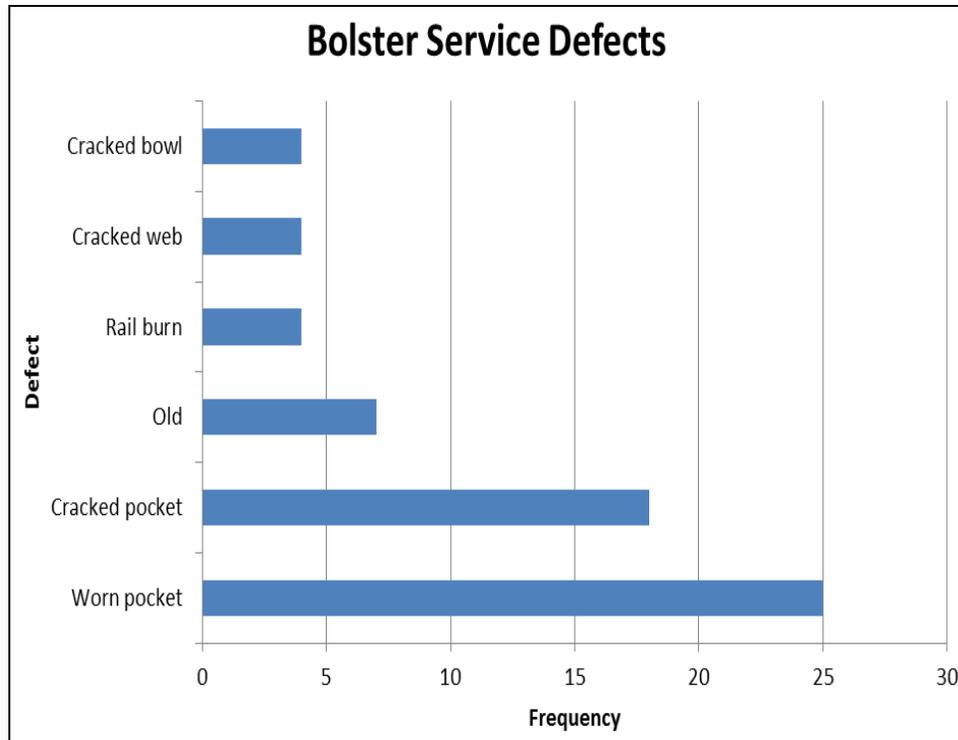
Figure 21. Common Bolster Defects Seen during Survey [9]

The majority of the bolster defects were cracked pockets and worn pockets. Old castings, rail burns, cracked webs, and cracked bowls were the other leading defect causes in bolsters.

The remaining causes of scrapped bolsters were bowls not machined correctly, oversize pinholes, gouges around bowls, worn bowls, cracked liners, and bent castings.

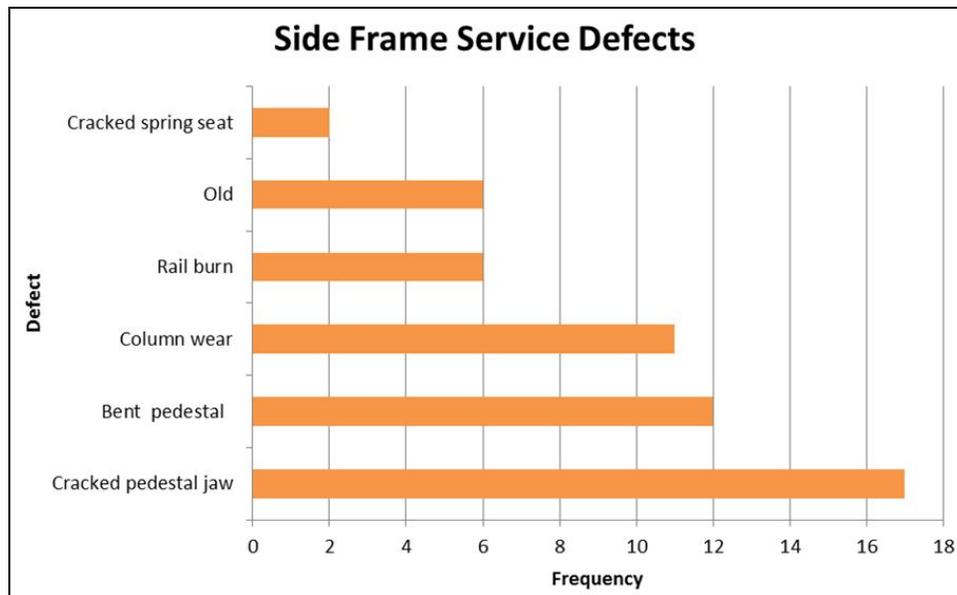
Figure 22. Common Side Frame Defects Seen during Survey [9]

Figure 22 shows the top six side frame defects, which represent 93 percent of the defective side frames examined.

The remaining defects were cracks below the wear plate, bent spring seats, and cracks on lightening holes.

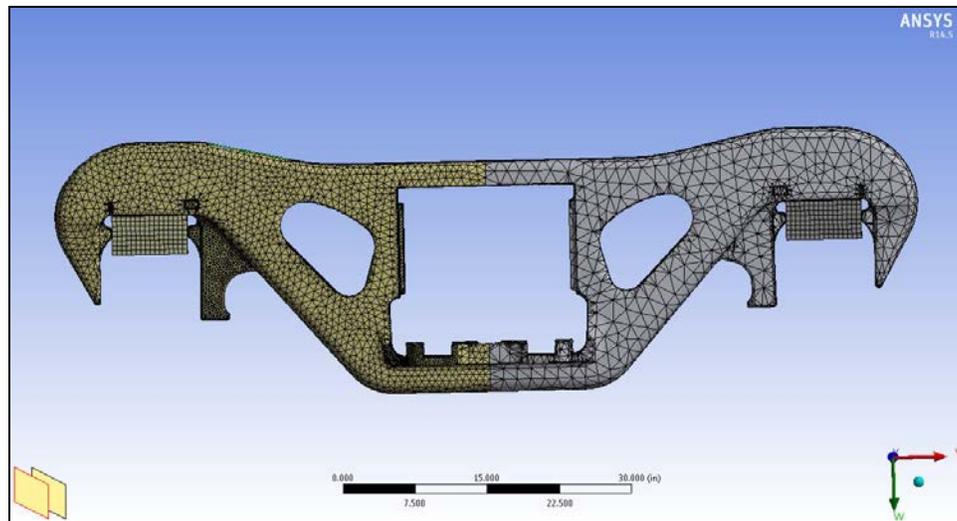
Figure 23. Symmetrical Mesh Used for the Stress Analysis

To compute the stresses, a solid model of a Barber S-2-HD side frame was used. An unmodified model was used as a baseline for the stress calculation. The stiffness of vertical supports was designed to allow approximately the same vertical deflection at the center of the casting as shown in Table 4.3 of the AAR M-203 standard [12], which is 0.051 inch (1.30 mm). Due to meshing difficulties, a symmetrical model using one half of the side frame was used, as Figure 23 shows. The critical areas examined were the pedestal jaw and the tension member hole. The tension member hole allows access to some internal parts of the casting for removal of sand and can be an escape path for core gases.

To produce the most realistic analysis, a combination of vertical and lateral loading was used. The vertical load was 164,000 pounds, and a transverse load of 21,300 pounds was used at the side frame-to-bolster interface.

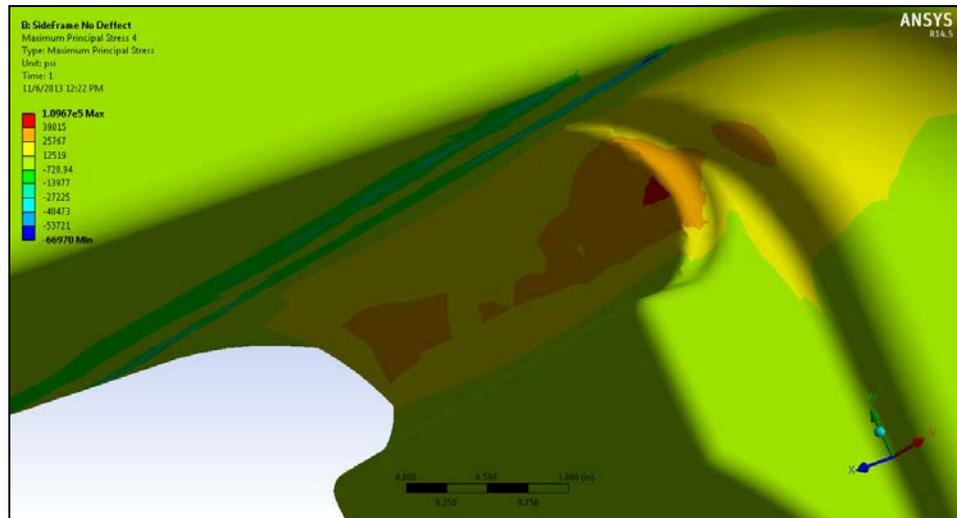
Figure 24. Stress Map of Pedestal Radius after Modification

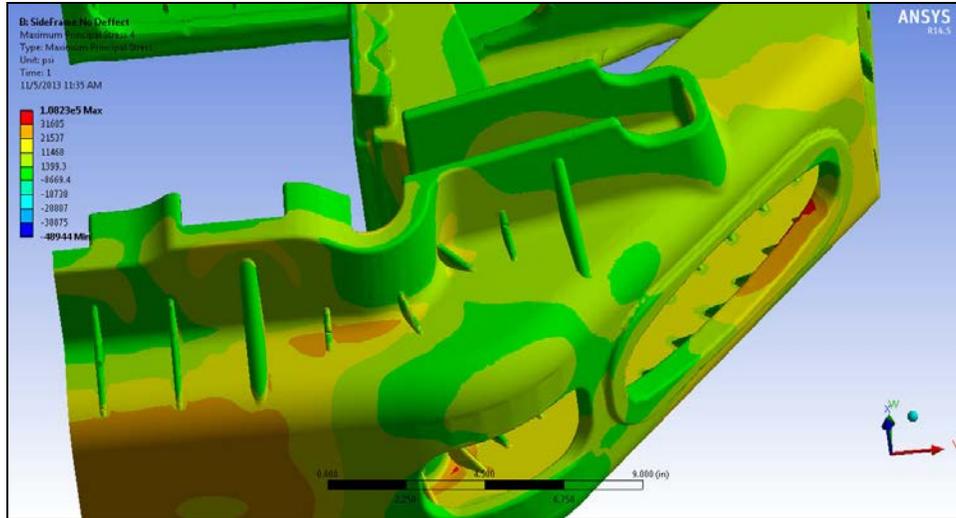
Figure 25. Stress Map of Tension Member Hole after Modification

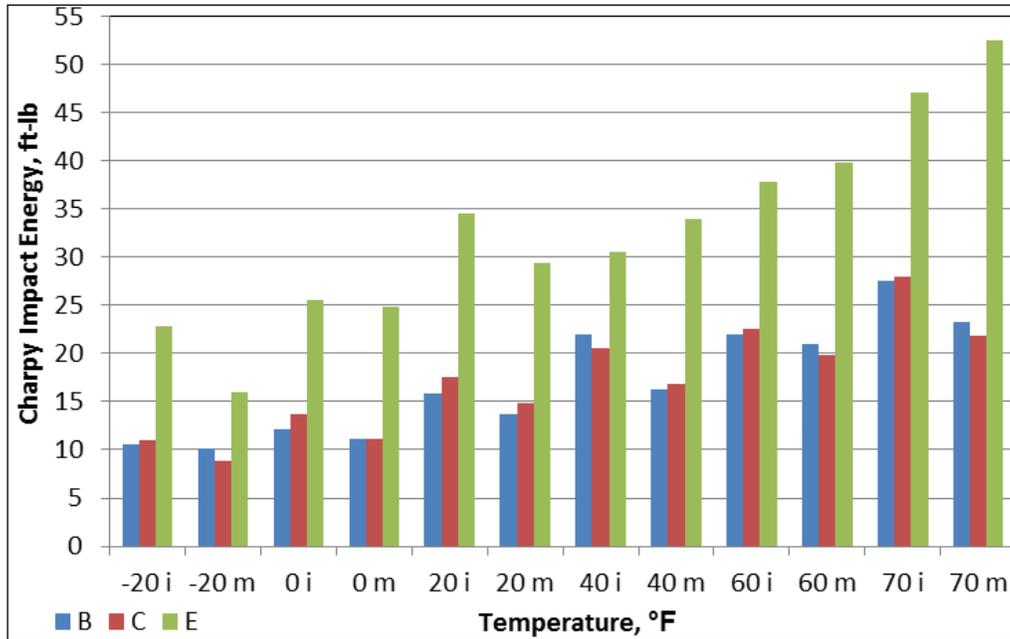
Figure 26. Comparison of Average Charpy Impact Values for Foundries B, C, and E

In the graphs below, the ‘i’ or ‘init’ designation stands for initial and ‘m’ or ‘mod’ stands for modified. Figure 26 compares the average impact energy for each foundry for both initial and modified processes. Figures 27–35 plot the values for the individual foundries.

The modified bolsters from Foundries B and C did not show an improvement of the average energy; at each test temperature, the average impact energy values decreased. Foundry E showed improvement at 40 °F and above. More detailed analysis occurs in the following sections.

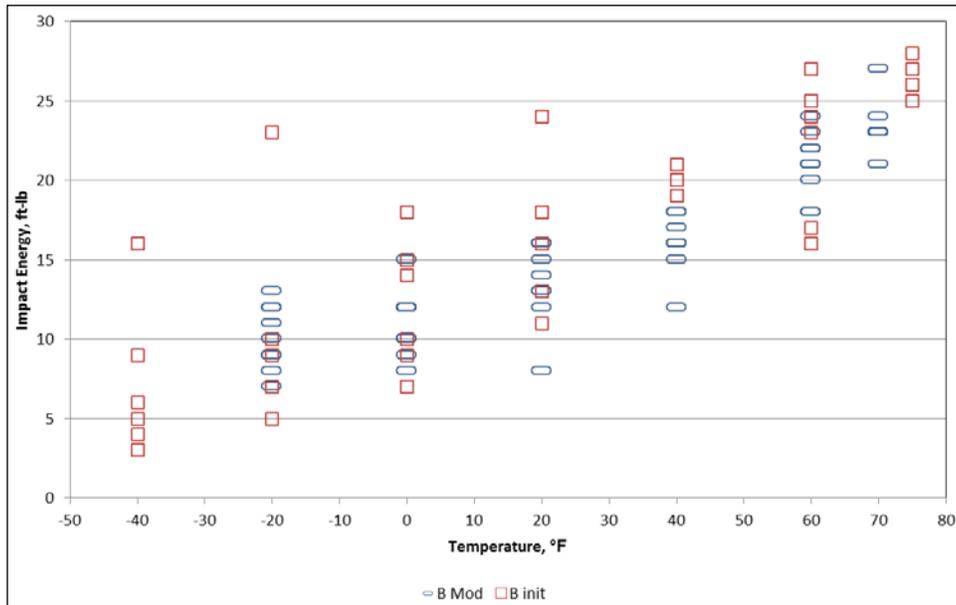
Figure 27. Charpy Impact Test Results from Standard and Alternate Parameters for Foundry B

Figures 27–29 show different representations of the Charpy impact test results for both sets of Foundry B tests. Samples tested at 75 °F (24 °C) in the initial round were tested at 70 °F (21 °C) during the second round of testing. Though there was little, if any, statistical difference in the impact energies, the mean impact energies decreased for the modified samples. This was not expected. However, the ranges and standard deviations showed definite decreases.

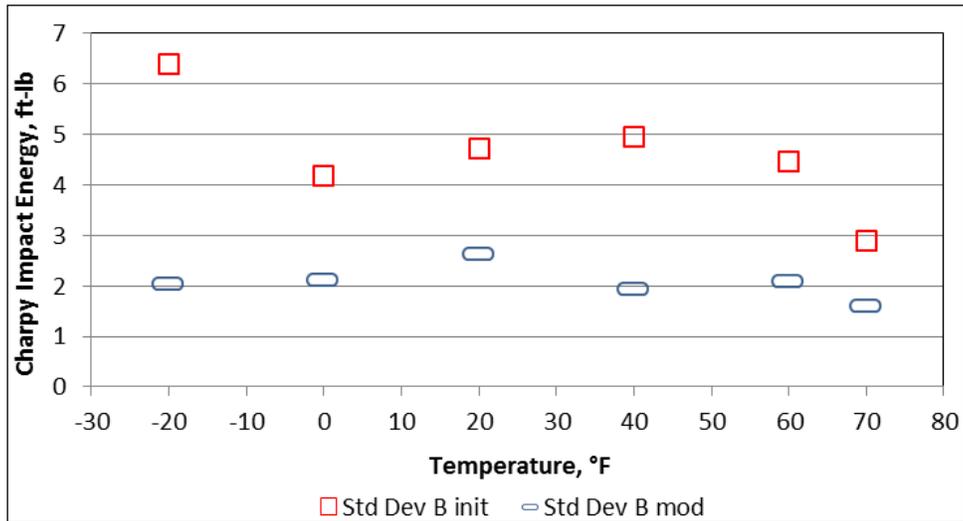
Figure 28. Standard Deviation of Foundry B Charpy Impact Samples

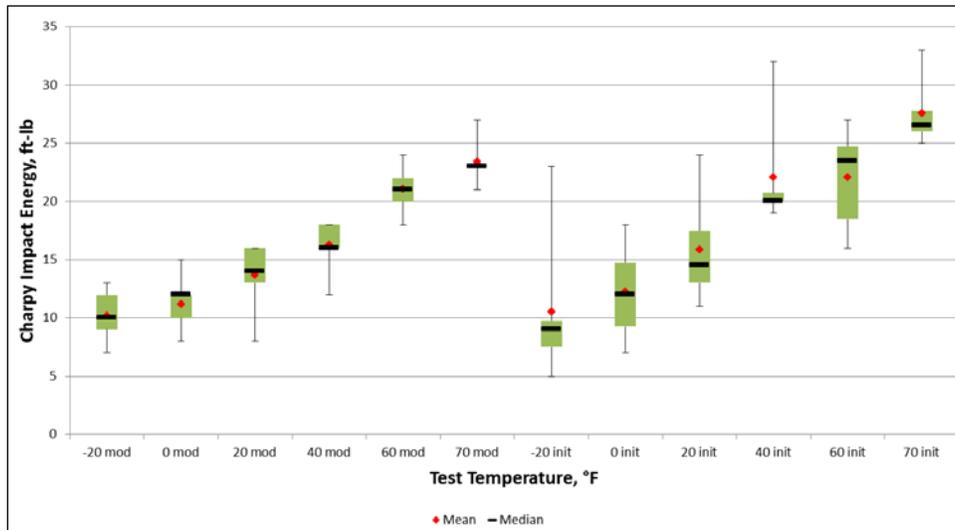
Figure 29. Box and Whisker Plot of Foundry B Charpy Results

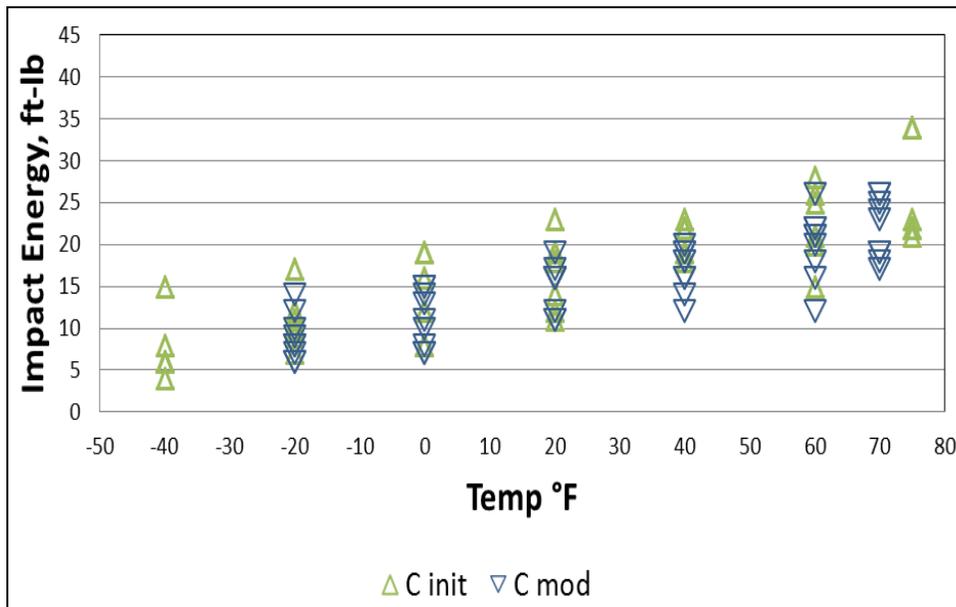
Figure 30. Charpy Impact Test Results from Standard and Alternate Parameters for Foundry C

Figures 30–32 show different representations of the Charpy impact test results for both sets of Foundry C tests. Samples tested at 75 °F (24 °C) in the initial round were tested at 70 °F (21 °C) during the second round of testing. As with the results from Foundry B, there was little statistical difference in the impact energies; again, the mean impact energies decreased for the modified samples. The ranges and standard deviations decreased as most test temperatures decreased.

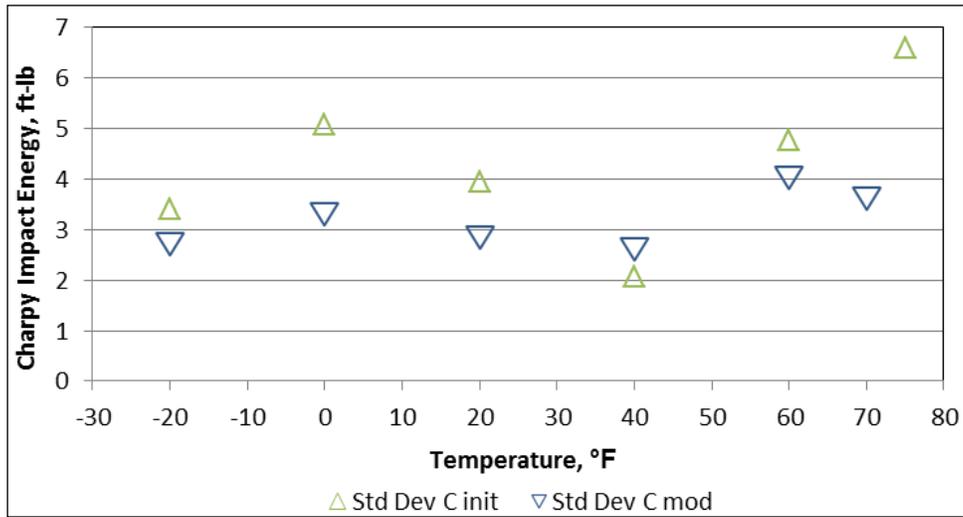
Figure 31. Standard Deviation of Foundry C Charpy Impact Samples

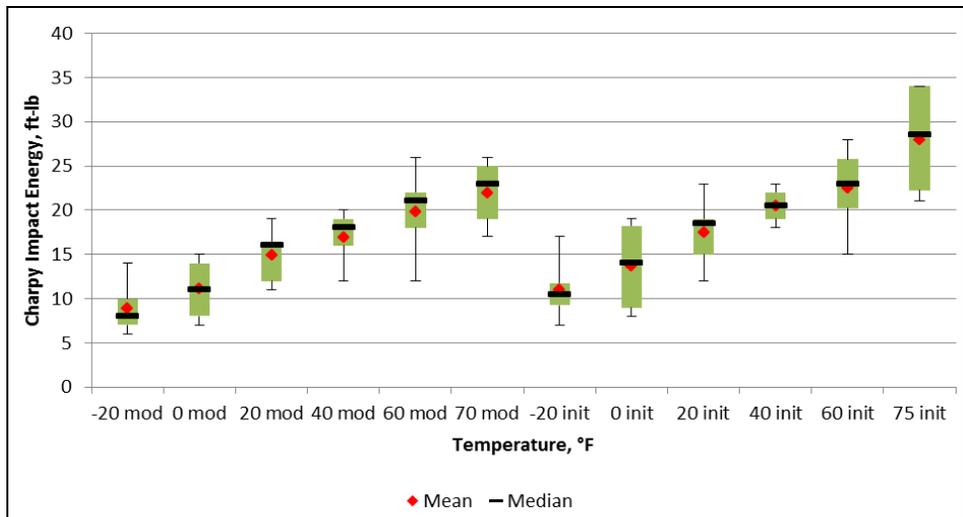
Figure 32. Box and Whisker Plot of Foundry C Charpy Results

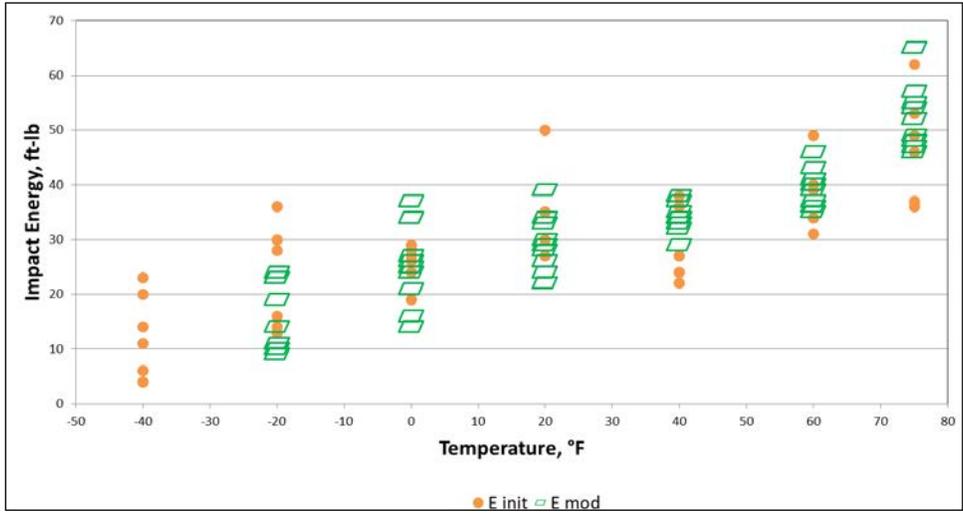
Figure 33. Charpy Impact Test Results from Standard and Alternate Parameters for Foundry E

Figures 33–35 show different representations of the Charpy impact test results for both sets of Foundry E tests. There was no statistical difference in the impact energies; at 40 °F (4 °C) and above, the mean impact energies increased for the modified samples. The mean energies for both the initial tests were much higher than those of Foundries B and C. The standard deviations decreased for most test temperatures, but were higher than Foundries B and C. There was an overall range decrease for the modified samples.

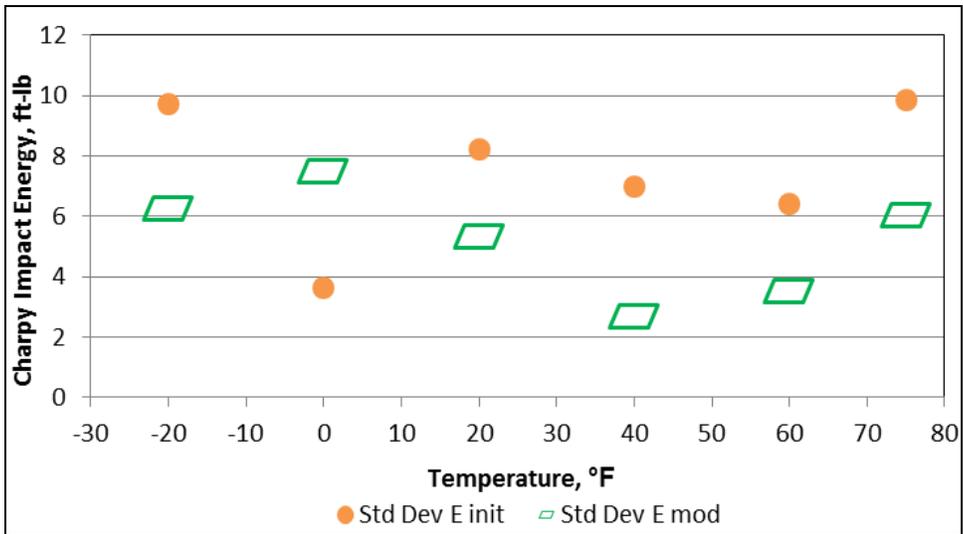
Figure 34. Standard Deviation of Foundry E Charpy Impact Samples

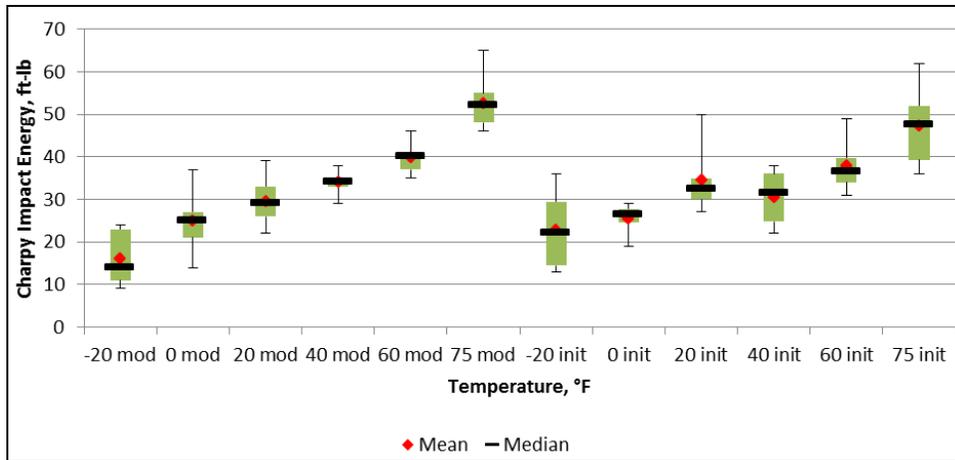
Figure 35. Box and Whisker Plot of Foundry E Charpy Results
