U.S. Department of
Transportation

**Federal Railroad
Administration**

Improved Quality Truck Castings

1. AGENCY USE ONLY (Leave blank)		2. REPORT DATE June 2016		3. REPORT TYPE AND DATES COVERED Technical Report – June 2014
4. TITLE AND SUBTITLE Improved Quality Truck Castings			5. FUNDING NUMBERS DTFR53-00-C-00012 FRA Task Order 254

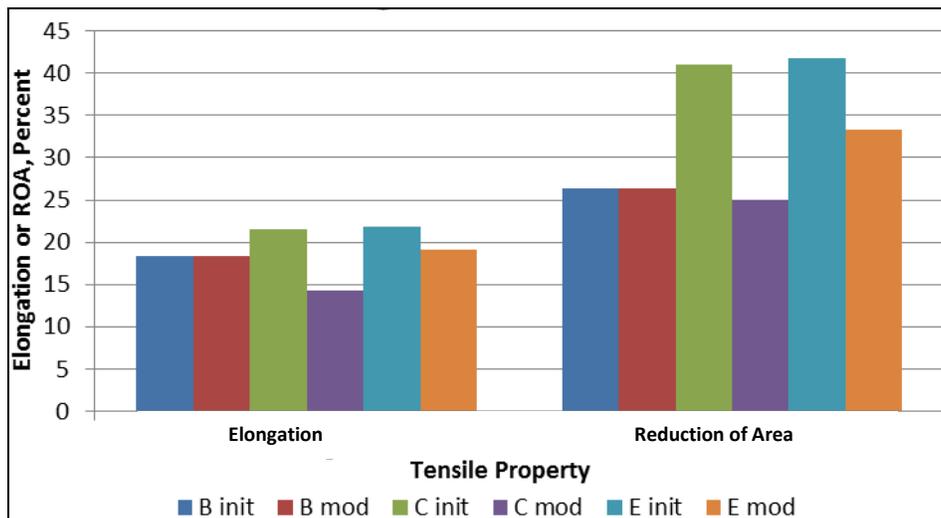
Figure 36. Mean Elongation and Reduction of Area Changes for Foundries B, C, and E

Figure 36 shows the elongation and reduction of area values for the three foundries; both of these properties are measures of ductility. All of the foundries had mean elongation values below the required 24 percent, though some were well above this. Two suppliers had reduction of area values above the required 36 percent for the initial set of tests. For the second set of tests, the mean value for all foundries was below the requirement. The results for each supplier are detailed in the following sections. In Figure 36, the “init” designation stands for initial and or “mod” stands for modified.
