# **ULTRASONIC INSPECTION OF RAILROAD RAILS BY ELECTROMAGNETIC ACOUSTIC TRANSDUCERS (EMATs)**

**ROCKWELL INTERNATIONAL SCIENCE CENTER  
1049 Camino Dos Rios  
Thousand Oaks, CA 91360**

**MAY 1986**

**FINAL REPORT**

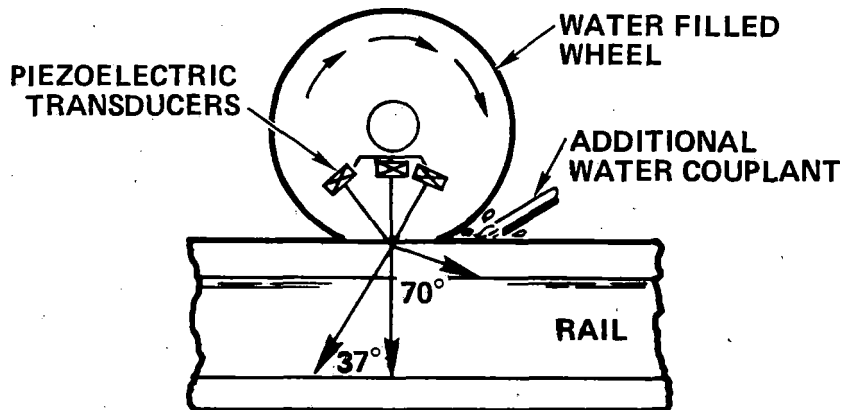
FIGURE 2-1 A CONVENTIONAL TYPE OF ULTRASONIC WHEEL PROBE UNIT.

The principal problem experienced with these ultrasonic probe units is the difficulty in maintaining adequate acoustic coupling at the contact between the probe and the rail surface. Under nonideal conditions, such as

when the rail surface is pitted or corroded, or when covered with a nonconductor such as sand, coal dust or grease, the acoustic coupling can be lost. For example, lubrication of the rails, a fuel conservation step introduced recently in rail transportation, leaves a continuous thin layer of grease on the rail surface that interferes with coupling. It is also inconvenient to have to provide storage for the large quantity of liquid couplant on the rail inspection vehicle for wetting the rail surface ahead of the ultrasonic probe unit and it is difficult to keep it from freezing in cold weather.

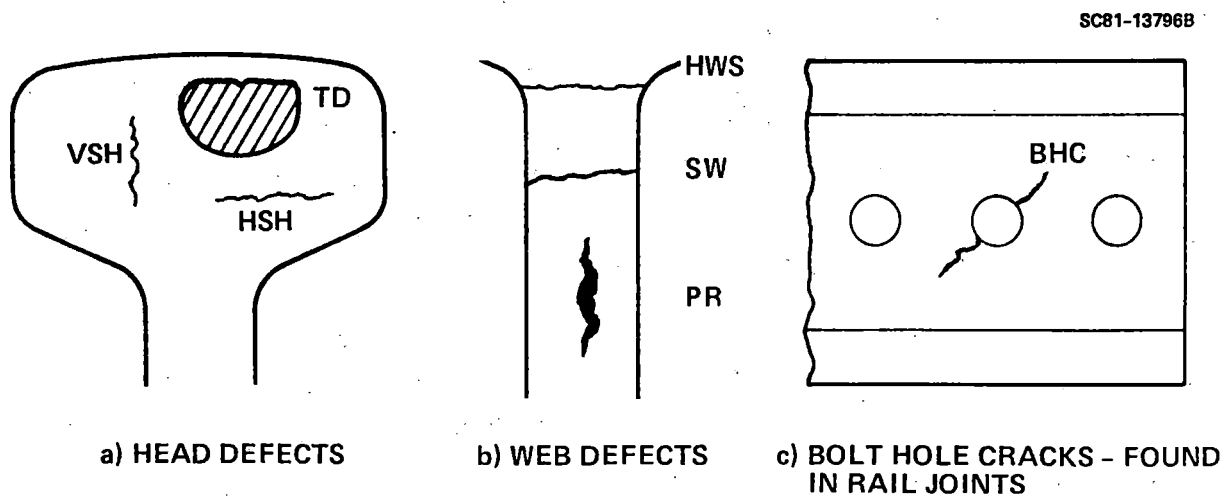
FIGURE 3-1 SHAPE AND POSITION OF SOME TYPICAL RAIL FLAWS.

Rail defects are categorized by the plane in which they lie. If their areas lie predominantly in a plane that is perpendicular to the length of the rail, they are classified as transverse defects. If their areas lie in the vertical or horizontal planes extending along the rail length, they are classified as longitudinal defects. They are further classified according to whether they exist in the head, web or base of the rail section. Some typical examples of rail defects that were of concern in this program are illustrated in Fig. 3-1.

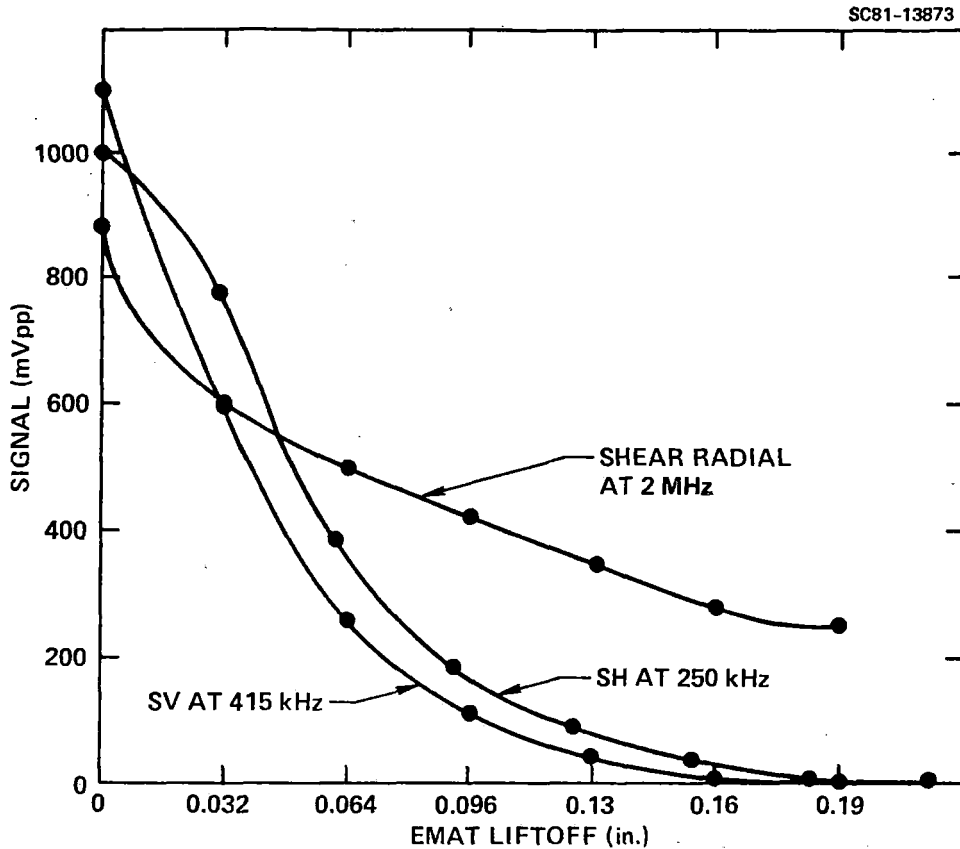
FIGURE 4-3 THE AFFECT OF LIFT-OFF DISTANCE ON THE SIGNAL SIZE IS DEPENDENT ON BOTH EMAT GEOMETRY AND FREQUENCY OF OPERATION.

Although the noncontact operation of EMATs is one of the features that makes them a valuable addition to the arsenal of ultrasonic inspection transducers, they need to be in close proximity to the test object for effective production of eddy currents. Figure 4-3 shows that the closer the EMAT coil is to the specimen, the higher the S/N ratio will be. These data exhibit an approximately exponential decrease in the received signal amplitude with

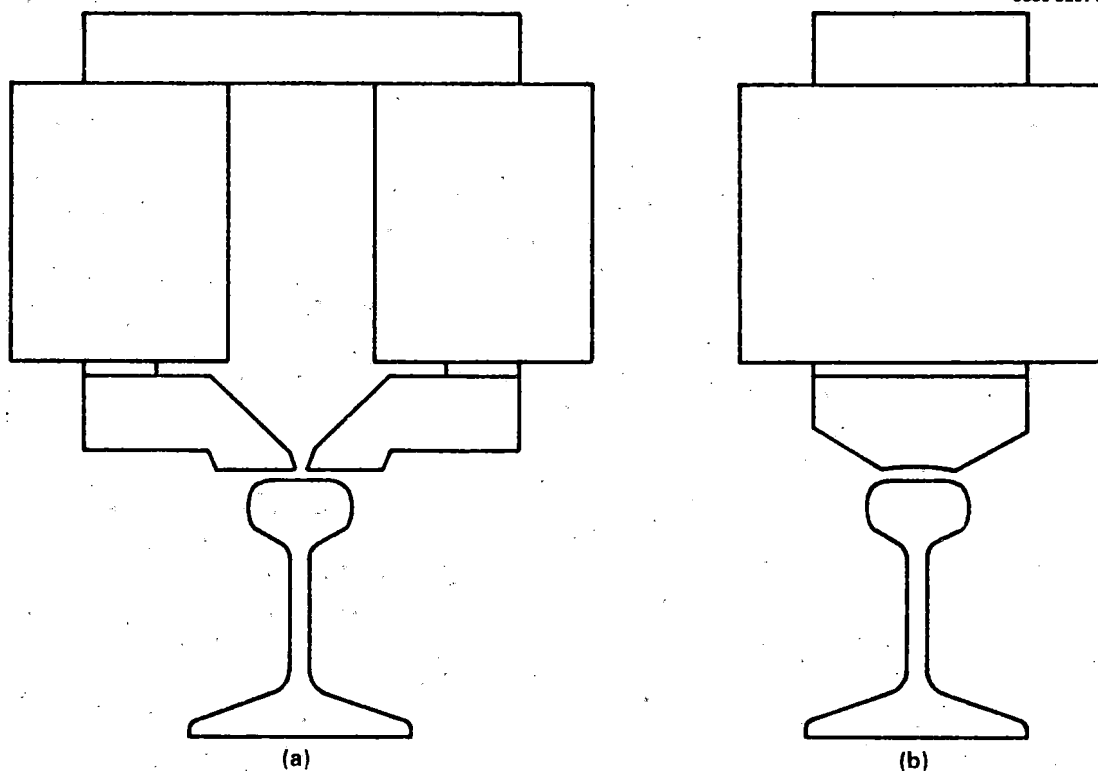
FIGURE 4-5 ORIENTATION OF ELECTROMAGNET OVER THE RAIL WITH (A) SH EMAT POLE PIECES; (B) SR AND SV EMAT POLE PIECES.

The solenoid for generating the bias magnetic field for the EMAT coils is shown in Fig. 4-5. It has an iron core 2 in. x 6 in. cross section (12 sq in. area) and has two encircling coils consisting of 1700 turns of #12 copper wire each. At its normal operating condition, it draws 6 amps and dissipates 300 W of electrical power. Its total weight is approximately

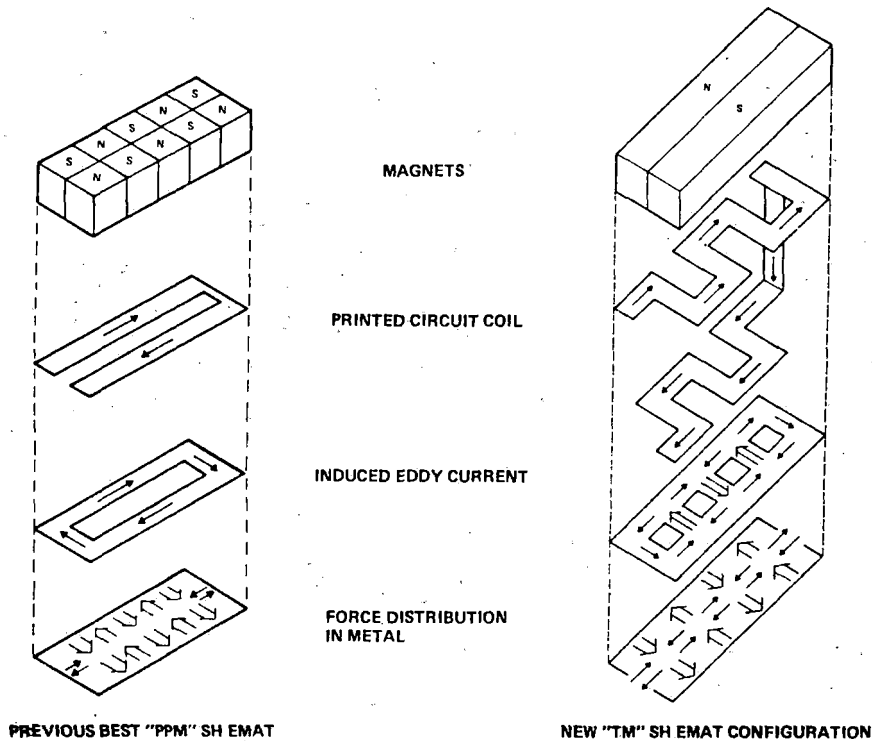
FIGURE 4-7 SIDE-BY-SIDE COMPARISON OF TM AND PPM GEOMETRIES.

An earlier version of the SH EMAT uses a simpler coil, but requires several periodic alternating magnetic poles which can be implemented more easily using permanent magnets than electromagnets. Figure 4-7 compares the periodic permanent magnet and the twin magnet SH EMATs in greater detail; they are nearly the same in their effect. In the TM version, the two straight, long magnetic poles of opposite polarity substitute for the straight, long electrical conductors of opposite current direction in the PPM version. Likewise, the meandering current conductor in the TM substitutes for the periodic magnetic pole configuration in the PPM EMAT. Both configurations produce the desired force distribution, indicated by the large arrows at the bottom of the figure. The new TM version is not quite as efficient, however, because part of the available energy goes into the production of forces at right angles to the desired direction, indicated by the small arrows at the bottom of the figure. However, the disadvantage of the PPM EMAT for use in testing ferromagnetic materials is that Barkhausen noise is produced if the PPM transducer is moved at any appreciable speed. In a railhead, the magnetic domains in the rail are flipped back and forth between north and south polarizations as the magnet segments of alternating polarization pass over, producing acoustic noise signals that can be comparable in amplitude to the flaw signals. Therefore, the PPM EMAT cannot be used as a moving receiver on a ferromagnetic

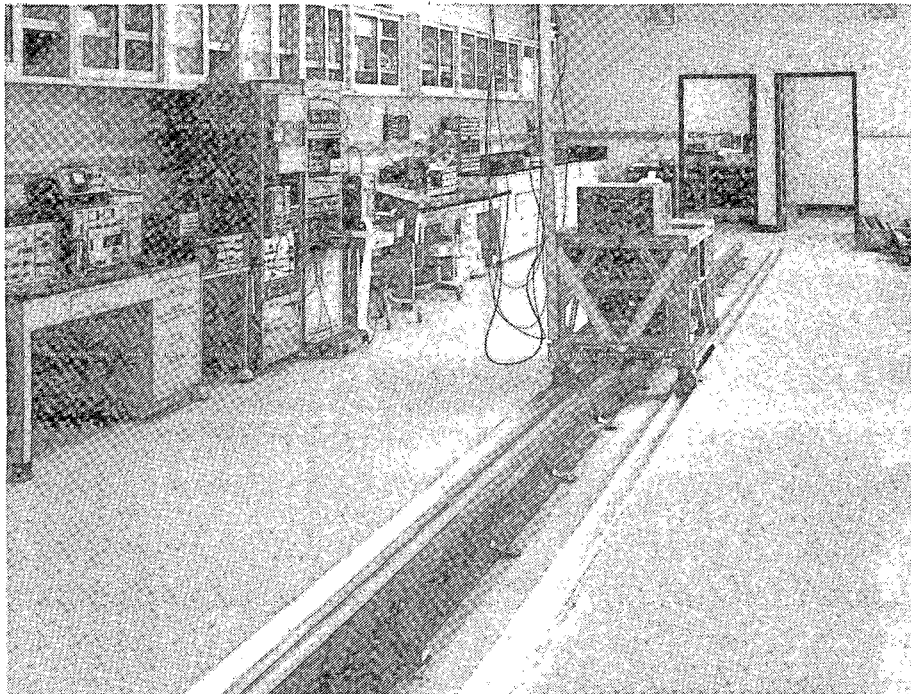
FIGURE 5-1 LABORATORY RAIL TEST FACILITY

The magnet support cart maintained alignment of the EMATs with the rail head and a magnet-to-rail gap of about 1/4 in. as it was moved down the line of rails. The EMATs and EMAT holders, the magnet power supply, the EMAT

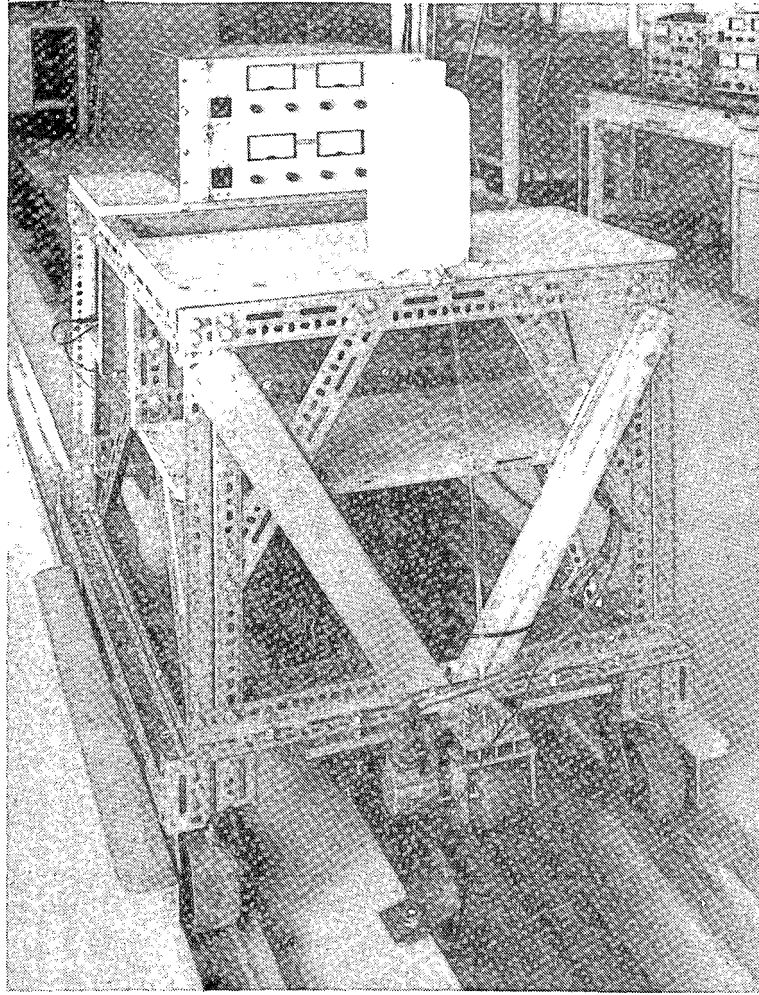
FIGURE 5-2 LABORATORY TEST CART.

Figure 5-2 shows a closer view of the magnet support cart. A distance encoder attached to the base of the cart rolled along the rail and provided synchronization between the strip chart recorder drive, the EMAT transmitter pulses and the cart movement. Also mounted on the cart in back of the distance encoder was a water-filled ultrasonic inspection wheel. It had two piezoelectric transducers inside, one to generate a  $0^\circ$  longitudinal wave in the rail (vertical) and the other to generate a  $70^\circ$  mode-converted shear wave. A water supply was kept on the cart to provide acoustic coupling between the

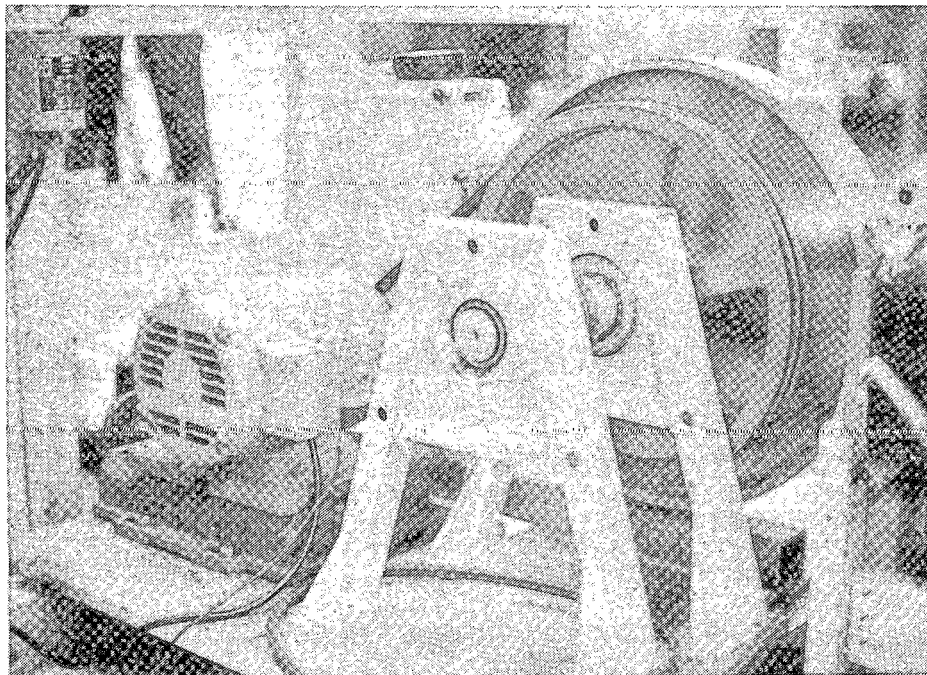
FIGURE 5-5 MOTION EMULATION MACHINE FOR EVALUATING EMAT PERFORMANCE UNDER DYNAMIC CONDITIONS.

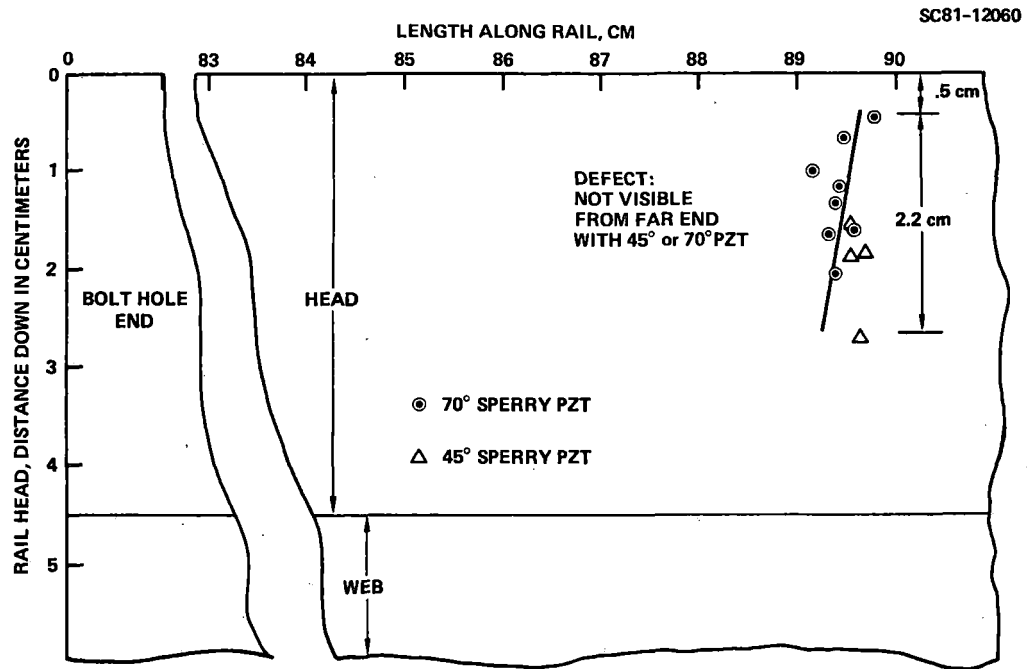
FIGURE 5-6 RESULTS OF HAND MAPPING THE TRANSVERSE DEFECT IN RAIL SPECIMEN NO. 320.

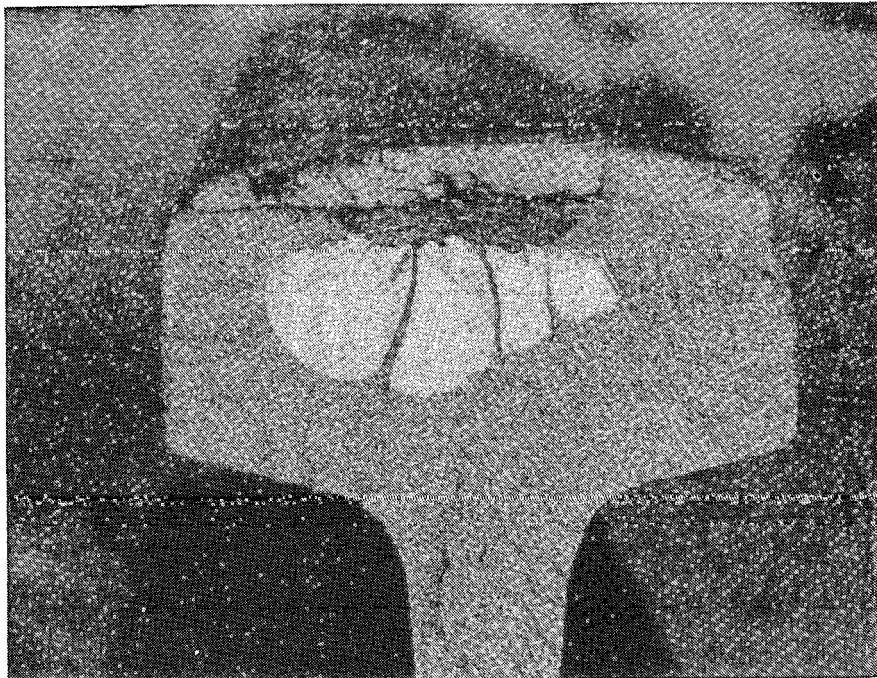
FIGURE 5-7 APPEARANCE OF THE DEFECT IN RAIL SPECIMEN NO. 320 AFTER BREAKING THE RAIL.

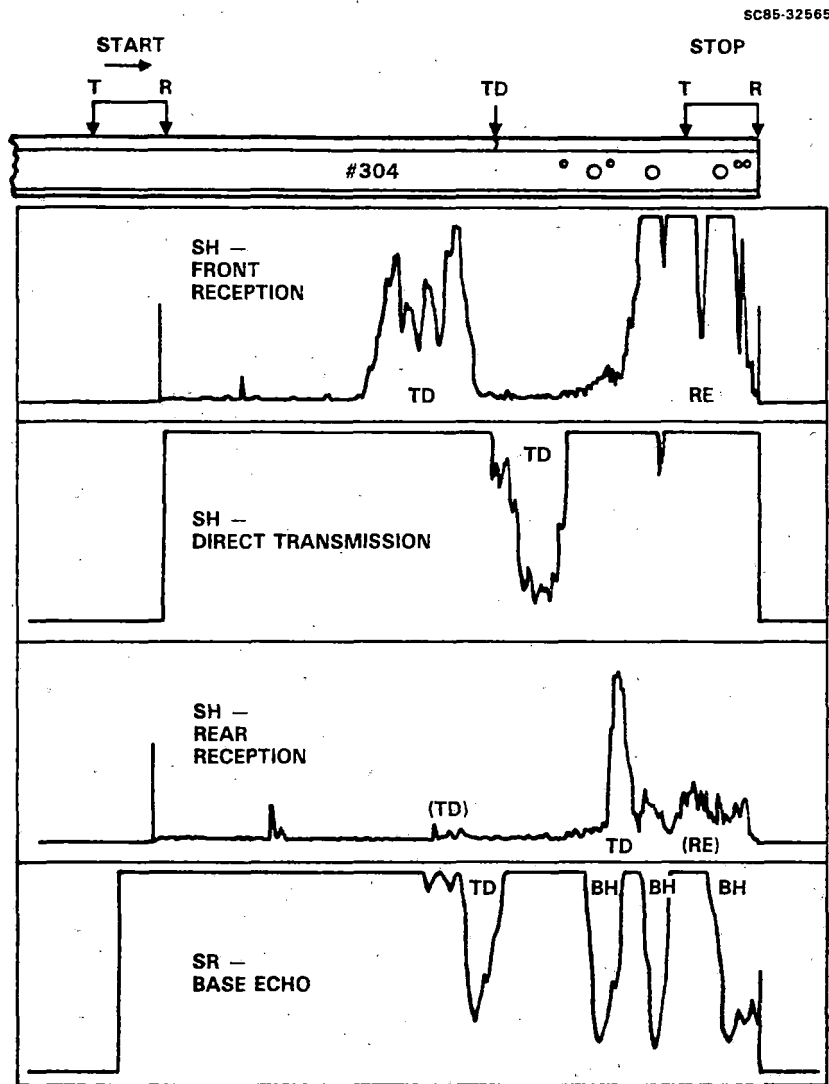
FIGURE 5-9 EXAMPLE OF TD DETECTION WITH SH AND SR EMATS.

The third chart recording shows the amplitude of the signal reflected off the TD after both EMATs have passed over it. This is again the output of the rear-looking receiver, but in a later time window than for reception of the direct transmission signal. This signal is smaller than from the forward-looking direction, indicating that the top of the TD is tilted toward the rail end. Also seen in this trace is evidence of reception from the forward direction (TD) and (RE) reflections, but the amplitudes of these signals are down 16 dB from those detected by the forward-looking receiver shown in the top chart recording.

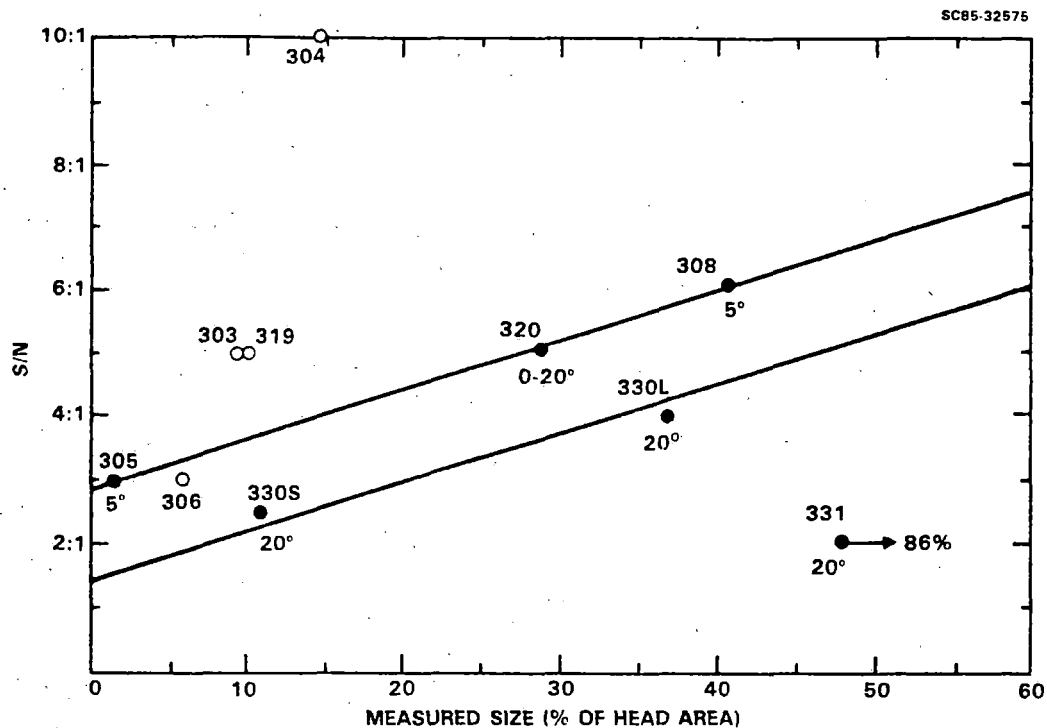
FIGURE 5-10 SIGNAL-TO-NOISE RATIO FOR SH WAVE DETECTION OF THE SIX TRANSVERSE DEFECTS EXPOSED BY RAIL BREAKING.

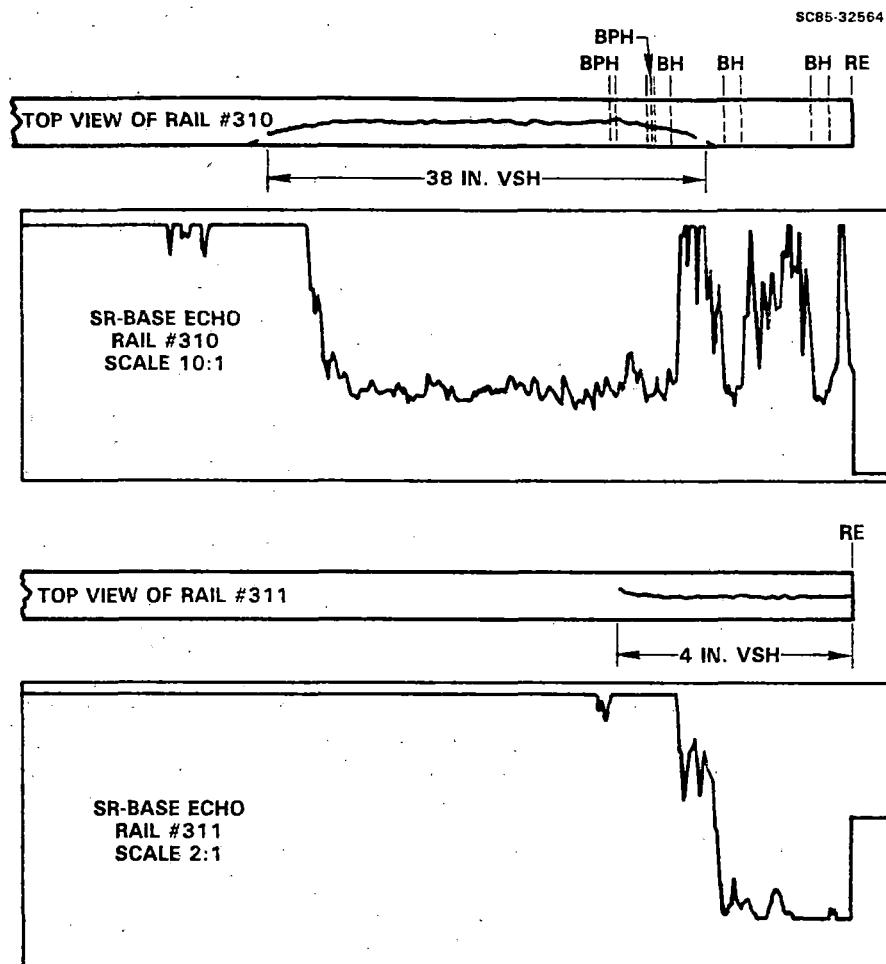
FIGURE 5-11 DETECTION OF VSH DEFECTS WITH SR EMAT.

Fig. 5-11 for rail specimens No. 310 and 311. Above each strip chart recording is a same scale representation of the result of mapping the location of the VSH defect using a conventional hand-held transducer on the side of the rail head. This measurement only defines the side-to-side position of the crack with position along the length of the rail, but does not have the resolution to define its vertical position or its height. It is presumed that the crack tapers down in vertical height near its ends, and that effect plus the tendency of the crack to curve toward the side of the rail head accounts for the failure to attenuate the base-echo signal near the ends of the cracks. However, the base-echo is effectively attenuated for 31 in. of the 38 in. length of the VSH in No. 310 and 2.9 in. of the 4.0 in. in No. 311. The amount of attenuation is about 100%, as can be deduced by comparison with the signal level at the 1-3/8 in. diameter bolt holes in No. 310. The S/N for detecting these defects is then just the ratio of the normal base-echo amplitude to the electronic noise level which is greater than 10:1 in most of the rail specimens.

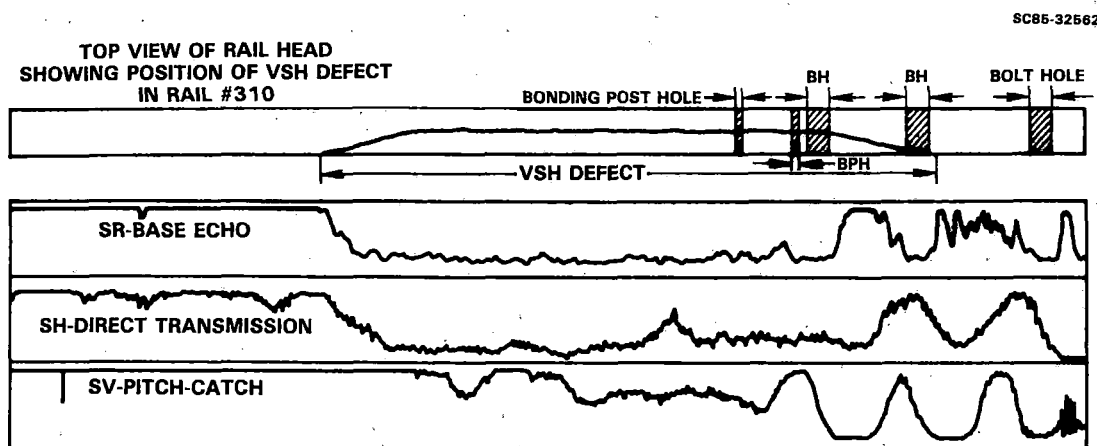
FIGURE 5-12 DETECTION OF VSH DEFECT WITH SR, SH AND SV EMATS.

Detection of VSH defects is also possible using the SH and SV EMATs. This is illustrated by the three strip chart recordings in Fig. 5-12 for the defect in specimen NO. 310. The direct transmission signal from the SH transmitter to the receiver, located about 9 in. away along the rail head, is attenuated by the VSH nearly as effectively as is the SR base-echo signal. Both of these ultrasonic waves have the same shear polarization relative to the crack faces so they are expected to be attenuated similarly. However, there is a greater proportion of the SH beam width that travels in the rail head parallel to the VSH defect than in the SR beam which travels vertically through the web to the base of the rail and back. Therefore, the effective attenuation of the SH wave by a VSH may not always produce as large a S/N for defect detection as the SR wave. The spatial resolution of the SH detection is not as good for this type of defect either, especially near the ends of a

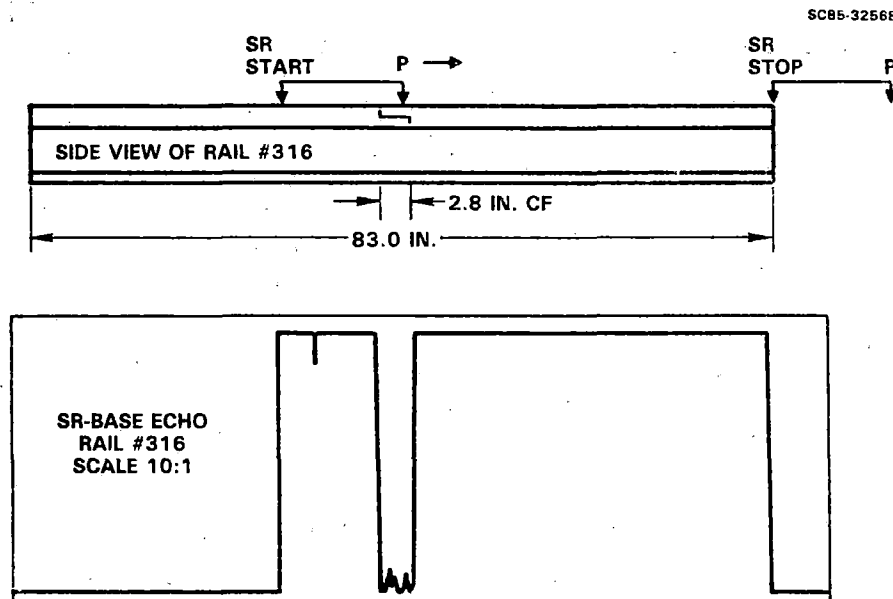
FIGURE 5-13 DETECTION OF A CF DEFECT WITH SR EMAT.

The compound fracture has a horizontal length of 2.8 in. with very small vertical components at each end, as determined by using a 70° wedge transducer. The SR base-echo was completely blocked for a distance of 3.2 in. which, accounting for the size of the EMAT, accurately represents the size of the defect to within 0.1 in. The S/N is that of the base-echo amplitude above electronic noise or greater than 10:1.

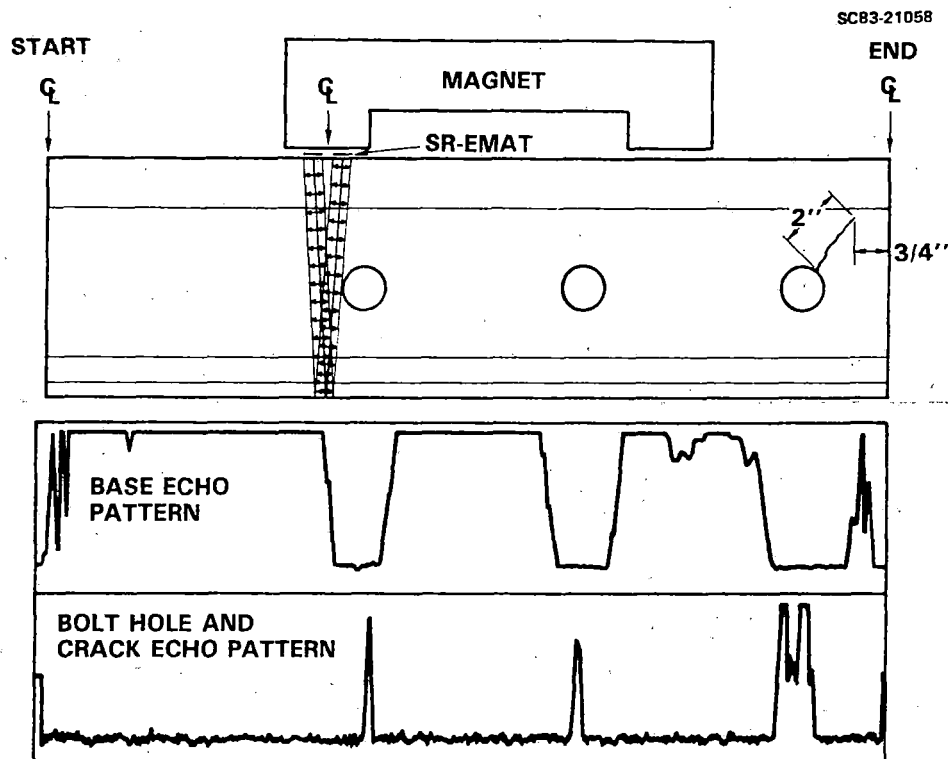
FIGURE 5-16 DETECTION OF BHC WITH SR EMAT.

Only one BHC specimen, No. 32, was available for testing (except for specimen No. 303 which had a 1/4 in. deep horizontal saw cut at a bolt hole). A scale drawing of the side view of specimen #32 is shown in Fig. 5-16, indicating the location, size and orientation of a service induced BHC. Also shown to scale are the 1/2 in. diameter spiral wound SR transmitter and receiver EMATs located close together under one of the magnet pole pieces and operating essentially in the pulse-echo mode. Below the drawing are strip chart traces of the amplitudes of the signal reflected off of the base of the rail and off of the bolt holes and the bolt hole crack, obtained by two different settings of the position of the detection time window. From the width of the base-echo extinction region, the bolt hole diameter and the length of the horizontal projection of the BHC could be reproducibly determined to within 0.1 in. (by analysis of many chart recordings of both specimens Nos. 32 and 303). The bolt hole echo pattern does not as reliably provide a quantitative measure of the projected crack length, since there may not always be facets along the entire length of the crack that are oriented properly to reflect the ultrasonic energy back to the receiver transducer. However, an anomalously wide reflection pattern was observed in all of the strip chart recordings which at least indicated the presence of the crack (or the saw cut in No. 303).

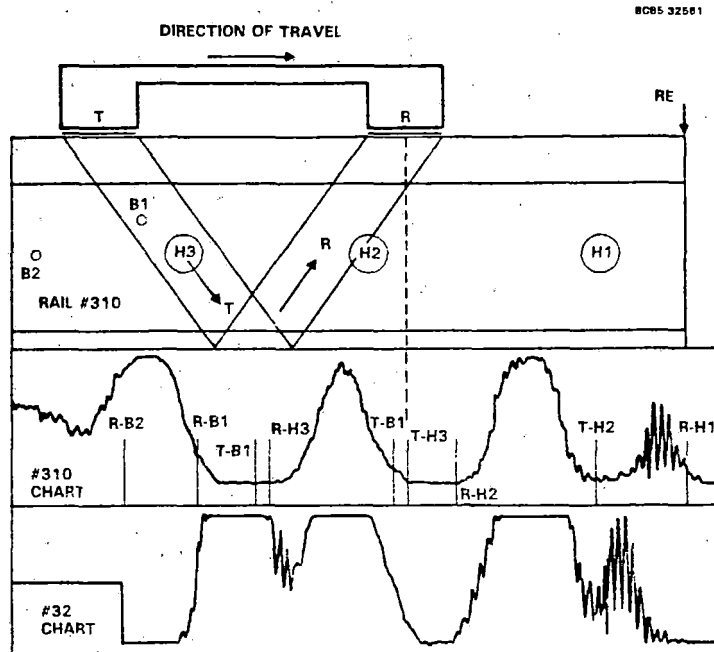
FIGURE 5-17 SIGNAL PATTERN FROM BOLT HOLES FOR SV EMAT OPERATING IN THE PITCH-CATCH MODE.

The use of the 35° SV wave for detecting and measuring the length of a BHC is conceptually the same as for a 0° SR wave when the bolt hole is located away from a rail end. The different beam angle provides an additional measure of BHC detection to allow for the possibility of the crack plane lying entirely within the shadow of the bolt hole for either one of the ultrasonic beam angles. There are "blind spots" for BHC detection for either beam angle and, in particular, the proximity of the BHC in specimen No. 32 to the rail end. The reason for this can be understood in terms of the more complex ultrasonic beam geometries of the SV EMATs in both the pitch-catch and pulse-echo modes, as illustrated in Figs. 5-17 and 5-18. For the case of pulse-echo detection, the path of the ultrasonic beam from the transmitter to the base of the rail is designated as T, and the path between the base of the rail and the receiver is designated as R. In rail specimen #310, there are three 1-3/8 in. diameter bolt holes drilled through the web designated as H1, H2 and H3 in the scale drawing in Fig. 5-17, and two 3/8 in diameter bonding post holes desig-

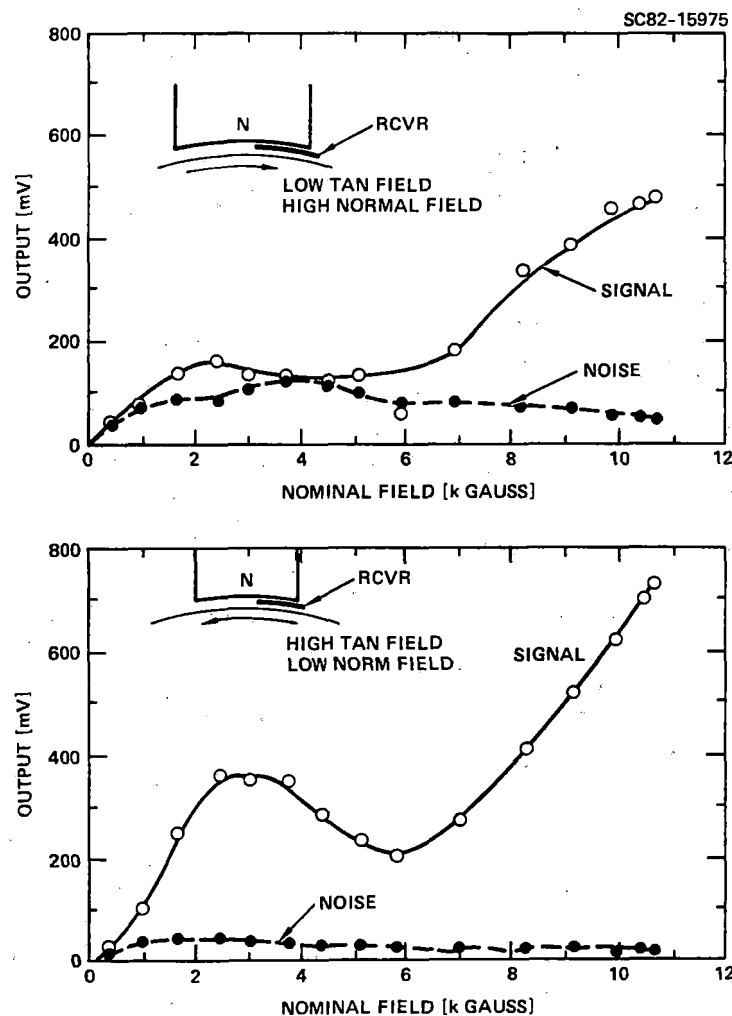
FIGURE 5-22 DEPENDENCE OF SIGNAL AND NOISE AMPLITUDES AT 30 MPH ON THE MAGNETIC FIELD AND DIRECTION OF ROTATION.

If the Ti were removed and the EMAT coils were held against the pole pieces by adhesive tape, the noise signals were much smaller and it was observed that the location of the EMAT receiver coil relative to the edge of the magnet pole pieces had a striking influence on the noise. Figure 5-22 shows how the signal and noise varied with magnetic field and direction of rotation of the wheel. In this case, the transmitter and receiver were

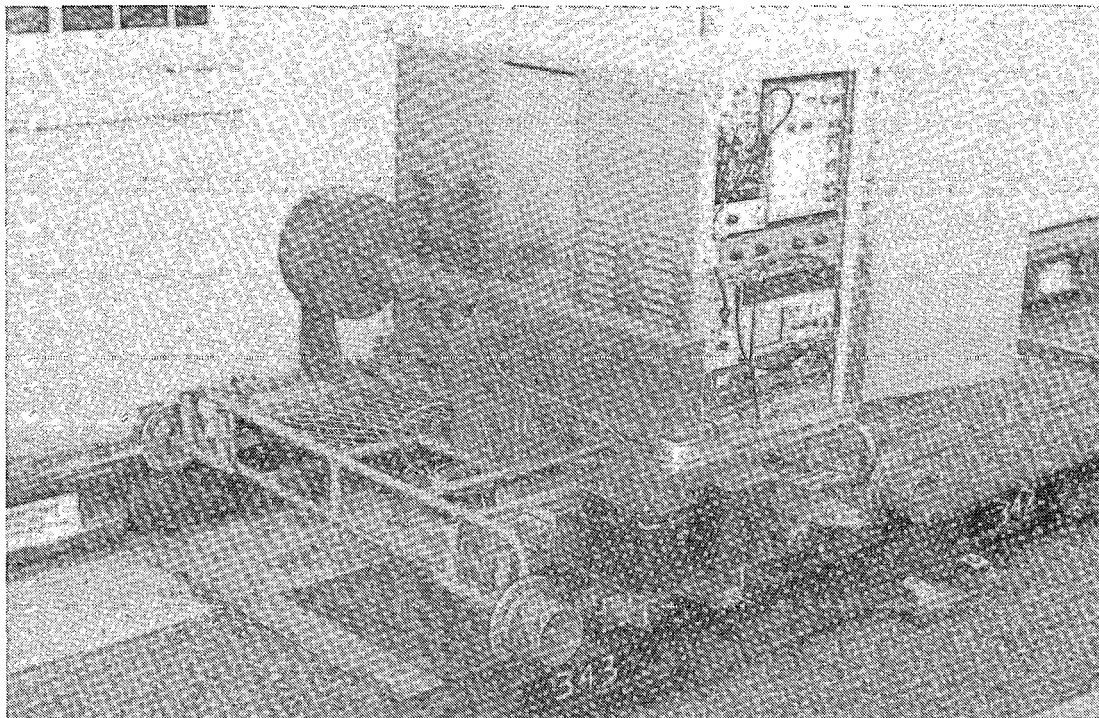
FIGURE 6-1 EXPERIMENTAL EMAT RAIL INSPECTION TEST CART.

Lateral tracking of the magnet pole pieces above the railhead was maintained by forcing the cart wheel flanges to stay in contact with the gauge side of the rail being inspected. This was accomplished by two pneumatic

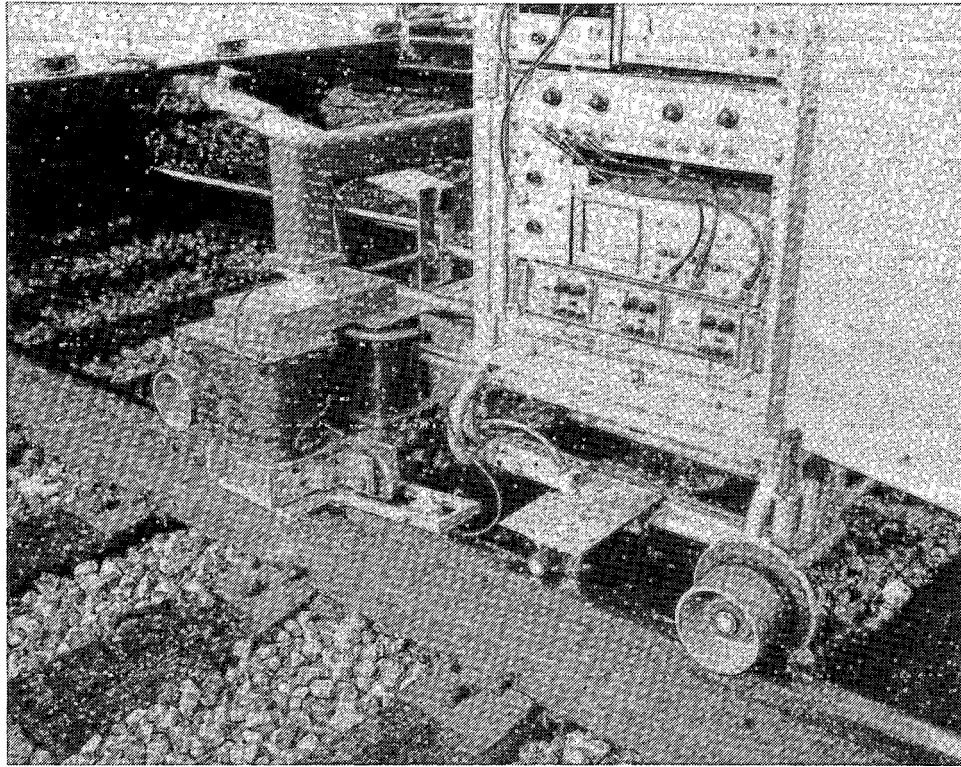
FIGURE 6-3 TEST CART BEING TOWED AT FAST TRACK.

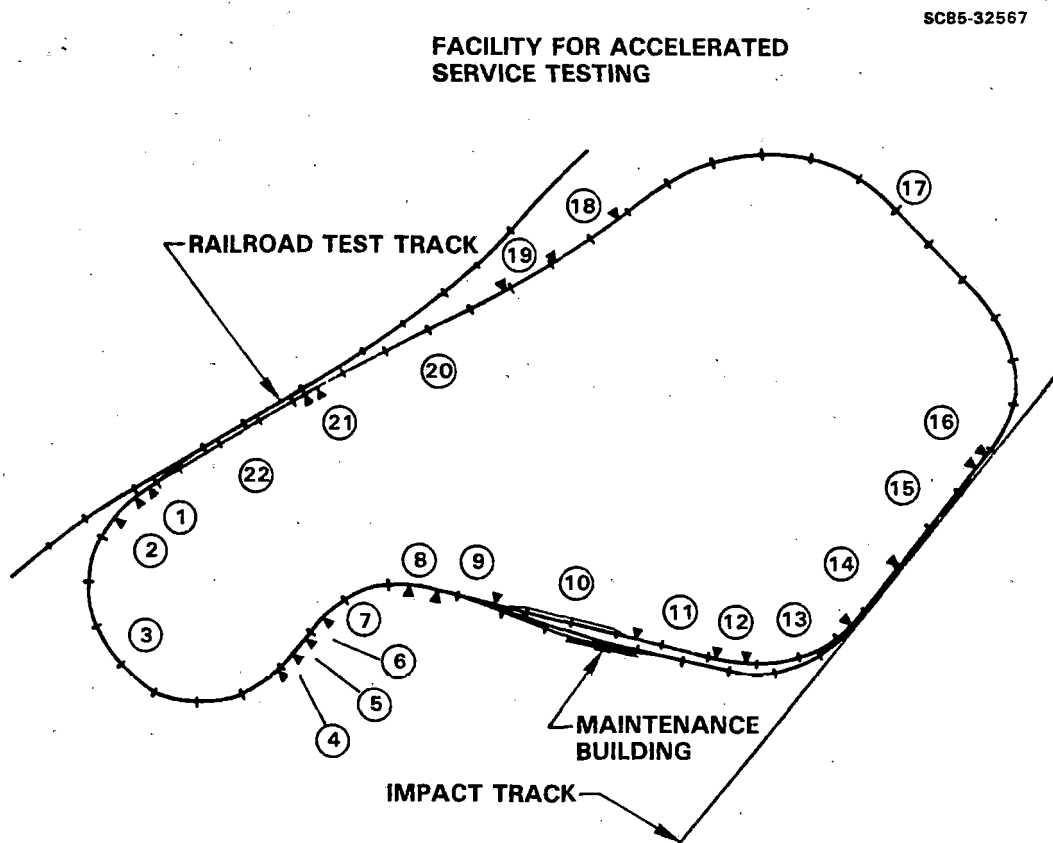
FIGURE 6-8 FACILITY FOR ACCELERATED SERVICE TESTING (FAST).

A map of the FAST track facility is shown in Fig. 6-8. Access to the track was just outside of the maintenance building, which also served as over-

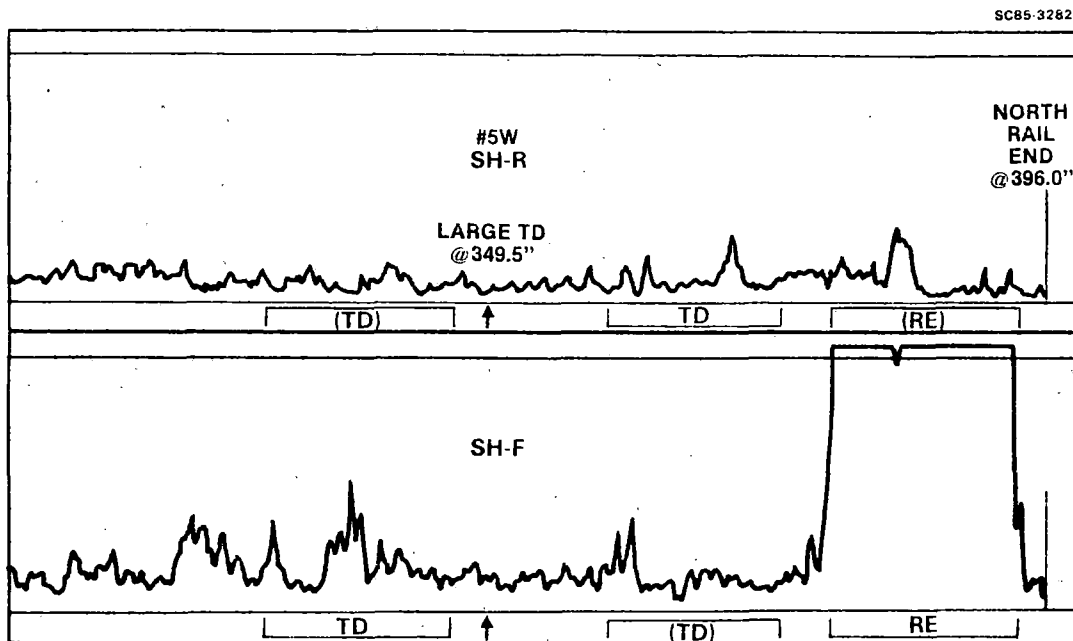
FIGURE 6-10 ILLUSTRATING THE POOR DETECTABILITY OF LARGE TD IN NO. 5W, POSSIBLY DUE TO AN ELECTROMAGNETIC COUPLING ANOMALY.

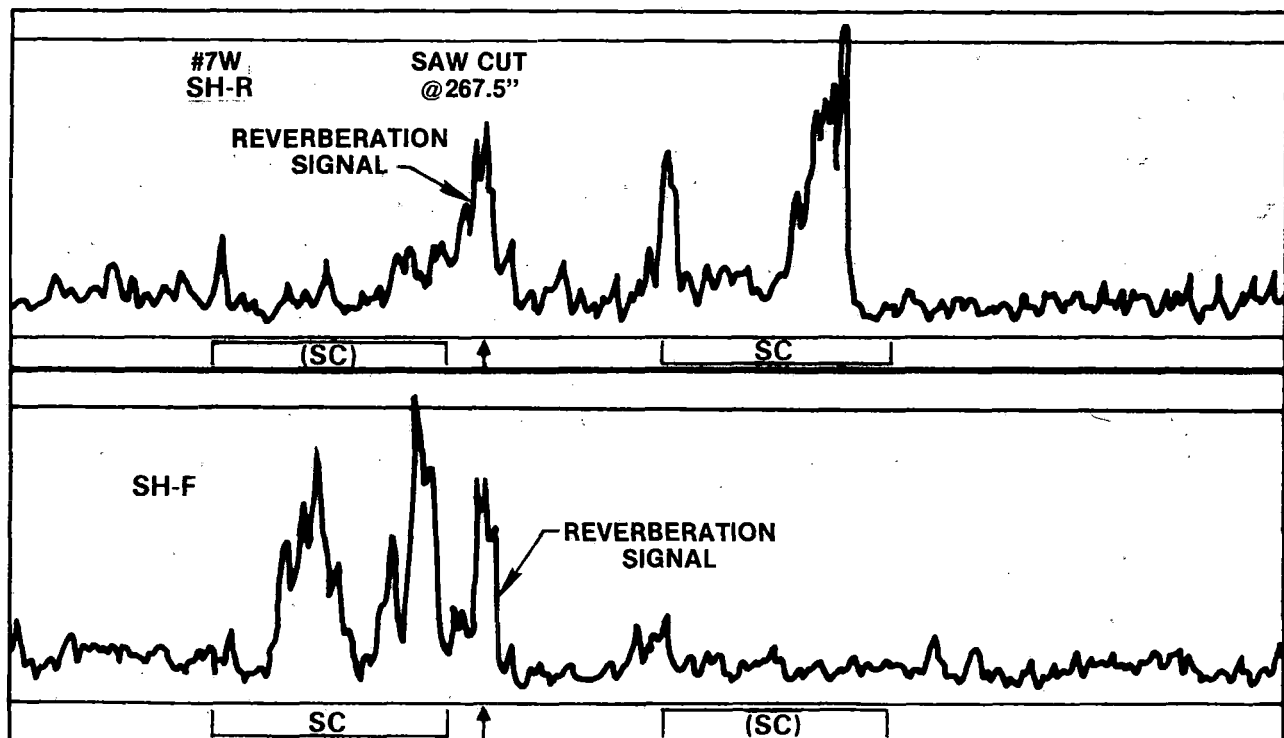
FIGURE 6-11 DETECTION OF 1/4 IN. DEEP SAW CUT IN SIDE OF RAIL HEAD IN NO. 7W.

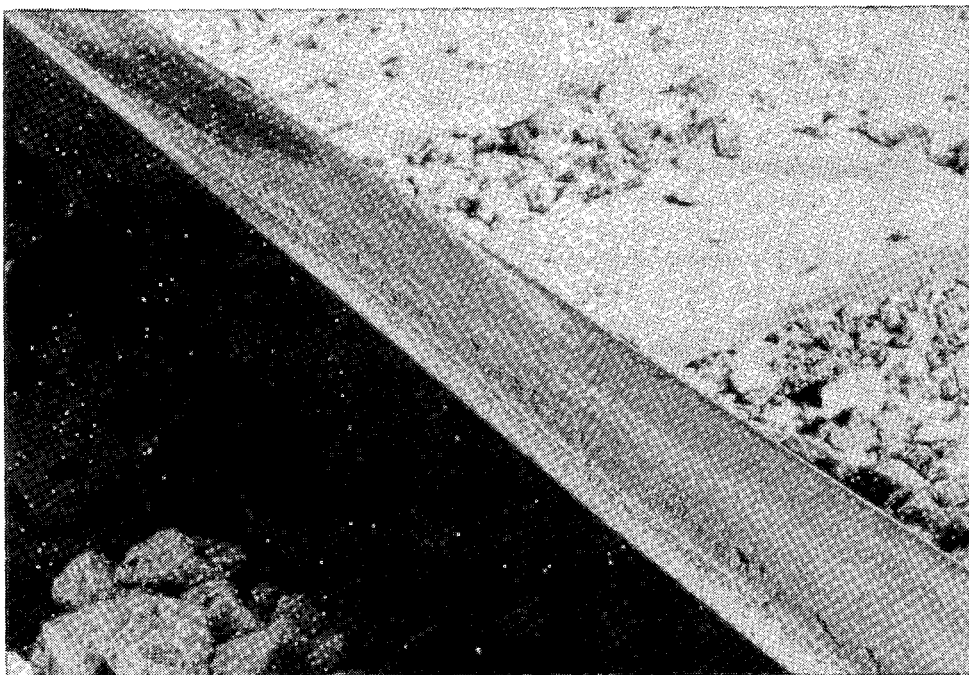
FIGURE 6-14 THE GAUGE SIDE WEAR PATTERN ON THE OUTSIDE RAIL IN THE CURVE.

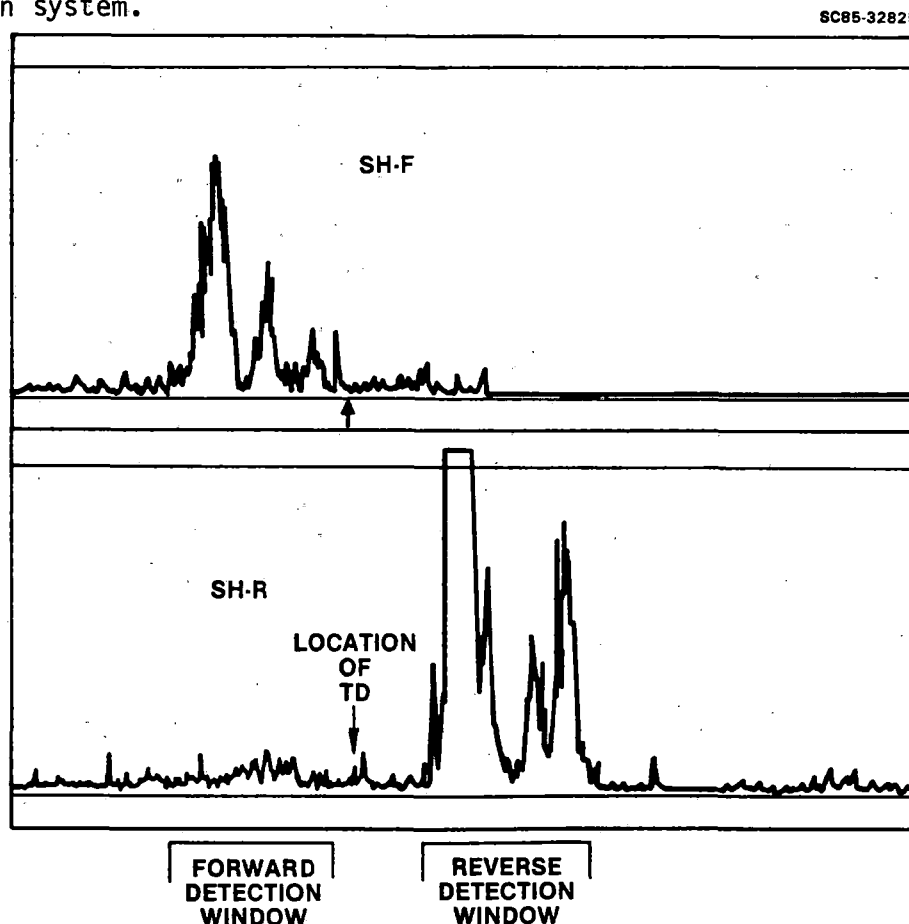
FIGURE 6-15 FORWARD AND REVERSE REFLECTION TRACES BY SH EMATs FROM LARGE UNMARKED TD IN INSIDE RAIL IN FAST SECTION NO. 10.

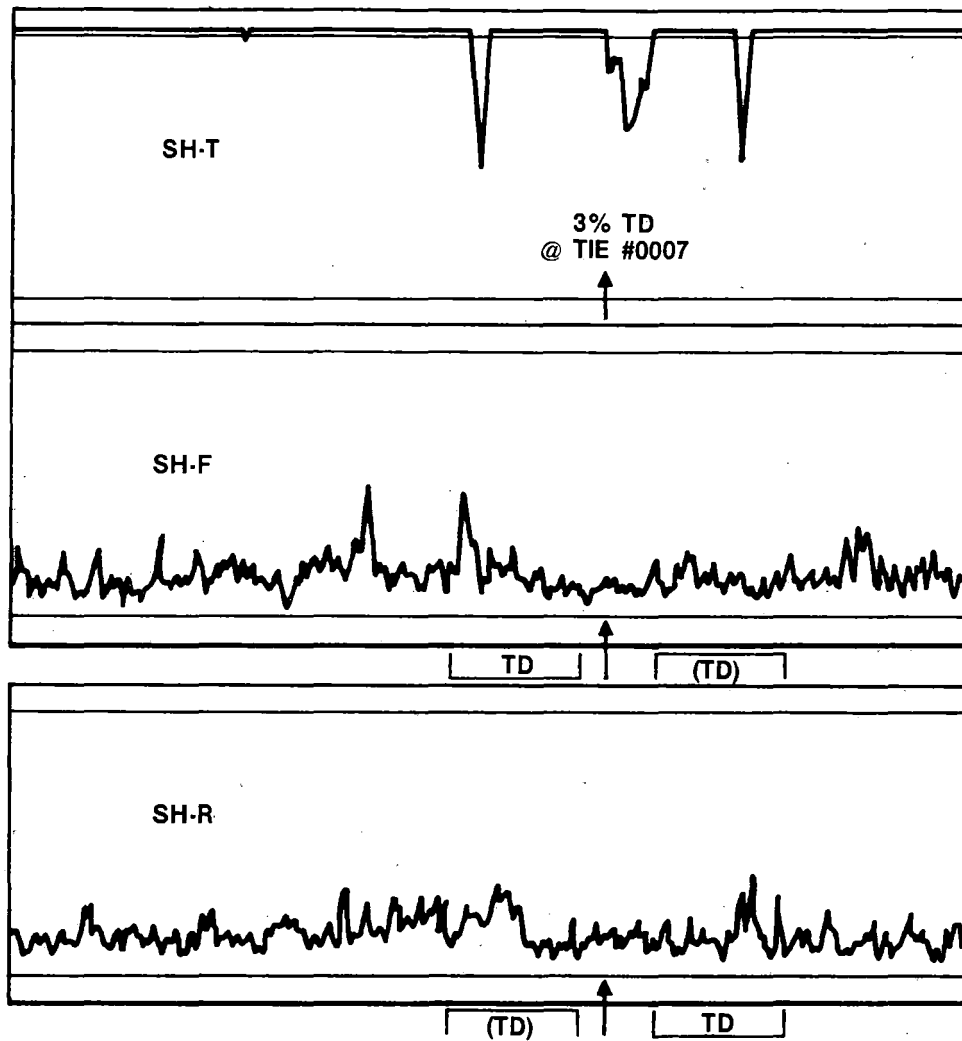
FIGURE 6-16 MARGINAL DETECTION OF 3% TD IN FAST SECTION NO. 7.

Of the five shells that were inspected with the SH EMATs, only one resulted in a measurable reflected signal which was about the size of that produced by the 3% TD in Fig. 6-16. Shelling is not considered to be a defect but a rail surface condition that is preferred not to be detected by the inspection system.
