# **ULTRASONIC INSPECTION OF RAILROAD RAILS BY ELECTROMAGNETIC ACOUSTIC TRANSDUCERS (EMATs)**

**ROCKWELL INTERNATIONAL SCIENCE CENTER  
1049 Camino Dos Rios  
Thousand Oaks, CA 91360**

**MAY 1986**

**FINAL REPORT**

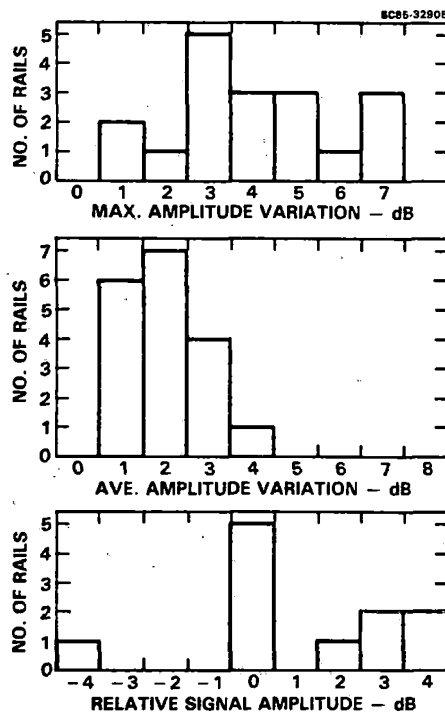
FIGURE 6-17 HISTOGRAMS OF SH DIRECT TRANSMISSION SIGNAL AMPLITUDE AND VARIABILITY WITHIN A RAIL SECTION FOR THE SANTA FE TEST TRACK RAILS.

Electromagnetic Coupling Variability. During the rail testing, local variations in the coupling efficiency of the EMATs were observed within a given section of rail, as well as systematic variations between sections. This variability could be most directly quantified by measuring the amplitude of the direct transmit signal between the SH transmitter and receiver since it does not depend on the reflective or geometric variations of, for example, the rail end or the base of the rail. Measurements of this variability were made for the rail sections at the Santa Fe Test Track from strip chart recordings of the direct transmit signal amplitude. For each rail section, the variation in the average signal amplitude along the entire length of the rail section was noted, as well as the maximum value of local variations, excluding variations due to known defects. Figure 6-17 shows histograms of the results of these measurements, as well as for the relative average signal amplitude between rail sections. In this later histogram, at the bottom of Fig. 6-17, the one rail section displaying the lowest transduction efficiency was section No. 5W, which contained the large TD that had the anomalously low reflected signal amplitude.

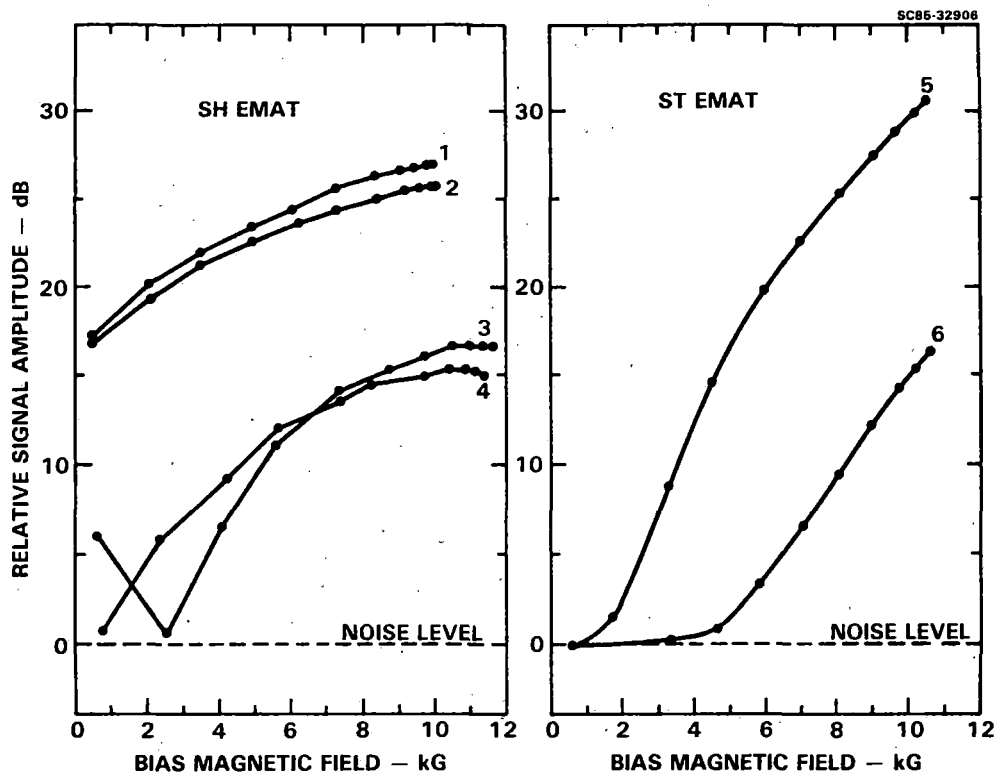
FIGURE 6-18 DEPENDENCE OF SIGNAL AMPLITUDE ON APPLIED BIAS MAGNETIC FIELD AT SELECTED POINTS ON FAST RAILS.

Test No.	V @ B = 10 kg	$B_0$	$V_0$
SH	1	0.810	+3.80
	2	0.642	+4.80
	3	0.358	-1.16
	4	0.245	+1.47
ST	5	1.075	-0.48
	6	0.357	-3.00

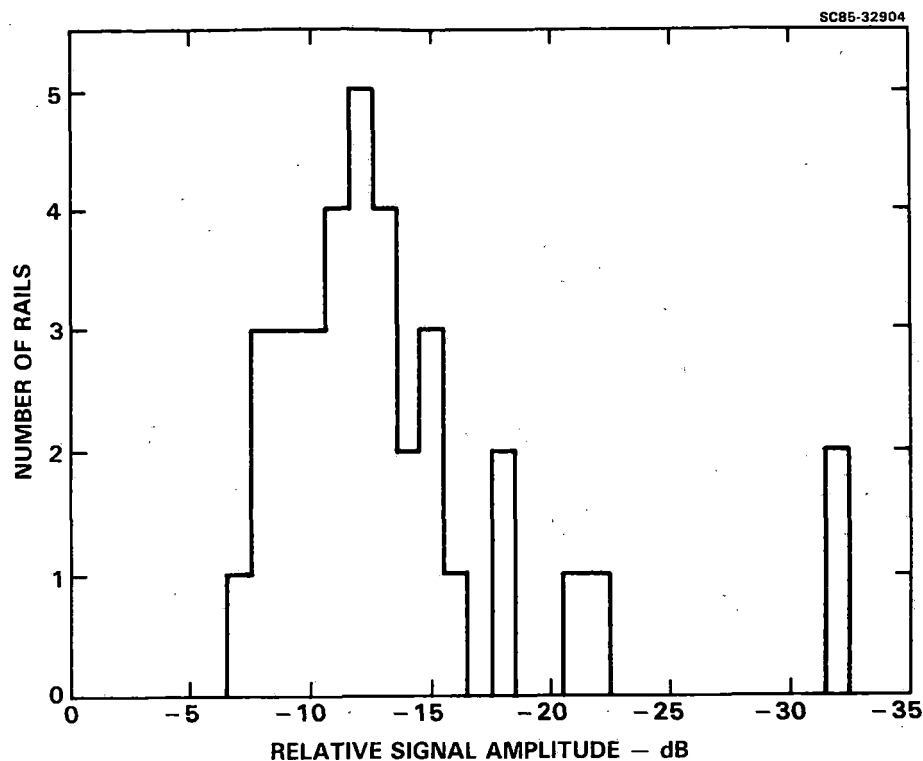
FIGURE 6-19 AMPLITUDE OF RAYLEIGH WAVES EXCITED BY A MAGNETOSTRICTIVE MECHANISM IN LABORATORY RAIL SPECIMENS RELATIVE TO A FLAT PLATE OF ANNEALED STEEL.

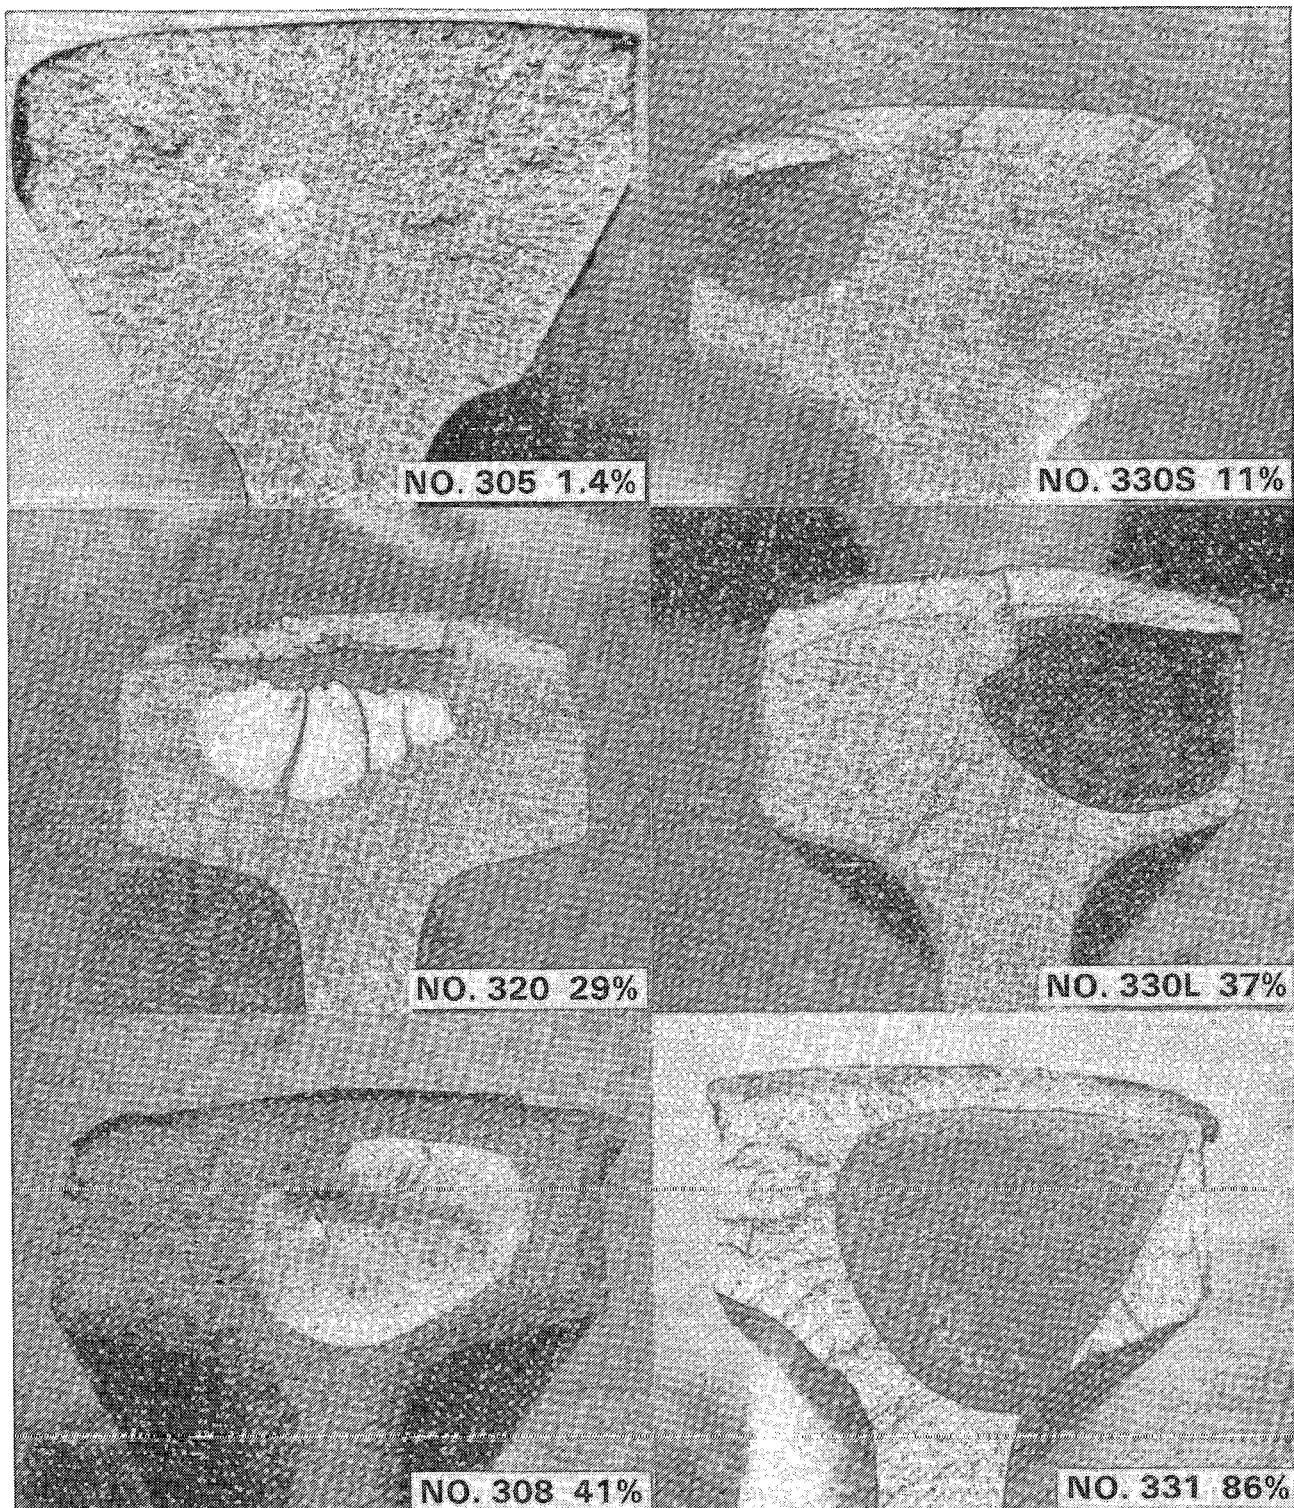
Figure B-1. Photographs of rail ends broken at six of the transverse defects tested.

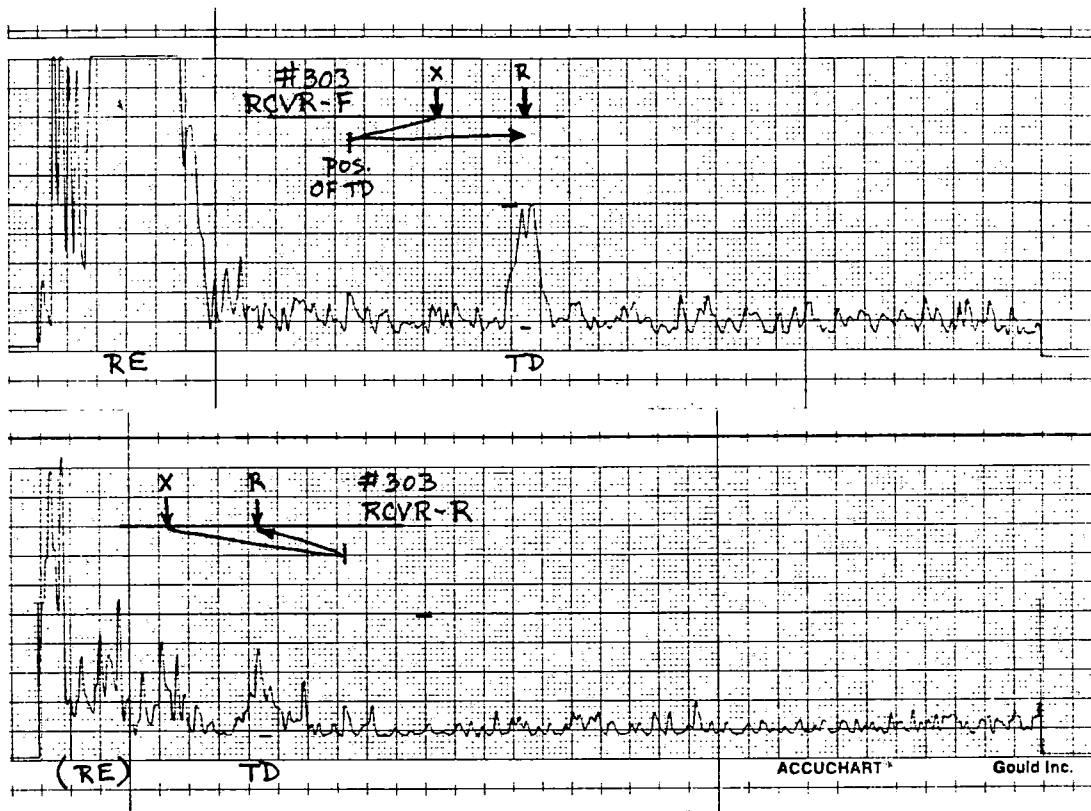
Figure C-1. Lab. Spec. #303 - 10% TDT

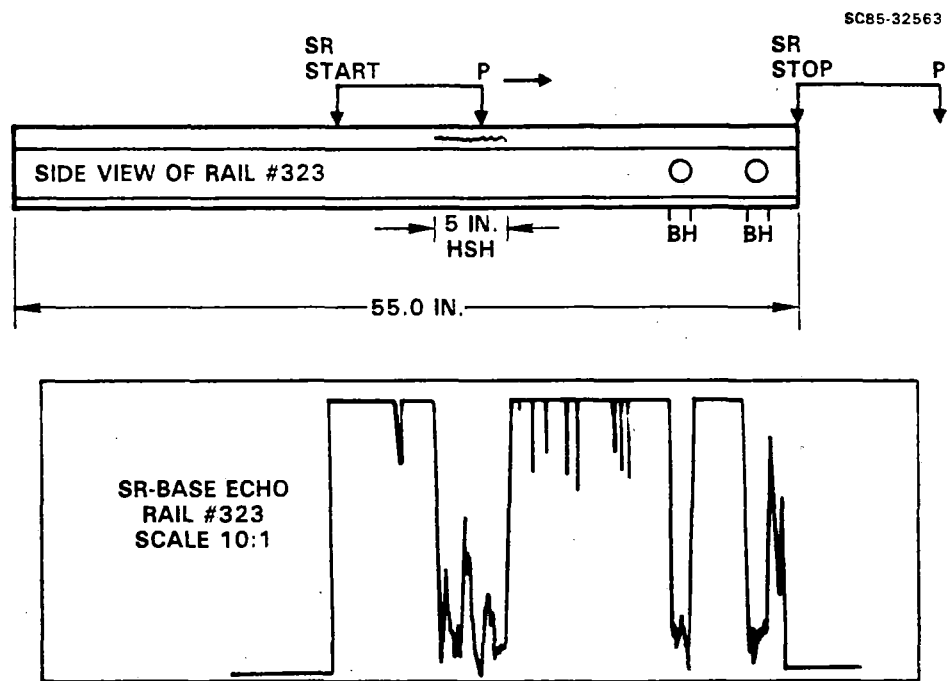
Figure C-11. Lab. Spec. #323 - 5 in. HSH.

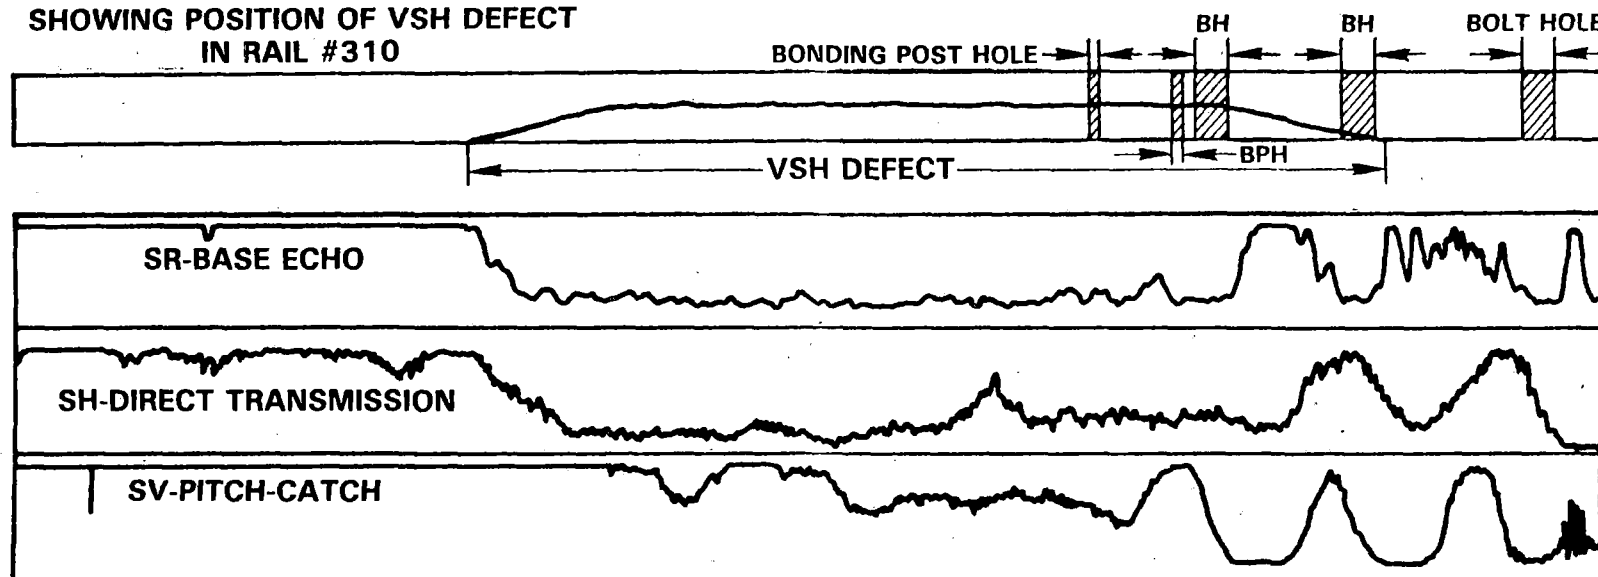
Figure C-12. Lab. Spec. #310 - detection of 38 in. VSH with SR, SH and SV EMATs.

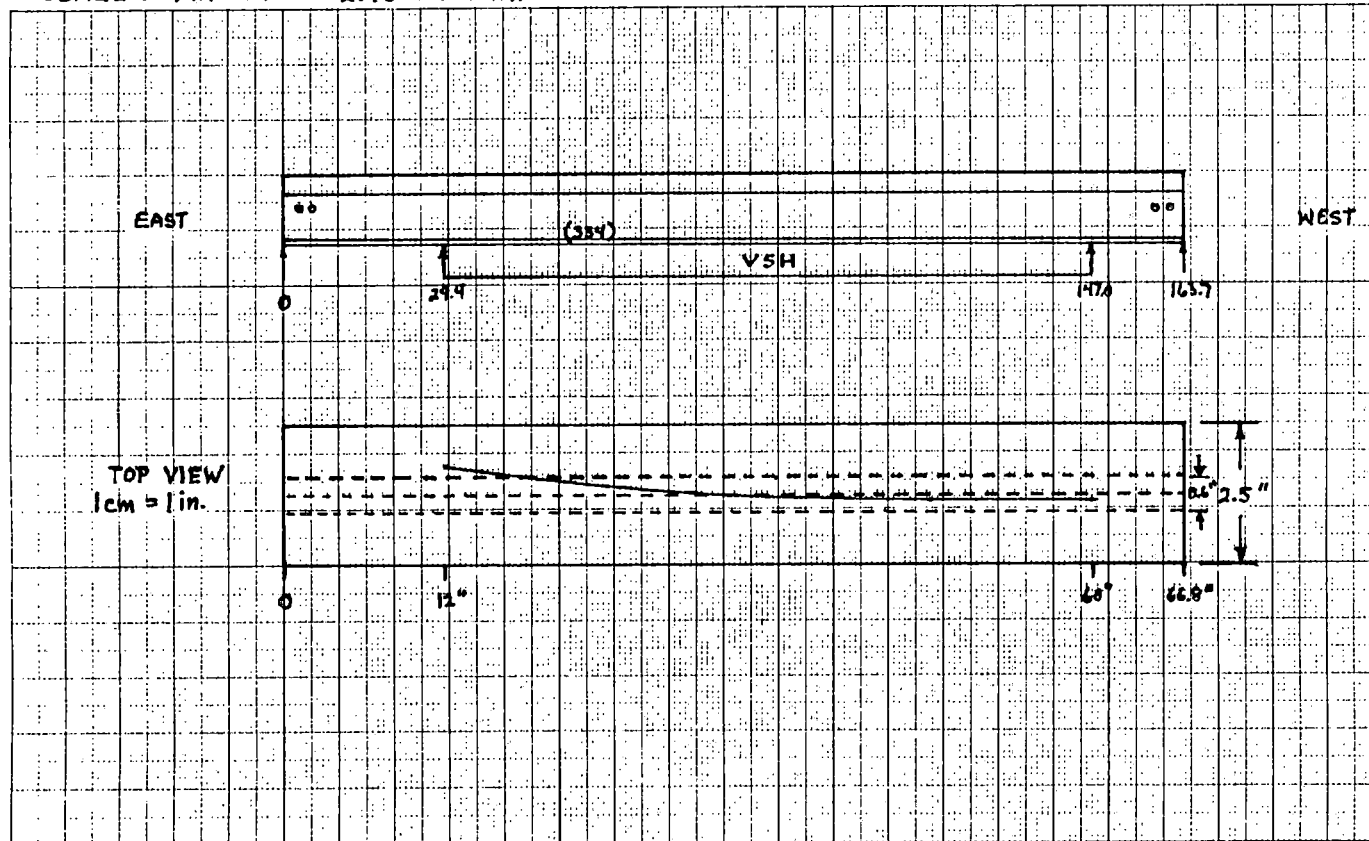
Figure C-14. Lab. Spec. #334 - 48 in. VSH defect (chart recording not available).

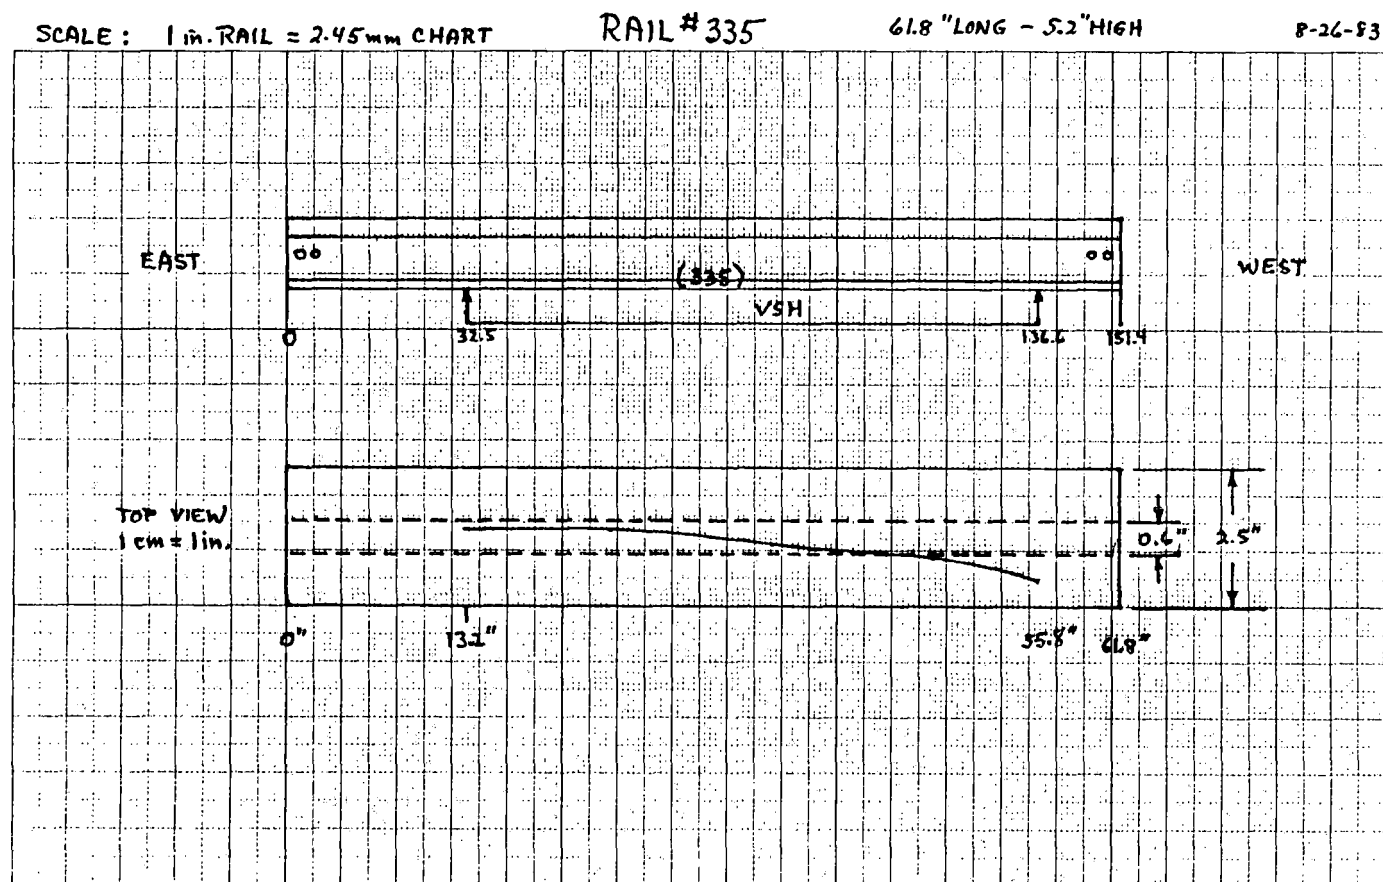
Figure C-15. Lab. Spec. #335 - 43 in. VSH defect (chart recording not available).

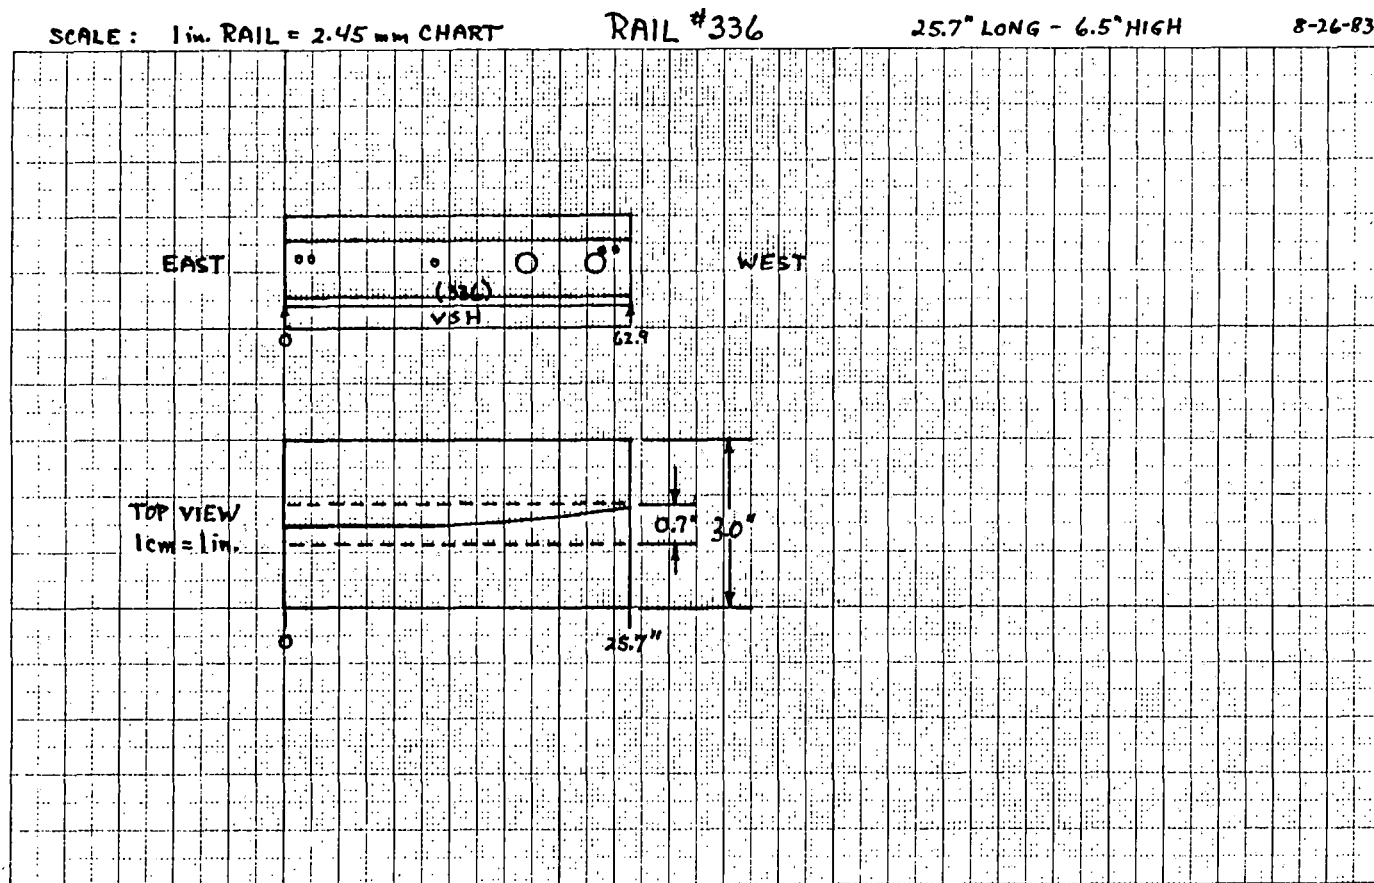
Figure C-16. Lab. Spec. #336 - 26 in. VSH defect (chart recording not available).

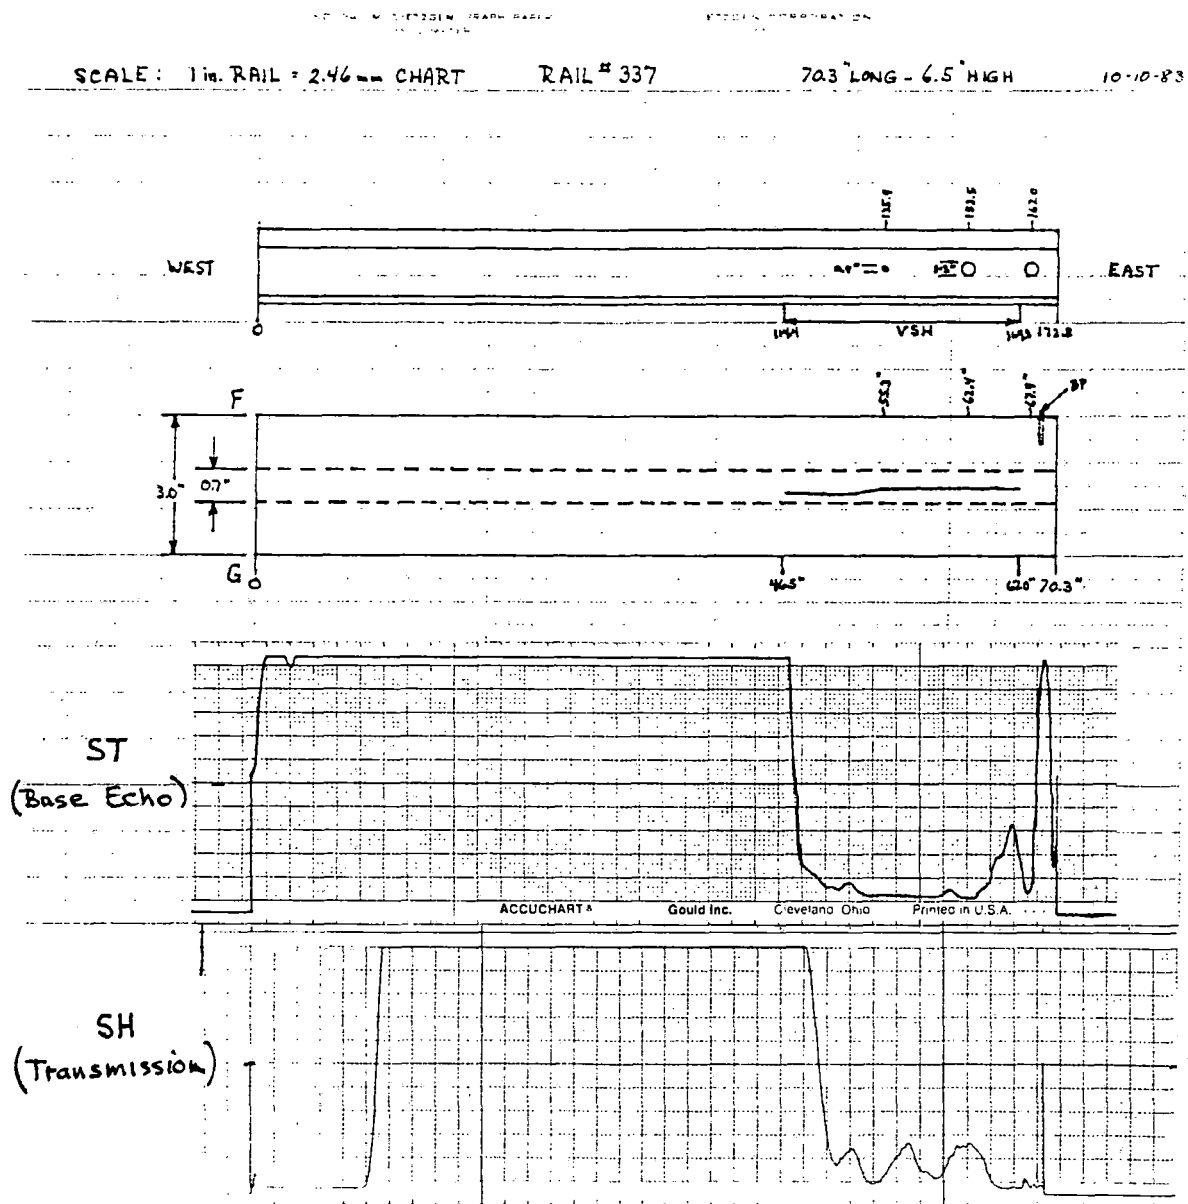
Figure C-17. Lab. Spec. #337 - 21 in. VSH defect.

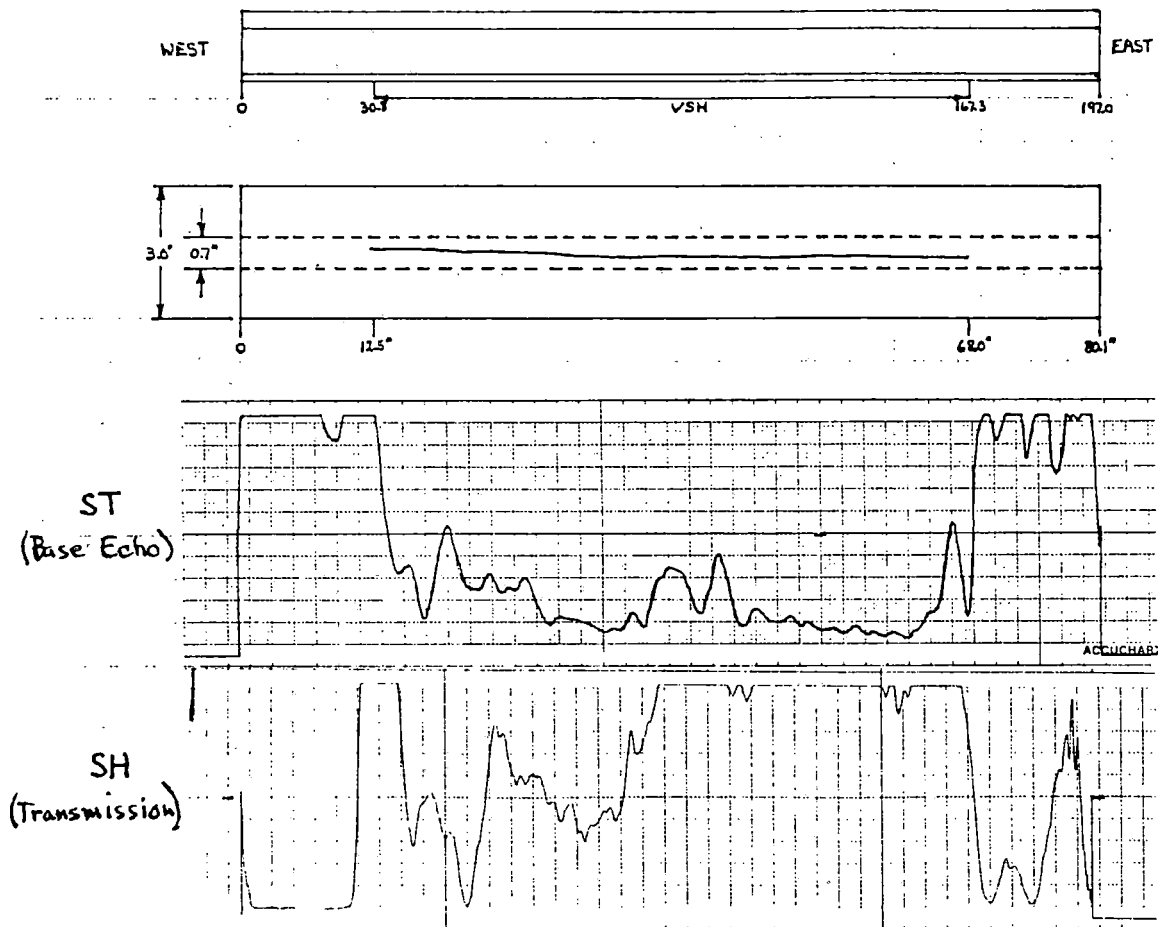
Figure C-18. Lab. Spec. #338 - 56 in. VSH defect.

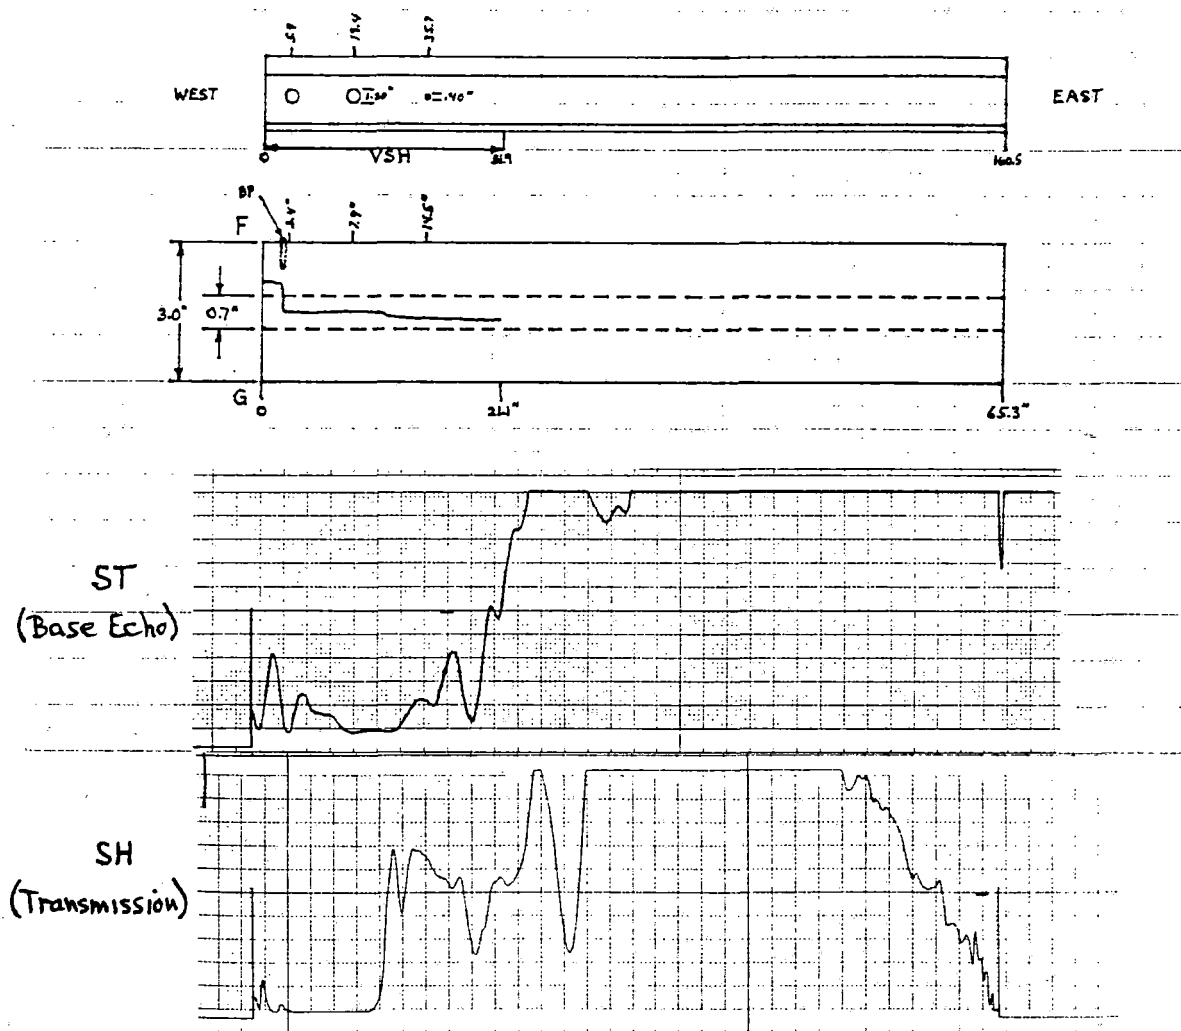
Figure C-19. Lab. Spec. #339 - 21 in. VSH defect.

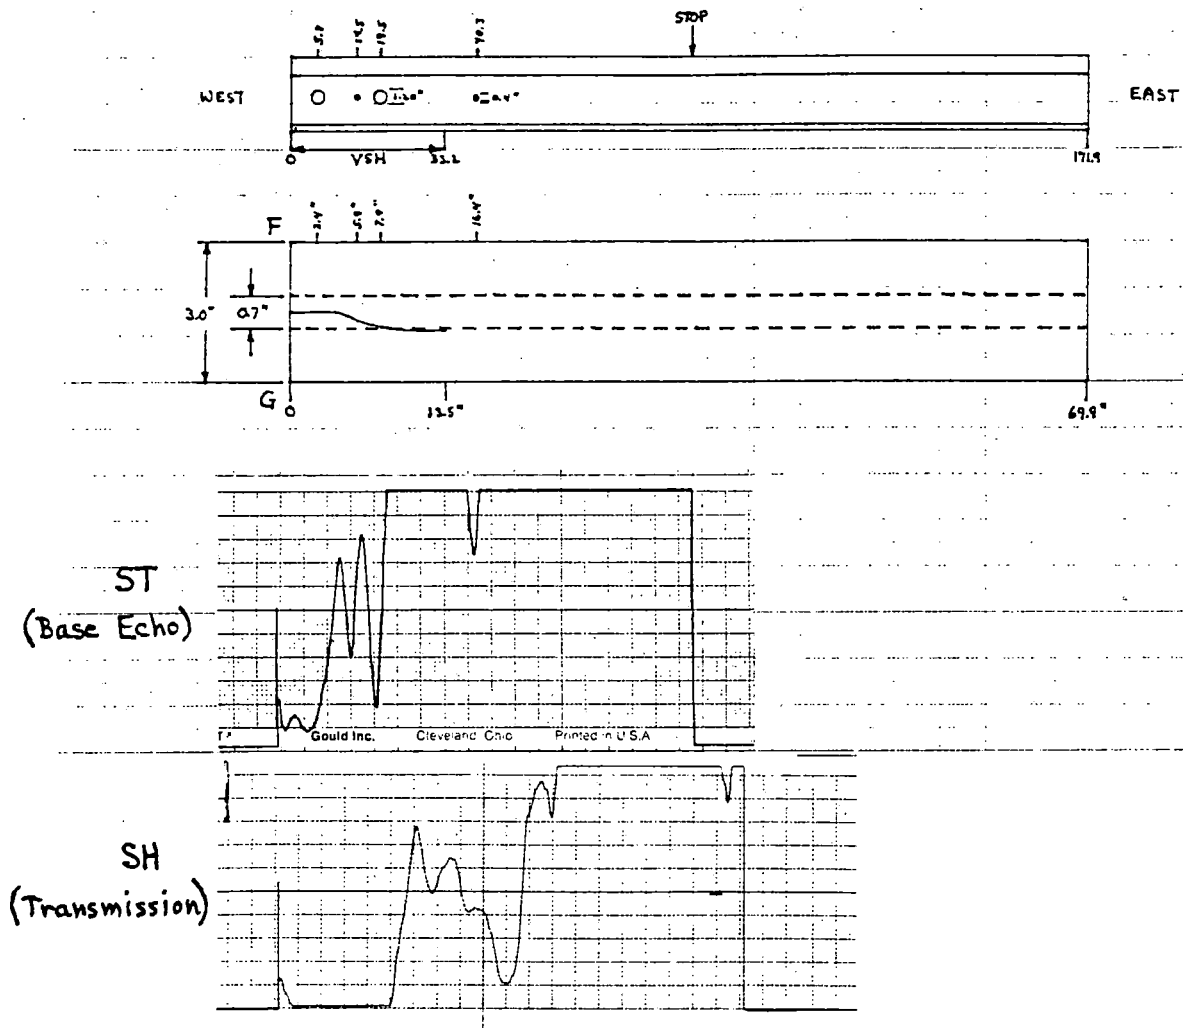
Figure C-20. Lab. Spec. #340 - 14 in. VSH defect.

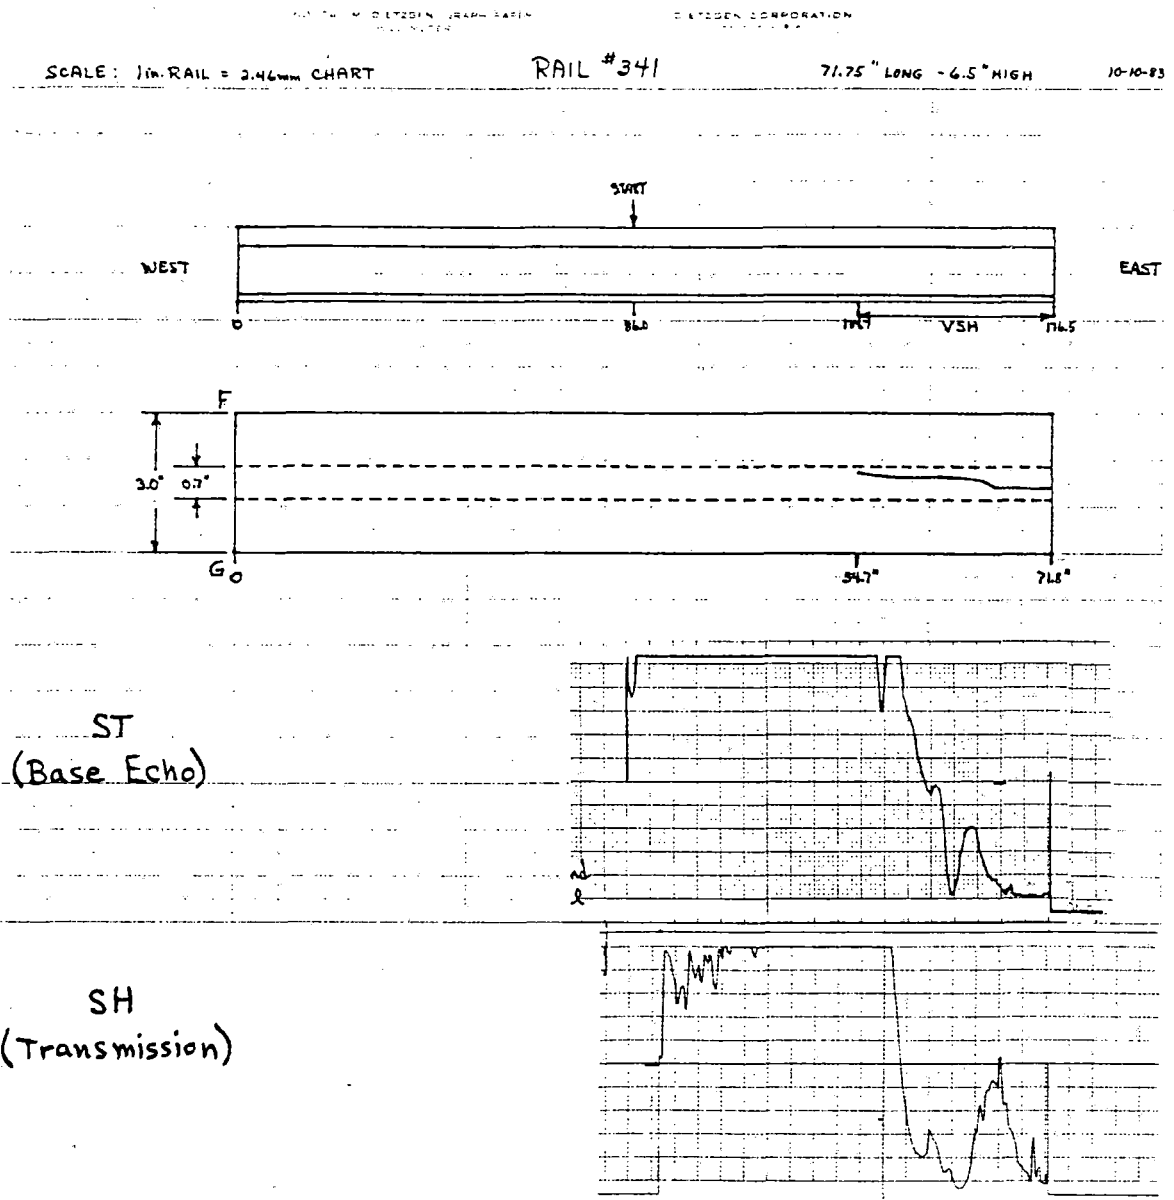
Figure C-21. Lab. Spec. #341 - 17 in. VSH defect.

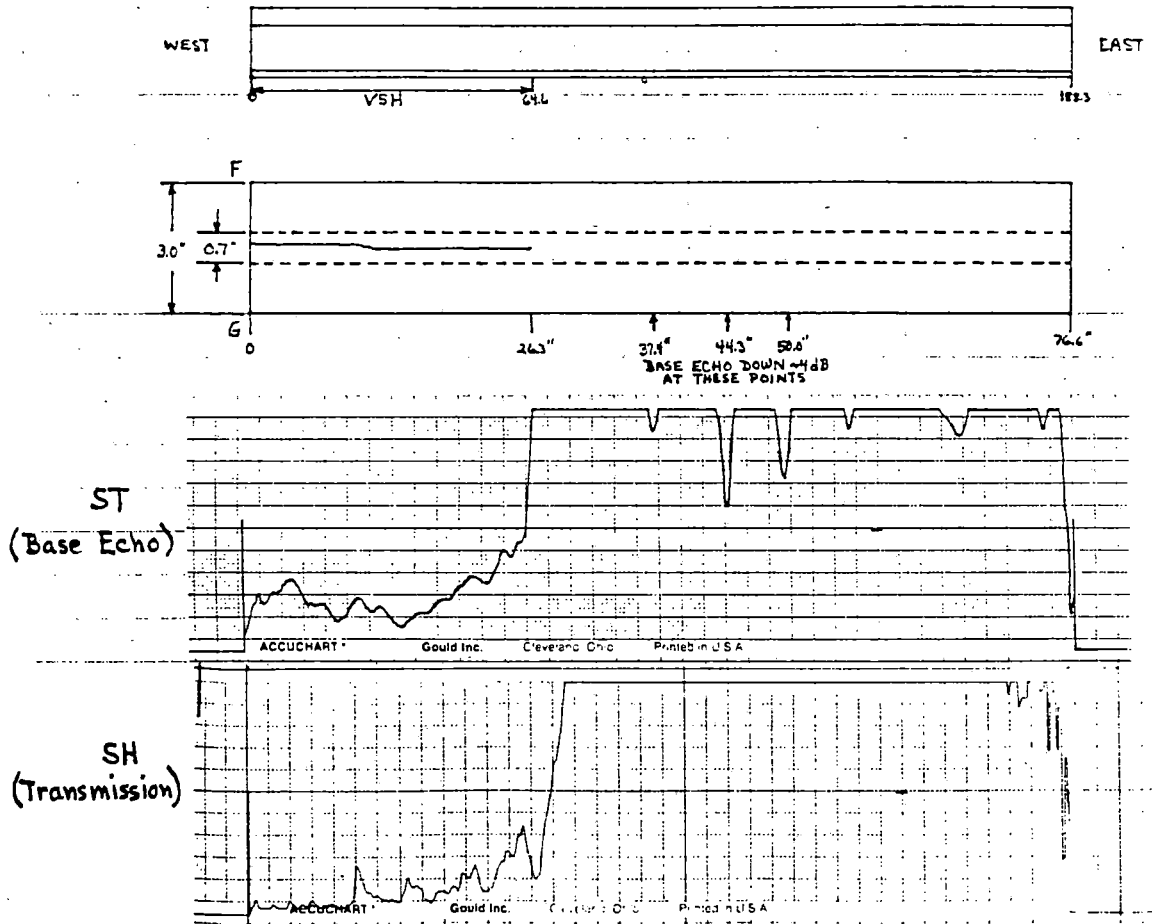
Figure C-22. Lab. Spec. #342 - 26 in. VSH defect.

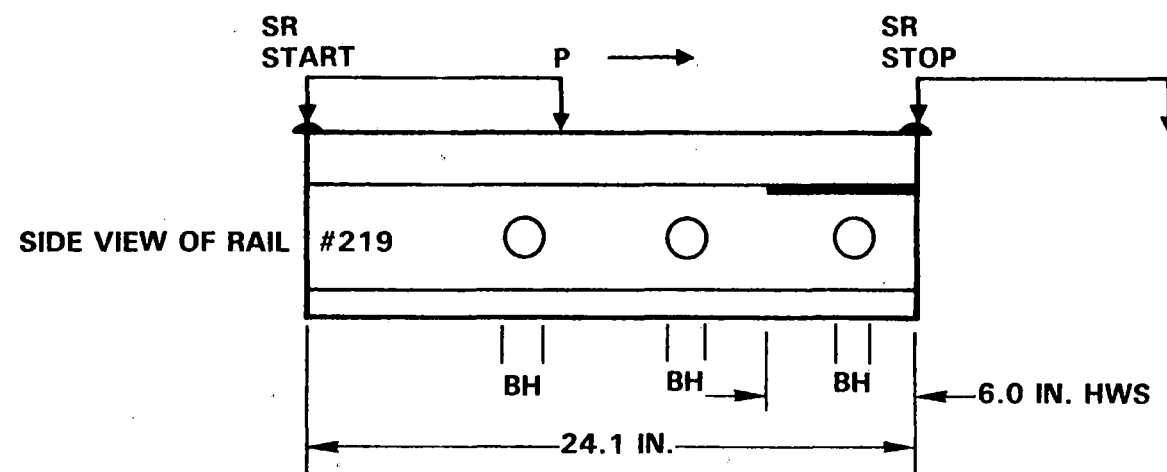
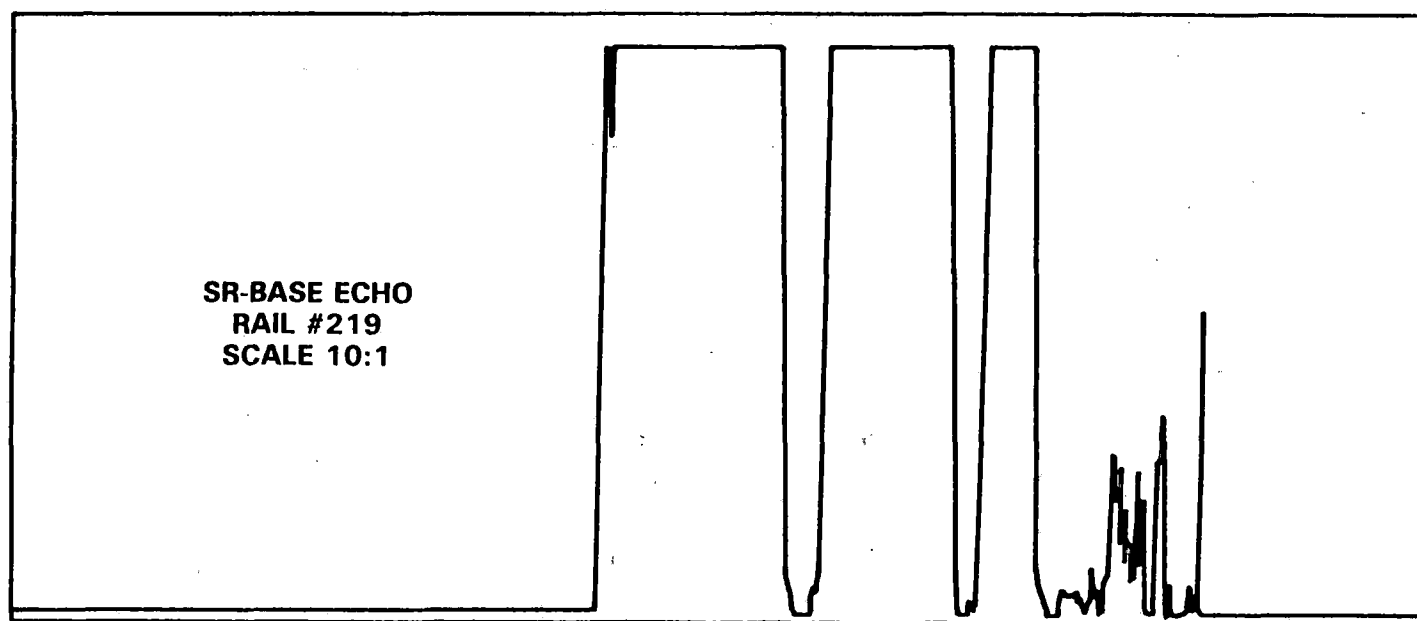
Figure C-23. Lab. Spec. #219 - 5 in. HWS defect.

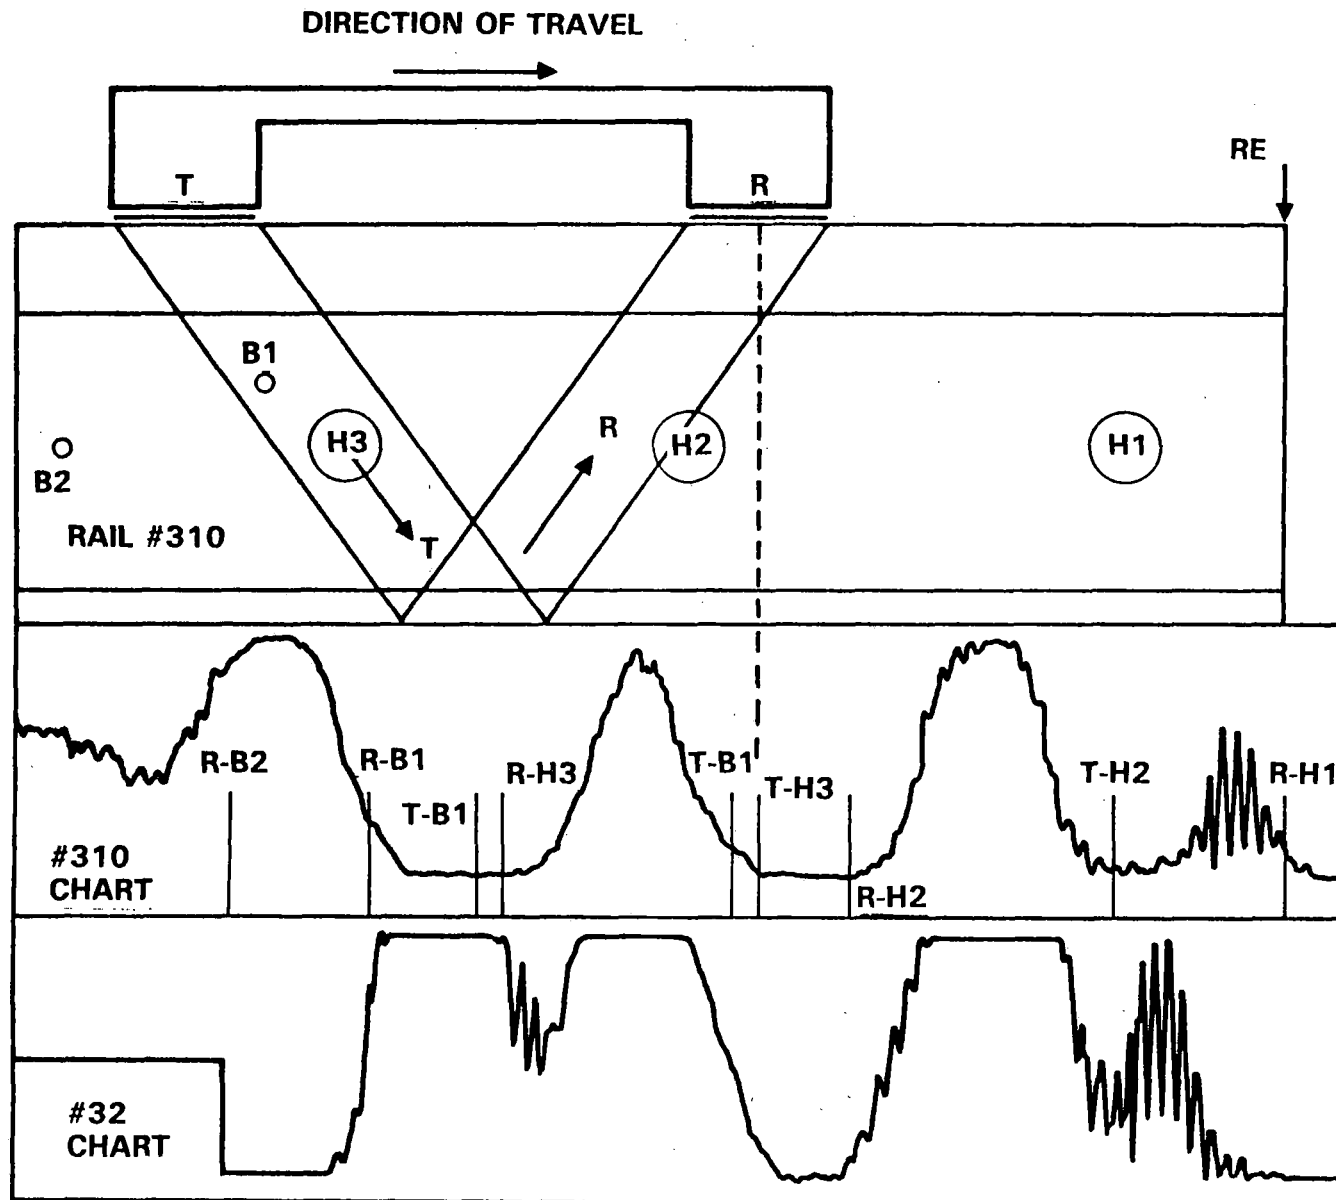
Figure C-25. Lab. Specs. #32 and #310 - SV-EMAT pitch-catch patterns at bolt holes.

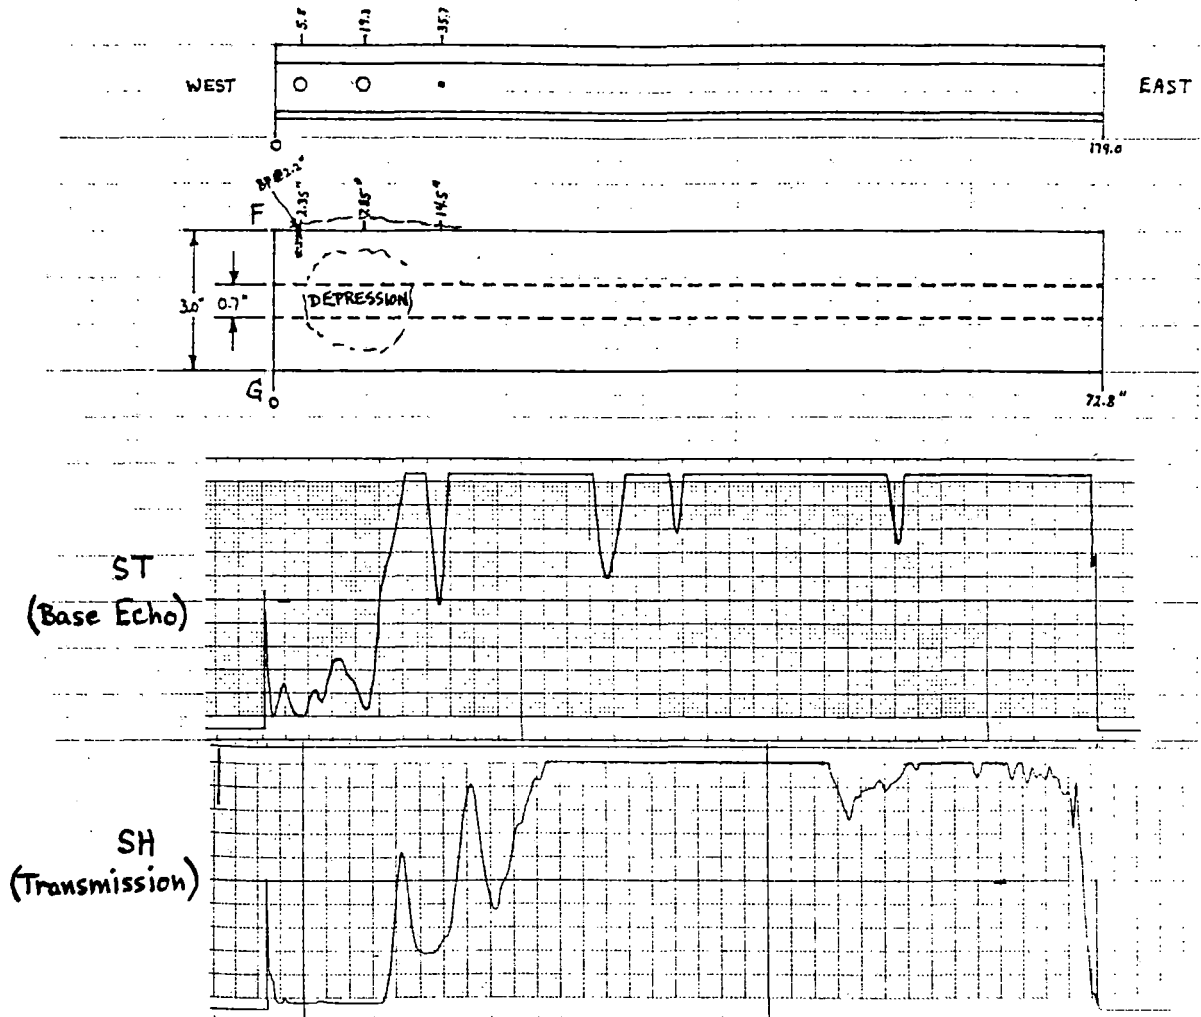
Note: This was labelled as a VSH but was not - instead it had an ~ 8 in. long region on top of the head that was depressed and rough (weld repair? , EB?).
