# **ULTRASONIC INSPECTION OF RAILROAD RAILS BY ELECTROMAGNETIC ACOUSTIC TRANSDUCERS (EMATs)**

**ROCKWELL INTERNATIONAL SCIENCE CENTER  
1049 Camino Dos Rios  
Thousand Oaks, CA 91360**

**MAY 1986**

**FINAL REPORT**

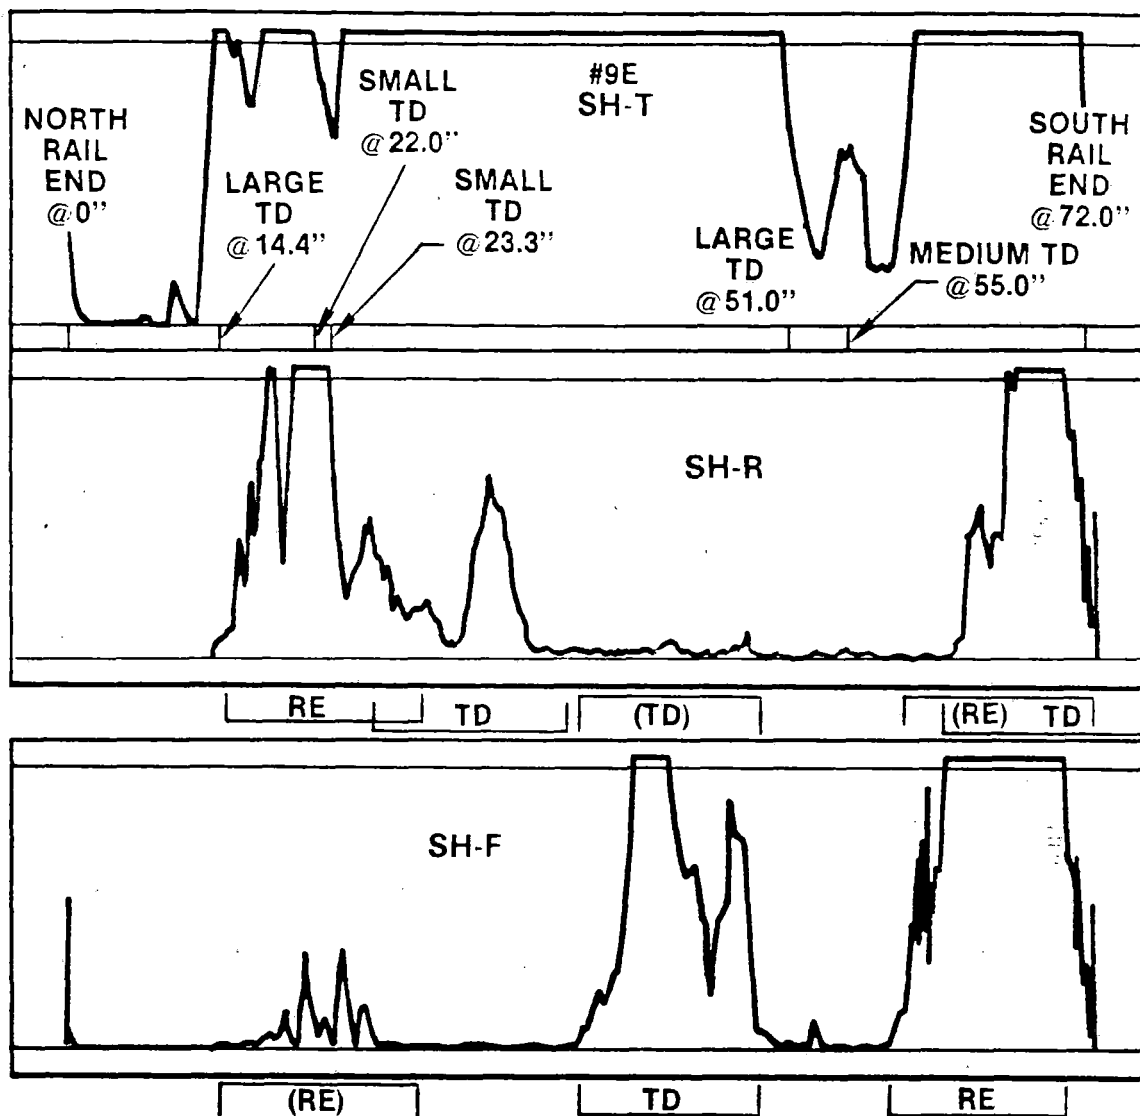
Figure C-33. Three modes of detection of large TDs with SH-EMAT in #9E.

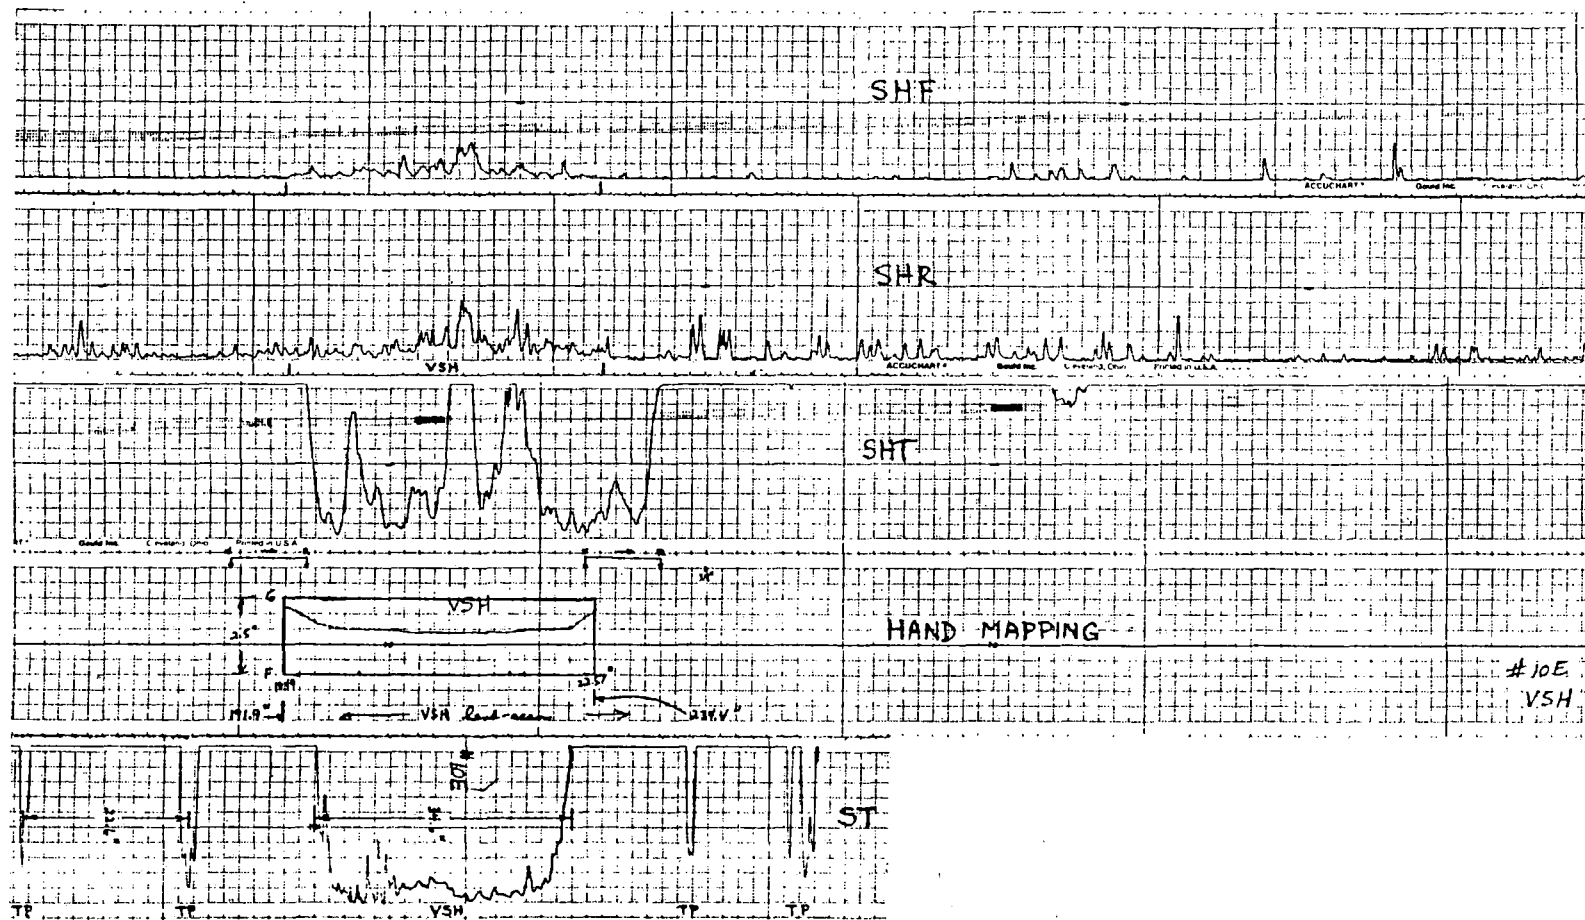
Figure C-35. Detection of VSH defect in #10E with ST- and SH-EMATs compared to hand-mapping results. Scattering of SH-wave from defect also seen in reflection modes at the top of the figure.

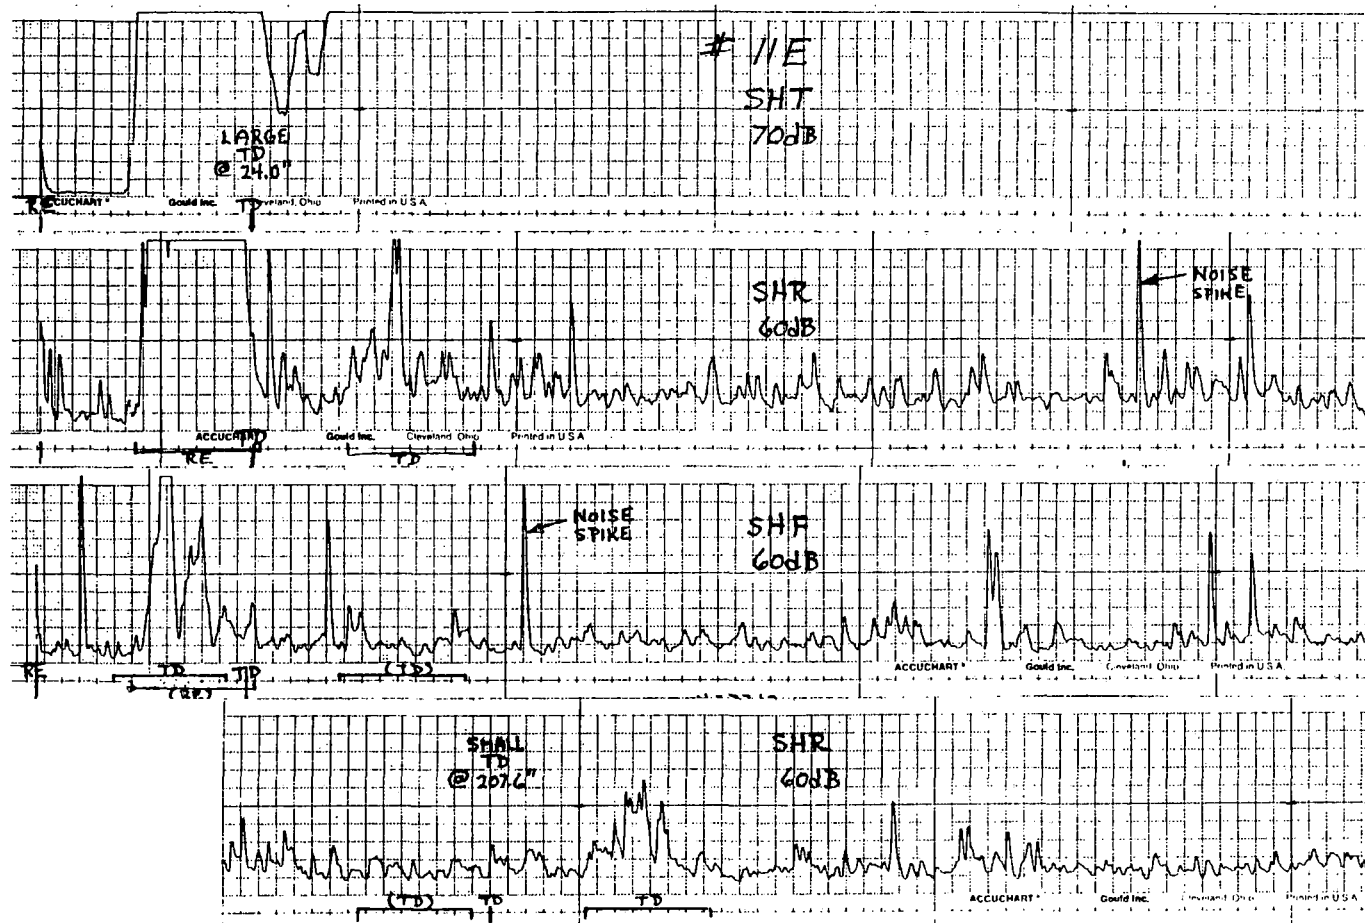
Figure C-36. Detection of 2-TDs in #11E with SH-EMAT. Also illustrates the electronic noise problem that occurred at times.

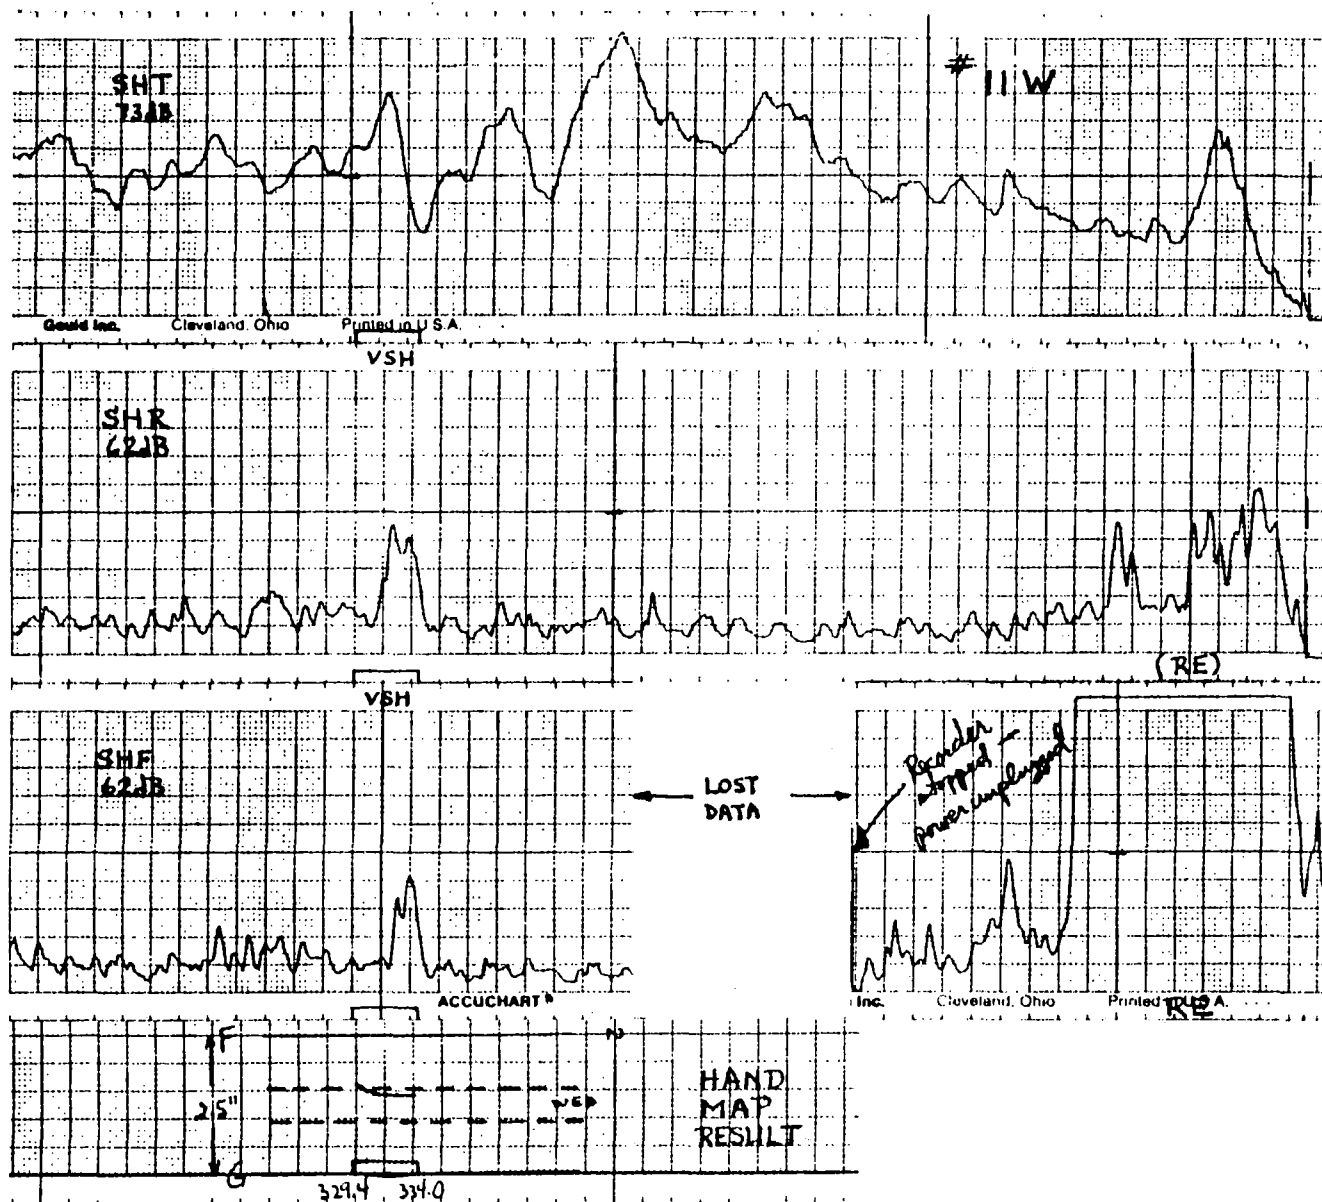
Figure C-42. Detection of small VSH with SH-EMAT in #11W. The ST-EMAT did not detect this defect.

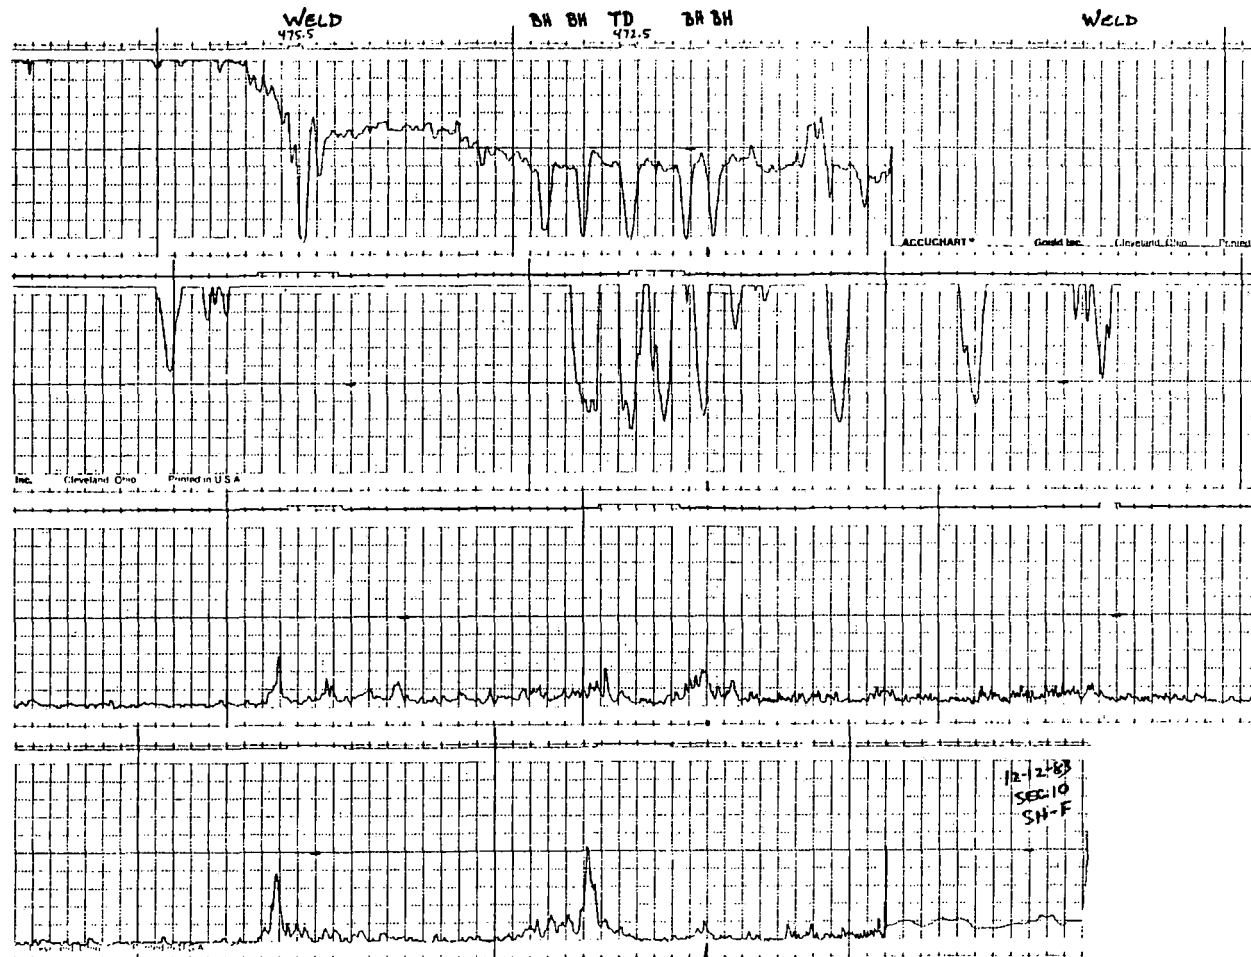
Figure C-43. FAST Sec. #10, TD-472-0, 0.5 MPH; a) ST, 17 dB; b) SHT, 60 dB; c) SHR, 64 dB; d) SHF, 64 dB.

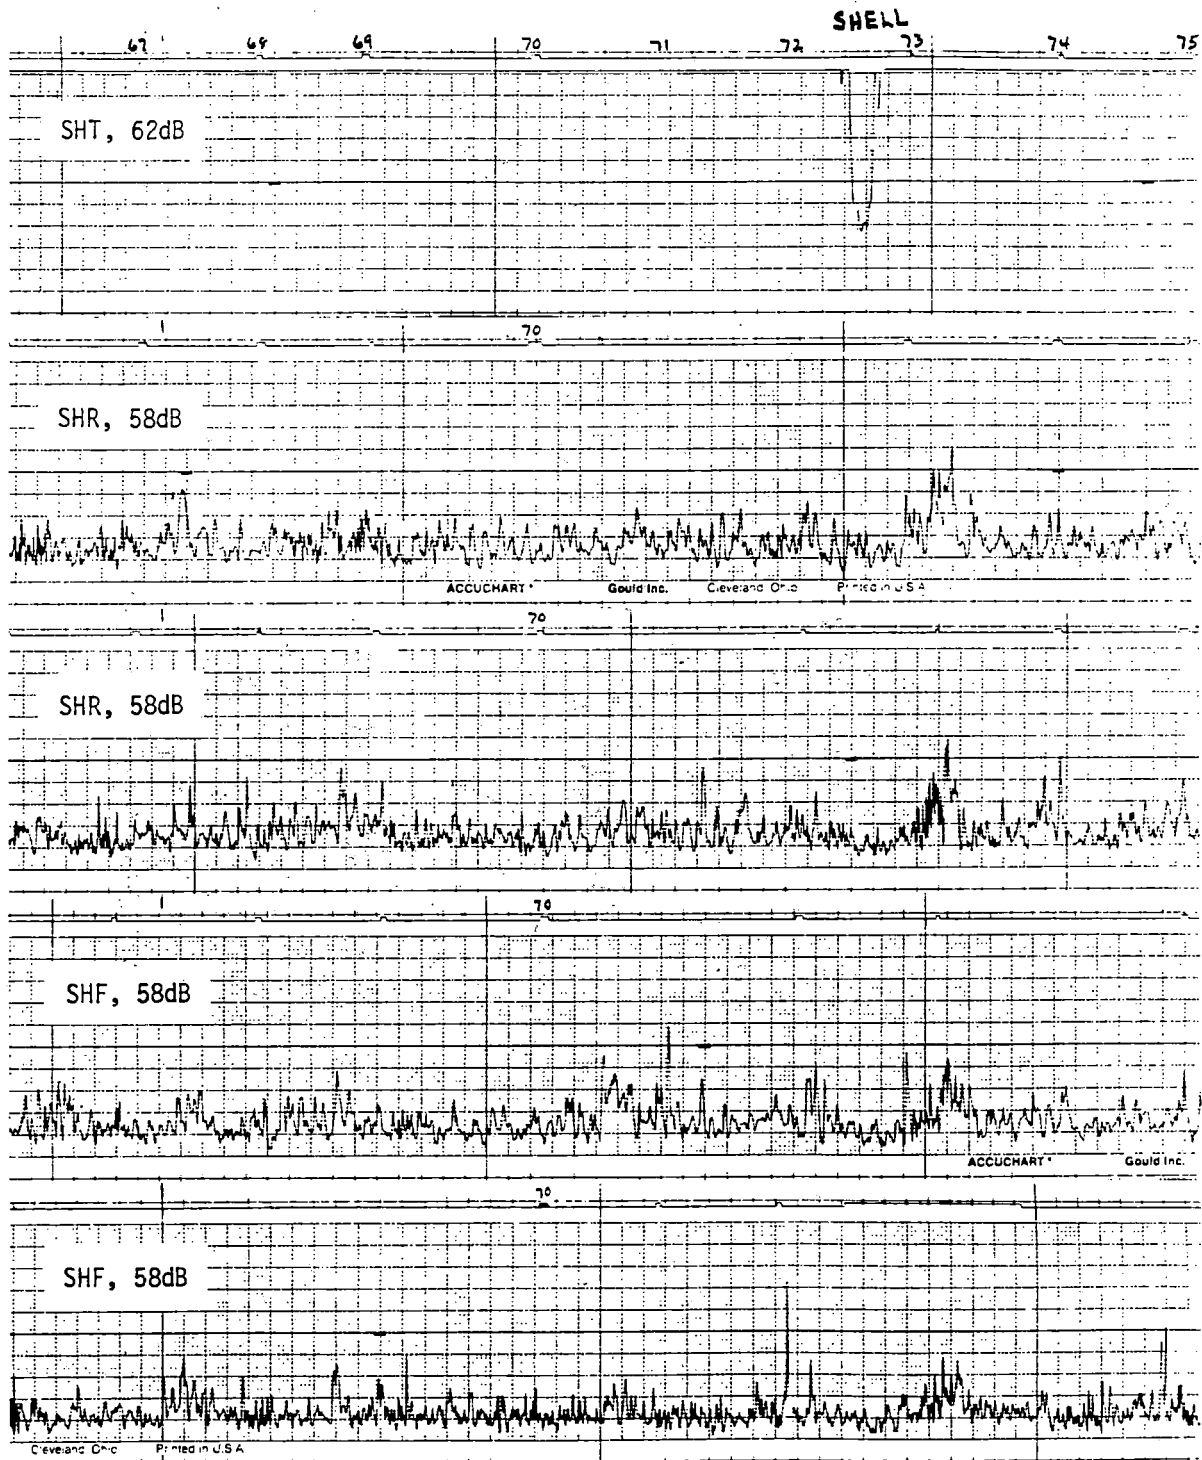
Figure C-57. FAST Sec. #7; 2" SHELL at Tie #073. Rare example of a SHELL being nearly detected as a defect by SH-EMAT.

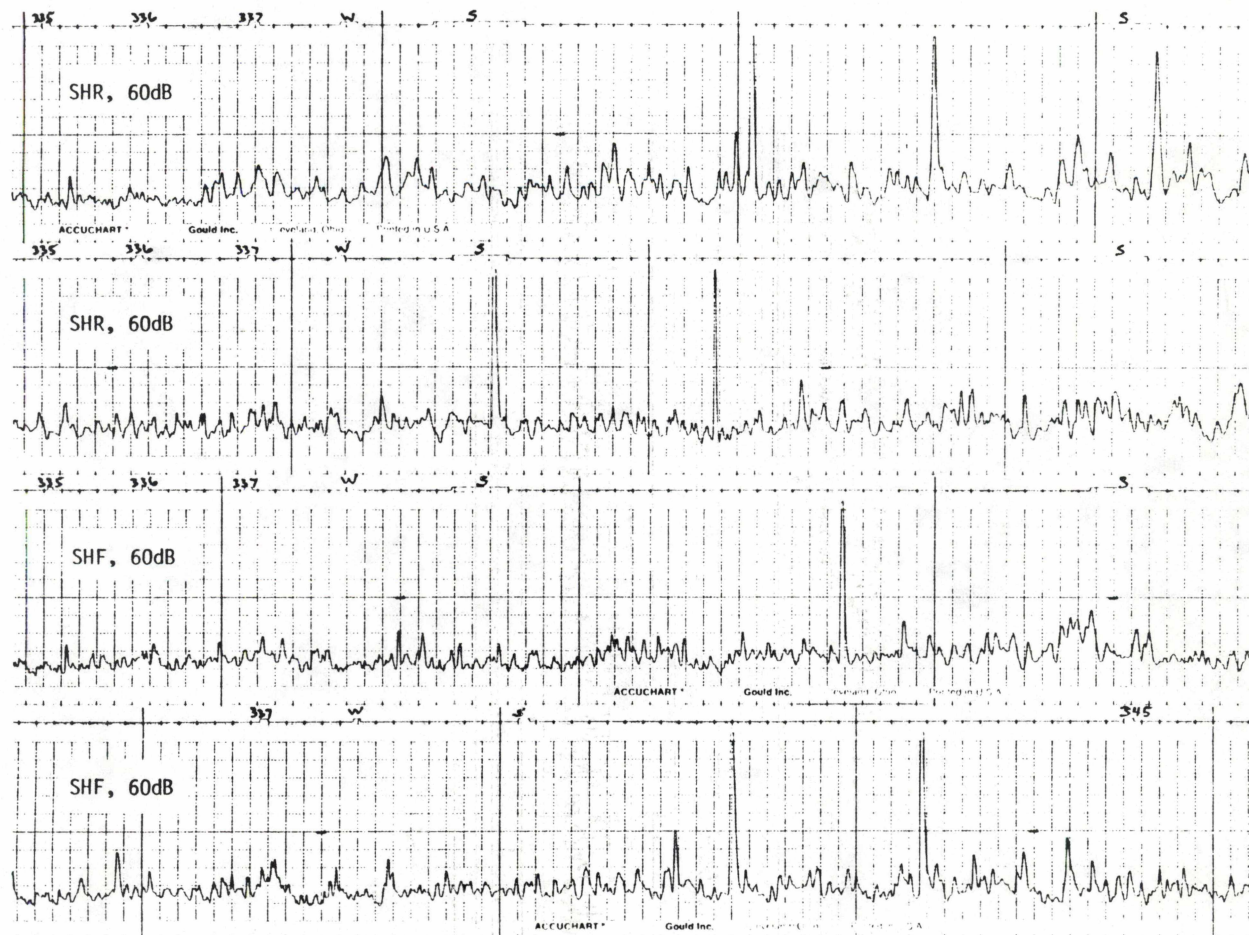
Figure C-58. FAST Sec. #7; 1" SHELL at Tie #345. SHELL is not detectable as a defect; motor/generator electrical noise spikes are apparent.
