FRA/ORD-91/18

## FATIGUE DEFECT ORIGATION AND GROWTH EXPERIMENT

DECEMBER 1991

U.S. Department  
of Transportation  
**Federal Railroad  
Administration**

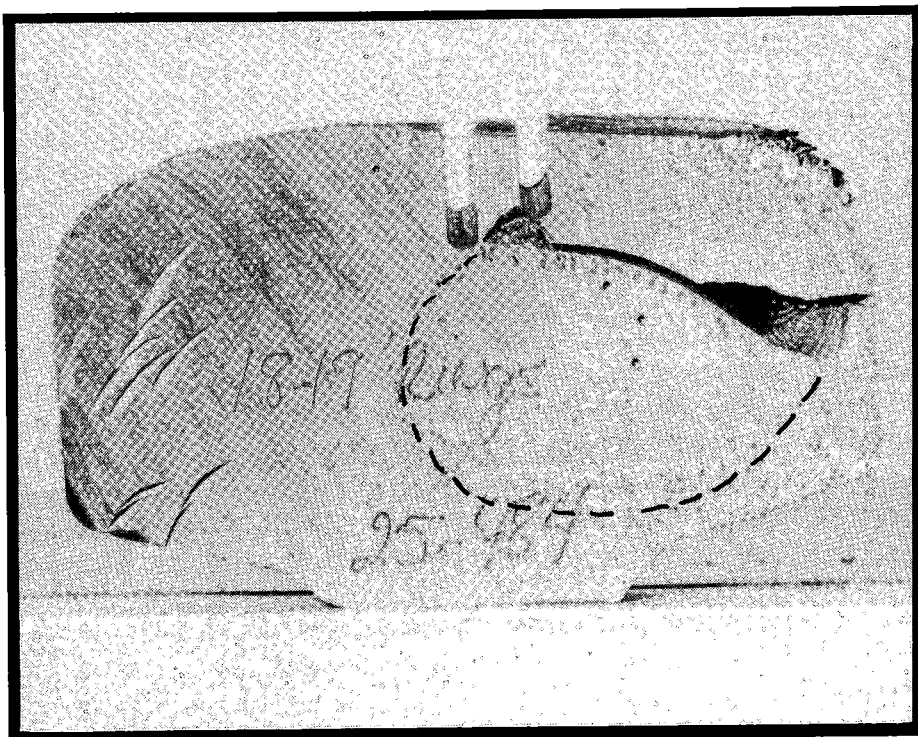
From the DF's examined in the laboratory, it was found that the defects are typical of those reported previously (7-10). A thorough examination of one of the detail fractures, 25-0484, revealed that the relationship between the initiating shell and the transverse defect is also consistent with past findings.

The central linear feature of the shell (Figure 17) is considered to be the initiation site of the defect. In this particular case it is about 4.25 mm long and 70 $\mu$ m high. It has been shown previously (7-10) that this step-like feature is usually associated with a stringer of oxide inclusions. A vertical transverse cross-section through the step shows (Figure 18) that there are indeed large oxide inclusions present in this case too.

**Figure 15. Transverse Section through Defect 25-0484**

**Figure 16. Transverse Defect Originating from Shell**

**Figure 17. Top View of Shell Surface showing Initiating Step and Transition into DF**

**Figure 18. Transverse Cross Section through the Step in Shell of Defect 25-0484**

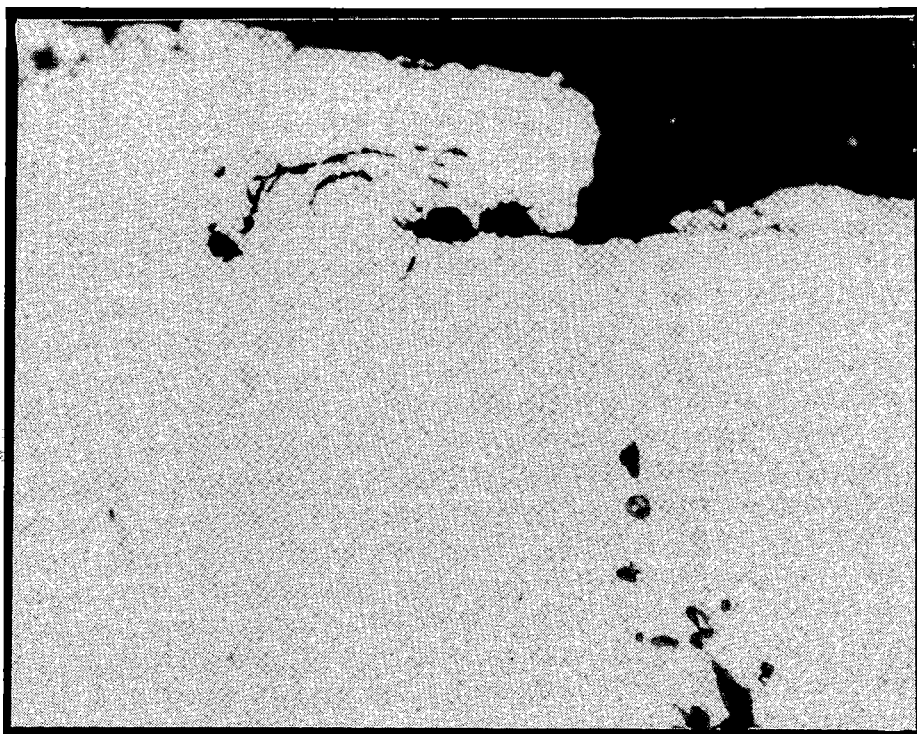
The link between inclusions and a shell step was examined for other defects. Figure 19 shows a small shell, about 0.5 inch in diameter, from sample 25-7J. The step can be seen better in the close-up of Figure 20. Photographs taken with the SEM (Figure 21) and the optical microscope (Figure 22) reveal that there are numerous inclusion clusters at and near the step. Energy dispersive X-ray analysis indicated (Figure 23) that the inclusions are probably alumino-calcium silicates.

**Figure 19. Small Shell in Sample 25-7J**

**Figure 20. Step Feature in Shell from 25-7J**

**Figure 21. Scanning Electron Micrograph of Transverse Section through Shell in Figure 20**

**Figure 22. Optical Micrograph of Transverse Section through Shell in Figure 20**

**Figure 23. Energy Dispersive Spectrography Analysis of Inclusions Associated with Shell in Figure 20**
