U.S. Department of
Transportation

**Federal Railroad
Administration**

Validating Electromagnetic Walking Stick Rail Surface Crack Measuring Systems

6. AUTHOR(S) and FRA COTR Eric Magel				
7. PERFORMING ORGANIZATION NAME(S) AND ADDRESS(ES) National Research Council, Canada 2320 Lester Road, Ottawa, Canada K1V 1S2			8. PERFORMING ORGANIZATION REPORT NUMBER AST-R-LR-0102

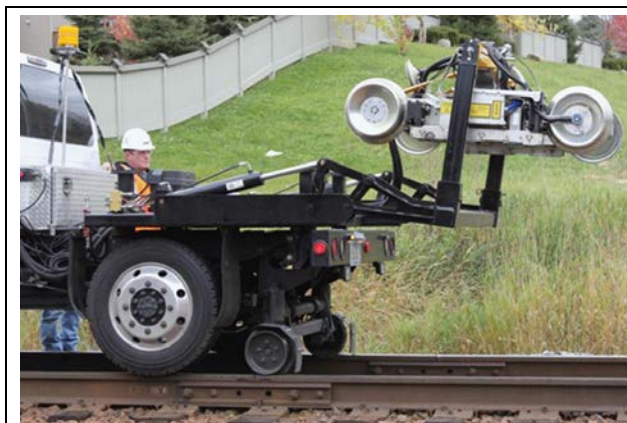
The MRX hy-rail RSCM unit

In North America, Loram Maintenance of Way, Inc. has acquired a system from MRX Technologies in Australia that uses the level of magnetic flux leakage to estimate the crack depth directly. Rohmann GmbH (based in Germany) has over the last several years continued to improve the capabilities of its eddy-current-based Draisine unit and has begun using it on select test locations in North America. Finally, Sperry Rail Services has introduced an eddy current based system, which is included in its multi-technology platform for complete rail inspection. Hy-rail based systems have arrived in North America and are now being tested in the field.

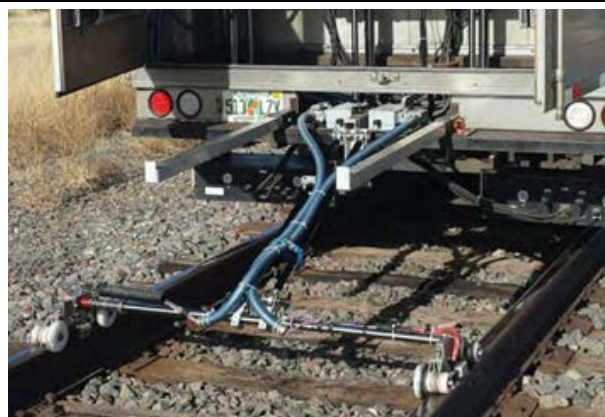
Rohmann's hy-rail eddy current unit can have as many as 6 probes per rail. Operating speeds are up to 40 mph.

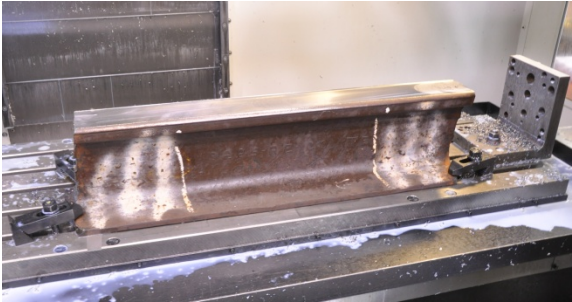
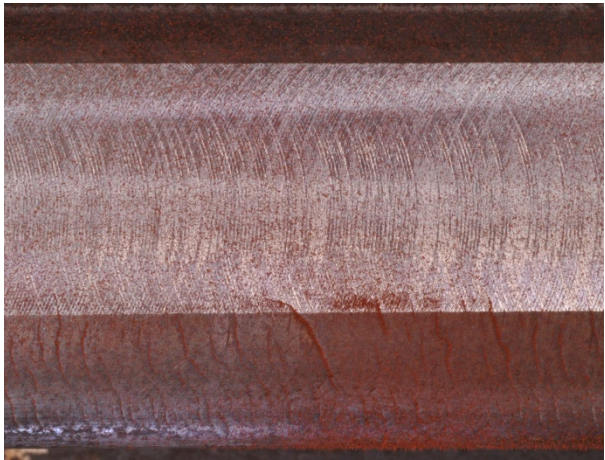
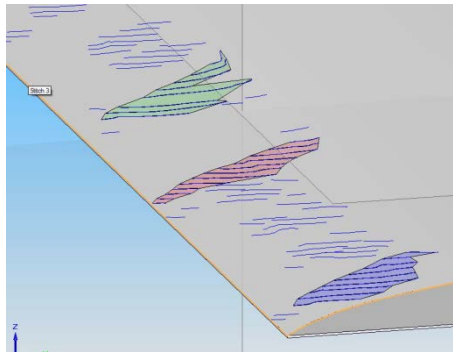
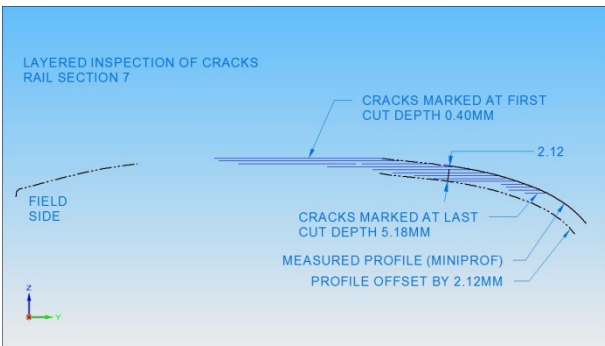
Figure 2: The process to mill and chase cracks through the rail head.

<p>a) Setting up on the milling machine to remove a skim of metal from the top of the rail</p>	<p>b) Magnetic particle enhanced photographs of the exposed surface</p>

<p>c) Importing images into Solid Edge and tracing cracks</p>	<p>d) The outer envelope of the cracks is believed to represent the greatest depth of cracking along the length examined</p>

enhanced cracks being collected at each height. Samples 7 and 14 were processed in this way with a total of thirteen and fourteen milling cycles being conducted, respectively. Subsequent processing of the images in a 3-D Computer Aided Design (CAD) package enabled the envelope of the deepest cracks to be evaluated. For sample 7, water jetting had given a crack depth of 2.0 mm (see Figure 1) while the milling method resulted in a depth of 2.1 mm. A third effort involved additional water jetting sections along the length of samples 6, 12, 16 and 18. Additional depth measurements were taken and gave greater confidence in the sectioning results. Upon completion of its first set of sectioning work, NRC shipped the remaining whole rail samples to the University of Alberta in Edmonton for further study. Three samples (numbers 1, 30, 33) were shipped directly from Evansville to the MRX facility in Australia for their further study. Those three samples were milled by MRX and the resulting measurements included with the NRC samples in Table 1 and Figure 3.

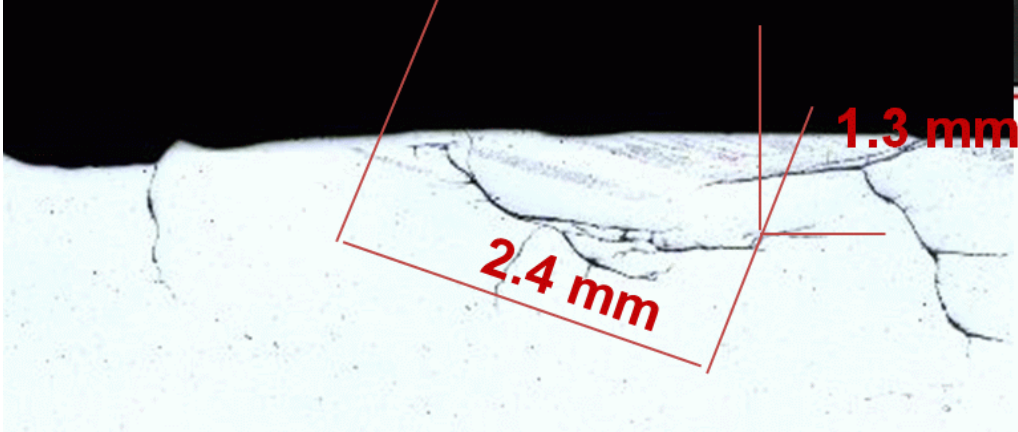
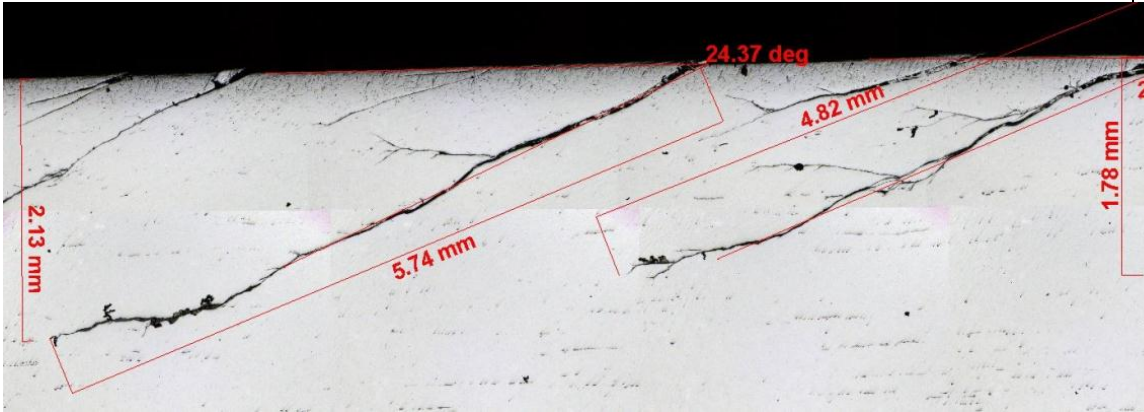
Figure 10: Sectioning of three rail samples and crack measurement were undertaken by NS Labs.

<p>Sample 4 (cross section)</p>

<p>Sample 5 (cross section) (Milling showed a depth of 2.3mm)</p>

<p>Sample 6 (longitudinal)</p>

NS Laboratories analyzed three of the rail samples. Examples of the metallurgical sections and crack measurements are shown in Figure 11.

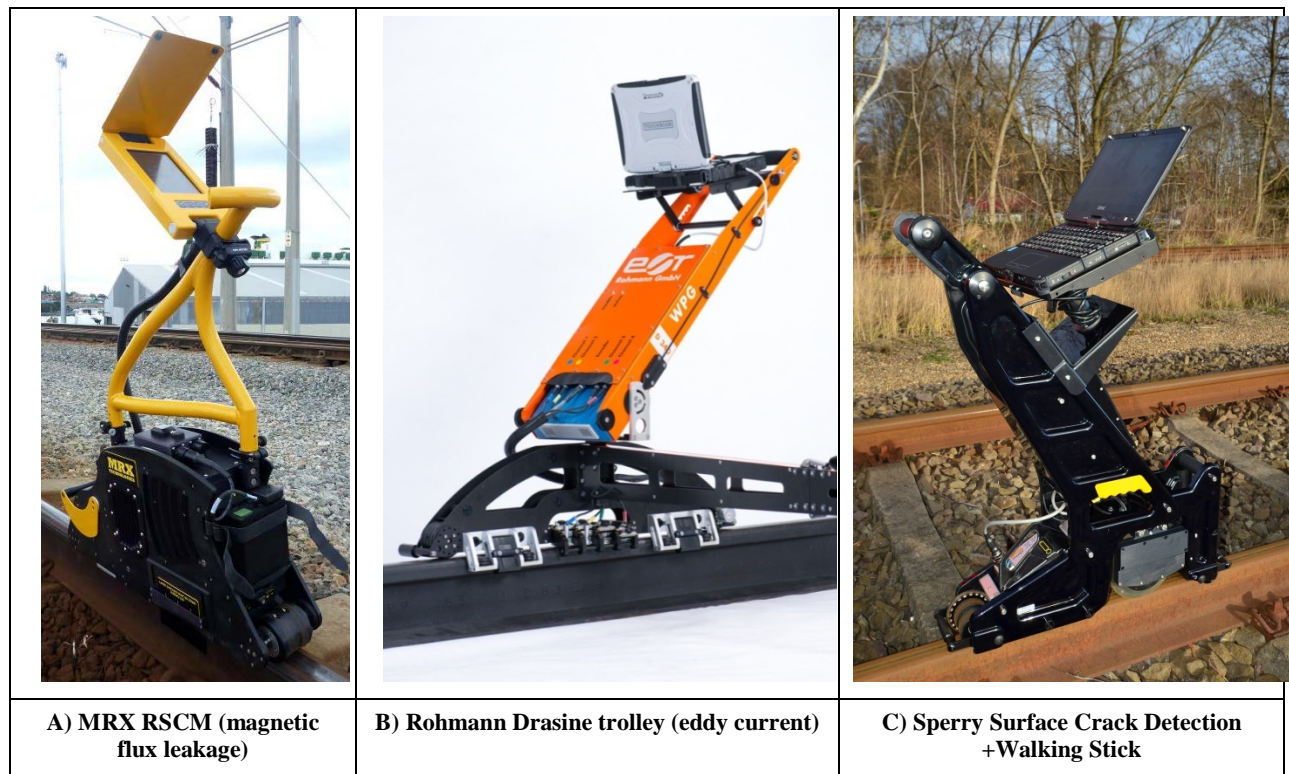
Figure 16: The three electromagnetic based systems evaluated through this program.

Furthermore, all of the systems measure along the trajectory of the walking stick and do not see cracks that have a strong longitudinal orientation. A comparison of several of these systems is shown in Table 4.

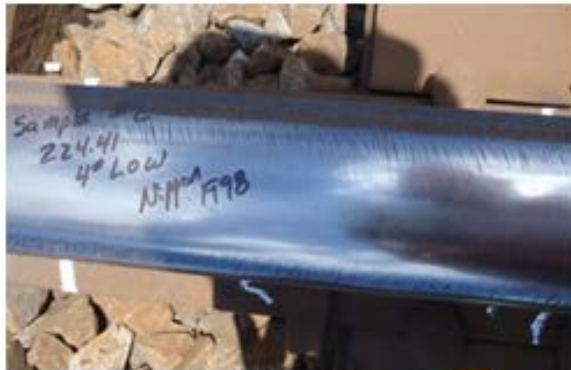
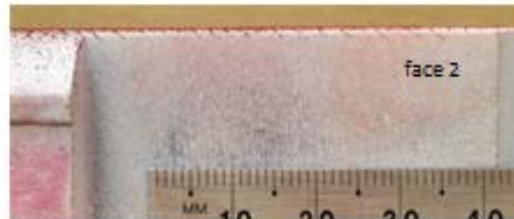
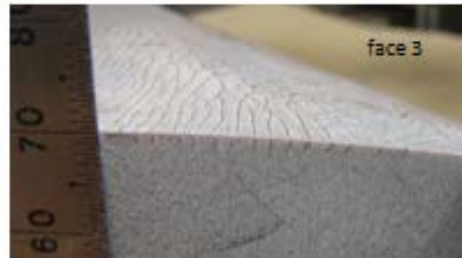
CSX Blue Ridge Subdivision Sample #2

MP 224.45 LOW
Rail Manufacturer: Nippon
Rail Year: 1996
Rail Type: VT
Rail Weight: N/A

Measured crack depth

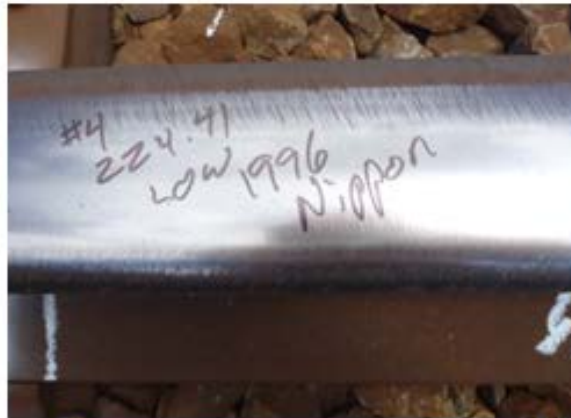
CSX Blue Ridge Subdivision Sample #4

MP 224.45 LOW
 Rail Manufacturer: Nippon
 Rail Year: 1996
 Rail Type: VT
 Rail Weight: N/A

Measured crack depth
 MRX: 0.1
 Rohmann: >5.0 mm

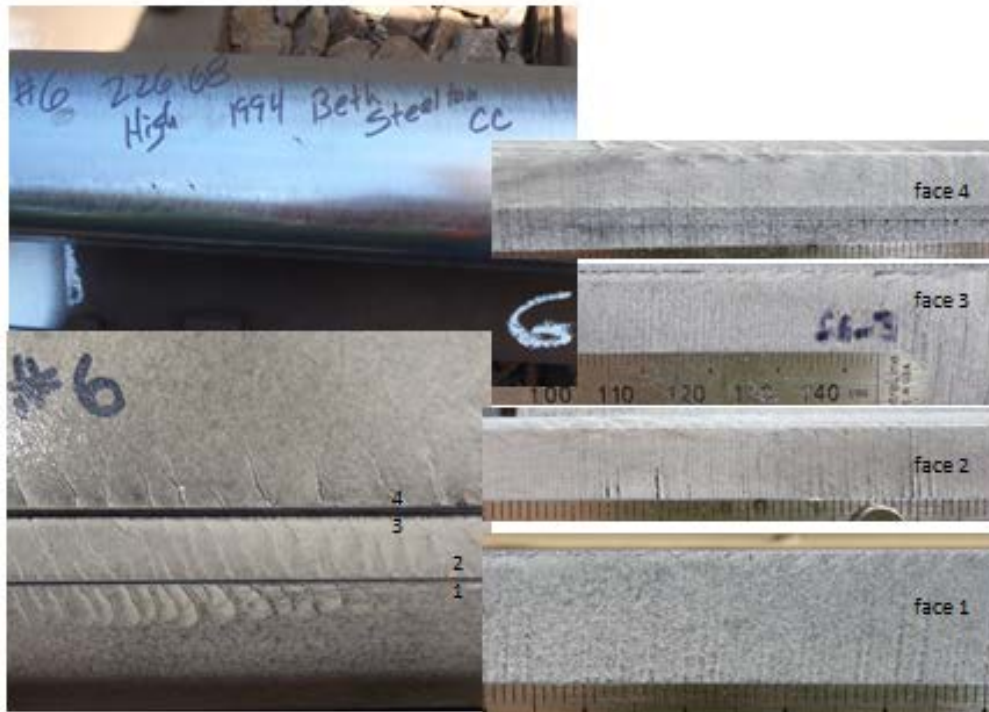
CSX Blue Ridge Subdivision Sample #6

MP 226.68 HIGH
 Rail Manufacturer: Beth Steelton
 Rail Year: 1994
 Rail Type: CC
 Rail Weight: 136-10

Measured crack depth

MRX: 4.3
 Rohmann: 3.1-3.8

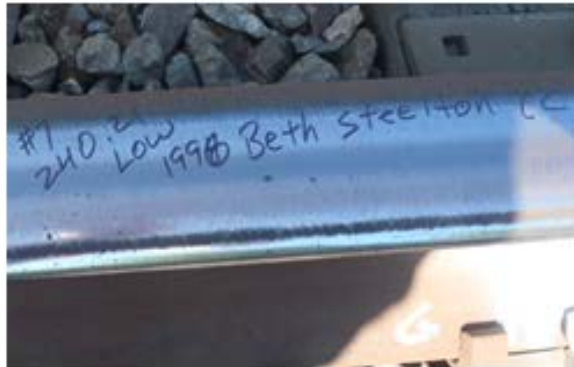
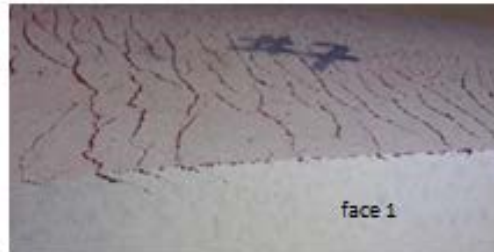
MP 240.21 HIGH
 Rail Manufacturer: Beth Steelton
 Rail Year: 1996
 Rail Type: CC
 Rail Weight: 136-10

Measured crack depth
 MRX: 6.3
 Rohmann: >5.0

Magnetic Particle Inspection

Face 1	Face 6
Max Length (mm)	2.8	4.2
Crack Angle (deg)	26	29
Max Depth (mm)	1.2	2.04
Surface Angle (deg)	63	63

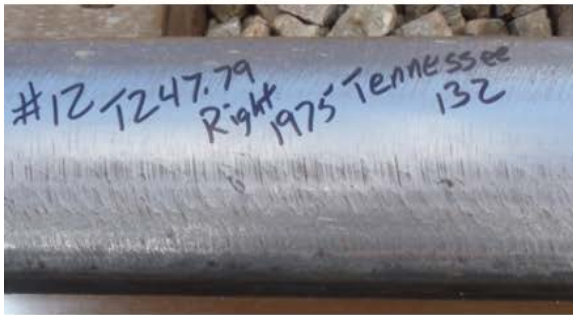
CSX Blue Ridge Subdivision Sample #12

MP T247.79 RIGHT
 Rail Manufacturer: Tennessee
 Rail Year: 1975
 Rail Type: CC
 Rail Weight: 132

Measured crack depth

MRX: 6.9
 Rohmann: >5.0

Figure 22: CSX Rail sample #12. Water jet cut perpendicular to surface cracks, and then along the length of the rail, dry (red) and liquid magnetic particle enhancement.

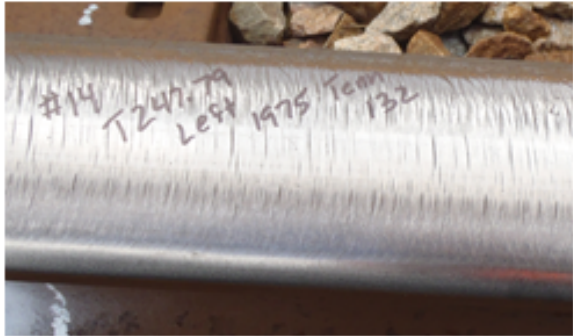
CSX Blue Ridge Subdivision Sample #14

Measured crack depth

MRX: 4.8

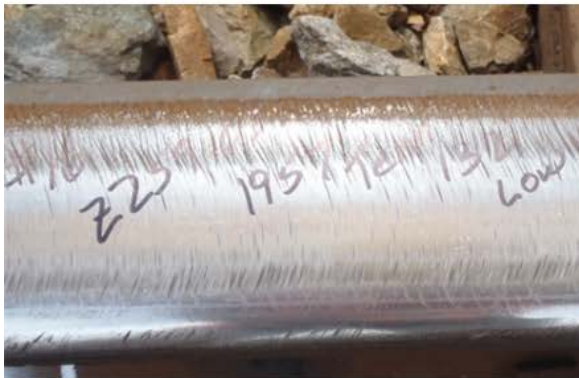
CSX Blue Ridge Subdivision Sample #16

MP 259.05 LOW
 Rail Manufacturer: Tennessee
 Rail Year: 1957
 Rail Type: C Rail
 Rail Weight: 132

Magnetic Particle Inspection

Face 9	Face 10
Max Length (mm)	2.0	2.43
Crack Angle (deg)	48	43
Max Depth (mm)	1.5	1.48
Surface Angle (deg)	77

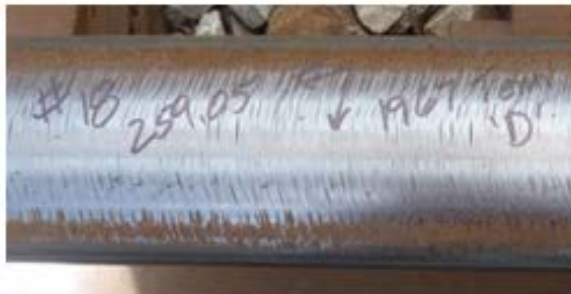
CSX Blue Ridge Subdivision Sample #18

MP 259.05 HIGH
 Rail Manufacturer: Tennessee
 Rail Year: 1967
 Rail Type: D Rail
 Rail Weight: 132

Measured crack depth

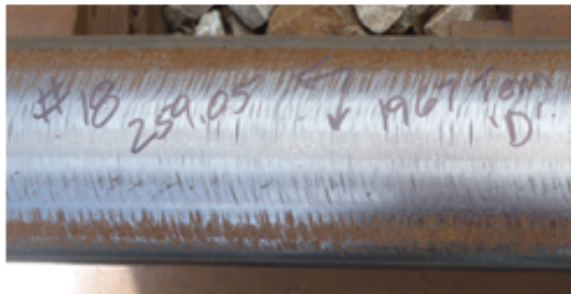
CSX Blue Ridge Subdivision Sample #18

MP 259.05 HIGH
 Rail Manufacturer: Tennessee
 Rail Year: 1967
 Rail Type: D Rail
 Rail Weight: 132

Magnetic Particle Inspection

face 1	face 2
Max Length (mm)	3	3.96
Crack Angle (deg)	13	20
Max Depth (mm)	0.9	1.20
Surface Angle (deg)	48	48

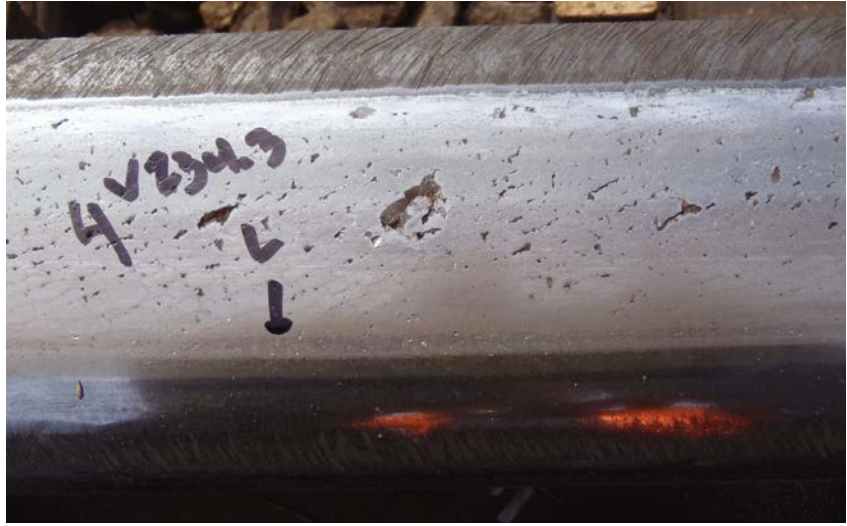
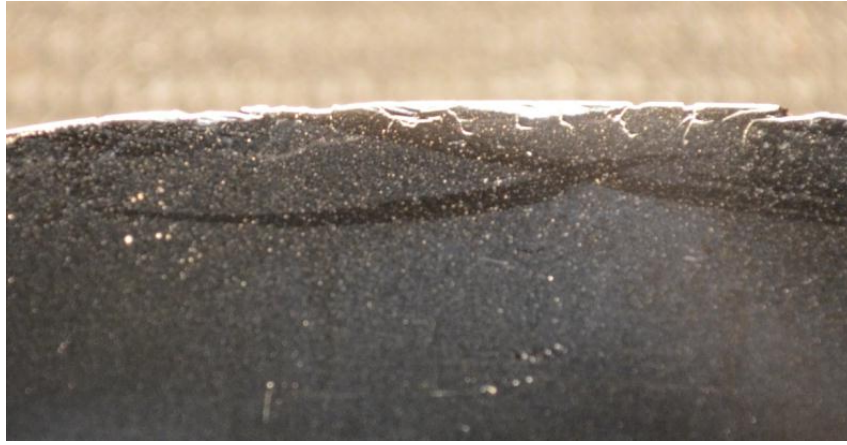
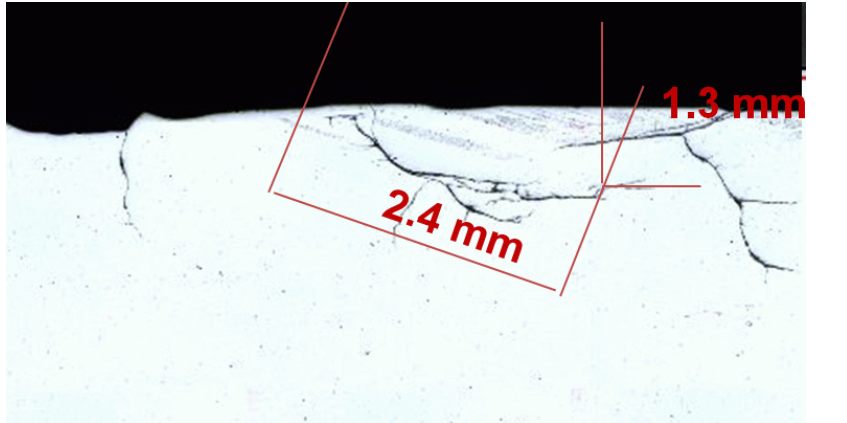
Figure 28: NS Labs analysis of Sample 4

A photograph of a rail's surface. The top half shows a dark, textured surface with some white markings, including the number '4' and '2343'. The bottom half shows a bright, orange-red, elongated crack or defect.		Surface condition

A photograph of a rail's cross-section. The top edge is dark and rough, while the interior is a lighter, more uniform color. A horizontal line is visible across the middle.		Cross section

A photograph of a rail's cross-section with a crack. Red lines and text indicate measurements: '1.3 mm' for the crack's width and '2.4 mm' for its length.		Crack measurement

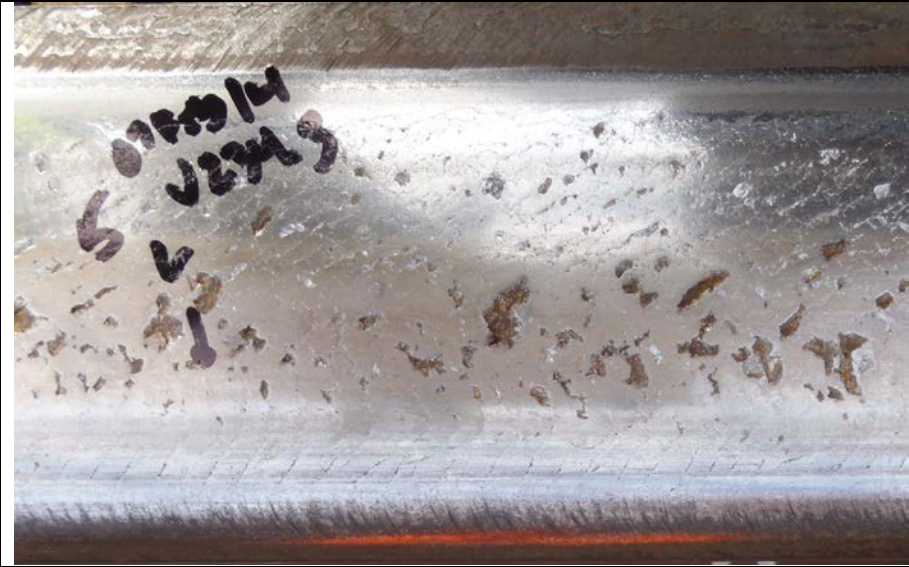
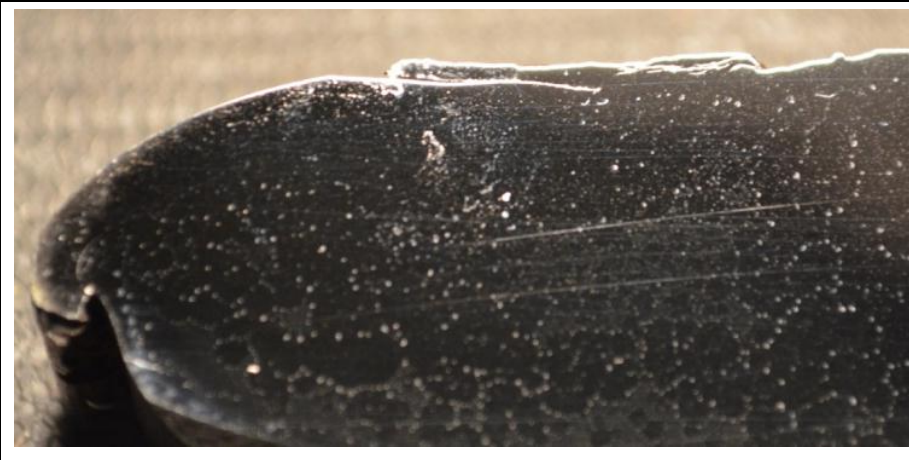
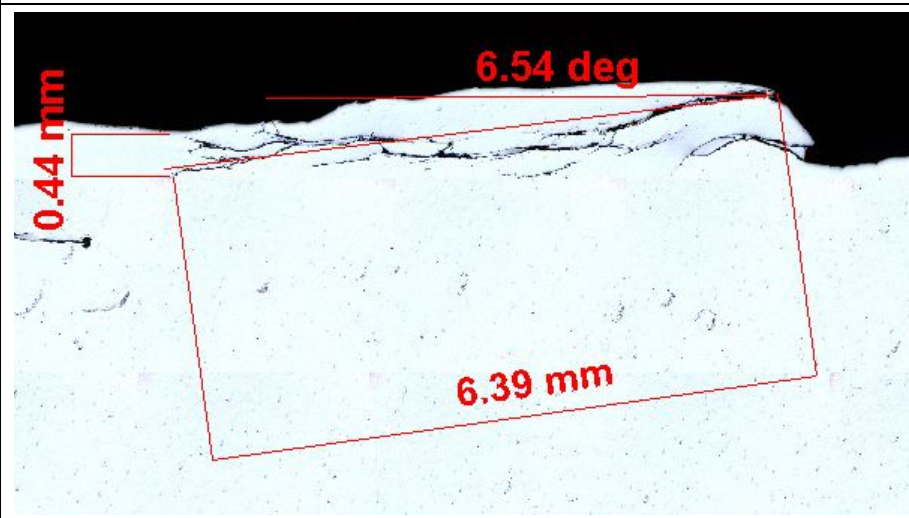
Figure 29: NS Labs analysis of Sample 5

<p>A close-up photograph of the surface of Sample 5. The surface is light-colored and shows numerous small, dark, irregular spots and pits, indicating surface degradation or corrosion. Handwritten markings in black ink are visible in the upper left corner, including the number '6' and some illegible characters.</p>		Surface condition

<p>A photograph showing a cross-section of Sample 5. The material appears dark and granular, with a rough, uneven surface. The cross-section reveals internal texture and some surface irregularities.</p>		Cross section

<p>A photograph showing a crack measurement on Sample 5. A red rectangular box highlights the crack area. The crack is labeled with a width of 0.44 mm and a length of 6.39 mm. The angle of the crack is labeled as 6.54 deg.</p>		Crack measurement

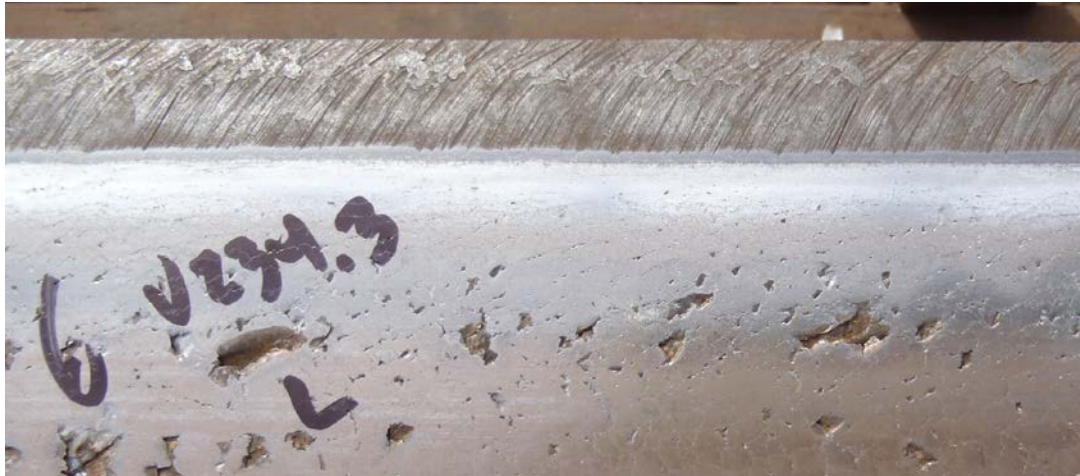
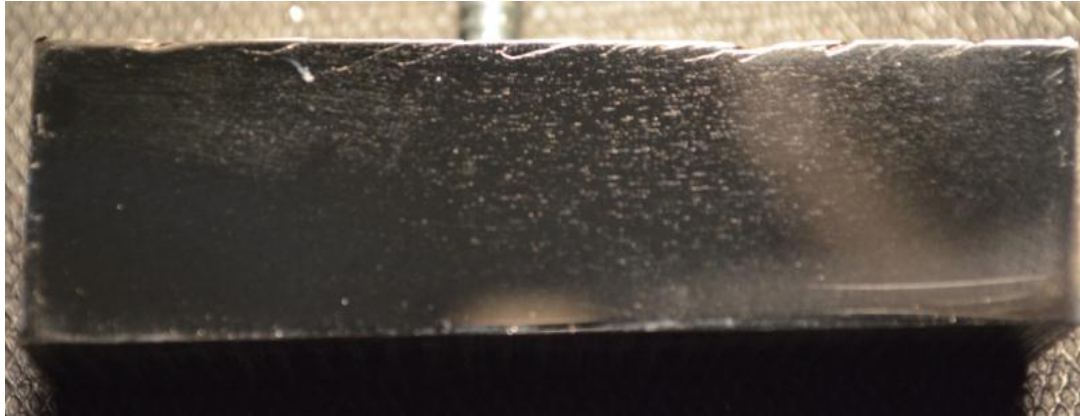
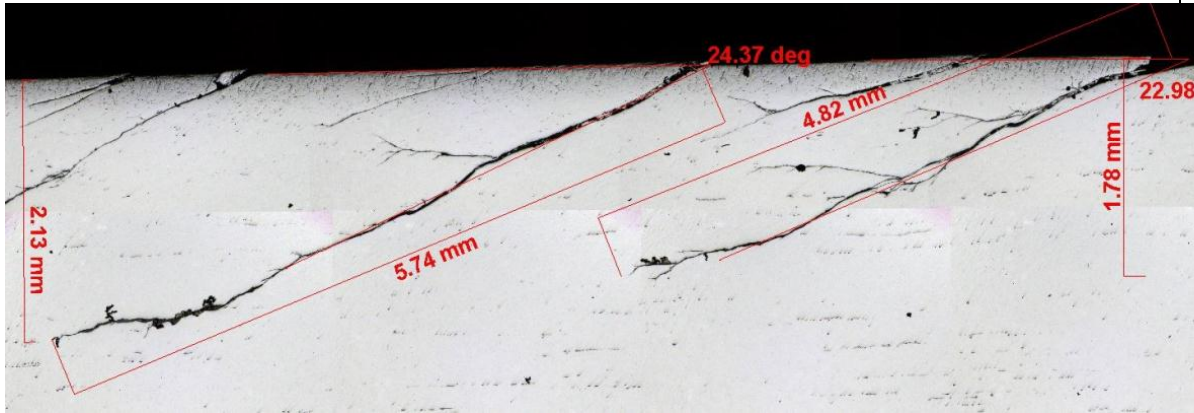
Surface condition

Longitudinal section

Crack measurement
