**Federal Railroad
Administration**

Force Environment Evaluation of Stub Sills on Tank Cars Using Autonomous Over-the-Road Testing of the Instrumented Tank Car

1. AGENCY USE ONLY (Leave blank)		2. REPORT DATE December 2016		3. REPORT TYPE AND DATES COVERED Technical Report – July 2014	
4. TITLE AND SUBTITLE Force Environment Evaluation of Stub Sills on Tank Cars Using Autonomous Over-the-Road Testing of the Instrumented Tank Car			5. FUNDING NUMBERS

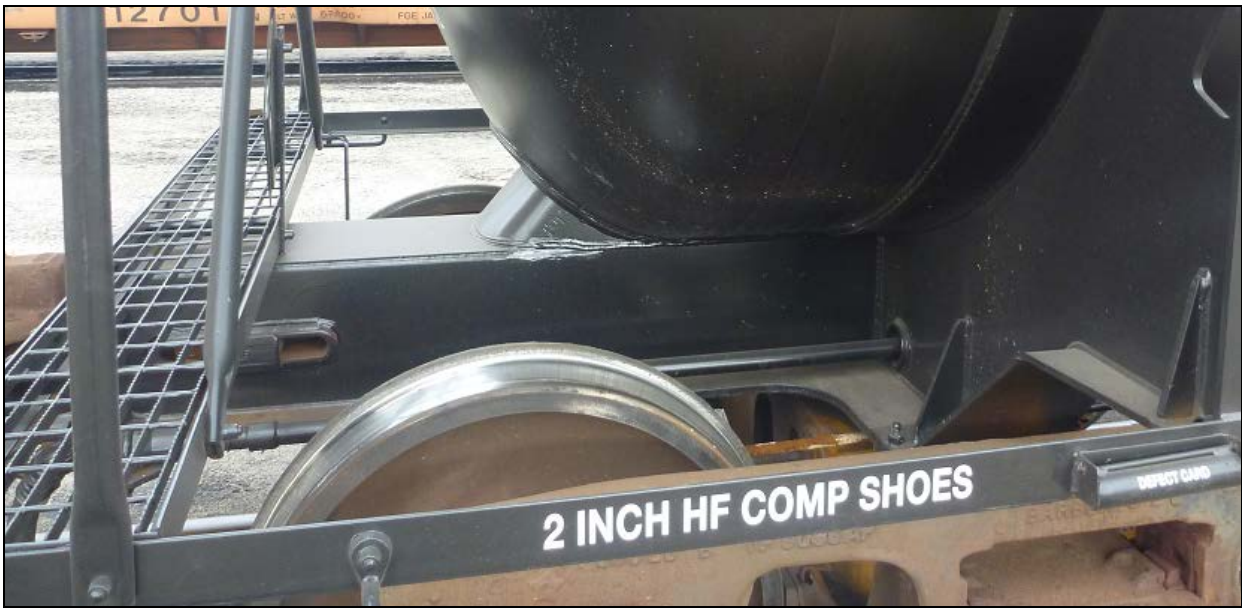
Figure 2. Detail View of the Stub Sill and Head Brace Attached to the Tank

Following Phase II, FRA contracted ENSCO, Inc., to instrument and run a second instrumented tank car over the road during a special test. This testing was conducted in a special consist, with the intent to collect data from the instrumented tank car, instrumented wheelsets, and track geometry. This test effort took place in June and July 2008. Results from this study resulted in recommendations to conduct an autonomous measurement test that would provide accurate information on the force environment spectrum that a tank car experiences during routine operations of transportation of materials. The tank car that had been instrumented in the earlier phase by ENSCO was routed through hazmat routes and through different yards to capture force environment information. The tank car used for this effort was provided by GE and is shown in Figure 1. A detailed view of the end of the tank car with the stub sill attachment is shown in Figure 2.

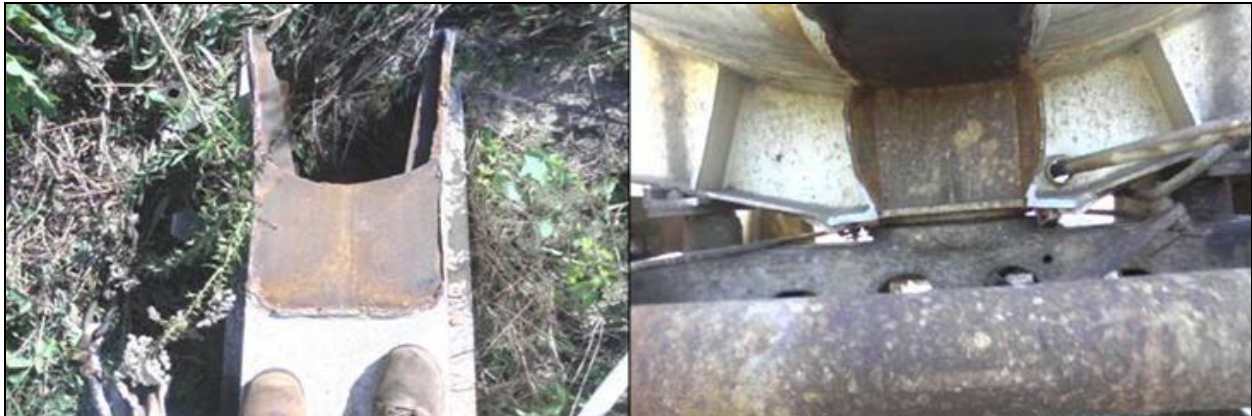
Figure 3. Stub Sill Fracture Observed in Callahan, FL (December 2009)

Examples of fractures observed by CSX (Figure 3 and Figure 4) were provided to ENSCO. As can be seen, these fractures are catastrophic in nature for the stub sill. The industry has improved the design of the welds such that the weld between the head brace and stub sill should fail before the weld between the pad and tank.

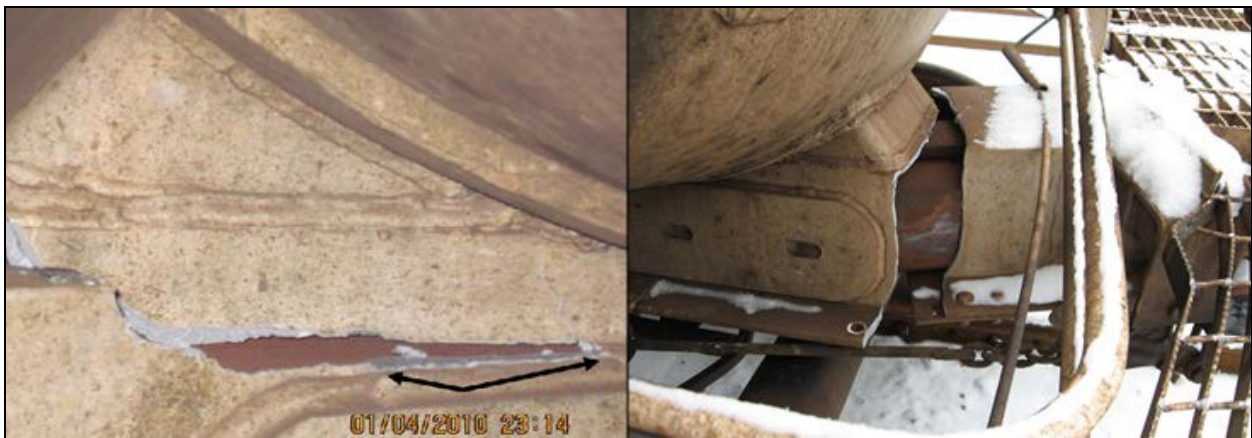
Figure 4. Stub Sill Fracture Observed in Charleston, WV (January 2010)

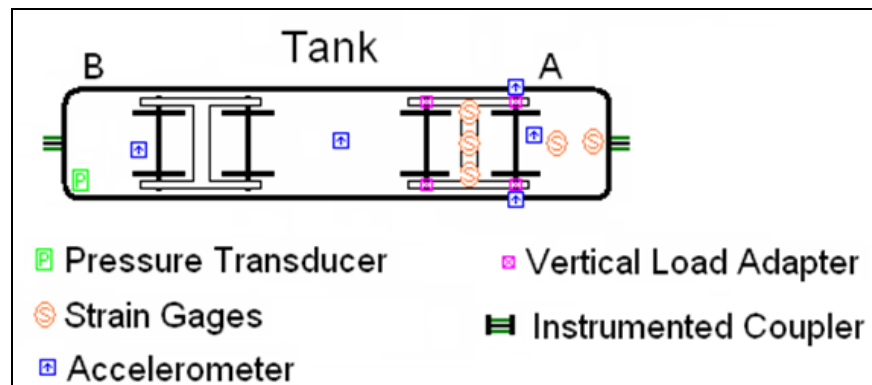
Figure 5. Instrumentation Layout for Over-the-Road Testing

The overall instrumentation layout is shown in Figure 5. Details for the sensors are provided in the following few paragraphs.

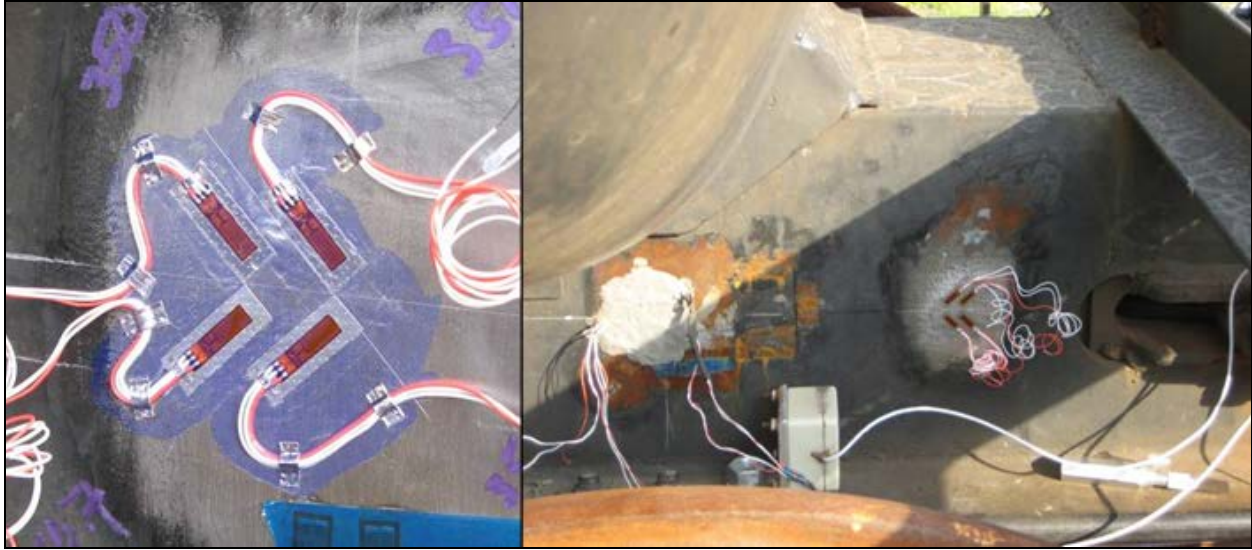
Figure 6. Shear Gauges Measuring Vertical Coupler Force

Left: Close-up of the installation. **Right:** New gauges on the right replaced gauges on the left (covered with sealant), which were then disconnected.

The shear gauges were wired using a completion card to form a full bridge. A second set of gauges were mounted next to the original set as a spare (total 8 gauges, 4 on each side). The mounting process included grinding and polishing the coupler surface to provide a smooth area to which the strain gauges were adhered. To increase resolution after unsatisfactory initial testing, new gauges were applied at a location closer to the end of the car, but not beyond the points of contact between the coupler channel and the coupler. These shear gauges were applied only on the A-end of the instrumented tank car.

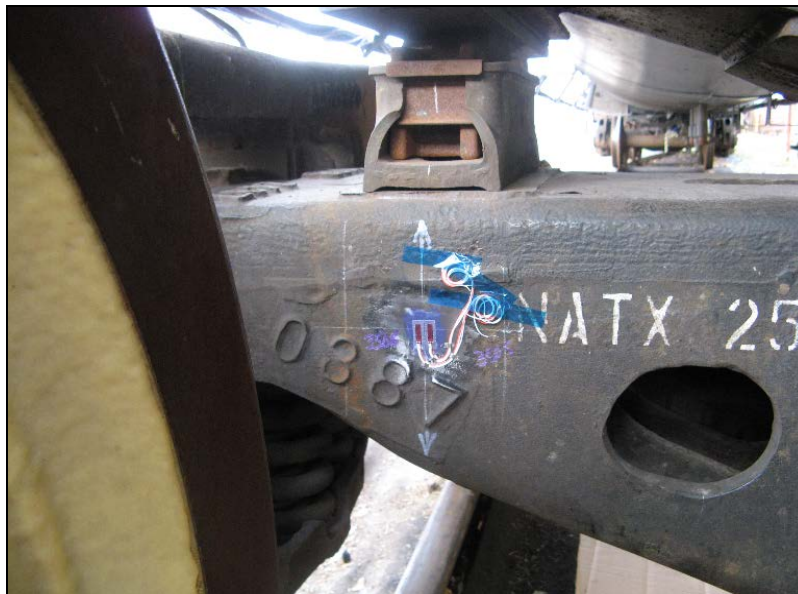
Figure 7. Strain Gauges Measuring Bolster Side Bearing Loads

A second set of strain gauges were mounted on the truck bolster underneath the side bearing (Figure 7). One gauge was mounted on each side to form a half bridge. Bridge completion resistors were used to complete the bridge. A spare set of gauges were mounted adjacent to the main gauges. An identical set of gauges, mounted on the truck bolster on the other side of the vehicle, were used to measure the side bearing loads.

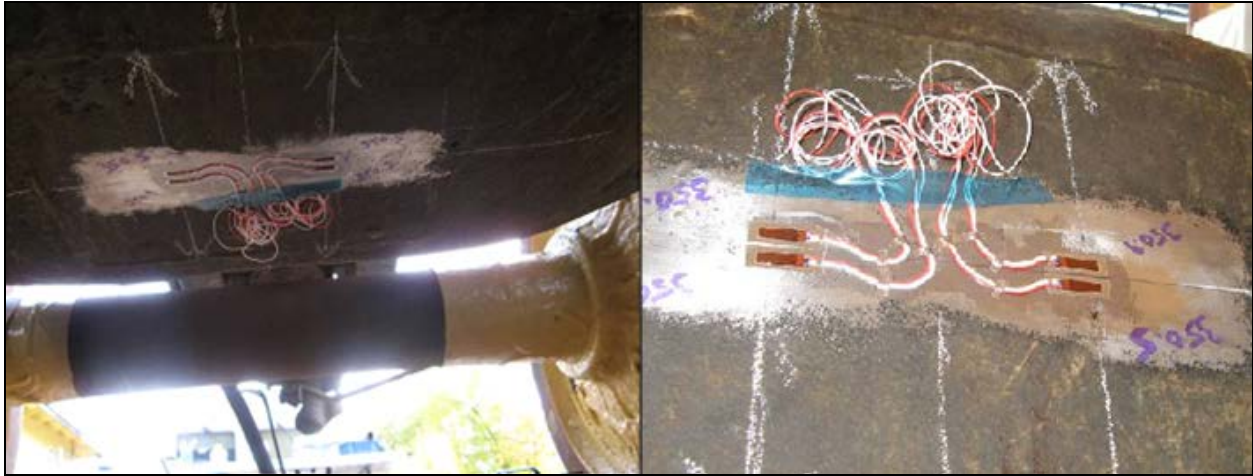
Figure 8. Strain Gauges Measuring Bolster Center Bowl Load

resistors were used to complete the bridge. A spare set of gauges, mounted adjacent to the main gauges, were used to measure the bolster center bowl load.

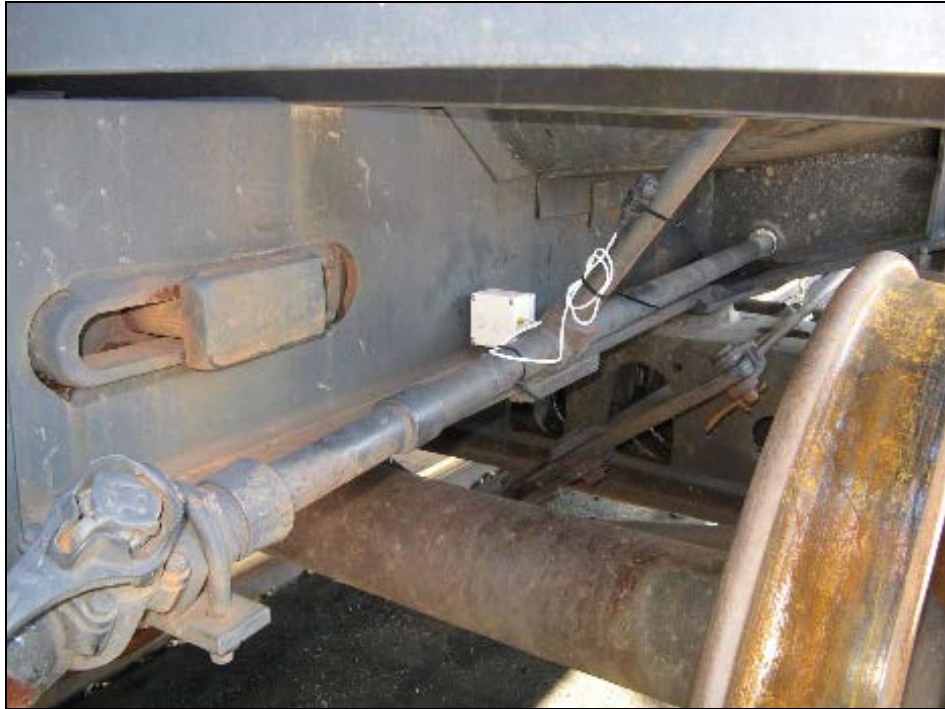
Figure 10. Vertical Accelerometer Mounted on the Stub Sill and Each End of the Car

Accelerometers were installed at several locations on the tank car. The first was a tri-axial accelerometer mounted on top of the carbody (Figure 9). The second and third accelerometers, mounted on the stub sill at each end of the car (Figure 10), measured accelerations in the vertical direction only. The fourth and fifth accelerometers, mounted on the bearing adapter on both sides of the first axle (Figure 11), measured accelerations on the axle in the vertical direction only.

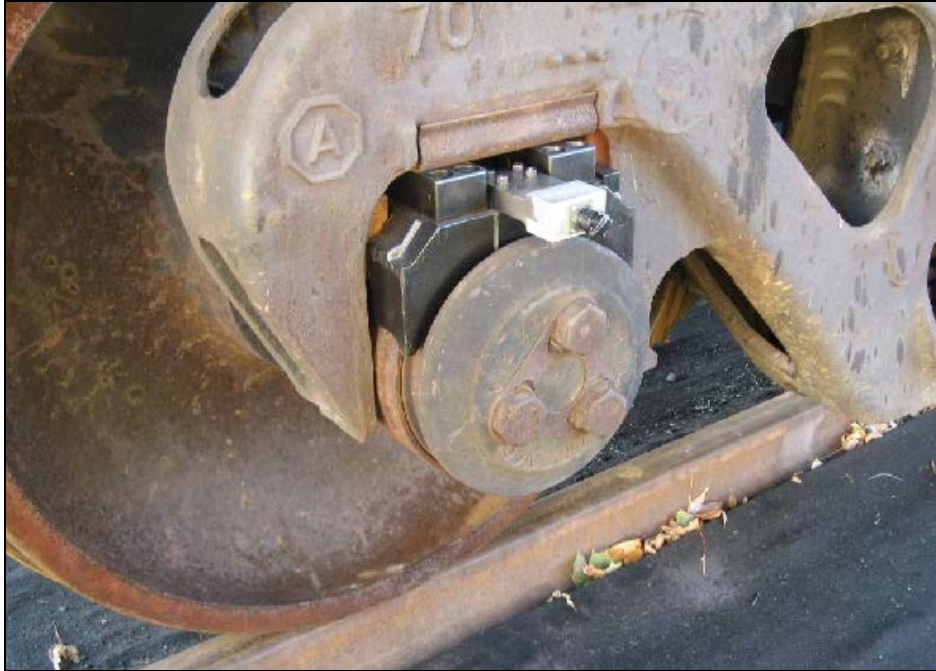
Figure 12. Vertical Load Adapter

Vertical load adapters are modified bearing adapters used to measure vertical wheel forces. The vertical load adapters are made using strain gauges. After they are calibrated, they are used like any other load cells. Figure 12 shows a vertical load adapter mounted on the tank car. Four of these were mounted on the A-End of the tank car.

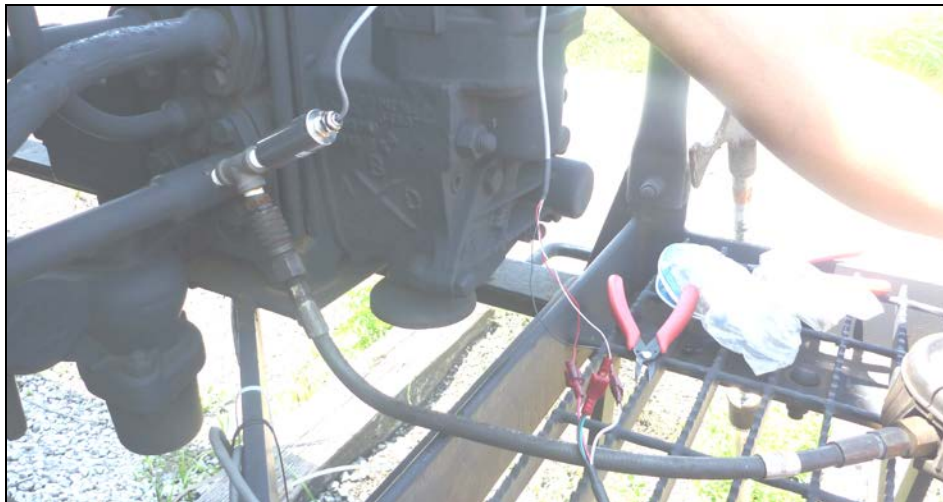
Figure 13. Brake Pressure Transducer

Brake application data were gathered to correlate the force and strain data to the operation of the car. This measurement was achieved by using a pressure transducer to measure the brake cylinder pressure. Only one pressure transducer was needed. Figure 13 shows the installation of the brake pressure transducer with the wires connected before they were fully protected from moisture.

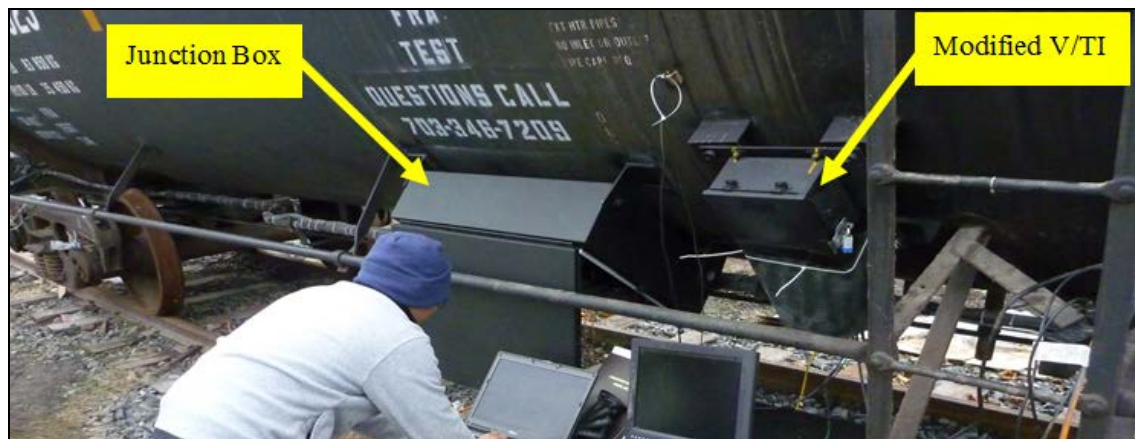
Figure 15. Modified VTI and Junction Box

system) then acquired and recorded the data in real time. Figure 15 shows the modified V/TI (on right) and the junction box (on left).

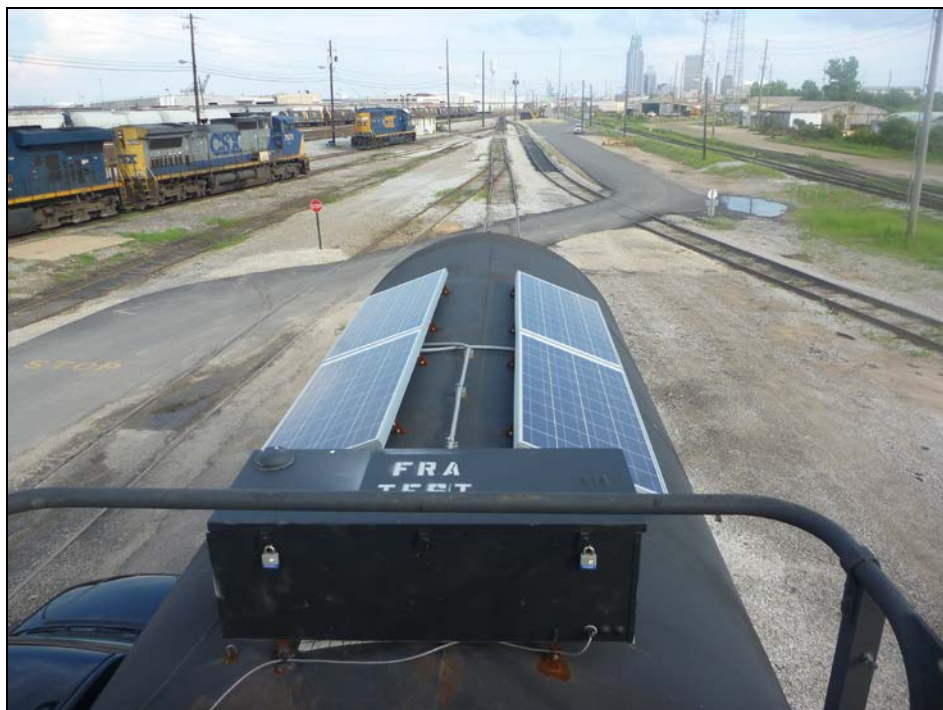
Figure 16. View of Solar Panels and Battery Box

Four solar panels and a set of batteries were used to power the system. Figure 16 shows the solar panels and the battery box. The battery box also contains the electronics that control battery charging.

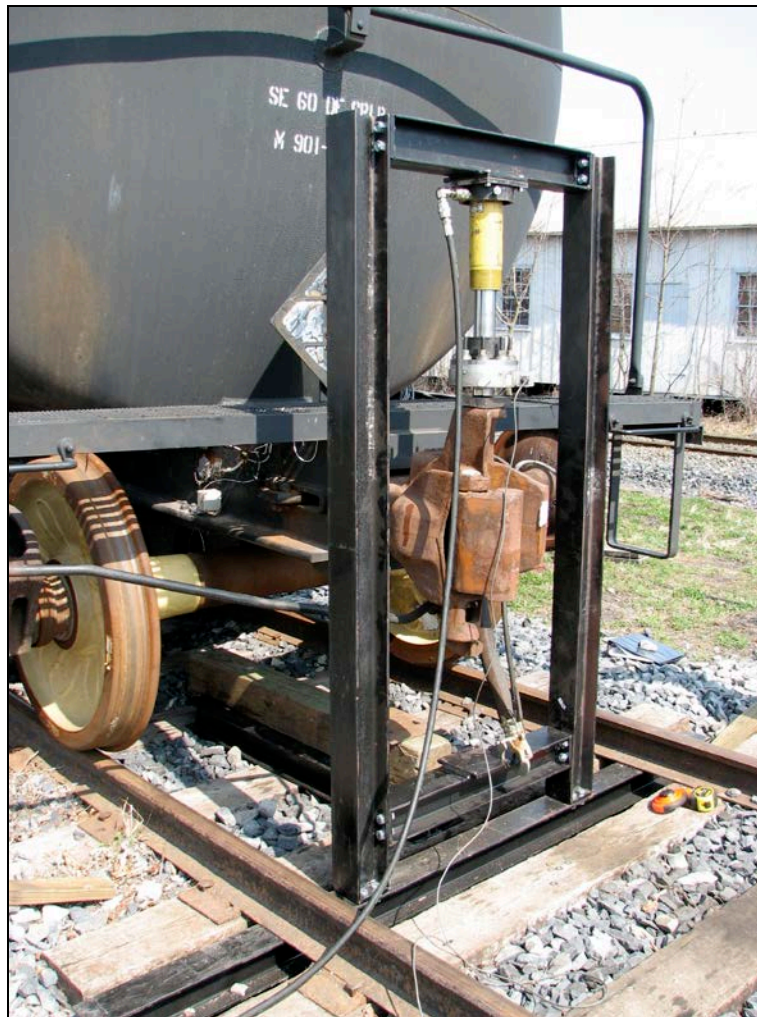
Figure 17. Vertical Coupler Force Calibration

The vertical coupler force was calibrated in the field using a special load fixture, which consisted of a metal frame, a load cell previously calibrated in the lab, and a ram to apply the load. Figure 17 shows the calibration fixture when a downward vertical force was applied.

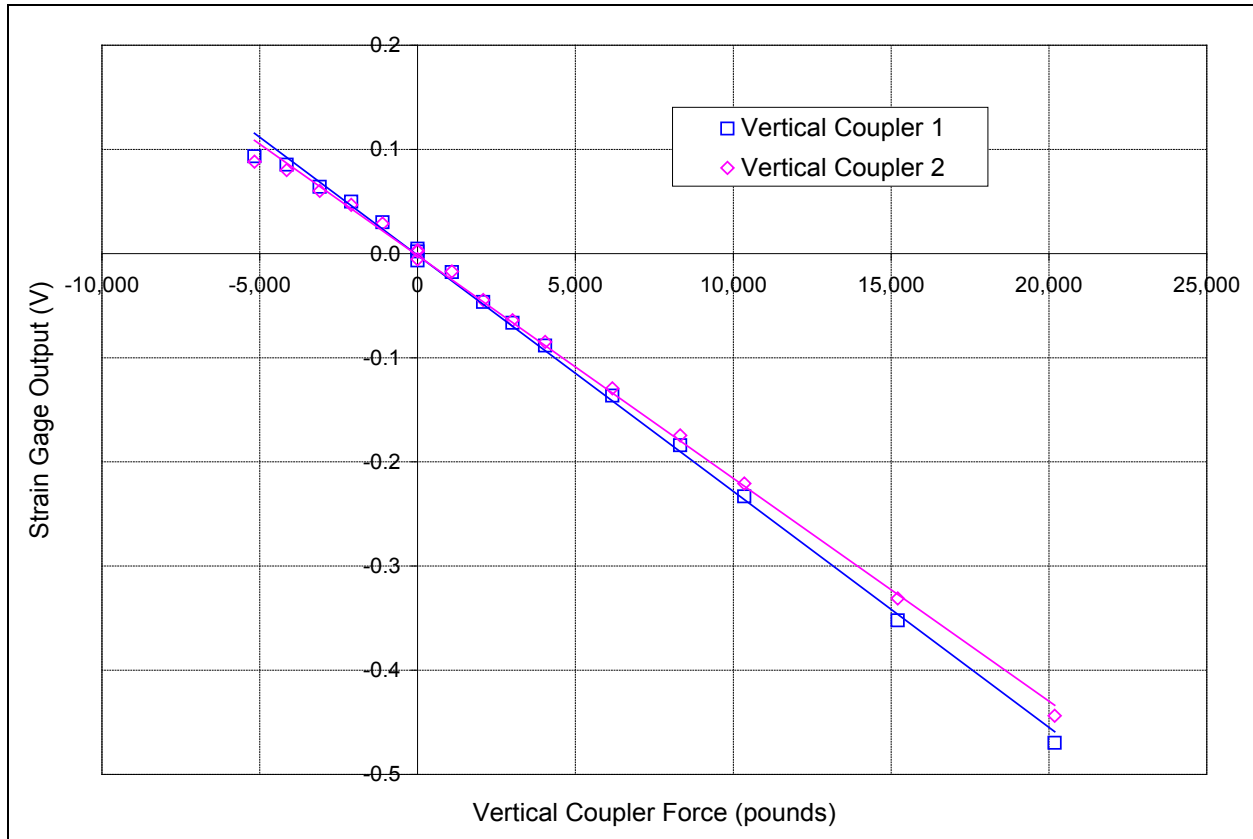
Figure 18. Vertical Coupler Force Calibration Graph

The setup was then reversed so that an upward vertical force could be applied. The applied force and the two strain gauge bridges were measured at several points for both positive and negative loadings. Figure 18 shows a graph of the calibration results for both of the vertical coupler forces.

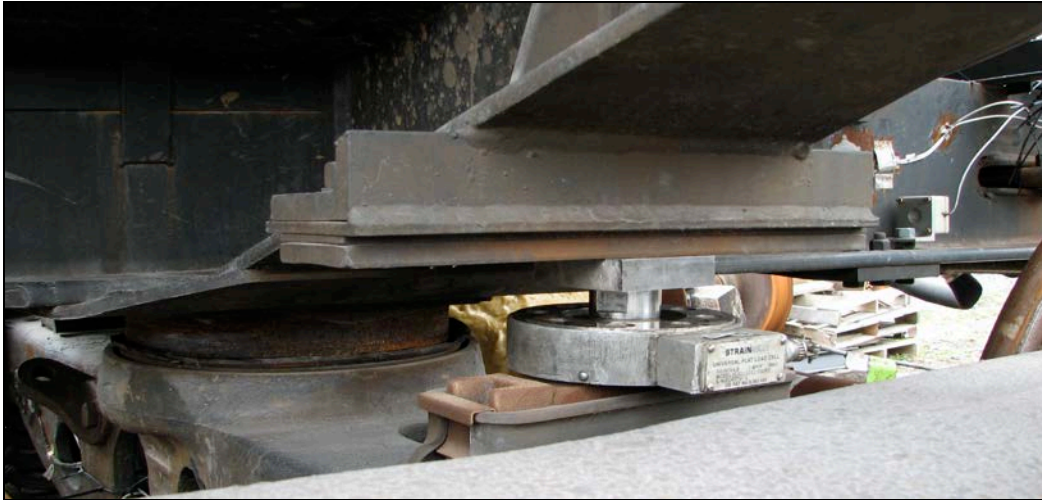
Figure 19. Side Bolster Force Calibration

The calibration consisted of three different configurations. In the first configuration, the car body was lifted completely off the A-end truck so that all three bolster loads were zero. In the second configuration, a load cell was inserted between both side bearers at the same time. (Initially, each side bearer was going to be done separately, but the vehicle was too unstable in this configuration.) Figure 19 shows the load cell inserted in one of the side bearers. In the third configuration, two load cells were inserted in the center bolster. Figure 20 shows the two load cells in this configuration.

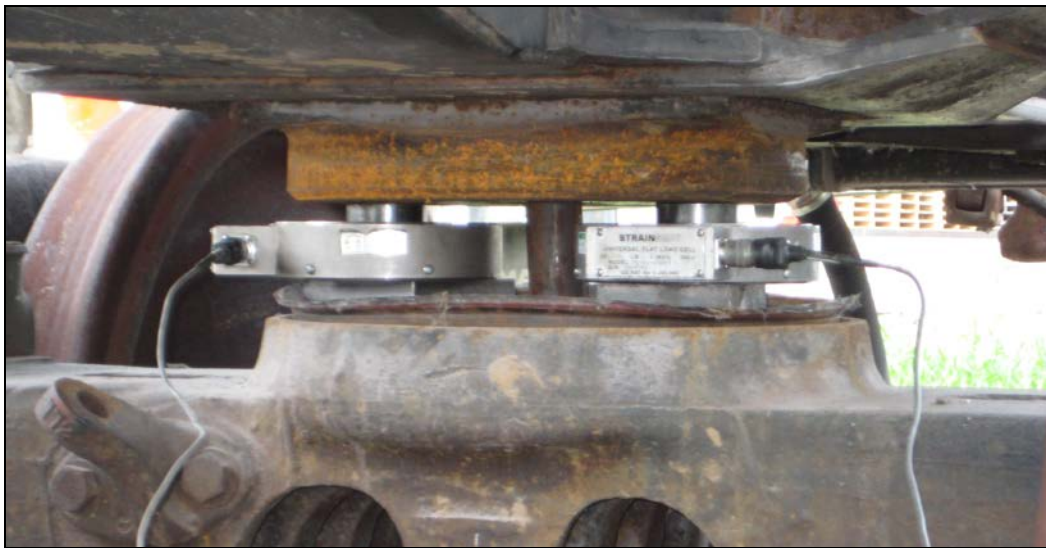
Figure 20. Center Bolster Force Calibration

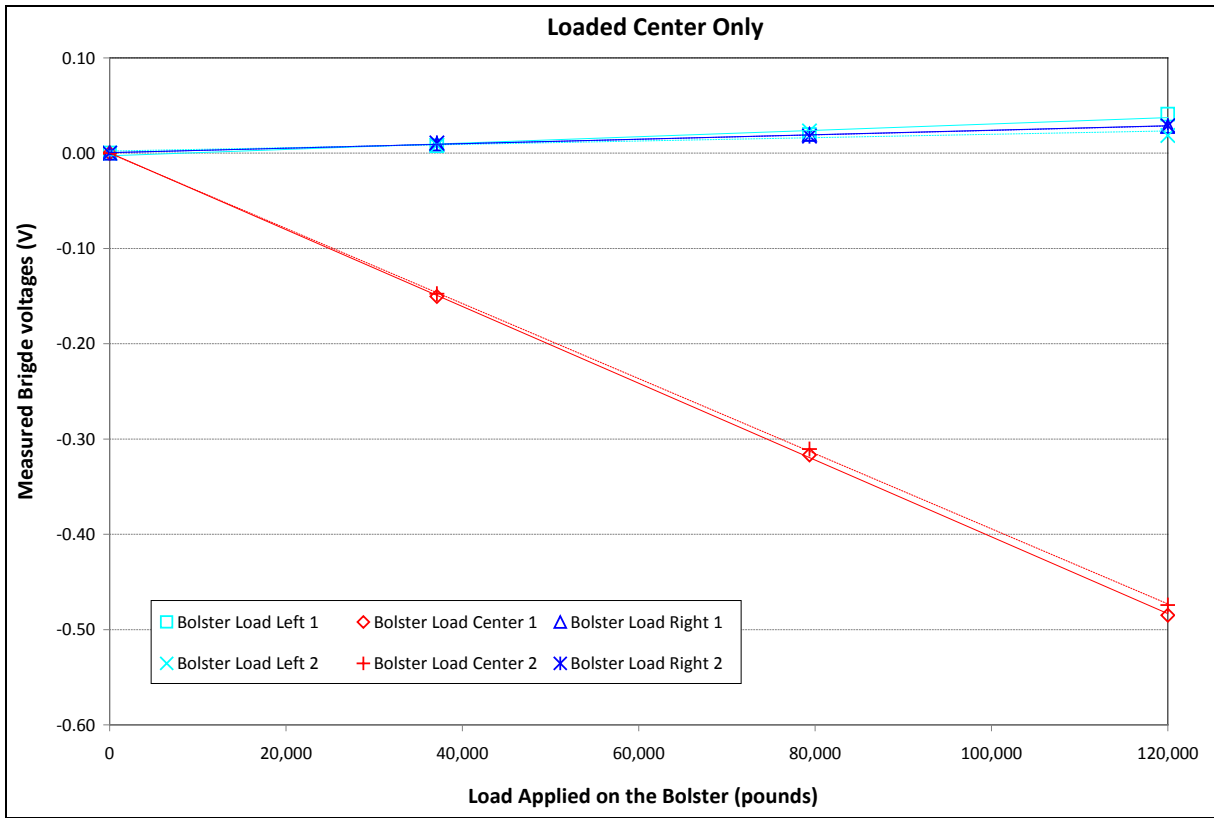
Figure 21. Bolster Loaded in Center Only

Several load readings were taken for each of these configurations. Figure 21 shows the strain gauge readings versus the bolster loading for the center only. Figure 22 shows the same data for loading both sides. Both graphs show good linearity for the strain measurements.

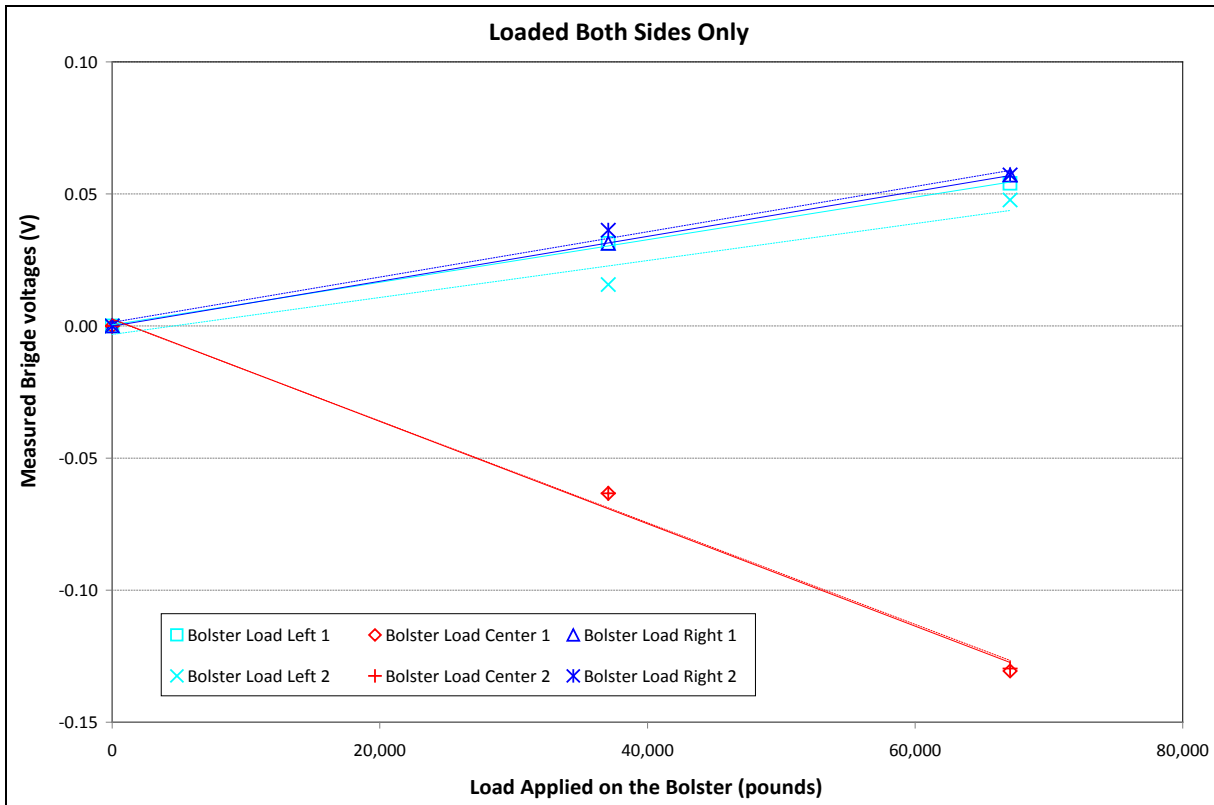
Figure 22. Bolster Loaded on Both Sides Only

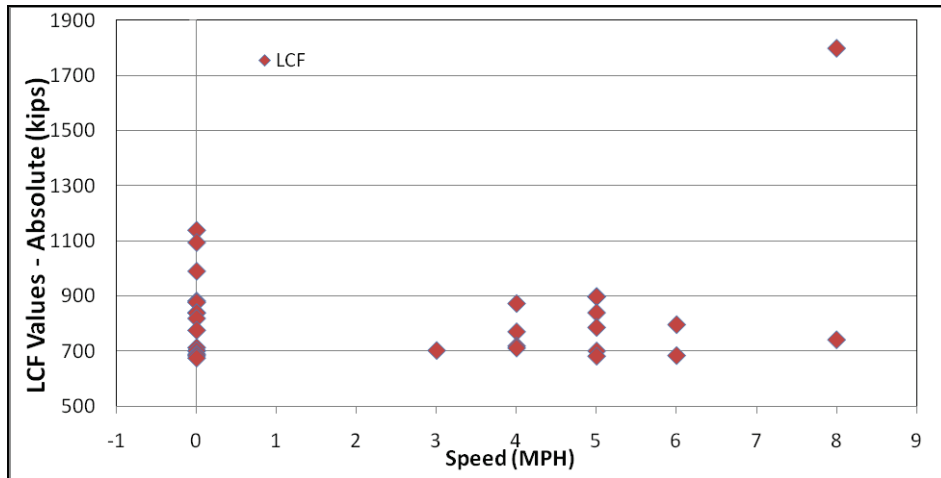
Figure 27. Characterization of the Top 30 Longitudinal Coupler Force Events with Respect to Speed

The LCF values measured for large impacts were plotted against speed (Figure 27). It should be noted that this plot also contains data from when the tank car was getting hit and was stationary before the impact; however, it is evident that even where the tank car was the hammer car, a strong correlation was not observed between the tank car speed and high LCF values. Some other factors are believed to be in play, such as the condition of the draft gears and the impacting and impacted masses during such an impact.

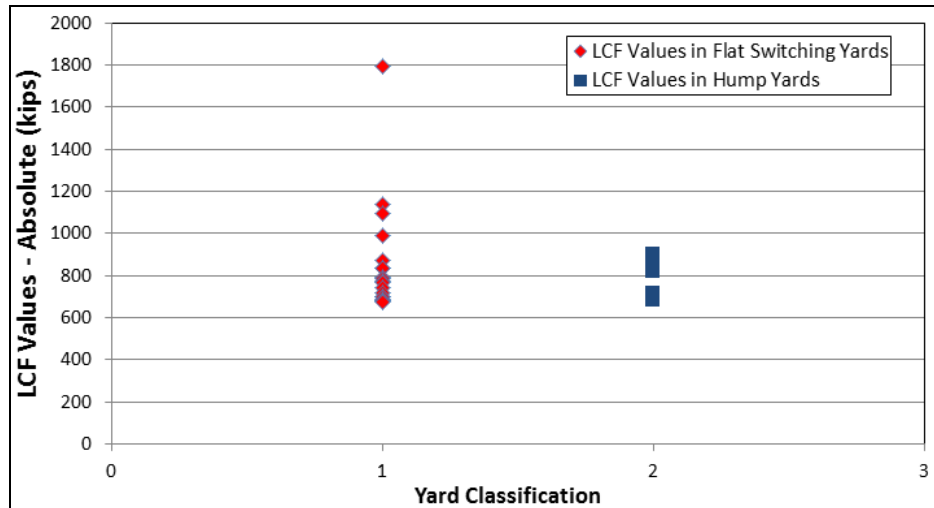
Figure 28. Comparison of Switching Yard Types

It has been believed that hump yards produce better coupling because of retarders and different shock-absorbing technology utilized in the yards. A comparison was conducted between the LCF values observed in hump and flat switching yards (Figure 28). It was observed that LCF impacts in hump yards lay in a tighter band as compared with those in flat switching yards.

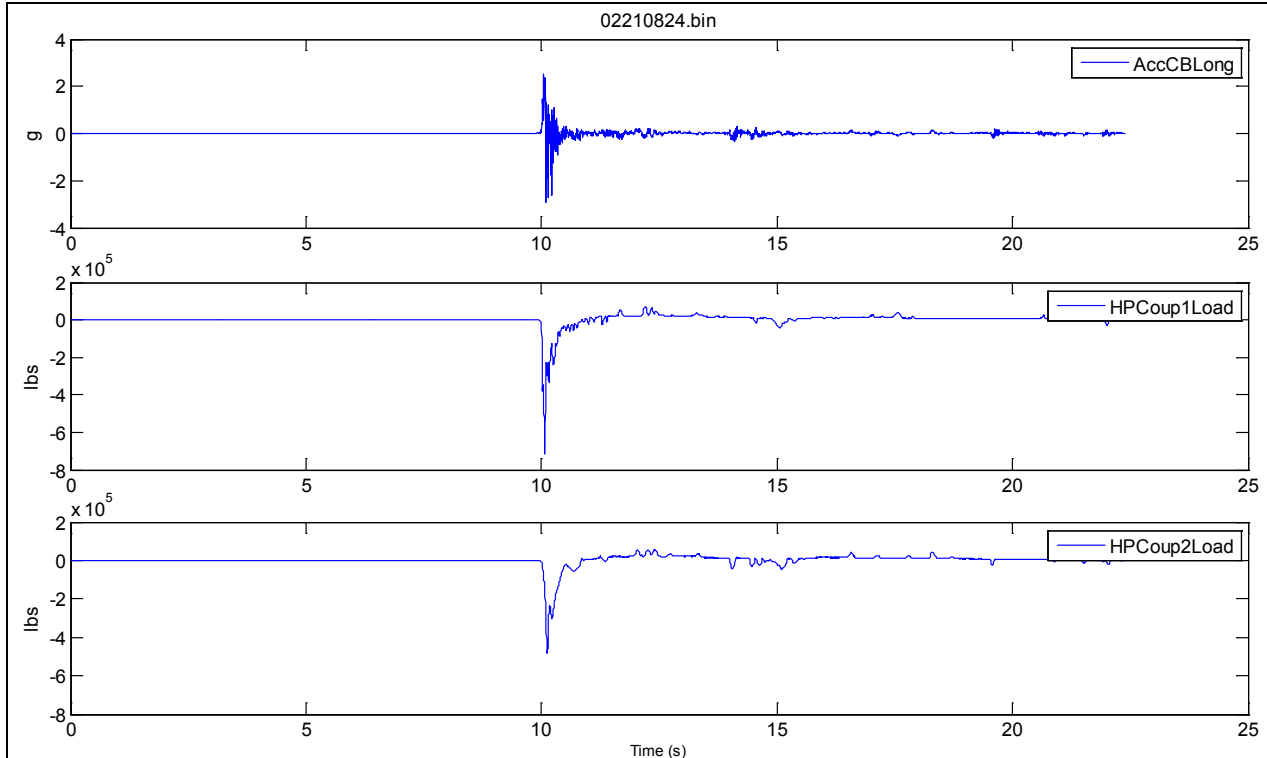
Figure 29. Longitudinal Accelerations and Longitudinal Forces at the A-End and the B-End

Note that the instrumented tank in this situation was not moving and was in a consist with an unknown position. During this event, a car or a set of cars were being coupled to this consist from the A-end. The A-end LCF maximum value was 711 kip, and the B-end maximum value was 479 kip. The difference between the LCF traces at the two ends of the instrumented tank car was calculated, and the trace was filtered at 15 Hz. The trace was divided by 263,000 lb, which is the weight of the car, and then compared to the measured accelerations as shown in Figure 30. The accelerations were also filtered using a 15 Hz low pass 2 pole Butterworth filter.

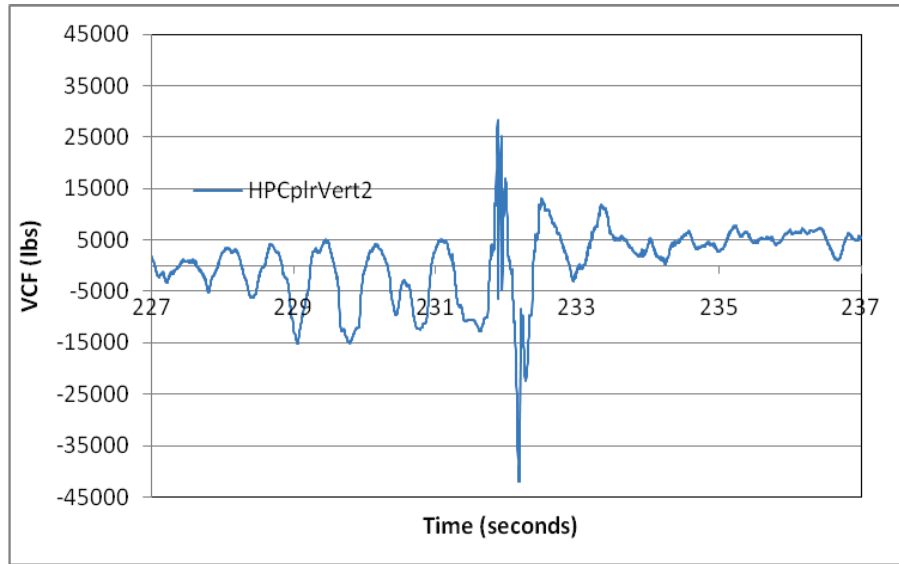
Figure 35. Snapshot of the Top VCF Event: 42 kip at a Road Crossing Near Bogart, GA

The top VCF event of 42 kip is shown again in Figure 35, and the corresponding track geometry data are shown in Figure 36. The track geometry data were collected by DOTX-217 on 10/30/2009 and were not an exception by current FRA Track Safety Standards (TSS) for surface deviations. Although the 62' surface parameters seem to be below the FRA TSS, the 31' profile parameters shown in the bottom part of Figure 36 show the same signature but with a significantly higher magnitude. Although the location was not a defect at the time the geometry car was tested (10/30/2009), it may have deteriorated by 06/14/2010, when the tank car traveled on the same route.

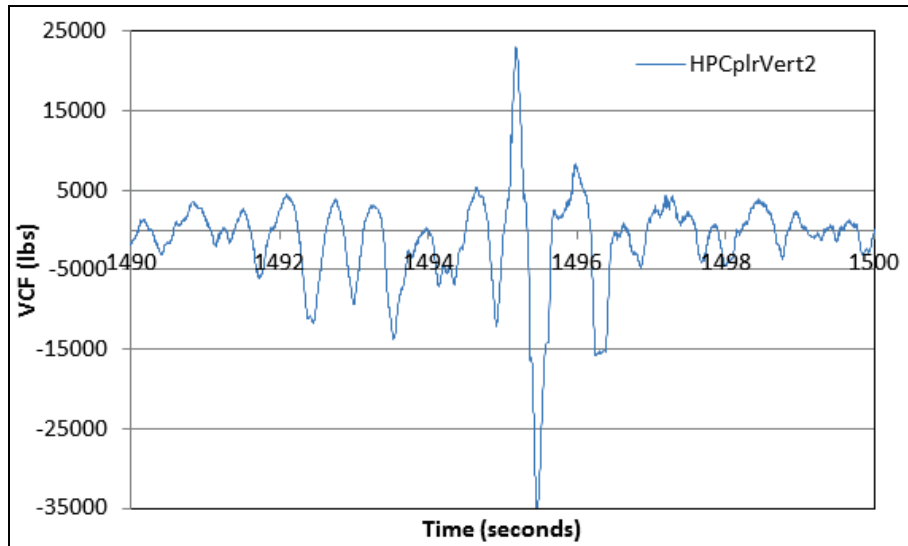
Figure 37. Second Highest VCF Event on Mainline Track: 35 kip Near Bogart, GA

The second-highest VCF event (on mainline track—yards excluded) was also similarly tied to short chord (31') vertical profile geometry, as shown in Figure 37 and Figure 38.

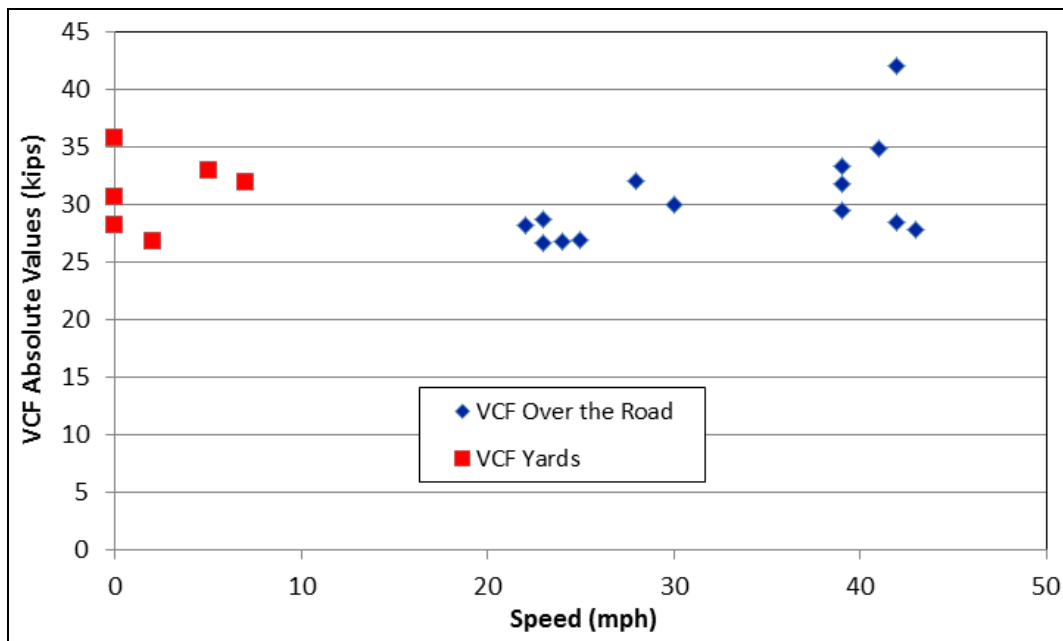
Figure 42. Mild Correlation of Train Speed and VCF Over the Road (Blue)

the vehicle speed, but also on the magnitude and frequency of the vertical perturbations on the track, such as road crossings, bridge transitions, etc.

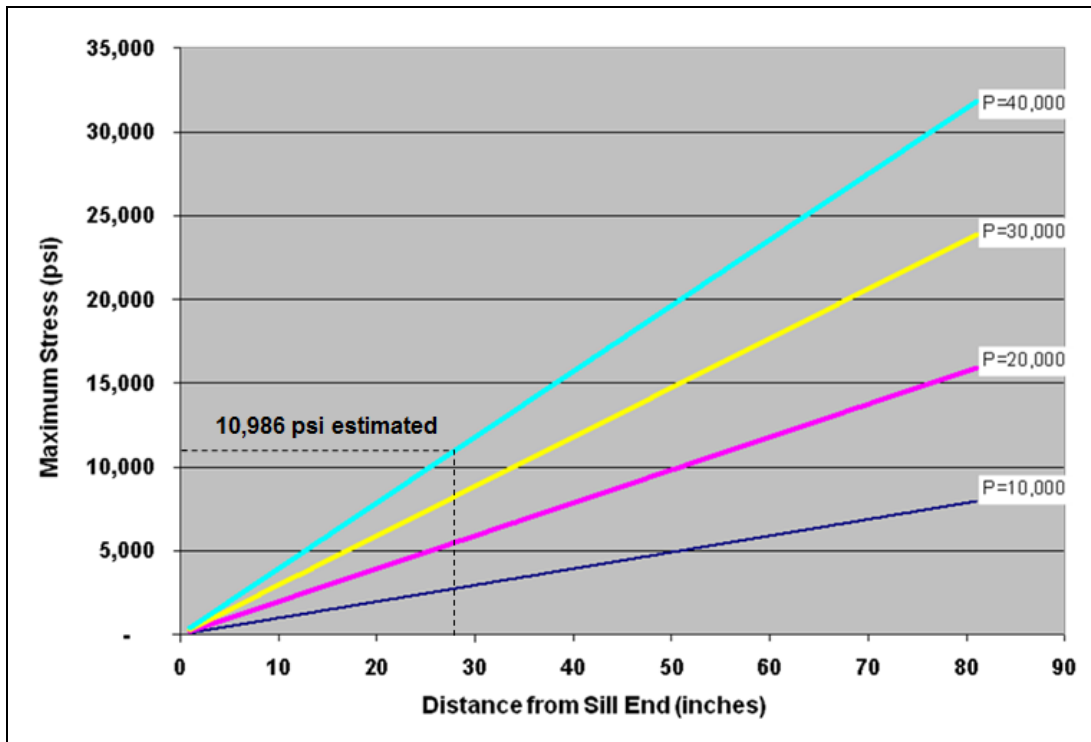
Figure 44. Estimate of Stress as a Relation to Distance from Striker Plate of Stub Sill Towards the Bolster

The stress estimate variation with the distance from the end of the stub sill is shown in Figure 44. The distance from the end of the stub sill to the start of the head brace is 27.25” for this stub sill. At that distance, the stress is estimated to be 10,986 psi—very close to the values presented in the TTCI report mentioned above.
