**Federal Railroad  
Administration**

# Research Results

RR09-15  
September 2009

## Update of Experiments at the Revenue Service Mega Sites

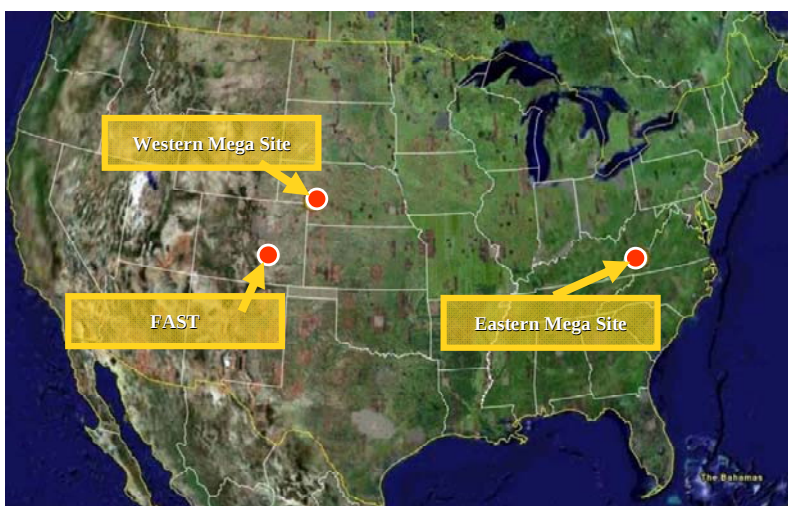
Figure 1. Location of Mega Sites and FAST Test Site

Revenue service testing by Transportation Technology Center, Inc. at the eastern and western mega sites (Figure 1) continues to determine the effects of heavy axle loads (HAL) on track infrastructure and to monitor performance of new technologies and designs intended to improve train operation safety and to mitigate detrimental effects of HAL on the track structure. The Federal Railroad Administration and the Association of American Railroads co-sponsor this research.

Two mega test sites were established in late 2004 to consolidate some of the heavy axle load (HAL) revenue service experiments. The eastern mega site is located near Bluefield, WV, on a heavy haul track of Norfolk Southern (NS) Railway. The western mega site is located near Ogallala, NE, on a heavy haul track of Union Pacific Railroad. In 2008 and during the first quarter of 2009, numerous experiments, most of which started before 2008, continued or were concluded. This *Research Results* gives a summary of findings from this revenue service test program.

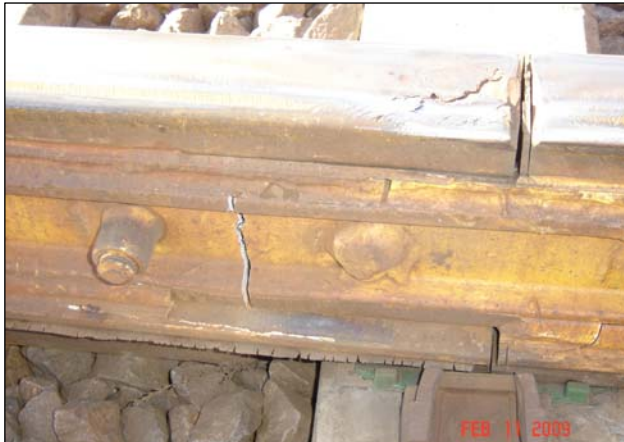
Figure 4. IJ Failed Due to Cracked Bar at 1,090 MGT

Eight test IJs were installed at the western mega site in the summer of 2004 [5]. Seven IJs had an improved design, whereas, one, which failed at 330 MGT in 2006, used a traditional design. This test was concluded in 2007 in terms of measuring load environment data of these test IJs, but monitoring of their long-term performance continued. After approximately 1,000 MGT, two of the seven test IJs failed from cracked joint bars, resulting in a life at least three times as long as the conventional design. Figure 4 shows a failed IJ due to a cracked joint bar. Notice the rough running surface that generated high wheel impact forces and contributed to the breakage of the joint bar.
