**Investigation of the Presence of Wetlands and
Other Waters of the United States
DesertXpress Project
HUC 8 Las Vegas Watershed
Clark County, Nevada**

July 2010

**DESERTXPRESS ENTERPRISES, LLC
6750 Via Austi Parkway
Suite 250
Las Vegas, NV 89119**

**HUFFMAN-BROADWAY GROUP, INC.
828 Mission Avenue
San Rafael, CA 94901**

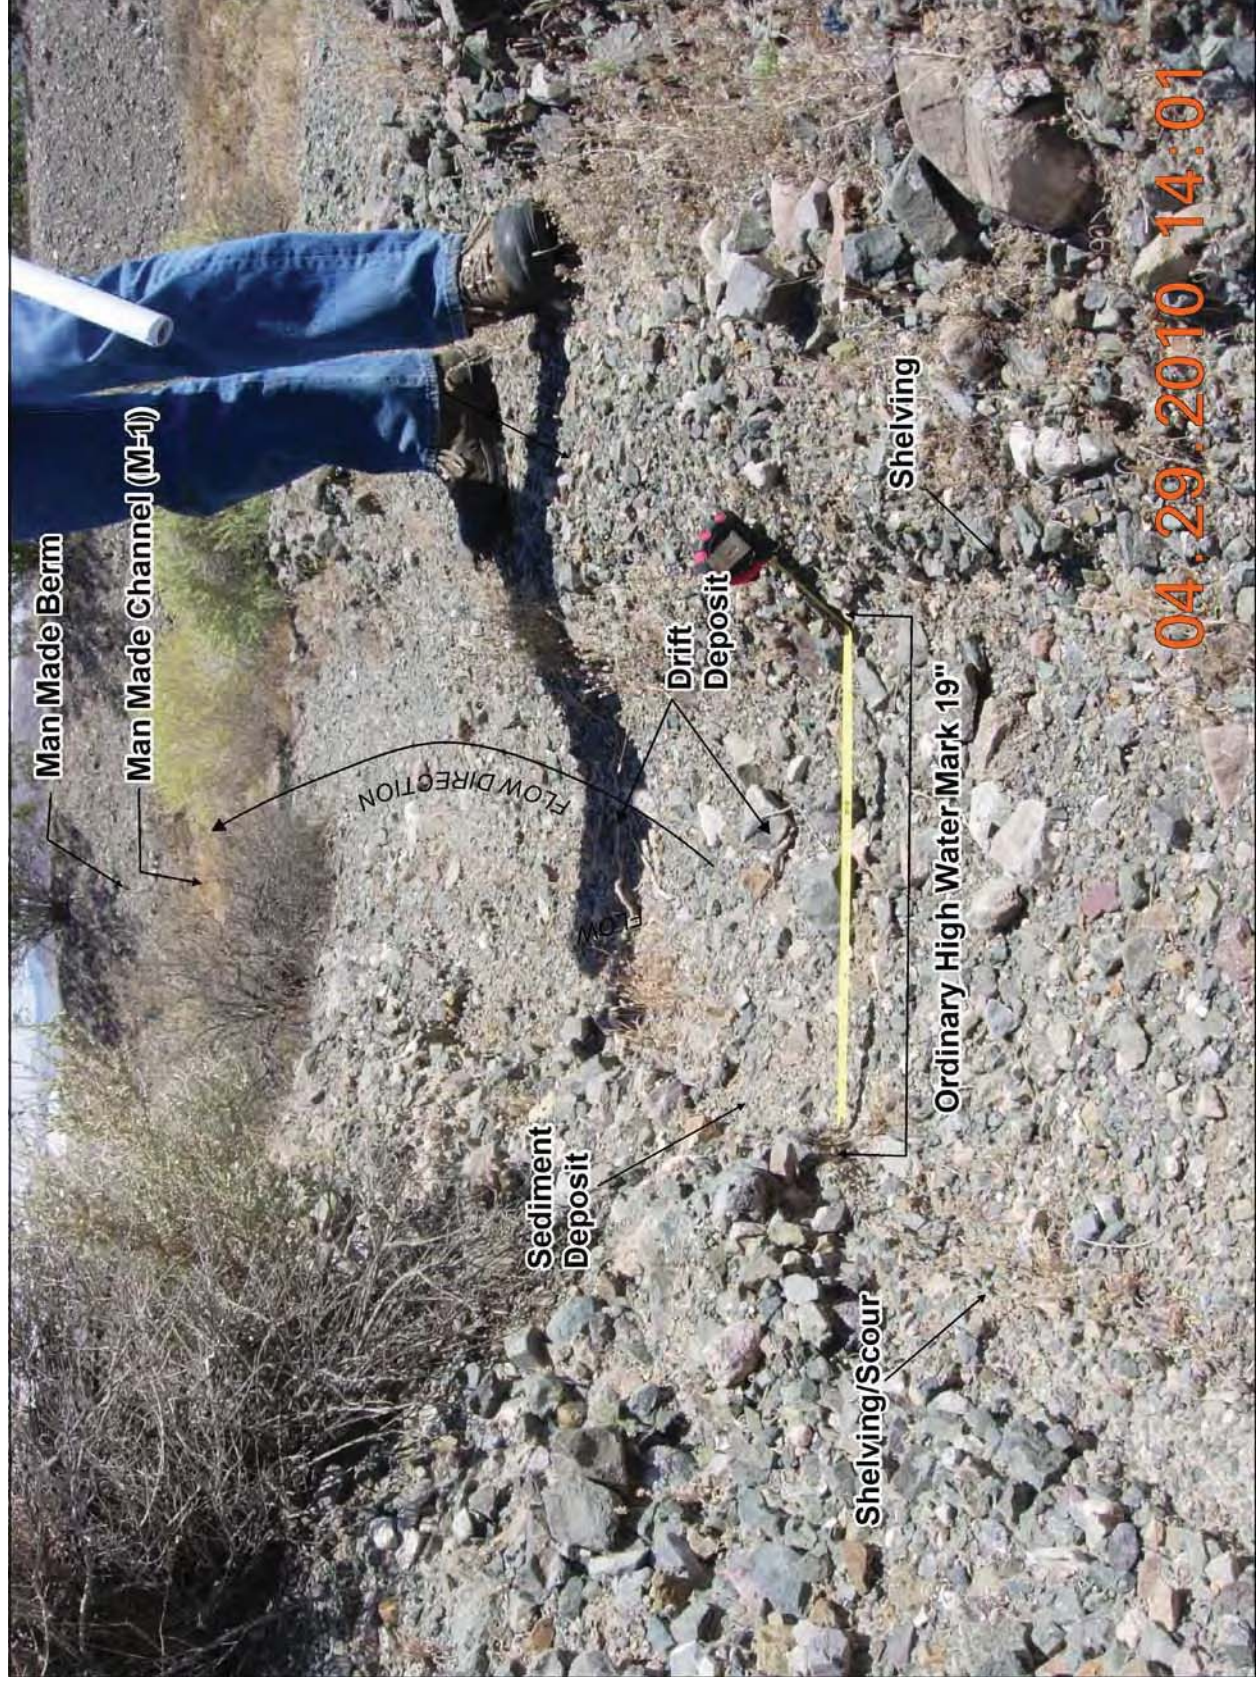
Exhibit A. Figure 5. Typical examples of field indicators of active surface water flow and Ordinary High Water Marks found within ephemerals drainages occurring within the DesertXpress Project Study Area.

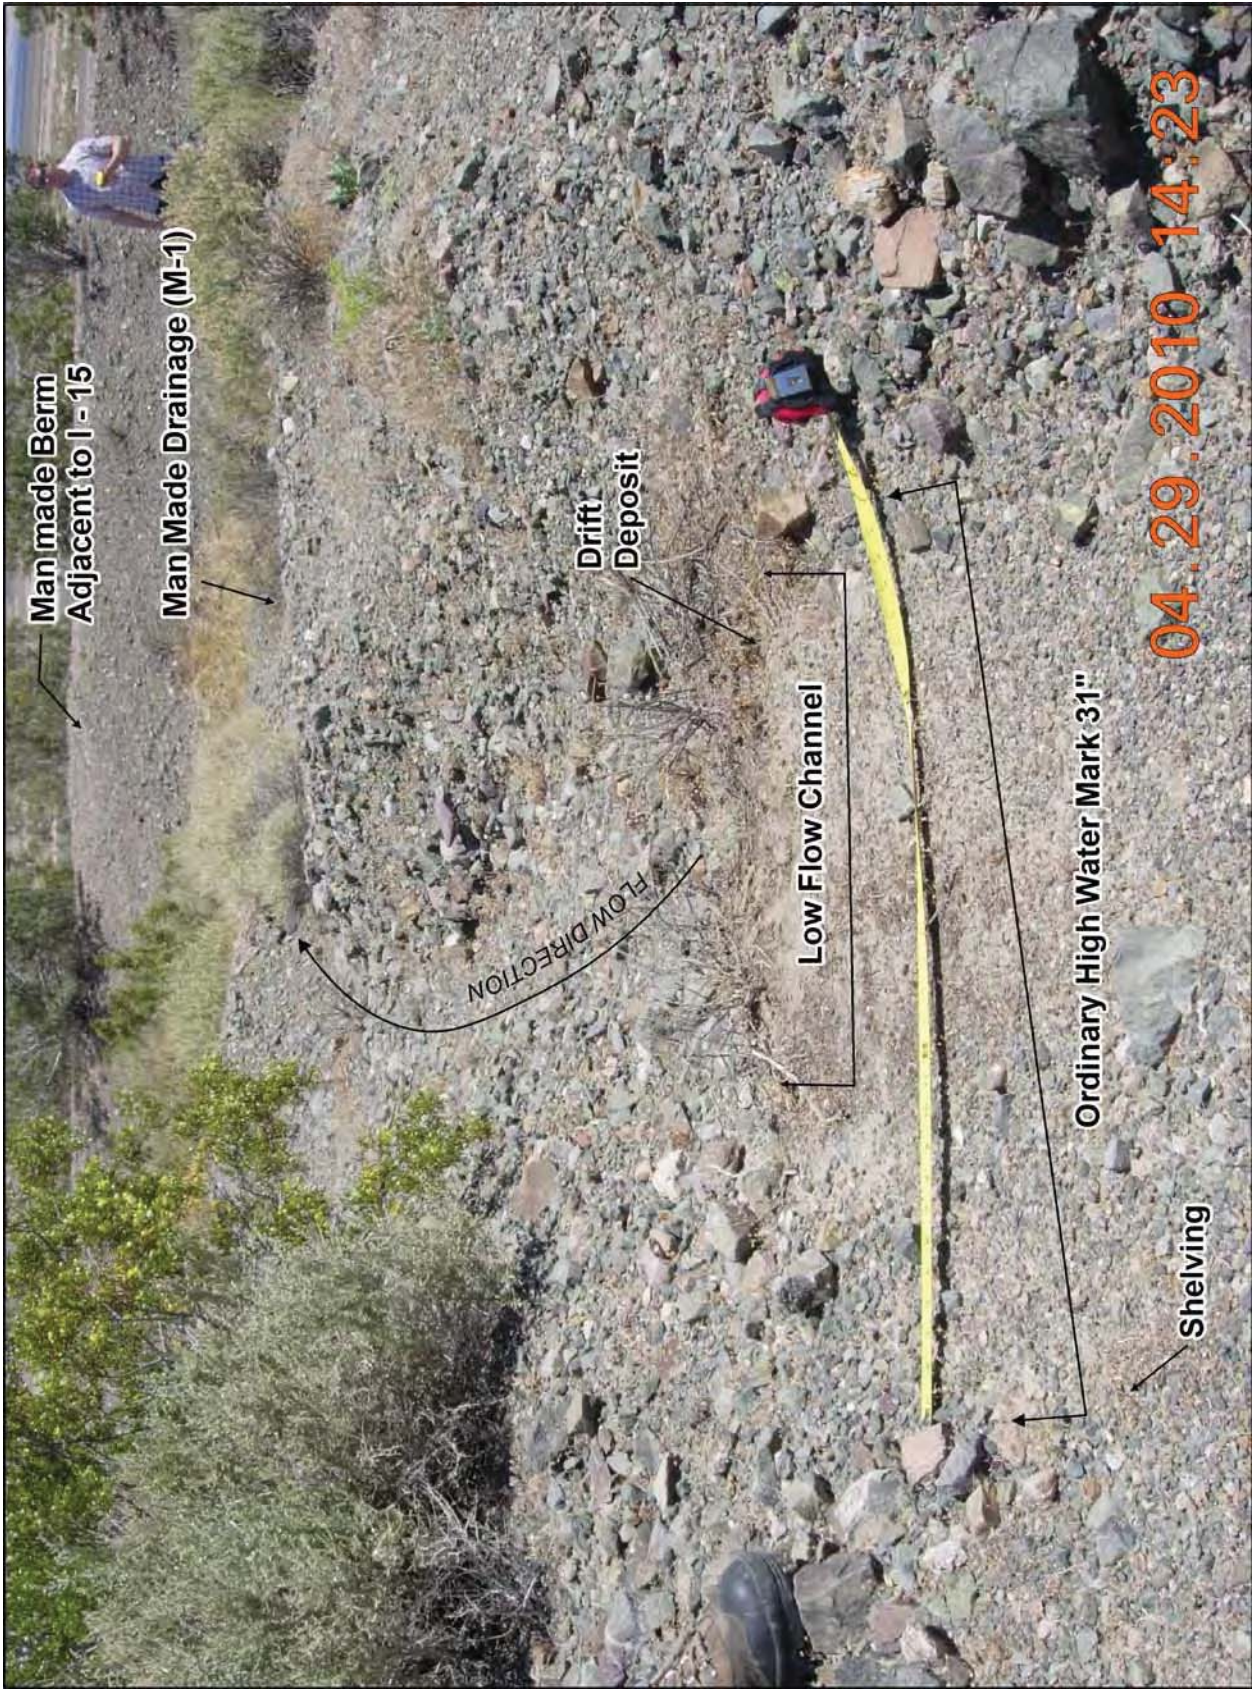
Exhibit A. Figure 7. Typical examples of field indicators of active surface water flow and Ordinary High Water Marks found within ephemerals drainages occurring within the DesertXpress Project Study Area.

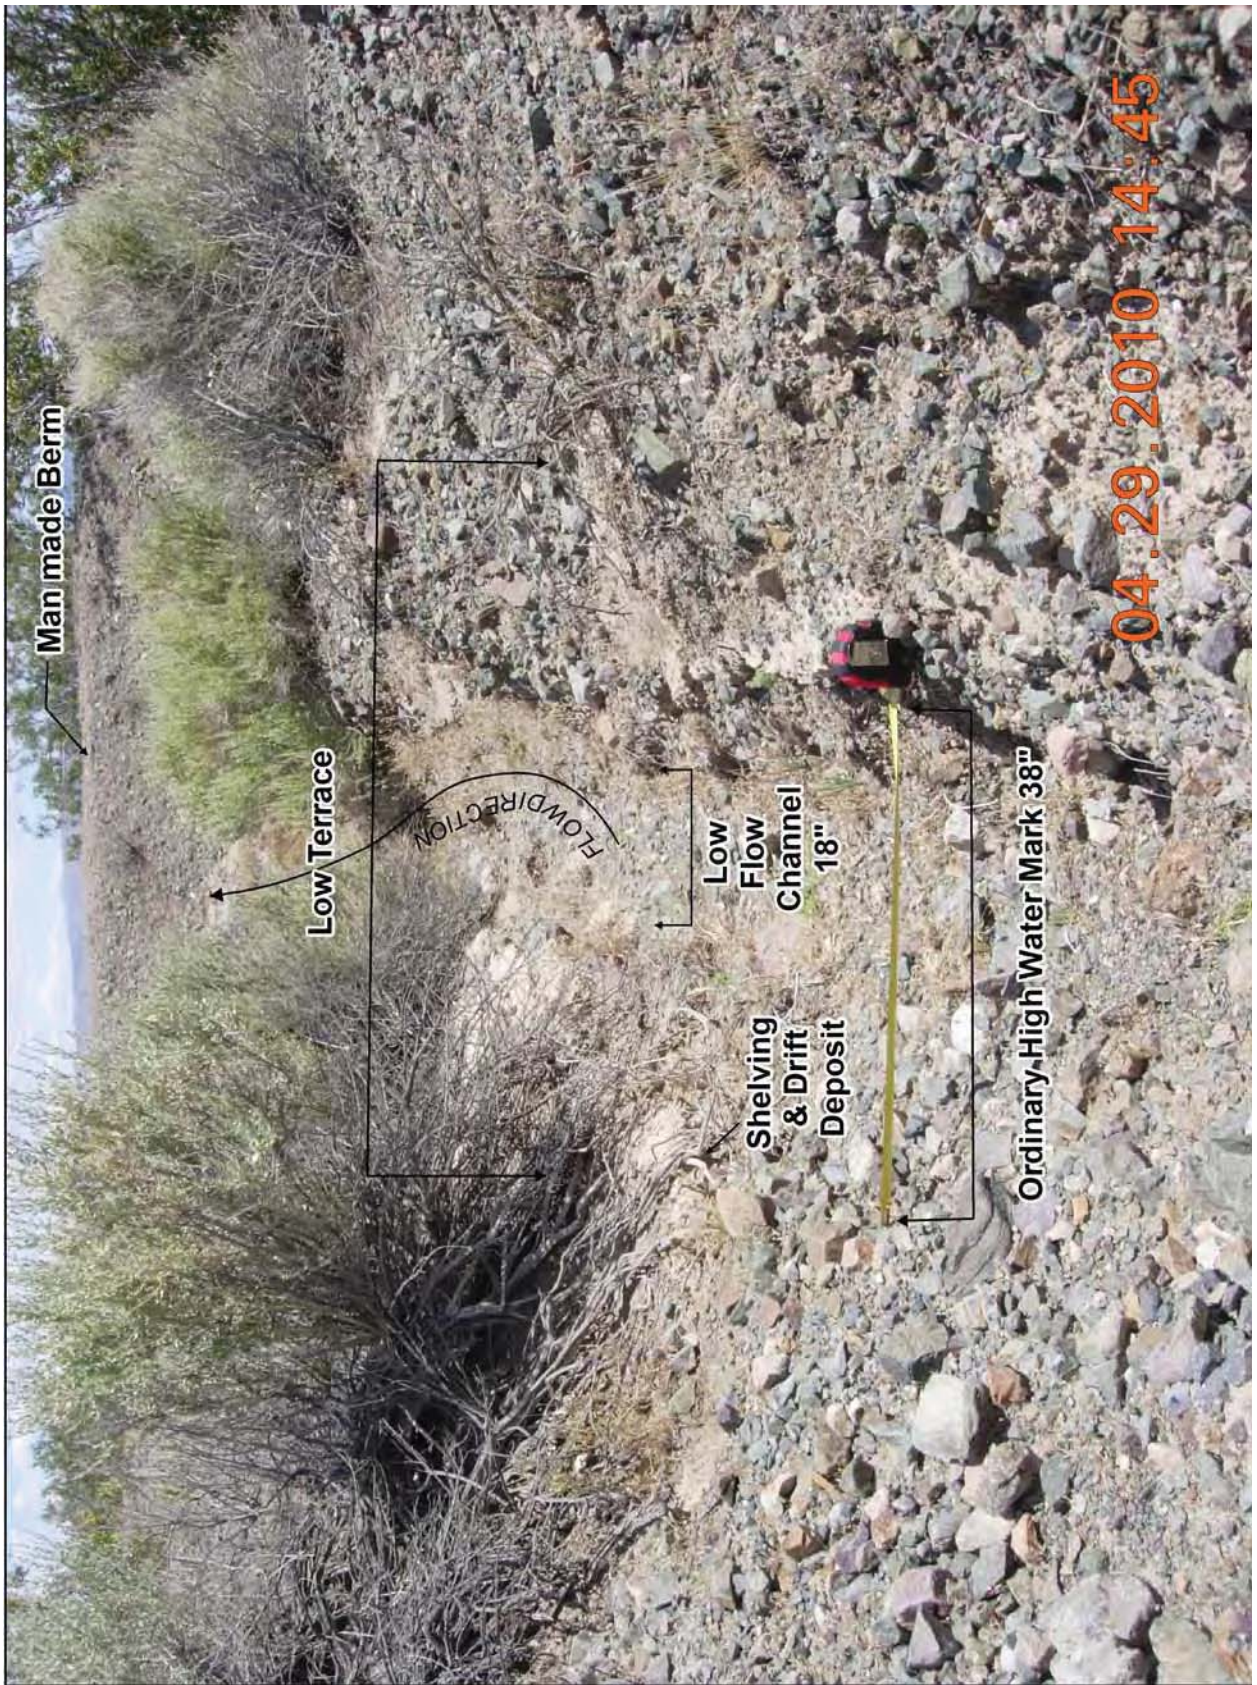
Exhibit A. Figure 8. Typical examples of field indicators of active surface water flow and Ordinary High Water Marks found within ephemerals drainages occurring within the DesertXpress Project Study Area.

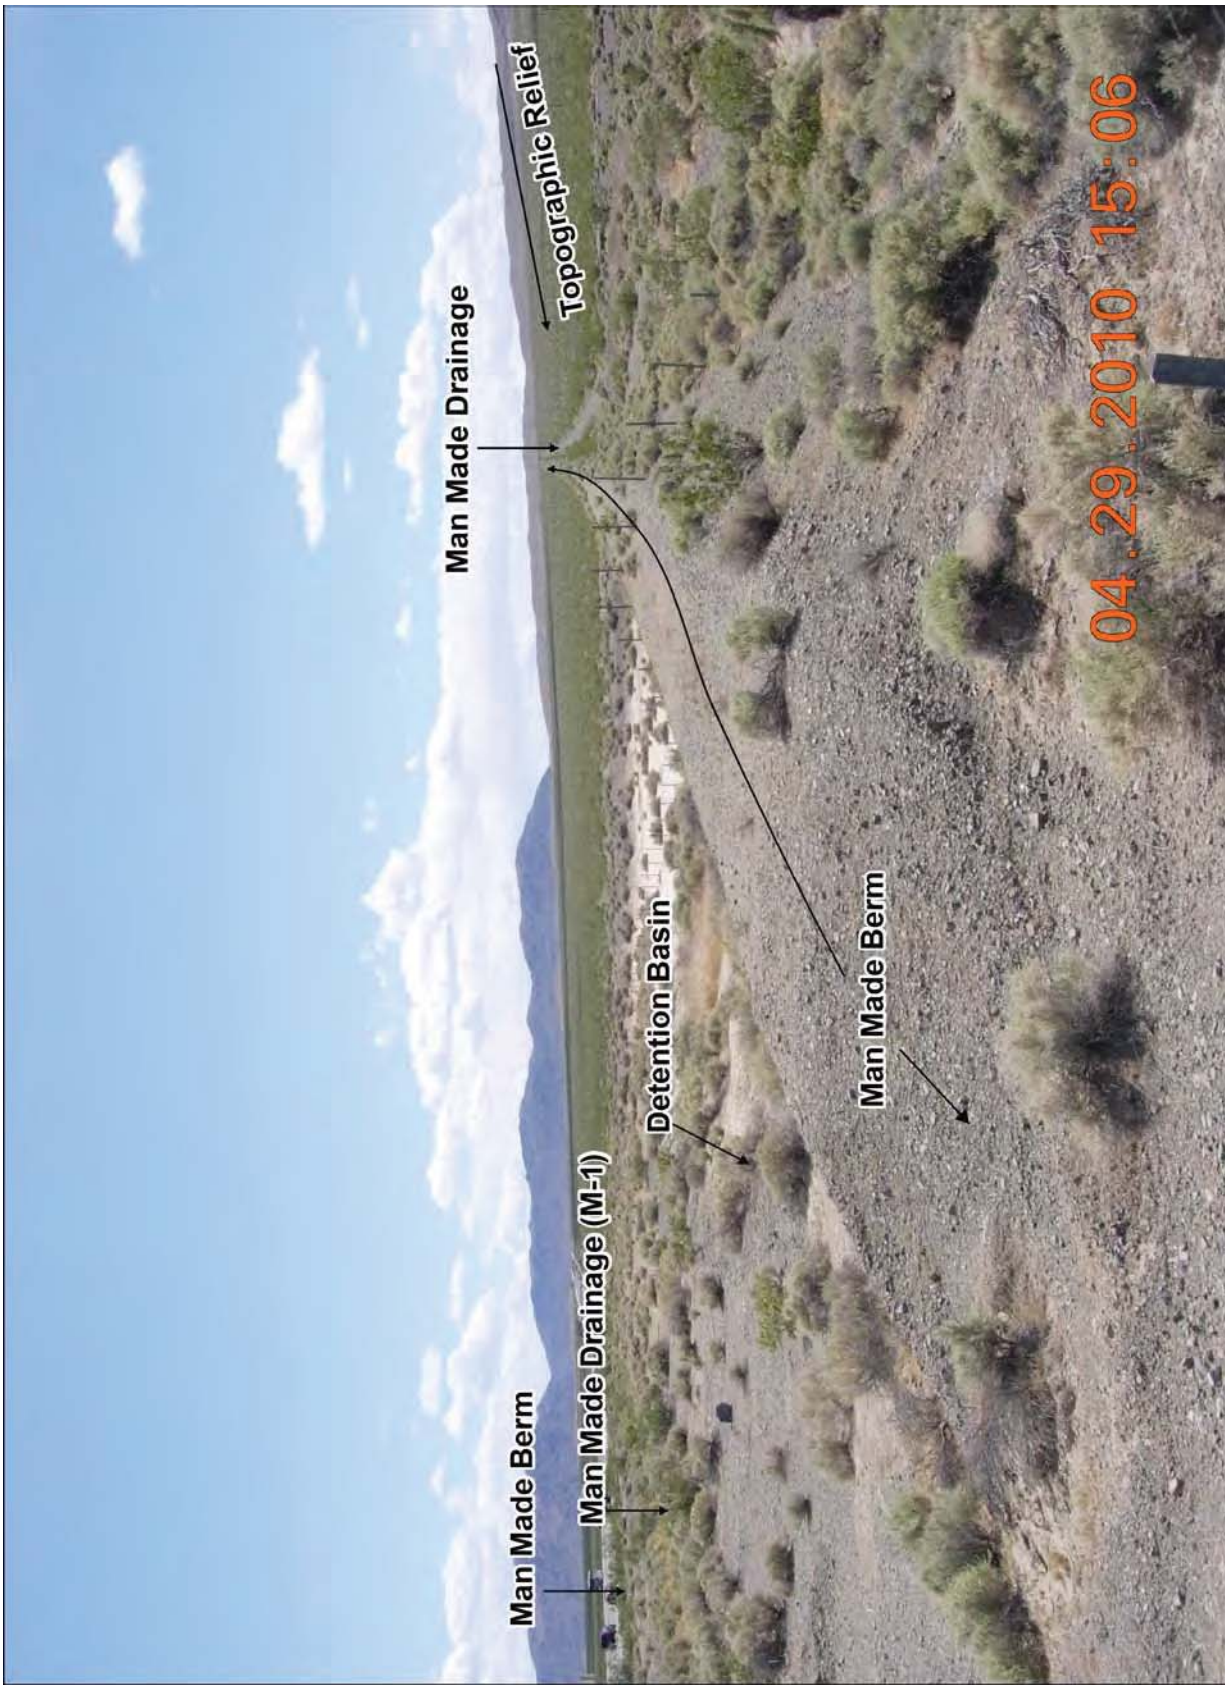
Exhibit A. Figure 10. Typical examples of field indicators of active surface water flow and Ordinary High Water Marks found within ephemerals drainages occurring within the DesertXpress Project Study Area.

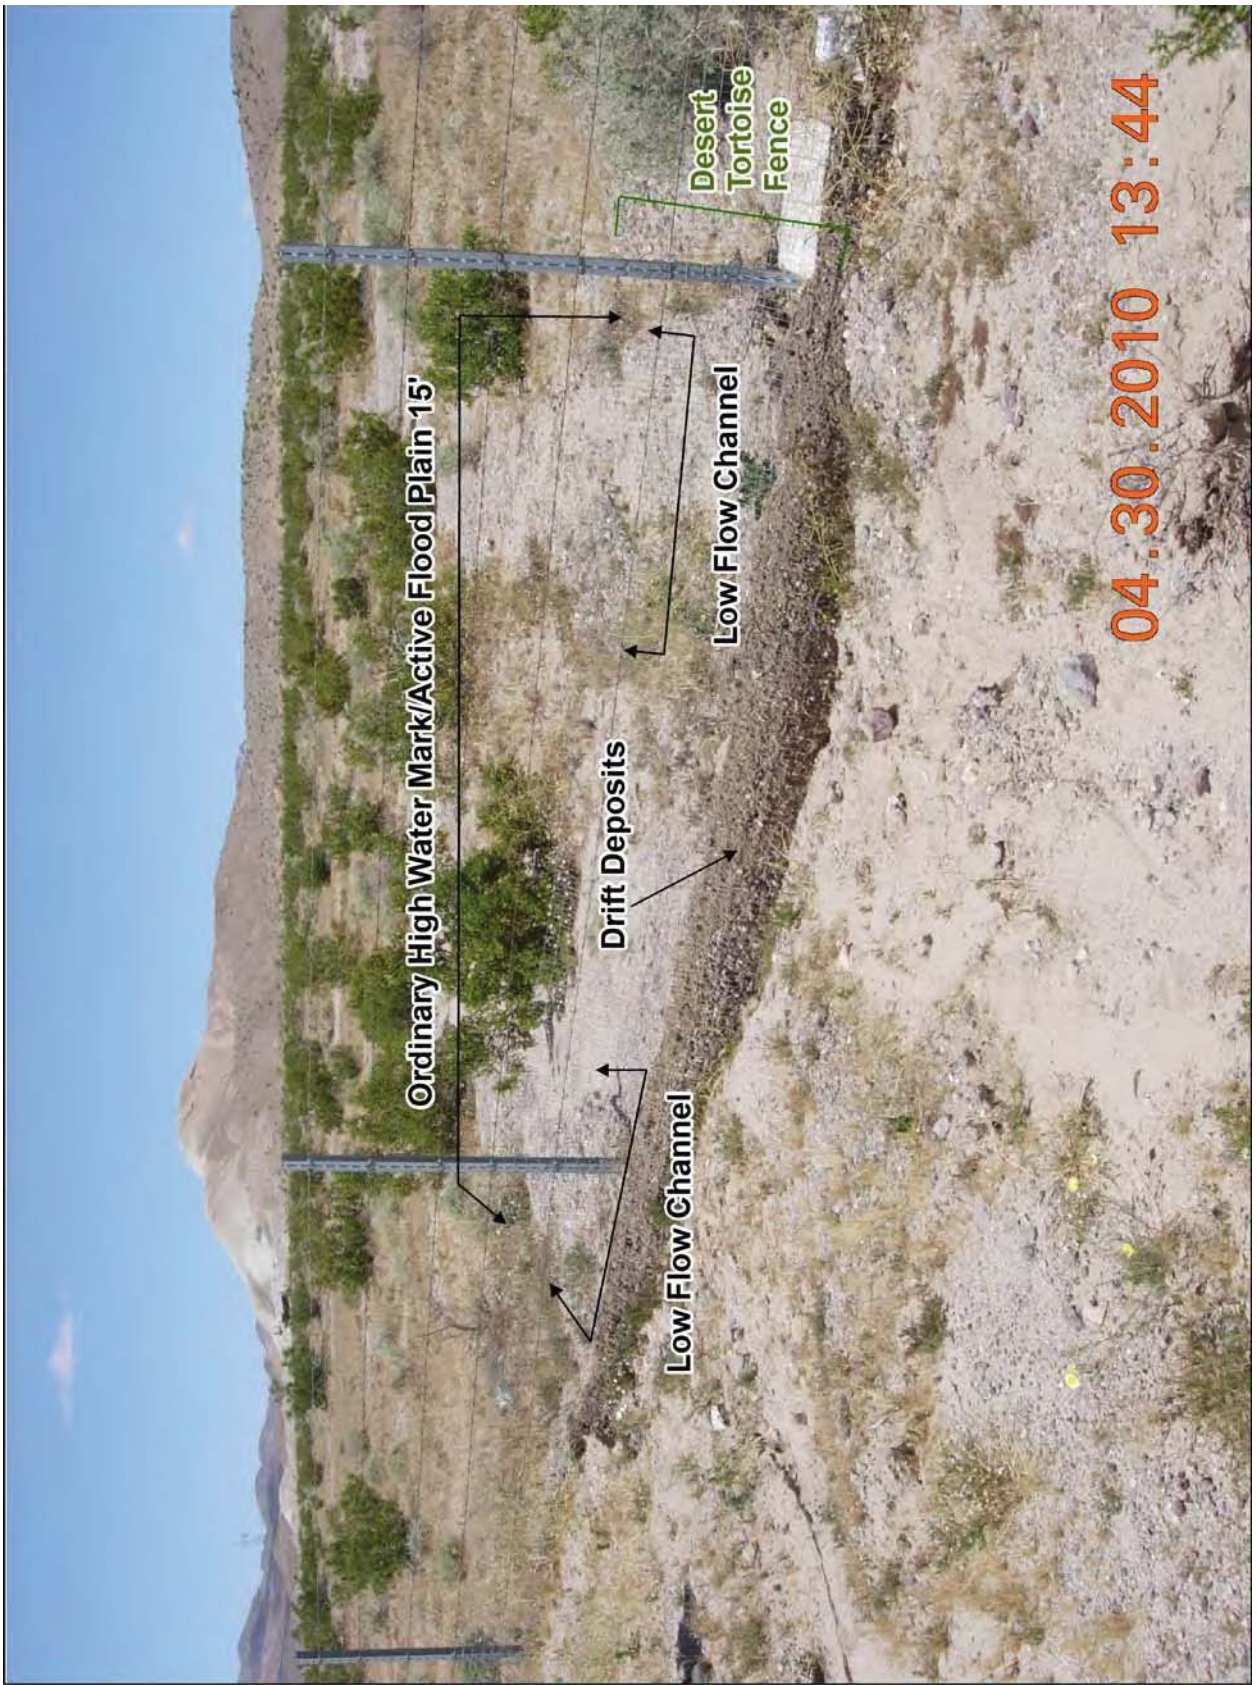
Exhibit A. Figure 11. Typical examples of field indicators of active surface water flow and Ordinary High Water Marks found within ephemeral drainages occurring within the DesertXpress Project Study Area.

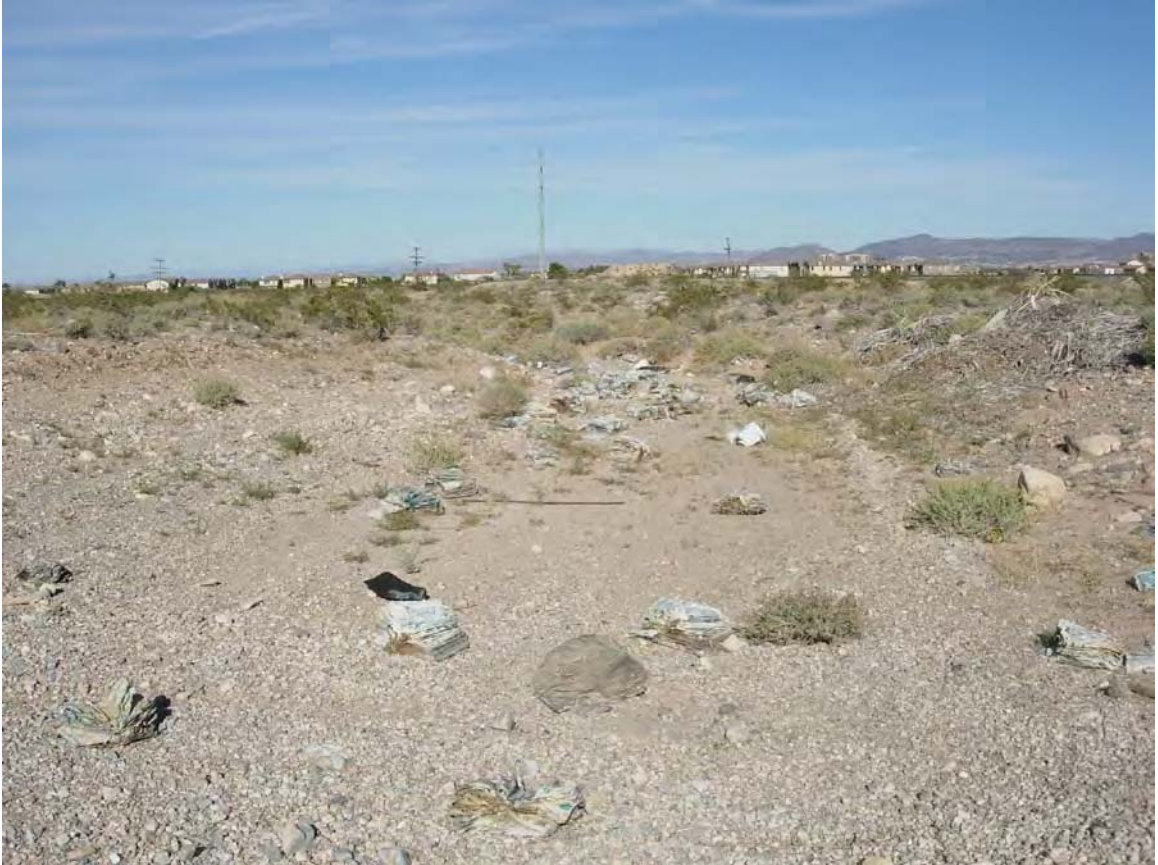
Exhibit A. Figure 13. Manmade drainage connecting to ephemeral drainage within HUC 8 Las Vegas Wash Watershed / HUC 12 Town of Sloan Subwatershed

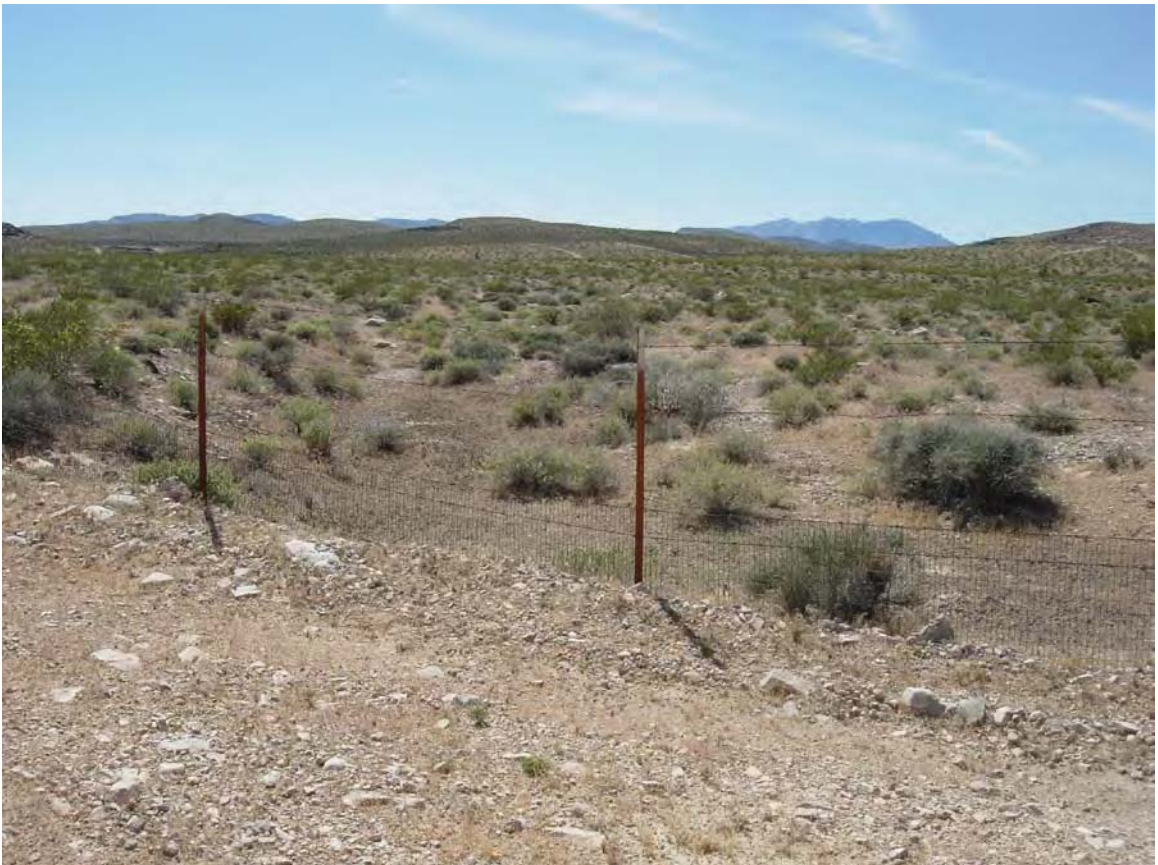
Exhibit A. Figure 14. Manmade drainage connecting to ephemeral drainage within HUC 8 Las Vegas Wash Watershed / HUC 12 Town of Sloan Subwatershed

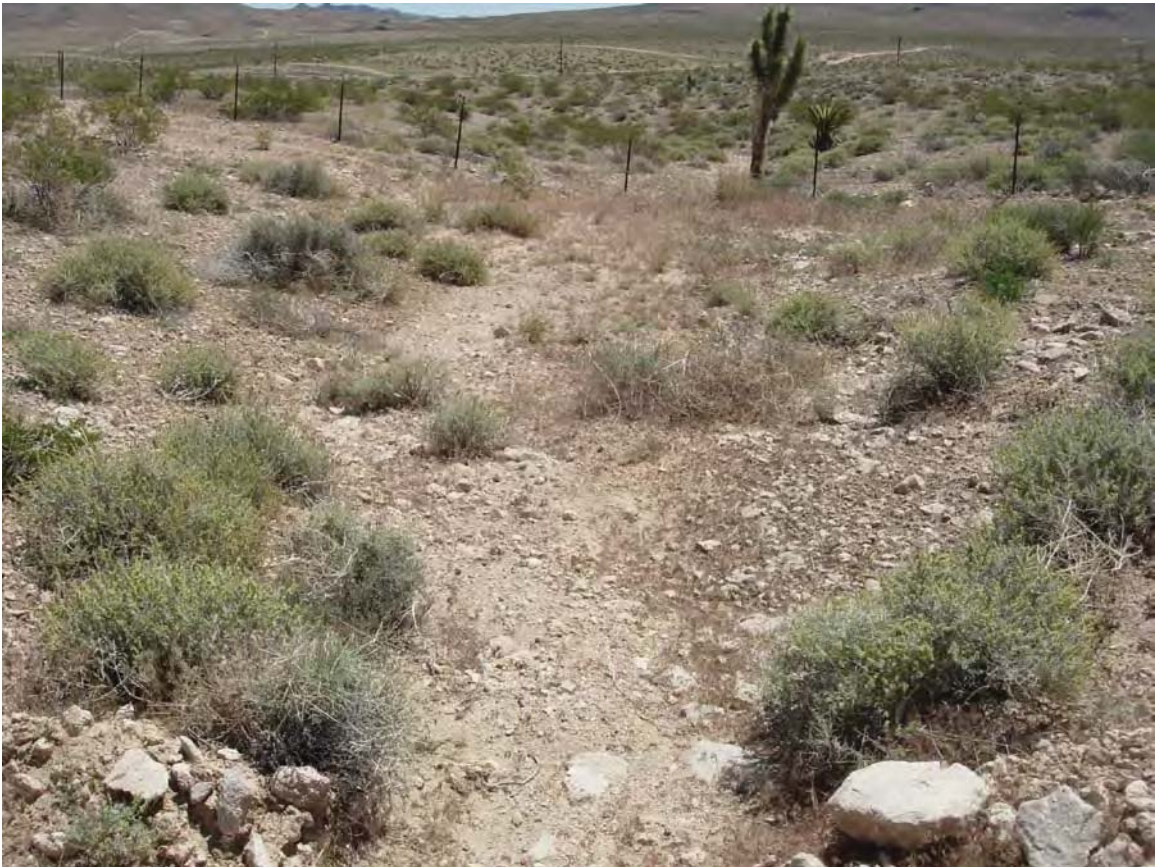
Exhibit A. Figure 15. Ephemeral drainage within HUC 8 Las Vegas Wash Watershed / HUC 12 Town of Sloan Subwatershed

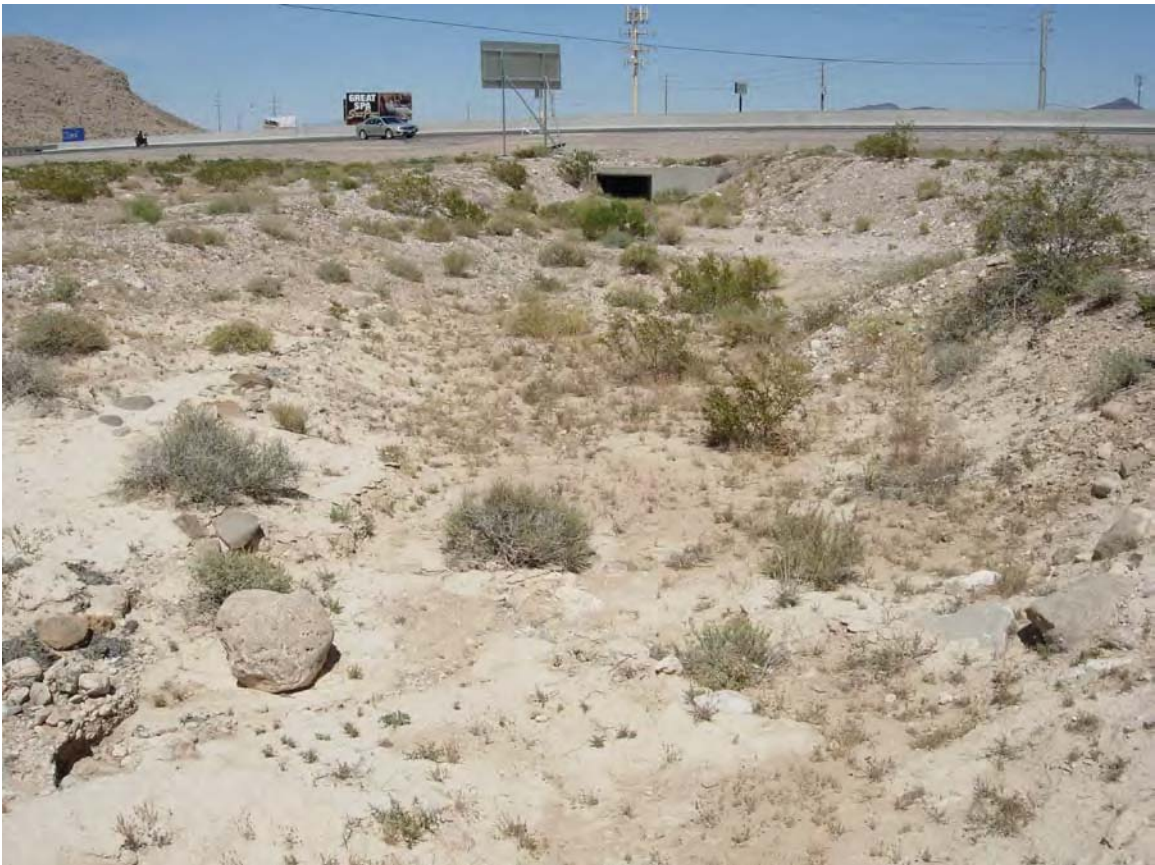
Exhibit A. Figure 16. Manmade drainage connecting to road culvert within HUC 8 Las Vegas Wash Watershed / HUC 12 Town of Sloan Subwatershed

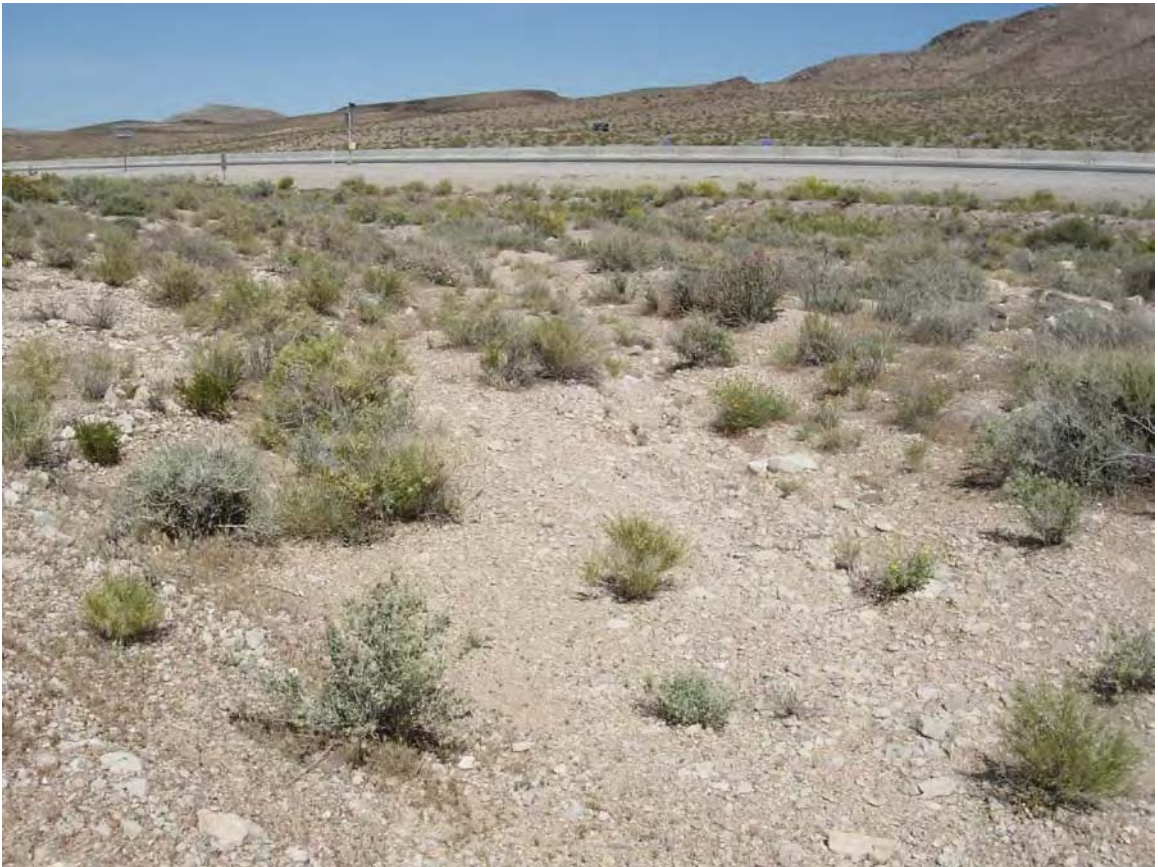
Exhibit A. Figure 17. Manmade drainage connecting to road culvert within HUC 8 Las Vegas Wash Watershed / HUC 12 Town of Sloan Subwatershed

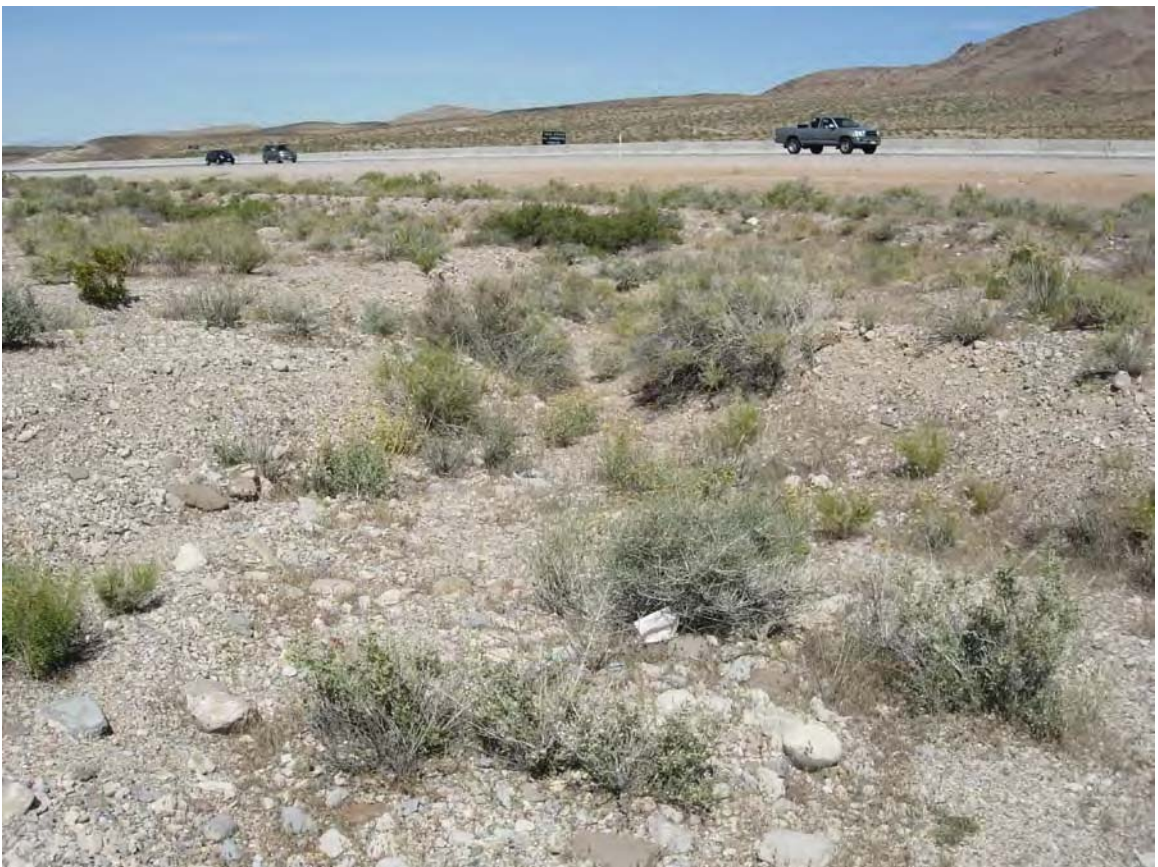
Exhibit A. Figure 18. Manmade drainage connecting to road culvert within HUC 8 Las Vegas Wash Watershed / HUC 12 Town of Sloan Subwatershed

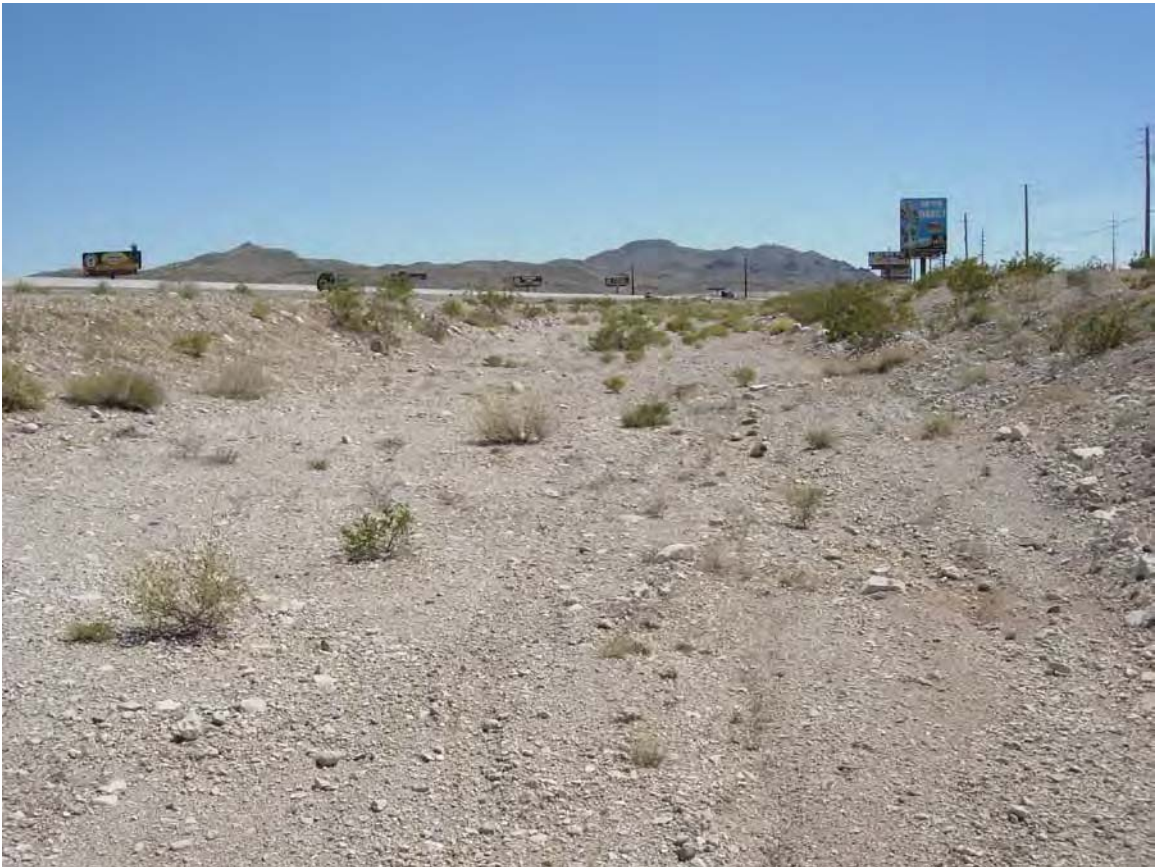
Exhibit A. Figure 19. Manmade drainage connecting to road culvert within HUC 8 Las Vegas Wash Watershed / HUC 12, Town of Sloan Subwatershed

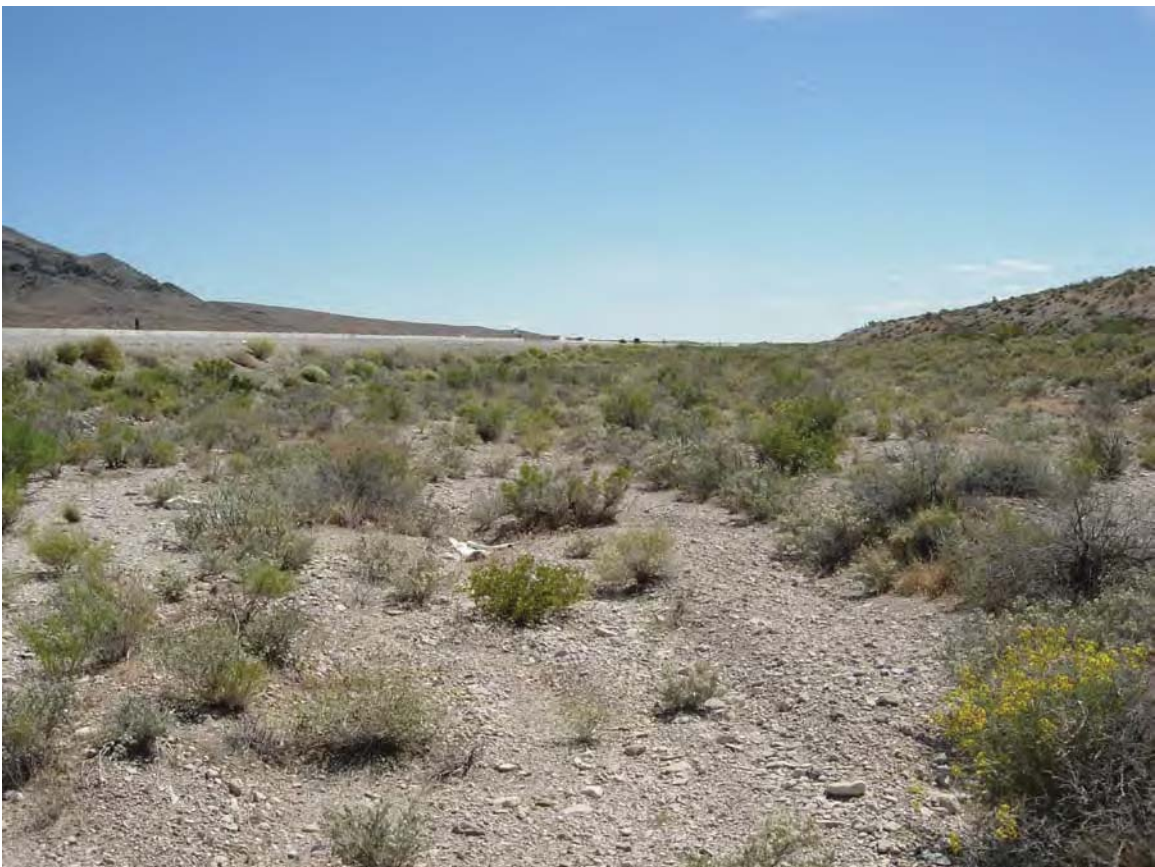
Exhibit A. Figure 20. Manmade drainage connecting to road culvert within HUC 8 Las Vegas Wash Watershed / HUC 12, Town of Sloan Subwatershed

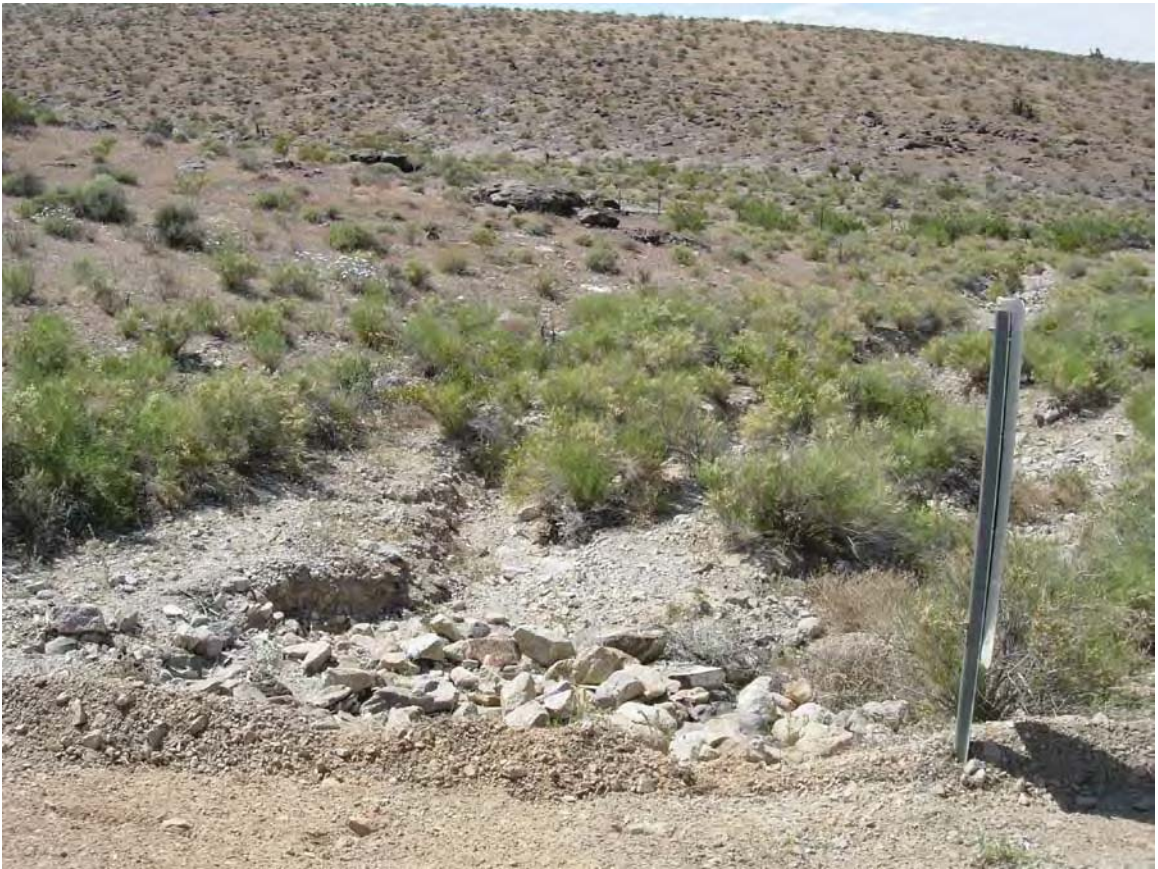
Exhibit A. Figure 22. Manmade drainage connecting to ephemeral drainage within HUC 8 Las Vegas Watershed Wash / HUC 12 Town of Sloan Subwatershed

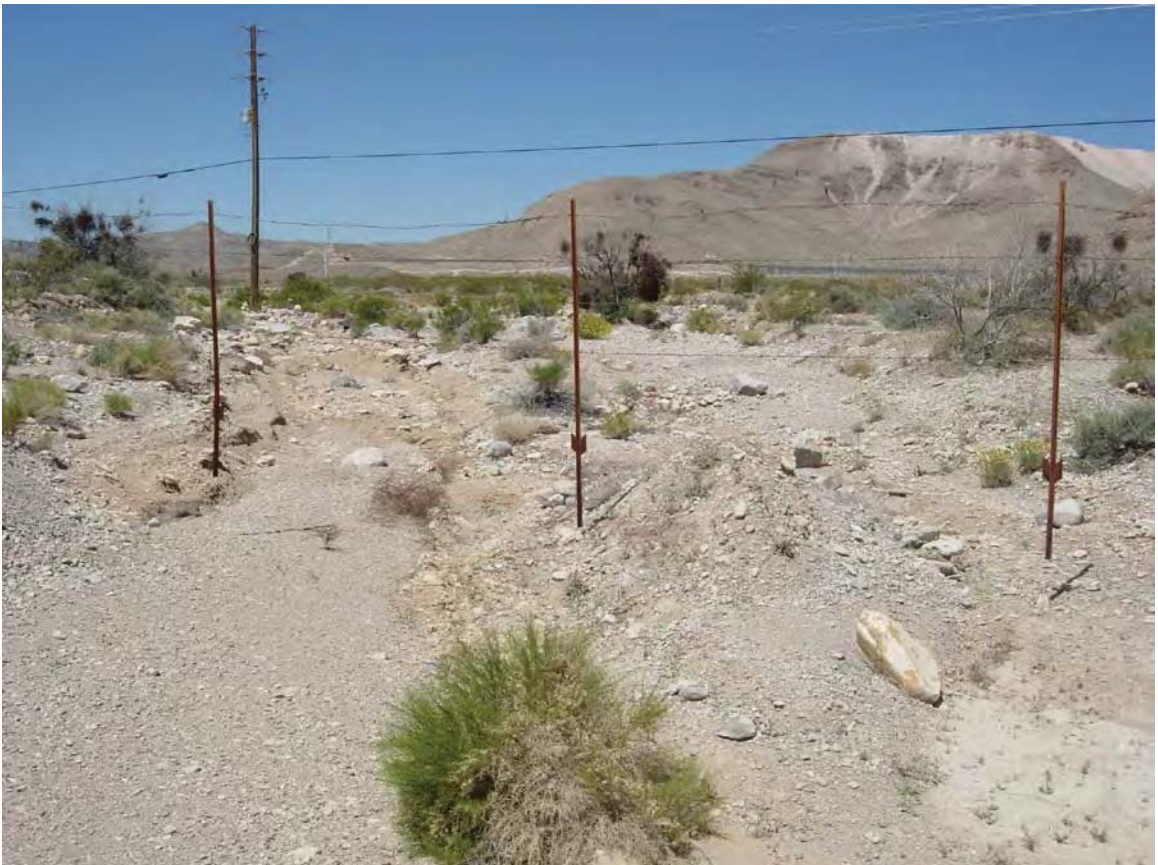
Exhibit A. Figure 23. Manmade drainage connecting to ephemeral drainage within HUC 8 Las Vegas Watershed Wash / HUC 12 Town of Sloan Subwatershed
