**Investigation of the Presence of Wetlands and
Other Waters of the United States
DesertXpress Project
HUC 8 Las Vegas Watershed
Clark County, Nevada**

July 2010

**DESERTXPRESS ENTERPRISES, LLC
6750 Via Austi Parkway
Suite 250
Las Vegas, NV 89119**

**HUFFMAN-BROADWAY GROUP, INC.
828 Mission Avenue
San Rafael, CA 94901**

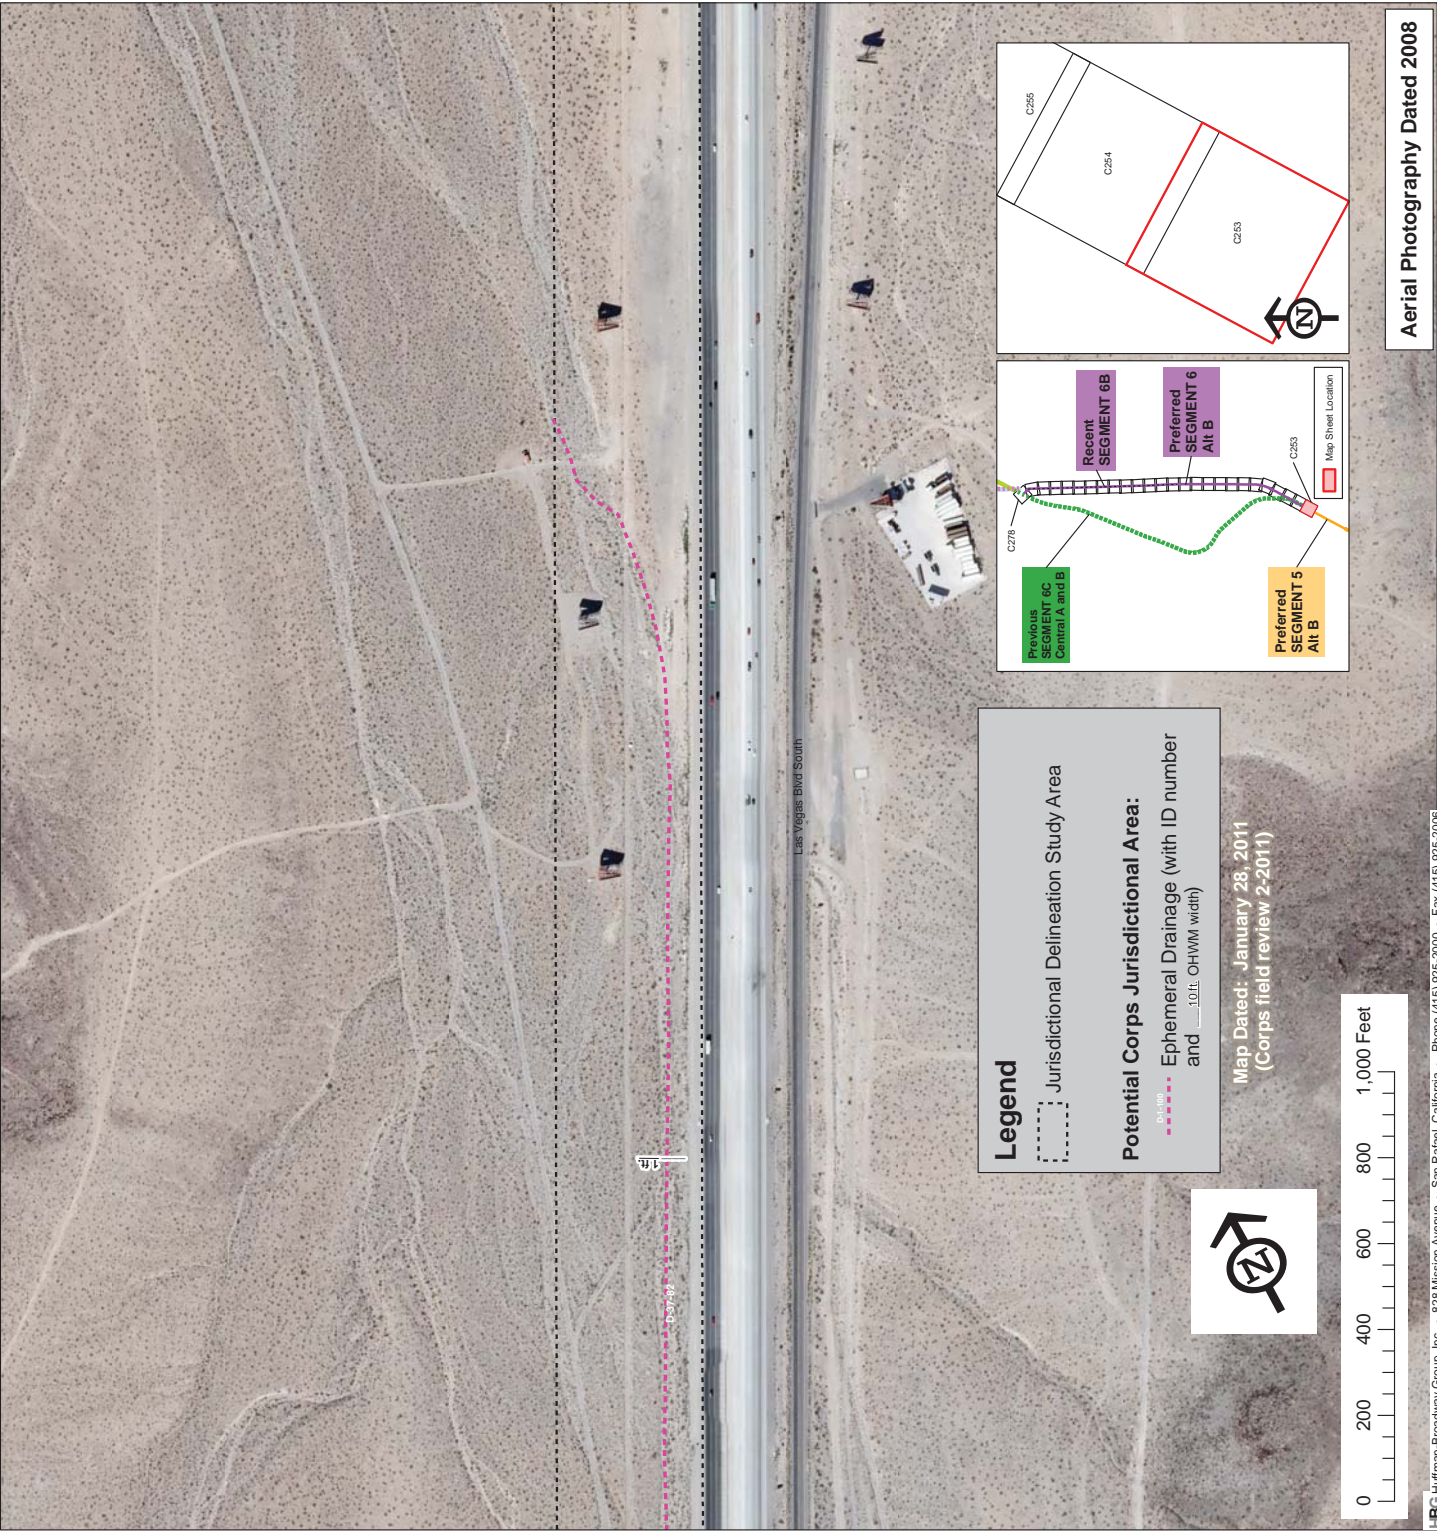
P.0290

Exhibit C. Areas Potentially Subject to Corps Jurisdiction Under Section 404 of the Clean Water Act, DesertXpress Project, HUC 8 Las Vegas Wash Watershed, Clark County, Nevada, Current Preferred Segment 5 Alt B, Map Sheet C252

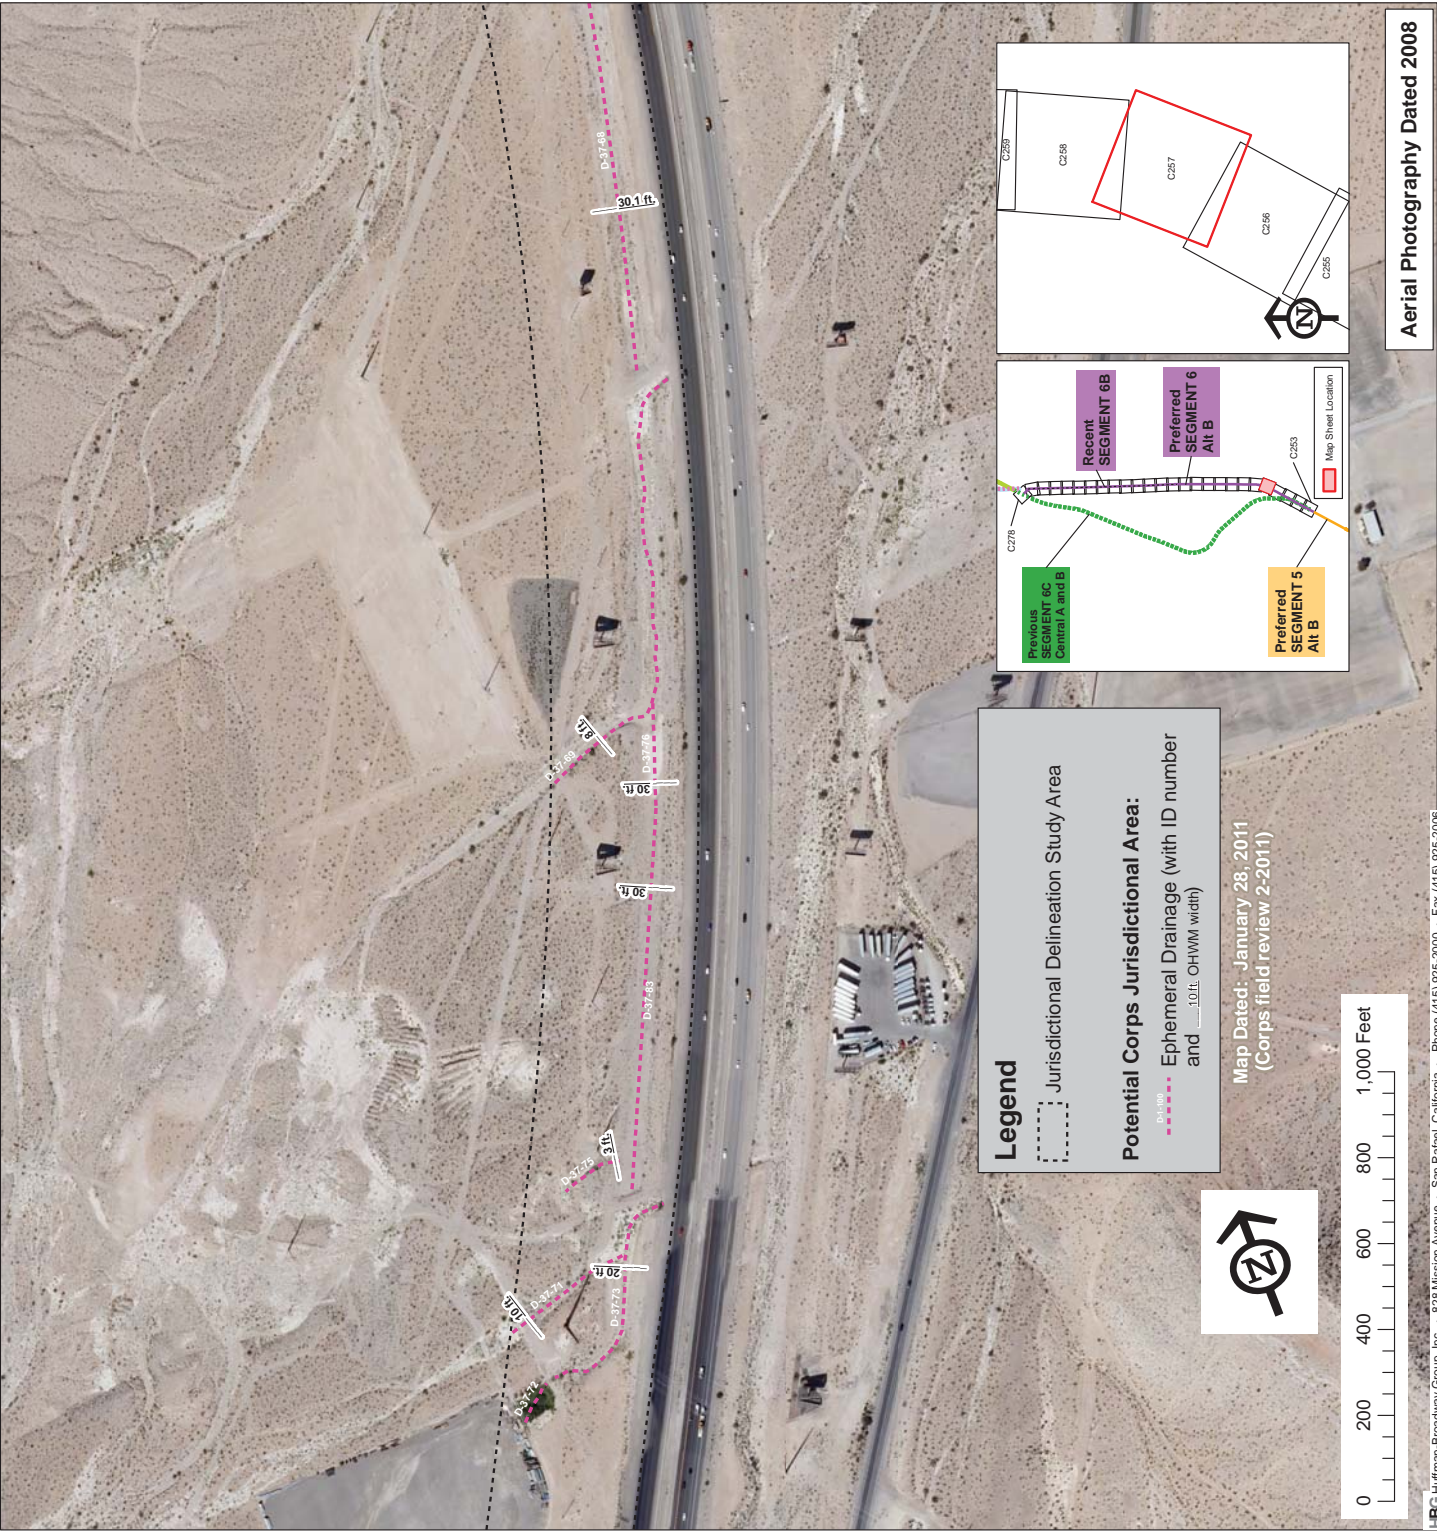
Exhibit C. Areas Potentially Subject to Corps Jurisdiction Under Section 404 of the Clean Water Act, DesertXpress Project, HUC 8 Las Vegas Wash Watershed, Clark County, Nevada, Current Preferred Segments 6 Alt B and 6 Alt C, Map Sheet C256

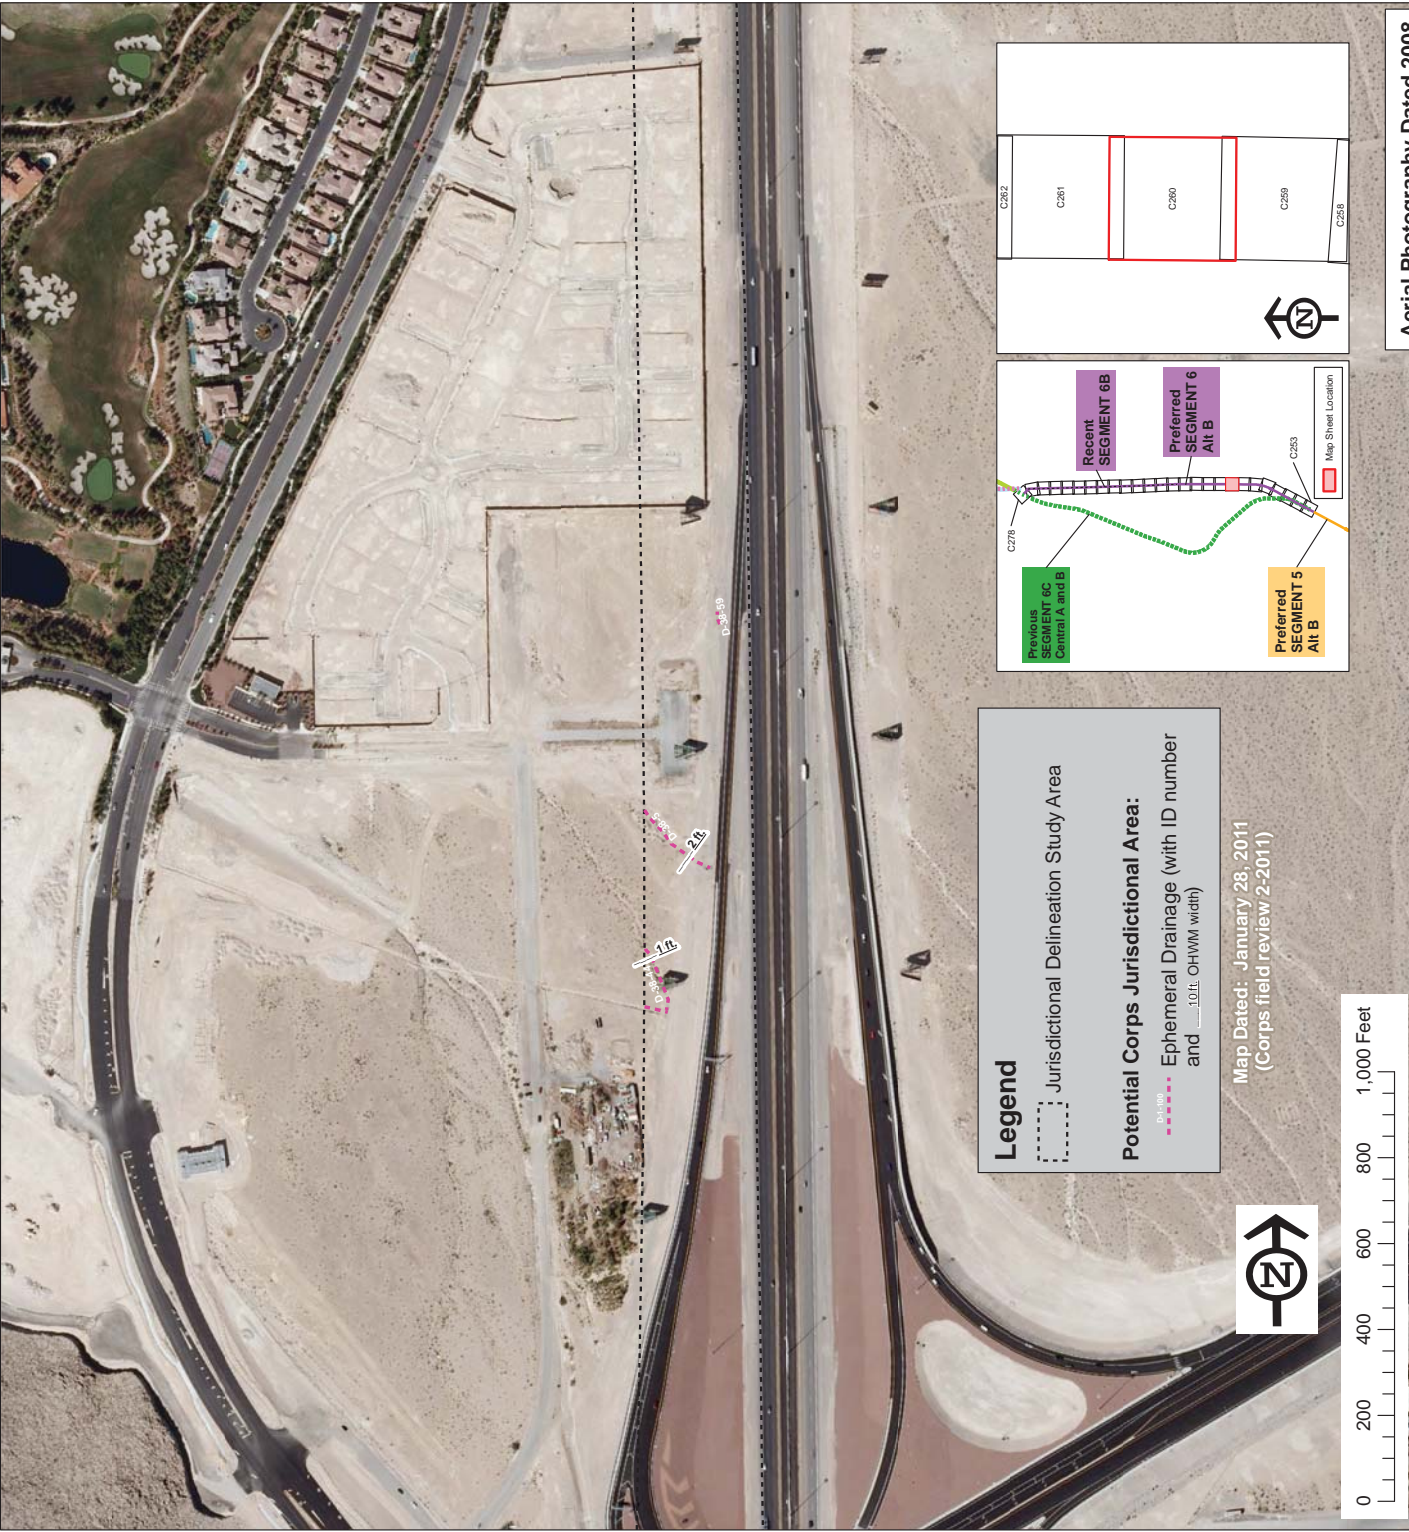
Exhibit C. Areas Potentially Subject to Corps Jurisdiction Under Section 404 of the Clean Water Act, DesertXpress Project, HUC 8 Las Vegas Wash Watershed, Clark County, Nevada, Current Preferred Segments 6 Alt B and 6 Alt C, Map Sheet C259

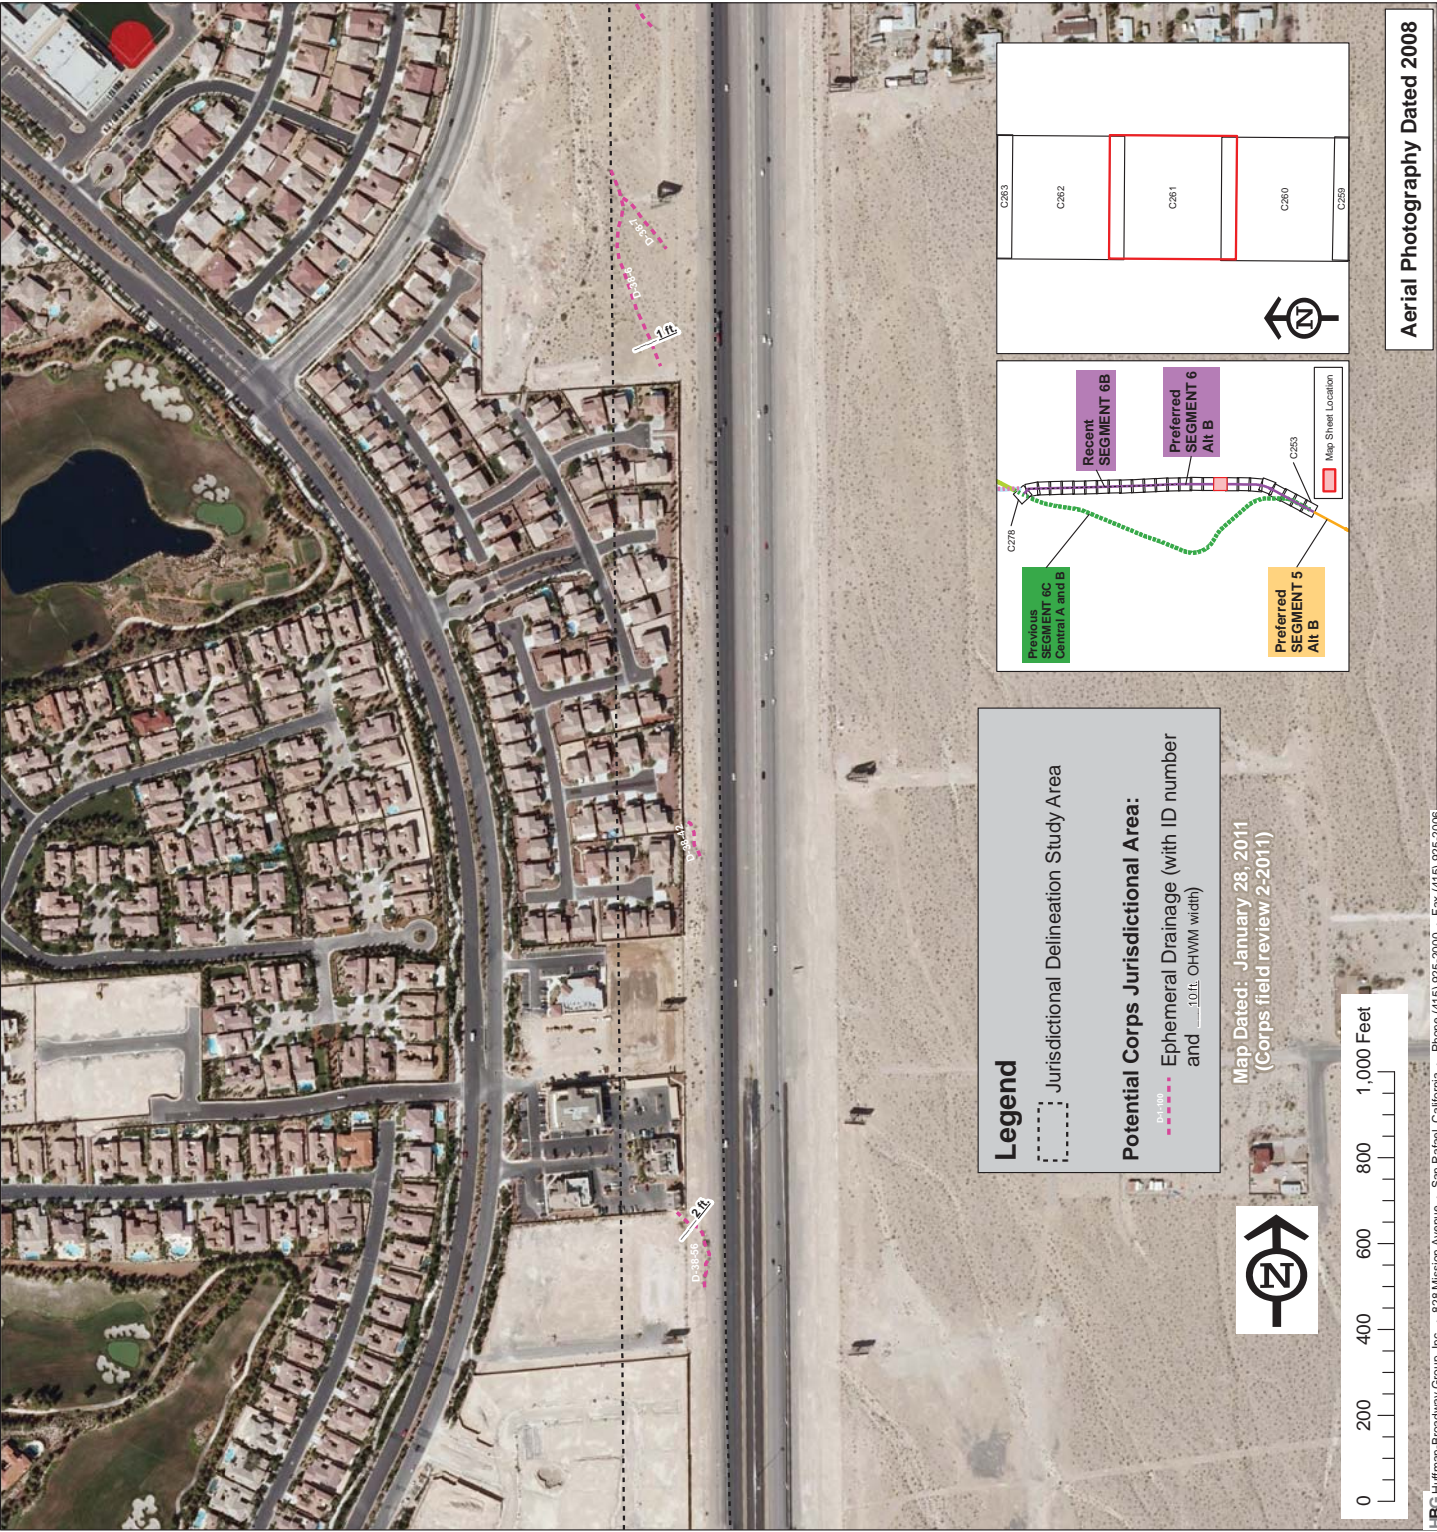
Exhibit C. Areas Potentially Subject to Corps Jurisdiction Under Section 404 of the Clean Water Act, DesertXpress Project, HUC 8 Las Vegas Wash Watershed, Clark County, Nevada, Current Preferred Segments 6 Alt B and 6 Alt C, Map Sheet C260

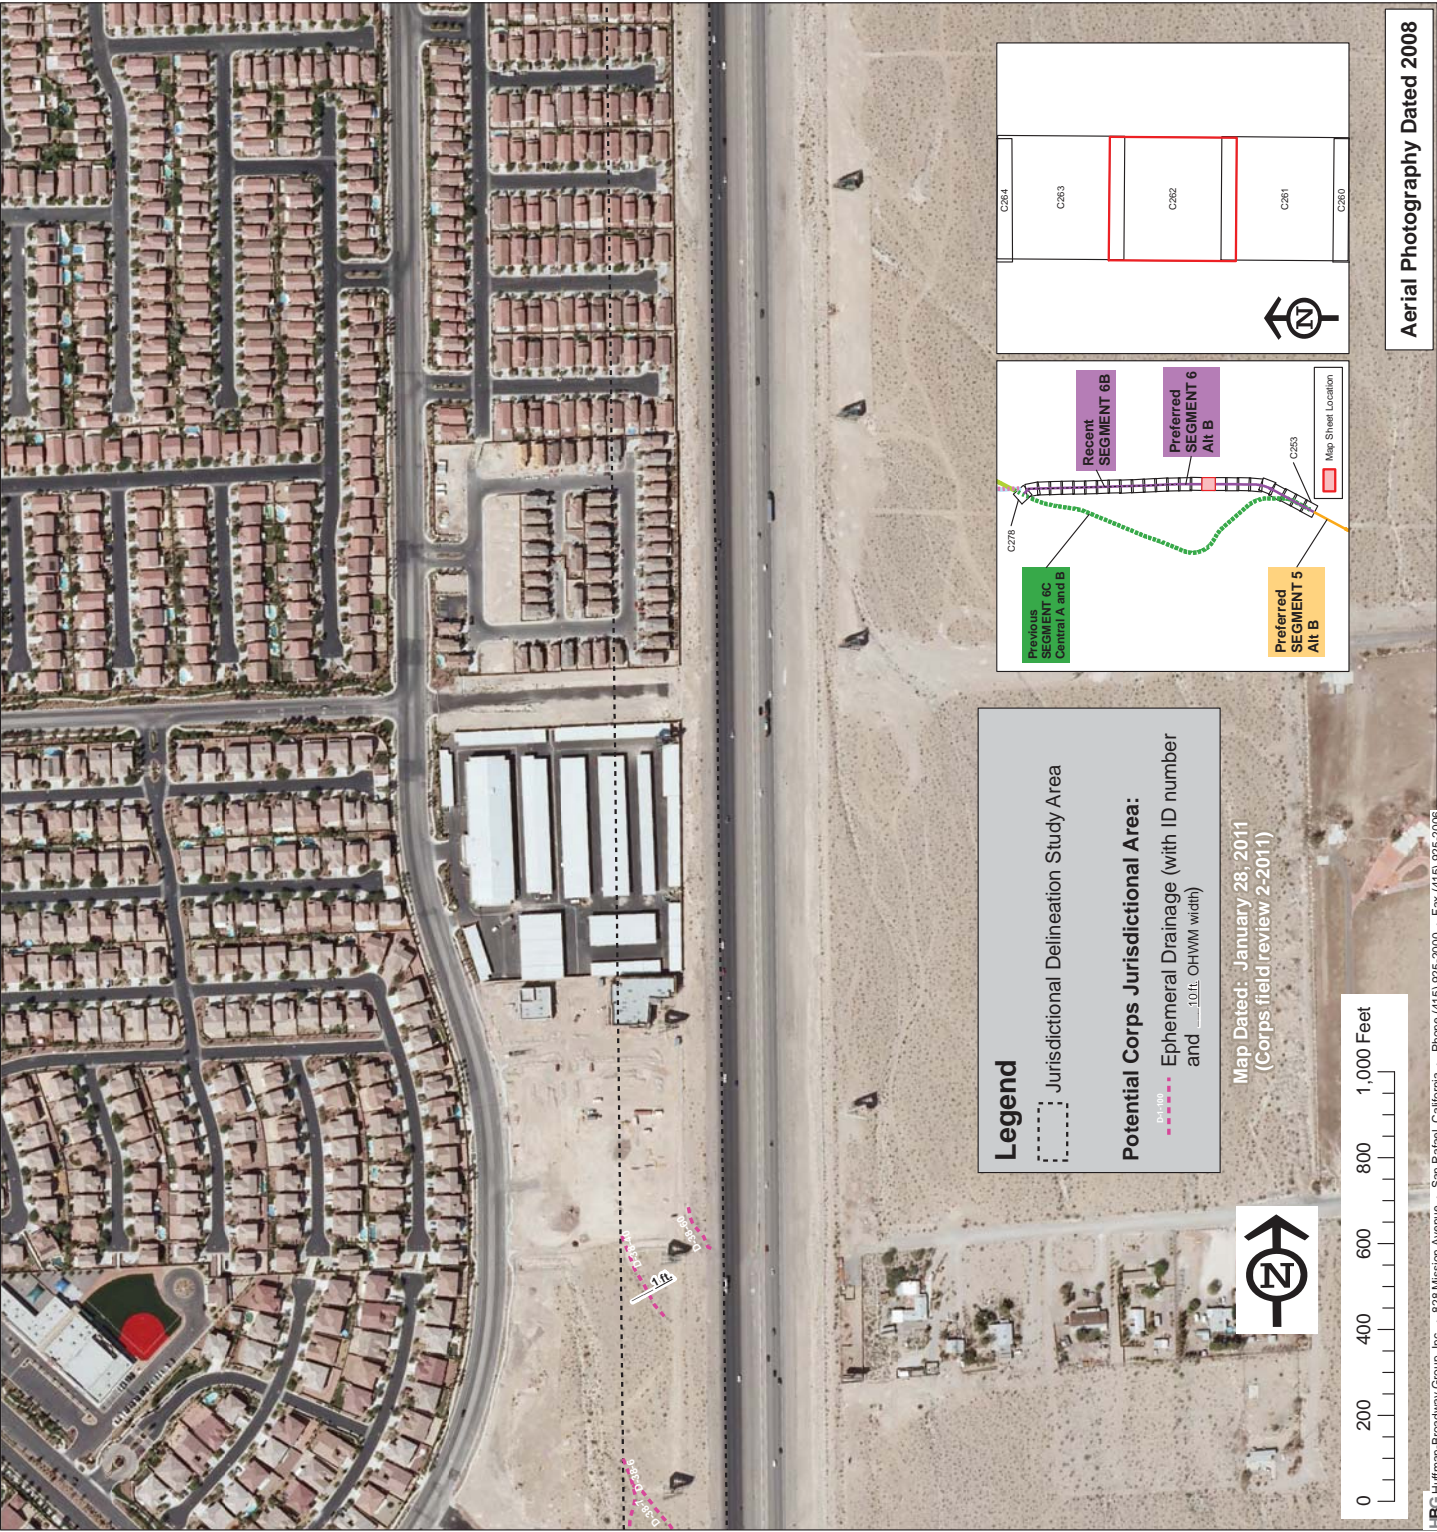
Exhibit C. Areas Potentially Subject to Corps Jurisdiction Under Section 404 of the Clean Water Act, DesertXpress Project, HUC 8 Las Vegas Wash Watershed, Clark County, Nevada, Current Preferred Segments 6 Alt B and 6 Alt C, Map Sheet C261

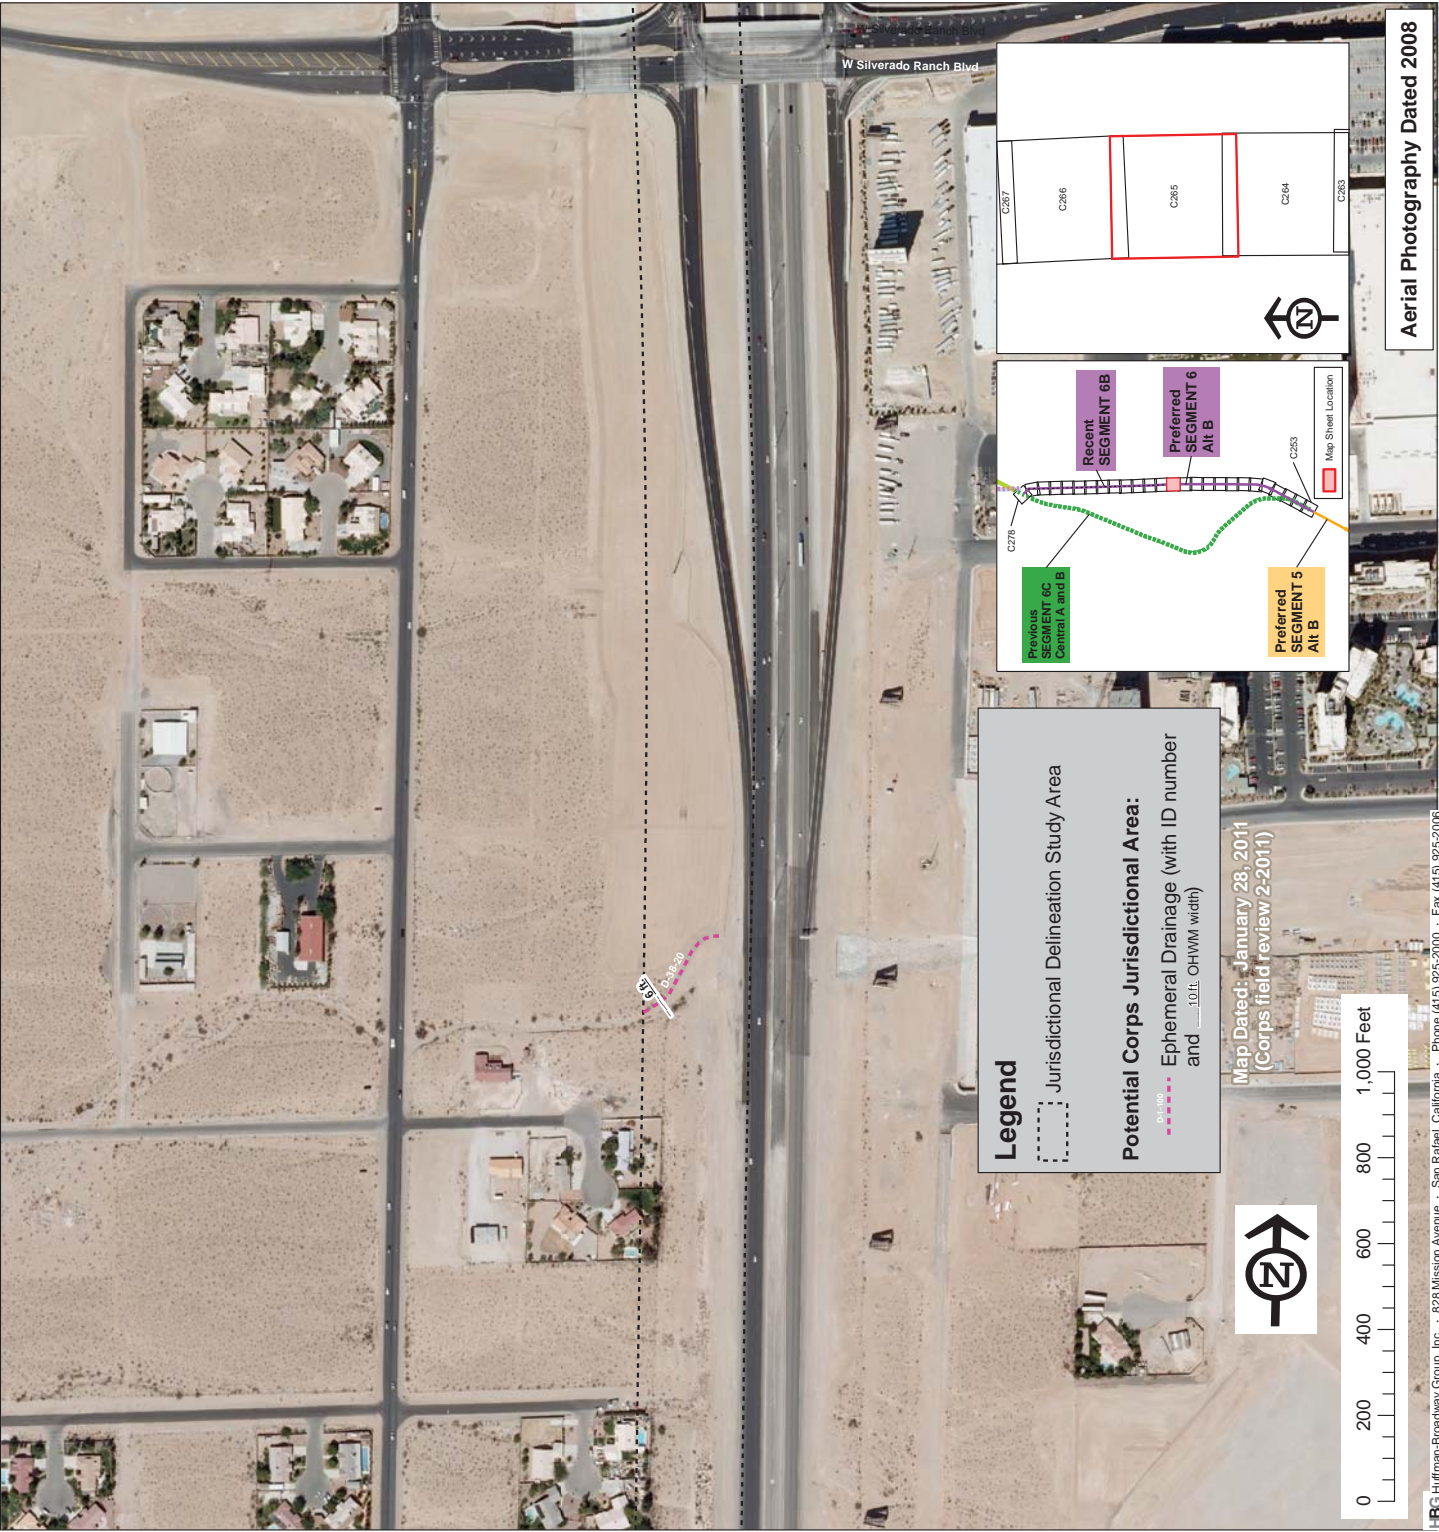
Exhibit C. Areas Potentially Subject to Corps Jurisdiction Under Section 404 of the Clean Water Act, DesertXpress Project, HUC 8 Las Vegas Wash Watershed, Clark County, Nevada, Current Preferred Segments 6 Alt B and 6 Alt C, Map Sheet C262
