Report No. FRA-OR&D 75-31

THE EFFECTS OF A FIRE ENVIRONMENT ON A RAIL TANK CAR FILLED WITH LPG

**SEPTEMBER 1974
FINAL REPORT**

Prepared For
**U.S. DEPARTMENT OF TRANSPORTATION
FEDERAL RAILROAD ADMINISTRATION
Office of Research, Development, and Demonstrations
Washington, D.C. 20590**

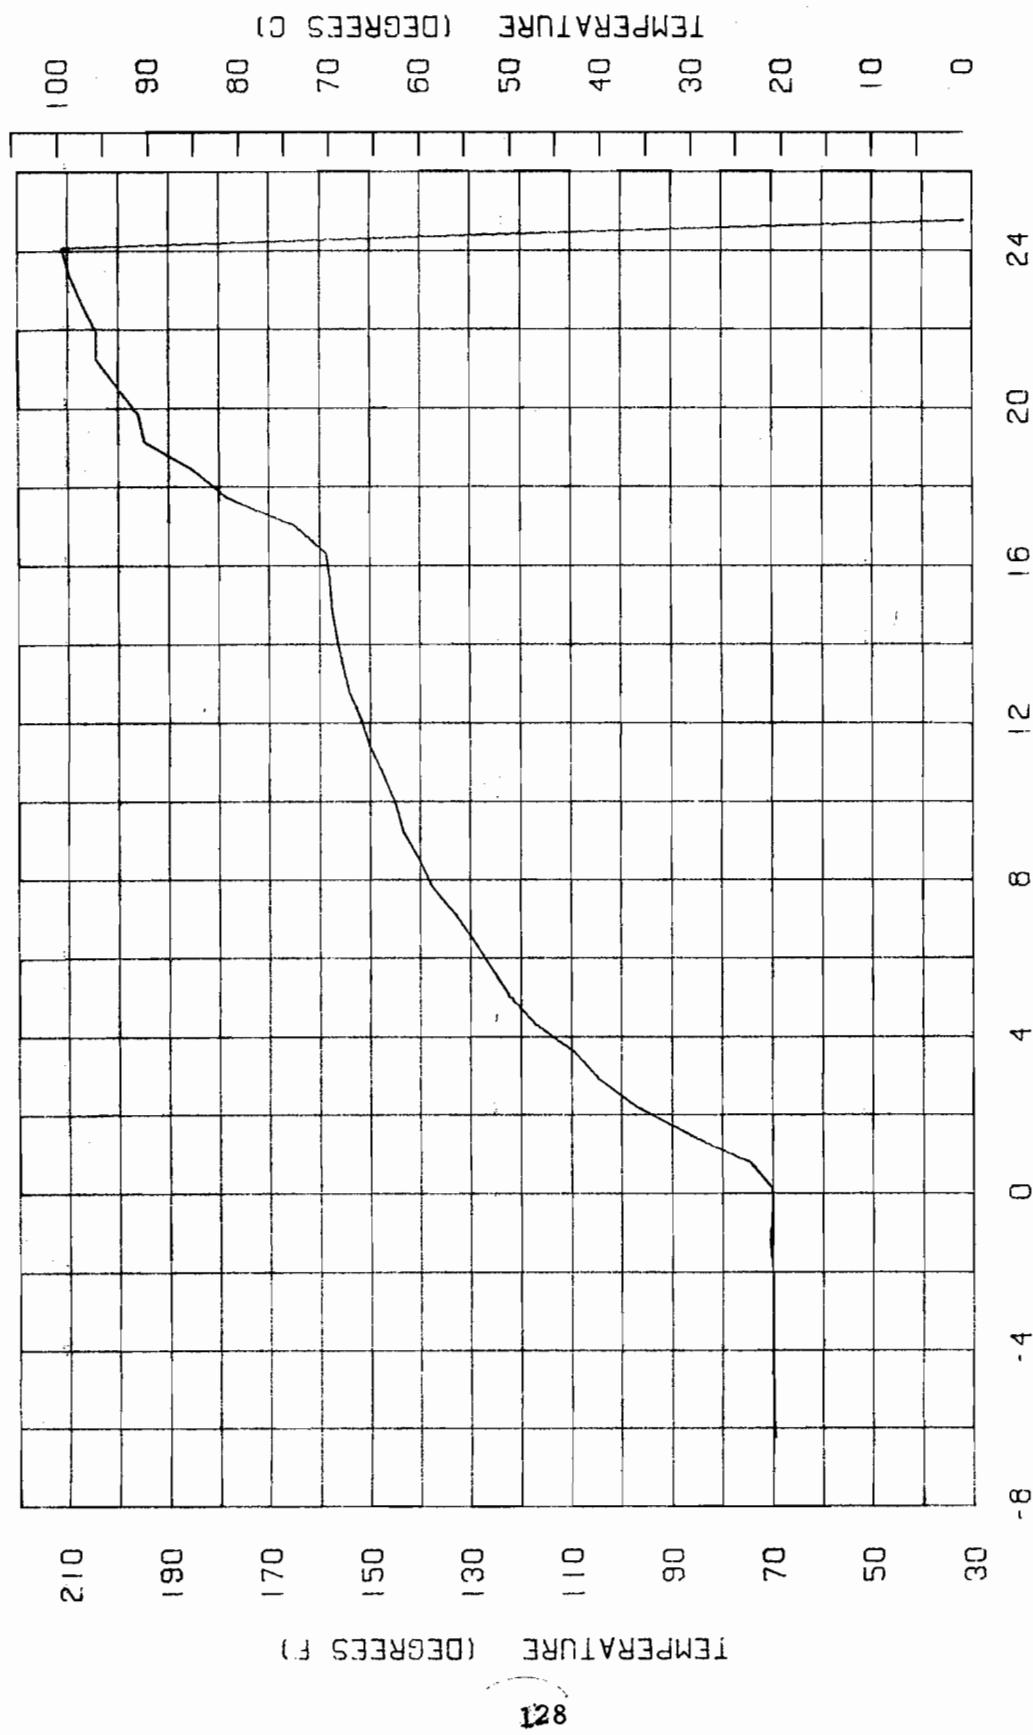
FIGURE A 17 THERMOCOUPLE TEMPERATURE VS. TIME
TIME FROM IGNITION (MINUTES)

VIDAR CHANNEL 21 OF TEST NUMBER 8
LOCATION IS REAR INNER WALL AT 10,00

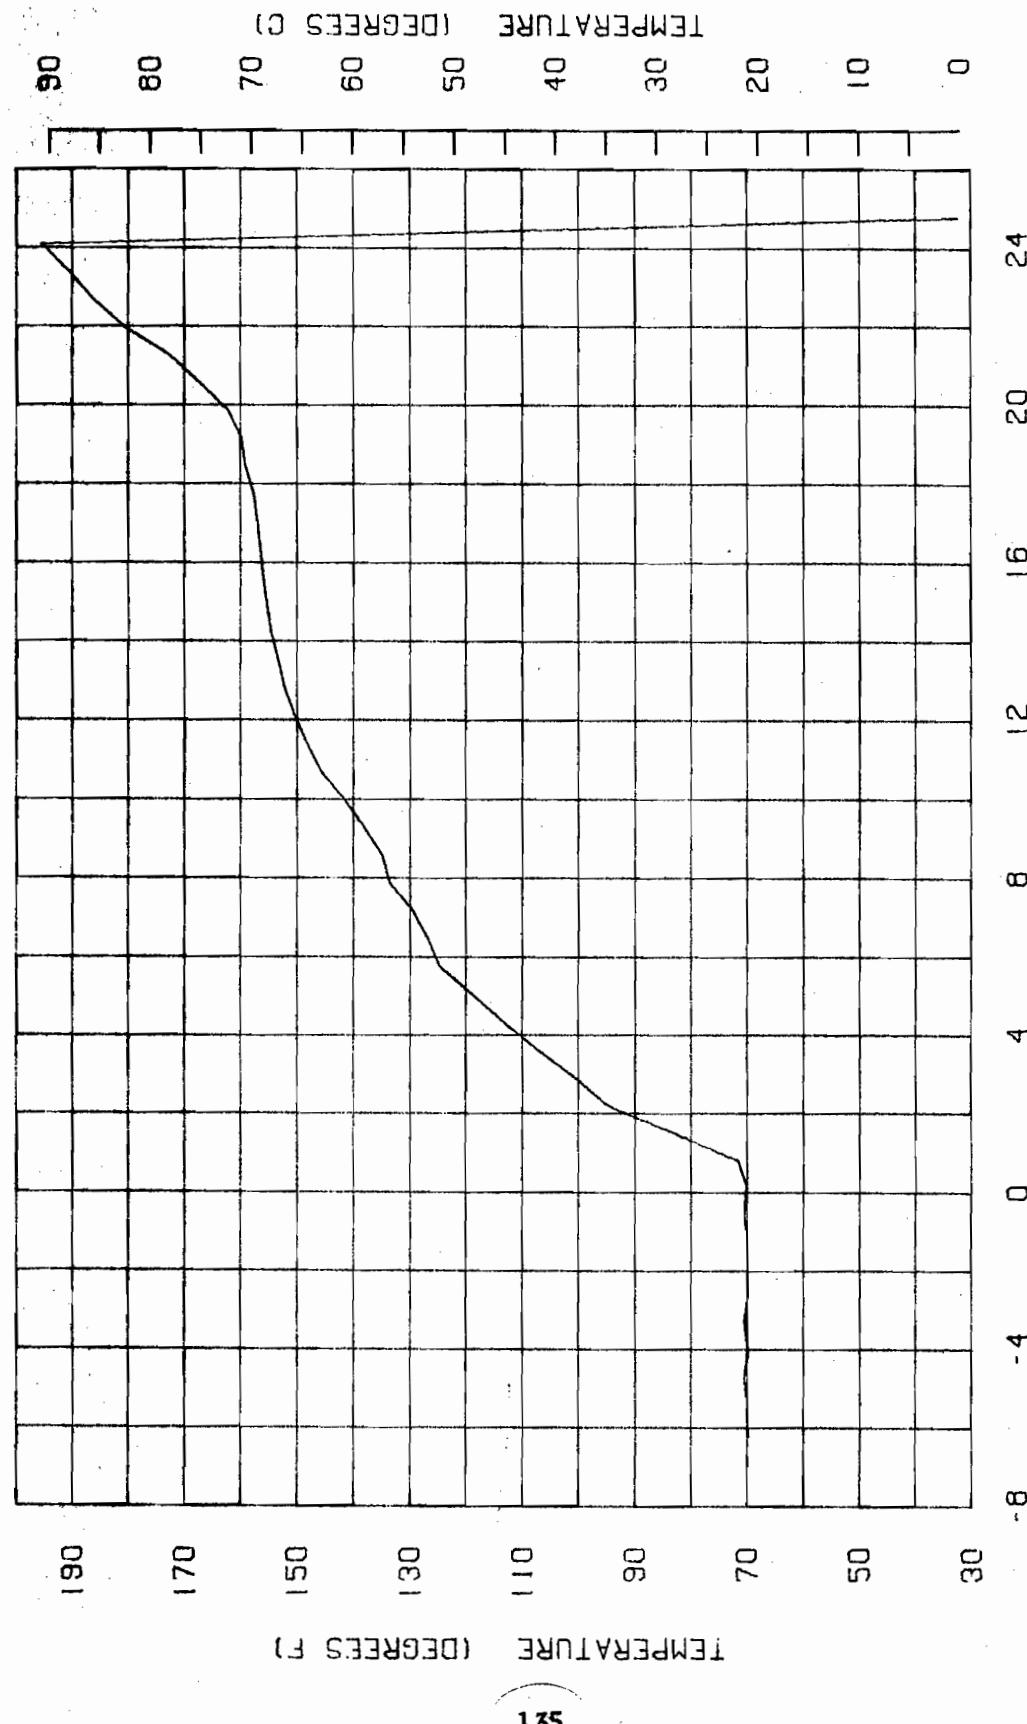
VIDAR CHANNEL 26 OF TEST NUMBER 6

LOCATION IS REAR GRID AT 1.30 LEVEL CEN

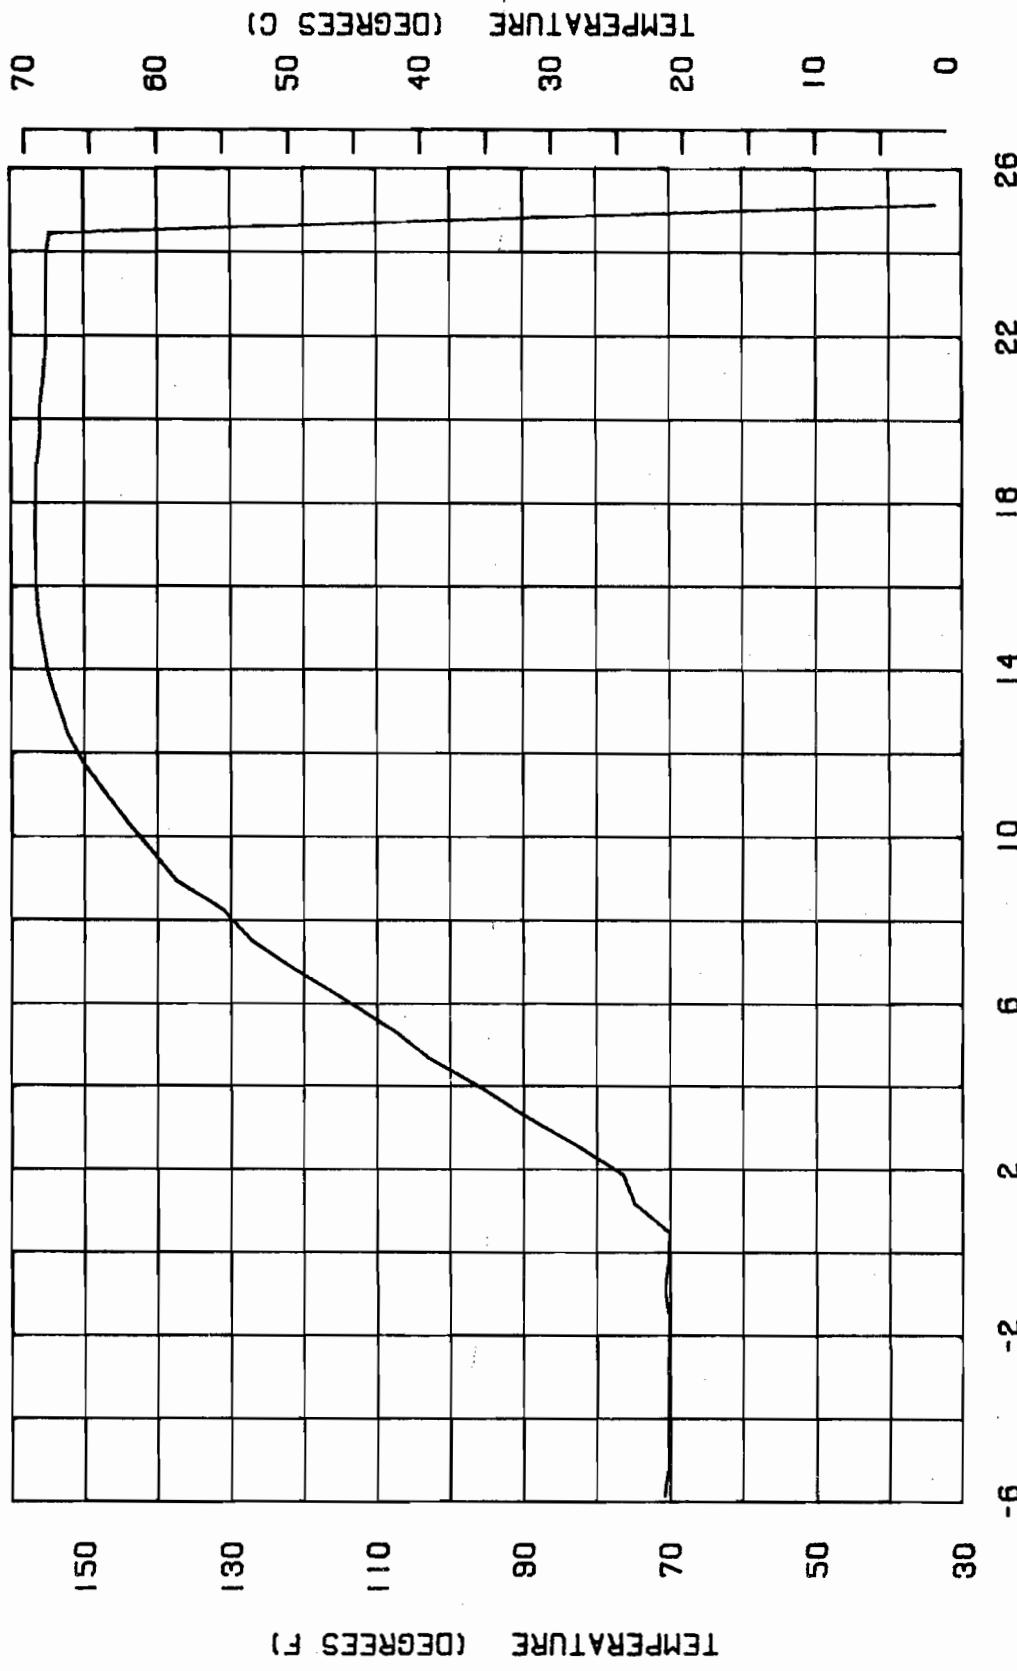
FIGURE A 98 THERMOCOUPLE TEMPERATURE VS. TIME

VIDAR CHANNEL 104 OF TEST NUMBER 8
LOCATION IS FRONT GRID AT 3.00 LEVEL CEN
