U.S. Department
of Transportation
**Federal Railroad
Administration**

Subsurface Evaluation of Railway Track Using Ground Penetrating Radar

1. AGENCY USE ONLY (Leave blank)		2. REPORT DATE 9/30/08		3. REPORT TYPE AND DATES COVERED Final Report, 12/04 – 09/08
4. TITLE AND SUBTITLE Subsurface Evaluation of Railway Track Using Ground Penetrating Radar			5. FUNDING NUMBERS DTFR53-05-D-00200

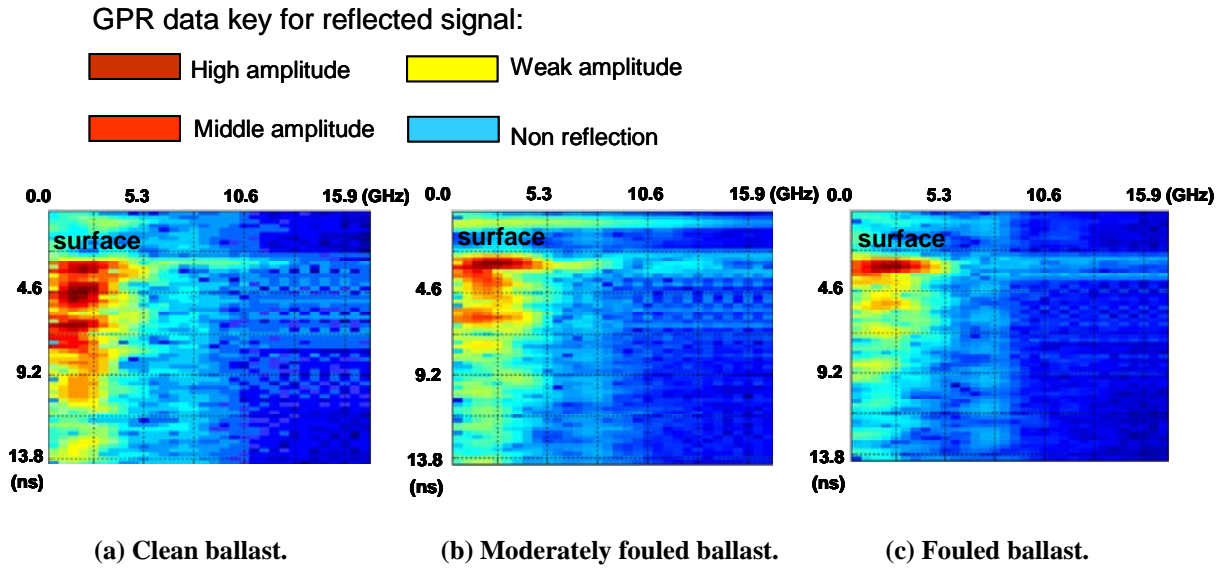
Al-Qadi et al. (2007) used the (STFT) to analyze the change in the frequency spectrum of the signal versus depth. Figure 3 shows the STFT of three scans representing different ballast conditions. The vertical axis of the images represents increasing depth and the horizontal axis represents the frequency spectrum. Near the ballast surface, the frequency spectra of the scans are very similar. However, with increasing depth there is a pronounced decrease in amplitude spectra amplitudes in the range from 0-3 GHz for the fouled ballast scan relative to the nonfouled ballast scan.

Figure 3. Results of ballast with various fouling conditions using short-time Fourier transform (Al-Qadi et al., 2007).

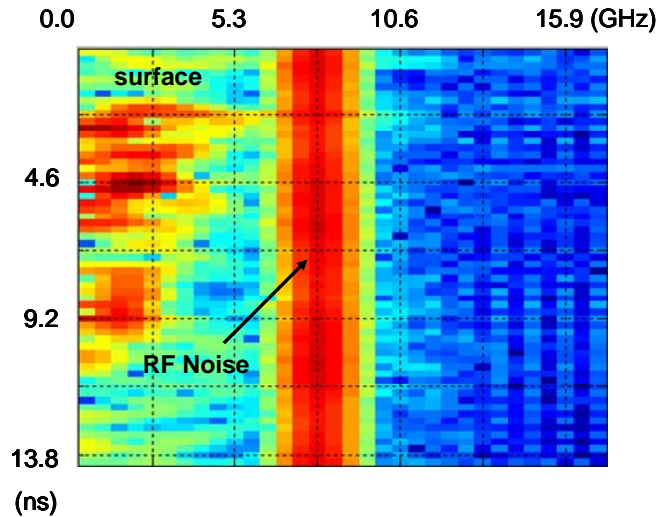
A second application of the STFT is isolating signal from coherent clutter in the data from external radio frequency interference (RFI). Figure 4 illustrates the STFT of a scan with significant RFI. The portion of the frequency spectrum associated with the scattering from the ballast aggregate is clearly isolated from the RFI band.

Figure 4. STFT result for the scan with coherent RF Interference (Al-Qadi et al., 2007).

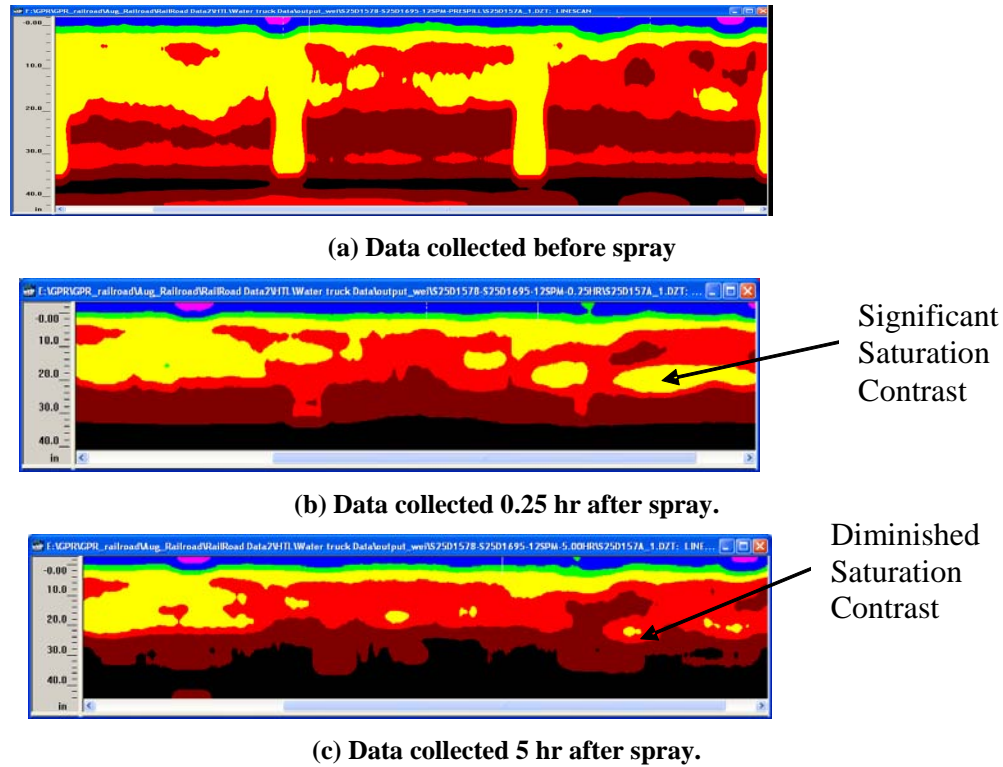
Al-Qadi et al. (2007) used 2 GHz antenna to measure the effects of moisture on the clean and fouled ballast, as shown in Figure 5. A water truck was used to control the moisture content of a railroad section at the Transportation Technology Center (TTC). The data collected over the same section at various times showed that the clean ballast allows water to flow through easily. In slightly fouled ballast, fine particles partially block the air voids and influence drainage capability, resulting in greater saturation. Consequently, this results in a significant GPR reflection at this saturation contrast. Over time, the water drained from the slightly fouled section, resulting in much lower reflection amplitude. The results revealed that GPR may be an effective technique to measure moisture content in the ballast.

Figure 5. Data collected from ballast after water sprayed on surface at various times (Al-Qadi et al., 2007).

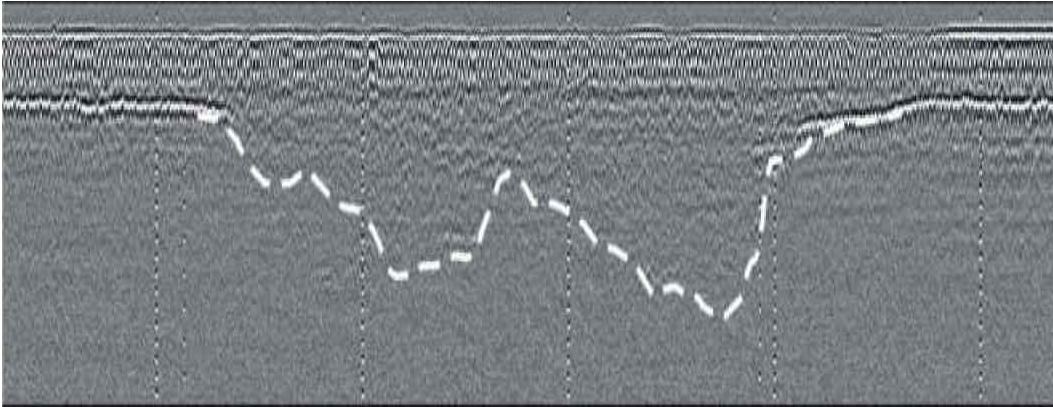
Figure 6. Section of GPR data obtained with 1 GHz horn antennas during first three phases of FRA project (modified from Hyslip et al., 2005).

Detailed inspection of Figure 6 reveals slight textural differences between the ballast and subballast layers in the central portion of the figure. A dotted line demarcates the interpreted boundary between the two layers. The inherent difficulty in accurately mapping the ballast condition and predicting ballast thickness in this region is readily apparent. This limitation in the technique has been eliminated using higher-frequency air-launched antennas. However, the trade-off of the enhanced resolution provided by the higher-frequency antennas is less penetration depth.

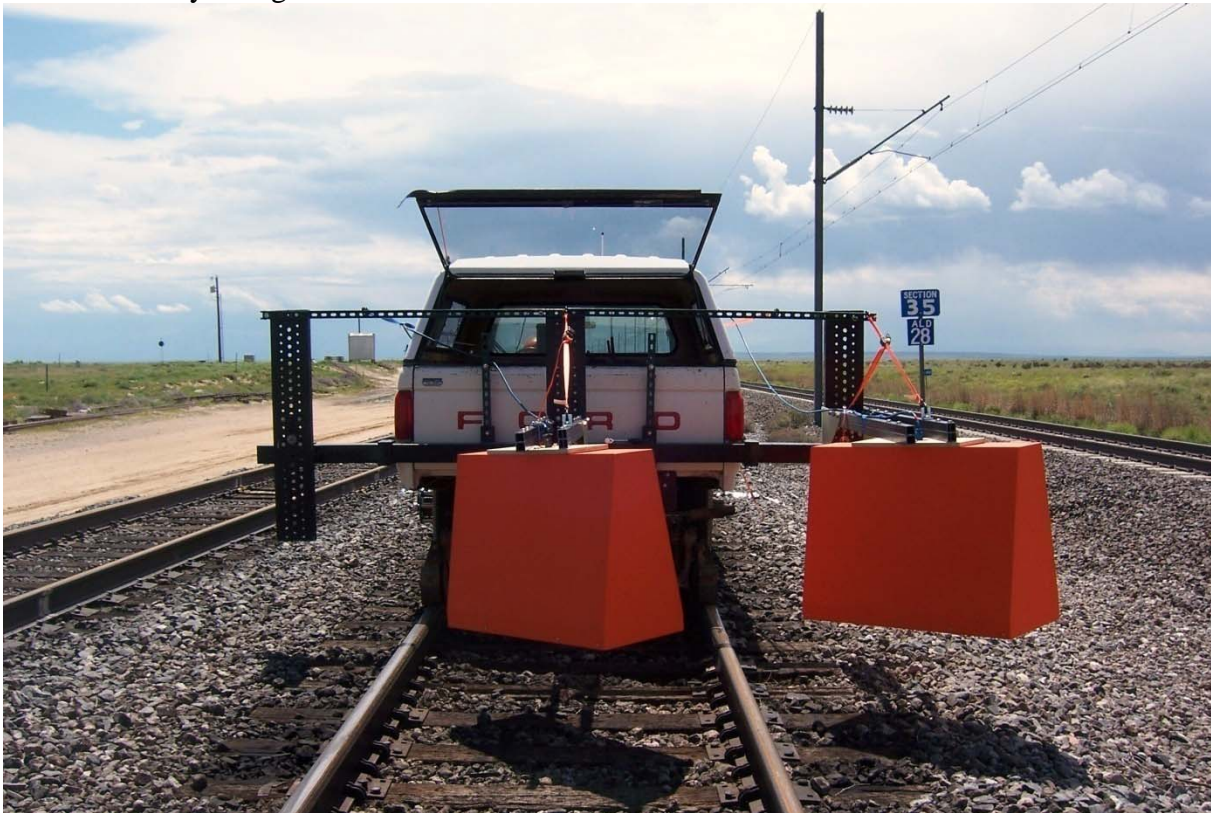
The newly developed 500 MHz air-launched antennas were tested on the HTL at TTC in June, 2007. The data obtained at TTC were obtained with two antennas, one mounted between the rails and the other mounted 6 in off the end of the ties. Several antenna orientations were tested. By mounting the antennas at an orientation of 45 degrees relative to the rails, the reflections from the rails and reinforcement in the concrete ties were optimally reduced. Figure 11 shows the data collection setup. This configuration was subsequently used for data collected in Wyoming and Alaska in 2007.

Figure 11. Data collection setup for initial TTC data collection.

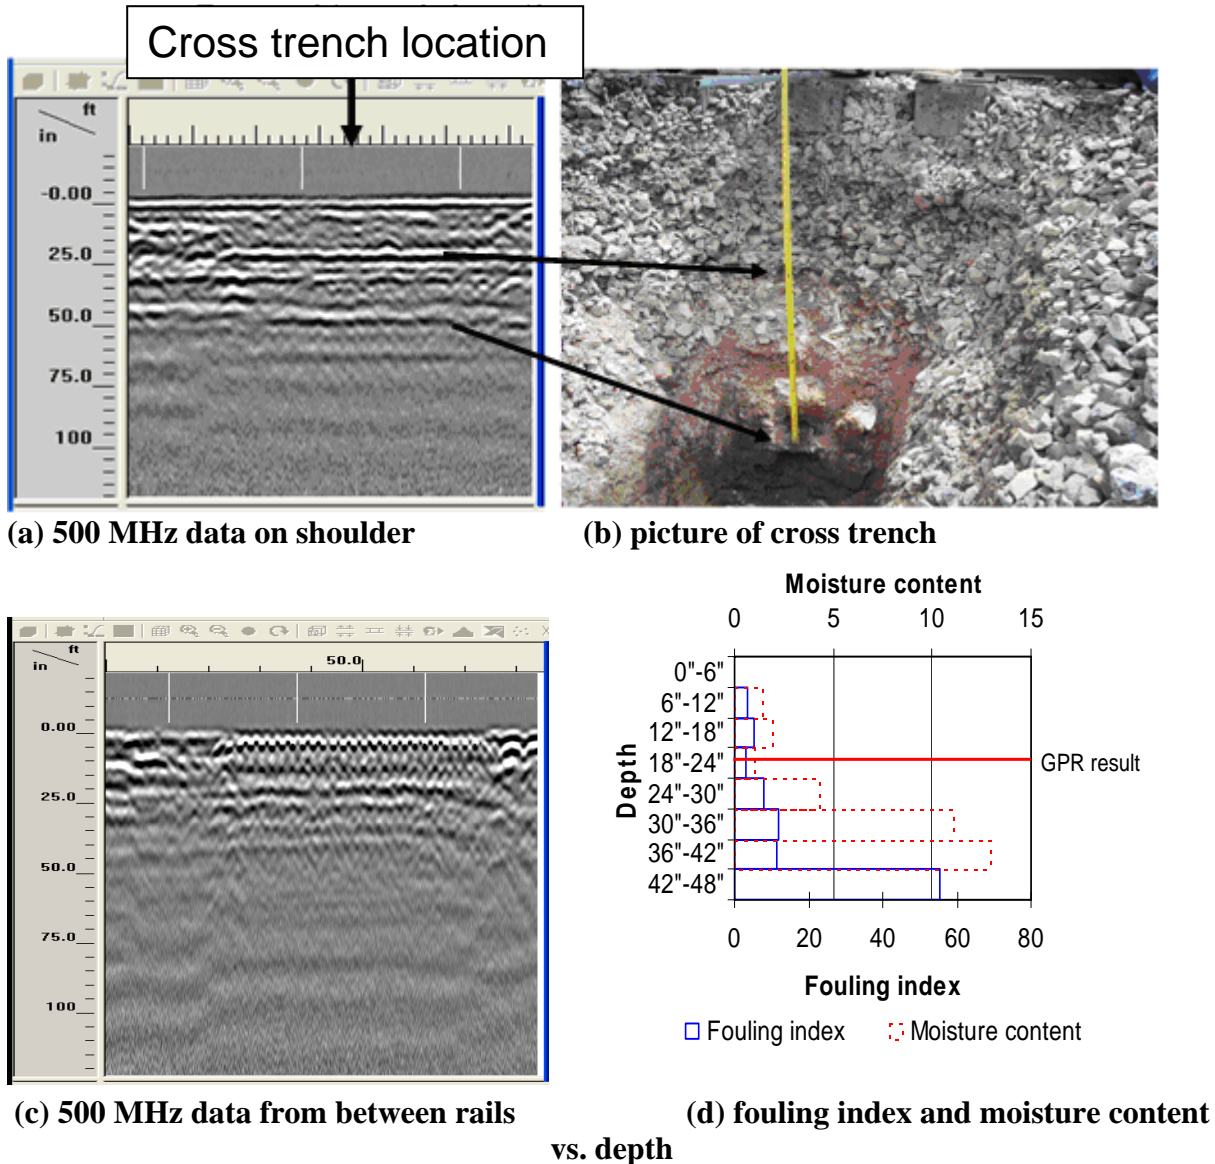
A series of 12 cross trenches were dug to verify the outer and inner antennas could map the subballast and subgrade layer interfaces. Good correlation was observed between the layers tracked in the 500 MHz antenna data and the observed layering in the cross trenches. Figure 12 shows the 500 MHz data versus ground truth at one of the ground truth locations.

Several findings from examination of Figure 12 included: (a) good correlation occur between the locations of reflections in the GPR data and the ground truth; (b) the reflections from the layers are observed in data obtained from the center antenna and the antenna on the shoulder, though the data from the shoulder is less cluttered because there are no tie reflections; and (c) the deepest reflection in the GPR data corresponding to a layer interface in the cross-trench is at 42–48 in. Though no ground truth was obtained from layers below 48-inches deep at TTC, it was anticipated that the antenna would be able to resolve deeper layers because the amplitude of deeper reflections at TTC were well above the noise floor of the data. This assumption was validated by analysis of data obtained in Wyoming and Alaska, which is presented later in this report.

Figure 12. Comparison of 500 GPR data and ground truth at one of cross trenches dug at TTC: (a) 500 MHz data on shoulder; (b) picture of cross-trench; (c) 500 MHz data from between rails; and (d) fouling index versus moisture content obtained from analysis of samples extracted from cross-trench.

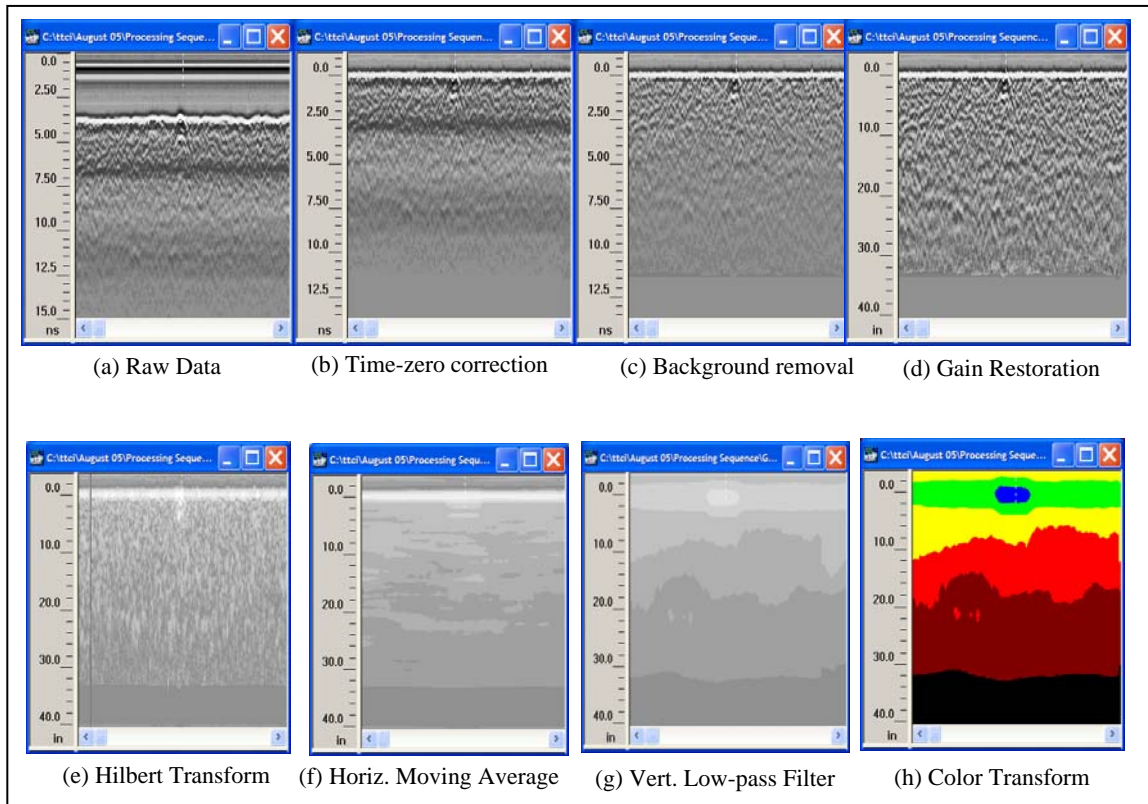
Figure 14. Data processing and display steps applied to TTC 2 GHz GPR data.

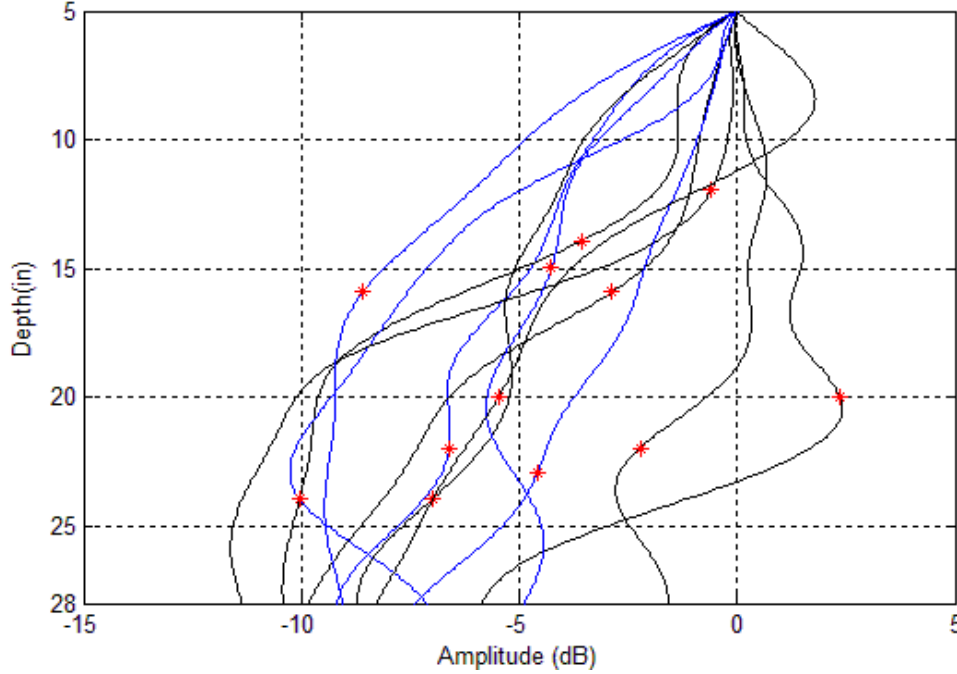
Figure 20. Scattering amplitude envelope at cross-trench locations with the location of the first major layer boundary indicated by red asterisks. Black lines are stepped-type decay curves and blues lines represent relatively steady slope amplitude decay. (Data from 3 cross-trench locations excluded due to incomplete or inconsistent sampling).

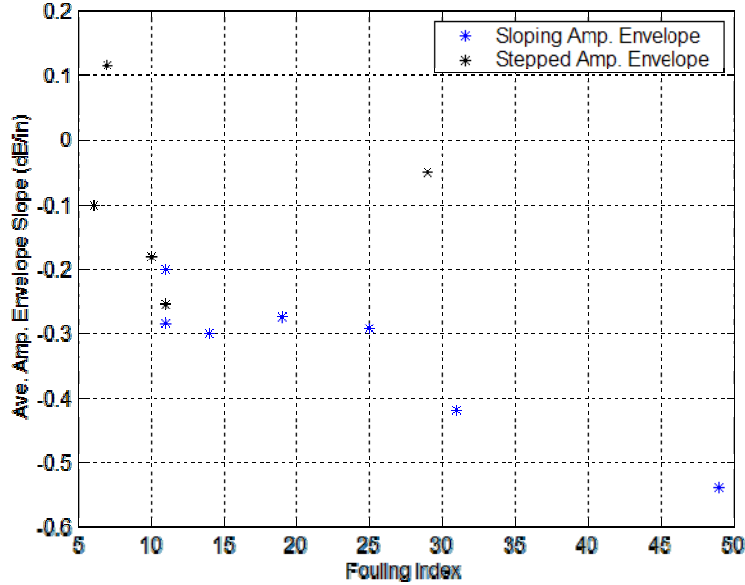
Figure 23. Average amplitude envelope slope in ballast layer versus weighted fouling index from sieve analysis of sample obtained within ballast. Blue and black points are from sloped and stepped scattering amplitude envelopes, respectively.

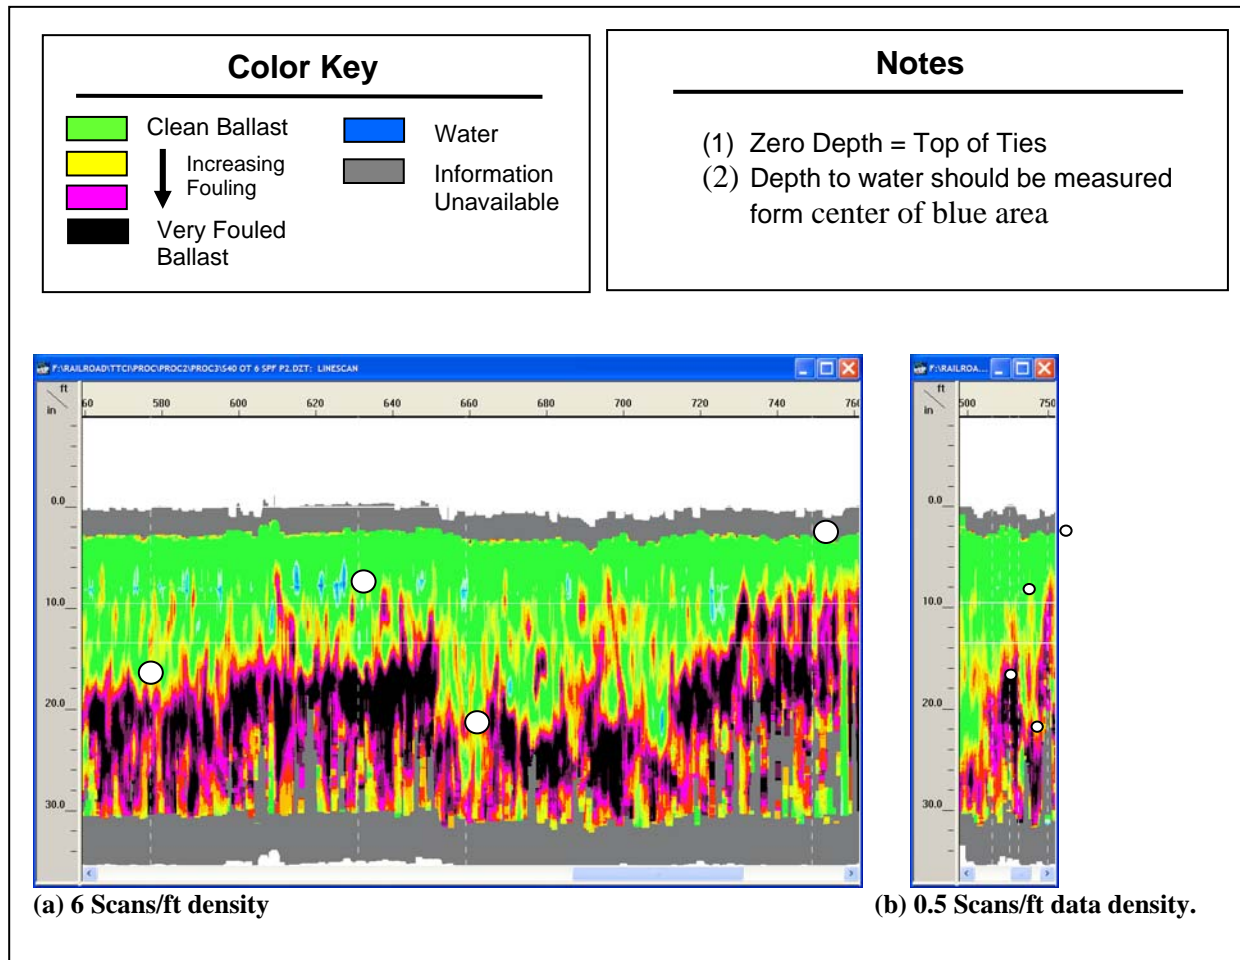
24(a) are not observed in Figure 24(b). However, the thinning of clean ballast from the left side of the section to the right side of the section is evident in both figures.

Figure 24. Processed TTC data along a section with 4 cross trenches shown at a density of (a) 6 Scans/ft and (b) 0.5 scans/ft. The ballast fouling depths based on cross-trench data are represented by the white circles.

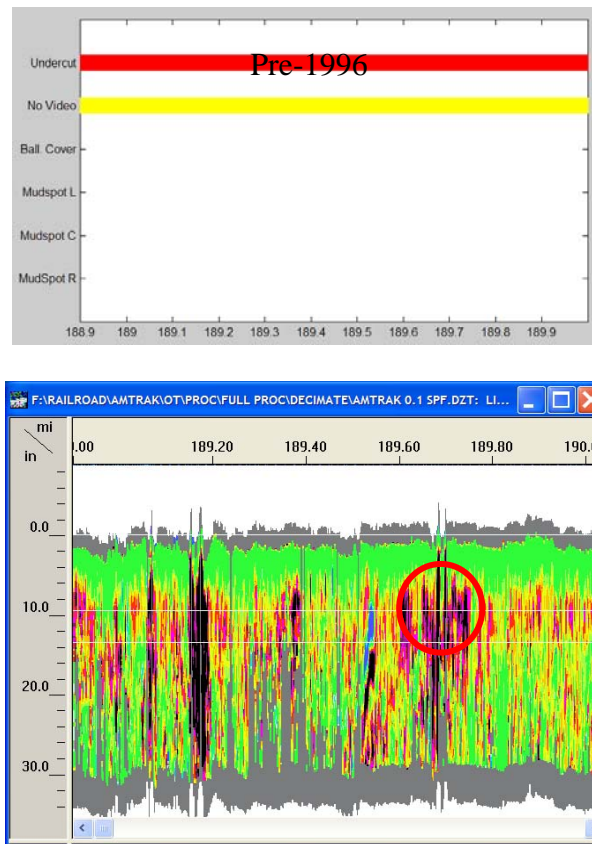
Figure 25. Available ground truth data (top) and automatically processed GPR data on right shoulder from MP 189-190 on Amtrak track (bottom). Red ovals denote large areas of significant fouling near the bottom of the ties

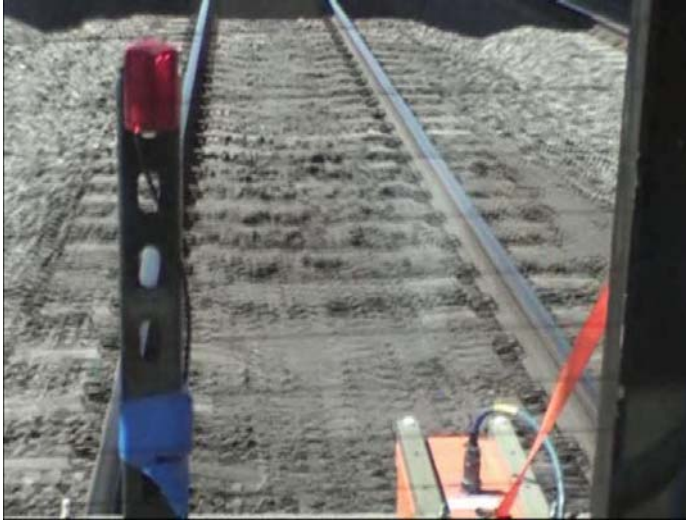
Figure 41. Mudspot data: (a) Picture of mudspot on BNSF track Main at MP 109.61; (b) corresponding ground truth; and (c) processed GPR data.

(a) Mudspot location at MP 109.61. Left side of track corresponds to right side of video.

Figure 41 shows high resolution mudspot data from MP 109.61. This portion of the track was undercut in 2004. The mudspot captured by the video camera clearly reveals fouling extending to the ballast surface. This was inferred from examination of the GPR data presented in Figure 41(c). The most severe fouling indicated by the GPR data corresponds to the physical location of the mudspot. The entire section of GPR data in addition to the mudspot appears to be severely fouled near the surface. Additional GPR data were obtained along a parallel track between MP 82.9–117.4. The data and ground truth are in good agreement.

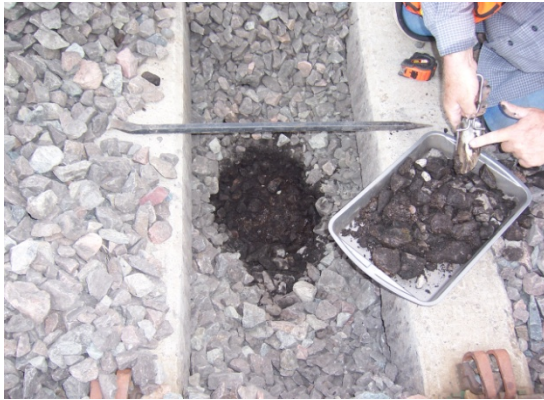
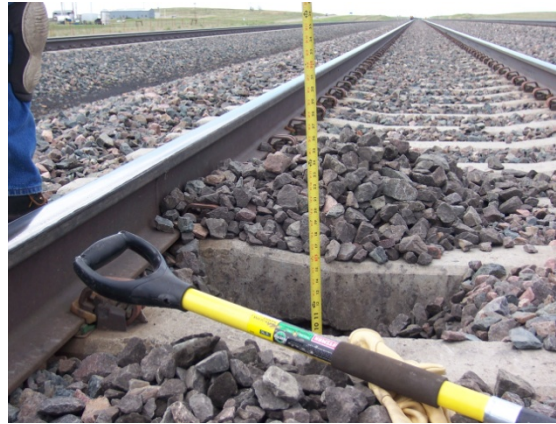
Figure 42. Ground truth data from MP 97 on Main 2: (a) Pictures of sample location; (b) Processed GPR data; and (c) analysis of ground truth sample.

(a) Pictures of sample location. Note the moisture on the spade in the left picture.

The undercutting and mudspot ground truth data are supplemented by five ballast samples that were dug between the rails. Comparisons of processed data to ground truth at three of these sample locations are presented in Figures 42 and 43. The sample shown in Figure 42 was obtained at MP 97 on Main Track 2, which was undercut two months before GPR data collection. Very clean ballast was measured to a depth of 15 in between the rails. A sample extracted between 15- and 18-inches in depth was very moist, as shown by the mud on the spade in Figure 42(a). This moisture corresponds well to the blue band in the GPR data centered at approximately 16-inches in depth.

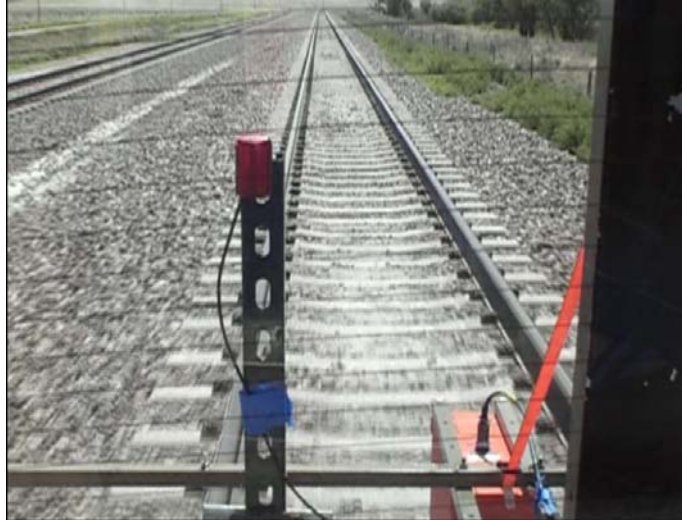
(a) Mudspot location at MP 446.02. Left side of track corresponds to right side of video.

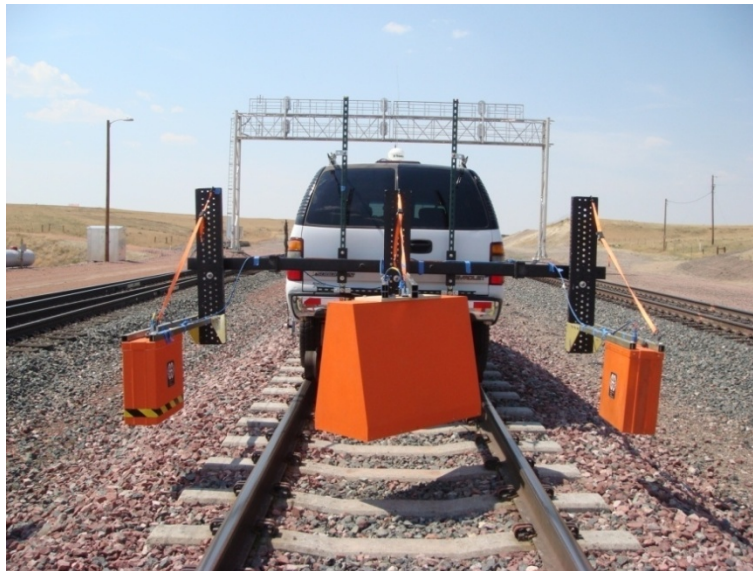
Figure 50. Data collection setup. Two 2 GHz horn antennas were mounted on the shoulders and a 500 MHz horn antenna was mounted between the rails.

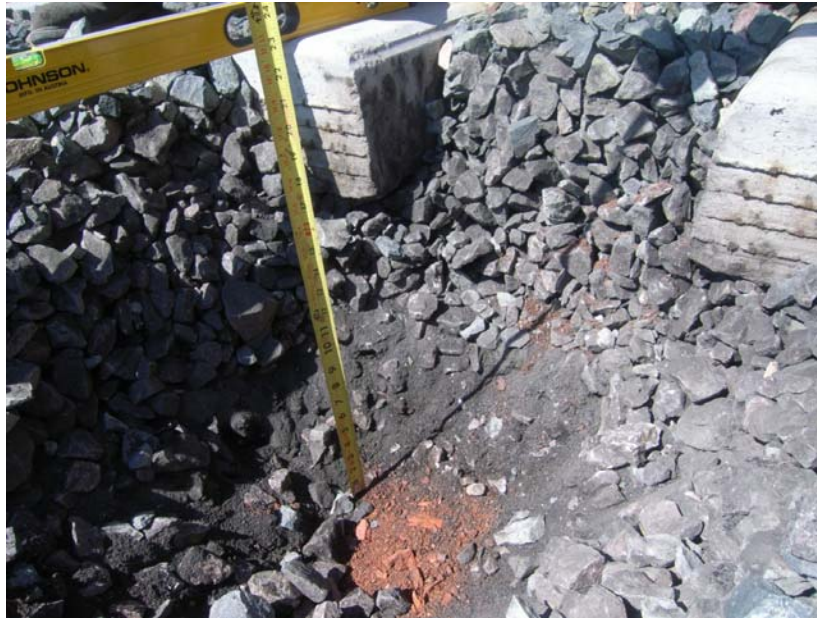
Figure 51. Typical ground truth hole. Pink material at bottom is top of the subballast.

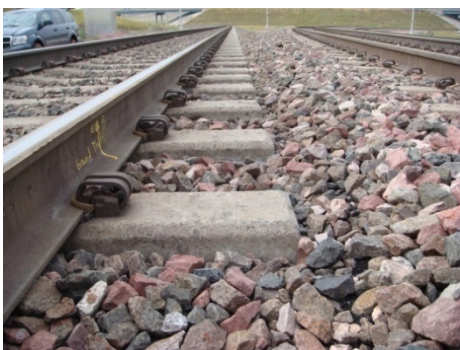
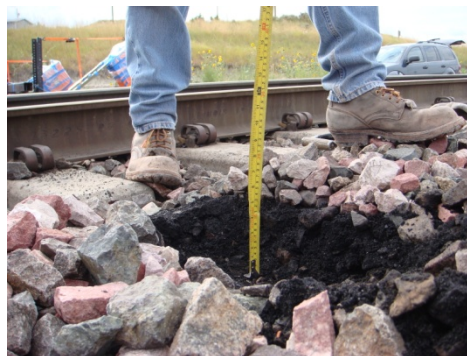
(a) Surface at Donkey Creek Junction

(b) Coal dust just beneath top of ballast

Figure 52. Donkey Creek Junction ground truth location exhibiting no fouling based on surface inspection, but 4-inch thick layer of coal dust just beneath the top of the ballast.

The subgrade layer was located in only two of the 20 ground truth holes. At both locations the subballast layer was approximately 10-12-inches thick. The ballast fouling material was often visually identifiable as coal dust. The coal on the cars is piled above the top of the car and blows off while the train traverses along the tracks. Figure 52 shows one location near Donkey Creek Junction where a 4-inch thick layer of coal dust was just beneath the top of the ballast that was not identifiable from the surface.

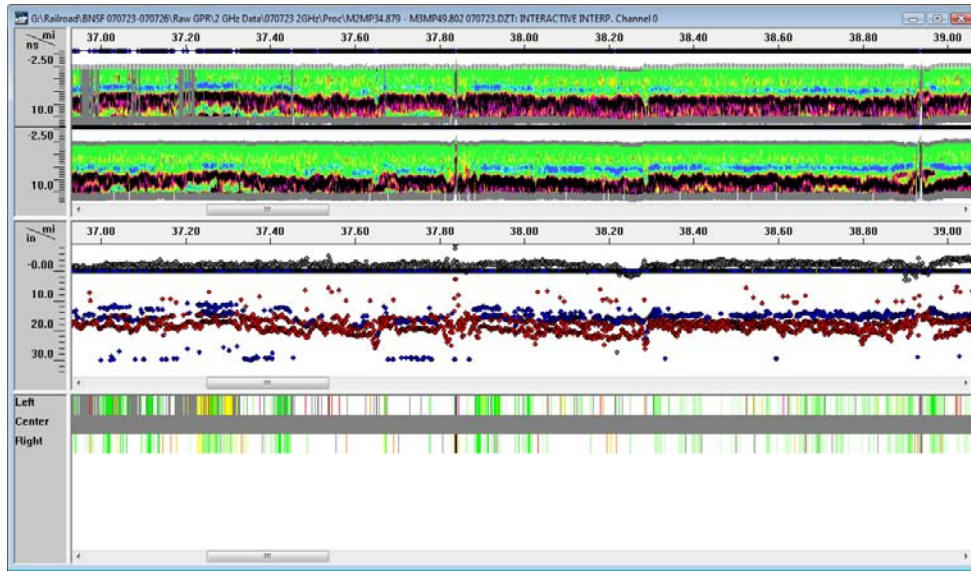
Figure 59. Processed 2 GHz data obtained between MP37 and 39 on track Main 2 before a rainfall event.

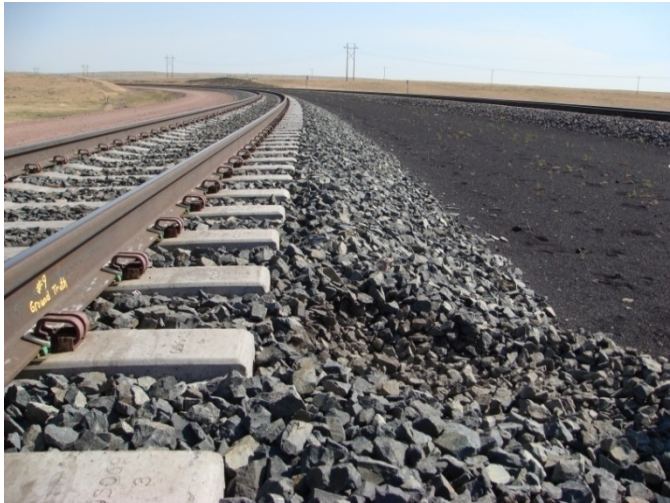
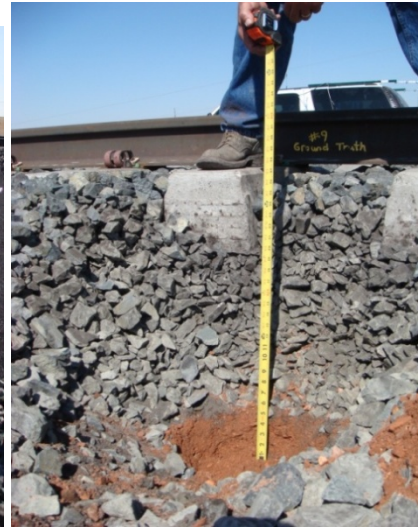
Figure 64. Ground truth of hole dug on track Main 3 at MP 52 +286 ft.

(a) Location of ground truth

(b) Cross-section of hole

At ground truth locations where the subballast thickness could be measured, typically a reflection occurred between the subballast and subgrade interface. Exceptionally clean ballast is observed at the ground truth location shown in Figure 64. A significant moisture contrast occurred between the ballast and subballast layers as shown in Figure 64(c). Apparently a negligible moisture contrast occurred between the subballast and subgrade layers at the location of the ground truth hole. The 500 MHz data, shown in Figure 65, contains reflections that are in good agreement with the locations of the layer interfaces mapped at the hole's location.

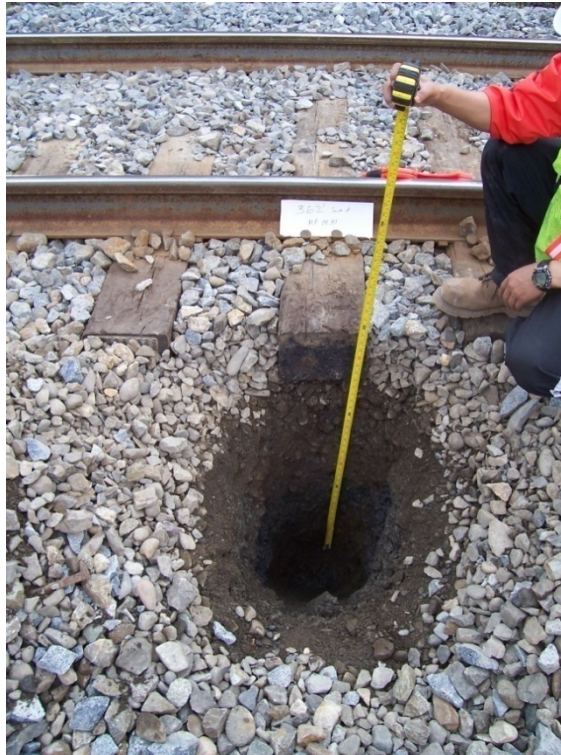
Figure 69. Typical ground truth hole. The depth of this hole relative to the top of the tie was 3 ft.

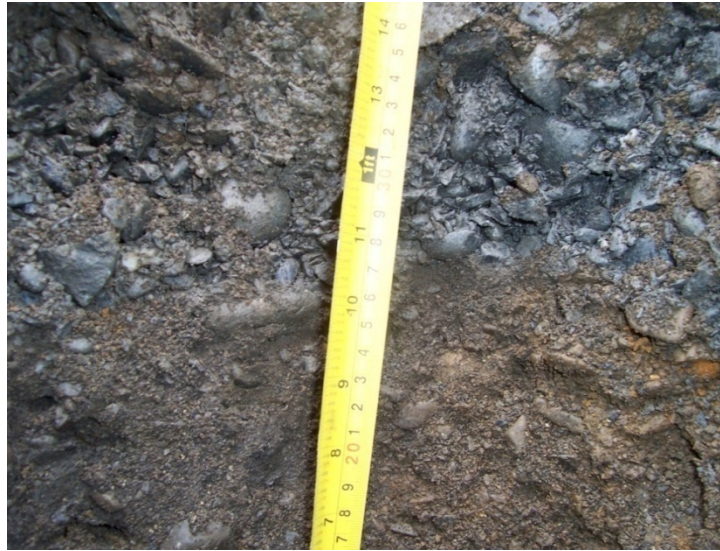
Figure 70. Layer of distinct blue-gray crushed stone that is typically near 24-inches deep at most ground truth locations. The moisture content of the subballast beneath this layer was substantially higher.

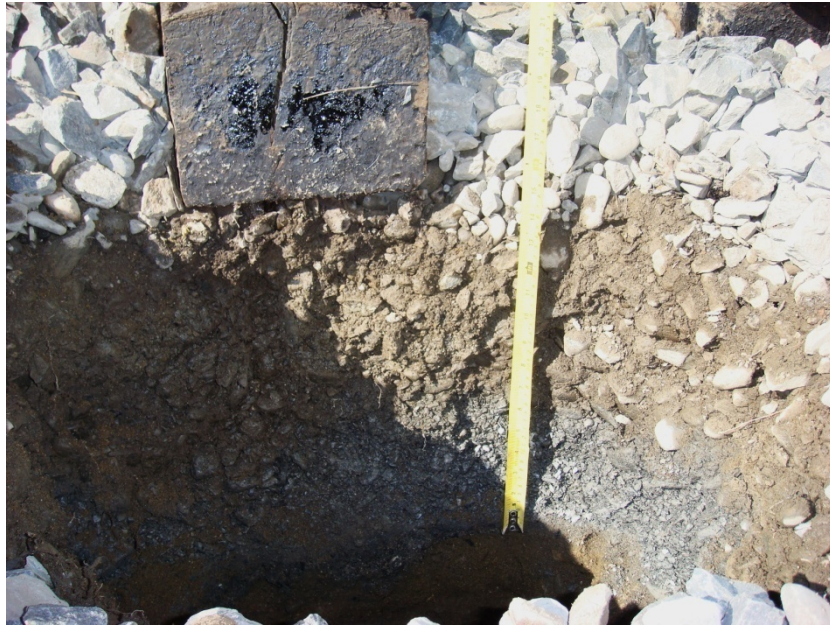
Figure 72. Another ground truth location exhibiting the layer of blue-gray stone.

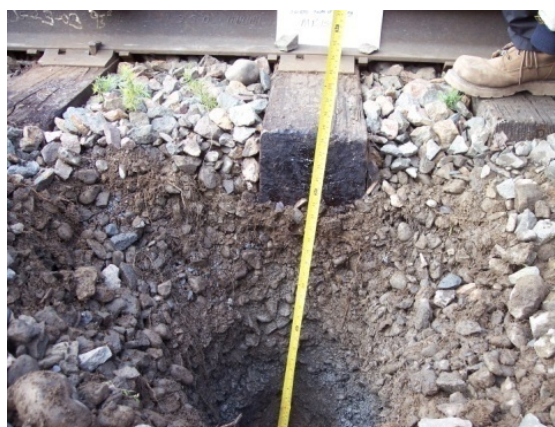
(a) Picture of ground truth location of samples

A layer reflection was often observed in the 500 MHz data at 15–25-inches in depth. Comparison between the 500 MHz data and ground truth indicates this reflection is likely associated with a moisture increase at the bottom of the blue-gray stone layer. A good example of this layer reflection is shown in Figure 80.

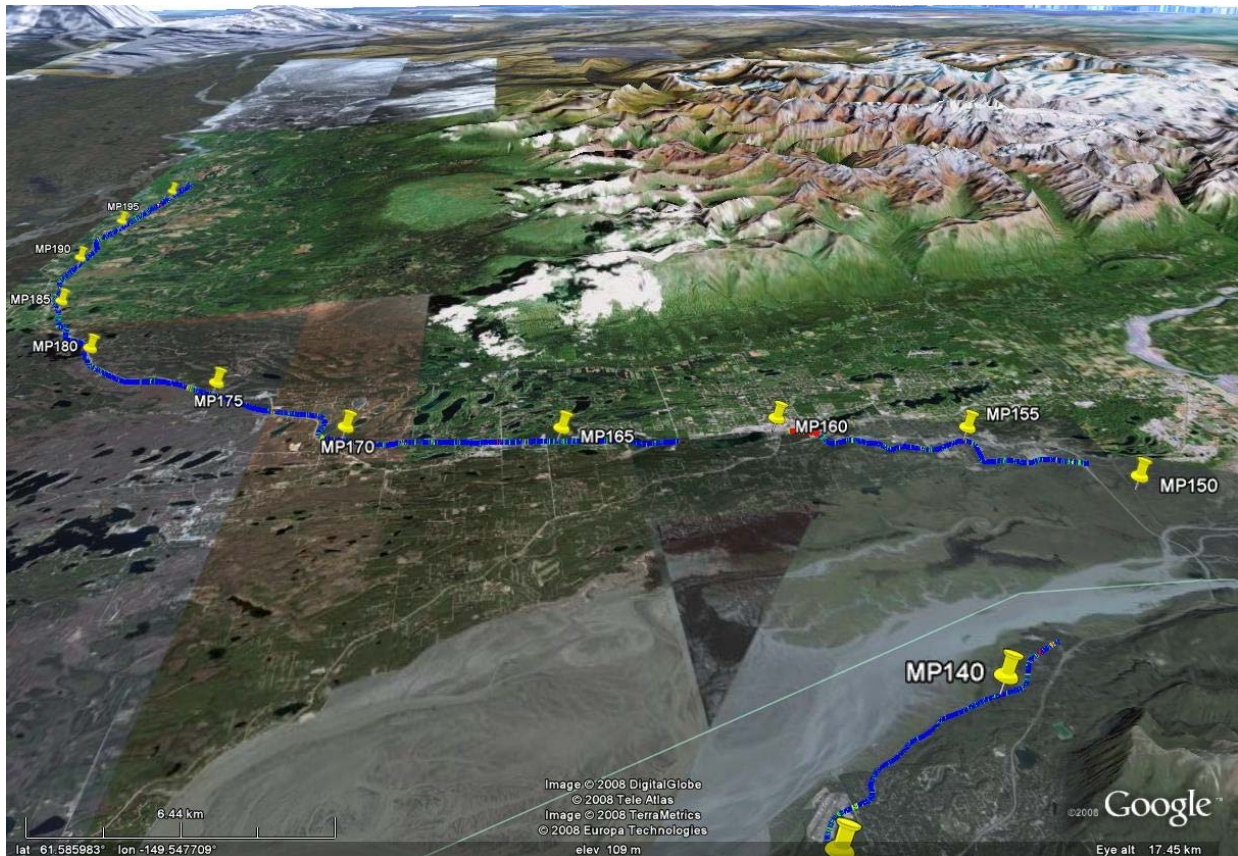
Figure 81. Automatically picked highest amplitude reflections between 30- and 75-inches deep. Color key: Blue < 67.5 dB, Green 64.5–70 dB, Yellow 70–72.5 dB, Red > 72.5 dB.

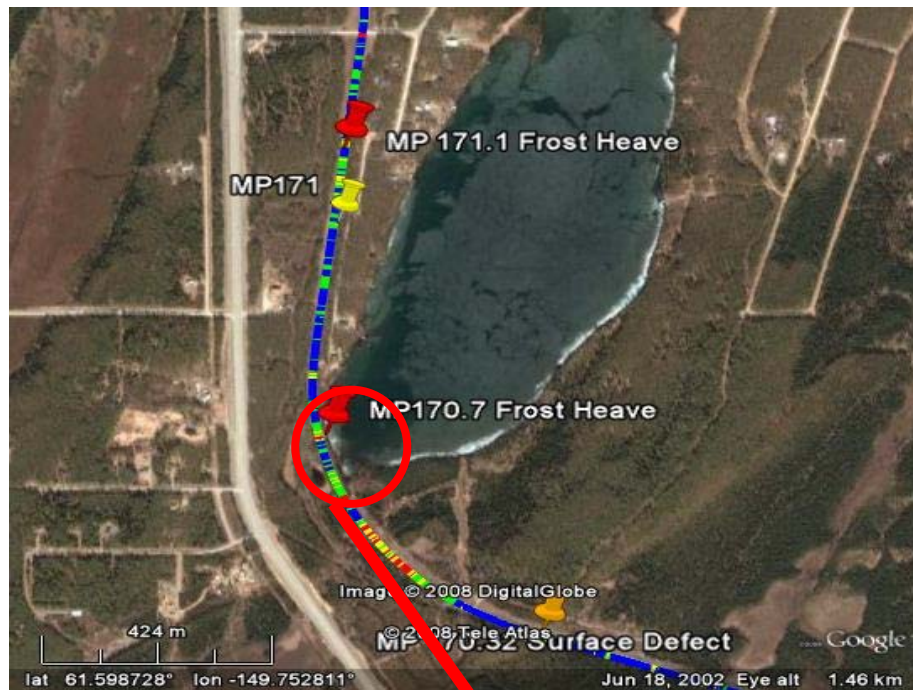
Figure 85. Location frost heave at MP 170.7 superimposed on top of the highest amplitude GPR reflections between 30- and 75-inches deep (top) and corresponding 500 MHz GPR data (bottom).

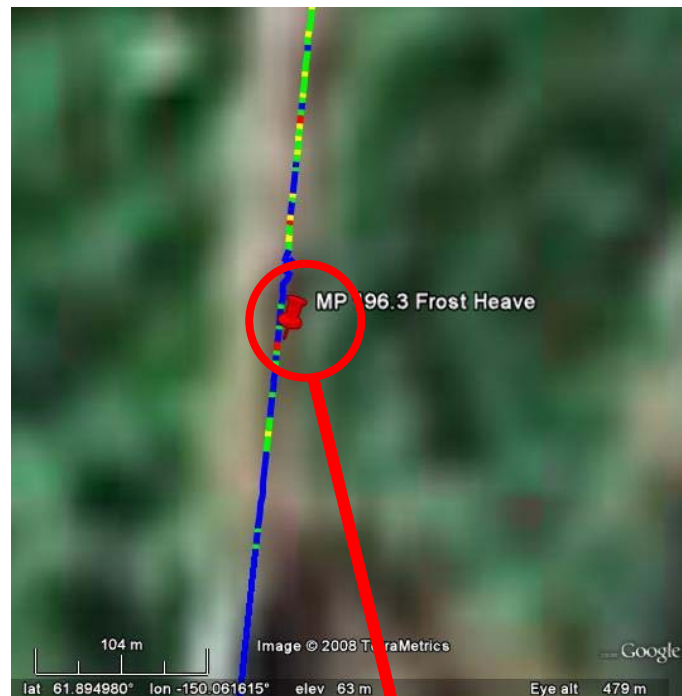
Figure 86. Location frost heave at MP 196.3 superimposed on top of the highest amplitude GPR reflections between 30- and 75-inches deep (top) and corresponding 500 MHz GPR data (bottom).
