**Federal Railroad
Administration**

Effect of an Active Another Train Coming Warning System on Pedestrian Behavior at a Highway-Rail Grade Crossing

1. AGENCY USE ONLY (Leave blank)		2. REPORT DATE July 2014		3. REPORT TYPE AND DATES COVERED Technical Report April 2012 – September 2013
4. TITLE AND SUBTITLE Effect of an Active Another Train Coming Warning System on Pedestrian Behavior at a Highway-Rail Grade Crossing			5. FUNDING NUMBERS RR97A6-LT925

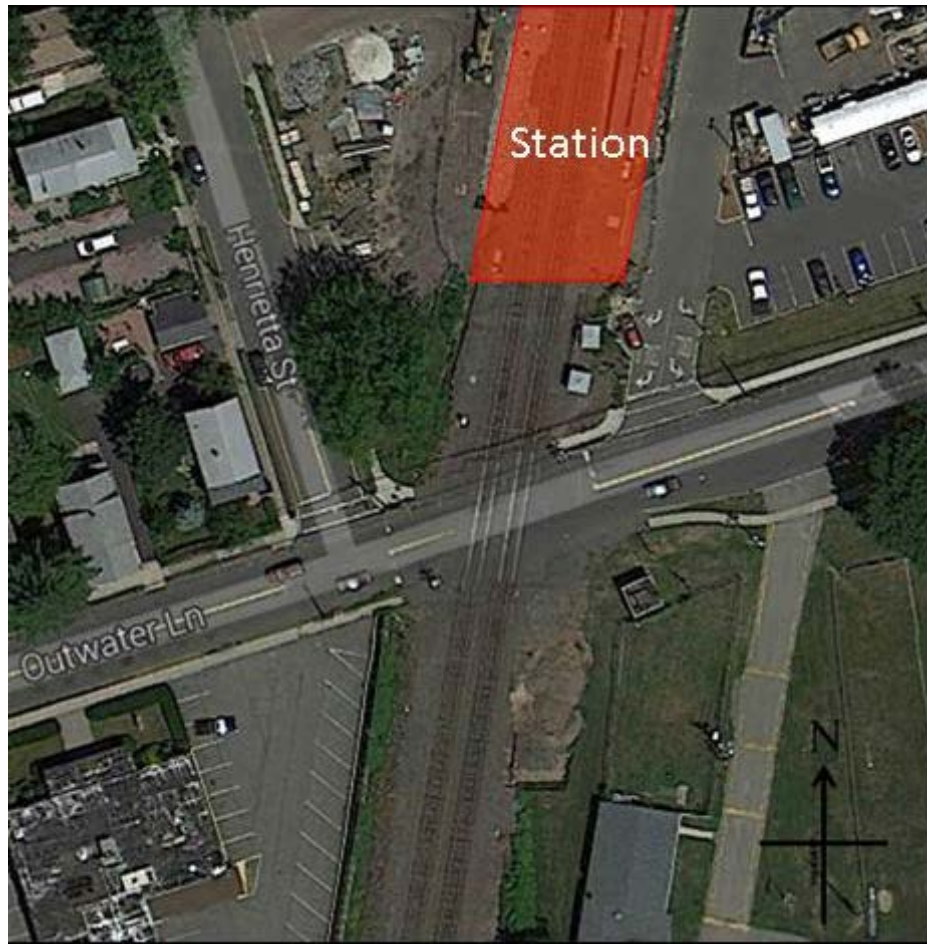
Figure 2. Outwater Lane Grade Crossing in Garfield, NJ

2. Test Site Location

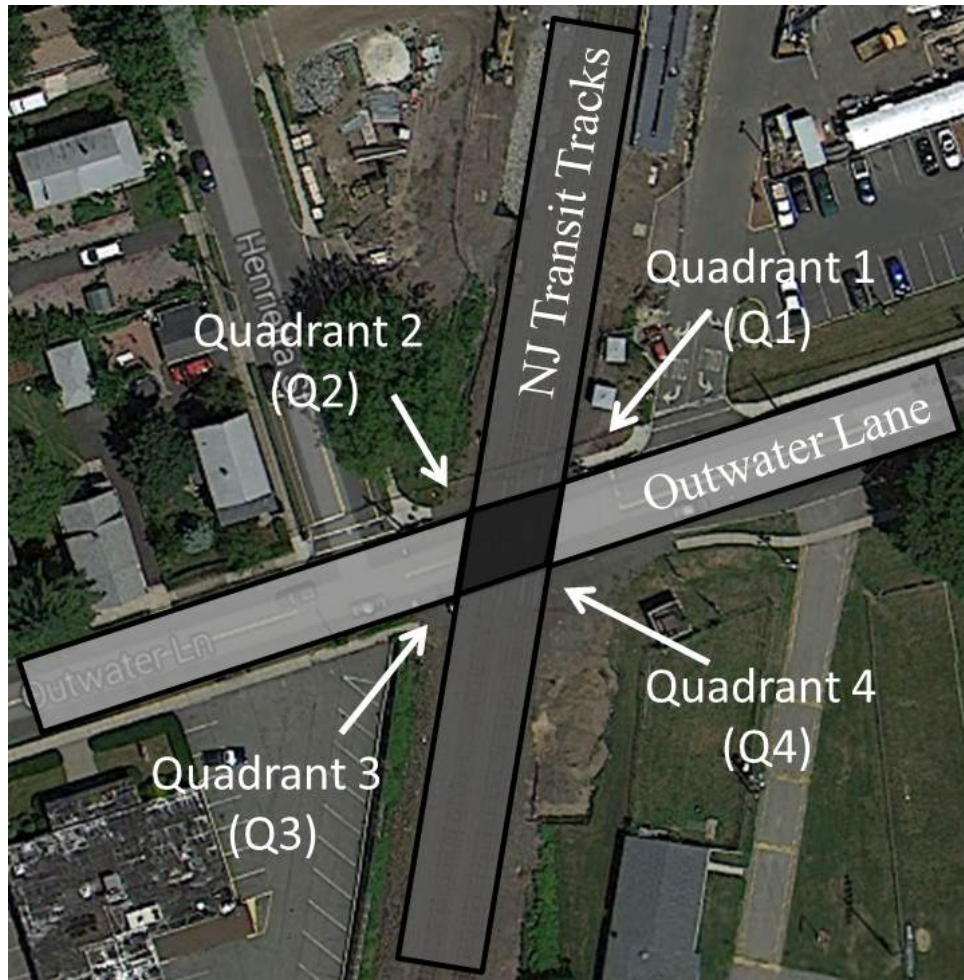
Figure 3. Outwater Lane Grade Crossing Quadrant Identification

At the start of data collection, the crossing at Outwater Lane was already equipped with several pedestrian safety enhancements, including pedestrian gates, signage, and channelization. The four potential locations at which a pedestrian can legally cross the tracks are labeled by quadrant in Figure 3. The four potential crossing locations were not all equipped with the same safety enhancements.

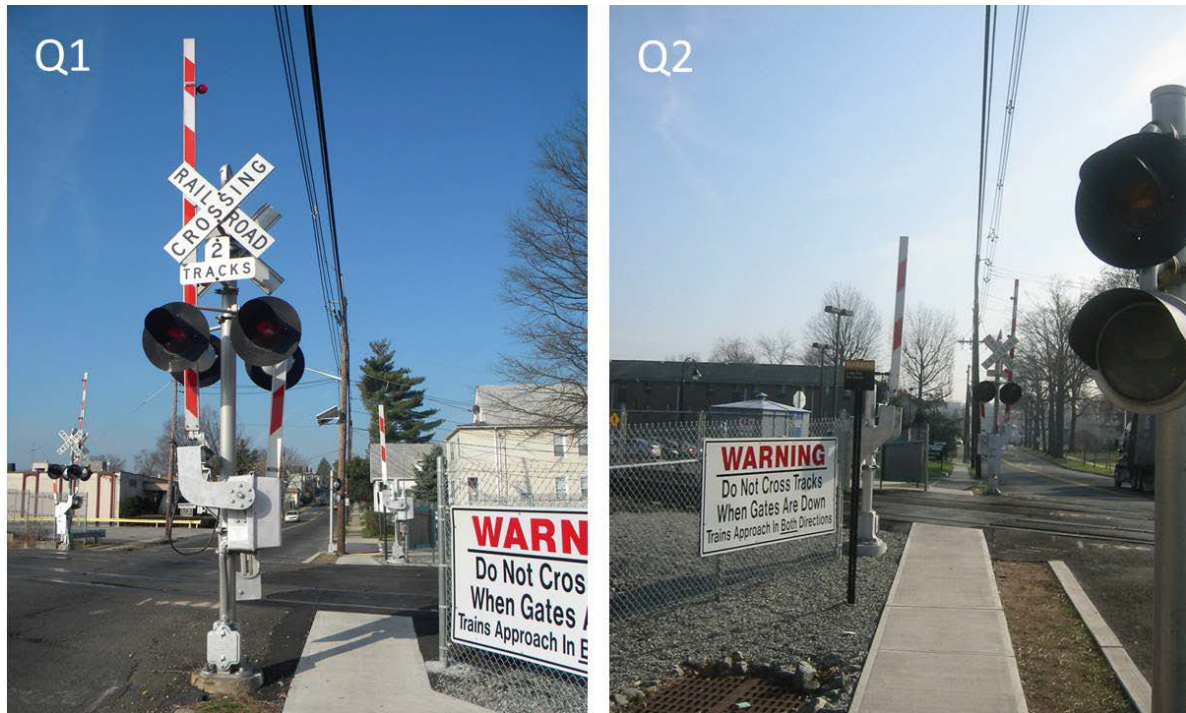
Figure 4. Quadrant 1 (left) and Quadrant 2 (right) Safety Enhancements at the Start of the Study

Quadrant 1 (Q1) and Quadrant 2 (Q2) had similar safety enhancements in place at the start of the data collection. As seen in Figure 4, both Q1 and Q2 had train activated pedestrian gate signage warning pedestrians of potential train activity. Both also had fencing to prevent pedestrians from travelling to the outside of the gate.

When the pedestrian gate is in the horizontal position (fully descended), it borders a fence and blocks pedestrians from walking around the gate and outer boundary of the sidewalk. In Quadrant 3 (Q3), there were train activated pedestrian gates; however, this quadrant lacked the channelization and signage that was found in Q1 and Q2. The pedestrian gates in Q3 are depicted in Figure 5.

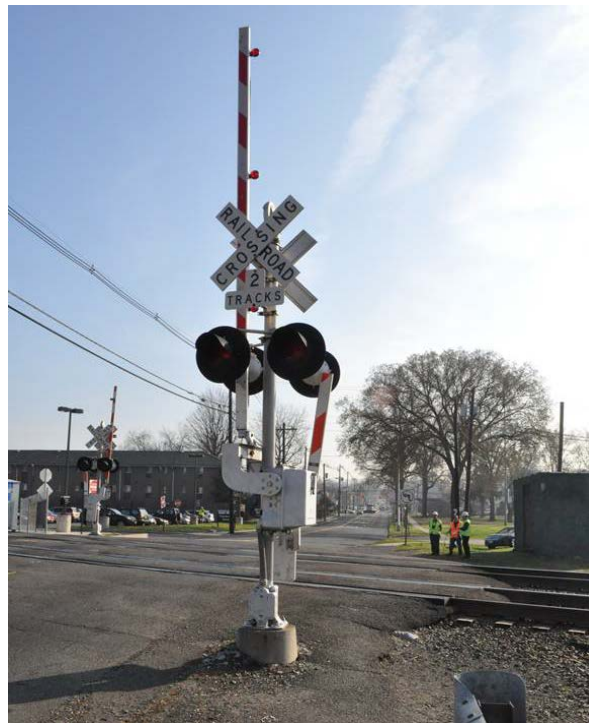
Figure 5. Quadrant 3 Safety Enhancements at the Start of the Study

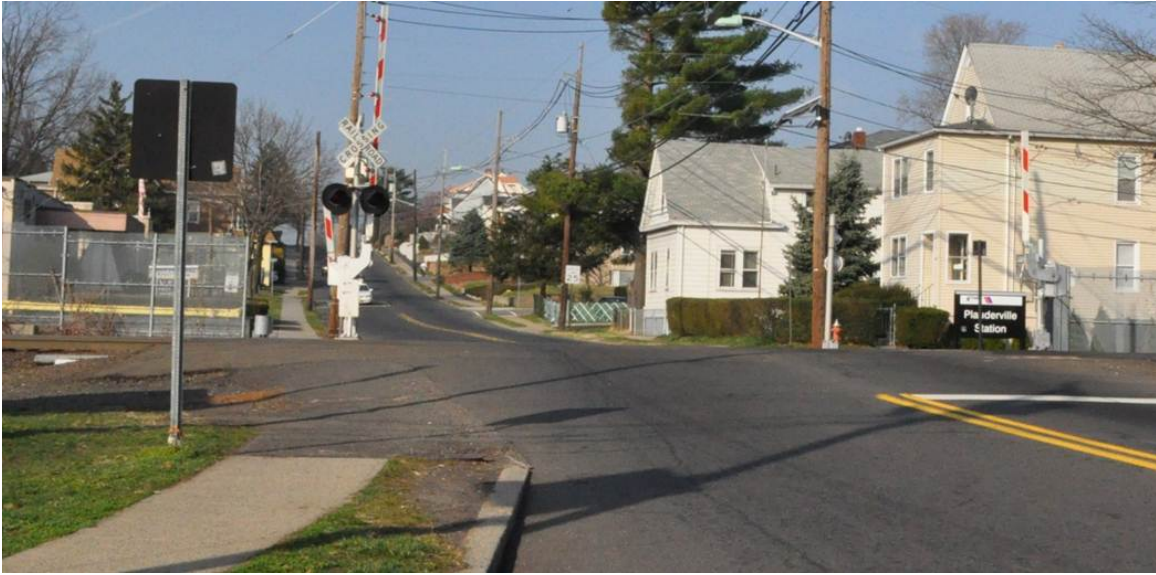
Figure 6. Quadrant 4 at the Start of the Study

There were no safety enhancements installed in Quadrant 4 (Q4) at the start of the study, as seen in the left foreground of Figure 6.

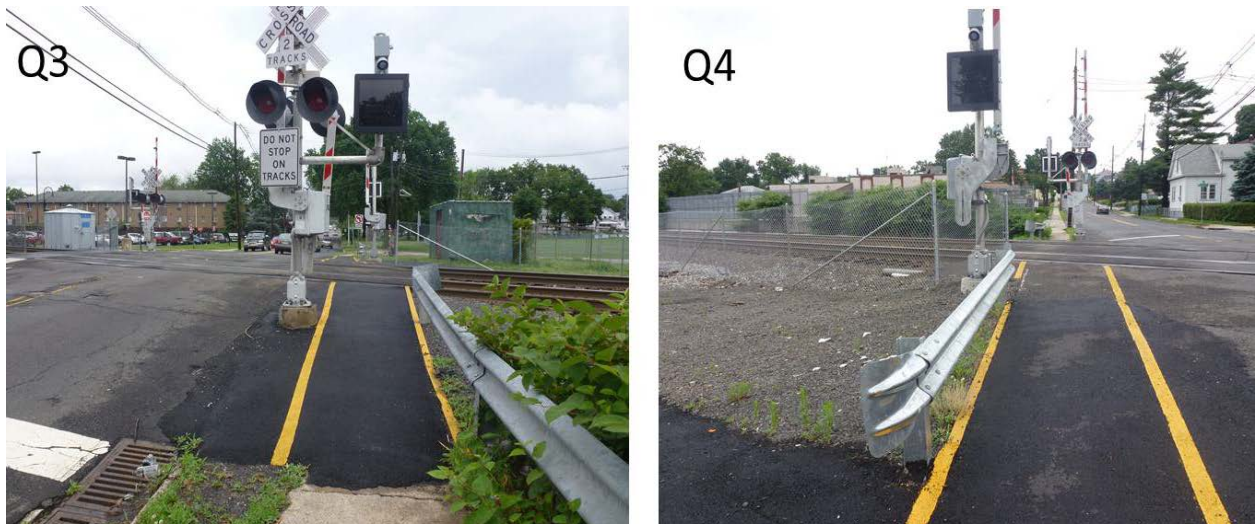
Figure 7. Added Safety Enhancements in Quadrant 3 (left) and Quadrant 4 (right) in August 2012

Enhancements were made to both Q3 and Q4 after data collection began for this study. In August 2012, train activated pedestrian gates were added to Q4, and channelizing guard rails were added to both Q3 and Q4. These guard rails were intended to deter pedestrians from travelling around the pedestrian gates (to the outside) once the gates had descended. The extended guard rail in Q3 and the new pedestrian gate and guard rail are depicted in Figure 7.

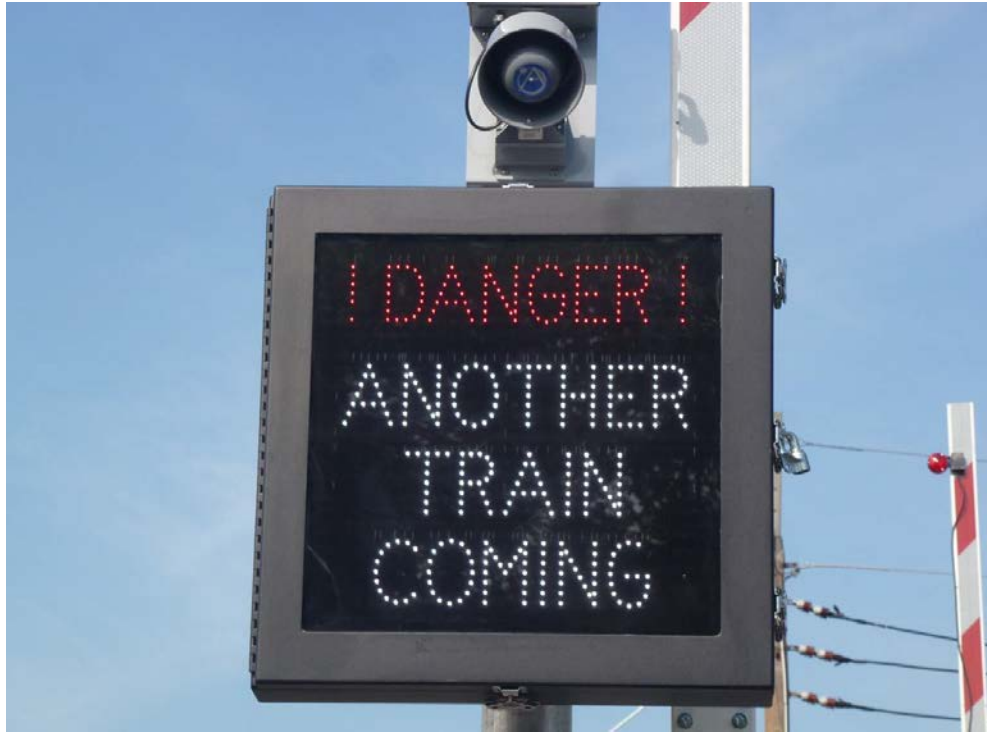
Figure 8. Another Train Coming Signage and Auditory Speaker

The sign chosen by NJ Transit Rail for the current study is the same type presently in use at near-station crossings along the Union Pacific West Line in the Chicago area [6]. The system, which is depicted in Figure 8, flashes the word “Danger” in red and displays “Another Train Coming” below it in bright, white Light Emitting Diode (LED) lights. Above the sign is mounted a speaker, which is also depicted at the top of Figure 8, which repeats the phrase “Danger, another train coming” in a male voice for the duration of the activation.

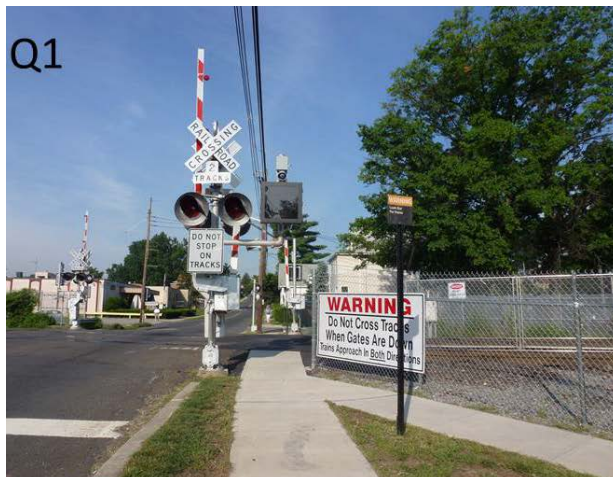
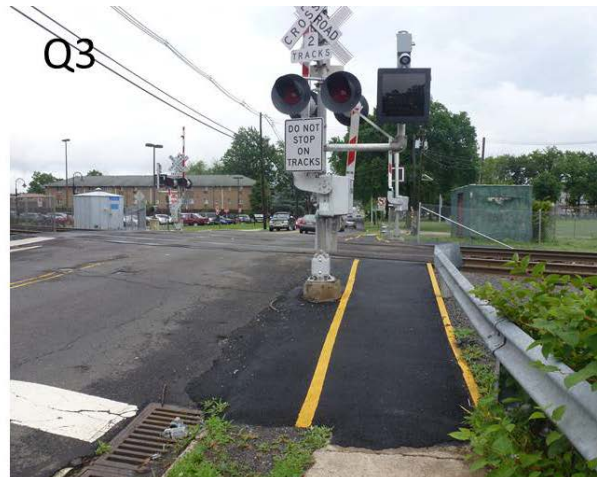
Figure 9. Another Train Coming Signage Placement in Q1 and Q3

The systems were mounted at the crossing in one of two ways. In Q1 and Q3, the sign and speaker were mounted on an arm sticking out from the gate pole, onto which were mounted both the street and sidewalk gates. As seen in Figure 9, the signage in Q1 (left) and Q3 (right) was positioned directly above the pedestrian walkway.

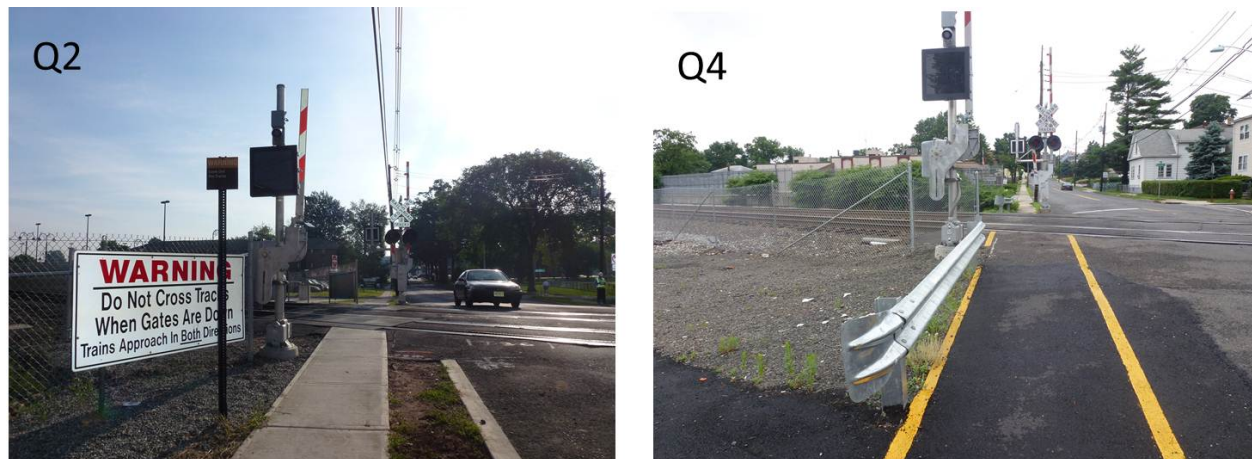
Figure 10. Another Train Coming Signage Placement in Q2 and Q4

Placement of the signage in Q2 and Q4 was slightly different. In each of these quadrants, the sign and speaker were mounted directly to the gate post without any arm extending the signage away from the post. In these quadrants, the signage was not directly above the pedestrian walkway, but instead to the left of the walkway, as depicted in Figure 10.

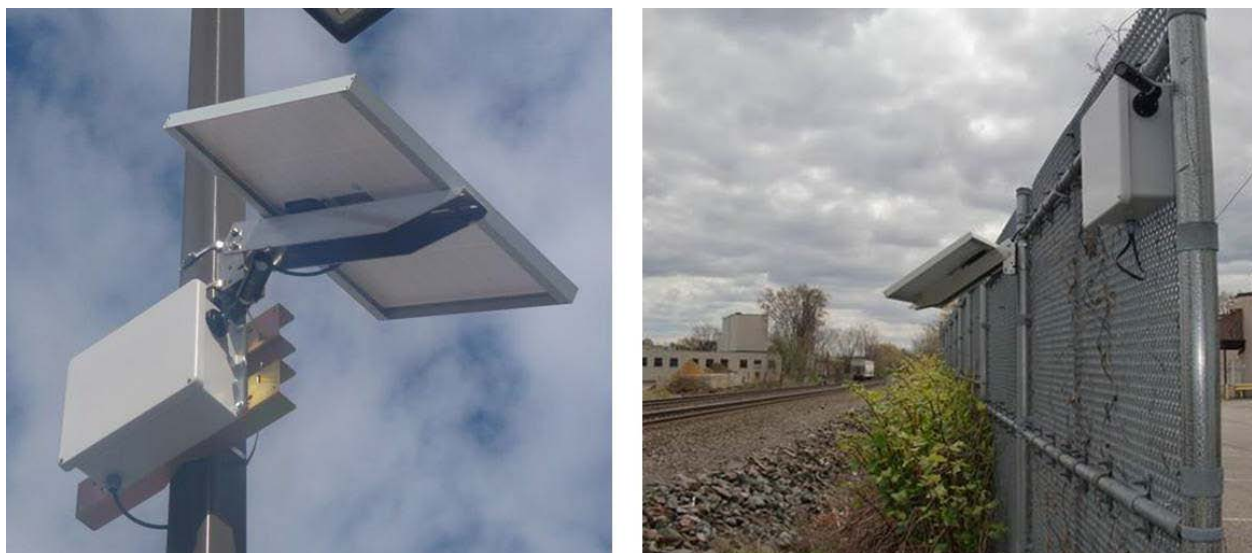
Figure 11. Solar Panel, Camera, and Box Housing the Digital Video Recorder

The data collection equipment consisted of two small video cameras connected to a digital video recorder and solar panel. Figure 11 shows the two systems, each consisting of a solar panel, camera, and box which housed the digital video recorder.

One of the two cameras was mounted to a pole located near Q1 (the pole-mounted setup is shown in the left half of Figure 11). The view from this camera captured pedestrian movements in all four quadrants; however, pedestrians approaching Q4 could not be seen. A sample of the view from the camera is provided in Figure 13.

A second camera was mounted on the fence near Q3. This camera was connected to the same type of digital video recorder and solar panel as the pole-mounted camera. This camera was also capable of capturing pedestrian movements in all four quadrants; however, the vantage point was closer to the ground. Figure 14 provides a sample view from the fence mounted camera.

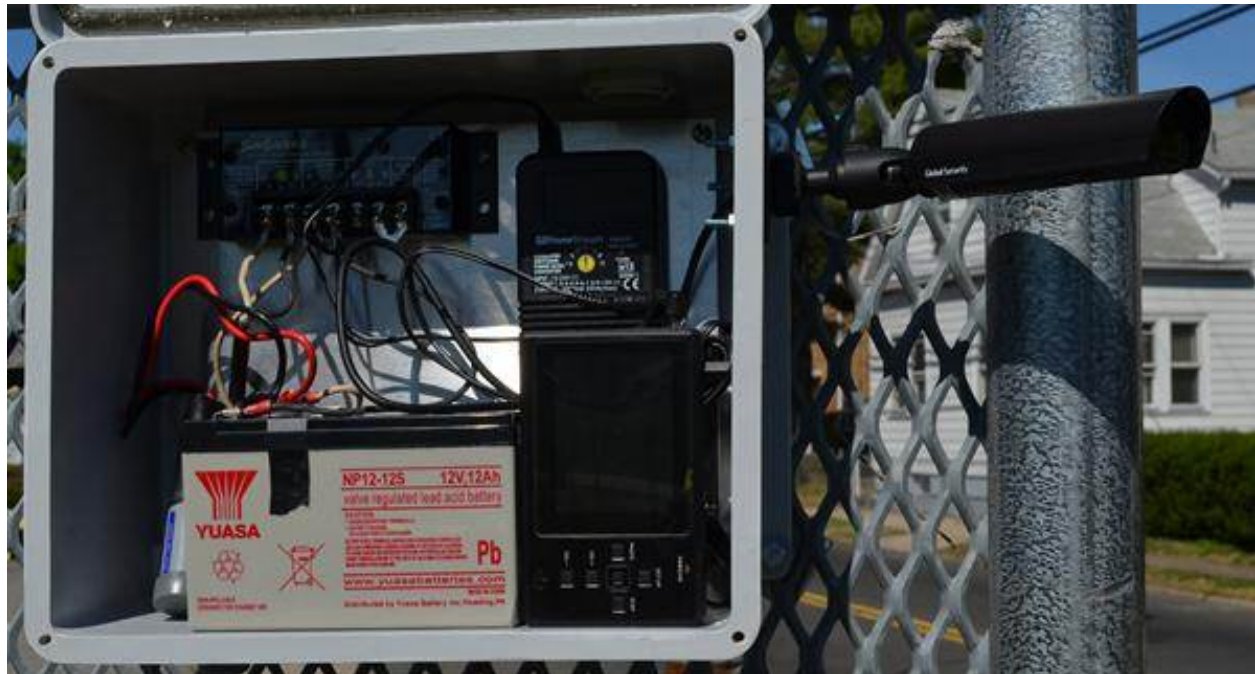
Figure 12. Digital Video Recorder

Inside each box was a digital video recorder that was able to record and store videos of the crossing. The digital video recorder was fully powered by the solar panel and is shown in Figure 12.

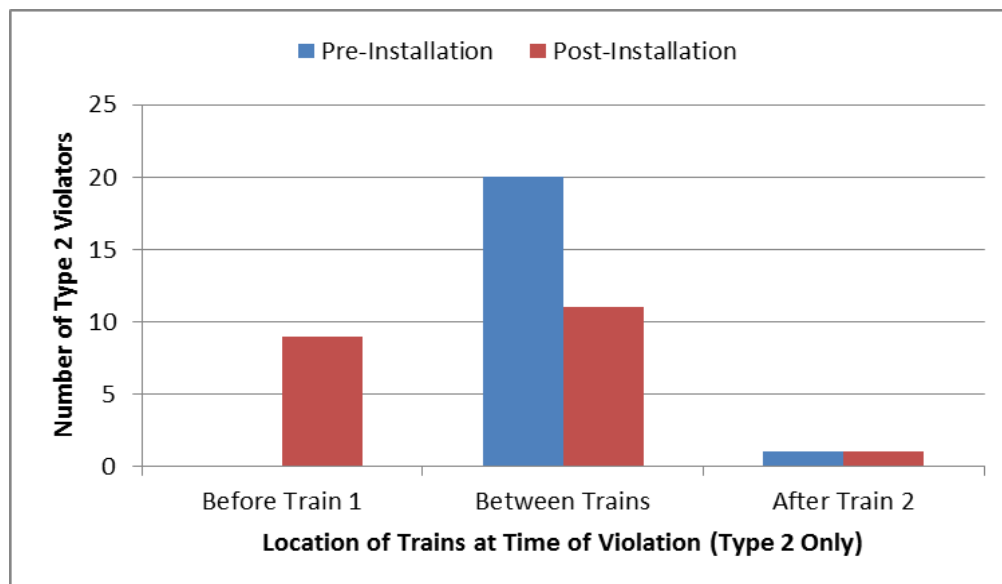
Figure 15. Number of Type 2 Violators by Location of Trains

Looking at Type 2 violation events, the number of violators who crossed before Train 1 jumped from zero before installation to nine after installation. Additionally, a complimentary drop of nine violations was found between Train 1 and Train 2 with 20 violations occurring before installation and 11 occurring after installation, as seen in Figure 15.

The number of Type 2 violators who crossed after Train 2 did not change; both pre- and post-installation events had only one violator. The number of Type 2 violators who crossed before Train 1 and between Train 1 and Train 2 is almost identical, but the number of violators before Train 1 increased after the signage was installed, while violators between Train 1 and Train 2 decreased after the signage was installed. This may indicate that the signage is changing the pedestrians' decisionmaking about *when* to violate but not *if* they should violate.

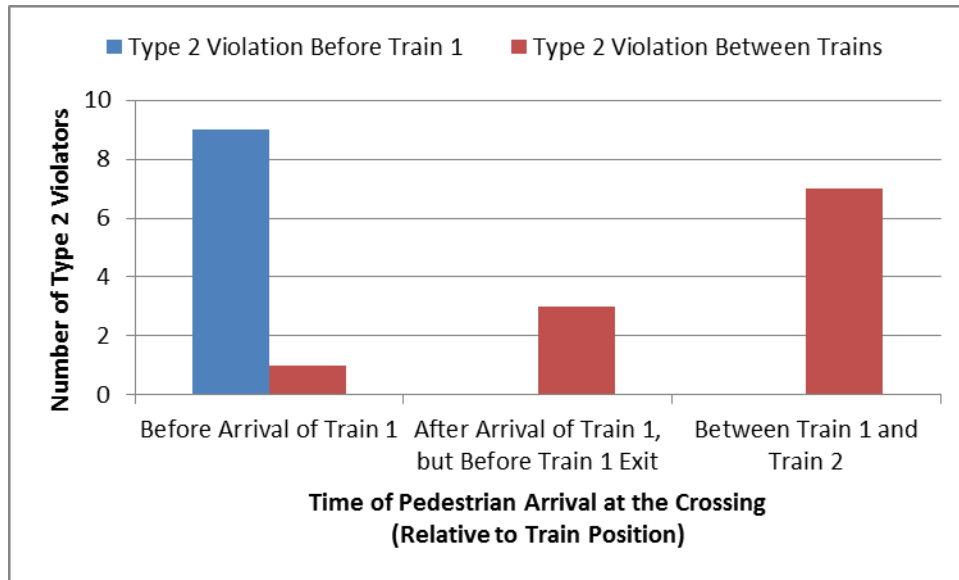
Figure 16. Number of Post-Installation Type 2 Violators by Arrival Time of the Pedestrian at the Crossing

Almost half (45 percent) of the individuals who violated between trains had arrived at the crossing prior to the arrival of the first train. Pedestrian arrivals prior to Train 1 were slightly higher in the post-installation condition (11 [52 percent] after installation compared with 8 [38 percent] before installation). Pedestrians, both before and after installation of the signage, may have had the opportunity to violate prior to the arrival of the first train, but many (and *all* of those in the pre-signage condition) waited until after the first train to violate. Figure 16 provides a more detailed look at the arrival patterns for *only the post-installation* condition by grouping the pedestrians into those who violated before Train 1 and those who violated between Train 1 and Train 2 (Note that arrival times after “Between Train 1 and Train 2” have been removed because no Type 2 violations occurred during these times.).

In Figure 16, those pedestrians in the post-installation period who arrived at the crossing prior to the arrival of Train 1 and went on to violate by going under the gates were most likely to violate before the first train arrived (as opposed to waiting to violate between or after both trains). This was not the case for the pre-installation condition where none of the eight violators who arrived prior to the arrival of Train 1 decided to violate before the first train had arrived.

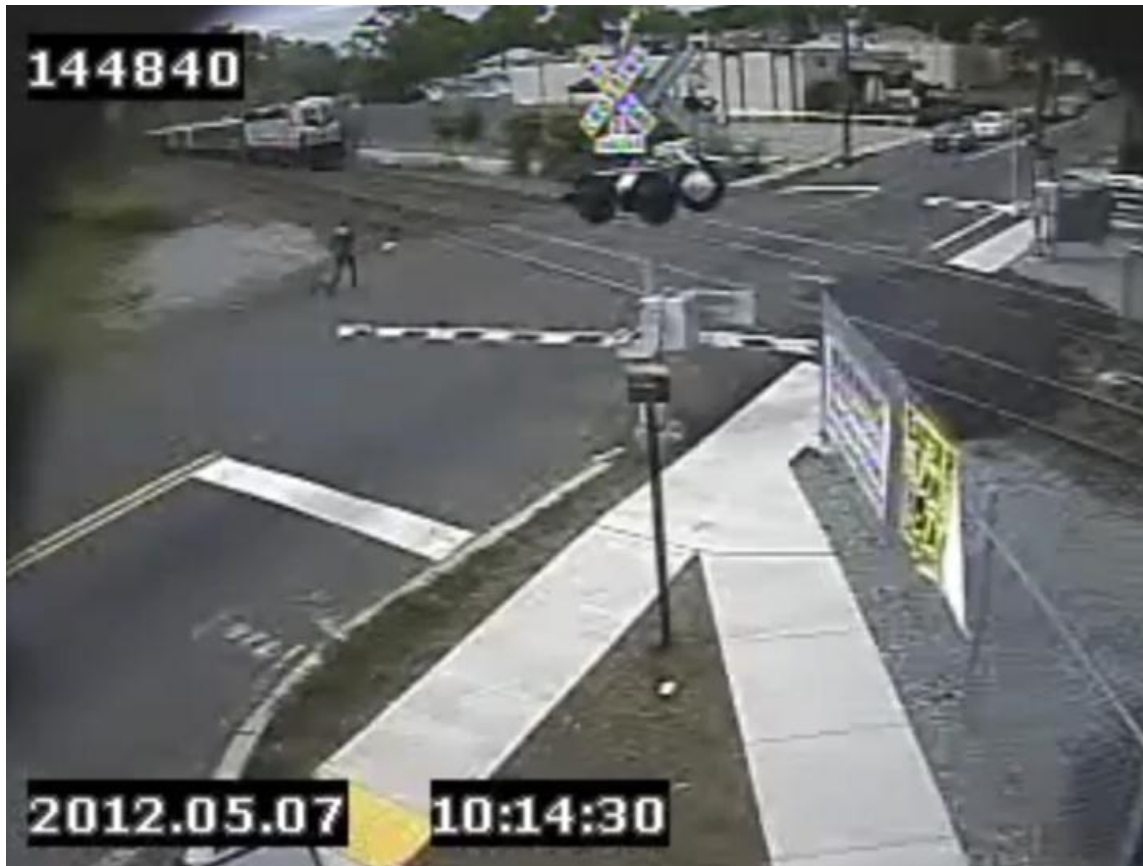
The first image below depicts a pedestrian violating the crossing in the road as a train approaches. This violation occurred prior to the installation of the second train warning system.

Figure 17. Pedestrian Violation Prior to Second Train Warning System Installation
