Railroad Infrastructure Trespassing Detection Systems Research in Pittsford, New York

Highway-Railroad Grade Crossing Safety Research

DOT/FRA/ORD-06/03

Final Report
August 2006

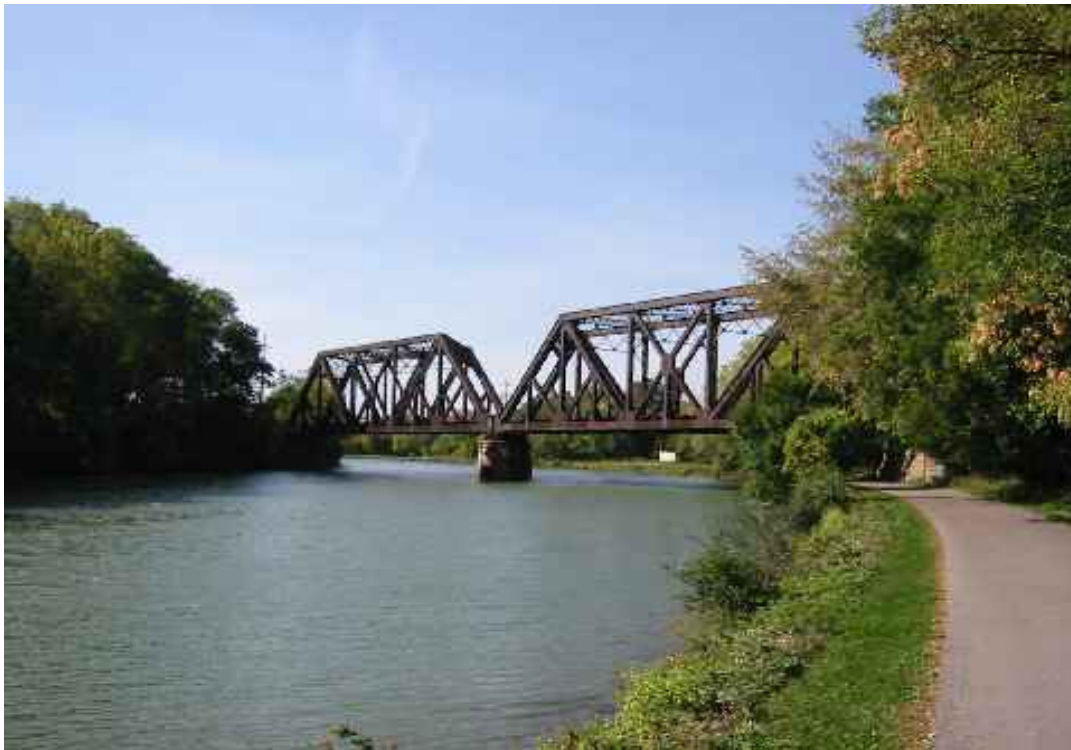
Figure 2. Railroad Bridge Chosen for Demonstration Project

A through-truss railroad bridge built in 1918 and owned by CSX Transportation was chosen for this demonstration project and is shown in Figure 2. The selection of this bridge, located in Pittsford, New York, was based both on the 1997 incident resulting in two trespass fatalities, as well as the bridge's prior trespassing history. Although not documented, teenagers have been historically known to use this railroad bridge as a meeting place, and locals were using it as a shortcut. A pedestrian walkway that passes under the bridge on the eastern approach provides easy access to the bridge. The bridge is also often used as a fishing spot. The bridge itself lies about 800 feet east of the Monroe Avenue railroad crossing and spans the Erie Canal (see Figure 3). It is situated at CSX Milepost 353.4, and the nearest crossing is designated identification number 521097M. The bridge was originally double-tracked, but only one track remains in place. The route serves as a mainline bypass around the city of Rochester and has centralized traffic control. An average of approximately nine freight trains travel over the bridge per day at speeds up to 60 mph. No regular passenger service exists on this line. The canal carries light boat traffic from May through November.

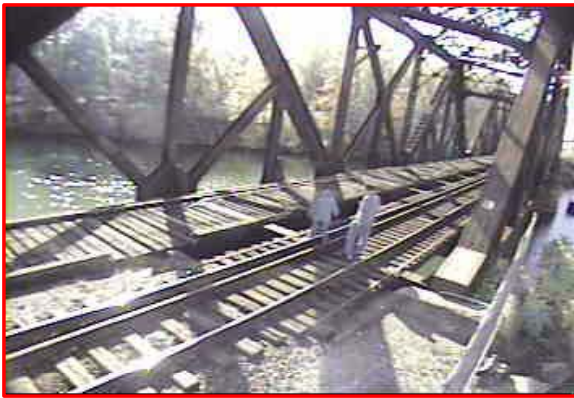
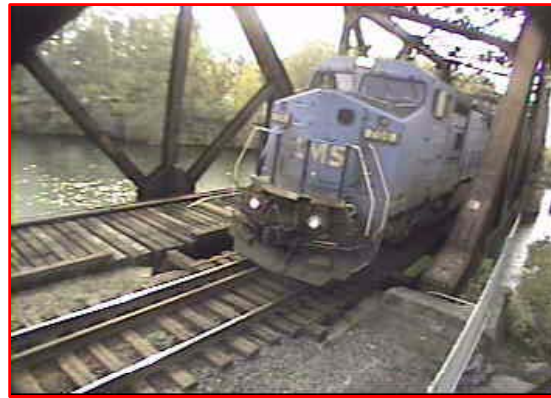
Event 1: At 1:40 p.m. on October 20, 2001, two teens were detected on the east end of the bridge and were subsequently warned by the Doyle Security attendant (Figure 13a). They left the scene, and the system recorded the presence of an eastbound train 1 minute later (Figure 13b).

Figure 13a. Two Trespassers at 1:40 p.m.

Figure 13b. Train at 1:41 p.m.

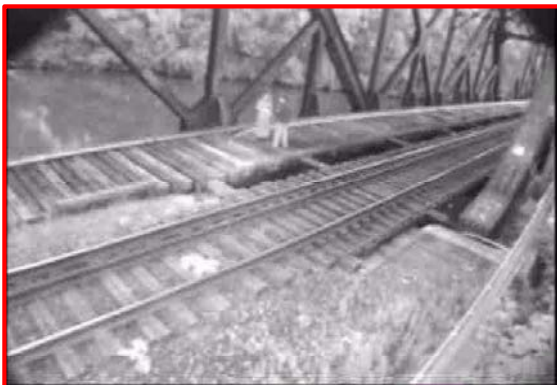
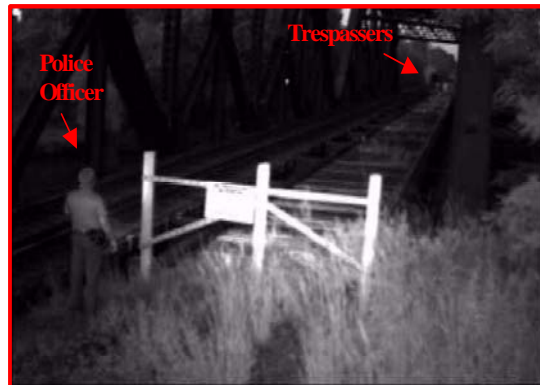
Event 2: At 9:11 p.m. on June 20, 2002, two trespassers were detected on the east end of the bridge (Figure 14a). They were immediately warned by the Doyle Security attendant but did not leave the area. The attendant followed procedures and notified the local police who responded to the scene and physically removed the trespassers from the bridge at 9:28 p.m. (Figure 14b). The detection system then recorded the presence of a train 5 minutes later (Figure 14c).

Figure 14a. Two Trespassers at 9:11 p.m.

Figure 14b. Police at 9:28 p.m.

Figure 14c. Train at 9:33 p.m.

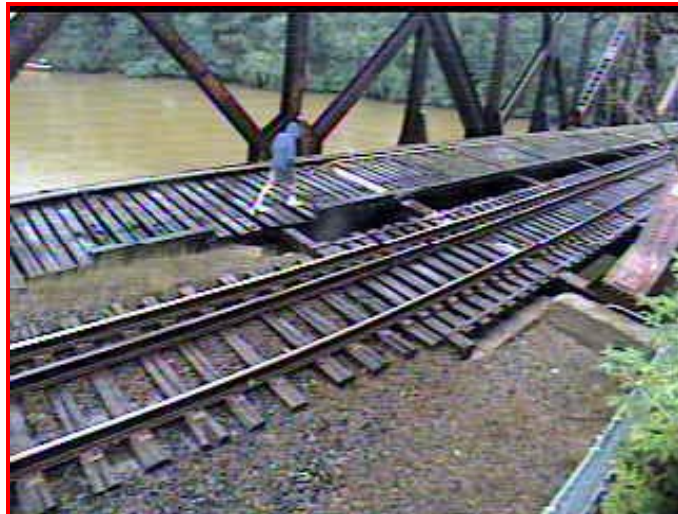
Figure 15. Trespasser Detected at 6:28 a.m.

Event 3: At 6:28 a.m. on September 8, 2004, one person was detected on the east end of the bridge and proceeded to walk across the bridge. The Doyle Security attendant subsequently warned the trespasser. He/she left the scene and the Doyle Security attendant noted the presence of a train immediately after.
