**Federal Railroad
Administration**

Assessment of Rail Seat Abrasion Patterns and Environment

1. AGENCY USE ONLY (Leave blank)		2. REPORT DATE May 2012	3. REPORT TYPE AND DATES COVERED Technical Report	
4. TITLE AND SUBTITLE Assessment of Rail Seat Abrasion Patterns and Environment			5. FUNDING NUMBERS DTFR53-00-C-00012 Task Order 246

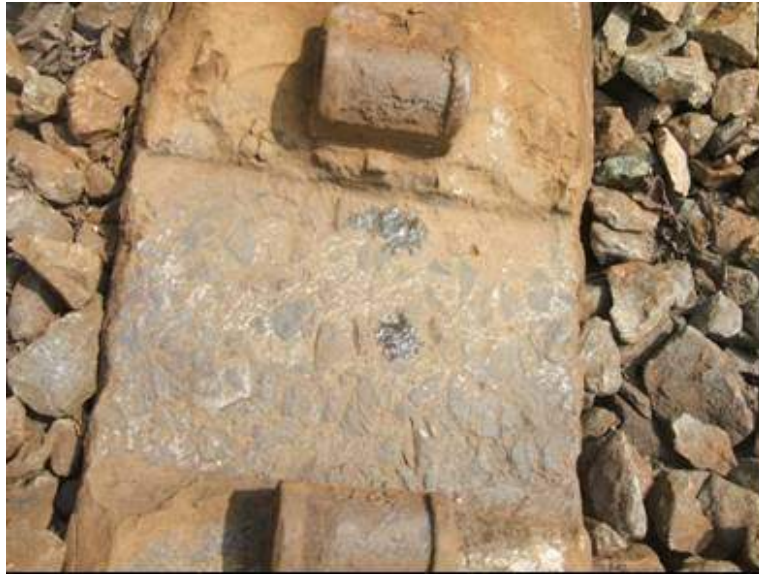
RSA of concrete ties is manifested by the loss of material under the rail seat area and reduction of rail clip holding power. This condition, especially at its onset, is difficult to detect visually. Severe abrasion can result in loss of clip toe load, rail tipping (cant), and wide gauge and can cause derailment. Figure 1 shows an example of severe RSA.

Figure 1. Example of Severe RSA

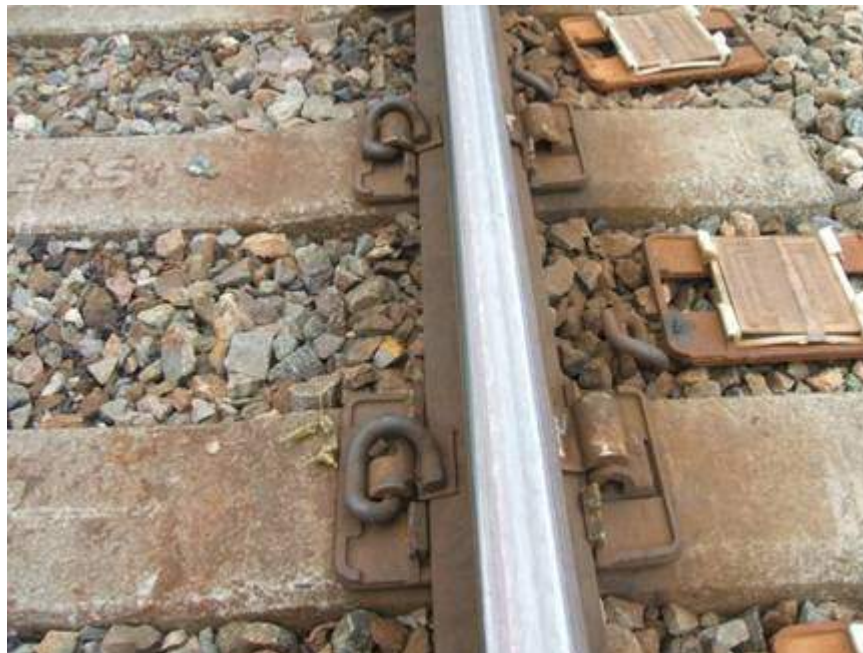
Figure 2. Example of Ties Reported to Have RSA, but with Rail in Place It is not Feasible to Measure RSA Depth

(New replacement rail pads are in ballast next to ties in preparation of RSA repair.)

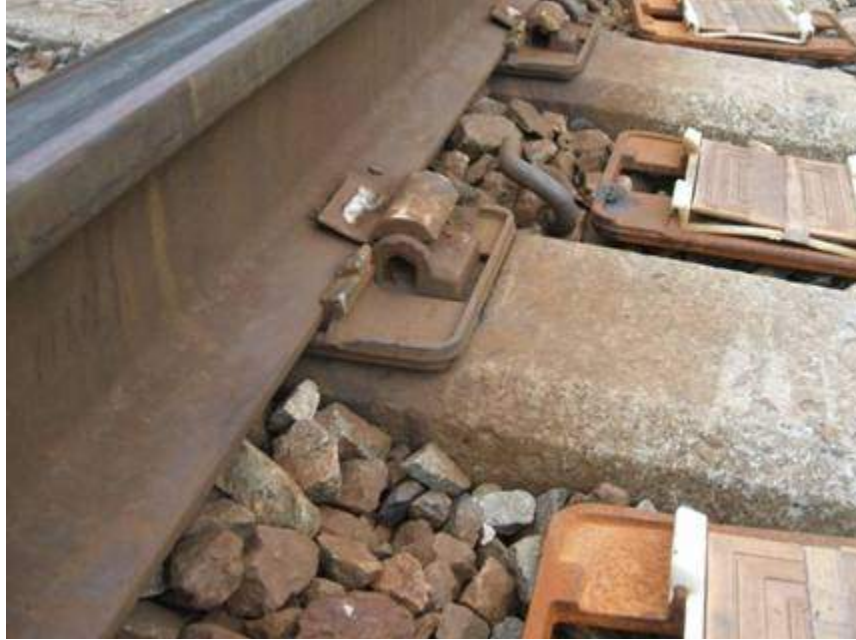
Figure 3. Another View of the Same General Location as Shown in Figure 2; Ties Reported to Have RSA, but with Rail in Place It is not Feasible to Measure RSA Depth

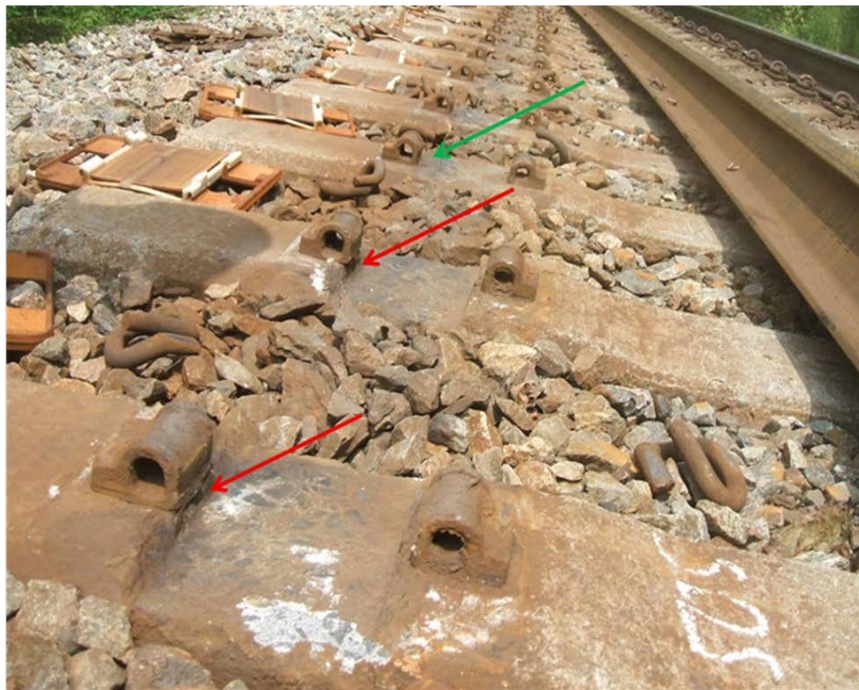
Figure 4. Example of Ties Shown in Figures 2 and 3 with Rail Removed, Showing Depth of RSA

(Note that RSA depth is not uniform from tie to tie. The red arrows show that the two nearest ties have RSA undercutting the fastener clip, whereas the green arrow shows that the third tie has much less RSA and no undercutting.)

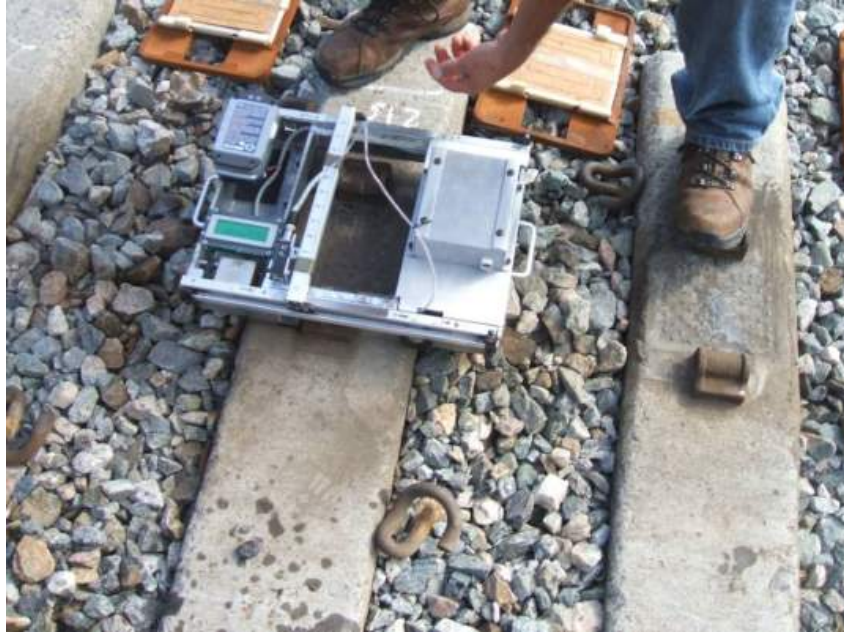
To aid in RSA depth and shape measurements, TTCI fabricated a prototype laser trace fixture that measures the RSA depth around the edge of the rail seat, as Figure 5 shows.

Figure 5. Automated RSA Profile Data Collection System Prototype Used to Collect the Perimeter Depth and Pattern of RSA

The automated laser device was a prototype and was not sufficiently robust to withstand field test environments and handling. Rain or moisture easily damaged controls and electrical systems, and it was too cumbersome to rapidly collect data. In addition, the large size and relatively small triangular-shaped base of the machine led to problems, because it tipped during the measurement process and created data errors. To supplement the automated system, manual measurements were utilized by using a flat template and dial indicator gauge. Figure 6 shows the template used in the manual system.

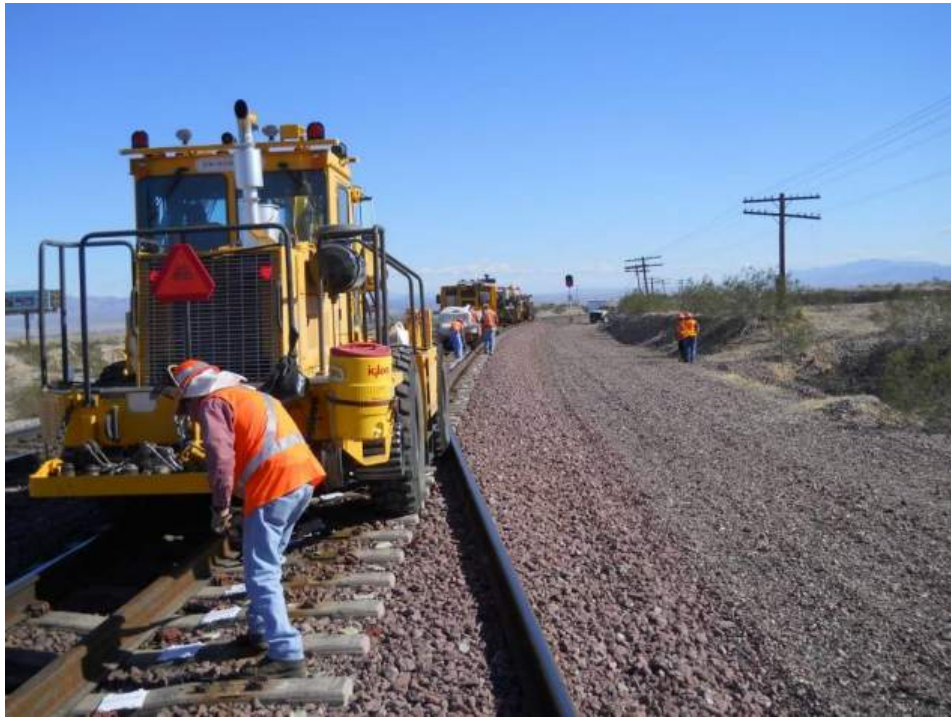
Figure 7. Typical Maintenance Gang Conducting a Rail Change and RSA Repair
(Existing, old rail is being removed and set to the field (outside, right) side of track.
Note new rail has already been placed in the center of the track.)

1. Unclip fasteners from both sides of the rail being lifted
2. Lift and slide rail to one side or the other (Figure 7)
3. Follow with a crew removing existing rail pads, then clean rail seats (Figure 8)
 - a. NOTE: At this point, rail seats are exposed and could be measured for RSA depth and photographed (Figures 9, 10)
4. Apply repair epoxy when RSA is of sufficient depth
5. Install new rail seat pads
6. Reinstall rail (or if a rail change, install new rail)
7. Adjust rail for proper longitudinal stress and reclip

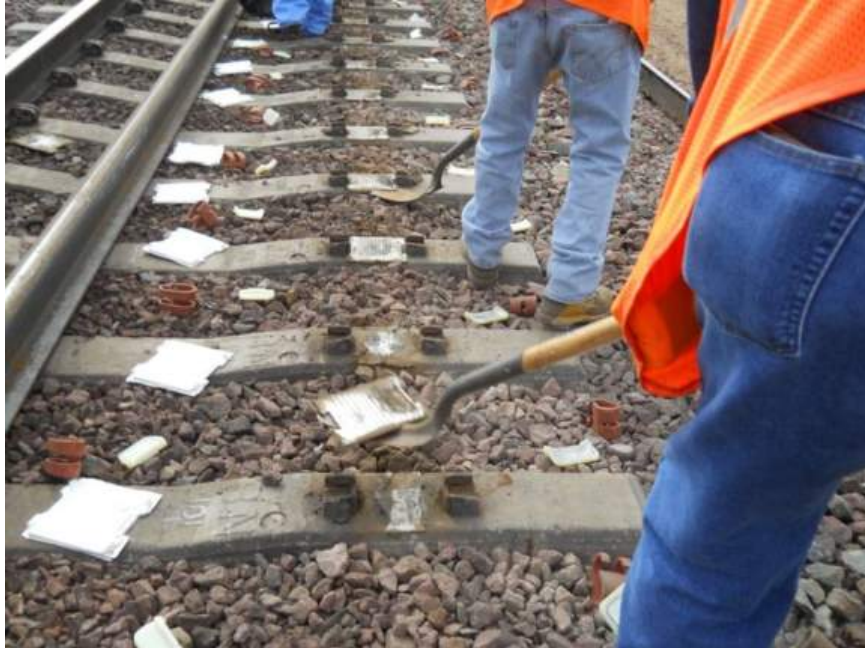
Figure 8. Following the Rail Removal (Figure 7), Old Pads Are Removed and the Rail Seat Is Scraped Clean

(Note new pads, insulators, and clips have been distributed. At this stage, RSA *cannot* be measured due to logistics and work space conflicts.)

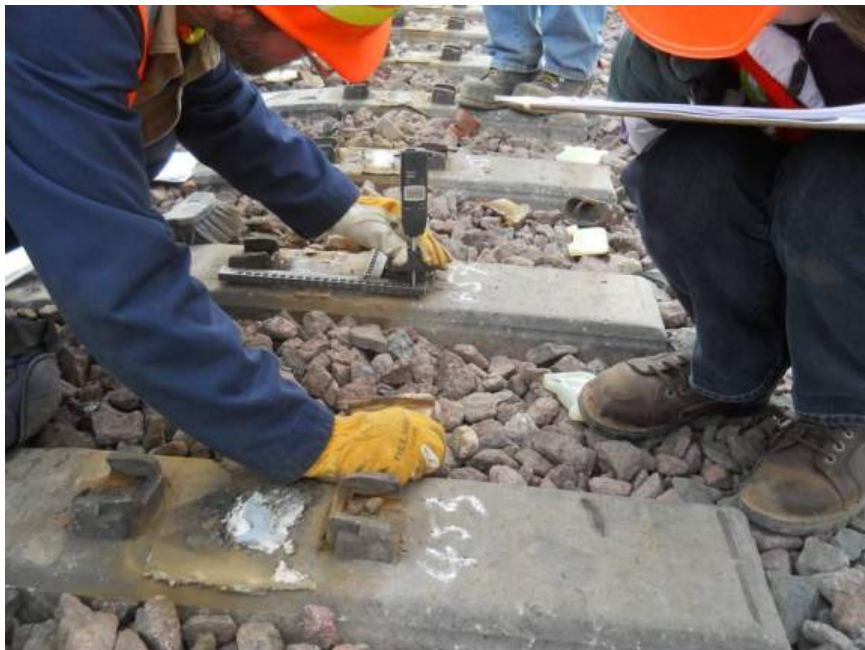
Figure 9. After Old Pads Have Been Removed, the Rail Seats Are Exposed

(The manual RSA measuring template and dial indicator are placed in position, and dial indicator readings are collected. In this photo the field (outside) of the rail seat is being measured.)

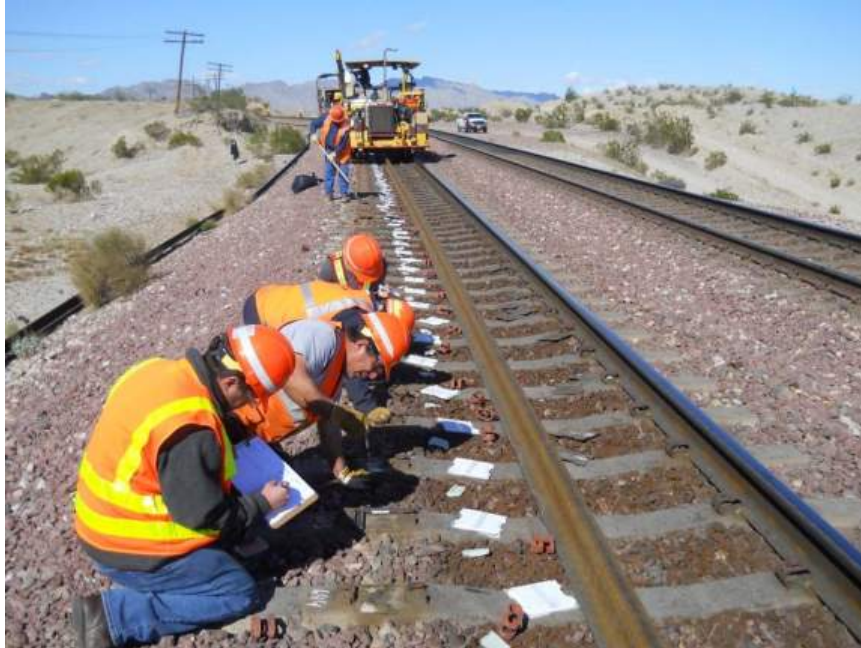
Figure 10. View from Figure 9 Looking Back to the Machine Repairing Rail Seats and Placing Pads in Position

(At this location, two RSA measurement groups are monitoring rail seat conditions, working in tandem. The “working window” for measuring RSA is from this site to about 30 feet (ft) toward the machine in this photo. Because the new rail in the center of the track is being placed into the rail seats directly behind the machine in the background, it is not safe to work more than 30 ft from this location.)

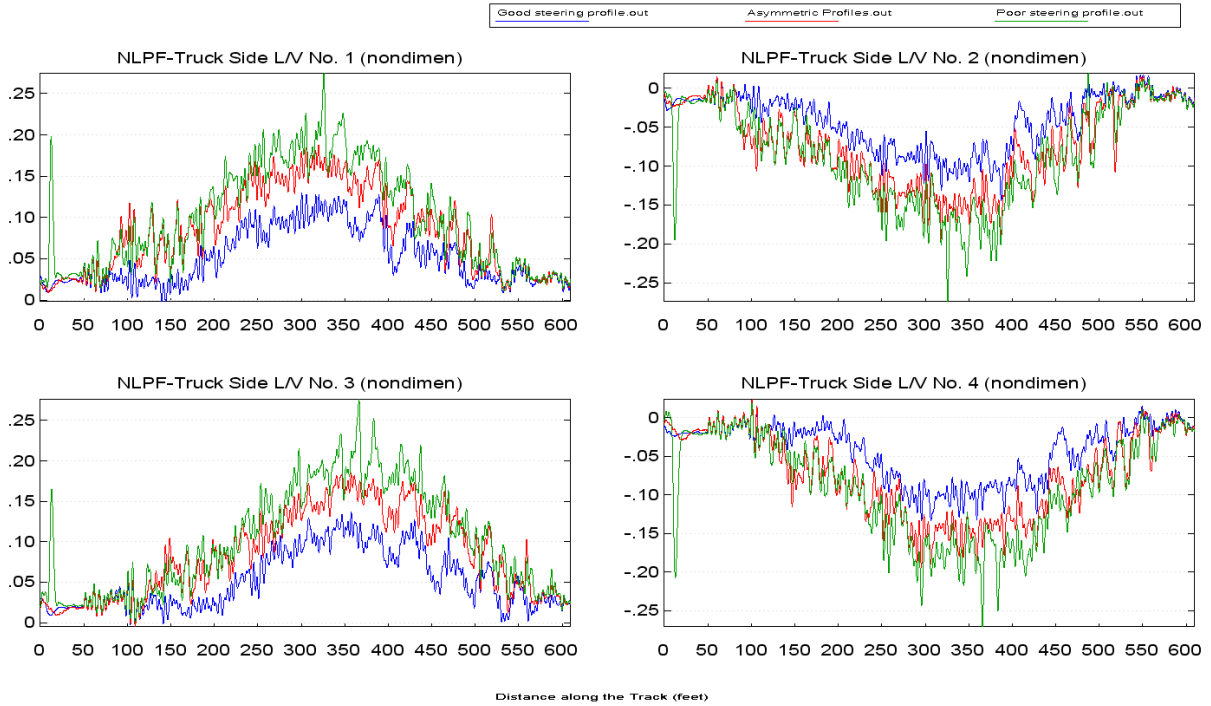
Wheel profiles were measured on four typical coal hoppers that ran over the St. Albans site. Figure 11 shows the results of NUCARS trial simulations conducted with some of these different profiles. It can be seen that different wheel profiles can generate different levels of wheel/rail forces, although the trends of higher L/V ratios in the body of the curve are the same. From these trial simulations, the wheel profile that generated the largest truck side L/V ratios was selected for use in all further simulations. The truck side L/V ratio was selected as the primary performance parameter, because it represents the combined effect of two adjacent axles acting on the rails.

Figure 11. Example Comparison of Truck Side L/V Ratios from NUCARS Simulations Using Different Combinations of Wheel Profile Measurements

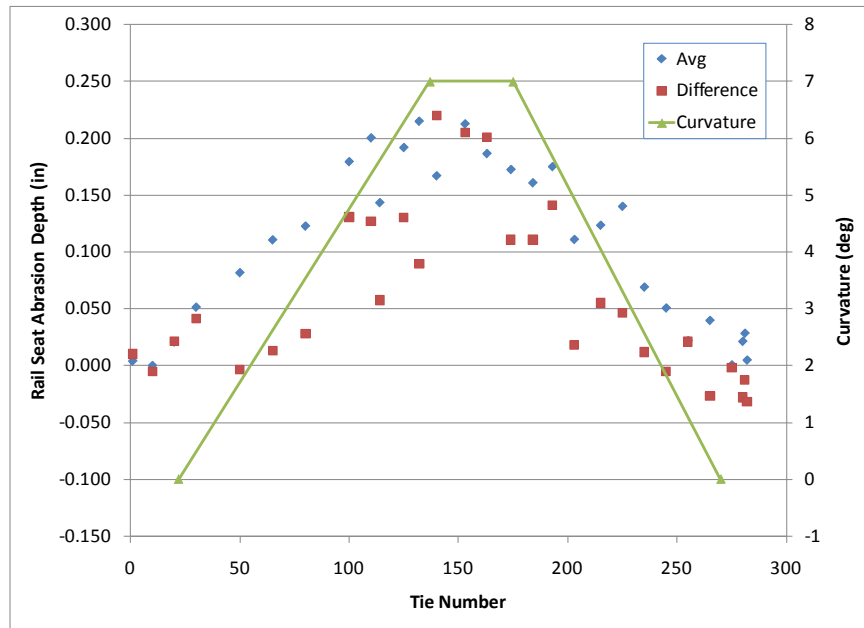
Figure 13. Low Rail MP 16.78–16.68; This Curve Shows a Very Clear Relationship between Track Curvature and RSA Depth

Figure 13 through Figure 15 show the abrasion data collected in the curves at MP 16, MP 17, and MP 19, respectively. These curves were measured with the more accurate manual gauge. The other three curves were measured with the automated system only. The first 208 ties of the curve at MP 19 were measured with the automatic machine until rain damaged the equipment. A large amount of scatter in that part of the plot is apparent (Figure 15). A similar amount of scatter was seen in the other three curves. Because of this, results from those curves are not shown. In Figure 13 through Figure 15, the *Average* is the aggregated value of the RSA depth measurements taken on the rail seat. Positive values indicate wear into the tie. The *Difference* is the average of the data from the field side of the rail seat minus the average of data from the gauge side of the rail seat. The abrasion measurements are referenced to the original cant of the rail seat. Therefore, a difference value of zero indicates no rail roll, but the rail will be canted to the angle that was built into the rail seat. A positive difference indicates abrasions that would tend to cause the rail to roll (cant) outward relative to the original rail seat and a negative difference would cause the rail to roll (cant) inward.

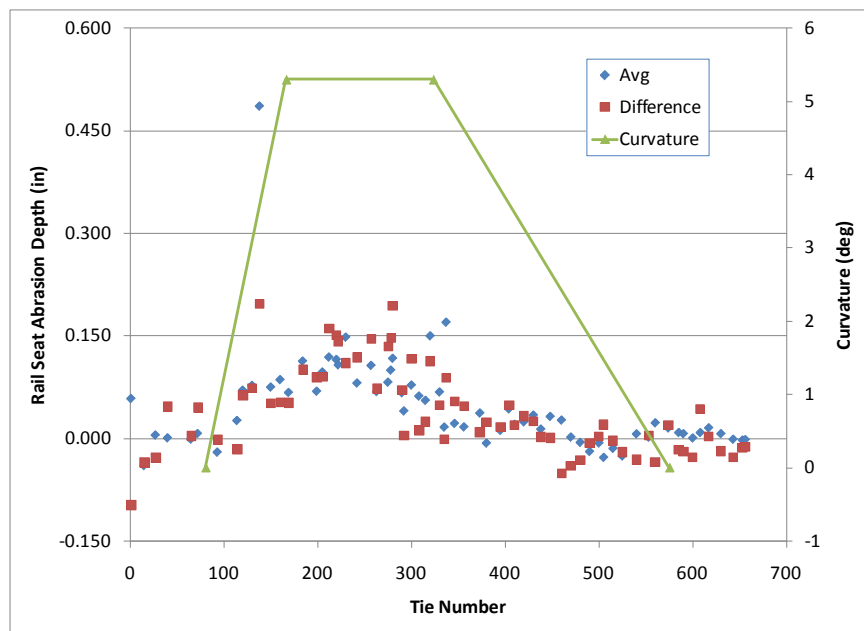
Figure 14. High Rail MP 17.49–17.3, although Less Distinct Than the Curve at MP 16; This Curve Shows a Correlation between Curvature and RSA Depth

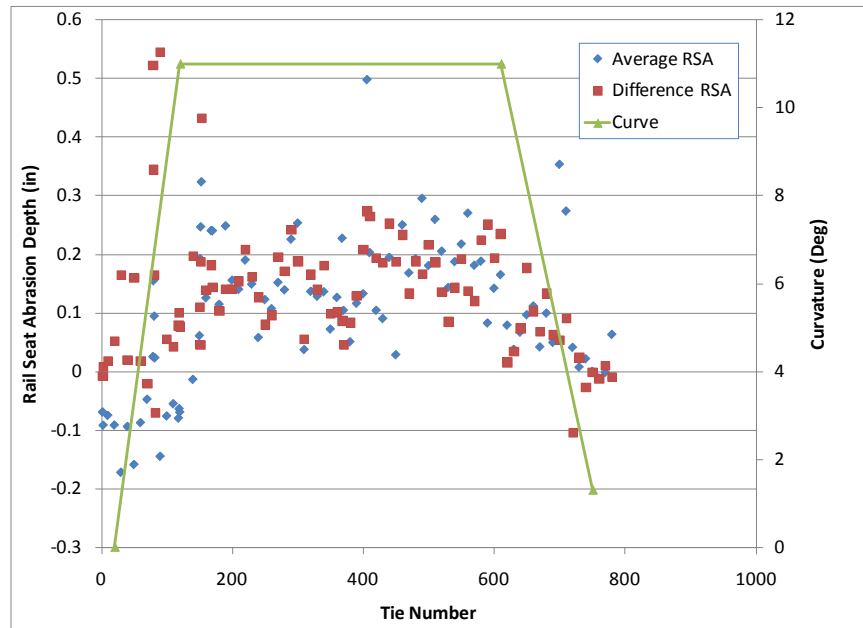
Figure 15. High Rail MP 19.7

(The first 208 ties in the spiral and beginning of curve were measured with the laser trace machine before wet weather damaged it, and the rest of the ties were measured with the manual gauge. The larger scatter apparent in the laser trace machine data is thought to be to the result of the large machine tipping on its relatively small triangular base.)

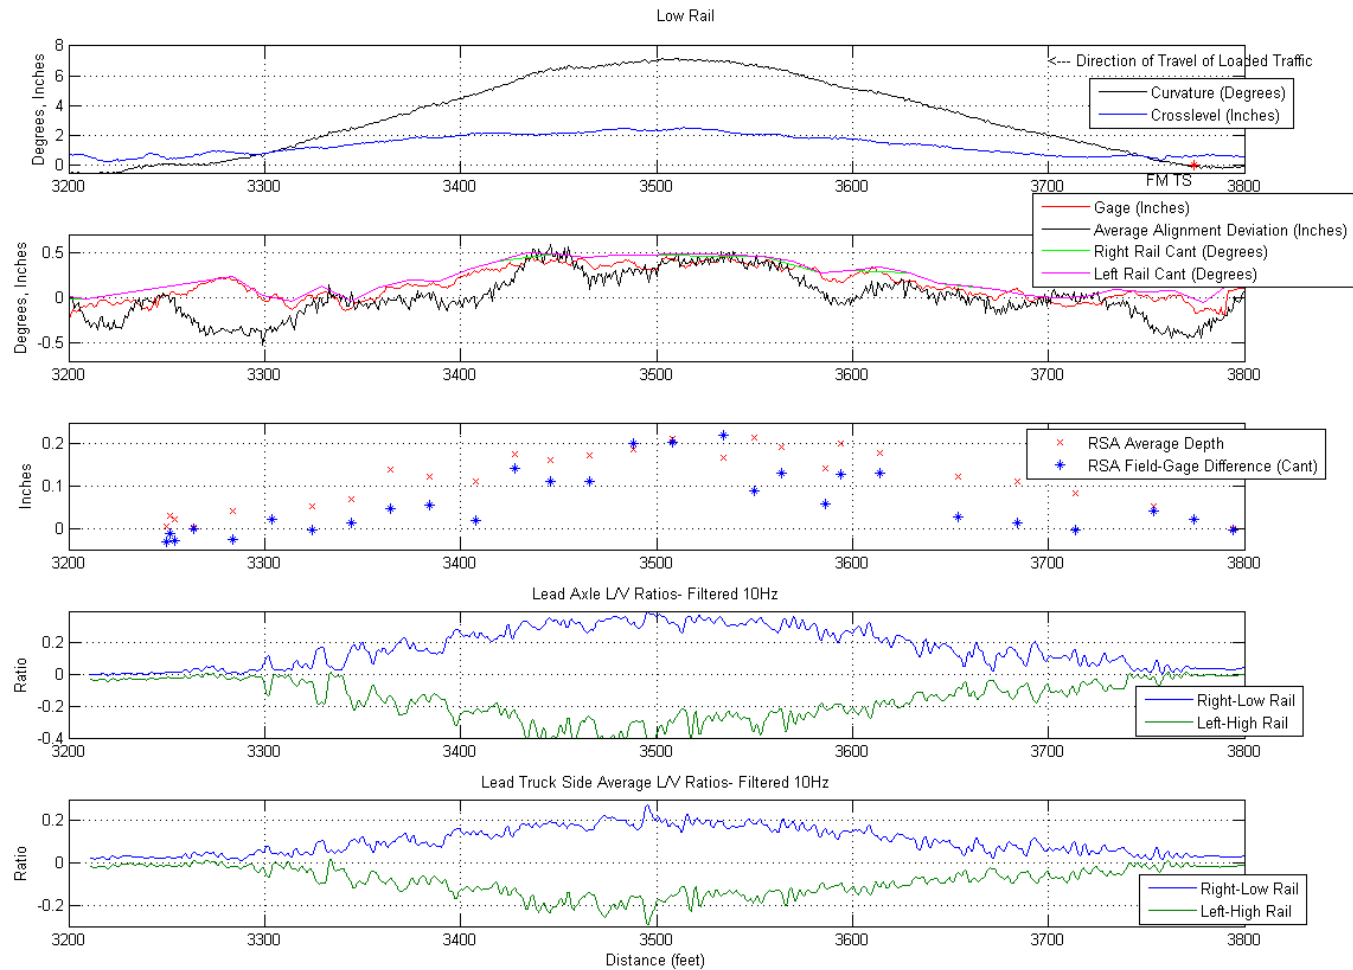
The track geometry data (curvature, superelevation, alignment, and gauge) was used as input to the NUCARS simulations. The fourth and fifth graphs show the NUCARS predictions of lead axle single wheel L/V ratios and lead truck side L/V ratios, which were performed with the assumption of dry rail (rail friction coefficient of $\mu = 0.4$). In this graph, a positive L/V ratio on the right rail and a negative L/V ratio on the left rail represent gauge-spreading forces. Note that in actual practice the friction coefficients in this curve are probably different as a result of the presence of track lubricators in the vicinity, which would result in somewhat different forces and dynamic response. However, friction levels were not measured.

Figure 16. Curve Data for MP 16; Distance along Curve Measurements and Predicted Car Performance of a Loaded Hopper
 (Top to bottom shows curvature and superelevation, measured RSA average depth and difference, track geometry data, predicted lead axle L/V, and predicted lead truck side L/V.)

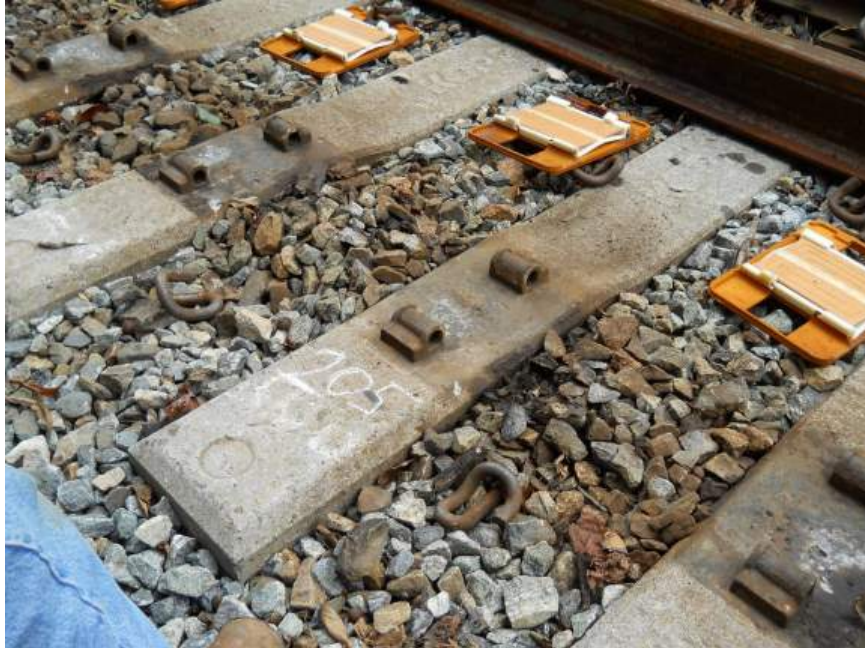
Figure 23. Curve 17, Typical Rail Seat Conditions near Tie 205

(Ties measured with Tie 0 at the beginning of the curve in direction of loaded traffic, located at approximately 2,150 ft.)

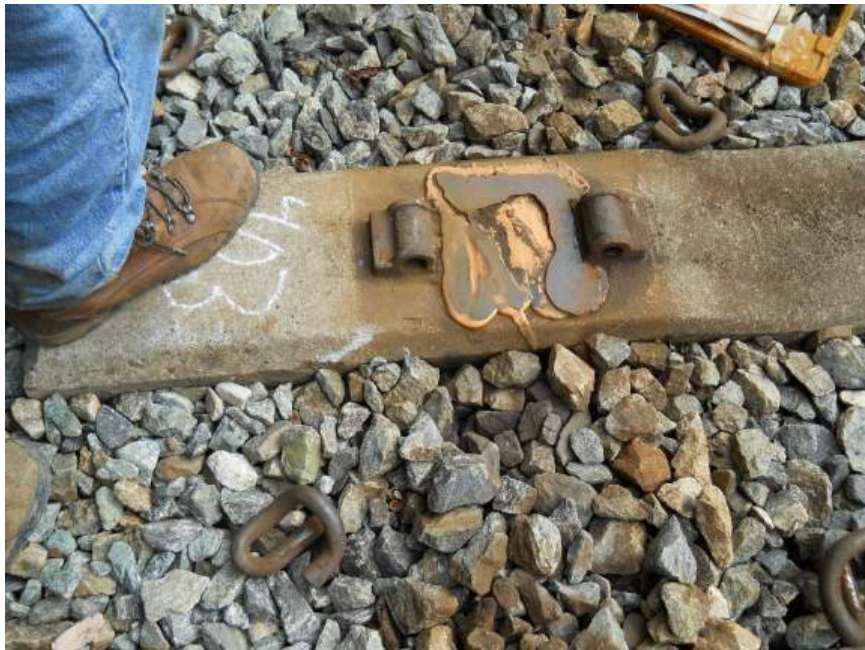
Figure 24. Curve 17, View of Rail Seat Previously Repaired

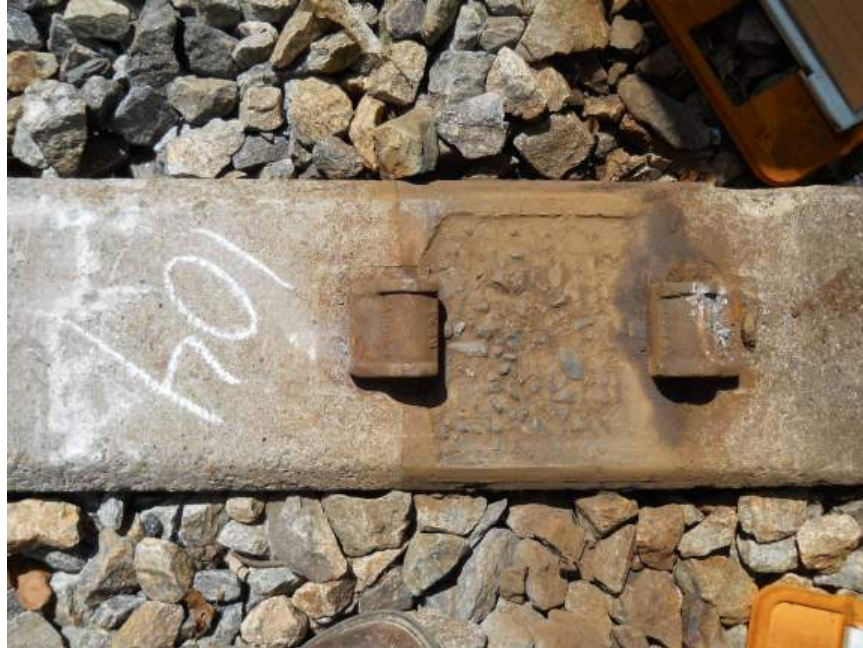
Figure 25. Curve 16, Tie 104, Left Is Field Side, with More RSA Depth on the Field Side of the Rail Seat, and It Results in Outward Tilt (cant) of the Rail

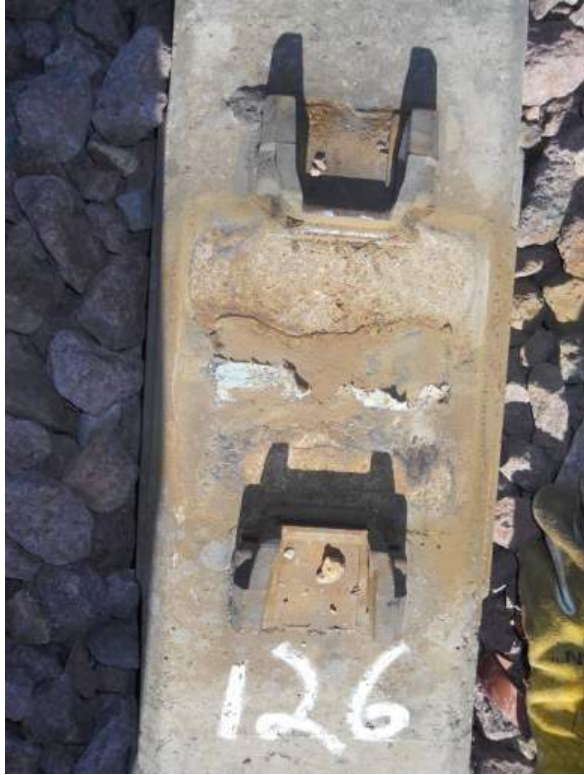
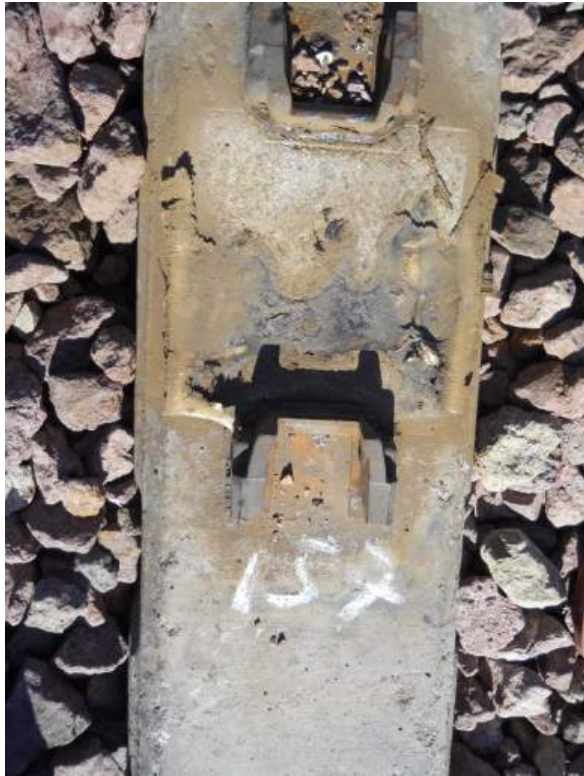
Figure 31. MP 584.5 Typical RSA in Curve, Tie 126, and Tie 157
(Gauge side is at top of photo and shows gauge side with deeper abrasion than field side, confirming inward tilt (cant).)

(RSA difference is negative in the curve, indicating inward cant (tilt). Photos (Figure 31) confirm this inward tilt. Note that there is a block signal, with insulated joints, both rails near midcurve, near Tie 205.)

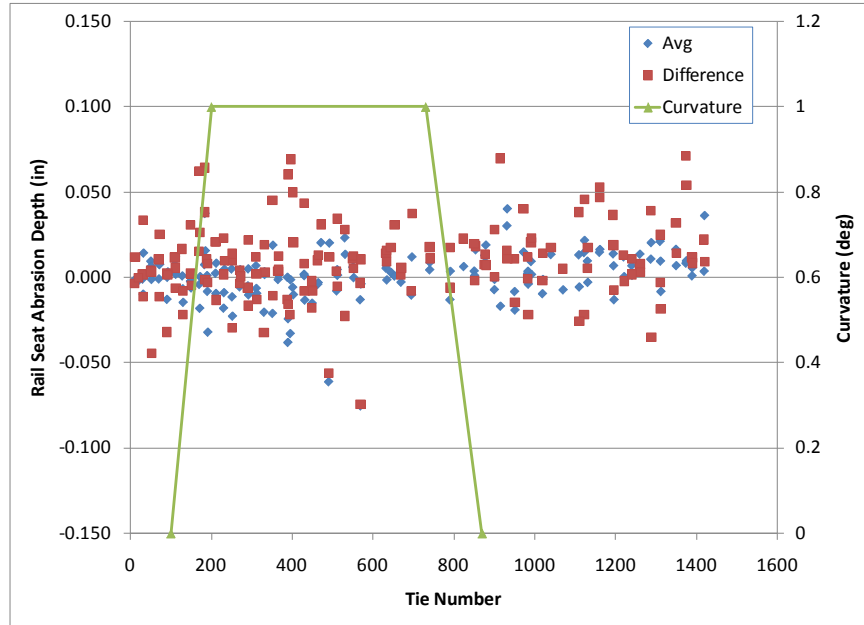
Figure 38. Alliance Curve between MP 12.96 and MP 12.62, Average RSA and RSA Cant, High Rail

Figure 37 through Figure 40 show the RSA measurements from the four curves. All of these plots use the same scales as those at the Needles site. The data shows that no severe RSA is in any of the curves measured at the Alliance site.

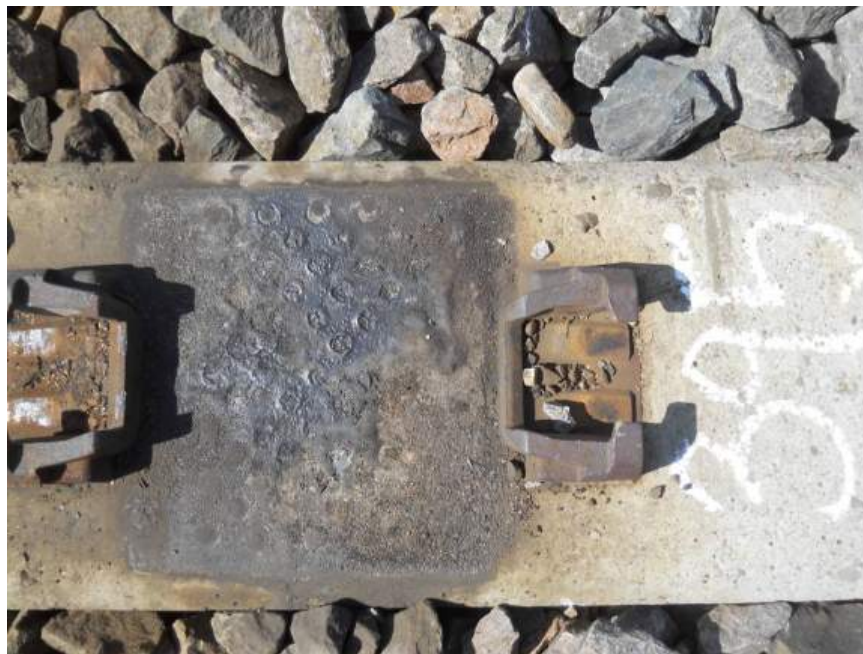
The Alliance curve at MP 12.8 seemed to have more abrasions than the other three curves measured. Good examples of abrasions are close to Tie 396. Figure 41 to Figure 43 show Ties 395, 396, and 401, respectively. Although these ties do not have deep RSA, they do show the rough texture of the onset of abrasion, especially at the field side of the rail seat.

Figure 41. High Rail Seat of Tie 395 on Curve at MP 12.8

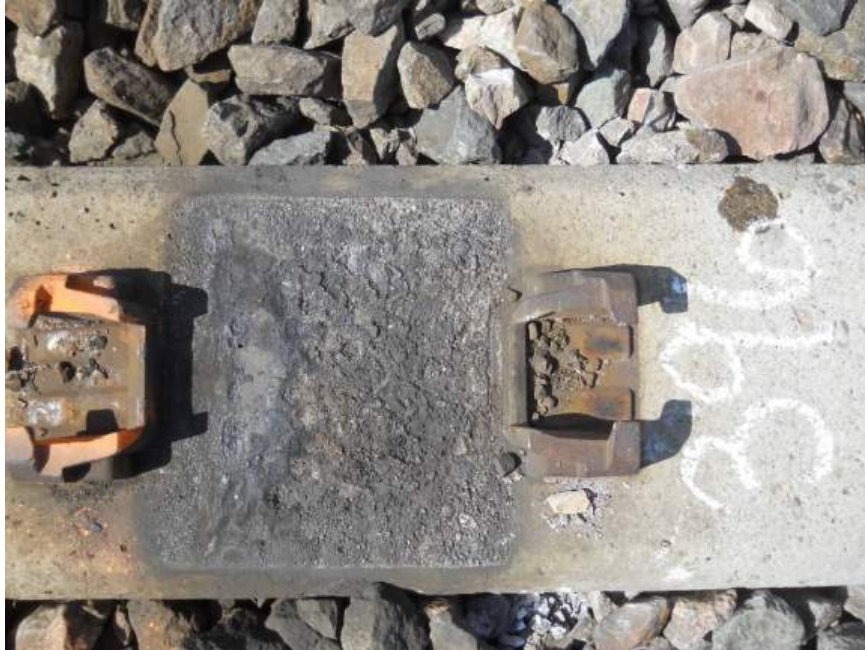
Figure 42. High Rail Seat of Tie 396 on Curve at MP 12.8

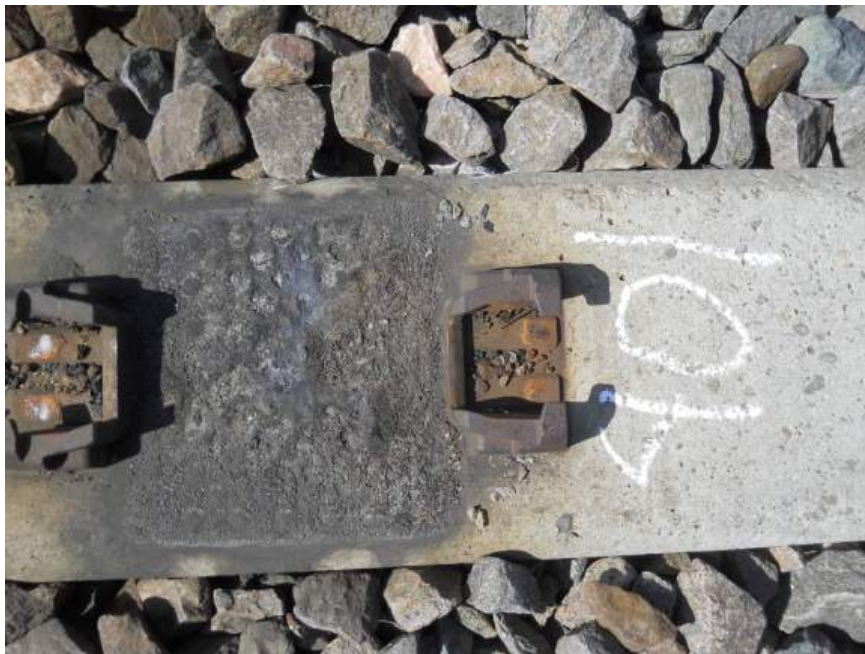
Figure 43. High Rail Seat of Tie 401 on Curve at MP 12.8
