Rolling Contact Fatigue: A Comprehensive Review

1. AGENCY USE ONLY (Leave blank)		2. REPORT DATE November 2011		3. REPORT TYPE AND DATES COVERED Technical Report	
4. TITLE AND SUBTITLE Rolling Contact Fatigue: A Comprehensive Review				5. FUNDING NUMBERS DTFR53-05-H-00203

6. AUTHOR(S) Eric E. Magel				8. PERFORMING ORGANIZATION REPORT NUMBER	
7. PERFORMING ORGANIZATION NAME(S) AND ADDRESS(ES) Centre for Surface Technology 2320 Lester Road, Ottawa, Ontario K1V 1S2, Canada				10. SPONSORING/MONITORING AGENCY REPORT NUMBER DOT/FRA/ORD-11/24

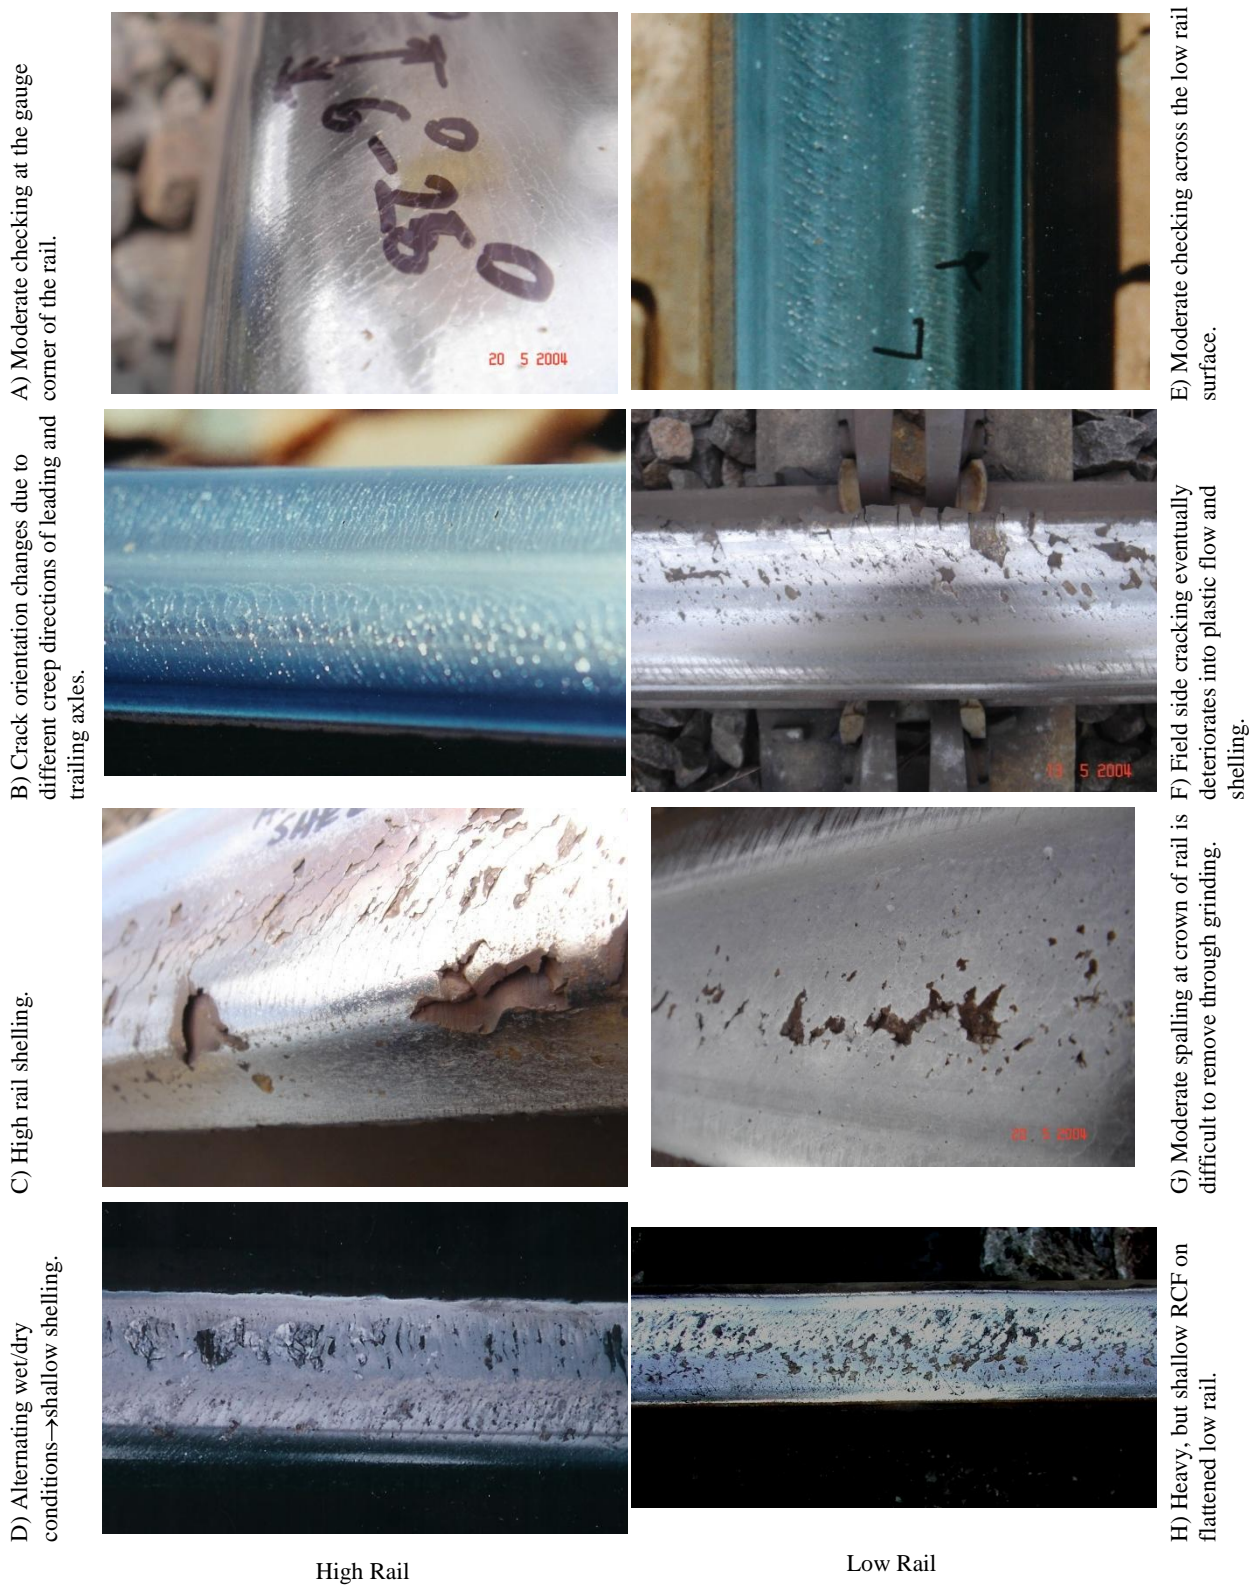
As GCC progresses, the cracks grow longer and deeper into the component and may eventually lead to pits and shells on the rail surface. Figure 3 shows examples of the different stages of crack growth on rails.

A) Moderate checking at the gauge corner of the rail.

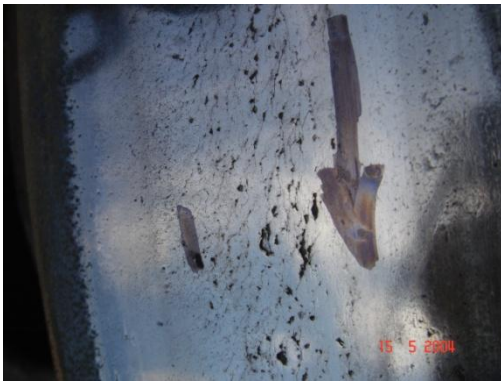
C) Well-defined cracks on the field/rim side of the wheel.

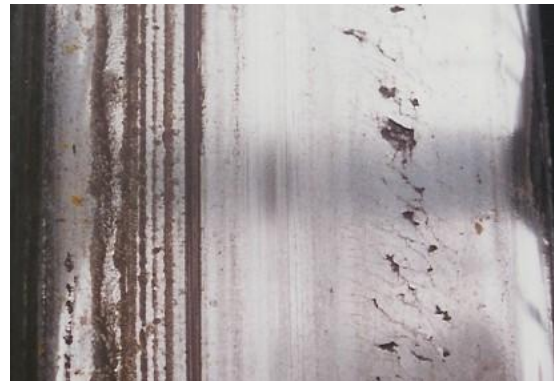
D) Deeper cracks on the field/rim side of the wheel tread with material starting to shell out.

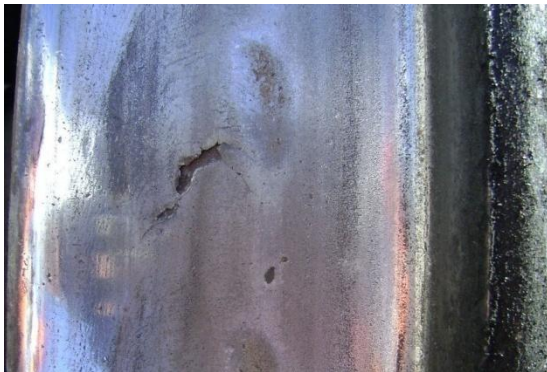
E) Incipient shells initiating at the field/rim side of the wheel.

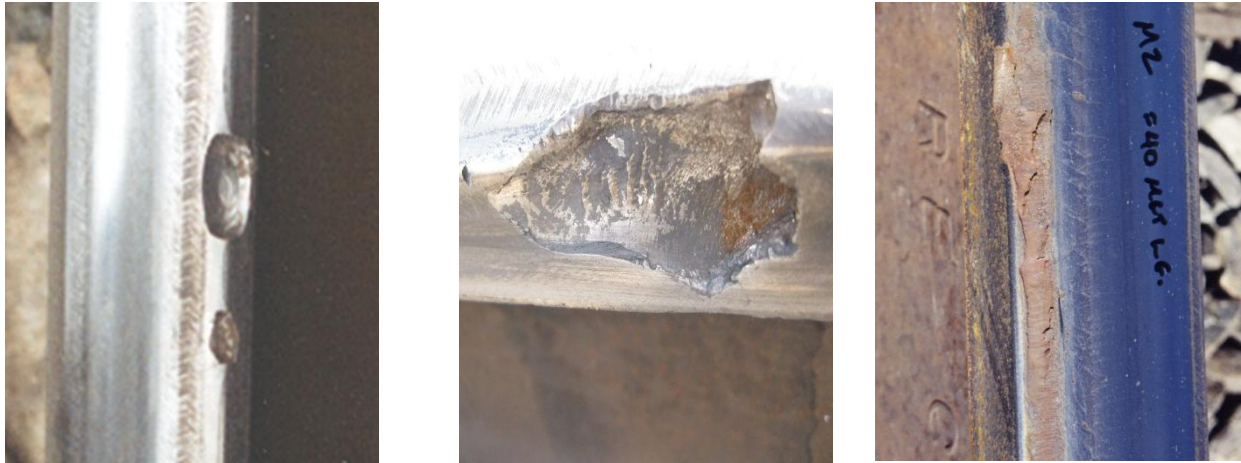
Poorly restrained high rails that rotate outwards under load (Figure 8A), well-lubricated rail with a particularly high-stress gauge corner shape (Figure 8B), and even some dry rails (Figure 8C) see large chunks of metal slough from the gauge corner. The most effective treatment for this is ensuring the implementation and maintenance of proper rail shapes that eliminate the overloading, reducing the stress for each contact and distributing contacts over a wider portion of the railhead. Modeling the system as a quarter space (see Section 2.1.2.1) found that in practice it is necessary to minimize the number of wheels that touch the railhead within three-eighths of 1 inch (9 mm) of the gage face to avoid gauge corner collapse.

A) Loss of rail cant due to rail seat abrasion resulted in overloading of the gauge corner B) Well-lubricated rail with a sharp gauge corner C) Gauge corner collapse in a dry environment

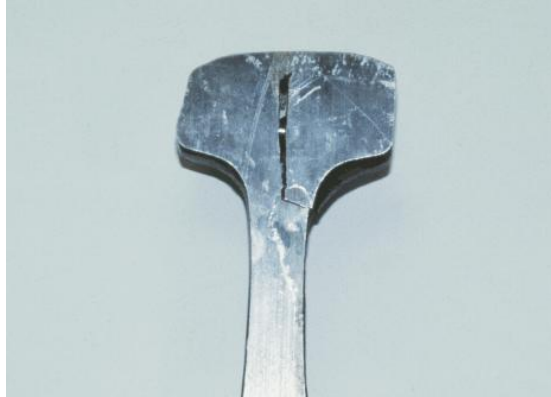
Figure 11. Vertical Split Head Defect

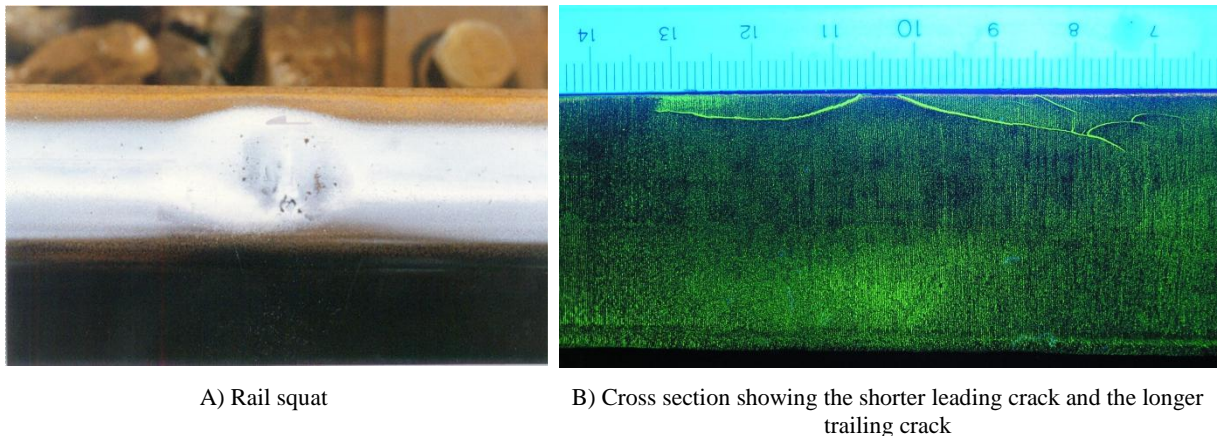
The squat is a surface defect most commonly associated with high-speed rail and areas of high tractive effort. It is characterized as a shallow depression more or less in the center of the rail head on tangent and mildly curved track. This depression is the result of subsurface cracking, reduced strength of the material, and deposits of debris in that depression, giving it the appearance of a dark spot.

A) Rail squat

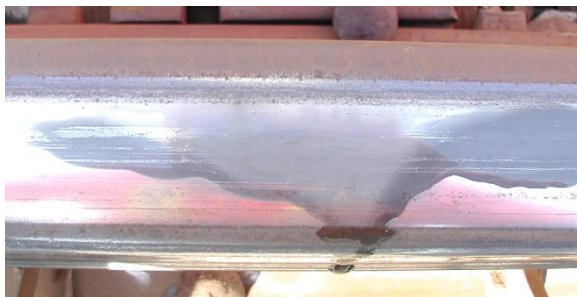
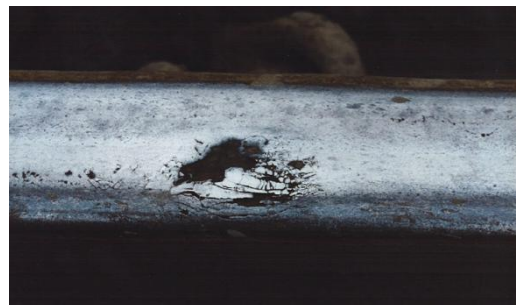
On the rail, a completely analogous effect arises because of the spinning of the wheel on the rail. High tractive effort can leave a more or less continuous thin layer of martensite on the surface of the rail, which has been postulated as the causal mechanism of rail squats (see Section 1.3.5). On a macroscopic scale, a wheel burn is a deep layer of martensite that, upon subsequent wheel passes, develops a whole network of surface cracks, any one of which might be the cause of a broken rail.

A) With a perchlorate etchant

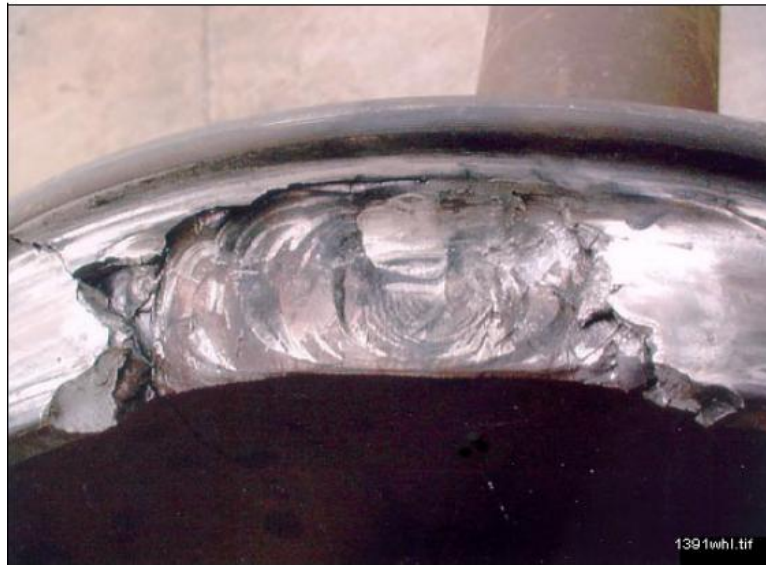
The shattered rim crack usually initiates approximately 12–20 mm below the running surface and then propagates roughly parallel with the wheel tread, eventually exiting out the rim side of the wheel. If a rim crack is discovered, then the wheel can be removed proactively; otherwise, a section of the wheel rim can separate from the wheel [262]. Many shattered rim failures develop early in wheel life—more than half fail within the first 10 percent of available rim thickness and more than 90 percent of the failures occur within the first 50 percent of the available wheel thickness.

Figure 16. A Shattered Rim Failure [262]

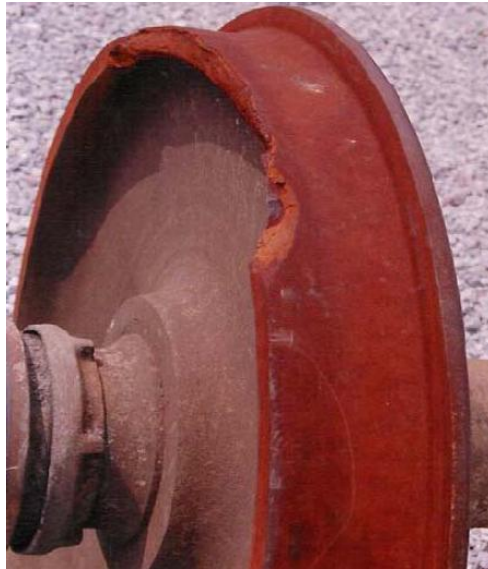
Less commonly, a length on the flange side can break from the wheel.

Figure 17. A Typical Vertical Split Rim [260]

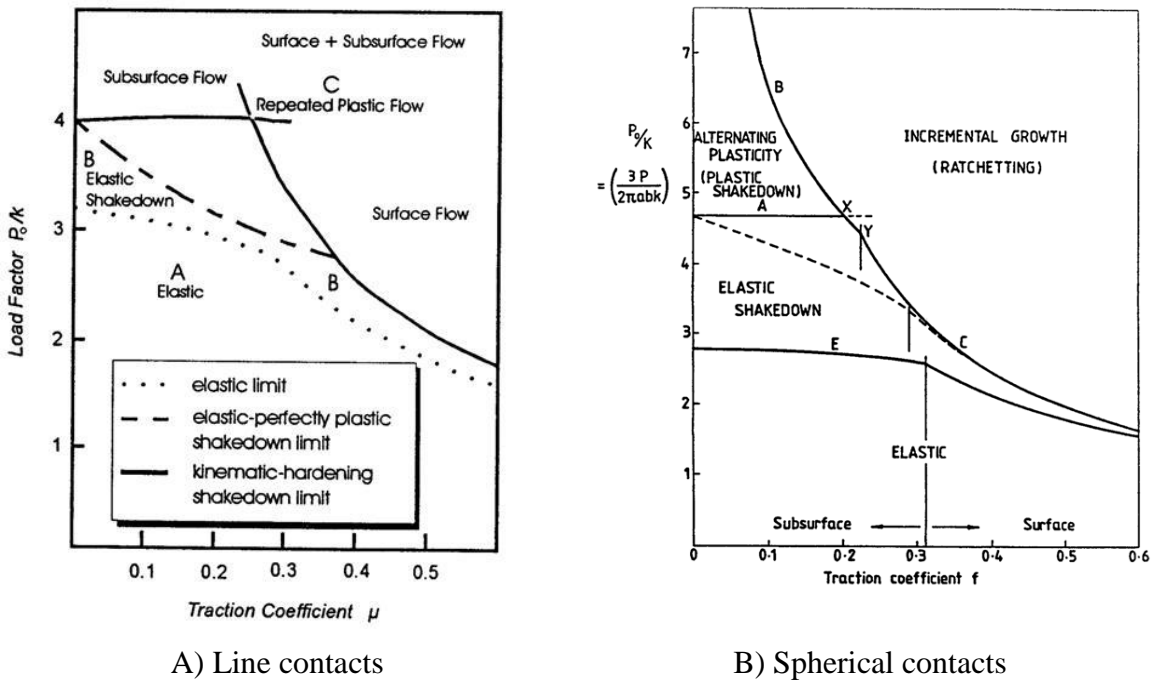
Figure 23. Shakedown Diagrams for A) Line and B) Spherical Contacts [108]

The values of the principal stresses in the longitudinal plane, τ_{xz}/P_o versus $(\sigma_{xx} - \sigma_{zz})/2P_o$, are plotted in Figure 21. Johnson refers to these as the stress trajectories. This plot represents the deviatoric (the dynamic or nonhydrostatic) stress cycle that an element of material on ($z/a = 0.0$) or below (e.g., $z/a = 0.5$) the surface encounters because of the passing wheel load. If that stress cycle can be contained within the yield space (a circle that represents the strength of the material), then the cycle will be wholly elastic. If the stress cycle falls outside the yield space, then an increment of plastic strain occurs. The difference between an elastic-plastic material and one that hardens is illustrated in Figure 22. In this way, Johnson's shakedown diagrams (Figure 23) were developed.

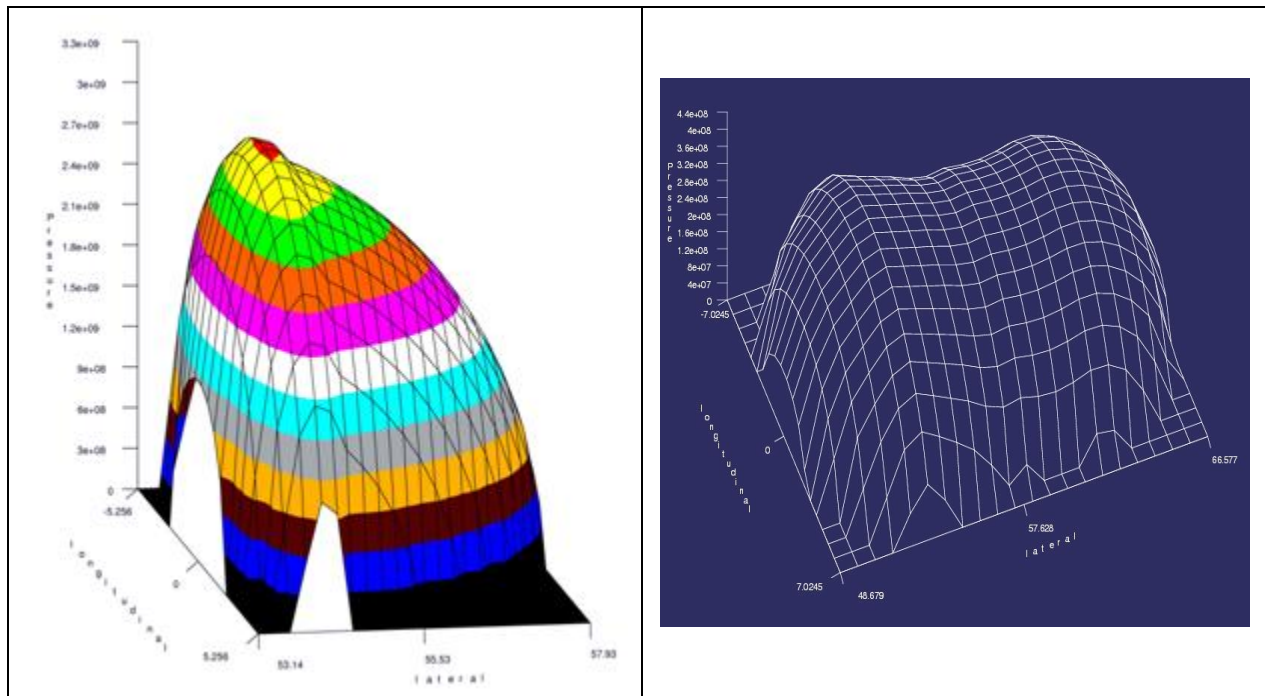
Figure 27. Examples of Nonelliptical Contacts Stress Distributions Calculated Using Non-Hertzian Models

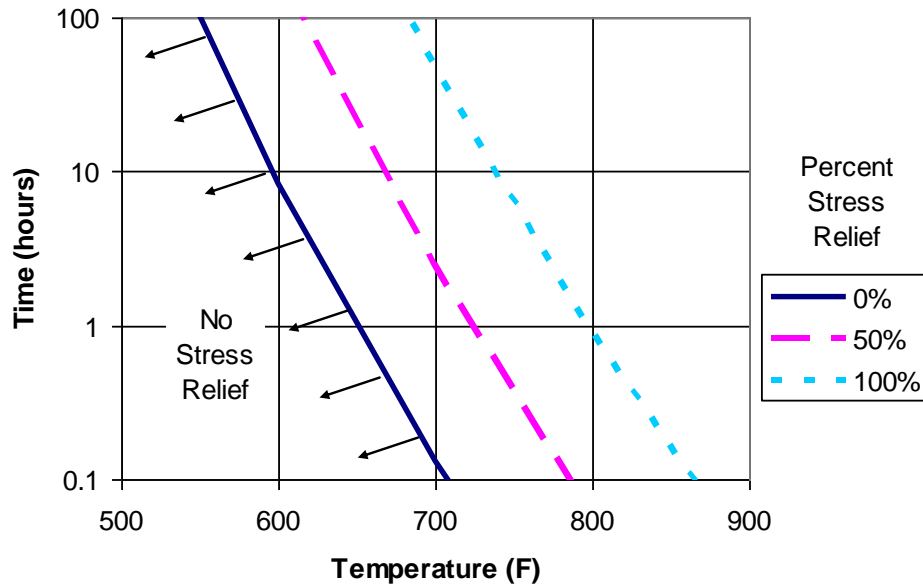
Figure 28. The Rate at Which Residual Stress Is Relieved Is a Function of Temperature and Time [198]

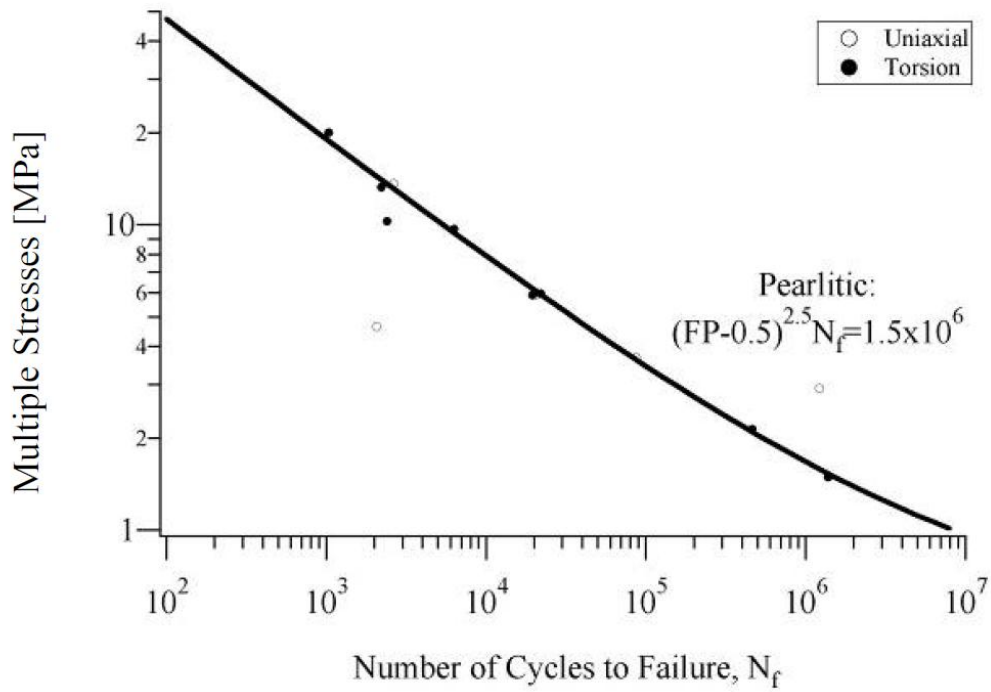
Figure 30. Effect of Stress on Material Performance [18]

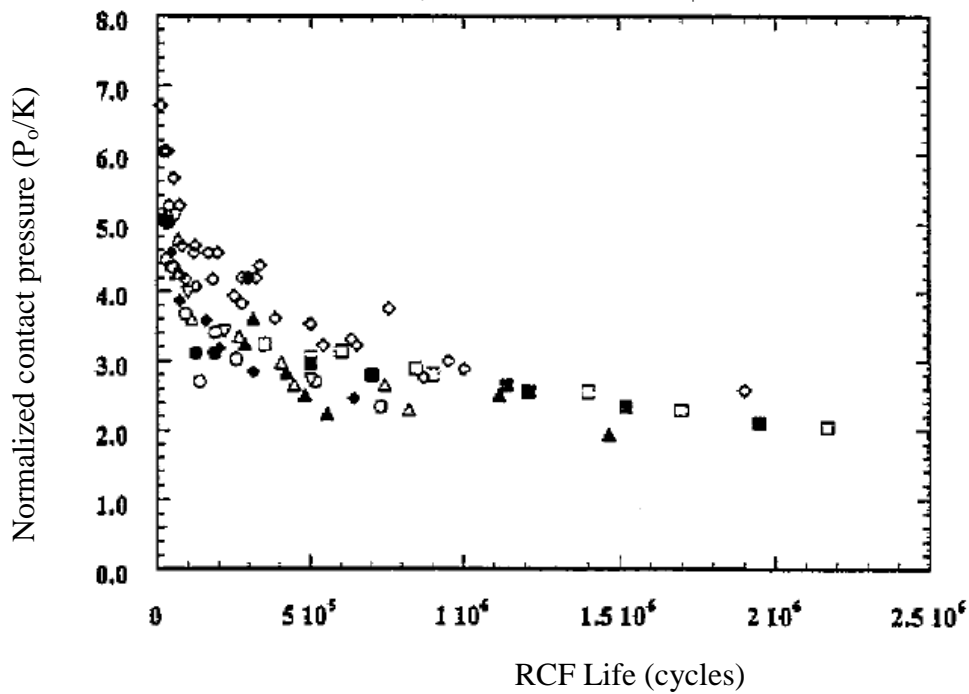
Figure 31. Effect of Contact Pressure on Nine Different Rail Steels [33] for a Creep Ratio of 10 Percent

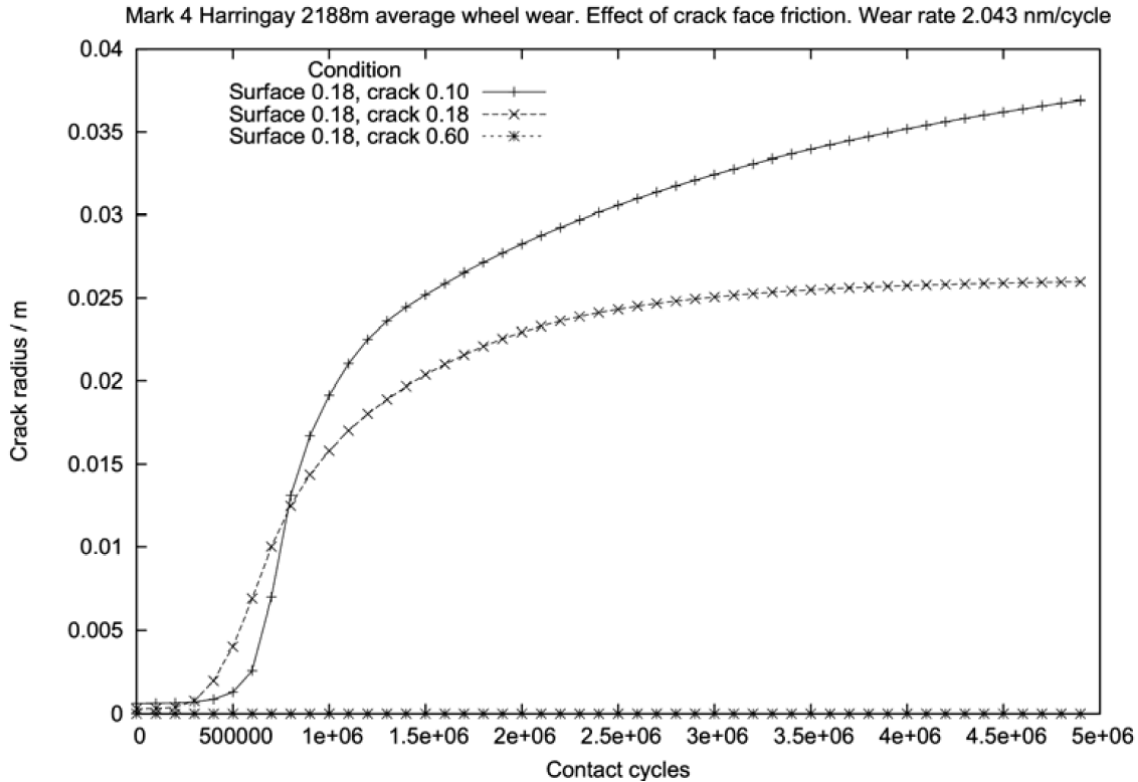
Figure 34. Predicted Crack Growth Rates for Three Different Values of Crack Face Friction (0.1, 0.18, and 0.6); The Friction at the Wheel-Rail Contact Is in All Cases 0.18 (from Reference 66)

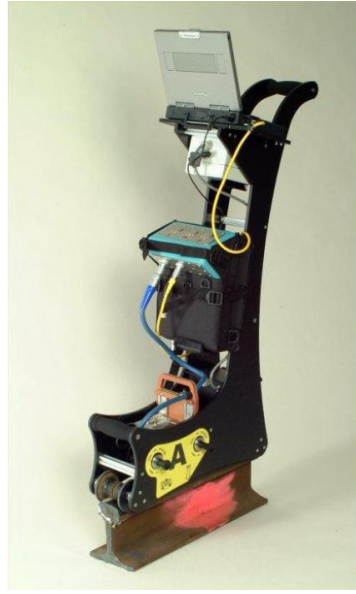
A) The TSC ACFM walking stick

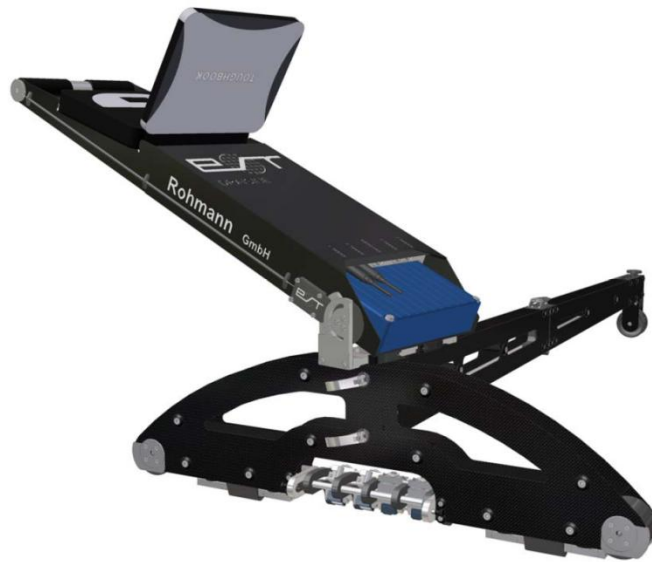
C) Rohmann Drasine trolley

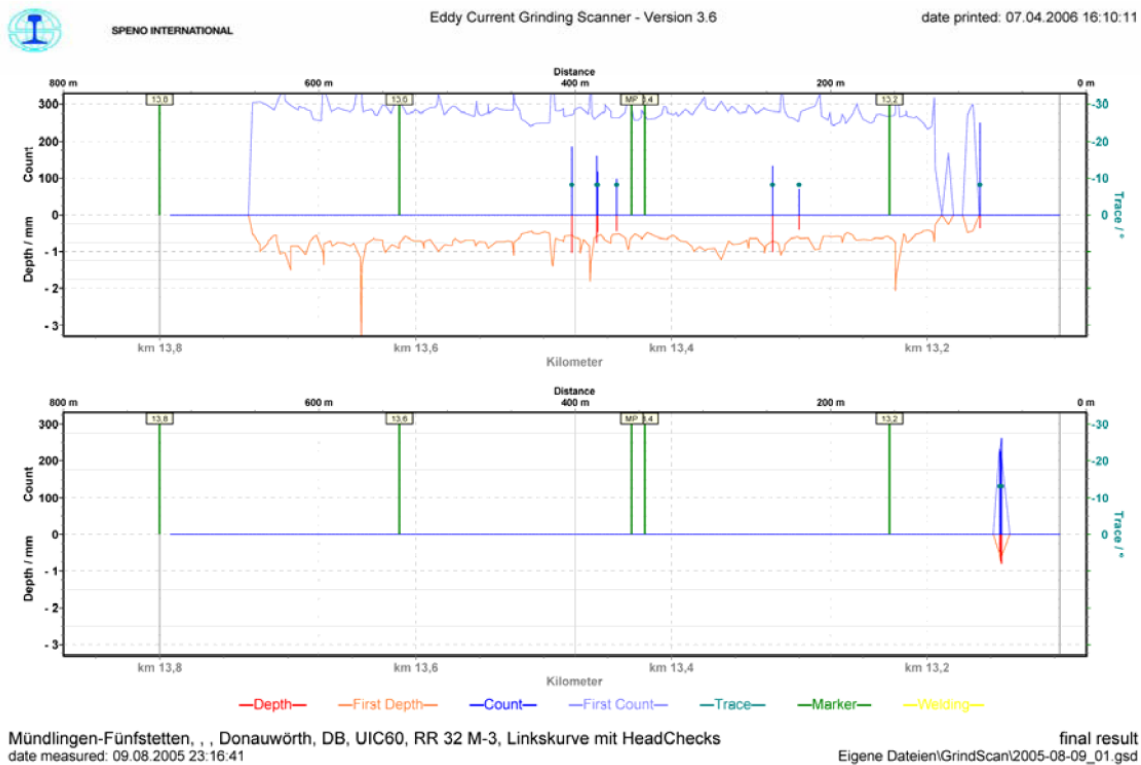
Figure 38. Example Plot of Processed Data from the Speno Rail HC Grinding Scanner System

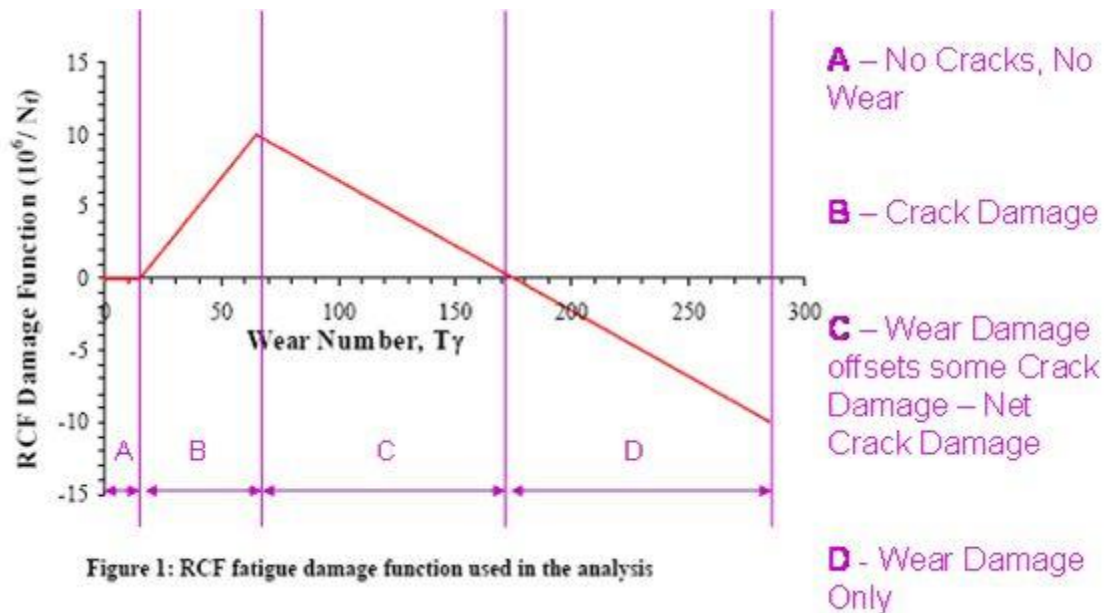
Figure 1: RCF fatigue damage function used in the analysis

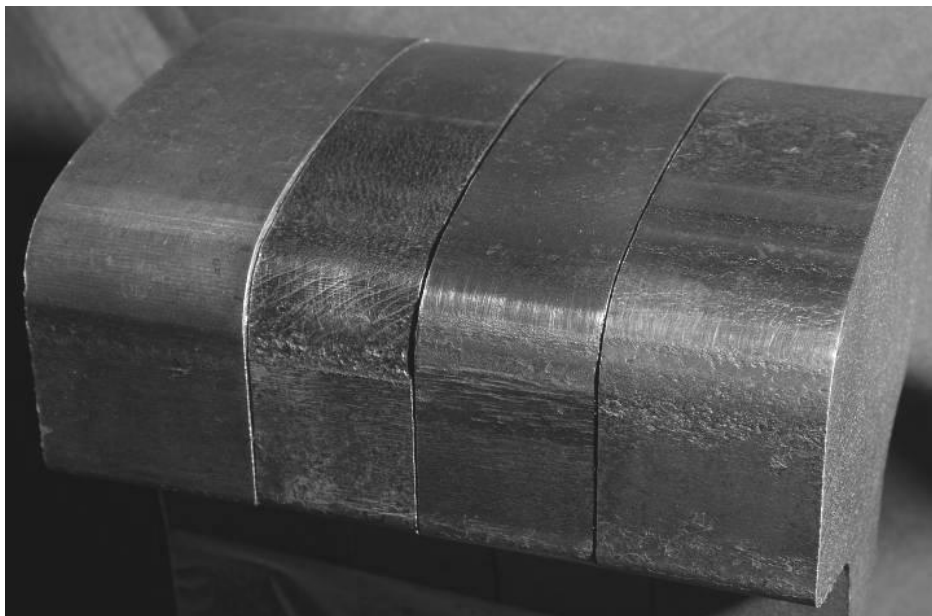
R350HT rail samples
