Conventional and Crash Energy Management
Locomotive Coupling Tests

REPORT DOCUMENTATION PAGE

9. SPONSORING/MONITORING AGENCY NAME(S) AND ADDRESS(ES) U.S. Department of Transportation Federal Railroad Administration Office of Railroad Policy and Development Office of Research and Development Washington, DC 20590			10. SPONSORING/MONITORING AGENCY REPORT NUMBER DOT/FRA/ORD-19/36

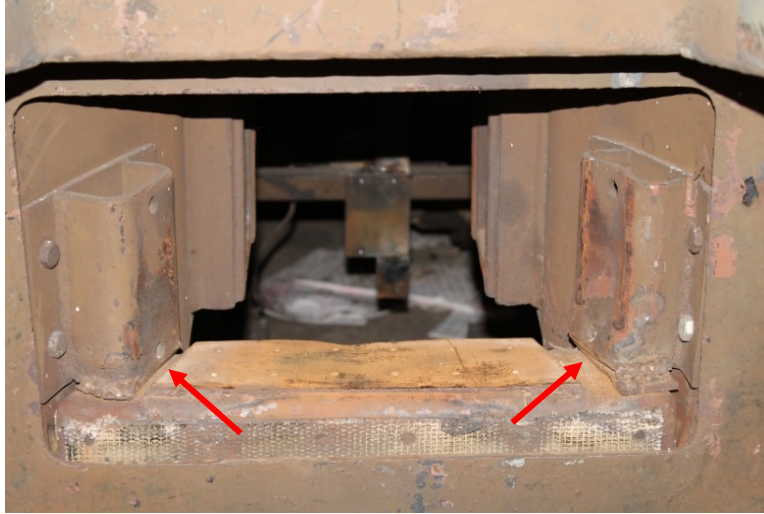
Figure 12. M1 coupler stops deformed by coupler shank

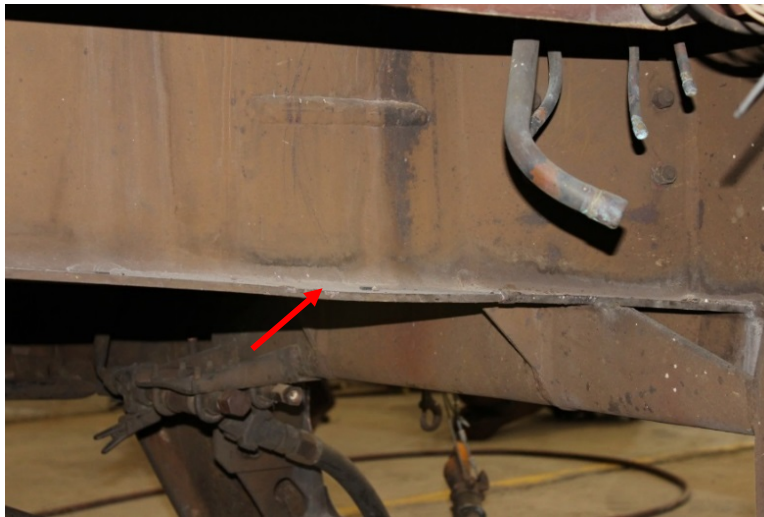
On the M1 car, the impact force developed in the 10 mph impact caused the exterior right flange of the draft pocket to deform, as indicated in Figure 13. The force of the impact through the draft gear also caused one of the buff plates in the draft gear to bend, as indicated in Figure 14.

Figure 13**. Deformed exterior right flange of M1 draft pocket**

Figure 14. M1 bent buff plate in draft gear

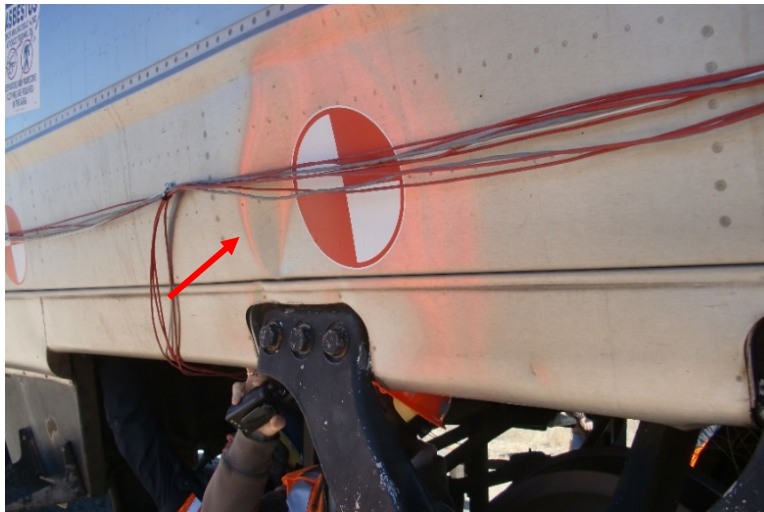
On the M1 car, this impact caused the side sill to buckle at the front-left truck connection. Figure 15 shows an exterior view of the buckle of the side sill, and Figure 16 shows an interior view of the buckled side sill at the front-left truck connection. There was also some minor dimpling of the M1 shell at the side sill on the right side at the front truck connection, but the damage was more extensive on the left side.

Figure 15. M1 side sill buckled at front-left truck connection (exterior view)

Figure 16. M1 side sill buckled at front-left truck connection (interior view)

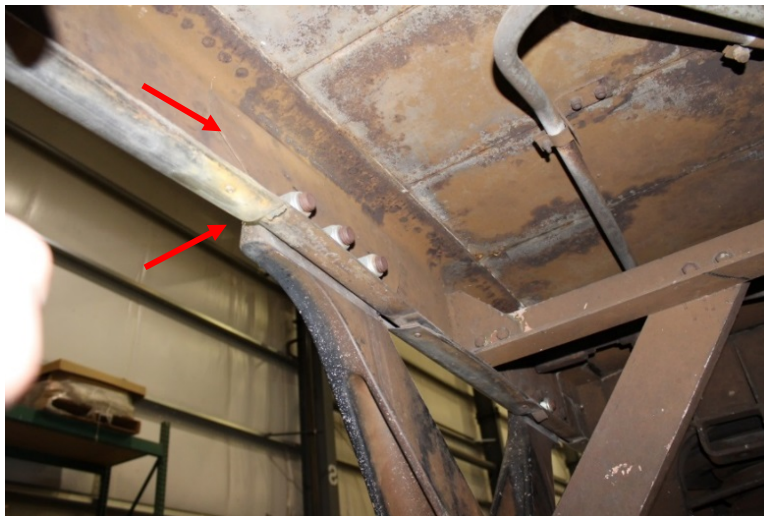
Figure 23. M1 side sill front-right truck connection (interior view)

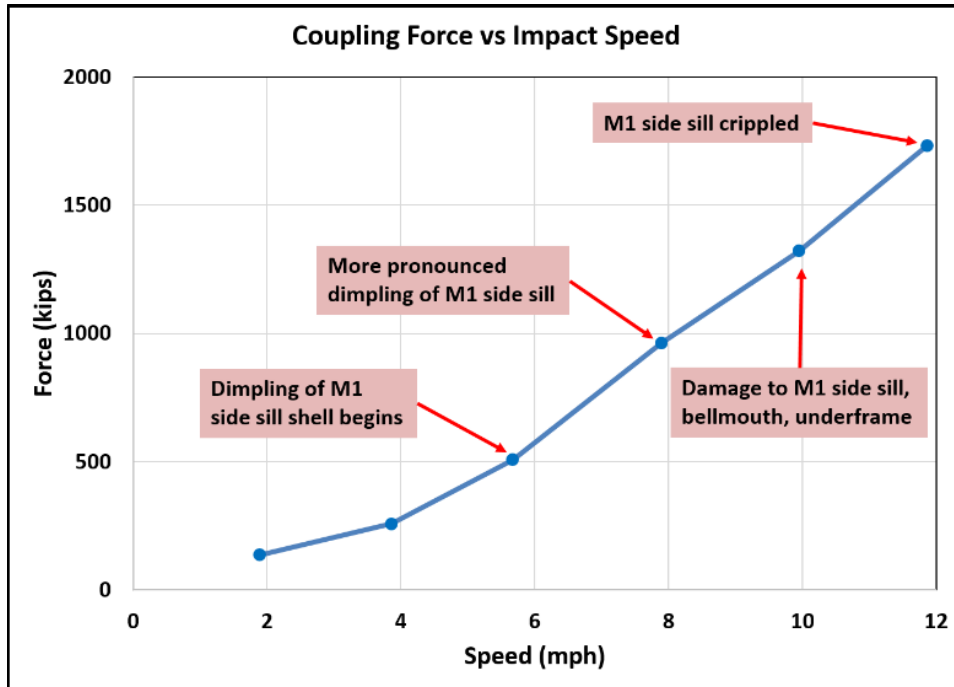
The coupling force as a function of the impact speed is plotted in Figure 27. The plot is annotated to show the progression of damage to the M1 cab car. Again, very little damage was incurred by the locomotive through all six impact tests. As shown in the figure, no damage to the M1 occurred in the first two impact tests (1.9 mph and 3.9 mph). Dimpling of the M1 shell at the location where the side sill meets the front truck attachment occurred as a result of the 5.7 mph impact. This dimpling became more pronounced as a result of the 7.9 mph impact. The 10.0 mph impact resulted in more damage to the side sill at the front truck connection, as well as damage to the bellmouth and underframe. The 11.9 mph impact resulted in effectively crippling the side sill of the M1 cab car.

The main objective of this effort was to determine the maximum non-destructive conventional coupling speed. Figure 27 shows the measured coupling force as a function of impact speed. At 2 mph and 4 mph, no visible damage occurred to either vehicle. Between 4 mph and 6 mph, damage began to occur. At speeds greater than 6 mph, there was visible damage. Therefore, coupling speeds should be kept under 6 mph to prevent damage. This is consistent with the Association of American Railroads' General Code of Operating Rules [10], which specifies that couplings occur "at a speed of not more than 4 mph."

Figure 27. Coupling force as a function of impact speed

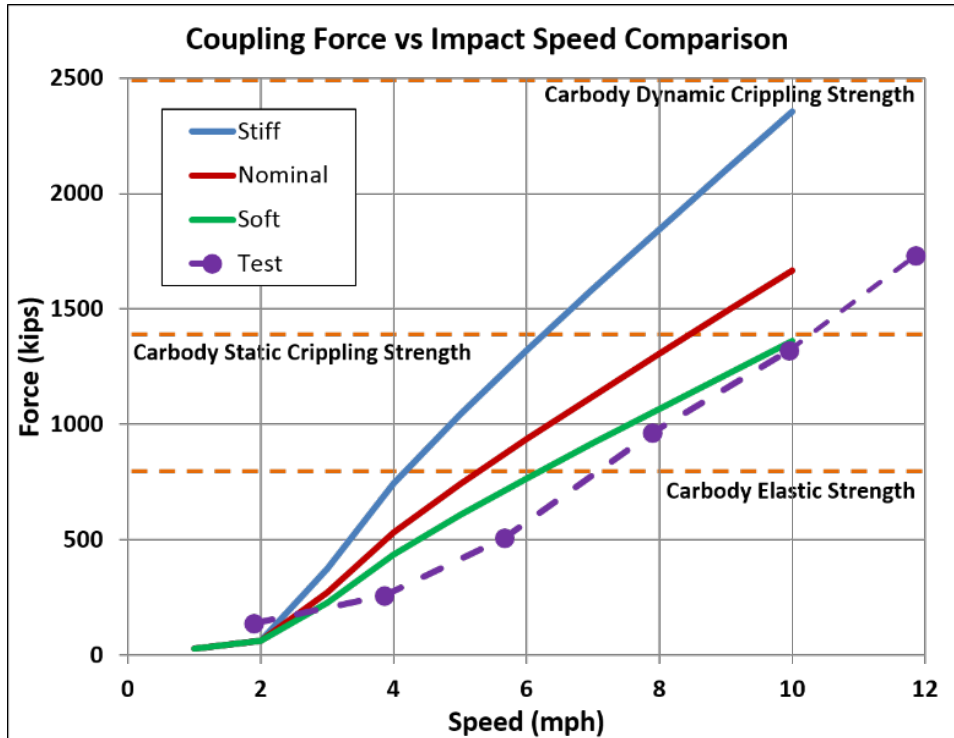
Figure 30. Peak coupling force as a function of coupling speed compared to results from lumped-parameter model

Figure 30 shows peak coupling force as a function of coupling speed for the three bottoming stiffnesses: stiff, nominal, and soft. The graph is also annotated with the M1 car elastic strength, static crippling strength, and dynamic crippling strength [11]. Prior to the test, the coupler load was predicted to exceed the M1 carbody's static elastic strength for coupling speeds between 4 and 7 mph. The coupler load was predicted to exceed the M1 cab carbody's static crippling strength for coupling speeds between 6 and 10 mph. Researchers predicted that damage would occur for coupling speeds between 6 and 8 mph. This compared favorably with the test result that coupling speeds should be kept under 6 mph to prevent equipment damage.

Note that the three M1 carbody strengths and the three predictions shown in Figure 30 were based on the assumption that the load path passed through the carbody alone. However, the dimpling and subsequent crippling of the M1 side sills that resulted from the impact tests indicated that a substantial portion of the load was borne by the truck attachments. This behavior could not have been captured by the simplified, one-dimensional model, since the entire M1 cab car was represented by a single mass.

The forces measured in the impact tests are also plotted with the model predictions and M1 carbody strengths in Figure 30. Despite the difference in load path, the figure shows that the results of these conventional coupling tests compared favorably with pre-test predictions of the simplified model utilizing the soft stiffness assumption.

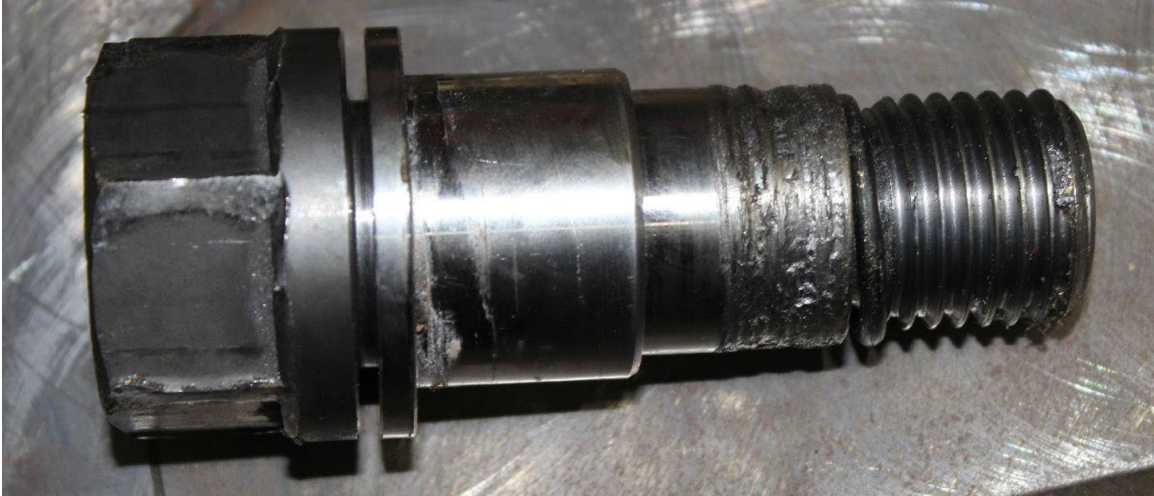
There was minor damage found on the shear bolts and the draft pocket. Shear bolt 4 (left-rear middle position) experienced substantial galling between the bolt surface and the inner shear bushing. It was unclear if this damage was caused by the test or occurred when the bolt was removed.

Figure 51**. Galling of shear bolt 4 (left rear middle position)**

The draft pocket bolt hole for shear bolt 4 also experienced surface damage. It was unclear if this was the result of the test, or occurred during the bolt's removal. It was unclear if any damage was done to the threads for this bolt in the sliding lug.

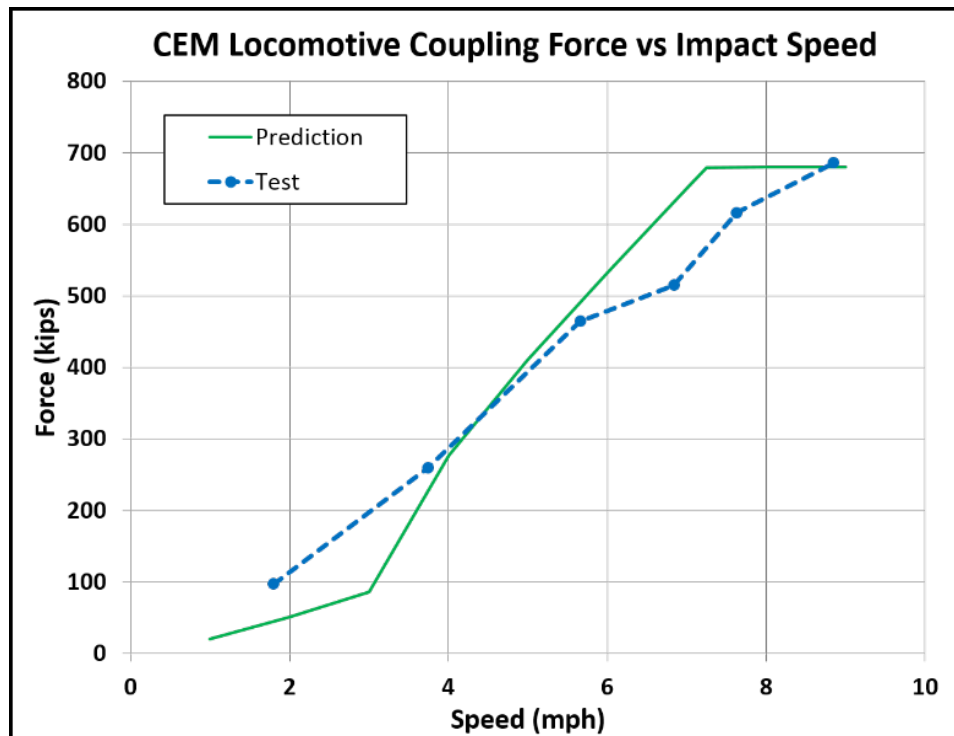
Figure 54. **Peak coupling force as a function of impact speed**

Prior to the test, a simplified lump-mass model was created to estimate the speed at which the PBC would trigger. This model estimated the PBC force-displacement behavior and utilized typical vehicle weights and the force-crush characteristic of a typical conventional locomotive draft gear. Figure 54 shows peak coupling force as a function of impact speed comparing the pre-test prediction with the test results. The figure shows that the test results compared favorably with the prediction.

However, the model predicted that triggering of the PBC would occur at an impact speed between 7 mph and 8 mph. The test demonstrated that the PBC triggered at just under 9 mph. Additionally, the pre-test modeling predicted that damage would occur in the M1 truck-to-carbody connection at speeds above 5 mph. This occurred in the tests, as shown in Figure 39. The traction rod experienced bending in the 5.7 mph test as well as in each successive test at higher impact speeds.

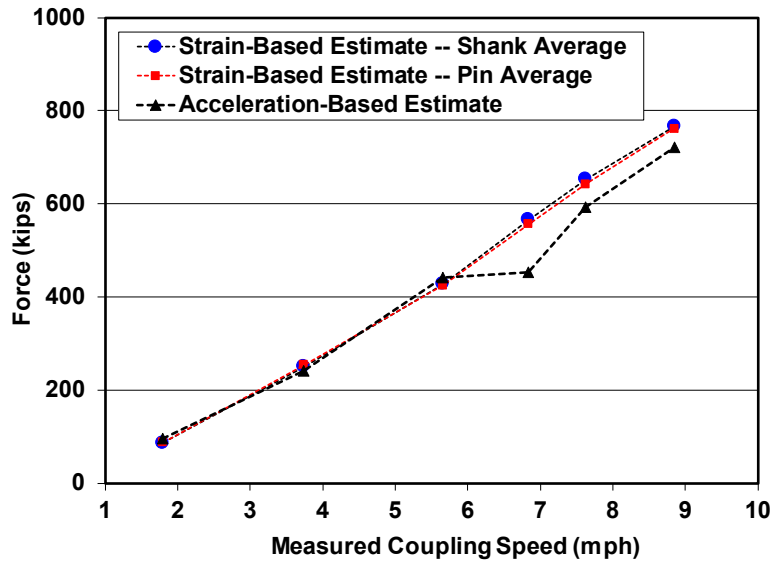
Figure 58. Comparison of strain-based estimates of force through coupler with acceleration-based estimate

through the shank and pin regions is plotted in Figure 58 as a function of coupling speed. For comparison, the estimate of force through the coupler that is derived from car body acceleration data (as calculated by TTCI) is also plotted. As is evident, the force through the two coupler locations were remarkably consistent with one another and indicated an effectively linear increase in coupler force with impact speed. For lower coupling speeds, these strain gage-based estimates of force were also consistent with acceleration-based estimates of force. For higher coupling speeds, the agreement was not as good, which may have been because the dynamics of the impact at these higher speeds did not lend themselves to estimates that assumed the entire mass of the vehicle was decelerating uniformly. The acceleration-based estimate of force at 7 mph seemed particularly low with respect to the other calculated values. During this test, the traction rod was deformed and was not replaced for the subsequent tests.

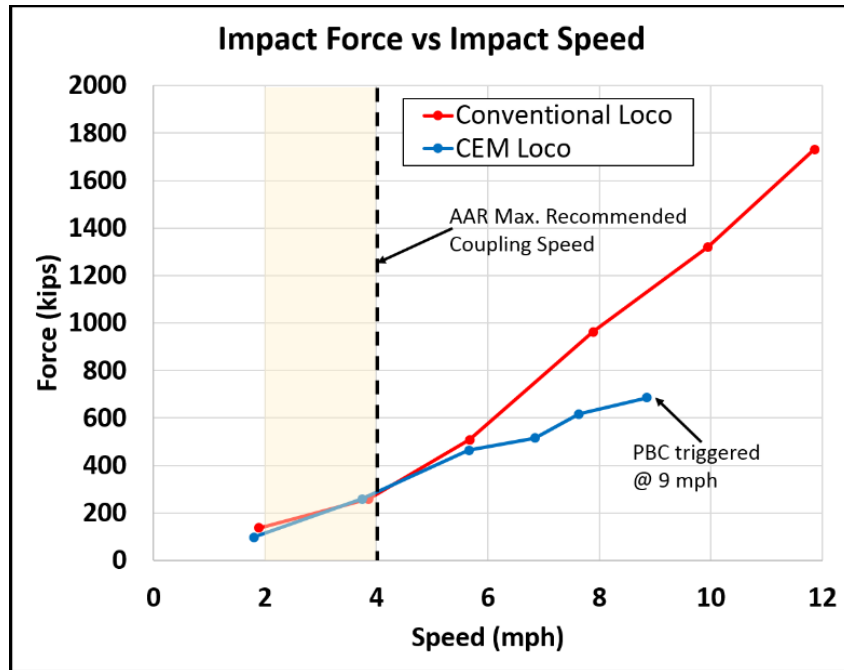
Figure 65. **Impact force vs. impact speed comparison**

Figure 65 compares the test results for conventional coupling tests with those of the CEM coupling tests. The figure shows the impact force with respect to impact speed for both series of tests. The results were almost identical for impact speeds of less than 6 mph. However, the results diverged at impact speeds greater than 6 mph. This was due to the draft gear system on the Voith PBC design on the CEM locomotive. The draft gear effectively limited the impact force until the PBC was triggered at 9 mph.

In common practice, railroads typically couple vehicles at speeds between 2 mph and 4 mph, shown as the yellow shaded area in Figure 65. These results showed that the PBC behaved very much like the conventional coupler for the complete range of typical coupling speeds. Note that triggering of the PBC occurred at a speed much greater than the 4 mph maximum coupling speed recommended by the Association of American Railroads [15], shown as the vertical, black-dashed line in Figure 65. Additionally, the likelihood of coupling became less likely at the higher coupling speeds.

The CEM coupling tests successfully demonstrated the force level at which the PBC is designed to trigger. The PBC triggered at a force of approximately 670 kips, as predicted. The impact speed required to trigger the PBC was higher than previously predicted. However, this prediction was based on higher vehicle weights and a softer elastic characteristic of the draft gear in the Voith PBC. The CEM coupling tests showed that for the given vehicle-to-vehicle coupling scenario, it is unlikely that the PBC will trigger within the common coupling speed range recommended by AAR. Additionally, the PBC has a conservative tolerance for overspeed coupling. Computer models can be used to extrapolate and determine coupling speeds for other coupling scenarios. Most PBC manufacturers utilize modeling and testing to design and ensure their PBC will not trigger in coupling scenarios defined by the purchaser. Additionally, the draft gear components of the PBC can be designed to have a higher elastic capacity for cushioning higher-speed coupling events to protect the PBC from premature activation.
