U.S. Department of  
Transportation

**Federal Railroad  
Administration**

## **Ground Penetrating Radar (GPR) Technology Evaluation and Implementation: Appendices A Through F**

**BB/Zetica - ZR0345-15-R01-B (Ravenna Sampling Report) -  
12.06.17b**

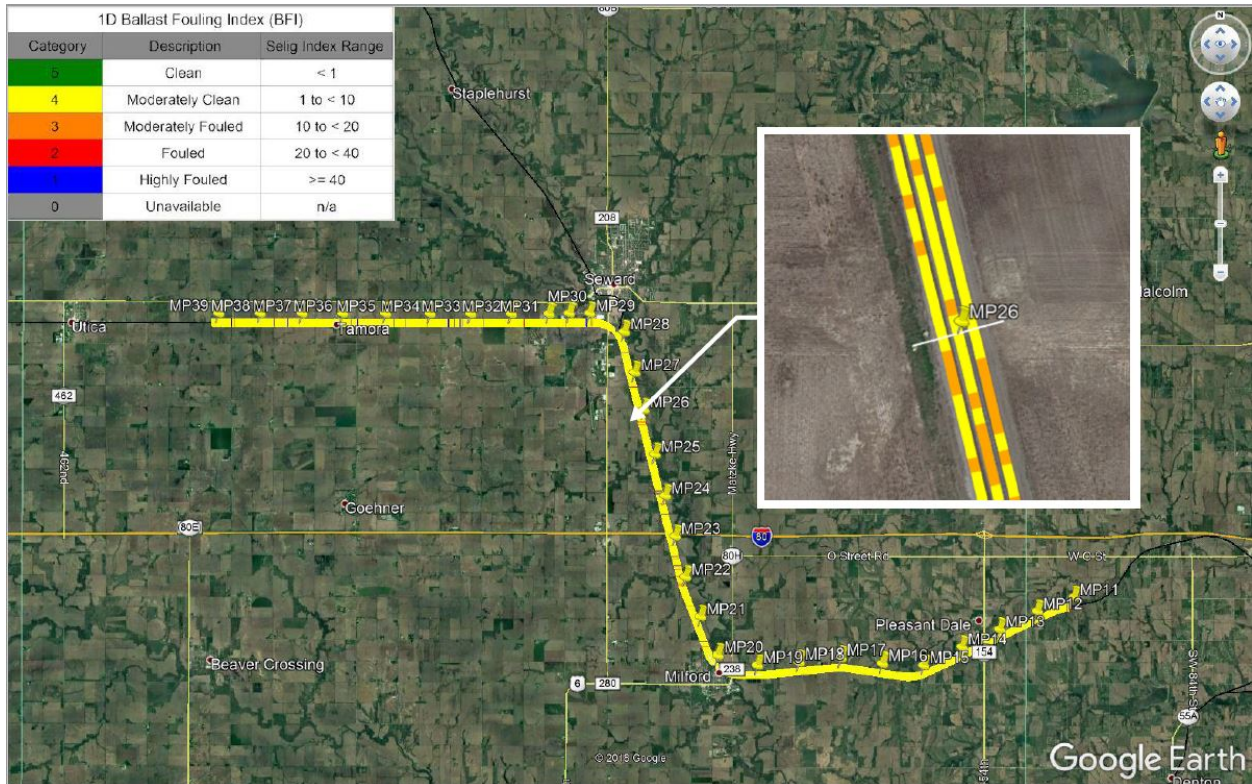
**Figure B 1. BFI with train insert**

These images show the survey limits on the Ravenna Subdivision and the fouling depth layer (FDL) (note, this is used interchangeably with free draining layer [FDL]) and ballast fouling index (BFI) metrics for both the hi-rail vehicle and DOTX220.

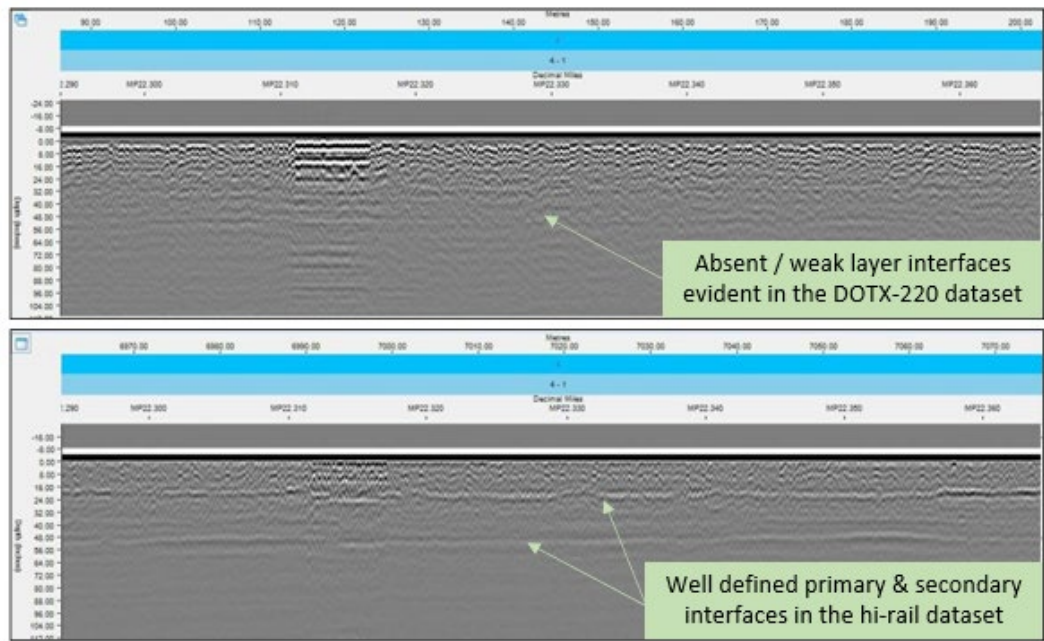
**Figure E 13. (Top) DOTX220, (bottom) hi-rail**

- Comparison of center 400 MHz data from hi-rail at the bottom and DOTX220 at the top over section of concrete ties on Main 1 around MP 22.330
- The primary and secondary layer interfaces evident in the hi-rail data are less apparent in the DOTX220 data, which also suffers from increased interference in the near-surface (~0–12”).

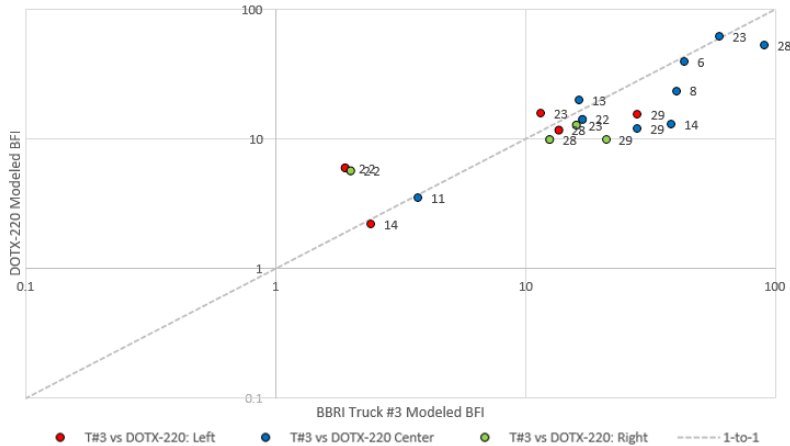
**Figure E 20. A comparison of the modeled BFI obtained on the hi-rail truck and DOTX220**

- The plot below presents a comparison of the modeled BFI obtained on the hi-rail truck and DOTX220 for all center samples acquired over wood and concrete ties together with the shoulder samples over wood ties on Main 2.
- Except for the shoulder data from Location #22, the match is considered to be good.

- Samples acquired on the ballast shoulders over concrete ties—exclusively Main 1—sit above the 1- to-1 line, indicating a discrepancy between the train and hi-rail results.
- Whilst this discrepancy may be partly due to the different positions of the shoulder antennas on the two vehicles it is also attributed to residual interference observed within the DOTX220 dataset.

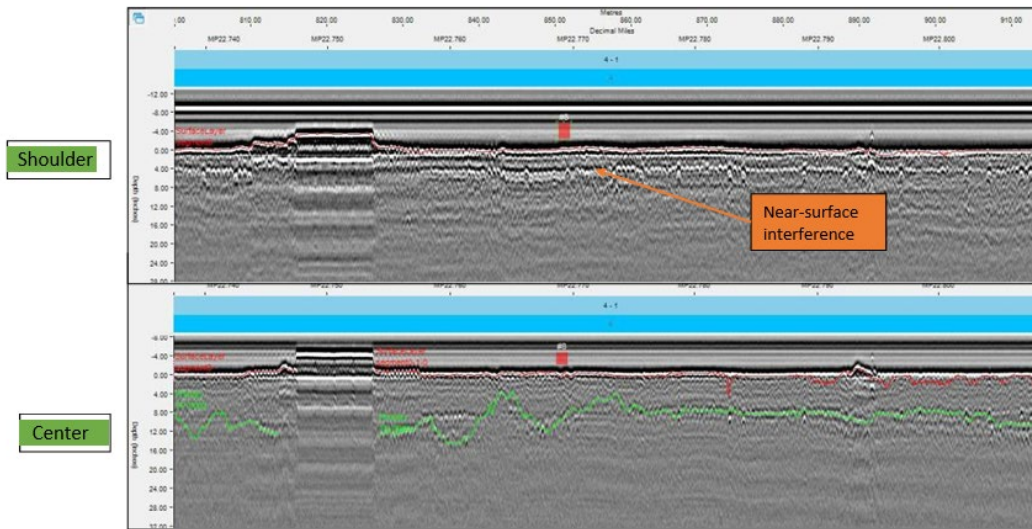
**Figure E 23. Interprets the provenance of each reflection interfaces**

- Examination of the raw 2 GHz data from these outlier shoulder locations suggests that the modeled BFI has been affected by residual near-surface hyperbolic artefacts highlighted in [Figure E 22](#) associated with the reinforcing bars within the ties.
- This effect is not observed in the track center data due to the different orientation of the antenna, which is optimized to avoid electromagnetic coupling with the reinforcing.

- The example in [Figure E 23](#) illustrates the interference, also seen in [Figure E 22](#), at the location of Sample #8. The corresponding track center data is included below for comparison. The green line on the center radargram represents the interpreted base of clean ballast.

- To address the issues identified with the DOTX220 datasets the following recommendations are made: Consider moving the shoulder 2 GHz antennas up by ~50 mm to take advantage of the increased width of the Plate C clearance envelope at 360 mm above top of rail. This is illustrated in the figure below.

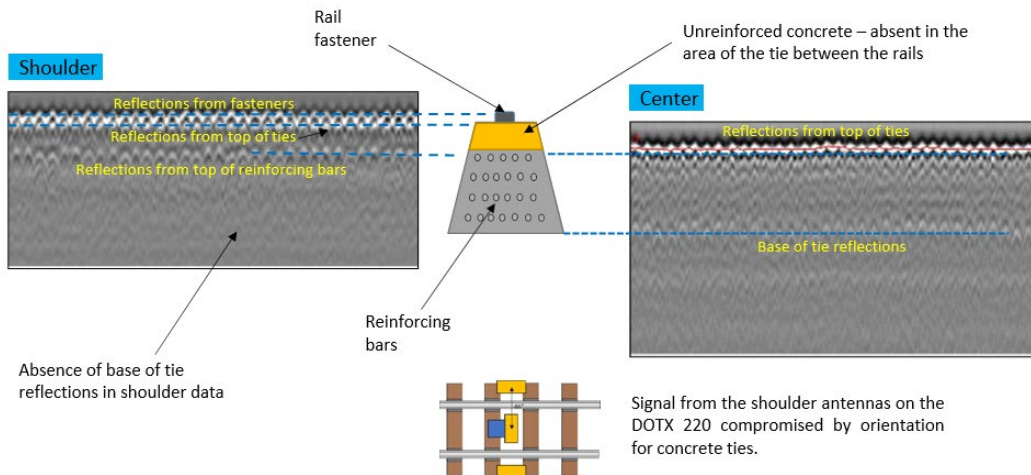
**Figure E 24. Interprets provenance of each reflection interface identified within the shoulder and center datasets from DOTX220**

- The diagram in Figure E 24 further illustrates the interpreted provenance of each of the reflection interfaces identified within the shoulder and center datasets from DOTX220 that are attributed to the ties:

- Data acquired with the shoulder antennas on the train over some concrete ties, are being affected by interference believed to be caused by a combination of reflections from clips and reinforcing within these ties. It is likely that this interference is being exacerbated—compared to the center—by the orientation of the antennas relative to the reinforcing.

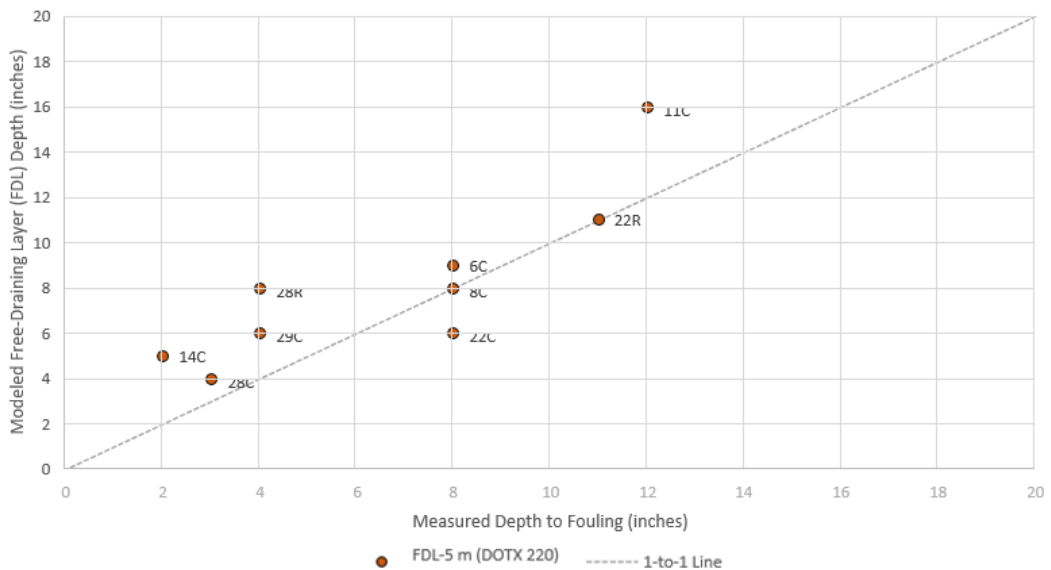
**Figure E 27. Modeled FDL vs. measured fouling depth**

- The modeled FDL generally shows good correlation with the measured fouling depth.
- The R2 value for a linear best fit through results acquired in the center over both wood and concrete ties and over wood on the shoulders is ~ 0.77.

- Samples acquired on the ballast shoulders over concrete ties, exclusively Main 1, are also affected by the residual tie interference previously discussed, with the points lying below the 1-to-1 line.

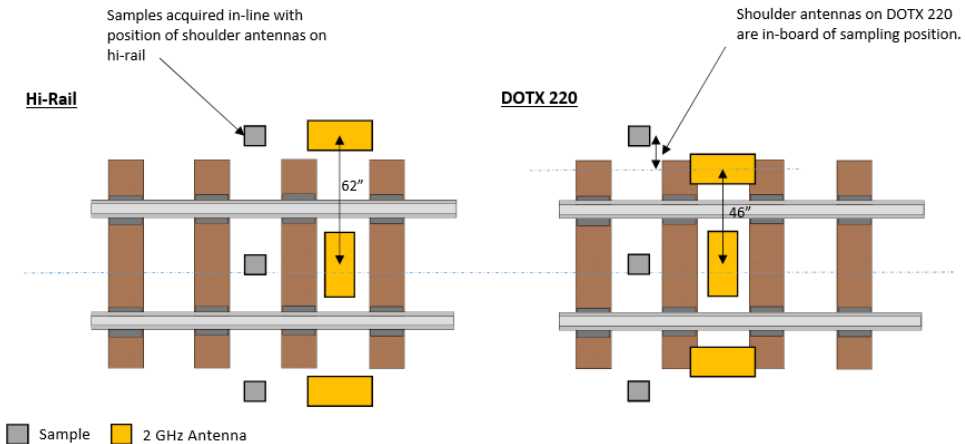
**Figure E 33. Relative positions of the 2 GHz shoulder antennas and the sampling tubes on the two platforms**

- As discussed, the improved correlation between the hi-rail FDL results and the measured fouling depth, compared to the equivalent with the DOTX220 results is likely to be in part due to the relative positions of the 2 GHz shoulder antennas and the sampling tubes on the two platforms:

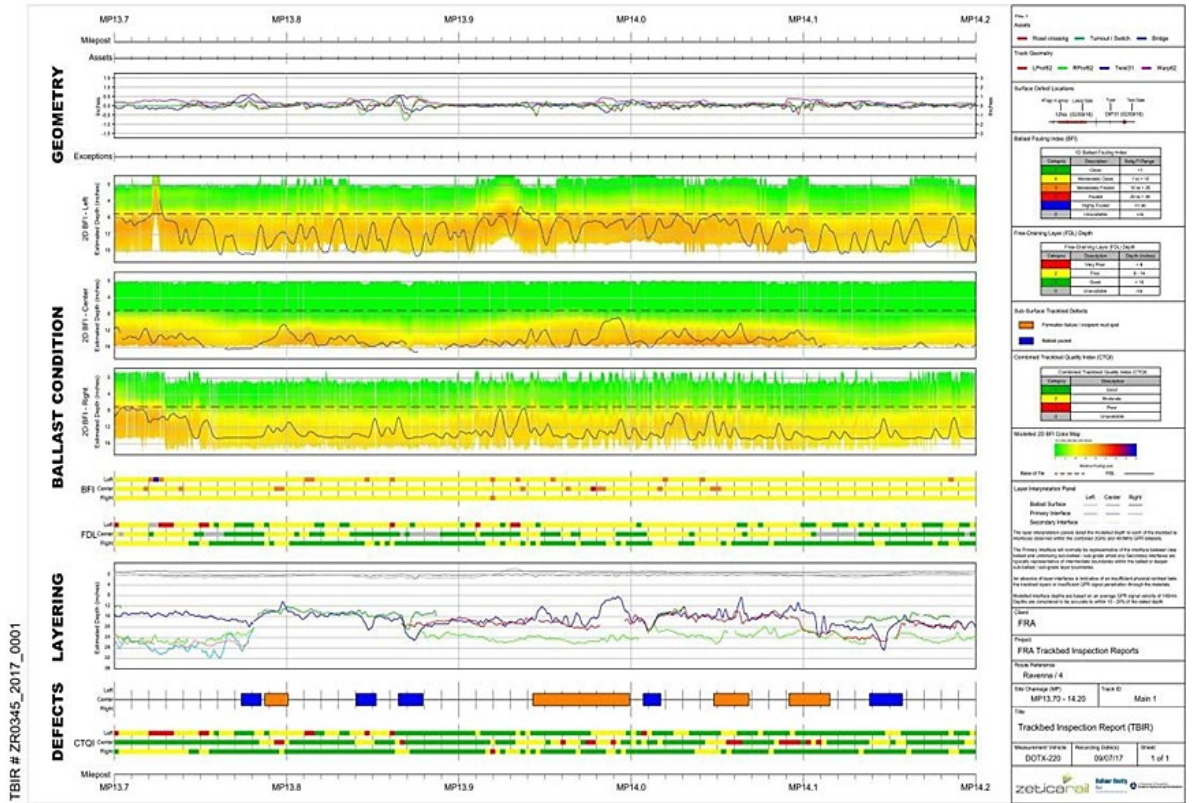
Figure E 35. TBIR: Main 2 MP 14.00–MP 14.50

<b>Trackbed Condition Summary</b>	The general condition of the trackbed within this 1/2 mile is classified by the Combined Trackbed Quality Index (CTQI) as Good, with relatively low levels of ballast fouling (predominantly CAT 4 - Moderately Clean) on all three data channels (left & right shoulders and track center) and a Good to Poor free-draining layer depth of between 8 to +16 inches. Short sections of Moderate to Poor quality trackbed are associated with localized defects (see below). Increases in track geometry Profile and Twist have been identified at a number of locations within this section but all lie within exception limits for the posted track speed / class.
<b>Trackbed Layer Summary</b>	A well-defined Primary layer interface interpreted as the base of clean ballast, has been identified in the track center for the majority of the 1/2 mile and less continuously on the ballast shoulders. <del>With the exception of</del> a number of identified ballast defects, the modeled depth to the interface is generally at or close to design depth, lying at between 16 - 20 inches from surface. Through much of this section, local increases in reflection strength on the primary interface and attenuation of the GPR signal in the underlying materials suggest that the sub-grade is likely to comprise relatively moist, cohesive materials. On the right shoulder, the Primary interface is generally absent and is instead replaced by a more uniform Secondary interface lying at modeled depths of between 24 - 28 inches. This interface is interpreted as the base of sub-grade. Between ~MP13.700 and MP13.780 it is additionally evident within the track center and on the right shoulder.

<b>Trackbed Defects Summary</b>	<b>MP13.774 - MP13.785, MP13.840 - MP13.852, MP13.865 - MP13.879, MP14.060 - MP14.018, MP14.149 - MP14.158 - Ballast pockets:</b> These are characterized by localized increases in the depth to the Primary layer interface of between 4 - 8 inches indicative of possible locally soft subgrade / soil conditions. They are predominantly observed within the track center. The three anomalies between MP13.774 and MP13.879, are associated with small-scale deviations (<math>\pm</math>0.5 inches) in track geometry Warp, Twist and Profile. Examination of aerial imagery of the site indicates that the defect between MP14.149 and MP14.158 coincides with an apparent cross-cutting drainage feature and may be associated with an unidentified cross-track culvert or pipe. A similar pocket has been identified at the same location in the GPR data acquired on Main 2 (see TBIR# ZR0345_2017_0002). <b>MP13.788 - MP13.801, MP13.943 - MP13.999, MP14.048 - MP14.069, MP14.091 - MP14.115 - Subgrade pumping / failure, mud spot development:</b> These defects are characterized by localized reductions in the modeled depth to the Primary layer interface, indicative of potential intermixing of the ballast and sub-ballast materials. The shallowest and most extensive of the defects occurs between MP13.943 and MP13.999. The western end of this feature is associated with a slight deterioration in track geometry quality. A similar deterioration is observed over the defect between MP14.091 and MP14.115.

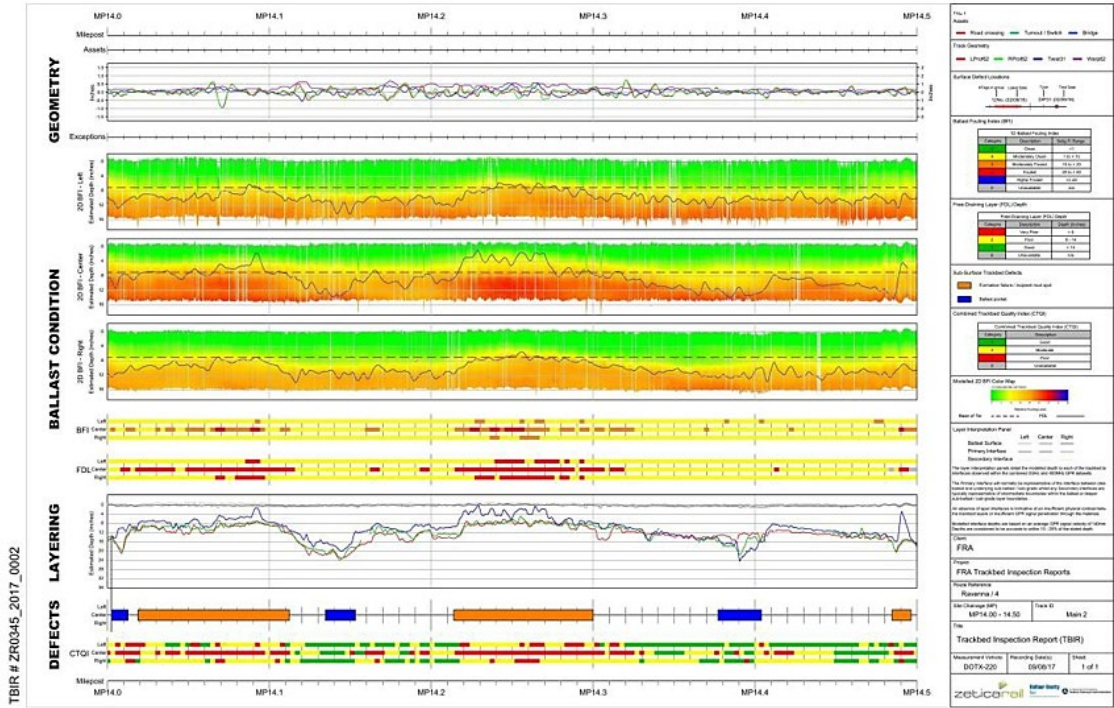
Figure E 36. TBIR: Main 2 MP 14.00–MP 14.50 (continued)

Trackbed Condition Summary	The condition of the trackbed within this 1/2 mile is classified as generally Moderate to Good within areas outside of the identified trackbed defects. The condition on the ballast shoulders is typically slightly better than that of the track center, primarily as a result of improved ballast quality. Areas of Poor quality trackbed are characterized by modeled ballast fouling ranging from Moderately Fouled to Fouled, a shallow (<8 inches) modeled free-draining layer (FDL) depth, particularly in the track center, and an irregular ballast profile.
Trackbed Layer Summary	A well-defined continuous Primary layer interface has been identified over the majority of the 1/2 mile on all three data channels (left & right shoulders and track center) at modeled depths of between <4 inches and 24 inches. The interface is variably interpreted as representing the boundary between clean ballast and fouled material, and clean ballast and sub-grade. There is no evidence of a deeper, secondary, interface within the 2GHz datasets indicating that the base of the trackbed lies below ~3 feet through this section. No 400MHz data was available from the DOTX-220 survey.

Trackbed Defects Summary	<p><b>MP14.000 - MP14.012 - Ballast pocket:</b> Characterized by a localized increase in the modeled depth to the Primary layer interface from ~10 - 16 inches to over 20 inches on both the left and right shoulders attributed to soft sub-grade conditions. Attenuation of the GPR signal below the interface is potentially indicative of increased % moisture within the underlying materials.</p> <p><b>MP14.019 - MP14.112 - Insufficient clean ballast thickness, mud spot development and surface mud:</b> This section of track is characterized by a shallow Primary layer interface (&lt; 8 inches in center) and correspondingly shallow FDL together with evidence of both active (surface) and developing (sub-surface) mud spots in the center and on the right shoulder. Coincident with this defect is a well-defined negative (Dip) left and right profile deviation of ~1 inch in the track geometry data, potentially indicating locally soft trackbed conditions. The deviation does not constitute a track geometry exception for the posted track speed/class.</p> <p><b>MP14.135 - MP14.153 - Ballast pocket:</b> This feature comprises a relatively broad low in the ballast profile that extends to a modeled depth of ~28 inches. It is coincident with a cross-track drainage feature visible in aerial imagery of the site and may be associated with an unidentified culvert/pipe. A similar anomaly is identified here in the GPR data acquired on Main 1.</p> <p><b>MP14.214 - MP14.300 - Developing and active mud spots, insufficient clean ballast thickness, elevated % moisture:</b> This defect is characterized by an irregular and very shallow (&lt;4 inches) Primary layer interface and correspondingly shallow FDL. The elevated reflection amplitude of the Primary interface and attenuation of the signal in the underlying materials is potentially indicative of elevated moisture levels within the near-surface materials. Various TG surface parameters are slightly elevated within this section but lie within exception limits.</p> <p><b>MP14.376 - MP14.404 - Ballast pocket (center only), MP14.485 - MP14.495 - Active mud spot (center only):</b> Well-defined ~30-ft wide anomaly. No significant track geometry response.</p>
