**Federal Railroad  
Administration**

## Broken Rims in Railroad Wheels

6. AUTHOR(S) and FRA COTR Scott Cummings			8. PERFORMING ORGANIZATION REPORT NUMBER	
7. PERFORMING ORGANIZATION NAME(S) AND ADDRESS(ES) Transportation Technology Center, Inc. 55500 DOT Rd. Pueblo, CO 81001			10. SPONSORING/MONITORING AGENCY REPORT NUMBER  DOT/FRA/ORD-14/41

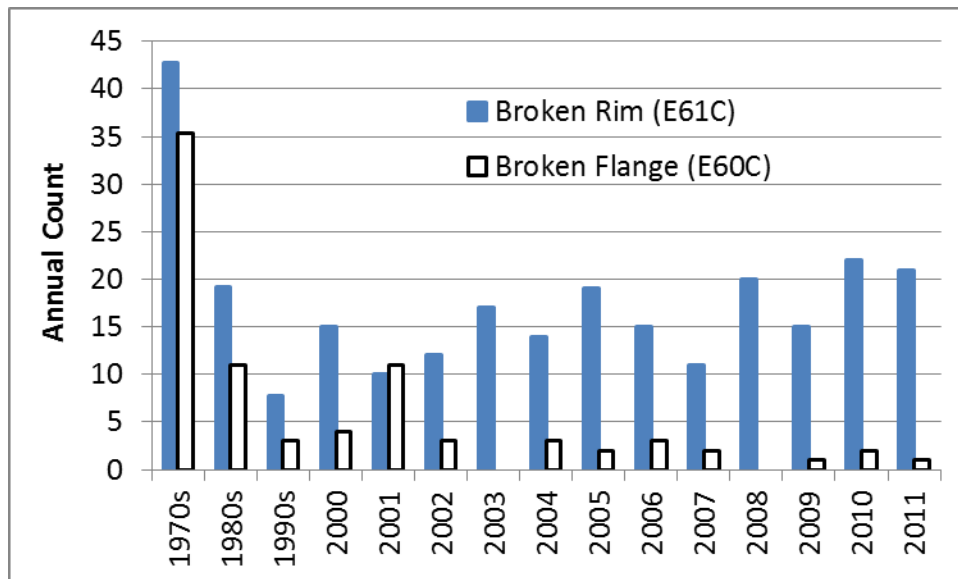
Figure 2. Broken Rim and Broken Flange Accidents from FRA Safety Database (2012)

The FRA safety database shows that broken wheel rims (cause code E61C “Broken rim”) are a high-ranking cause of FRA reportable train accidents. A broken wheel flange (cause code E60C “Broken flange”) is a much lower ranking cause of FRA reportable train accidents. The broken rim cause code includes wheels with shattered rims and wheels with VSR and does not distinguish between the failure modes. Between January 2004 and December 2011, a total of 137 accidents were attributed directly to broken rims—for an average of 17.125 broken rim accidents per year. Over this same period, 14 accidents were attributed to broken flanges. Of all equipment-related accidents, broken rim accidents are the third most common cause. Broken rims are the leading cause of wheel-related accidents (FRA 2012). Figure 2 shows the annual count of accidents attributed to broken rim and broken flange (the values for the 1970s, 1980s and 1990s are annual averages), and Figure 3 shows the broken rim and broken flange accidents as a percentage of accidents attributed to all equipment-related causes. The 3-year-average count of FRA reportable accidents attributed to broken rims has increased slightly in recent years from 16.0 (2004 to 2006) to 19.3 (2009 to 2011) (FRA 2012). The count of broken rim accidents has increased in recent years; Figure 3 shows that broken rims have not kept pace with the safety improvements seen in other accidents caused by broken flanges.

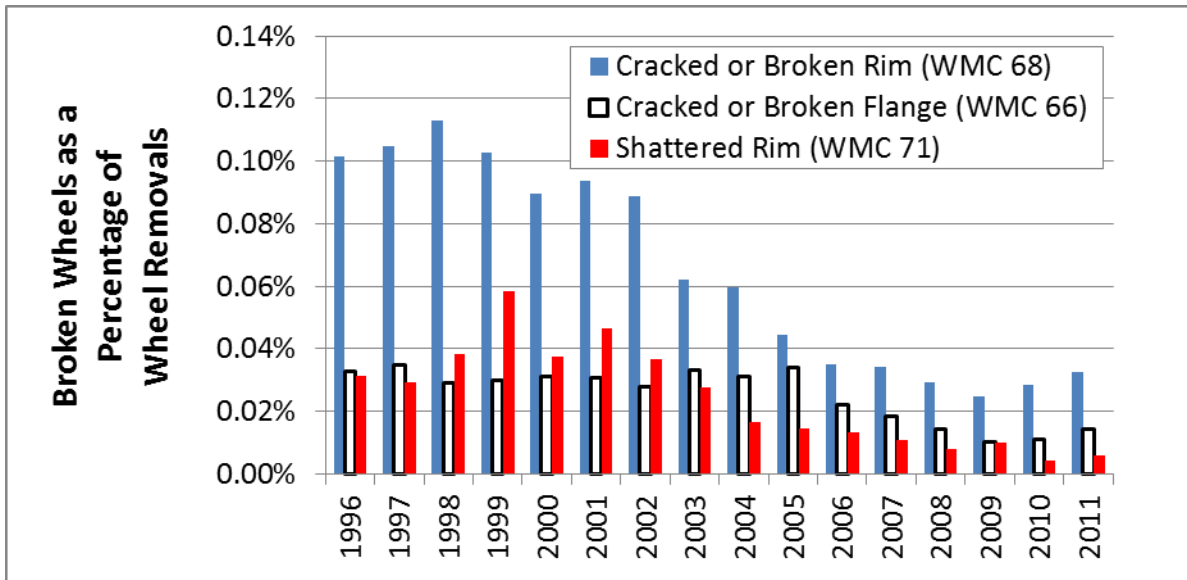
**Figure 4. Wheel Removals for Cracked or Broken Rim, Cracked or Broken Flange, and Shattered Rim from AAR Car Repair Billing Database**

A wheel with a cracked or broken rim or a cracked or broken flange is condemnable according to the *Field Manual of AAR Interchange Rules*, Rule 41, 2012. The AAR has assigned Why Made Code (WMC) 68 for cracked or broken rims and WMC 66 for cracked or broken flanges. Shattered rim is covered in the same rule and is assigned WMC 71. The AAR car repair billing database shows that WMC 66, 68, and 71 are the cause for only a small percentage of wheel removals each year. Removals for these defects declined over the period between January 2001 and December 2009 in terms of percentage of wheels removed. Between January 2010 and December 2011, the WMC 66 and 68 removals increased as a percentage of all removals, while the WMC 71 removals decreased even further (AAR 2012). Figure 4 shows the removals as a percentage of all wheel removals in the AAR car repair billing database. Between January 2004 and December 2011, a total of 1,107 wheels were removed for WMC 66, and 2,075 wheels were removed for WMC 68. A total of only 596 wheels were removed for shattered rim during this same period. Annual average removals for these causes over the period January 2004 to December 2011 were 138, 259, and 75 for WMC 66, 68, and 71, respectively. This data, combined with the FRA safety statistics, shows that most wheels are identified and removed without a safety issue. Only 4 percent of wheels with broken rims or flanges result in a train accident  $((137+14)/(1,107+2,075+596) * 100\% = 4.00\%)$ .

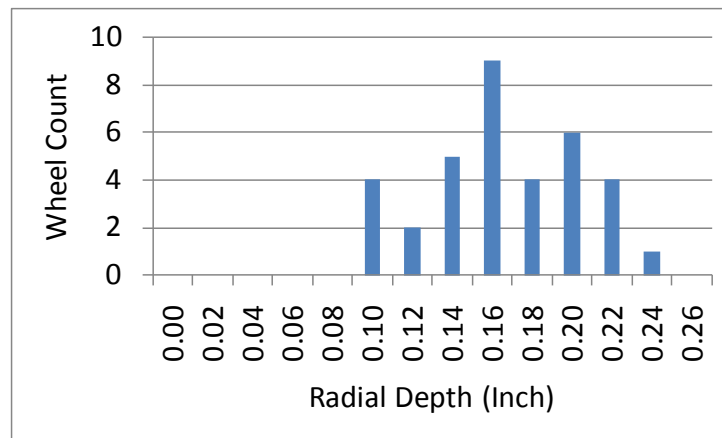
**Figure 6. Histogram of VSR Origin Depths Relative to Worn Tread Surface**

The location of the origin of the failure was determined by visually examining the failure surface. VSR and broken flange wheels usually exhibit faint markings on the failure surface that show the direction in which the crack propagated. By tracing these marks backwards, an origin point was established for each broken wheel. The radial depth of the origin point was then established relative to the existing tread surface and the axial location was established relative to either the front rim face or the back of the flange. Origin radial depths were similar for both VSR and broken flange wheels and ranged from 0.10 to 0.25 in below the tread surface with a median value of 0.17 in. Figure 6 shows a histogram of the origin radial depth relative to the worn tread surface. For VSR wheels, axial locations of the origin ranged from 1.25 to 2.60 in from the front rim face with a median value of 2.10 in. For broken flange wheels, axial locations of the origin ranged from 3 to 3.75 in from the front rim face with a median value of 3.25 in.

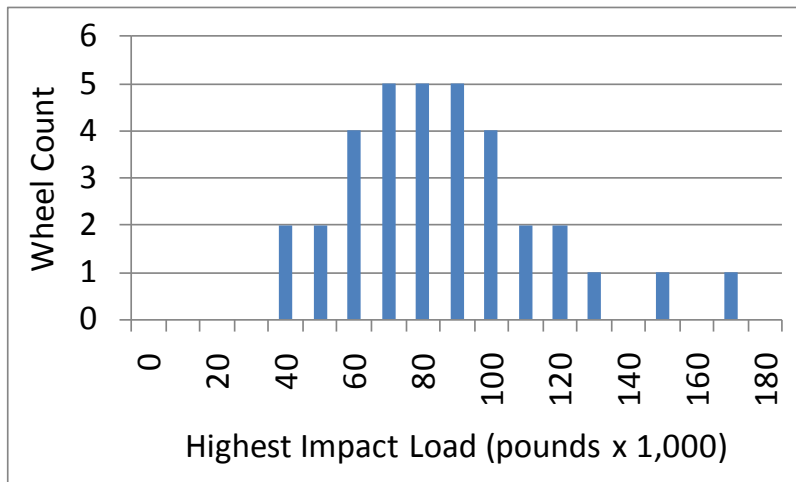
**Figure 8. Histogram of WILD Data**

The wheel impact load detector (WILD) data history from each broken wheel was analyzed. Figure 8 contains a histogram of the highest impact load for each broken wheel up to and including the official failure date. For some wheels, the failure may have occurred prior to passing a WILD site, and therefore the impact load would indicate the conditions after the failure rather than the conditions immediately prior to failure. Sixteen of the broken wheels analyzed had exceeded the AAR limit of a 90,000-pound impact load prior to removal.

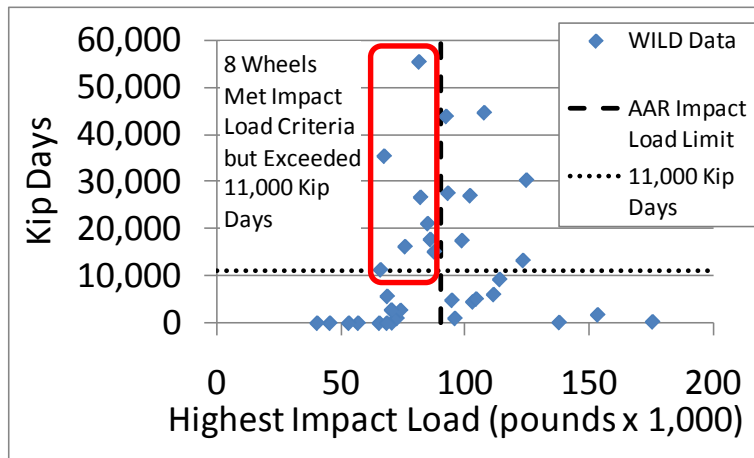
**Figure 9. Kip Days and Highest Impact Loads**

Another way to analyze WILD data is by calculating “kip days.” A kip is a unit of force equal to 1,000 pounds. The kip-day calculation is a way to identify wheels that have been producing noncondemnable impact loads for a long time. A wheel begins accumulating kip days the first time it exceeds a 30,000-pound dynamic load limit (impact load minus average load). Each day thereafter, the highest impact load (in kips) experienced by that wheel is added to the kip days total for the wheel. For example, a wheel with a maximum impact load of 70 kips (70,000 lb) would have a daily accumulation of 70-kip days. The kip days total for a wheel is rezeroed when the wheelset is changed. One railroad has suggested that 11,000-kip days could be used as a limit. Figure 9 shows that if an 11,000-kip day removal criterion was used along with the current 90,000-pound impact load limit, 24 of the 35 broken wheels would have been condemnable based on WILD readings.

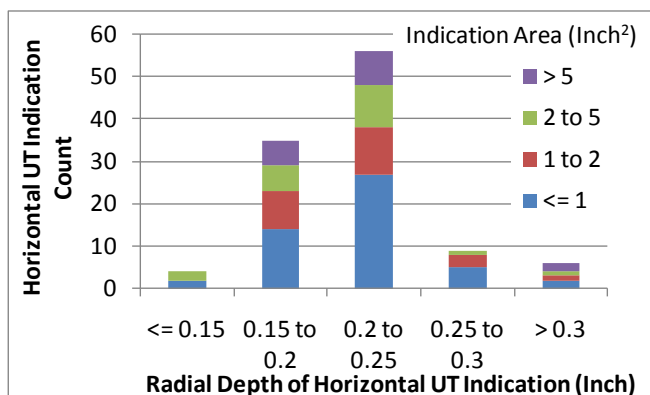
**Figure 10. Size and Depth of Horizontal UT Indications**

TTCI found 111 horizontal UT indications on 27 of the 35 broken wheels. No horizontal UT indications were found on the other eight broken wheels. The UT indications are considered subsurface cracks rather than manufacturing defects such as voids or inclusions because of their large size. The horizontal UT indications ranged in size from 0.1 in<sup>2</sup> to 24.7 in<sup>2</sup> with a median value of 1.3 in<sup>2</sup>. The radial depth of the horizontal UT indications ranged from 0.11 in to 0.60 in with a median value of 0.21 in. Figure 10 shows the depth and area of the horizontal UT indications found in the broken wheels. The majority of the horizontal UT indications (83 percent) were found in the same range of radial depths as the expected maximum stress and the failure origins.

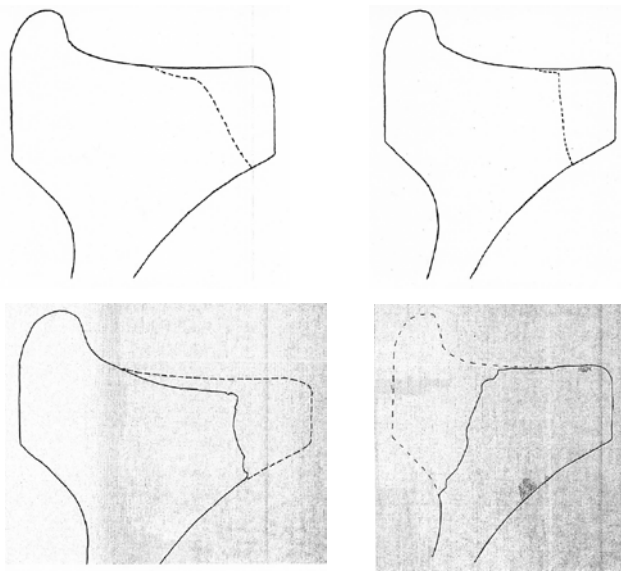
**Figure 14. Sketches of VSR and Broken Flange Wheel Profiles Showing the Broken Piece with a Dashed Line (Berge 2001)**

The horizontal separation of tread layers associated with VSR and broken flange wheels has been shown previously. However, it has typically been attributed to shelling rather than subsurface cracking (Berge 2001). Sketches of the transverse profiles of four broken wheels show a shallow horizontal component to the vertically broken piece. Figure 14 shows these profiles.

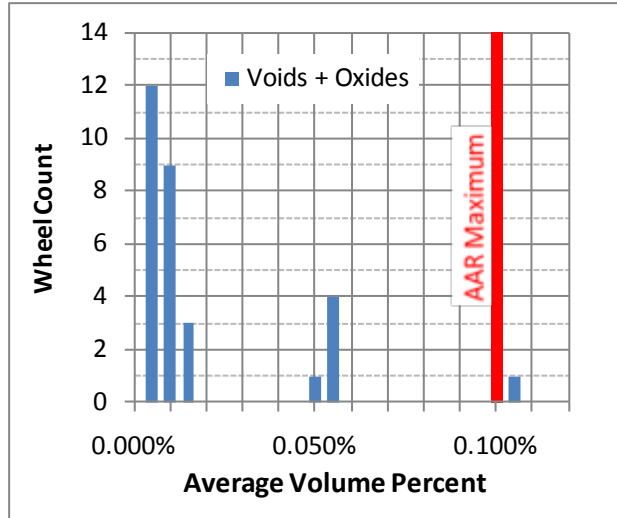
**Figure 19. Histogram of Average Volume Percent Microcleanliness Results**

Sample preparation and analysis was conducted according to AAR specifications. Figures 19 and 20 show the microcleanliness results of the VSR and broken flange wheels compared with AAR limits in terms of average volume percent and maximum volume percent, respectively. All but two of the wheels met the current AAR microcleanliness limits and most wheels met the current limits by a wide margin. Both wheels that exceeded AAR limits failed because of VSR and were manufactured prior to the AAR microcleanliness requirement.

These test results show that failure of the AAR microcleanliness test is not a prerequisite for VSR or broken flange failure. In a bulk sense, the steel in the wheels tested appears to be typical of many wheels in service today. Therefore, these results would not provide support for further tightening of the limits associated with the current AAR microcleanliness test. Unfortunately, the fracture surface of VSR and broken flange wheels nearly always sustains significant damage while in service making it nearly impossible to obtain conclusive evidence about voids or inclusions in the immediate fracture area that may have caused or contributed to the failure. Destructive microcleanliness tests only examine a tiny percentage of the steel in a tiny percentage of the wheels produced. As nondestructive testing methods improve, it may become practicable to substantially reduce the allowable defect size in both new wheels and reprofiled wheels.

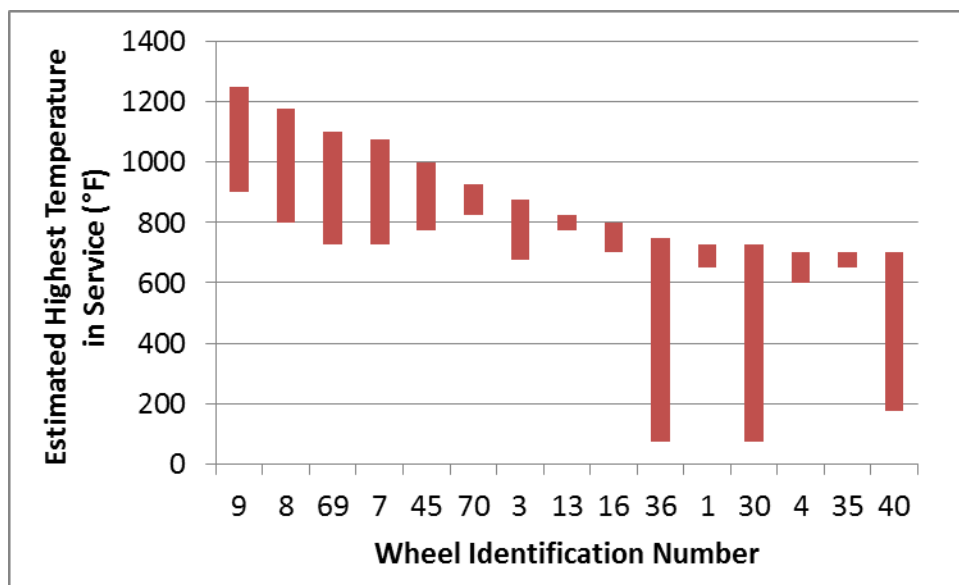
Figure 21. Estimated Maximum Temperature of Wheels

By comparing the microstructures of each sample with other samples of wheel steel that had been exposed to controlled temperature conditions (Dedmon 2009), a range of maximum temperatures was estimated for each of the 15 samples. Figure 21 shows these estimates. The published data regarding the microstructure following controlled thermal exposure was gathered using samples of wheels that had not been exposed to the service environment and therefore did not have any work hardening in the wheel rim. Because of this difference, the 15 samples all had hardness readings higher than the comparison wheel samples from the literature and therefore hardness could not be used to help increase confidence in the estimated thermal history.

The maximum temperature estimates of the wheel samples show that 5 out of the 15 VSR wheels examined may have been exposed to temperatures of 1,000 °F or greater while in service, resulting in substantial spheroidization of the microstructure. This transformation results in a decrease in strength and fatigue life and could potentially play a role in wheel shelling and VSR formation.

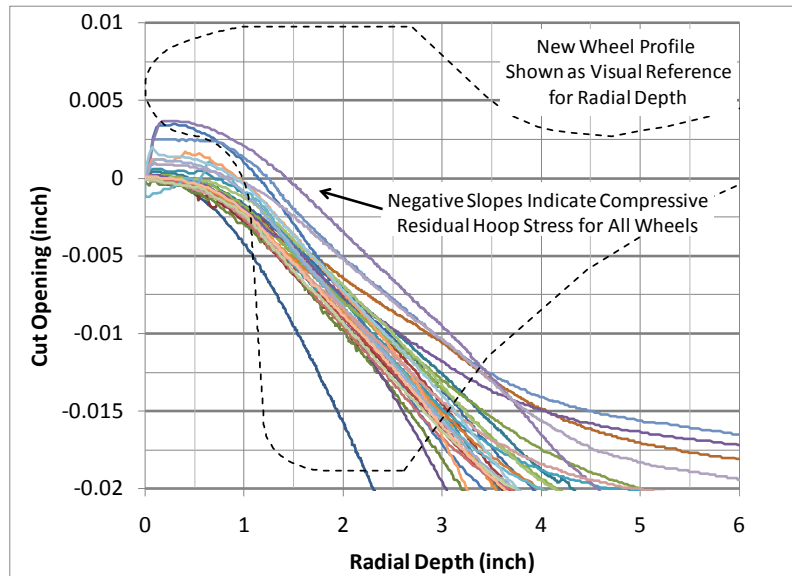
**Figure 23. Saw Cut Results Showing Compressive Residual Hoop Stress for All Wheels Tested**

Figure 23 shows plots of the changes in the kerf width as a function of the cut depth for each wheel. A new single wear wide flange wheel is also shown to provide a visual reference for the cut depth. For many of the wheels, the kerf increased in width during the initial 0.25 in of the cut depth indicating tensile residual hoop stress in the outermost tip of the flange. However, the kerf decreased in width for all wheels as the blade progressed further into the flange and rim indicating that all of the wheels were in a state of residual compressive hoop stress as desired. This state of stress would indicate that none of these wheels had been exposed to extreme heating immediately prior to VSR or broken flange failure. Any tensile residual hoop stress in the tip of the flange should not have a significant effect on VSR or broken flange failures that initiate near the tread surface.

The results from the thermal history tests and the residual hoop stress tests seem to contradict each other to some degree until examined further. The thermal history testing showed at least five wheels with estimated maximum temperatures that may have exceeded 1,000 °F, yet the residual hoop stress testing showed that all of the wheels were in a state of compressive residual hoop stress. Normal wheel-rail contact causes plastic deformation in the wheel rim, which imparts compressive residual hoop stress in the wheel. It is plausible that some wheels are temporarily heated in service to temperatures sufficient to cause changes in the microstructure (and change the residual stress state from compressive to tensile), but return to a state of compressive residual hoop stress after they cool down and experience normal cold working. This implies that none of the wheels failed while they were at temperatures high enough to relieve the compressive residual hoop stress, but instead failed (or were discovered and removed from service) after they had accumulated sufficient rolling cycles at a cool temperature to return to a state of compressive residual hoop stress.

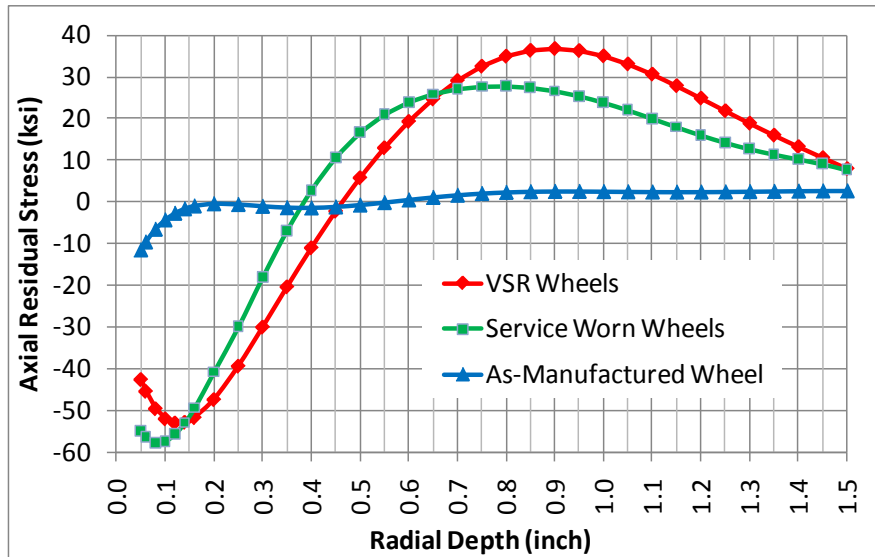
**Figure 25. Composite Results of Axial Residual Stress Testing of Class C Wheels**

Figure 25 shows the average composite axial residual stress as a function of radial depth for the VSR wheels, the service-worn wheels, and the as-manufactured wheel. A radial depth of 0.0 in indicates the tread surface.

The most striking observation from the results is the overwhelming influence the service load environment has on the axial residual stress in AAR Class C wheels. While the heat treatment during manufacturing imparts a relatively small compressive residual stress near the tread surface, the service load environment produces much larger compressive and tensile axial residual stresses from the plastic deformations associated with rolling contact. The VSR wheels and the service-worn wheels show similar trends—i.e., large compressive residual stress near the tread surface transitioning to large tensile residual stress at approximately 0.4-inch radial depth.

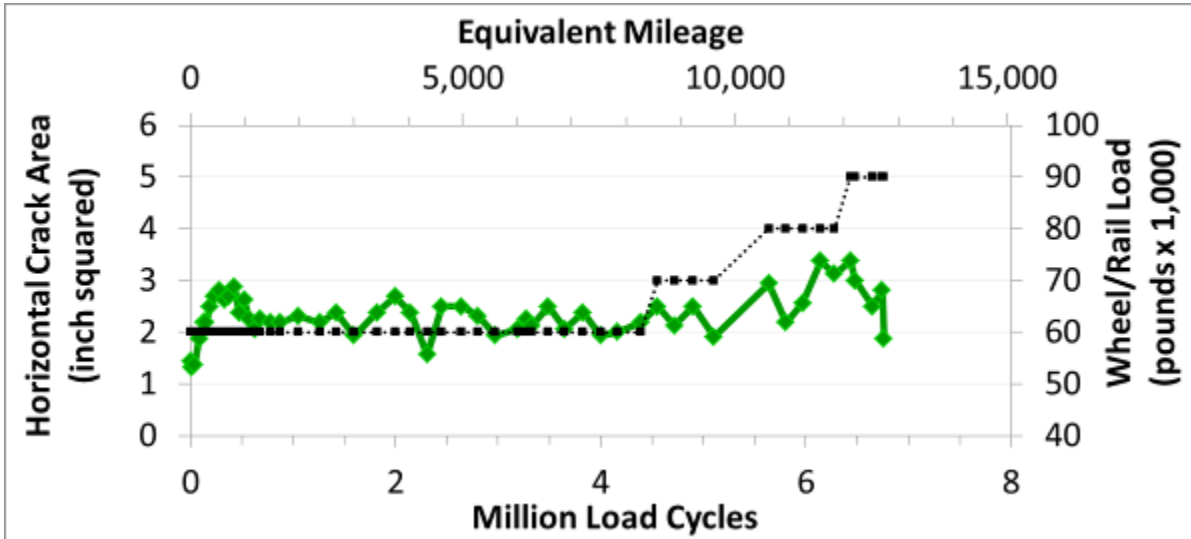
Significant runout of 0.110 in developed on the wheel tread from deformation and wear, forcing the rolling load machine to work harder on every load cycle. After approximately 6.8 million load cycles, the test was stopped because the machine was no longer able to cycle the rail because of the combination of large contact force and radial runout on the wheel. Figure 28 shows the effect of wear and deformation on the transverse wheel profile. Figure 29 shows the crack area and the wheel-rail contact force from this test as a function of the number of load cycles.

**Figure 29. Horizontal Crack Area (Green) and Contact Loads (Black) from the First Rolling Load Test**

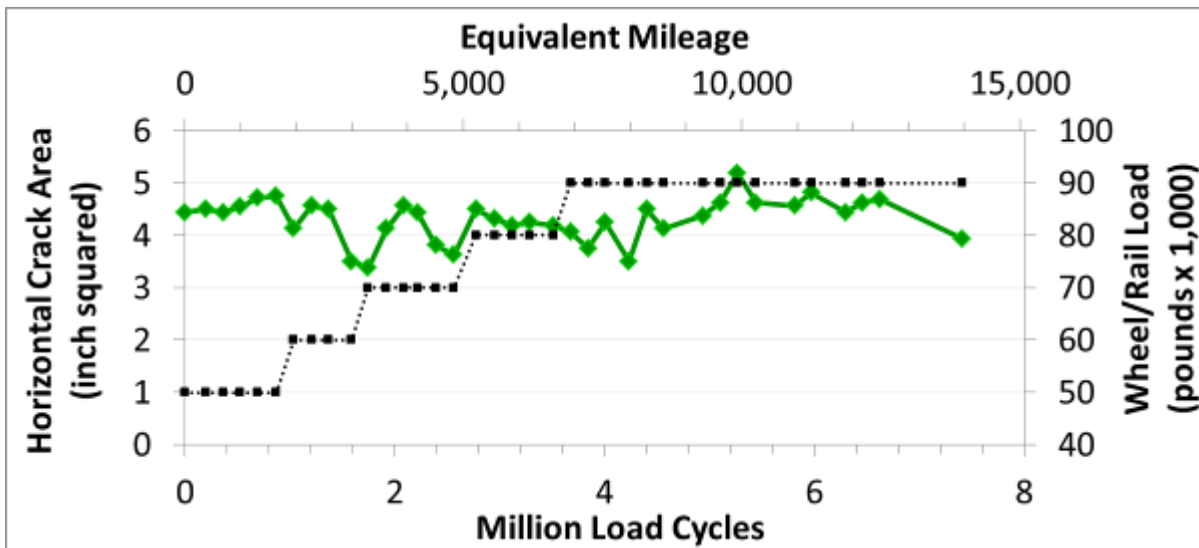
A second wheel with a 4.3 in<sup>2</sup> preexisting horizontal crack was selected (also originally mounted on the same wheelset as a VSR wheel), and testing was resumed. The vertical load was initially set to 50,000 lb and increased by 10,000 lb approximately every million-load cycle up to the machine maximum. Again, the wheel developed a significant radial runout of 0.120 in from deformation and wear during the test. After 7.4 million load cycles, the machine experienced a failure in one of the support posts, and the test was stopped. The crack area in the wheel did not change appreciably during this test. Figure 30 shows the crack area and the wheel-rail contact force from the second test.

**Figure 30. Horizontal Crack Area (Green) and Contact Loads (Black) from the Second Rolling Load Test**
