**Federal Railroad
Administration**

Tread Buildup on Railroad Wheels

1. AGENCY USE ONLY (Leave blank)	2. REPORT DATE April 2015	3. REPORT TYPE AND DATES COVERED Technical Report – May 2013	
4. TITLE AND SUBTITLE Tread Buildup on Railroad Wheels		5. FUNDING NUMBERS Task Order 253 Contract DTFR53-00-C-00012

9. SPONSORING/MONITORING AGENCY NAME(S) AND ADDRESS(ES) U.S. Department of Transportation Federal Railroad Administration Office of Research and Development Washington, DC 20590		10. SPONSORING/MONITORING AGENCY REPORT NUMBER DOT/FRA/ORD-15/06

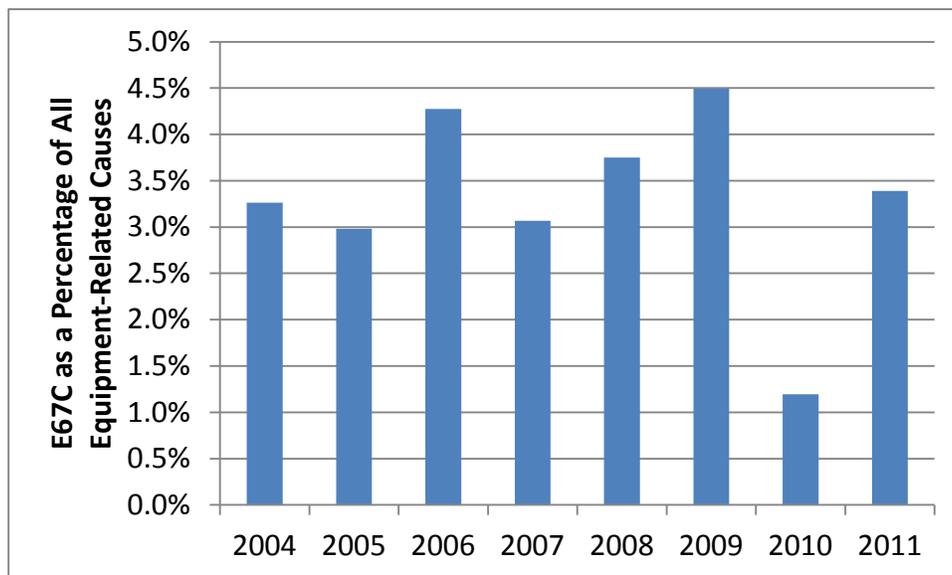
Figure 2. TBU Accidents from FRA Safety Database

FRA’s safety database shows that TBU (cause code E67C “Damaged flange or tread (buildup)”) is a high ranking cause of FRA reportable train accidents. Between January 2004 and December 2011, a total of 85 accidents were attributed to TBU for an average of 10.625 TBU accidents per year. Of all equipment-related accidents, TBU is the sixth most common cause. Of wheel-related accidents, TBU is the second most common cause (E61C “Broken rim” is the most frequent wheel-related accident cause and is the subject of related research conducted under this same contract). Figure 2 shows the accidents attributed to TBU as a percentage of accidents attributed to all equipment-related causes. No steady trend is evident. [1]

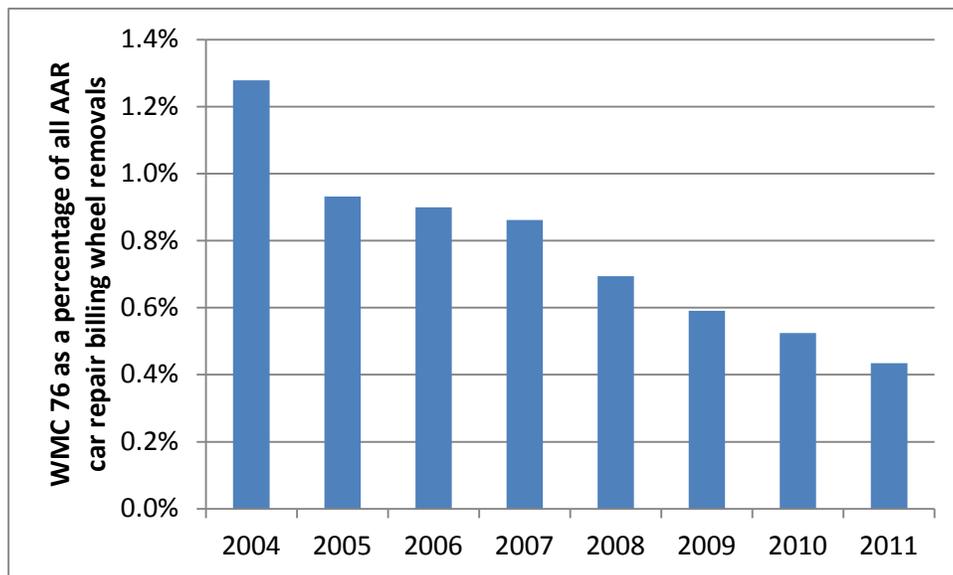
Figure 3. Wheel Removals for TBU from AAR Car Repair Billing Database

AAR's car repair billing database shows that TBU causes only a small percentage of wheel removals each year. TBU removals have been declining from January 2004 to December 2011, both in terms of the number of wheels removed and the percentage of wheels removed. Figure 3 shows TBU removals as a percentage of all wheel removals in the AAR car repair billing database. A total of 44,050 wheels were removed during this time because of TBU, resulting in an average of 5,506 TBU wheels removed per year [2]. This data, combined with FRA safety statistics, shows that the vast majority of TBU wheels are identified and removed in advance of a safety issue. Only about 0.22 percent of TBU wheels result in a train accident ($98/44,050 * 100\% = 0.22\%$).

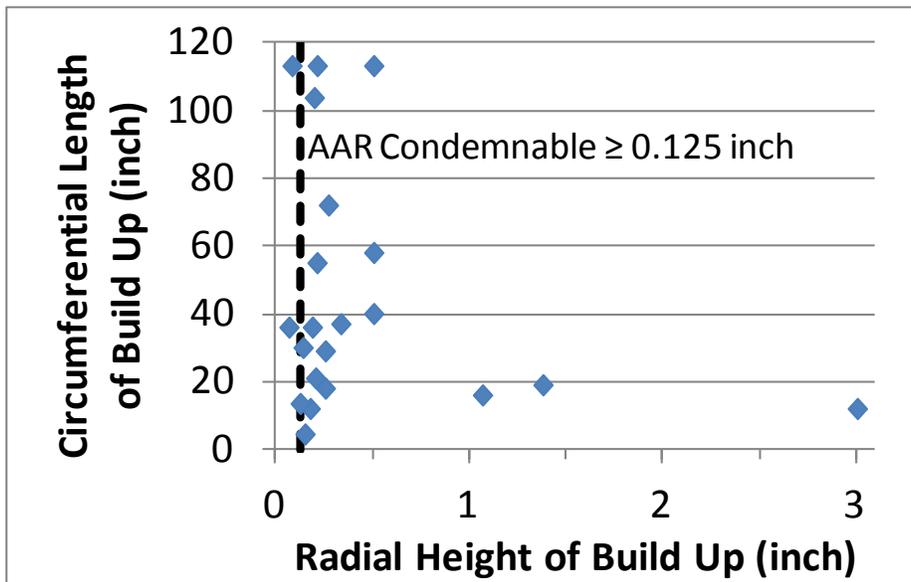
Figure 6. TBU Dimensional Data

Varying amounts of TBU were found. Three wheelsets had TBU heights greater than 1 inch; the highest measured 3 inches radially off the tread surface. Figure 5 shows this wheel. The wheels with the highest TBU measurements were also the wheels with some of the shorter TBU lengths. Figure 6 shows the circumferential length and radial height of the TBU on each wheel. From a safety standpoint, the radial height of the TBU material is of primary concern. The three wheels with a TBU radial height of more than 1 inch and a circumferential TBU length less than 20

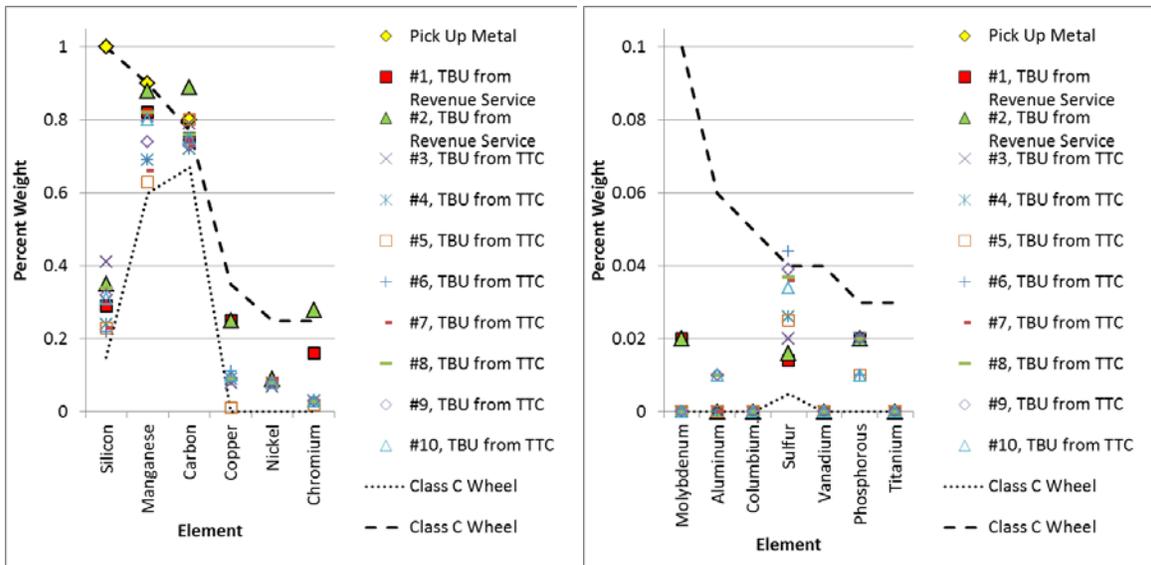
Figure 8. Chemical Content of Metal Pickup [11] and TBU Compared with Wheel Steel

A chemical analysis of TBU samples indicated that the source of the material is likely a combination of wheel and rail steel. The TBU material from two wheels removed from revenue service and from eight wheels that were dragged on the tracks by TTCI was evaluated for chemical content. The percentage of carbon in the TBU material was in the range of Class C wheel steel (0.67 to 0.77) for six of the TTCI-created samples and one of the revenue service samples. Two of the TTCI-created samples had carbon content between the maximum for wheels (0.77) and the maximum for standard rail steel (0.84). One of the TBU samples from revenue service had a carbon content of 0.89, which is higher than the maximum for wheels or standard rail steel, but within the range for premium rail steel (approximately 1 percent). The percentages of other elements in the TBU samples were generally within the specified limits for wheel steel. Figure 8 shows the chemical content by percent weight of 10 TBU samples in comparison with the specified minimum and maximum chemistry limits for AAR class C wheels. Also included in Figure 8 are the previously reported percentages of silicon, manganese, and carbon from brake shoe metal pickup [11].

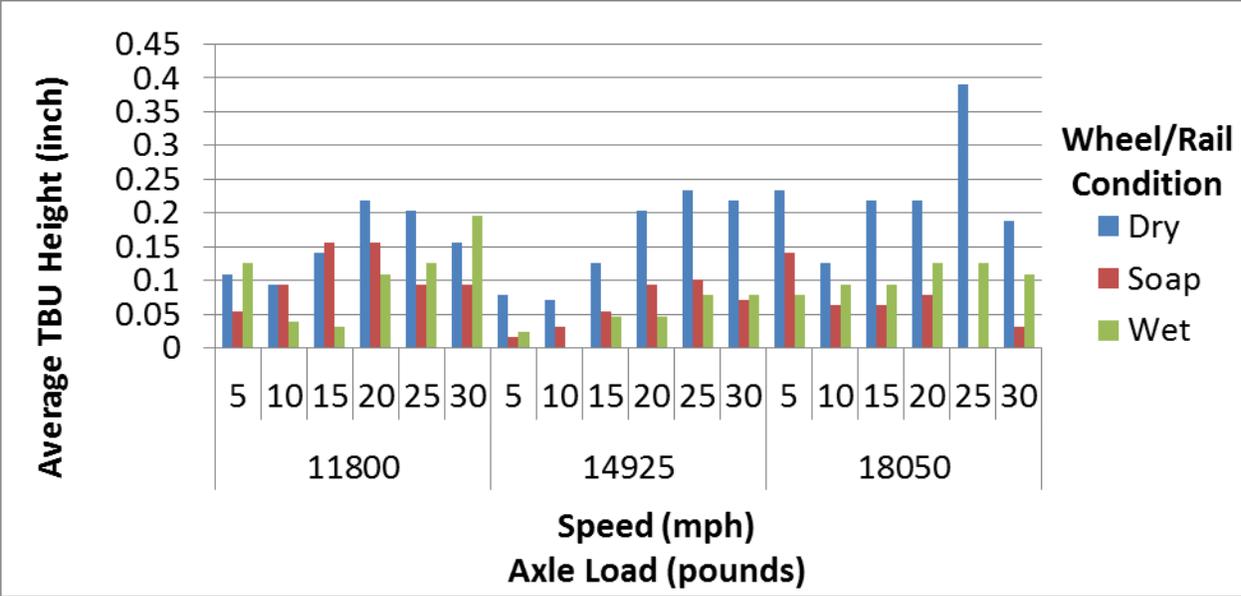
Figure 9. Average TBU for the Short Slide Tests

Figure 9 shows the average TBU height for the four sliding wheels from each of the short (4,000 feet) slide tests. Although there was much variation in the data, the measured TBU was highest when the rail was dry and the car was loaded to its heaviest test condition (18,050-pound axle load). Test speeds between 20 mph and the short slide maximum speed of 30 mph generally produced the most TBU. This is a logical trend, because the heat at the contact patch is related to the wheel-rail normal force and the friction conditions. Review of the video during the slide tests showed that, in some cases, TBU would form and fall off the wheel during the test. TBU measurements were recorded at the conclusion of the slide, so the final TBU height was not always indicative of the total amount of TBU formed during the slide.

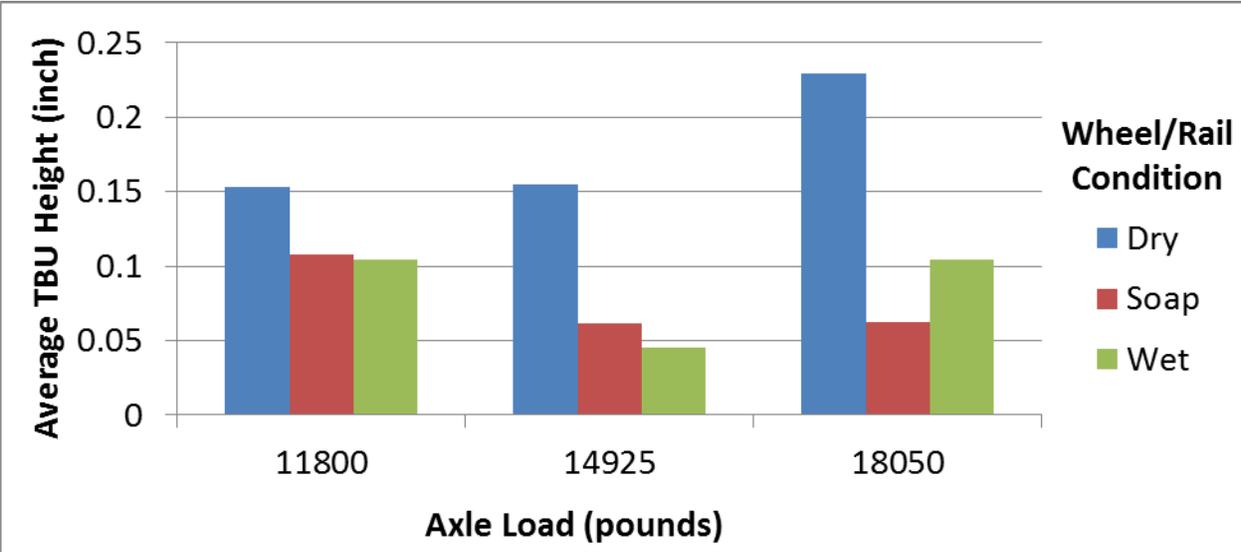
Figure 10. Average TBU for the Short Slide Tests Grouped by Axle Load

Figures 10 and 11 show the average and maximum TBU heights grouped by axle load and wheel-rail condition, respectively. The trends of the results are more obvious with the results grouped in this manner; they indicate that heavier axle load and dry rail produce more TBU. An exception to this trend can be seen in Figure 11 in which the test with the lightest axle load and wet rail produced a higher maximum TBU measurement than expected compared with the trends of the other tests.

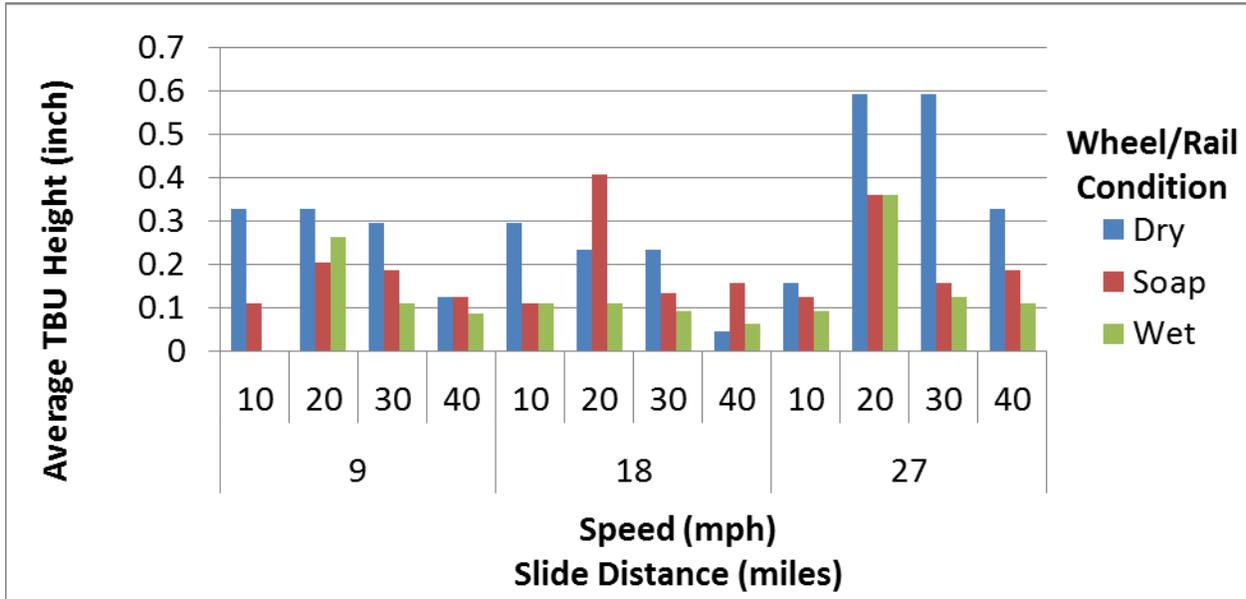
Figure 12. Average TBU for the Long Slide Tests

Figure 12 shows the average TBU height for the four sliding wheels from each of the long slide tests. As was the case with the short slide tests, the long slide data showed much variation. In general, TBU accumulated to the greatest heights under dry conditions and at longer slide distances. Train speeds between 20 and 30 mph appeared to optimize TBU height. Figure 13 shows a photo of the highest TBU created during the tests, measuring 1 inch high after a 27-mile slide at 30 mph in dry conditions.

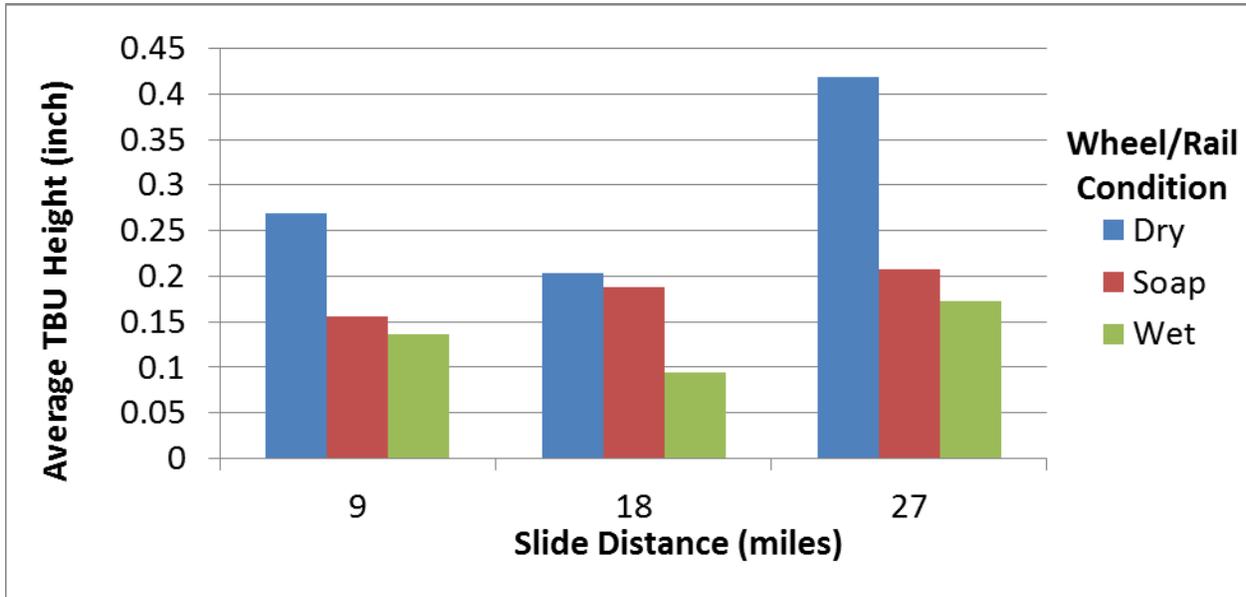
Figure 14. Average TBU for the Long Slide Tests Grouped by Slide Distance and Wheel-Rail Condition

Figure 14 shows the data grouped by slide distance and wheel-rail condition. Figure 15 shows the data grouped by test speed and wheel-rail condition. Grouping the data in these ways allows the trends to be more readily identified.
