U.S. Department
of Transportation
**Federal Railroad
Administration**

Safety Testing of Intermodal Hazmat Configurations, Summary Report

George Kachadourian

1. Report No. DOT/FRA/ORD-88/04	2. Government Accession No.	3. Recipient's Catalog No.	
4. Title and Subtitle Safety Testing of Intermodal Hazmat Configurations, Summary Report		5. Report Date March 1988

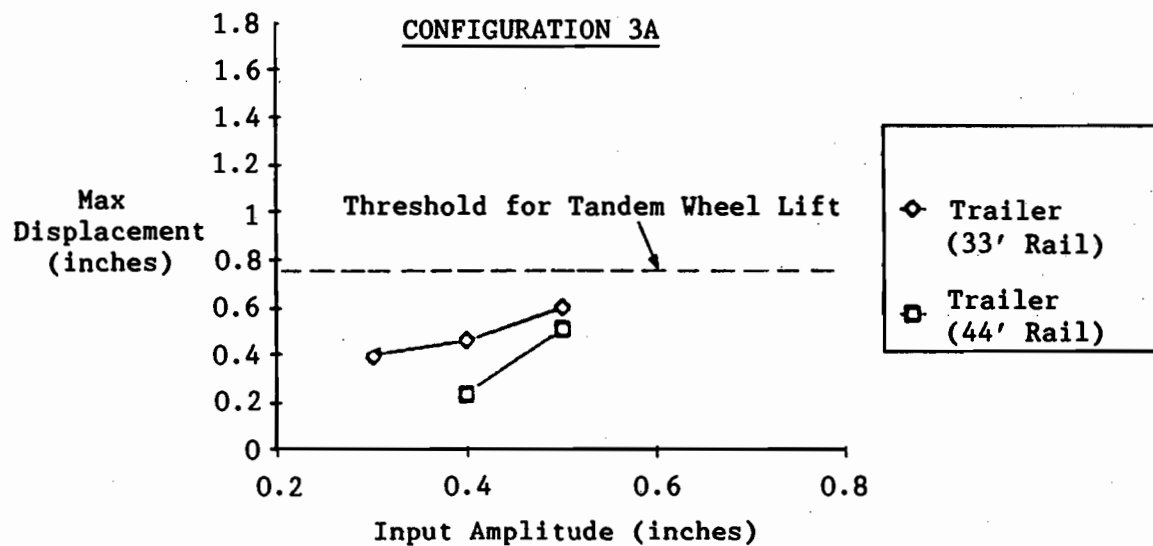
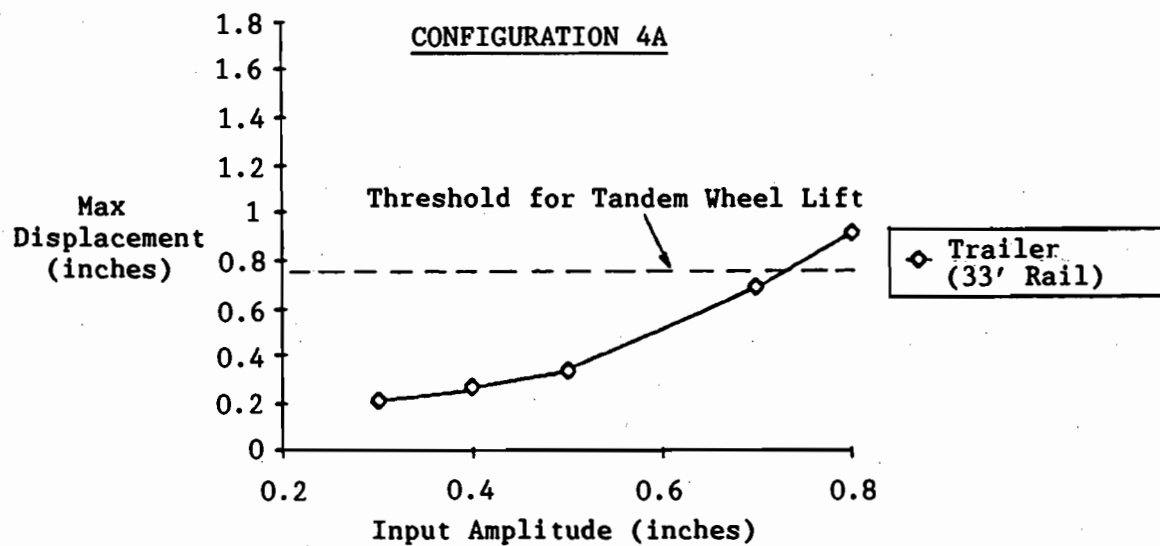
FIGURE 2-2
MAXIMUM TANDEM WHEEL DISPLACEMENTS RELATIVE TO
FLATCAR DECK, CONFIGURATIONS 3A AND 4A,
BOUNCE AND PITCH TESTS

The Bounce and Pitch Test Results are summarized in the tandem wheel displacements of Figures 2-2 and 2-3 and the flatcar vertical wheel loads of Figure 2-4. All of the configurations tested, i.e., 3A, 4A, 5A, and 6,

had wheel lift of the tandems at bump heights of less than 0.8 inches: Configurations 4A and 5A were between 0.7 and 0.8 inches, Configuration 3A was between 0.5 and 0.6 inches, and Configuration 6 was between 0.4 and 0.5 inches. Vertical wheel loads for the flatcar reached a maximum unloading of about 70% (where wheel lift would be 100%). Critical speeds ranged from 45 to 75 mph.

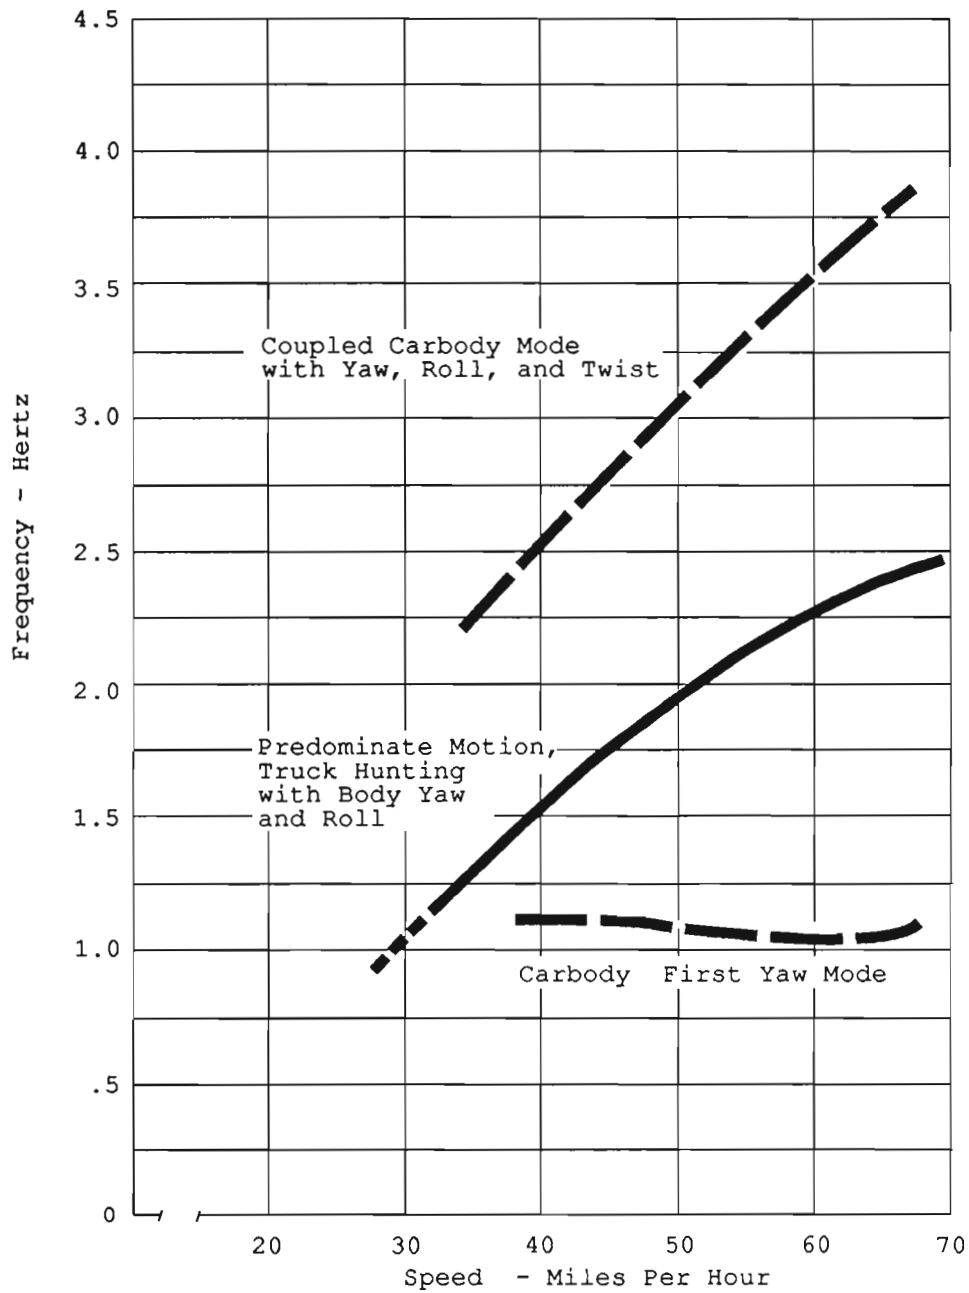
FIGURE 4-3
FREQUENCY CONTENT OF VEHICLE MOTIONS AT HUNTING SPEEDS,
COMPOSITE OF ALL CONFIGURATIONS

There were three characteristic frequencies found in the accelerometer and wheel force data. These frequencies are shown in Figure 4-3 plotted against track speed. The lowest frequency was between 1.0 and 1.1 Hertz and corresponds to the first yaw mode for this configuration. The middle frequency ranged from 1.0 to 2.5 Hertz with corresponding speeds from 30 to 70 mph and was the predominant hunting motion of the vehicles. The third frequency ranged from 2.0 to 4.0 Hertz for the same speed range. It should be noted that hunting motions occur at all speeds but have relatively small amplitudes and damp out after a few cycles at speeds below hunting. As the hunting threshold is approached the amplitudes increase and continue for a greater number of cycles. In full hunting the amplitudes are limited by gage clearance and the motions continue indefinitely. The hunting motion was a coupled body yaw and second roll with a nosing tendency, that is the leading end was at a larger amplitude than the trailing end. The motion of the third frequency is believed to be an occasional burst of coupled yaw, second roll and body twist with both ends at about equal amplitude.

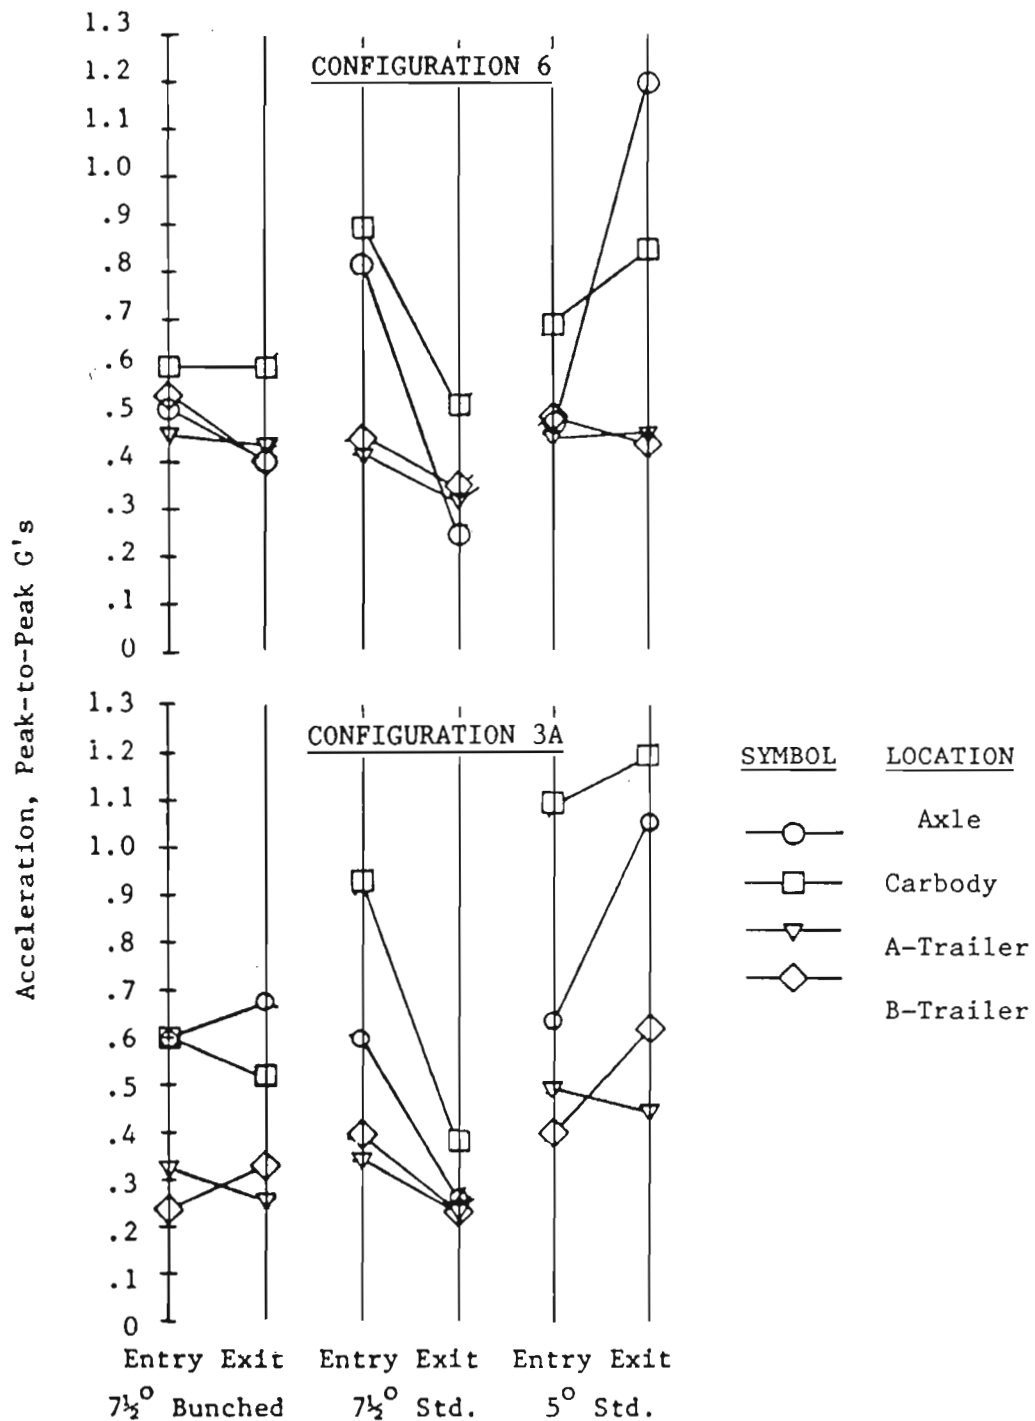
FIGURE 4-5
SUMMARY OF LATERAL ACCELERATION DATA FROM FOUR ACCELEROMETERS
DURING CURVE ENTRY AND EXIT

- The largest accelerations were experienced in the 5 degree curve entry and exit.
- There was little difference between bunched and standard spiral except that the highest lateral g values in the 7.5 degree curve were experienced in the standard spiral entry.
- Carbody and axle lateral accelerations were consistently at higher g values than trailer lateral accelerations.
- Carbody lateral accelerations were generally higher than for the wheel set.
- There were no significant differences in responses between configurations 3A and 6.

Two general conclusions are indicated by this accelerometer data: 1) since trailer response was less than carbody response, liquid lading seems to have a dampening effect on transient responses during curve entry and exit; and 2) bunched spirals do not worsen the lateral transient responses during curve entry and exit.

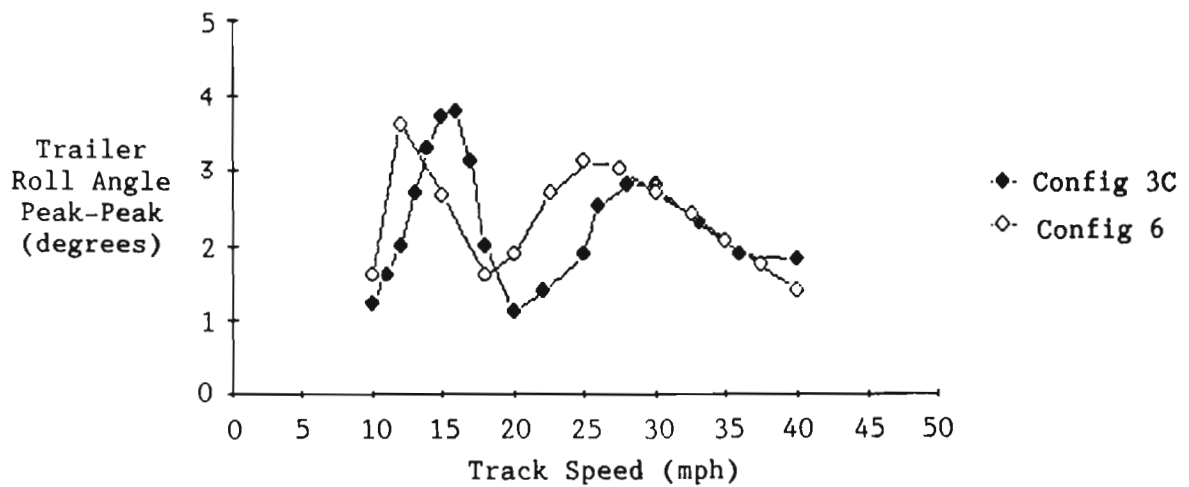
FIGURE 4-8
CONFIGURATIONS 3-C AND 6, BALLOON TRACK, PERTURBED SECTION
TRAILER ROLL ANGLES

The trailer roll angles, Figure 4-8, reached maximums of 4 degrees peak-to-peak in the first roll mode, and 3 degrees in the trailer roll mode. These are relatively mild responses for the perturbed track test.

The vertical displacement data for the trailer wheels reached values of 1.05 inches peak-to-peak in first roll and 1.22 inches peak-to-peak in trailer roll. These displacements are close to wheel lift conditions based on vibration tests in the Rail Dynamics Laboratory where it was estimated

that trailer wheel lift occurred between 1.2 and 1.4 inches peak-to-peak displacement measured at the axle.

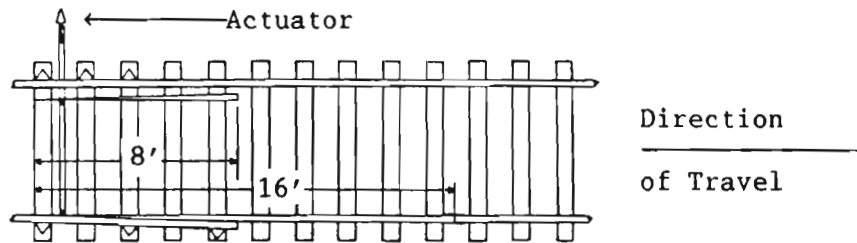
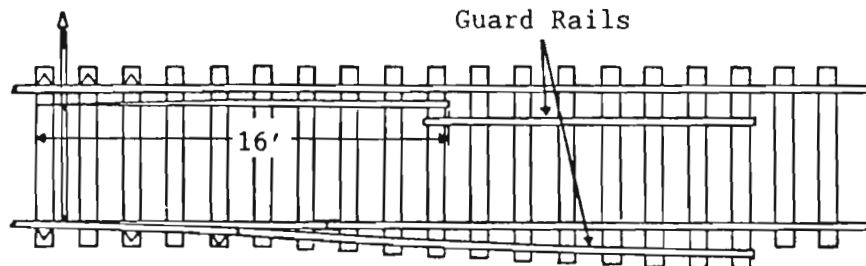
**FIGURE 5-6
DERAILING SWITCH CONFIGURATIONS FOR THE
BROKEN RAIL DERAILMENTS**

There were three changes made to the derailing switch. For Test 3, a guard rail was placed on the gage side of the left rail in an attempt to cause the derailed car to run parallel to the rails rather than move to the right. In Test 4 the right switch point was shortened from 16 to 11 feet to shorten the switch response time. In Test 6, the left switch point (8-foot) was replaced with a 16-foot switch point because it was found in Test 5 that at 60 mph the wheels were climbing the left switch point. Also, a guard rail was added outside the right rail to help keep the derailed car from moving to the right. Diagrams of the derailing switch in its several configurations are shown in Figure 5-6.

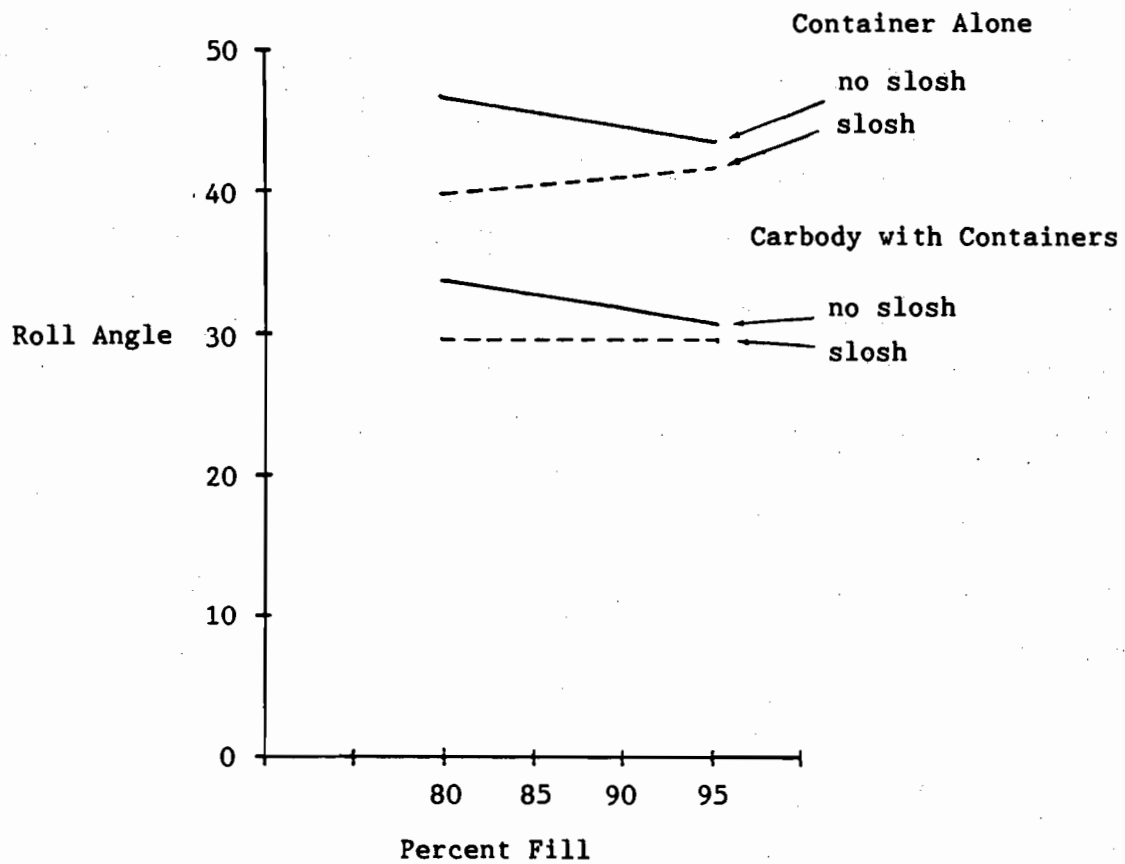
**FIGURE 6-2
COMPARISON OF CRITICAL ROLL ANGLES,
SPECIFIC GRAVITY OF 0.9**

Representative results of the static analysis are presented in Figure 6-2, a plot of critical roll angles for the range of percent of fill studied, for the specific gravity of 0.9. The plot shows that the critical roll angle is about 30 degrees. The analysis showed that with 95% fill the critical roll angle ranged from 29 degrees for specific gravity of 1.0 to 32 degrees for specific gravity of 0.70.

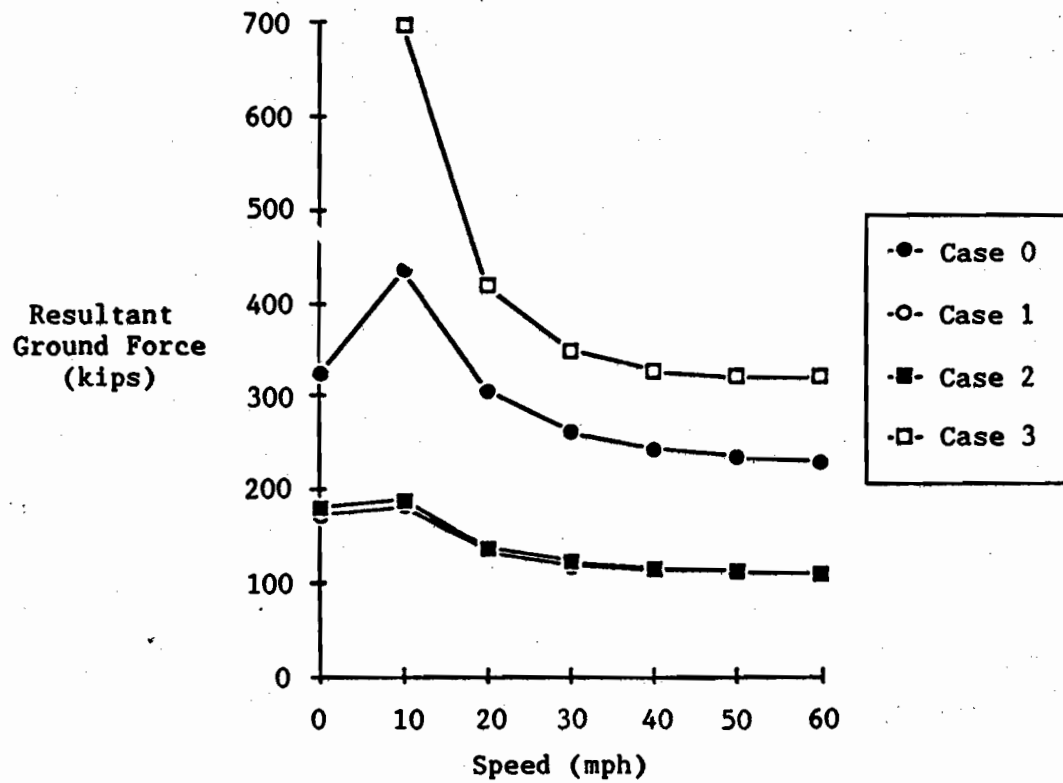
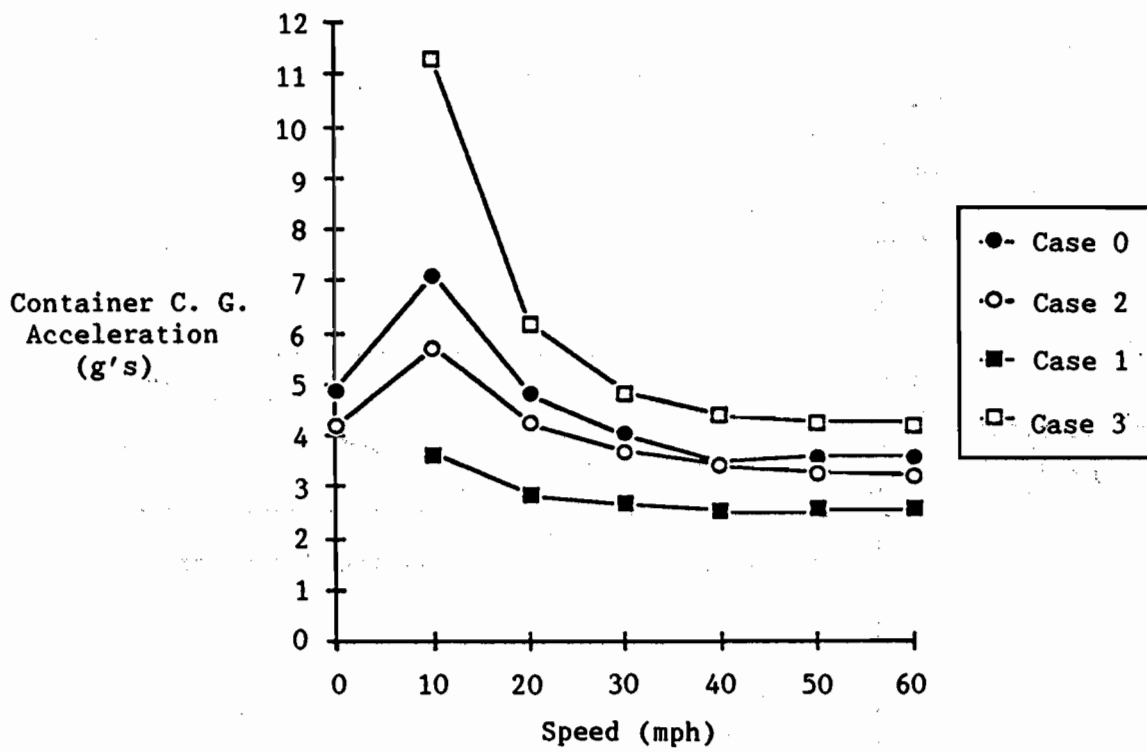
FIGURE 6-3
COMPARISON OF CONTAINER GROUND IMPACT FORCES

It should be noted in Figures 6-3 and 6-4 that the highest loads occur at or below 10 mph. This can be attributed to the soil properties used in the formulation of the ground impact forces. Soil properties were adjusted to duplicate soil conditions of the derailment test. More specifically, ground penetration forces were found to decrease with increased forward velocity because of the plowing effect resulting from the forward motion.

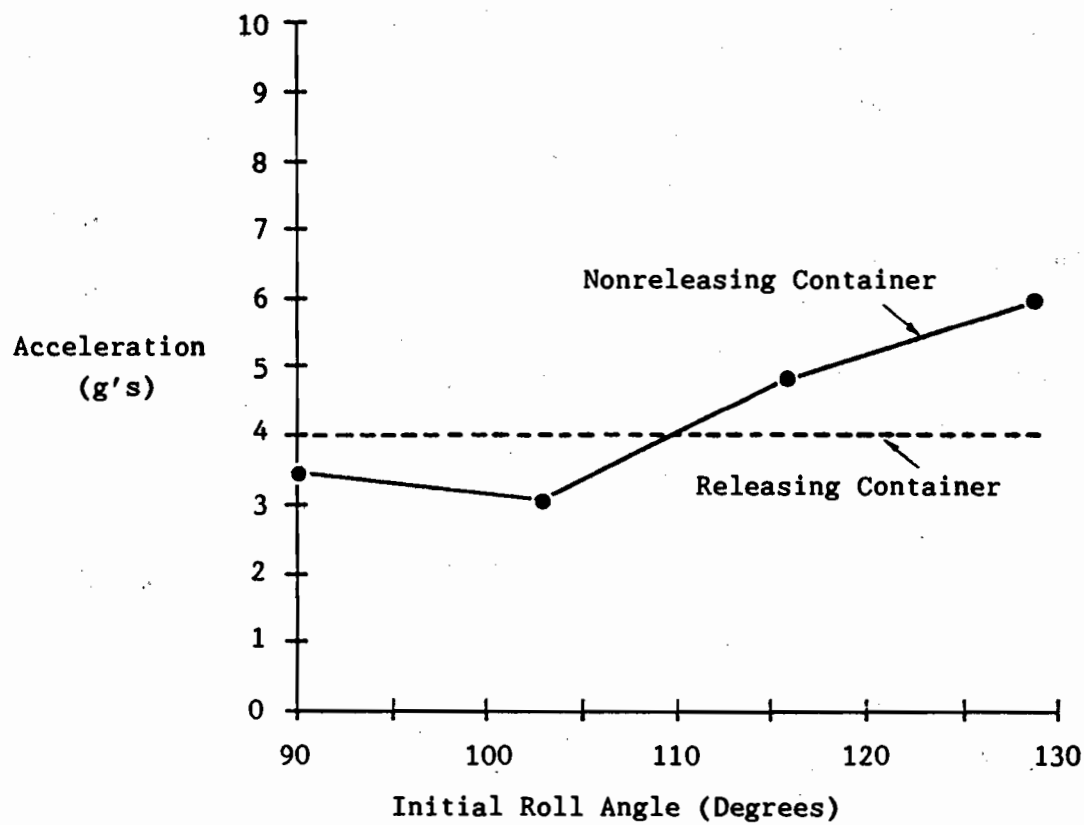
FIGURE 6-5
EFFECT OF ROLL ANGLE AT GROUND IMPACT ON CONTAINER
RESULTANT ACCELERATION FOR A
NONRELEASING ROLLOVER AT 30 MPH

The container c.g. acceleration is shown in Figure 6-5 plotted against initial roll angle. Below 110 degrees, the releasing container has the higher loading and above 110 degrees, the nonreleasing container has the higher loading.
