**Evaluation of Immediate Actions Taken to Deal with Cracking Problems  
Observed in Wheels of Rail Commuter Cars**

**(U.S.) John A. Volpe National Transportation Systems Center  
Cambridge, MA**

DOT/FRA/ORD-93/15  
DOT-VNTSC-FRA-93-3

Final Report  
July 1993

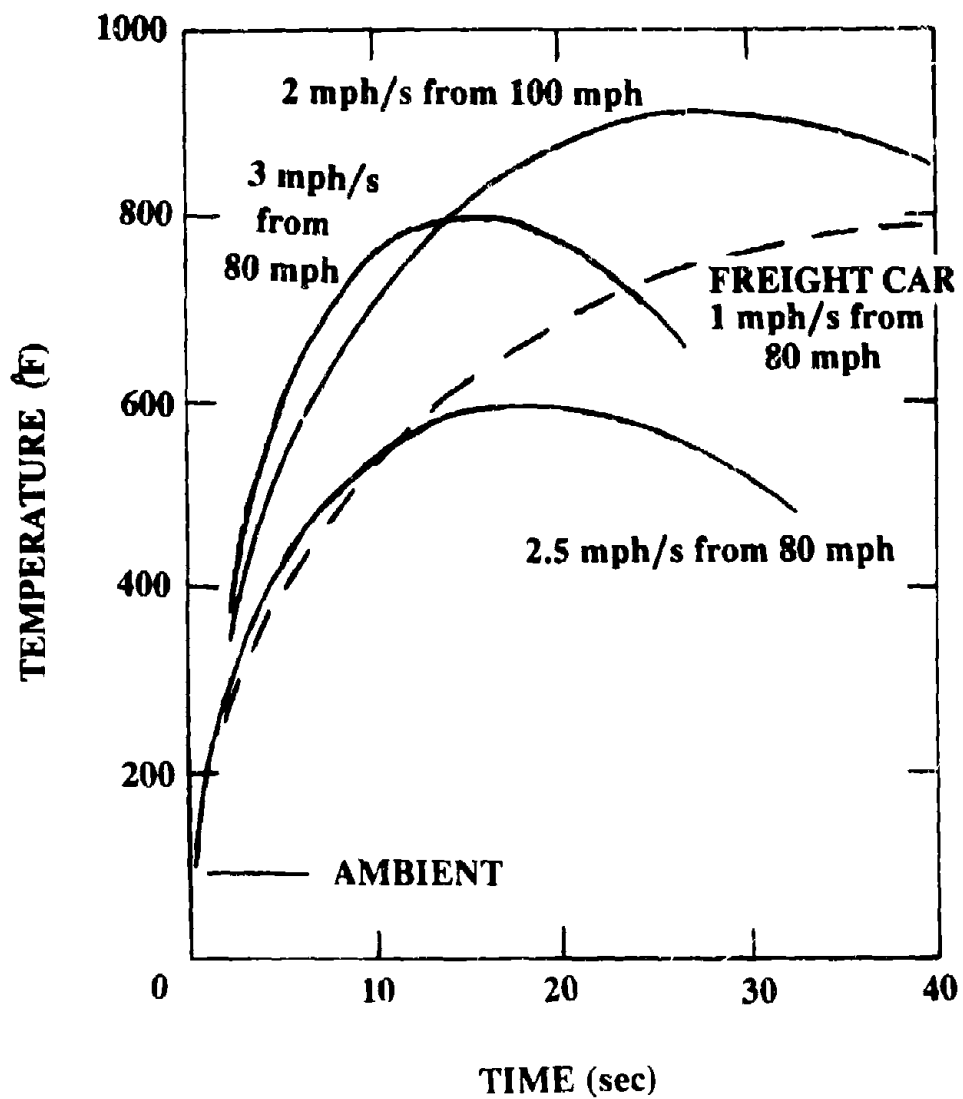
Figure 2. Approximate Estimates of Tread Temperature Versus Time.

The peak temperatures shown in Figure 2 are useful mainly as comparative indicators. Thus, actual tread temperatures should be affected strongly by both operating speed and braking rate, but only moderately by the relatively minor variations of MU car weight (see Table 1). Comparison of temperatures in the ten lumped elements at a fixed time revealed a steep gradient, suggesting that only the outer rim region would experience very high temperatures. The results also suggested that typical MU stopping profiles without the aid of dynamic braking could lead to tread temperatures in the tempering range of wheel steel.

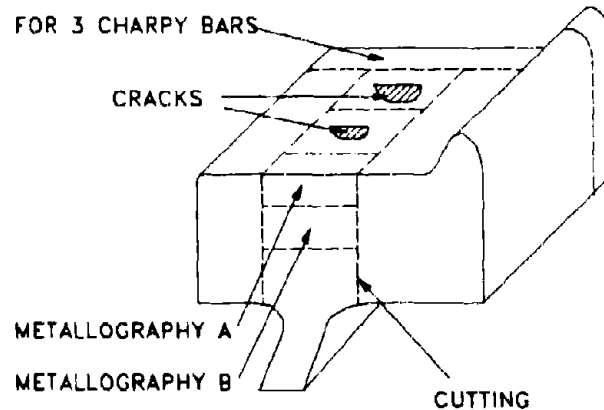
Figure 6. Specimen Locations (Car #1501 Mate Wheel) [6].

One of the car #1501 mate wheel rim blocks was examined at the Massachusetts Institute of Technology (MIT) [6]. Two specimens, each containing a center tread thermal crack, were cut from the outer region of one of the rim blocks and broken in liquid nitrogen to expose the crack propagation surfaces. Adjacent specimens were cut from the same block for metallography and fracture toughness testing (Figure 6).

Charpy bars were machined from a specimen of the car #1501 mate wheel rim block (see Figure 6) and tested at room temperature to provide data for estimation of the wheel steel fracture toughness. The fracture toughness of carbon steel alloys can be estimated from the empirical formula [9]:

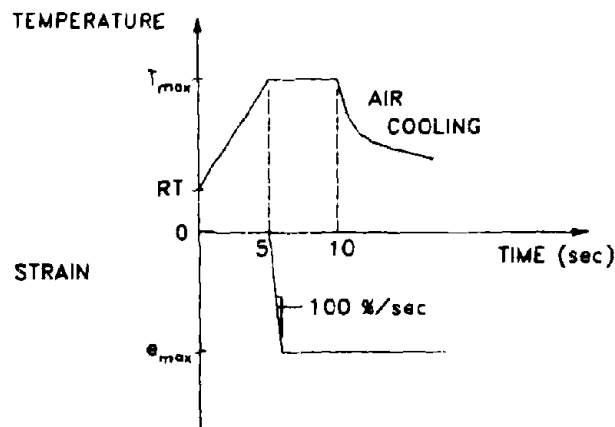
Figure 14. Specification for Gleeble Tests.

Specimens from the new wheel were subjected to combined high temperature and rapid plastic compression, followed by air cooling, in a Gleeble testing machine at the Oregon Graduate Institute of Science & Technology [10]. Figure 14 illustrates the schematic temperature-strain-time profile, which was designed to approximate the outer rim environment. The rapid heating rate and air cooling were chosen to simulate temperature-

time histories in the range expected for outer rim material subjected to stop-braking. One cycle of large plastic strain was imposed to approximate the effects of wheel/rail contact on the hot outer rim region. (Repeated strain cycling was not an available testing option.)
