REPORT NO. FRA/TTC-80/02

CONCRETE AND WOOD TIE TRACK PERFORMANCE THROUGH 150 MILLION GROSS TONS

TRANSPORTATION TEST CENTER
PUEBLO, COLORADO 81001

INTERIM REPORT

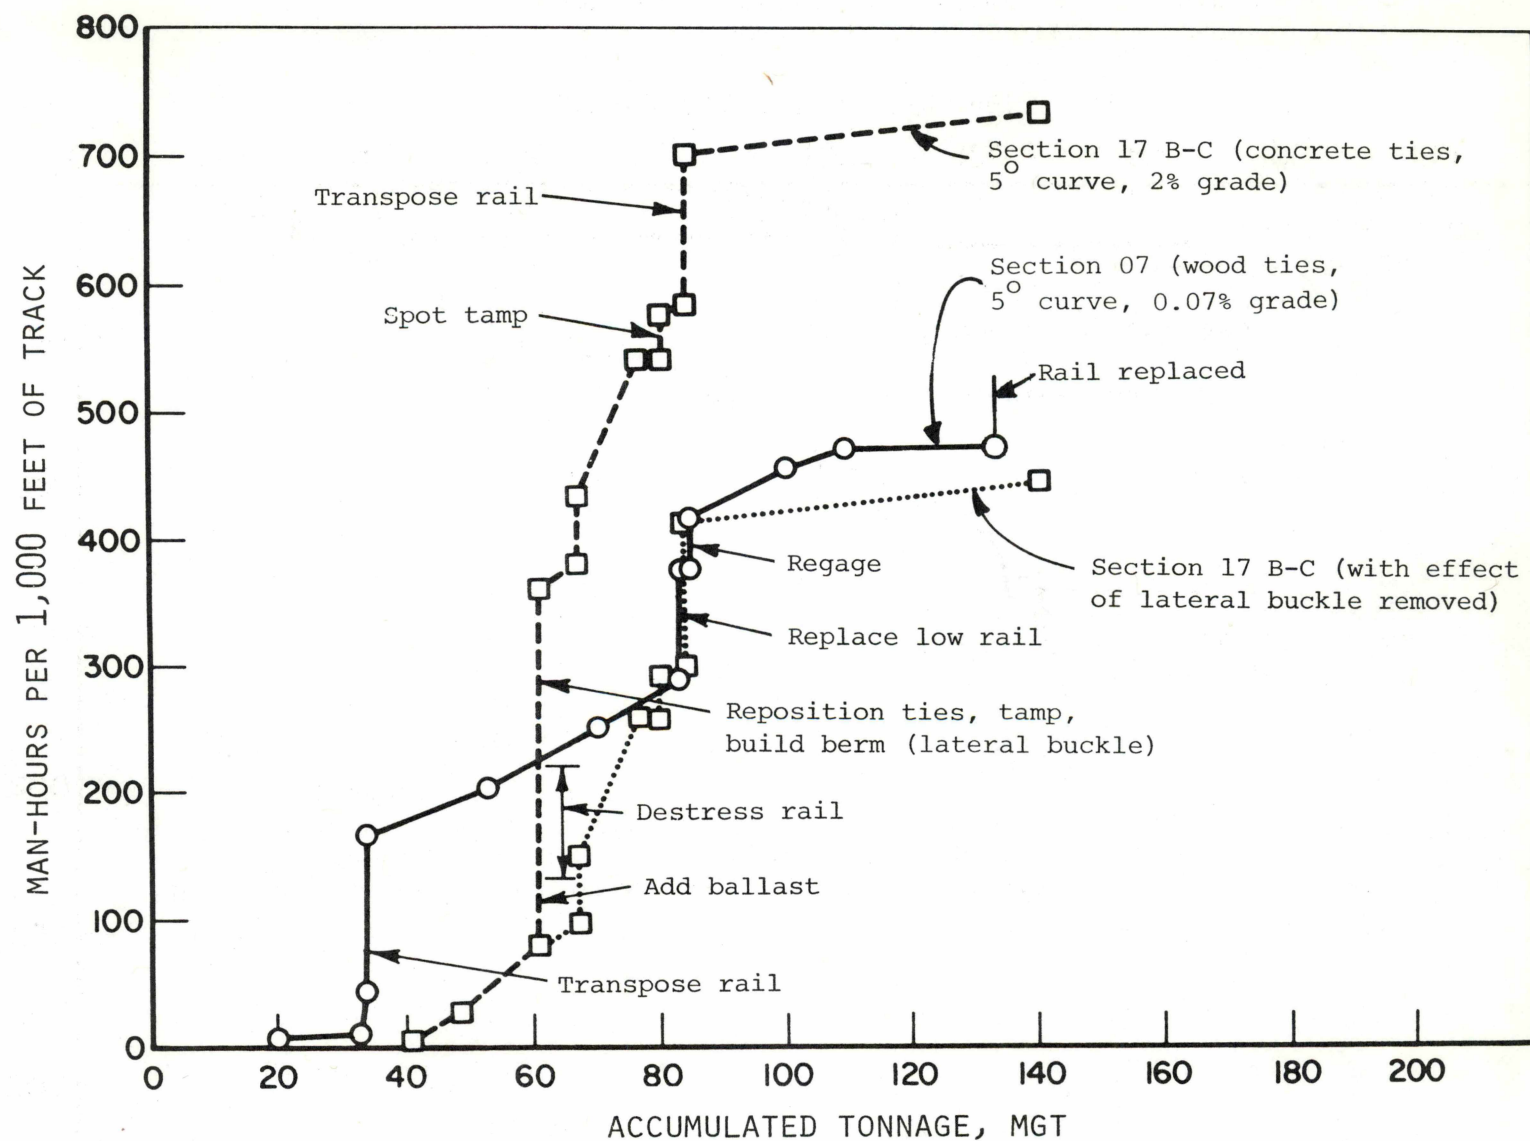
FIGURE 4-1. MAINTENANCE MAN-HOURS PER 1,000 FEET OF TRACK ON 5° CURVES OF CONCRETE AND WOOD TIE TRACK.

- a. Frequent tamping to correct ballast flow and geometry degradation in the period from 48 to 102 MGT,

- b. Track restoration (including the addition of a berm) after a lateral buckle at 61 MGT,
- c. Rail transposition at 84 MGT,
- d. Replacement of large numbers of rail fastener clips because of fatigue failures and fallouts, generally after 100 MGT (40 MGT service), and
- e. Rail grinding to correct corrugations.

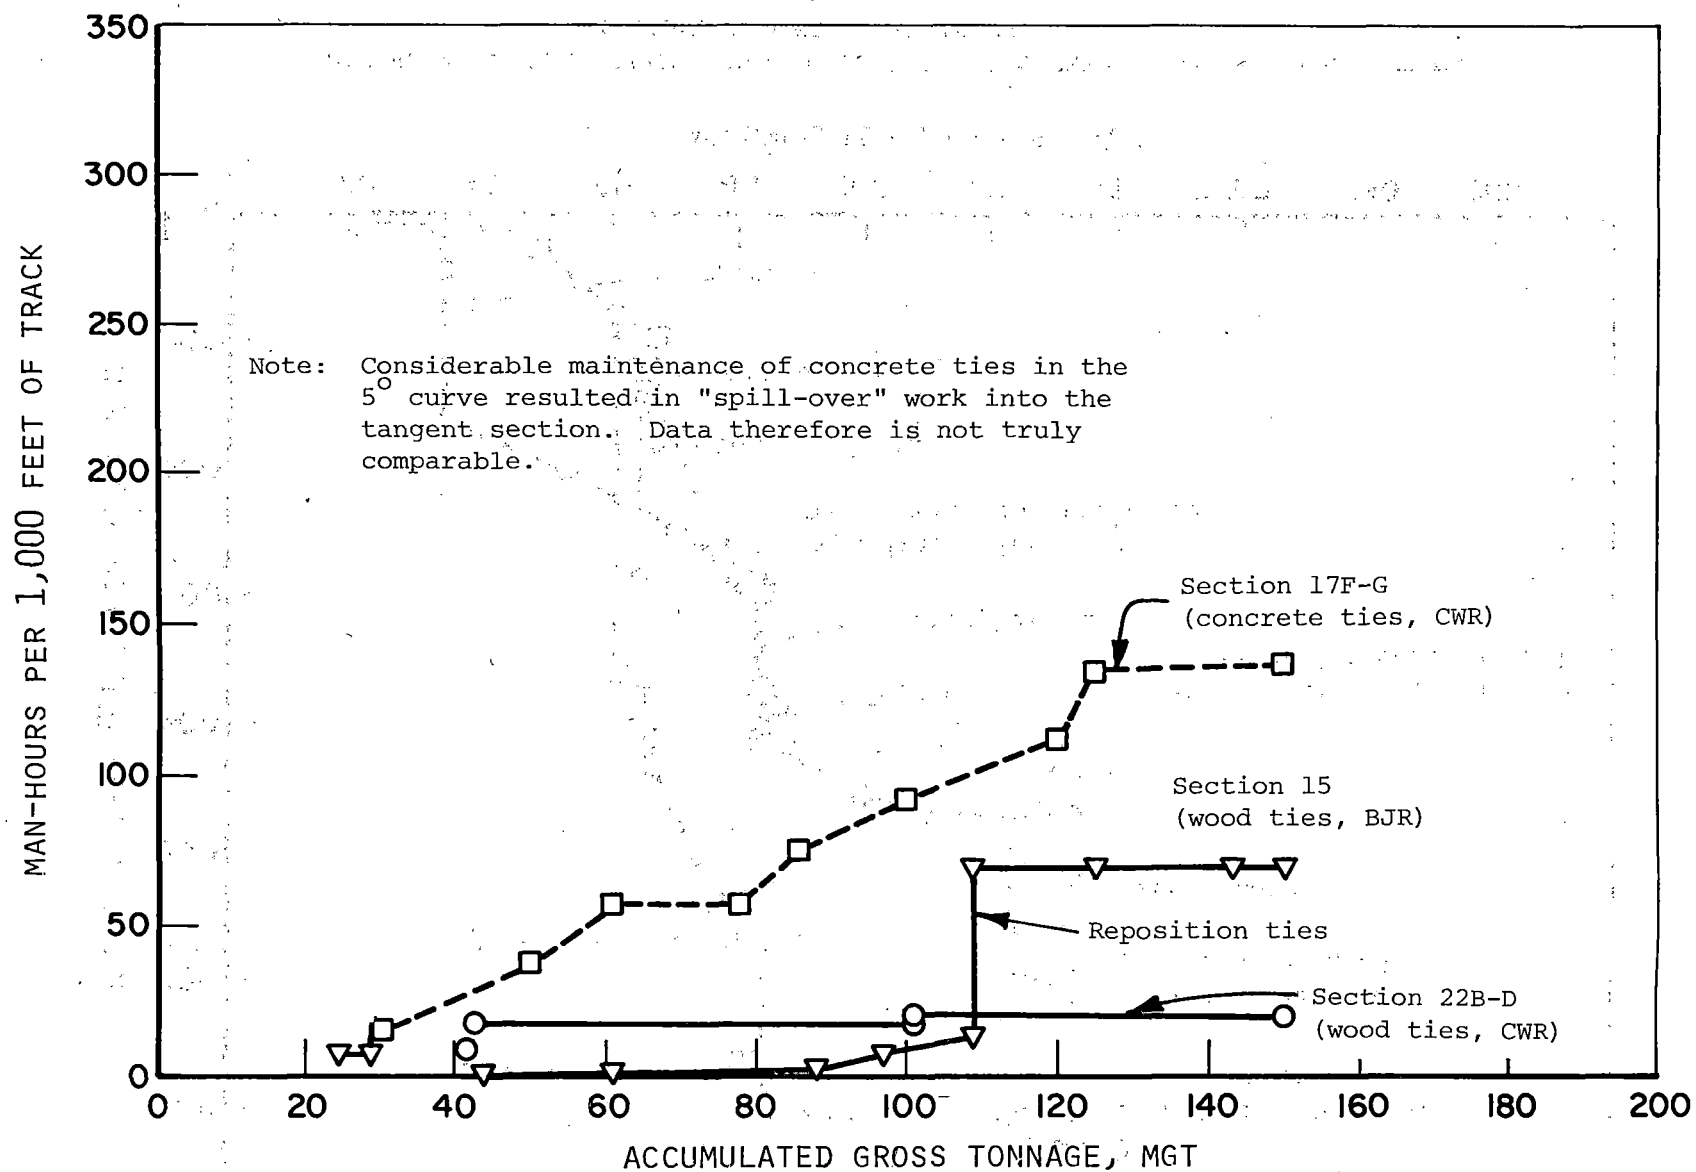
FIGURE 4-2. MAINTENANCE MAN-HOURS PER 1,000 FEET OF TRACK ON TANGENT SECTIONS OF CONCRETE AND WOOD TIE TRACK.

The concrete tie tangent segment received considerable ballast maintenance (shoulder reshaping, surface/line/tamping, and tamping only), which was mainly spillover of maintenance from work begun in the 5° curve. Other major items included the retightening of bolted fasteners and one rail plug was required at a defective weld.

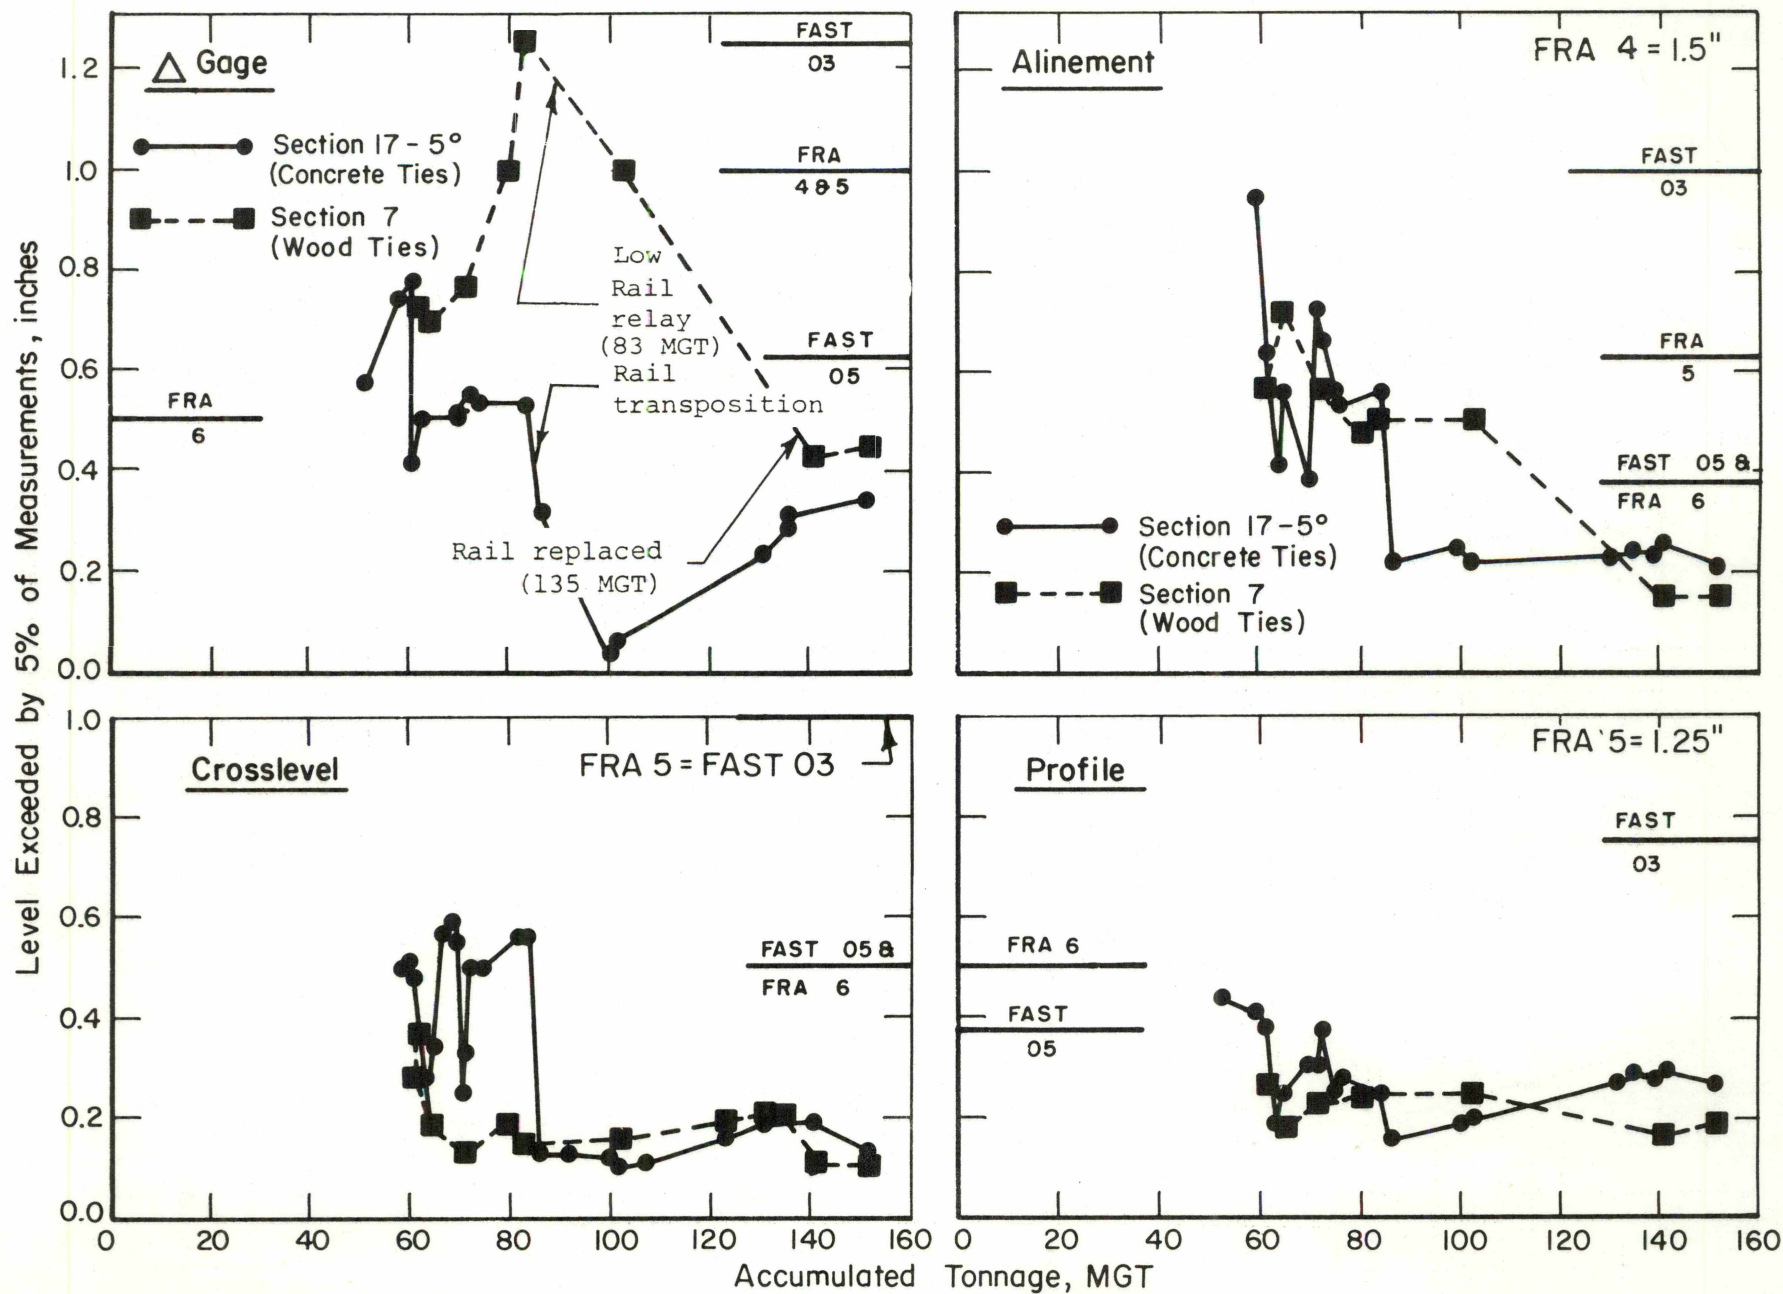
FIGURE 4-3. TRACK GEOMETRY ERRORS vs MGT ON 5° CURVES OF CONCRETE AND WOOD TIE TRACK.

In terms of crosslevel, alinement, and profile, track geometry was approximately equivalent for comparable sections of concrete and wood tie track. One exception was the very high rate of gage widening in the wood tie Section 07 caused by rail wear and failure of some types of fasteners. The initial wide gage and inadequate rail lubrication were contributing factors to the gage widening problem. Frequent regaging and rail transposition eventually resulted in the spike-killing of the ties.

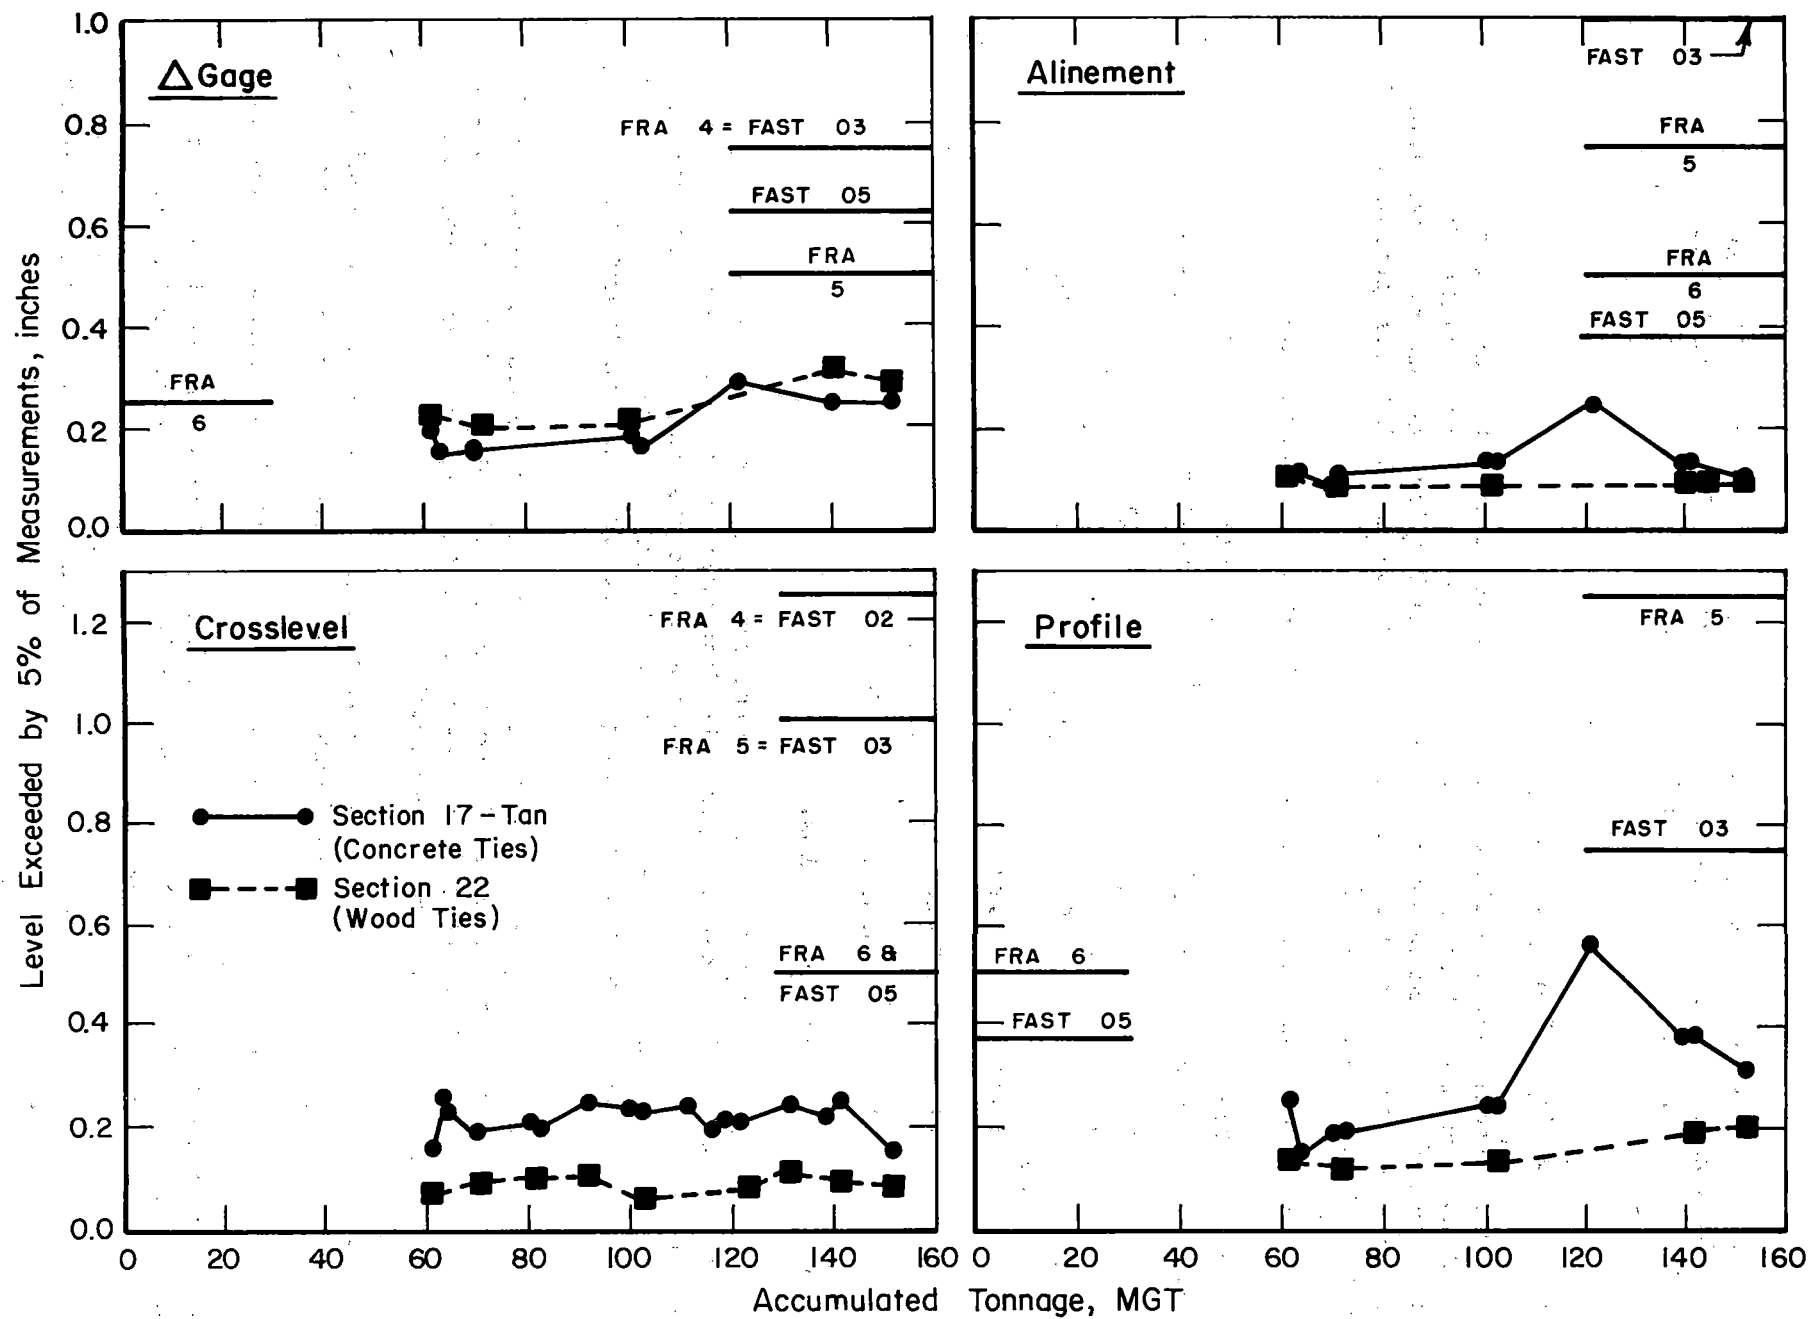
FIGURE 4-4. TRACK GEOMETRY ERRORS ON TANGENT SECTIONS OF CONCRETE AND WOOD TIE TRACK.

In summary, track geometry retention of the concrete and wood tie track was approximately equal through 150 MGT except for the high rate of gage widening in the wood tie, Section 07 track.

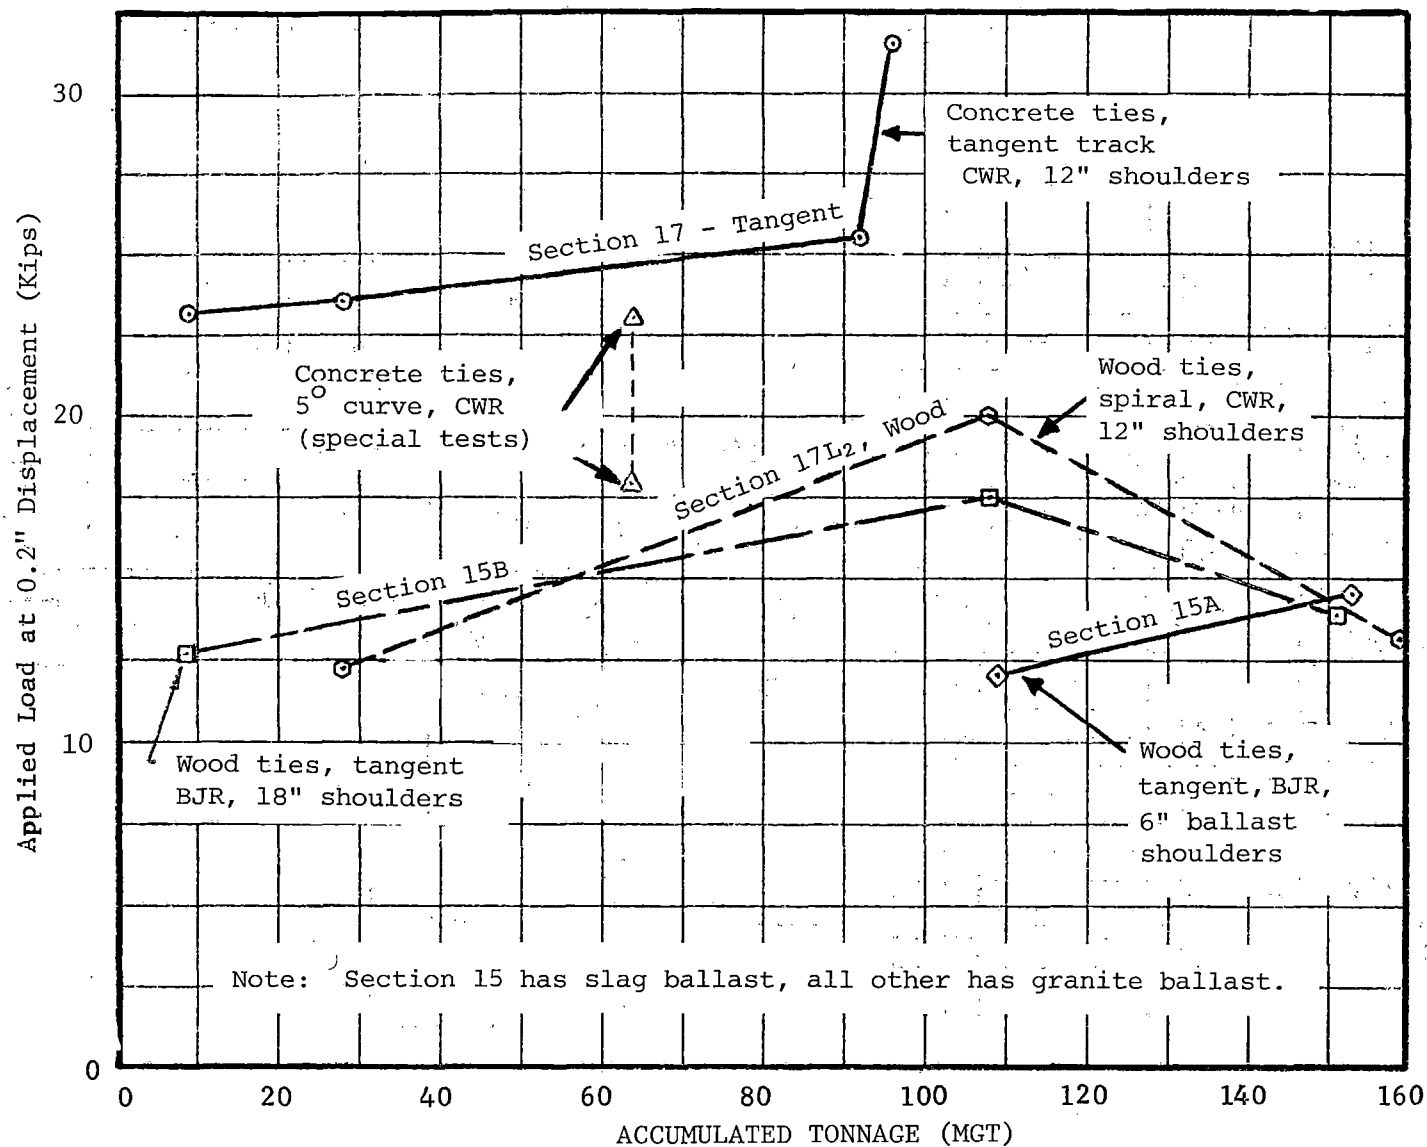
FIGURE 4-6. APPLIED LATERAL LOAD AT 0.2" DISPLACEMENT FROM HORIZONTAL TRACK STIFFNESS TESTS FOR SECTIONS OF CONCRETE AND WOOD TIE TRACK.

To compare performance in the different test segments vs. MGT, the load developed at 0.2" of centerpoint rail displacement is shown for each test in figure 4-6. A general increase in load at about the same rate occurs for both concrete and wood tie track up to about 100 MGT. Approximately 50% higher lateral resistance loads were developed on the concrete tie track than on the wood tie track.

Also shown on figure 4-6 are the results of two tests conducted on the same day at the same site in the concrete tie 5° curve. These were special tests conducted after the lateral track buckle that occurred at 61 MGT and are the only tests conducted on curved track.

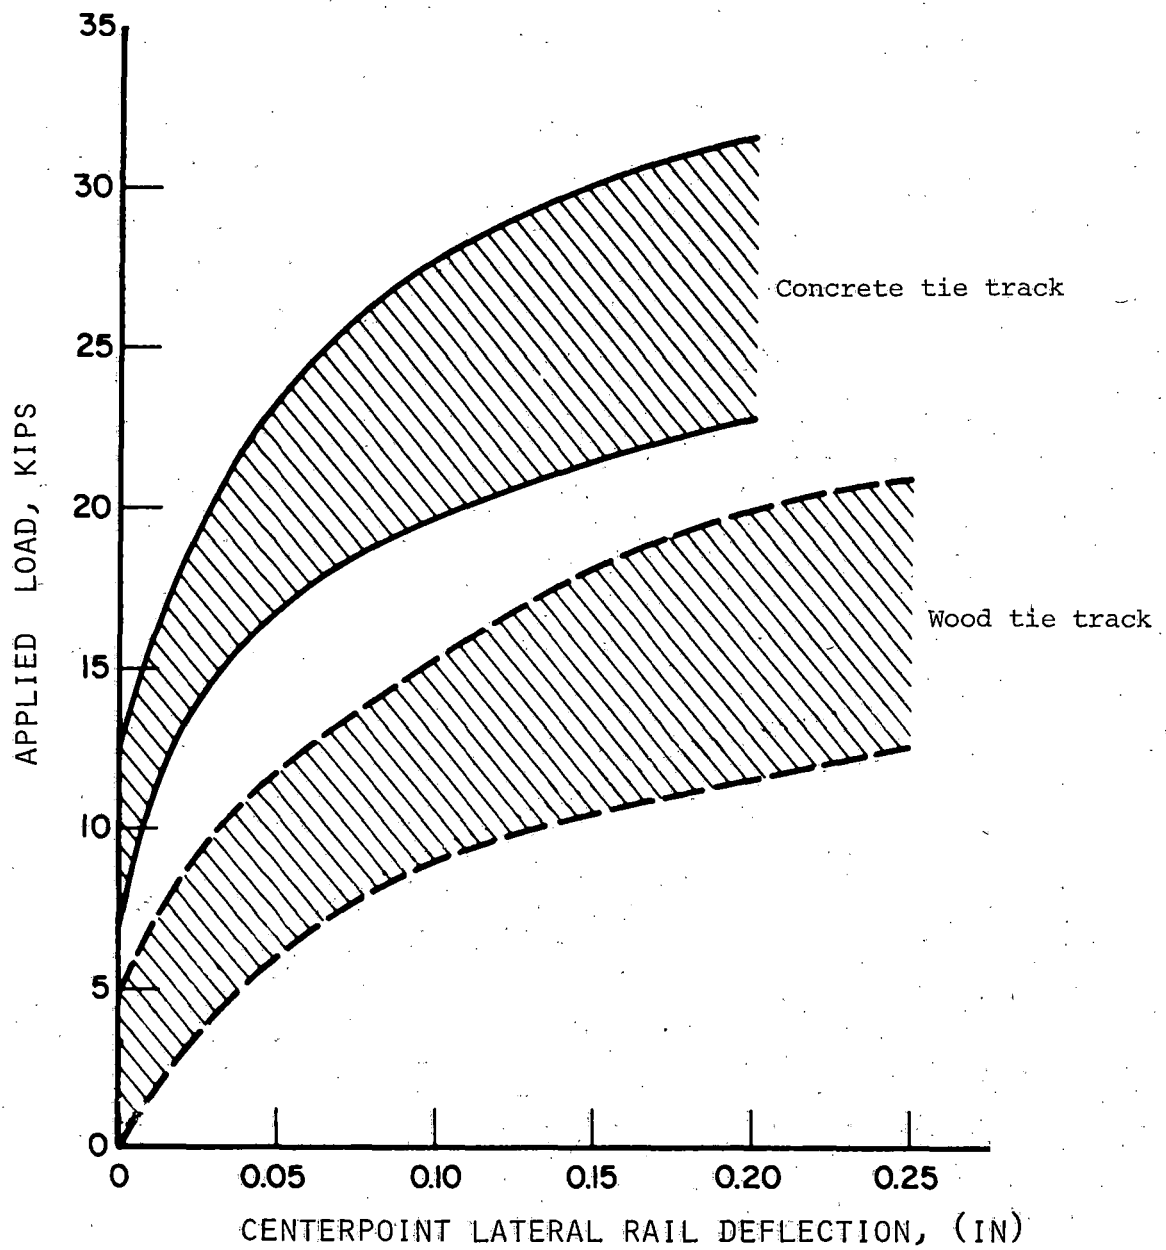
FIGURE 4-7.. ENVELOPES AND CURVES OF CENTERPOINT LATERAL RAIL DEFLECTION vs. APPLIED LATERAL LOAD FOR SECTIONS OF CONCRETE AND WOOD TIE TRACK, 0-150 MGT.

The two envelopes shown in figure 4-7 differ in these important respects:

- a. Concrete tie track shows higher initial stiffness than wood tie track as evidenced by higher initial breakout loads (loads at zero displacement) and higher slips in the small deflection range, and
- b. Concrete tie track shows consistently higher maximum lateral resistance loads than wood tie track.

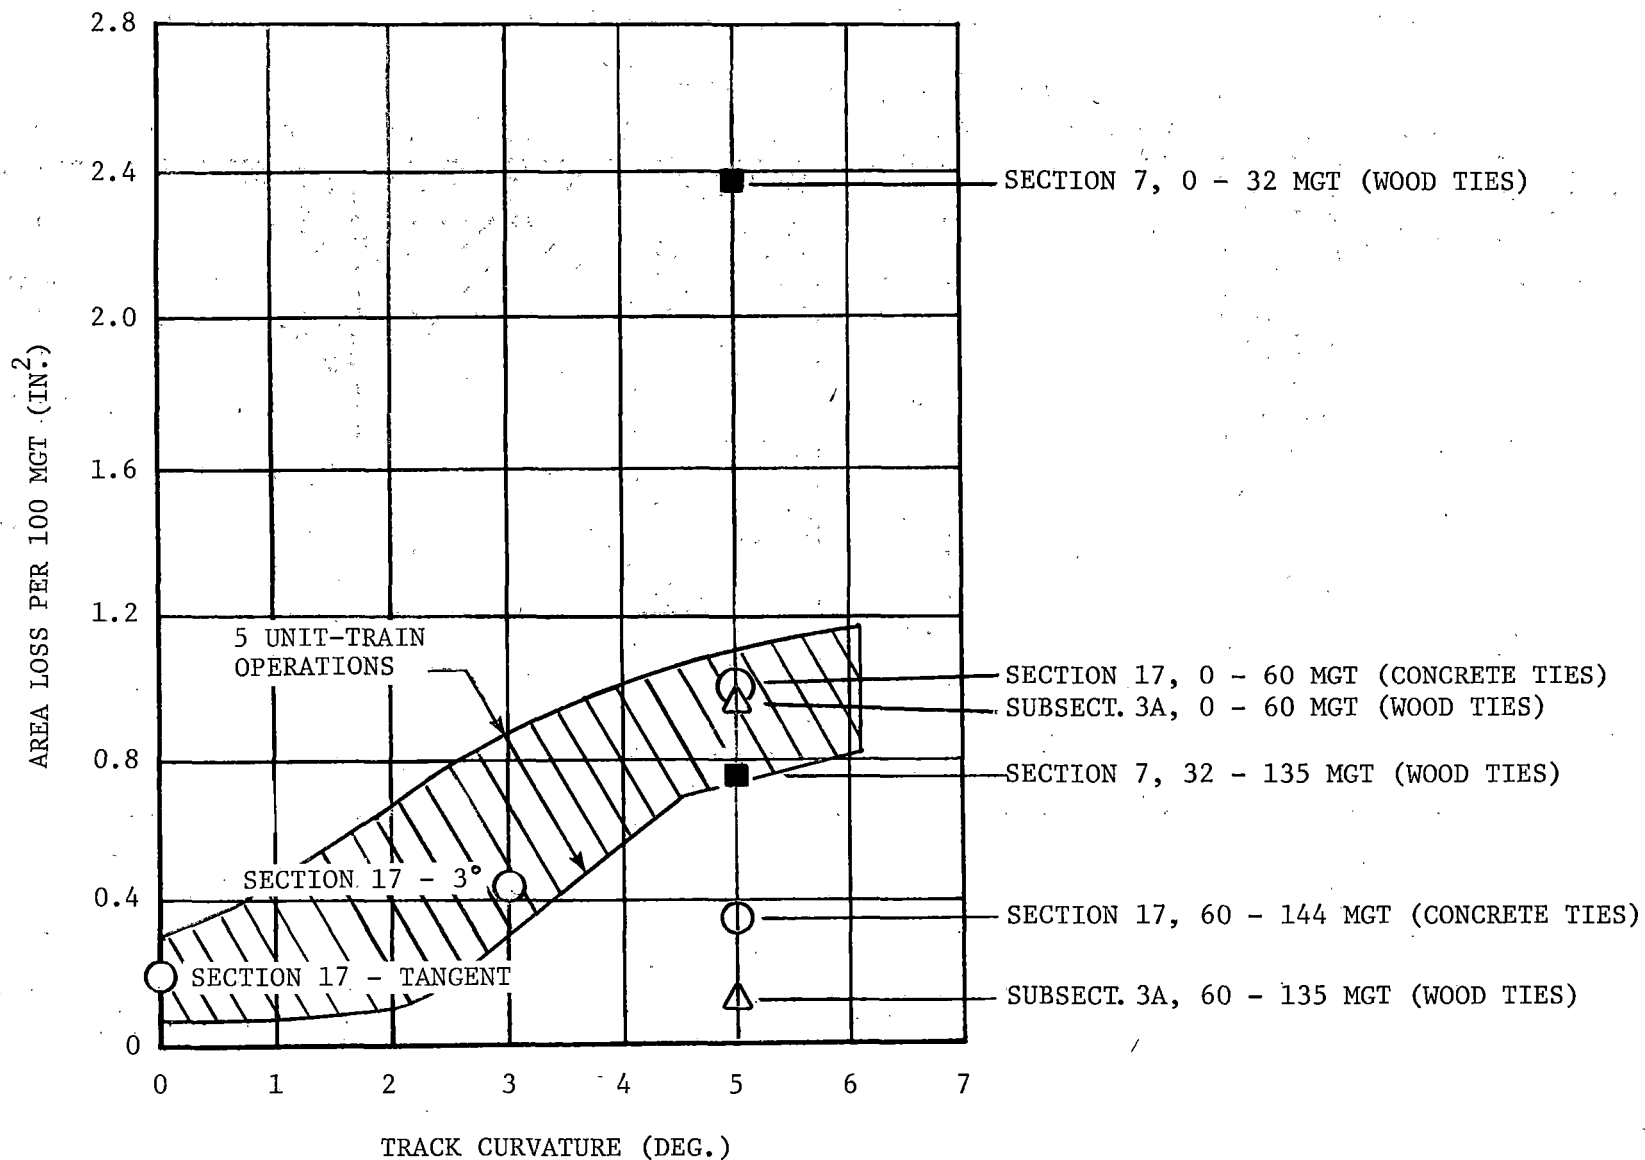
FIGURE 4-10. RAIL HEAD AREA LOSS PER 100 MGT VS. CURVATURE FOR SEVERAL SEGMENTS OF CONCRETE AND WOOD TIE TRACK.

In figure 4-10, average rates of wear from the FAST test segments are compared with those of five-unit train operations in Australia, Canada, Brazil, and the U.S.⁴⁻³ Wear rate is expressed as area loss per 100 MGT. By far the greatest wear rate occurred in Section 07 to 32 MGT, at which time the rail was transposed. All sections experienced much more wear during the early phase of operations than in later periods. Initial FAST operations with all new rail and new wheel profiles probably produced atypical wheel/rail contact geometry that caused unusually high wear rates when combined with little or no rail lubrication.

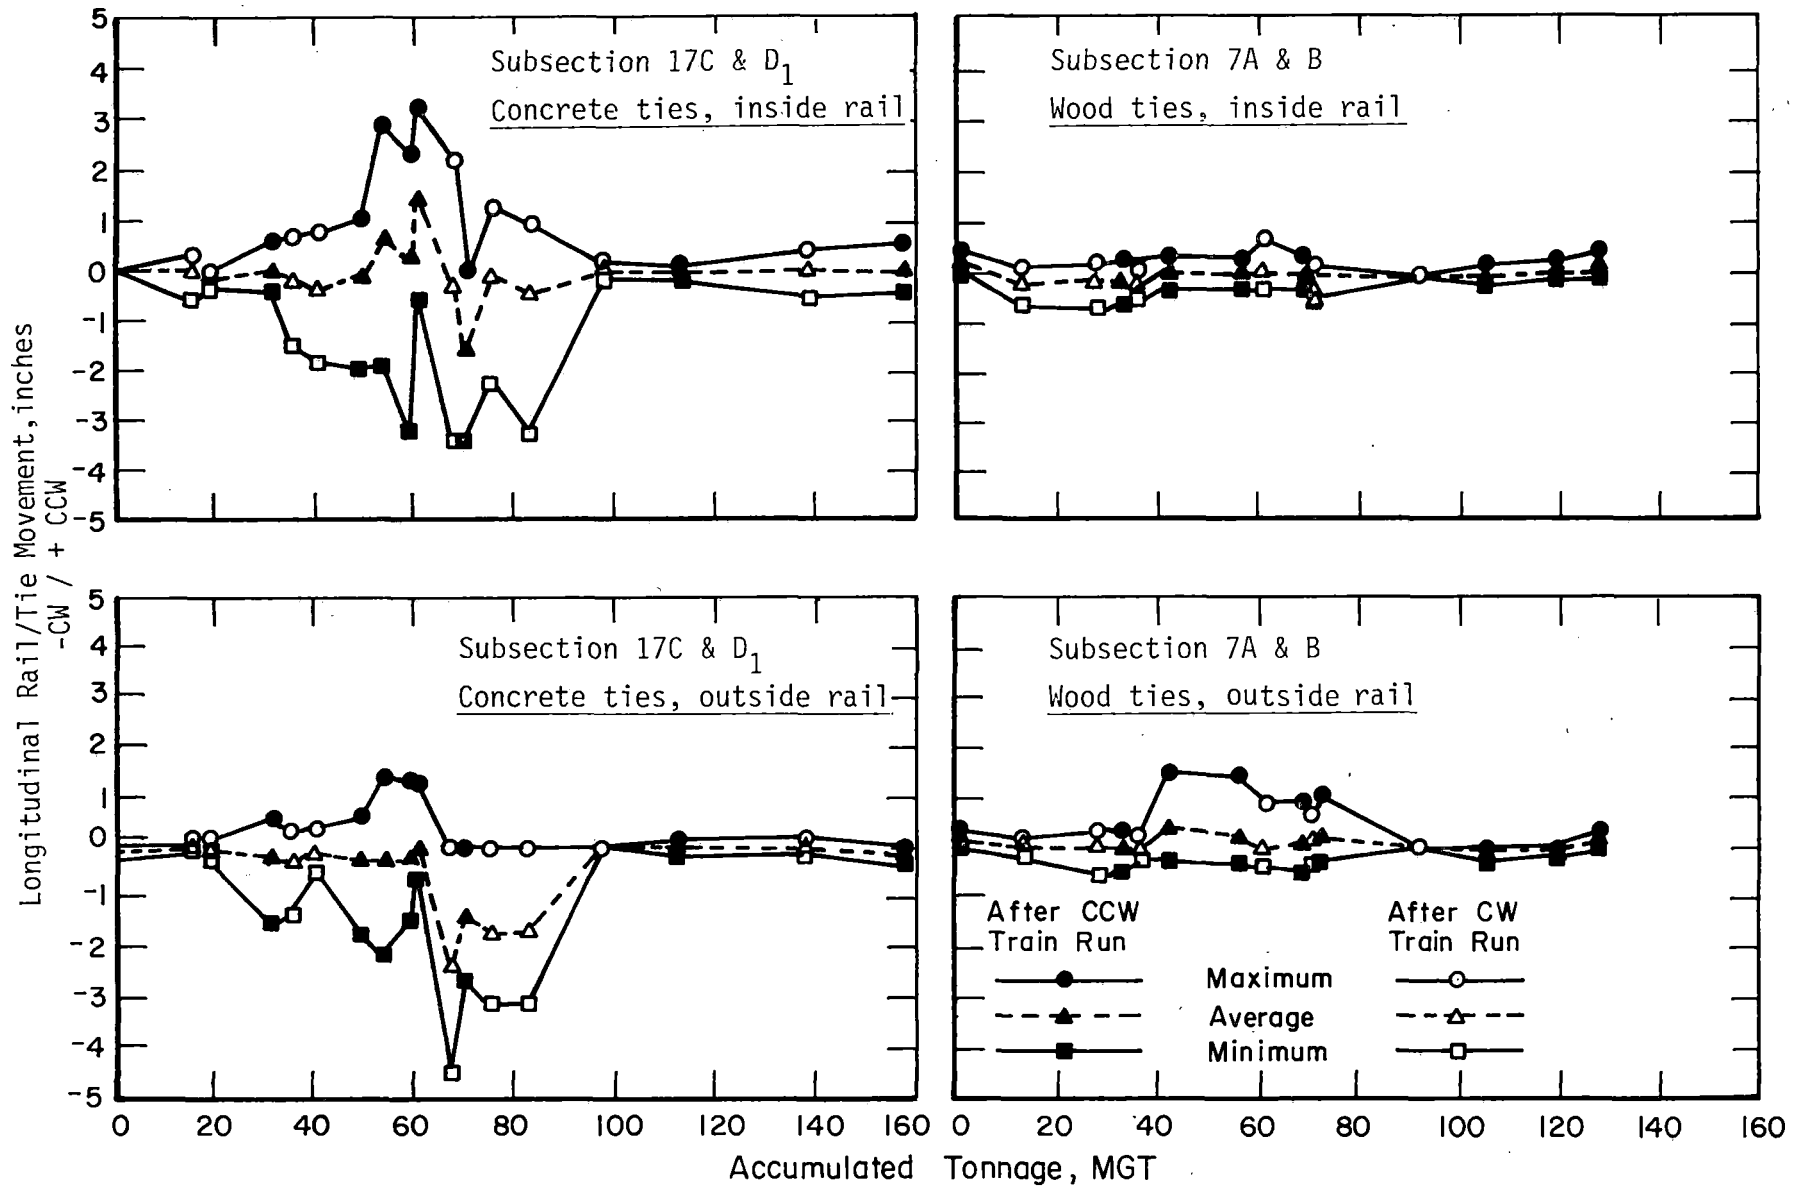
FIGURE 4-12. RAIL CREEP ON 5° CURVE SEGMENTS OF CONCRETE AND WOOD TIE TRACK.

- a. Creep in subsections 17C and 17D was substantial between 20 and 80 MGT, a period that also included frequent repetitions of maintenance affecting ballast compaction (as will be shown later),
- b. Section 17 creep reached a peak during the track buckle at 61 MGT,
- c. Substantial stabilization took place in Section 17 during a period of about 20 MGT after the track buckle,
- d. In Section 17 the creep markings were "rezeroed" following the rail transposition at 84 MGT; no significant rail creep was found from then to 150 MGT, and
- e. Rail creep was not substantial in either the tangent section of concrete tie track or the tangent or curved sections of wood tie track.

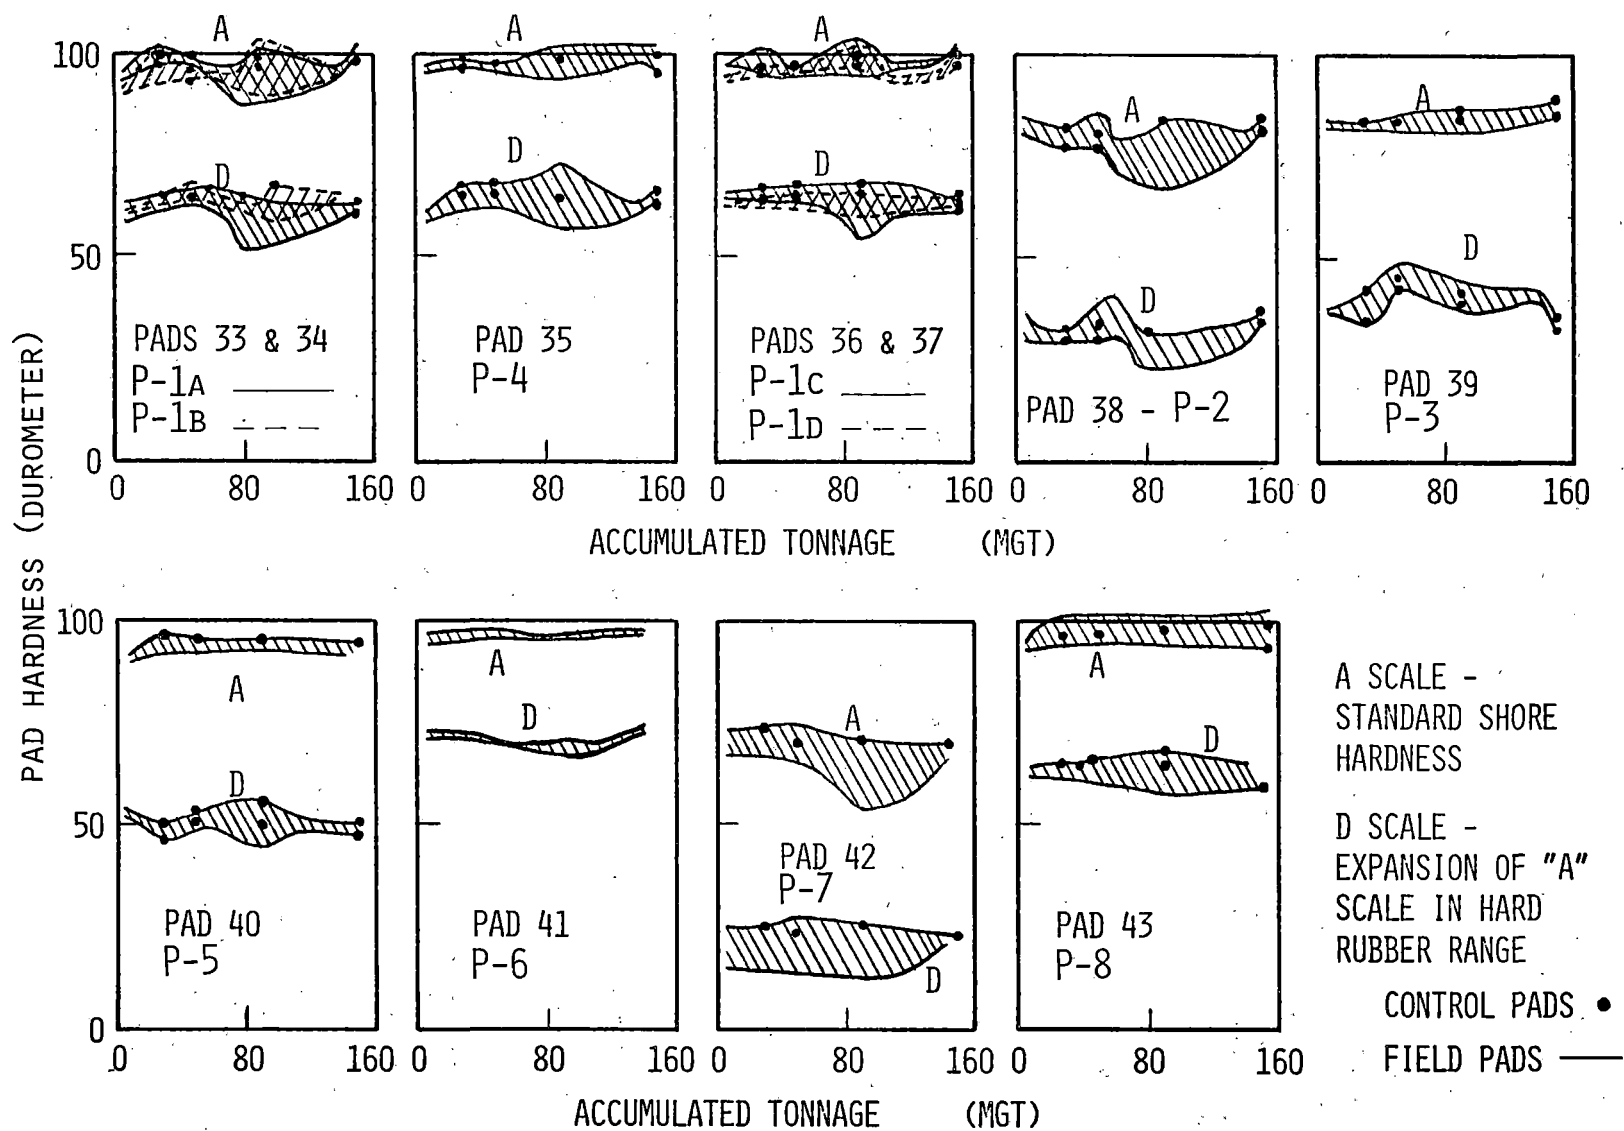
FIGURE 5-7. SUMMARY OF PAD HARDNESS MEASUREMENTS.

The softness of the P-2 pad probably contributed to the concentration of rail fastener clip failures in the 5° curve.

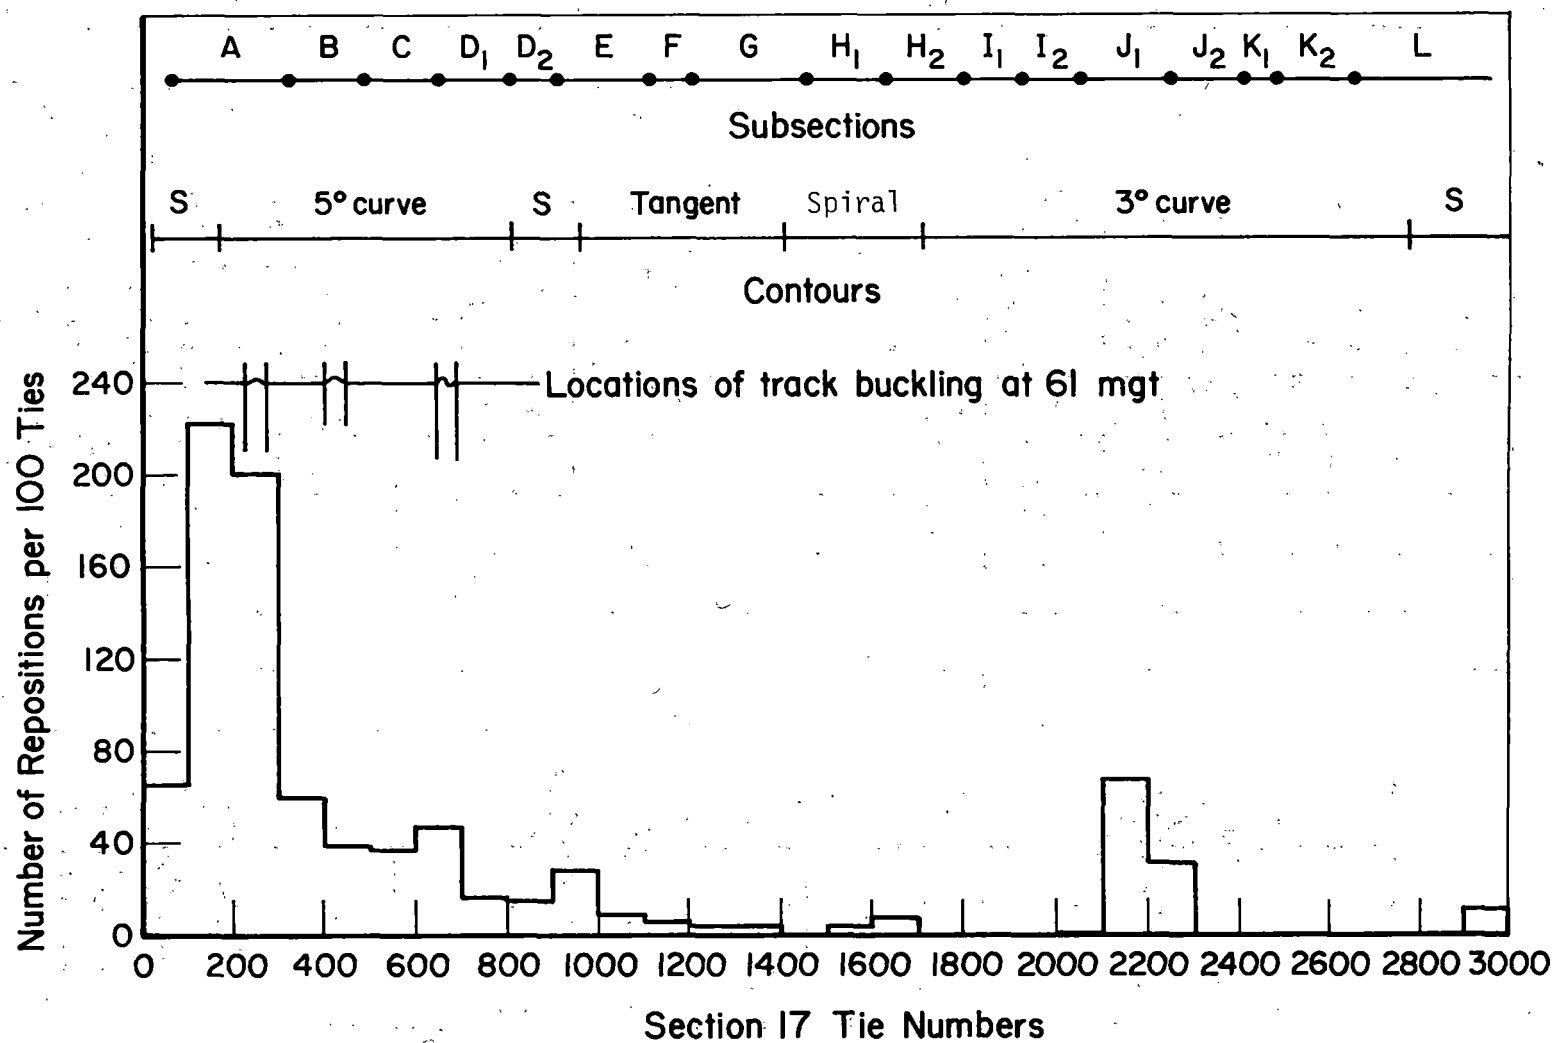
FIGURE 5-9. SUMMARY OF TIE REPOSITIONING IN SECTION 17, 0-150 MGT.

The problem of tie movement at the start of the curve is verified by figure 5-9, which summarizes tie repositioning activity over Section 17. Tie repositioning was required when longitudinal spacing varied from the standard 24" by more than 6", or if the skew (relative longitudinal position of the two ends of the tie) exceeded 6".

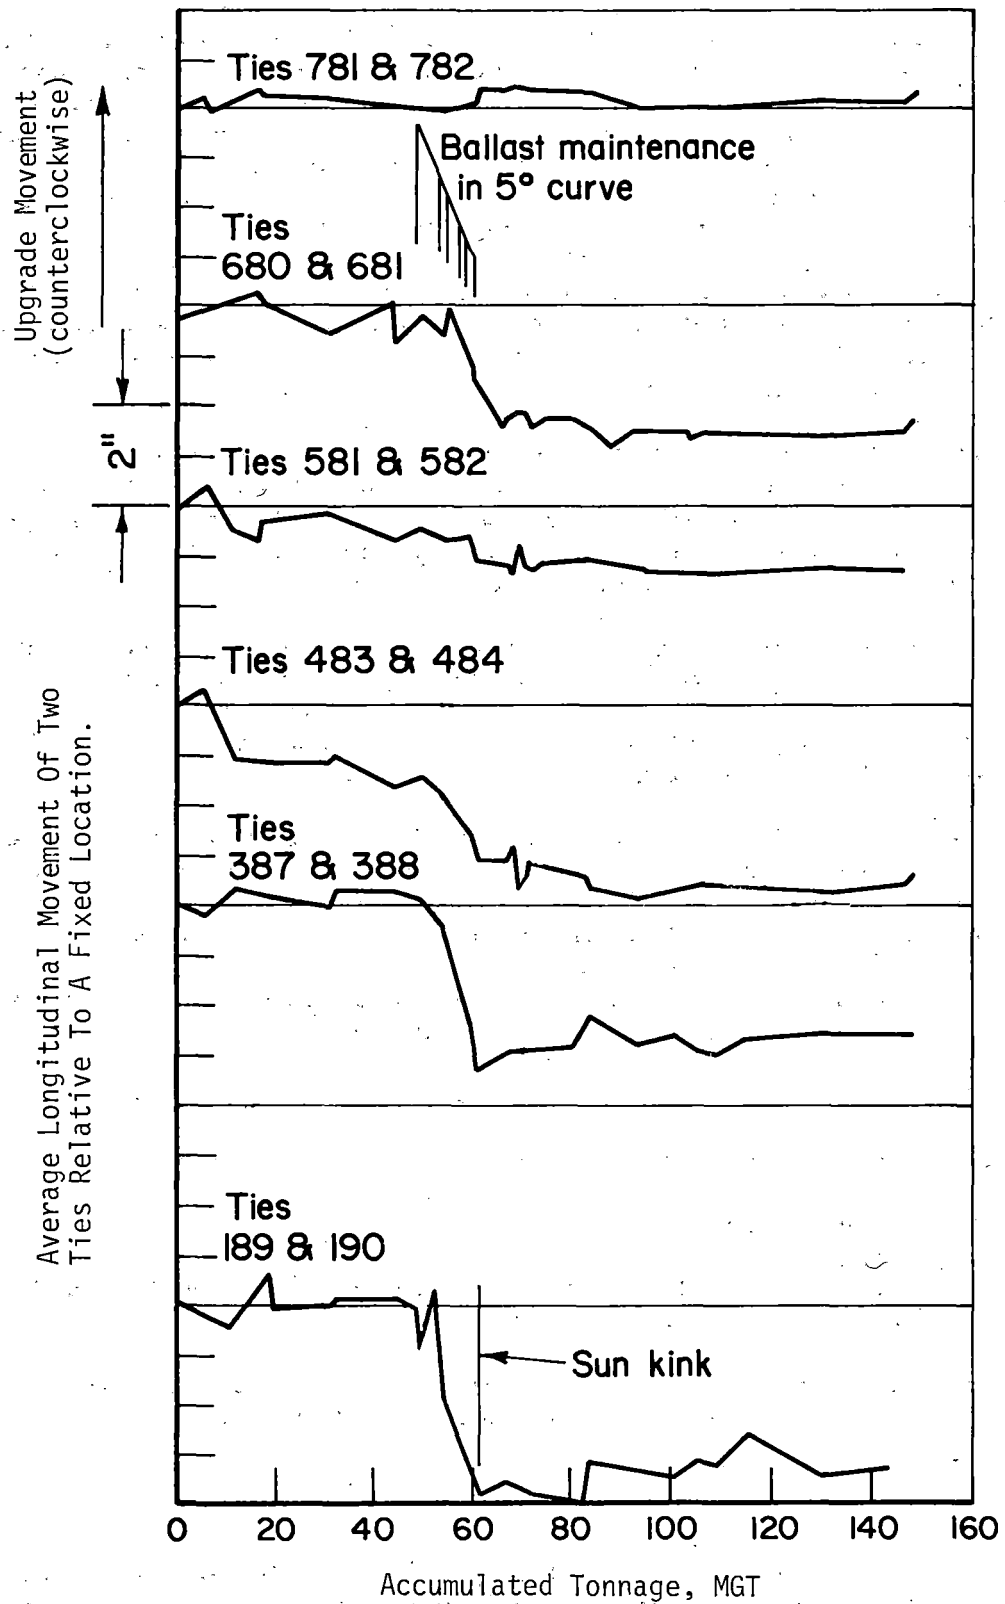
FIGURE 5-10. AVERAGE LONGITUDINAL TIE MOVEMENT VS. MGT FOR SPECIFIC SITES IN THE 5° CURVE, 2% GRADE OF SECTION 17.

In figure 5-10, average longitudinal movements of two ties at a number of measurement sites in the curve and grade are plotted versus MGT. The plot shows that rapid downhill movement of the ties began at about 54 MGT and culminated in the lateral instability at 61 MGT. This evidence of tie movement shows the need for good ballast compaction and for fasteners of sufficient holding capacity in track contours comparable to the FAST 5° curve, 2% grade.
