REPORT NO. FRA/TTC-80/02

CONCRETE AND WOOD TIE TRACK PERFORMANCE THROUGH 150 MILLION GROSS TONS

TRANSPORTATION TEST CENTER
PUEBLO, COLORADO 81001

INTERIM REPORT

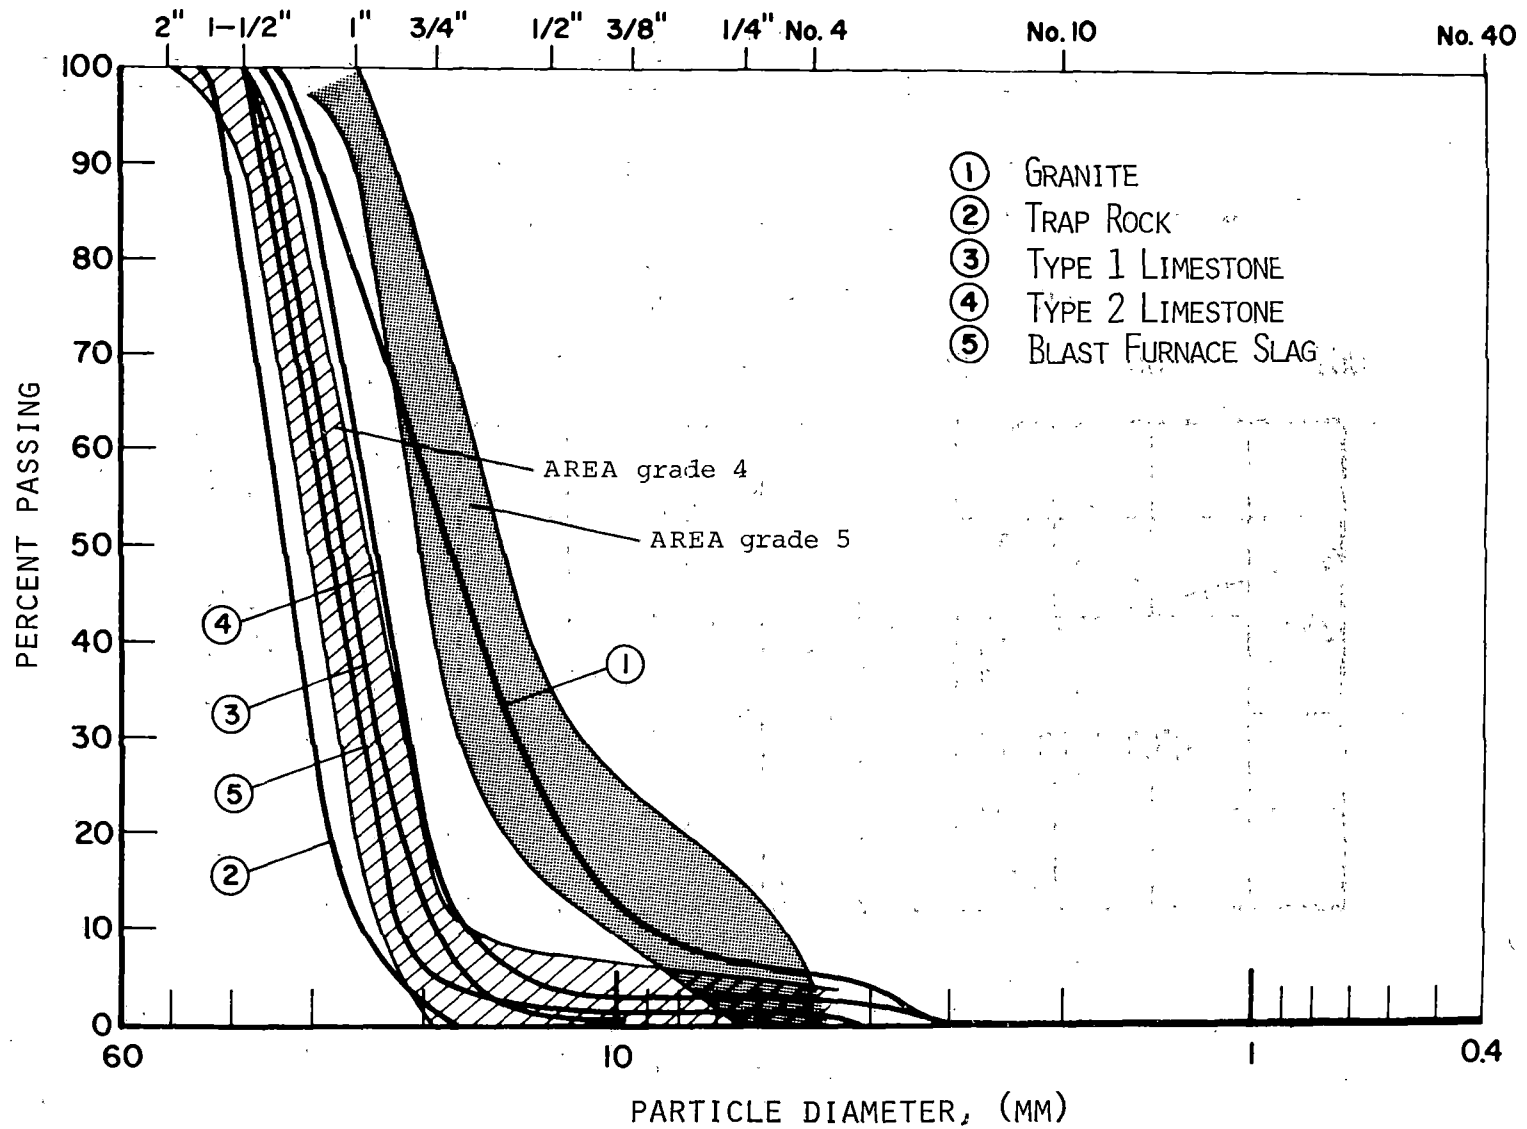
FIGURE 5-11. ORIGINAL PARTICLE SIZE DISTRIBUTION OF FAST BALLAST MATERIALS.

Ballast size is shown in figure 5-11, which compares particle size distributions from samples of new ballast taken from the five batches used to build the FAST Track. The granite ballast for the entire Section 17 shows a smaller mean particle size and percentage of fines than do the other samples.

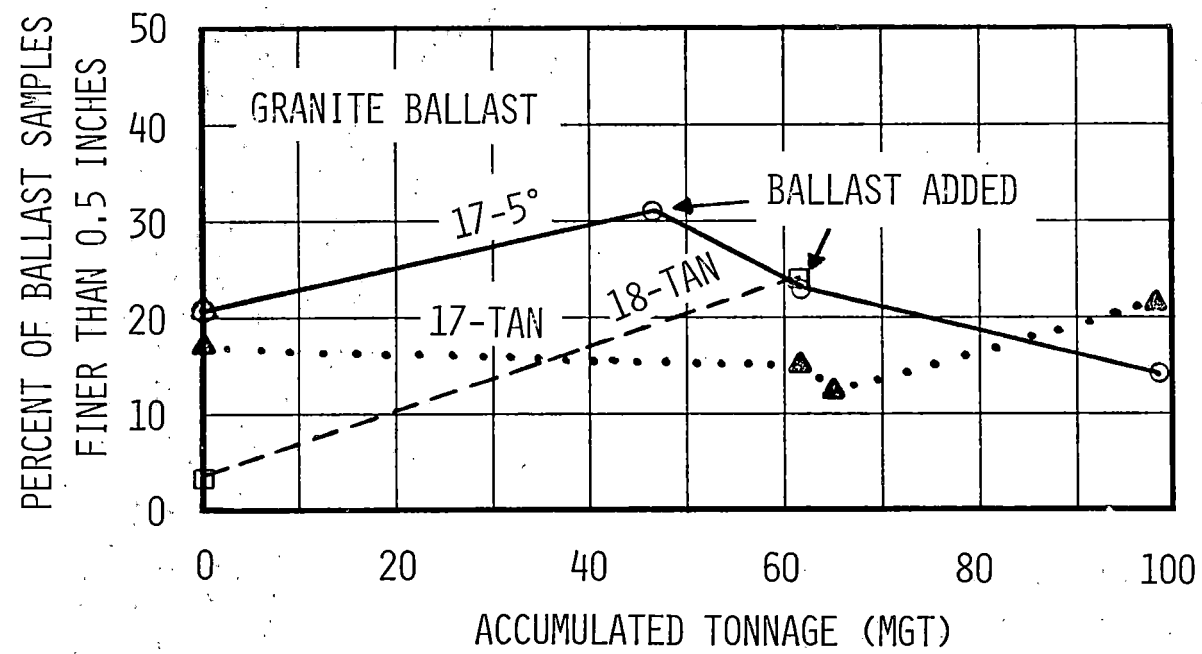
FIGURE 5-12. SUMMARY OF BALLAST GRADATION TESTS.

Figure 5-12 summarizes results from ballast gradation tests on the granite ballast in Sections 17 and 18. The figure shows the percentage of ballast finer than the 1/2" sieve dimension cited as an index of gradation. In two of the three test locations shown, significant increases in this index had taken place between 0 and 46 MGT and before any addition of new ballast. The particle size shown at zero MGT for Section 17 in the 5° curve agrees well with the sample of new ballast of figure 5-11; the change in gradation between 0 and 46 MGT was sufficient to advance the percentage of particles with 1/2" or less diameter across about half of the shaded zone defining Grade 5 ballast.
